Appendix A

Photograph Log

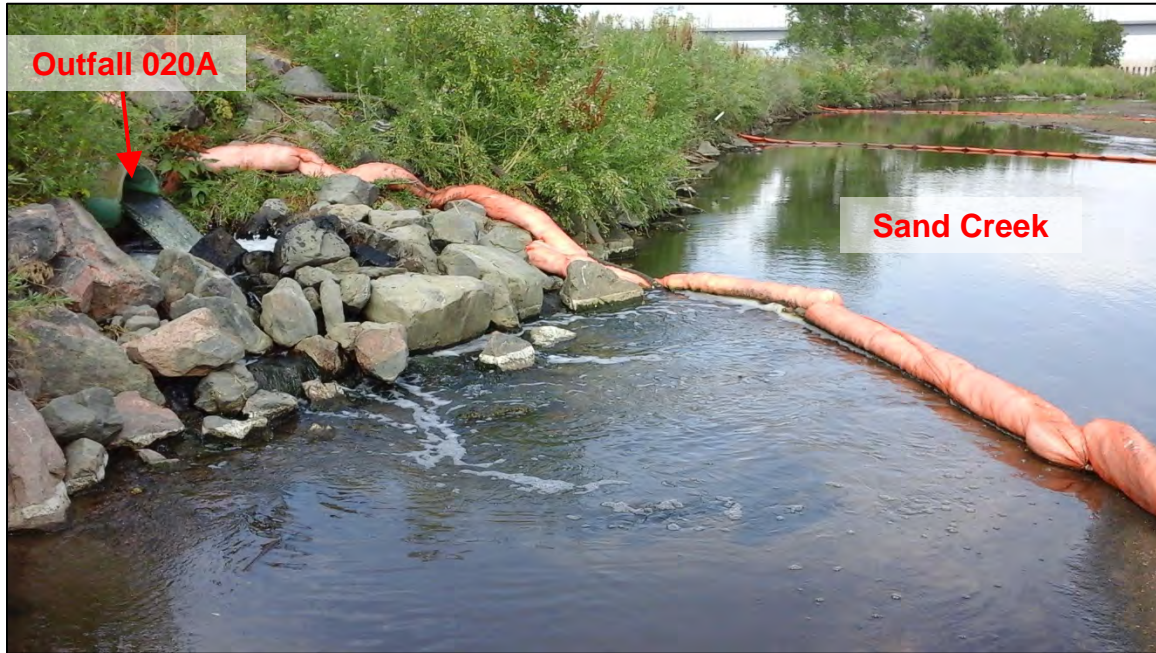
Photograph 1. View of Outfall 020A to Sand Creek.

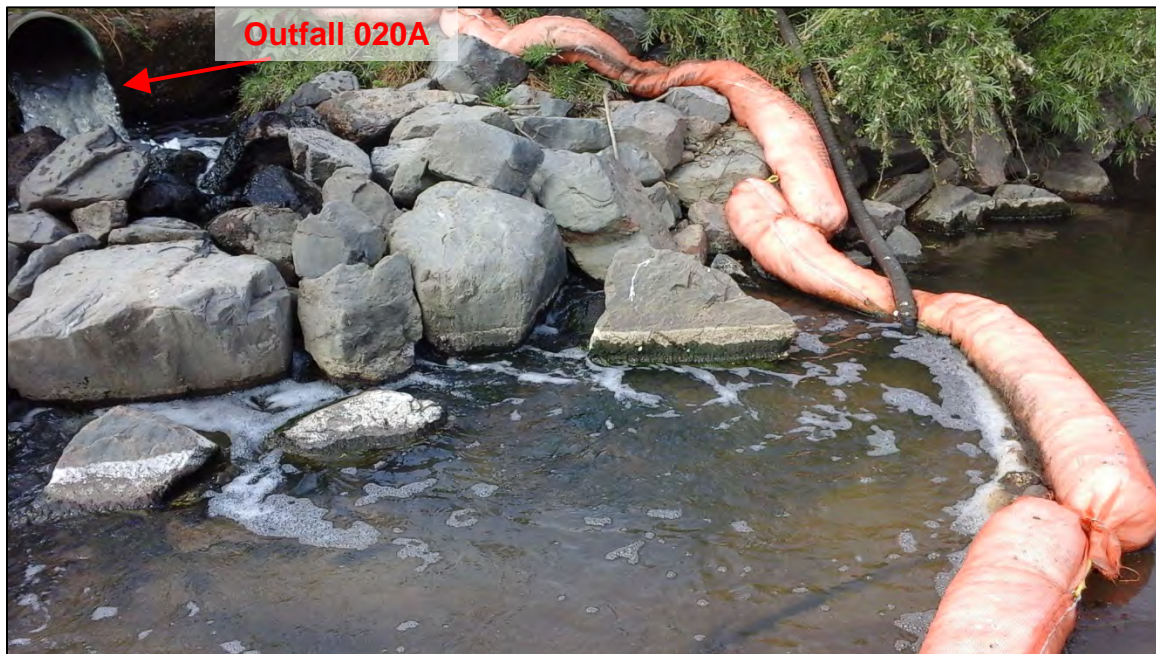
Photograph 2. Additional view of Outfall 020A to Sand Creek.

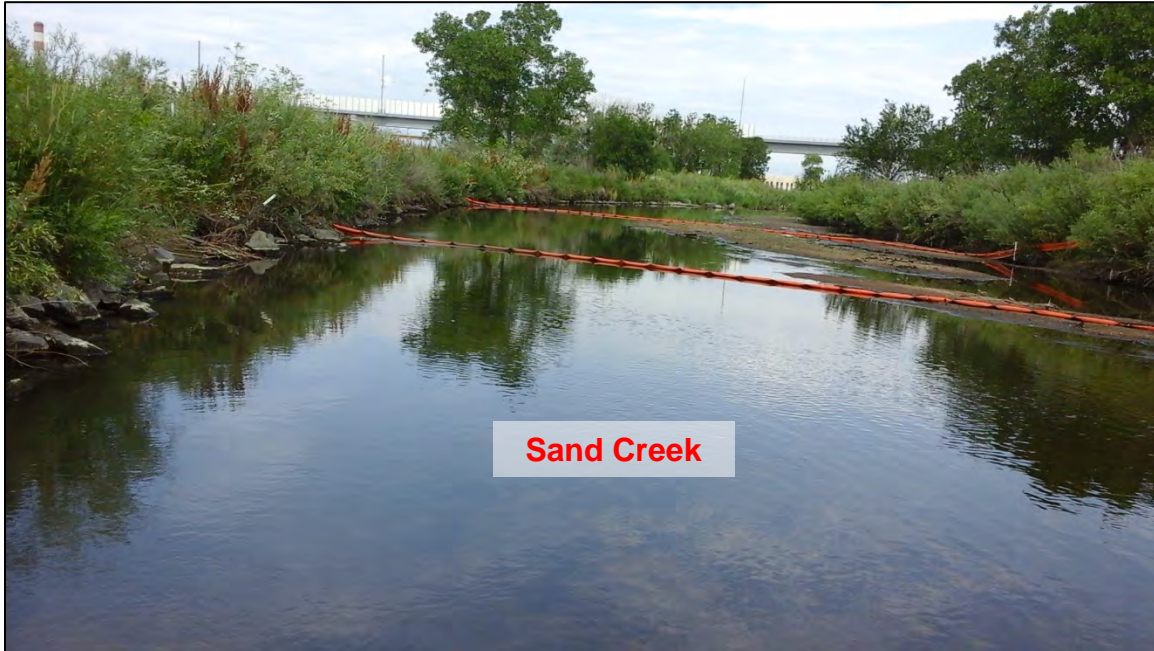
Photograph 3. View of Sand Creek downstream of Outfall 020A. Note the booms installed in the creek by the Permittee.

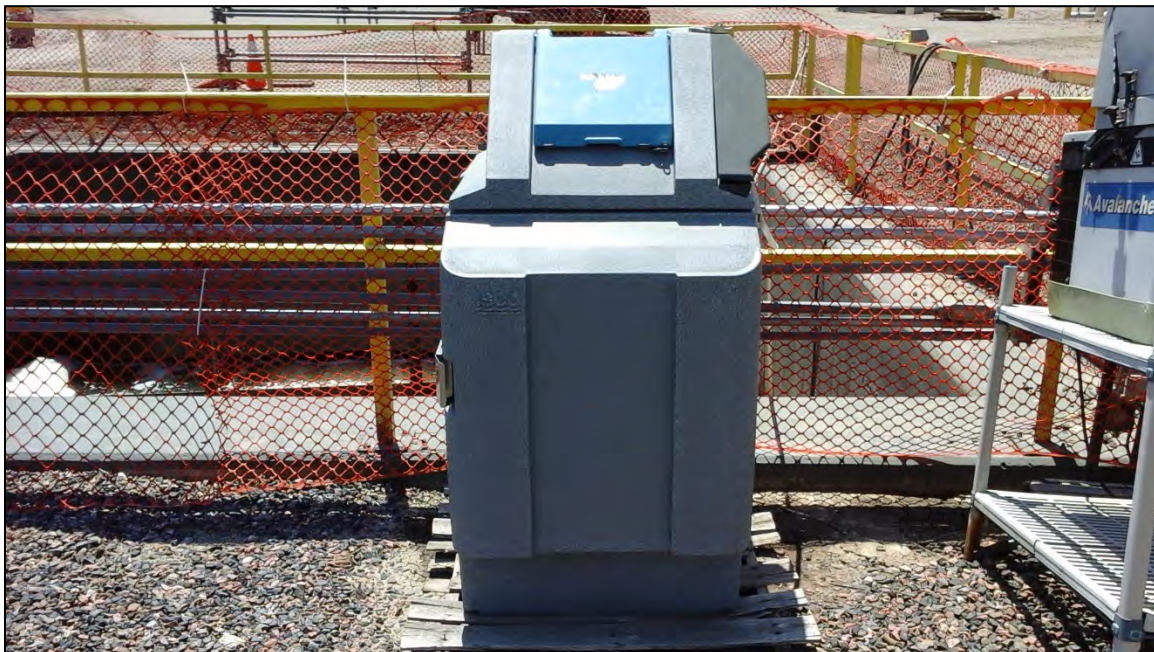
Photograph 4. View of the ISCO 4700 automatic sampler located at the Outfall 020A aerated sampling vault. This sampler was not equipped with an independently calibrated thermometer.

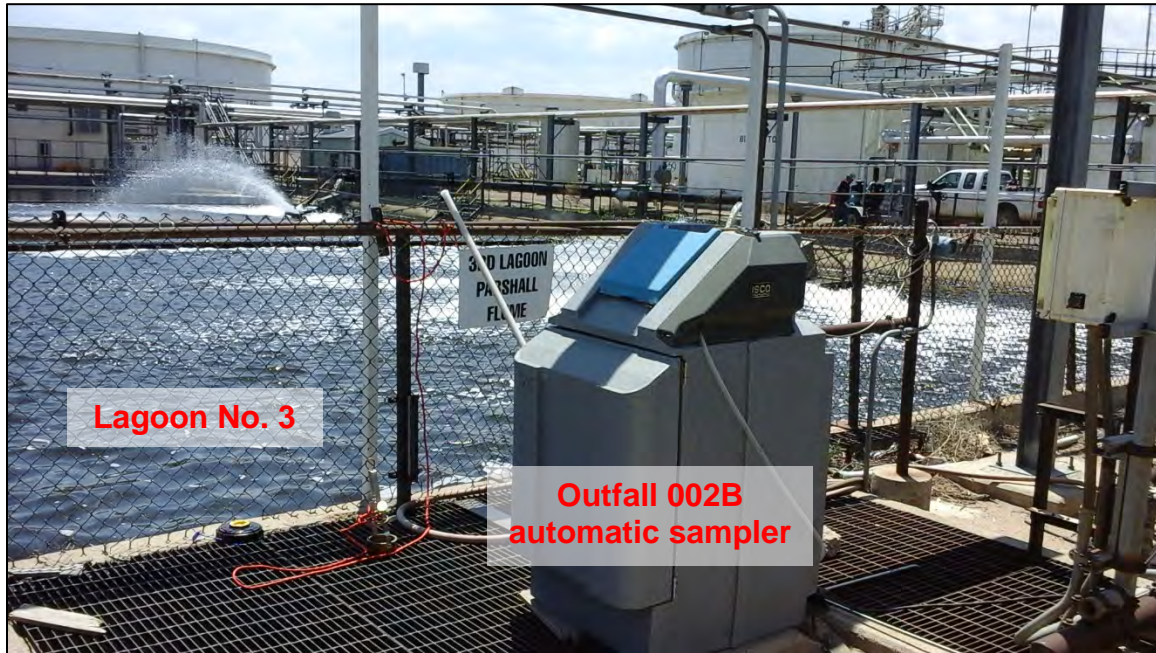
Photograph 5. View of the ISCO 4700 automatic composite sampler at Outfall 002B, downstream of Lagoon No. 3. This sampler was not equipped with an independently calibrated thermometer.

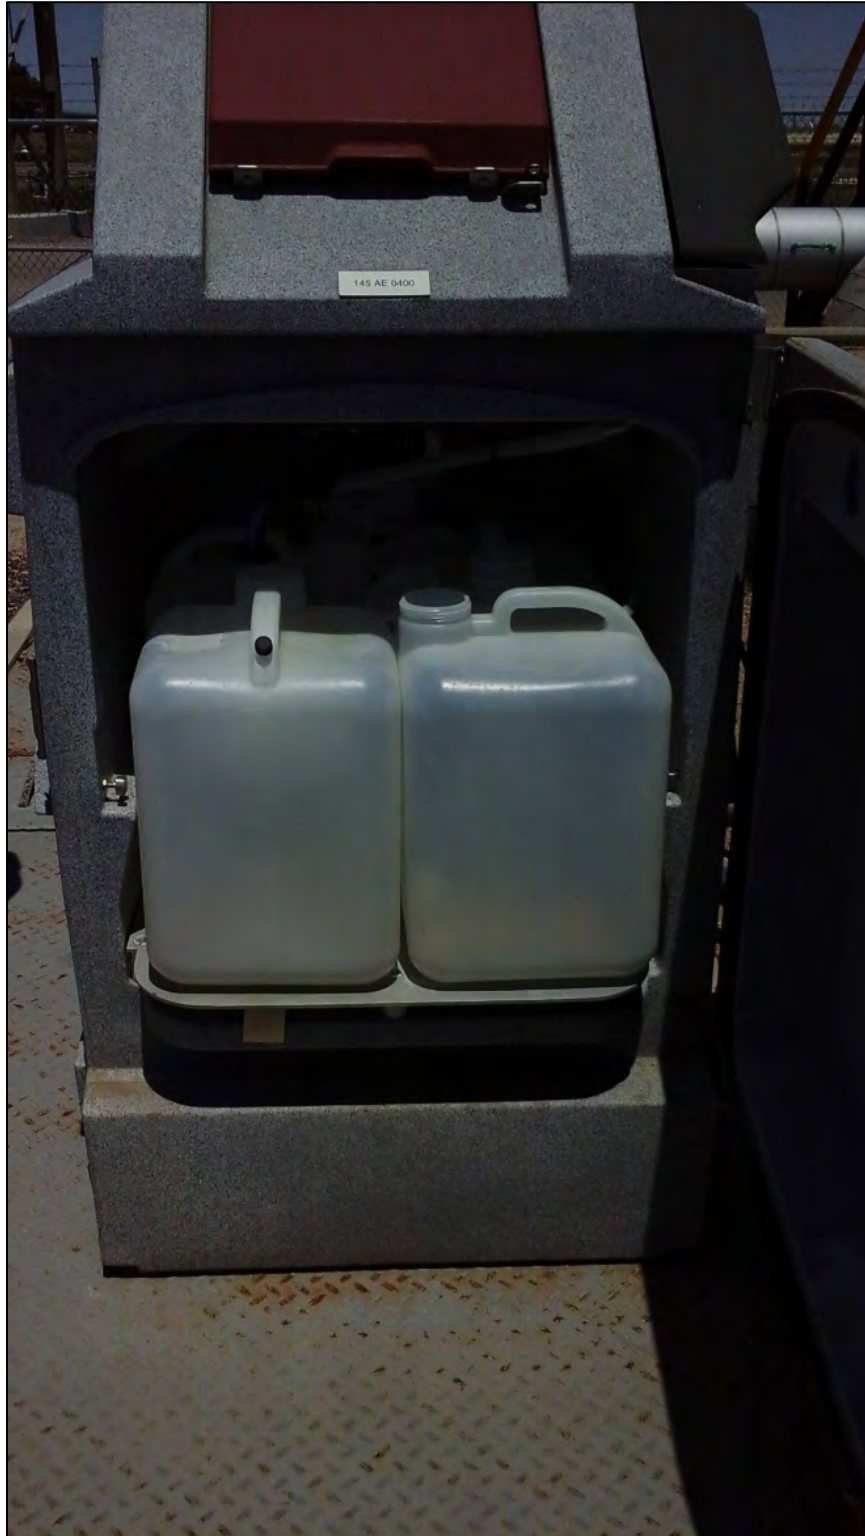
Photograph 6. View inside the ISCO automatic composite sampler at Outfall 003B. This sampler was not equipped with an independently calibrated thermometer.

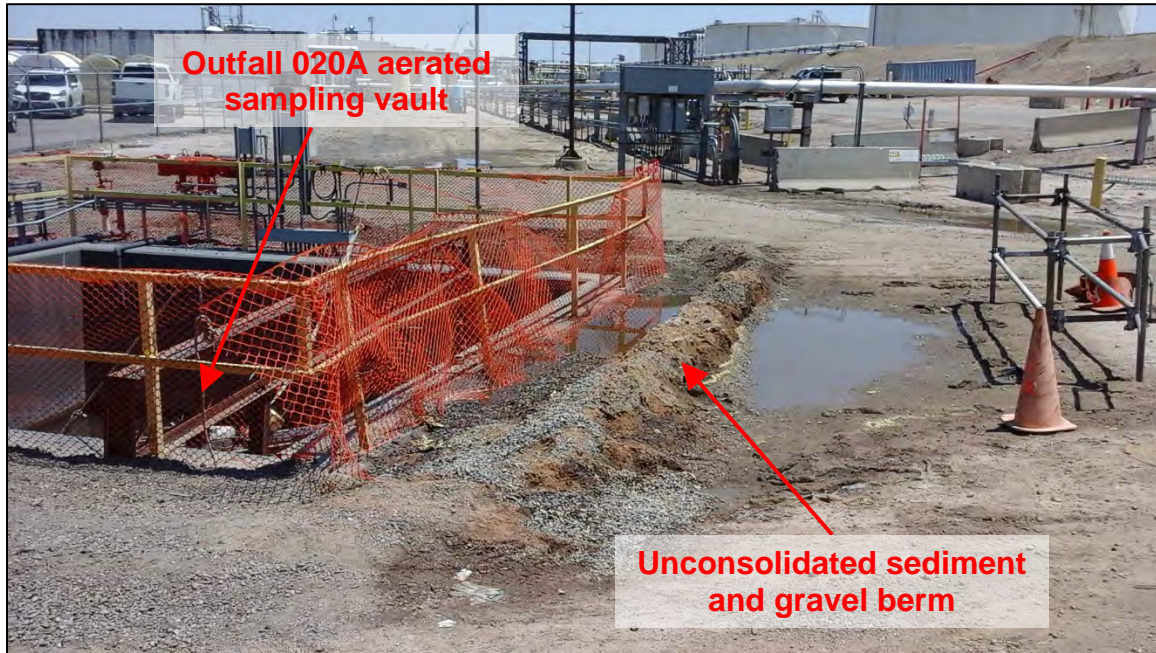
Photograph 7. View, facing east, of an improperly installed (i.e., unconsolidated) sediment and gravel berm located upgradient of the Outfall 020A aerated sampling vault. Note the berm was constructed to prevent contaminated stormwater runoff from Plant 1 from entering the uncovered sampling vault, which had occurred on May 22 and May 31, 2021, resulting in high levels of benzene and BTEX and a visible sheen into Sand Creek. Also note the accumulated stormwater runoff against the berm.

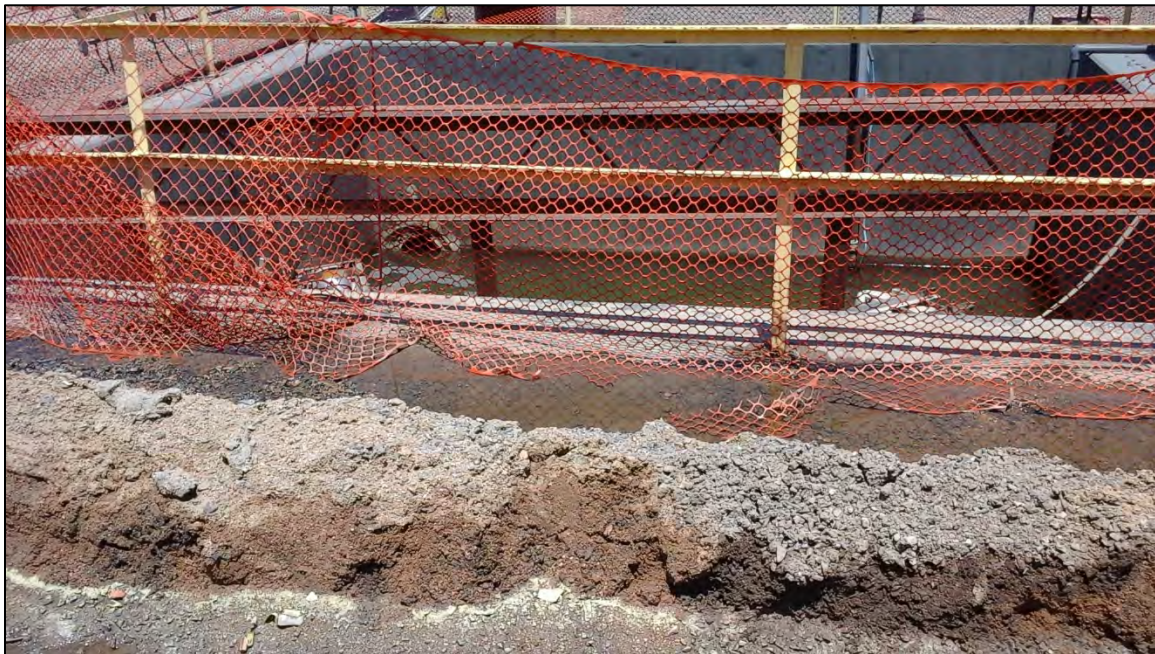
Photograph 8. Additional view of the unconsolidated sediment and gravel berm upgradient of Outfall 020A aerated sampling vault, as shown in Photograph 7.

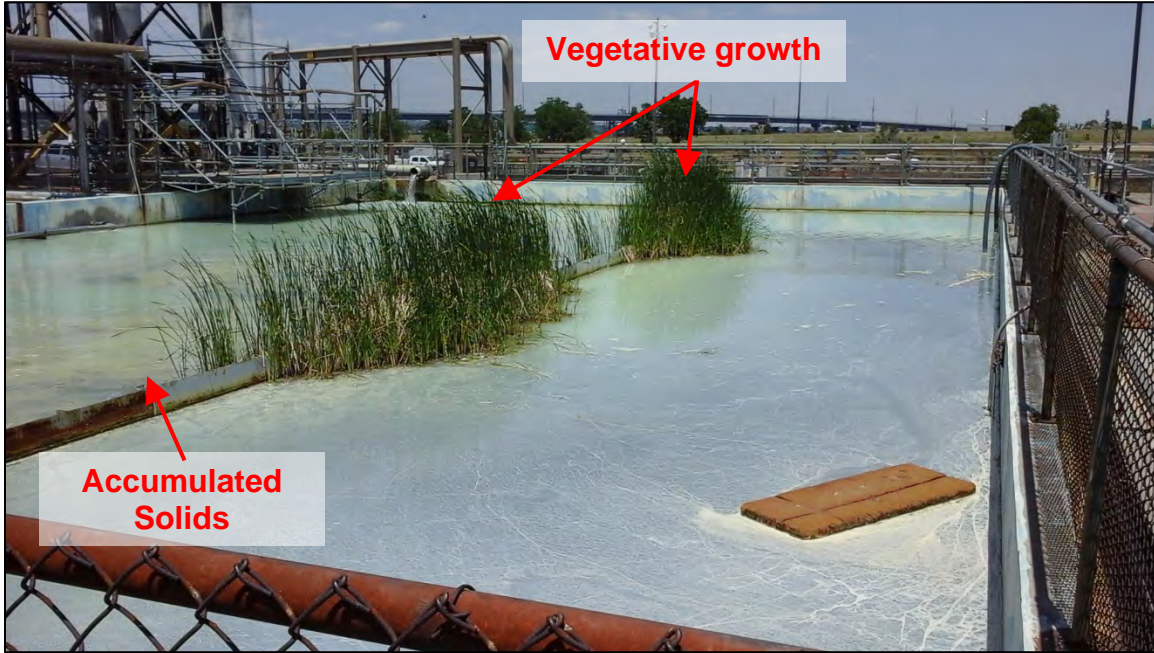
Photograph 9. View, facing north, of the GWTS surge basin. Vegetative growth and accumulation of solids were observed in the surge basin.

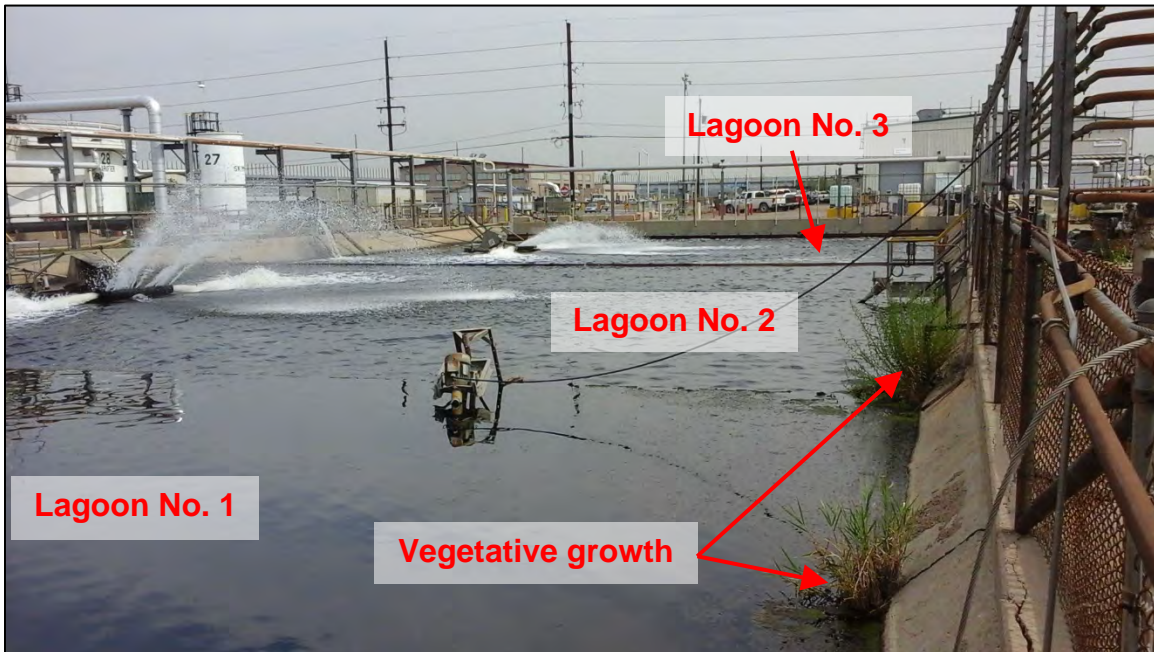
Photograph 10. View, facing north, of vegetative growth on the edge of Lagoon No. 1.

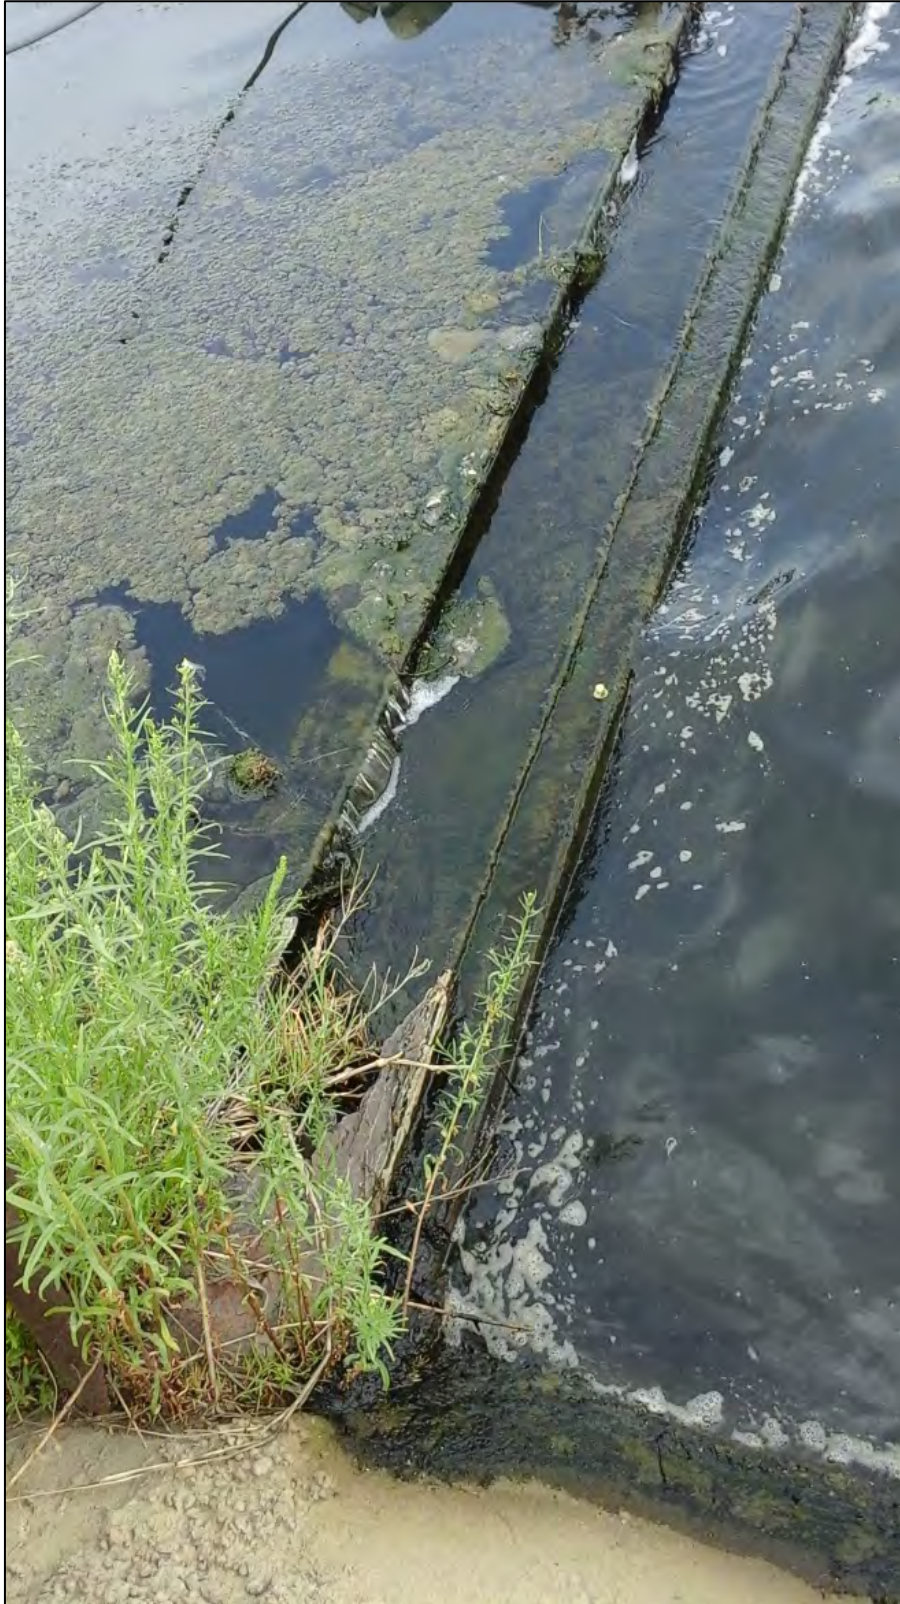
Photograph 11. View of accumulated solids and vegetative growth at the weir between Lagoon Nos. 1 and 2.

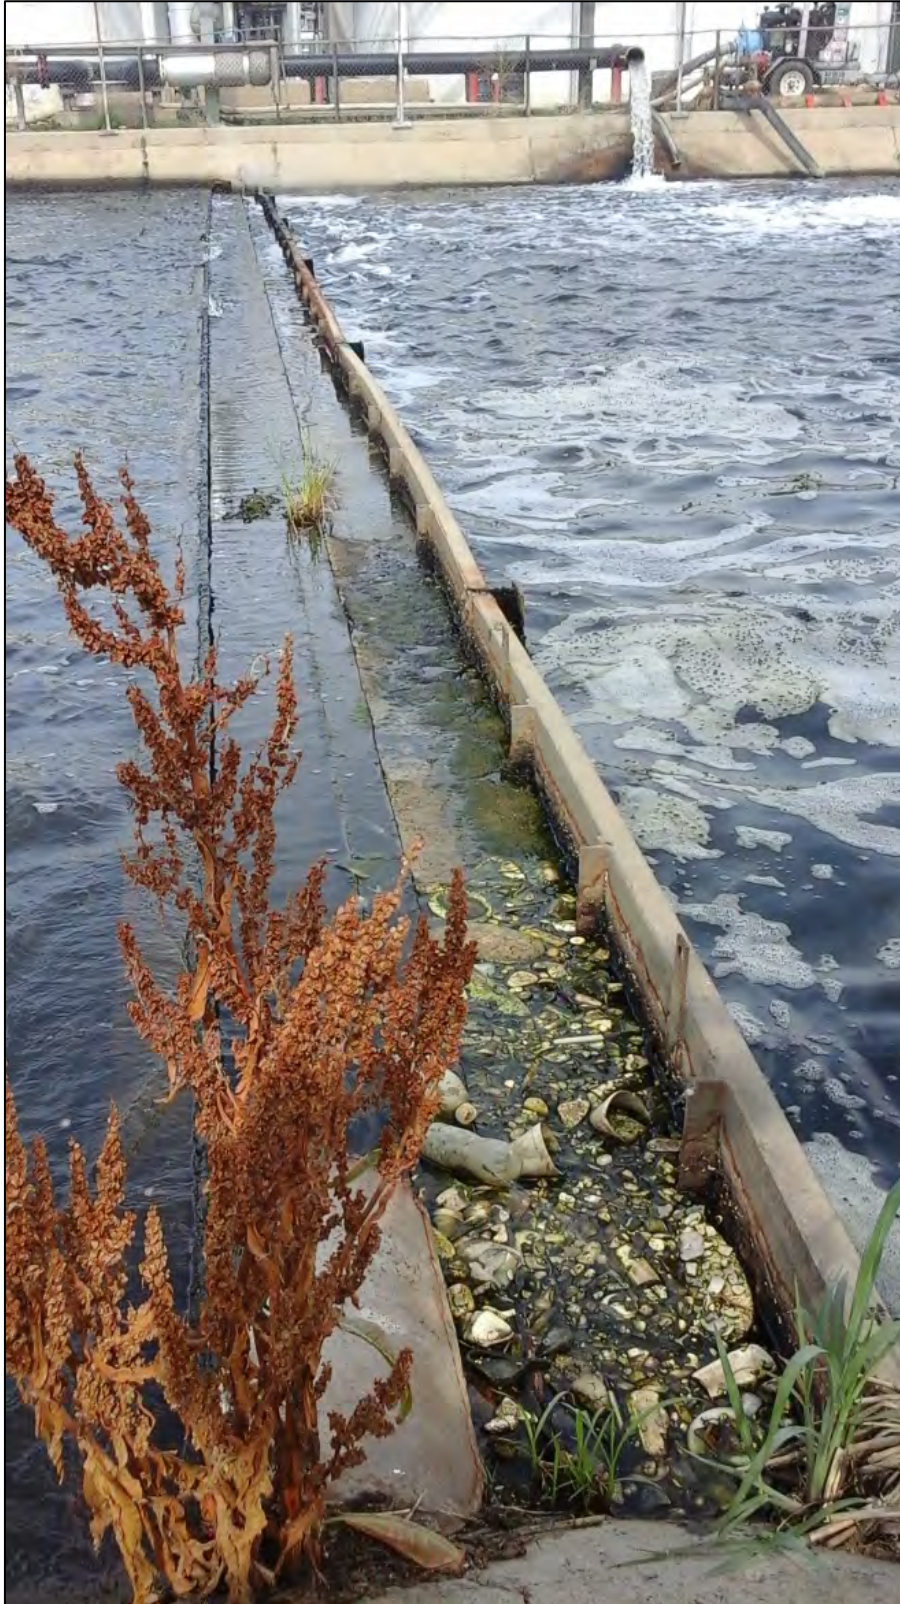
Photograph 12. View of accumulated solids and vegetative growth at the weir between Lagoon Nos. 2 and 3.

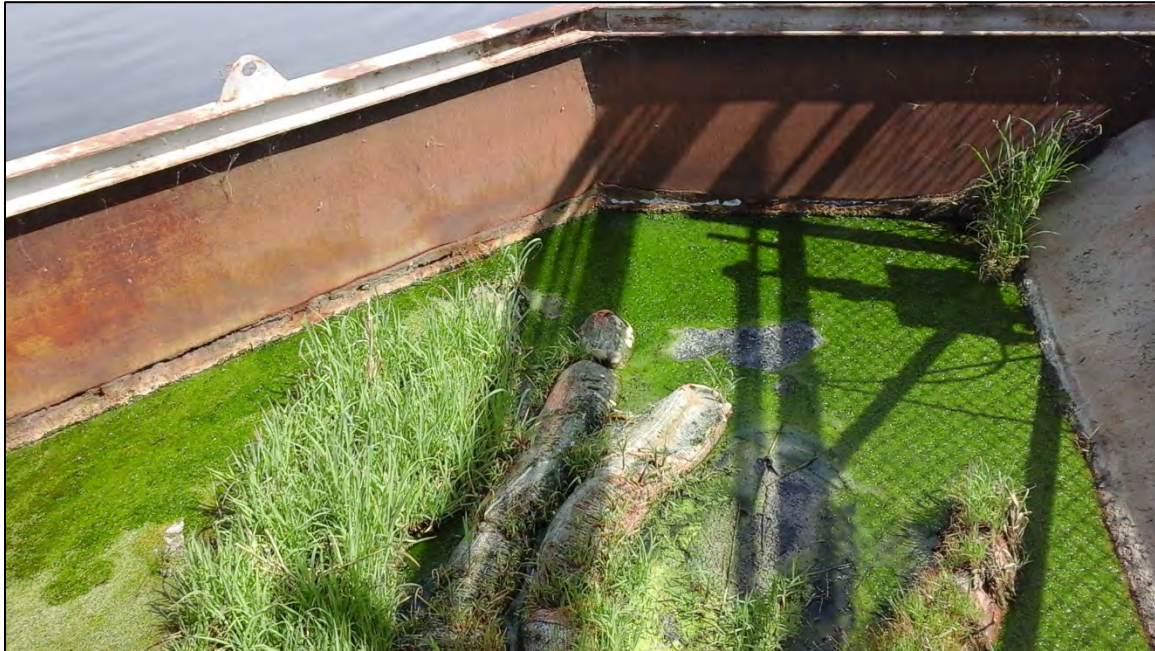
Photograph 13. View of accumulated solids and vegetative growth in the Lagoon No. 1 forebay which receives flow from the “Morgan Box.”

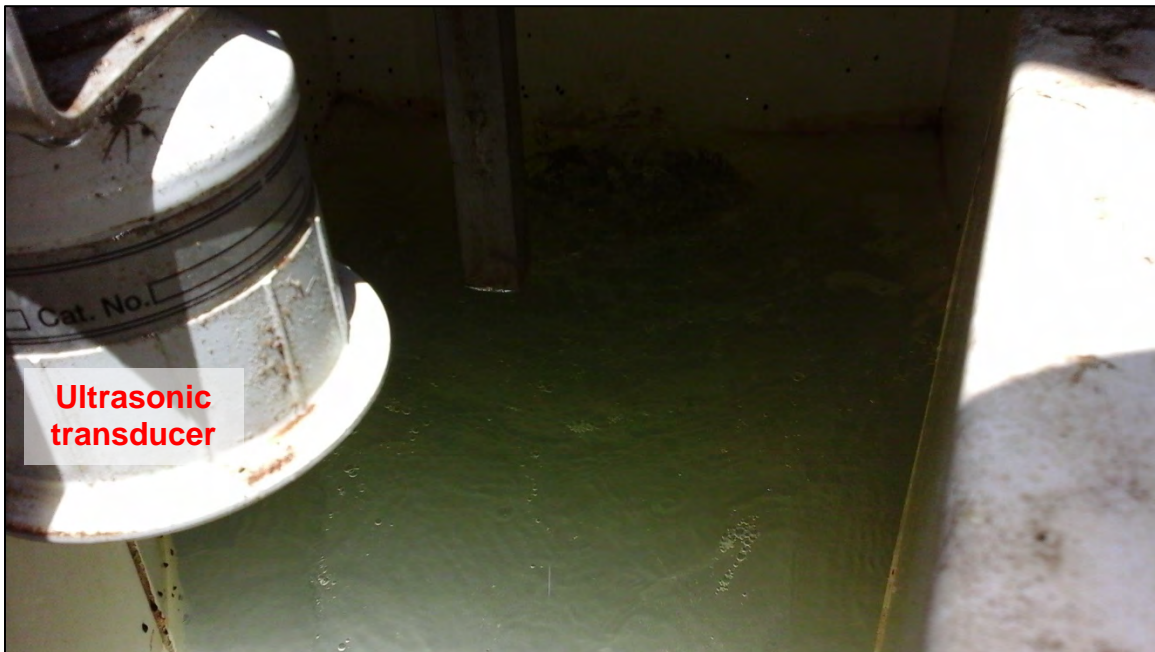
Photograph 14. View of the Outfall 003B Parshall flume and associated ultrasonic transducer for Permit flow measurements from the GWTS. Note the turbulence and disturbance (boils) observed in the approach channel run leading to the flume.

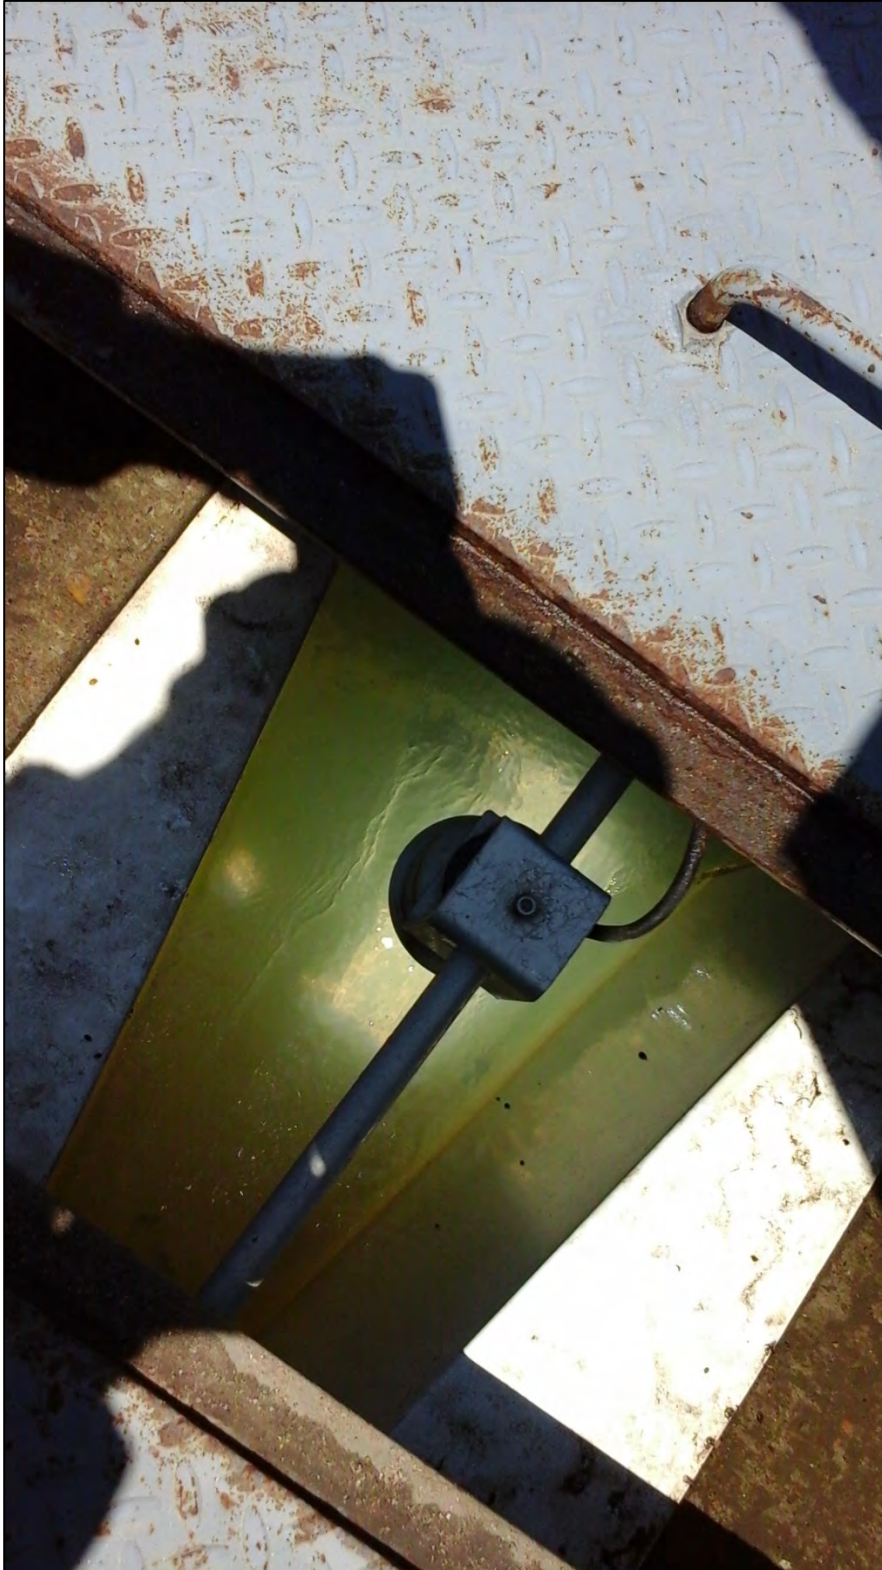
Photograph 15. Additional view of the turbulence observed in the Outfall 003B Parshall flume.

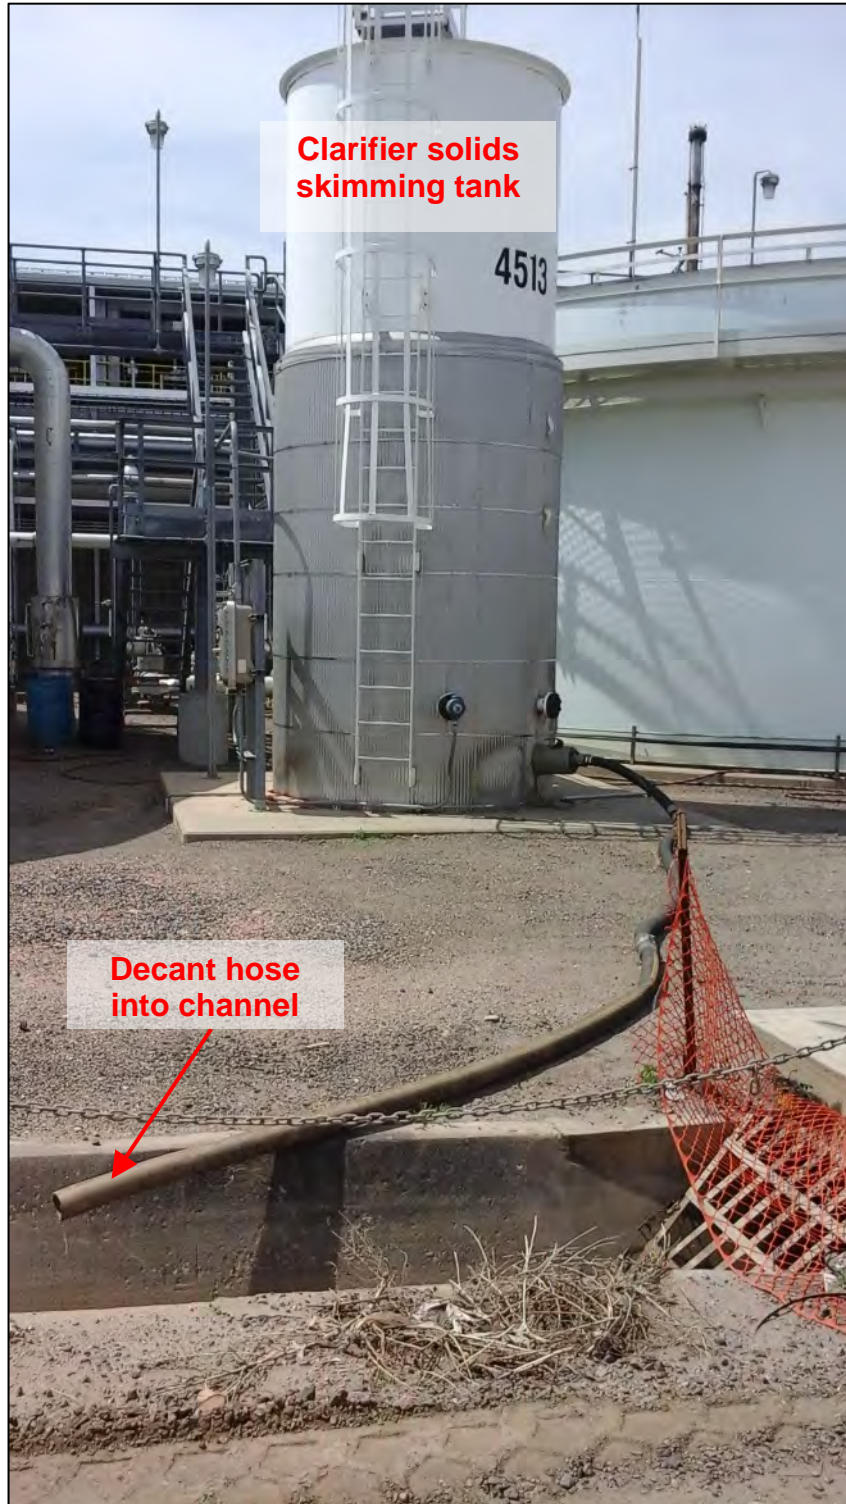
Photograph 16. View of a decant line from the Train B clarifier solids skimming collection tank (Tank No. 4513). Facility representatives suspected that the skimming tank contained only clarifier water, and therefore, it was decanted into an adjacent concrete conveyance channel instead of being pumped out by a vac truck. This channel subsequently flows to Finger Lake, shown in Photograph 18.

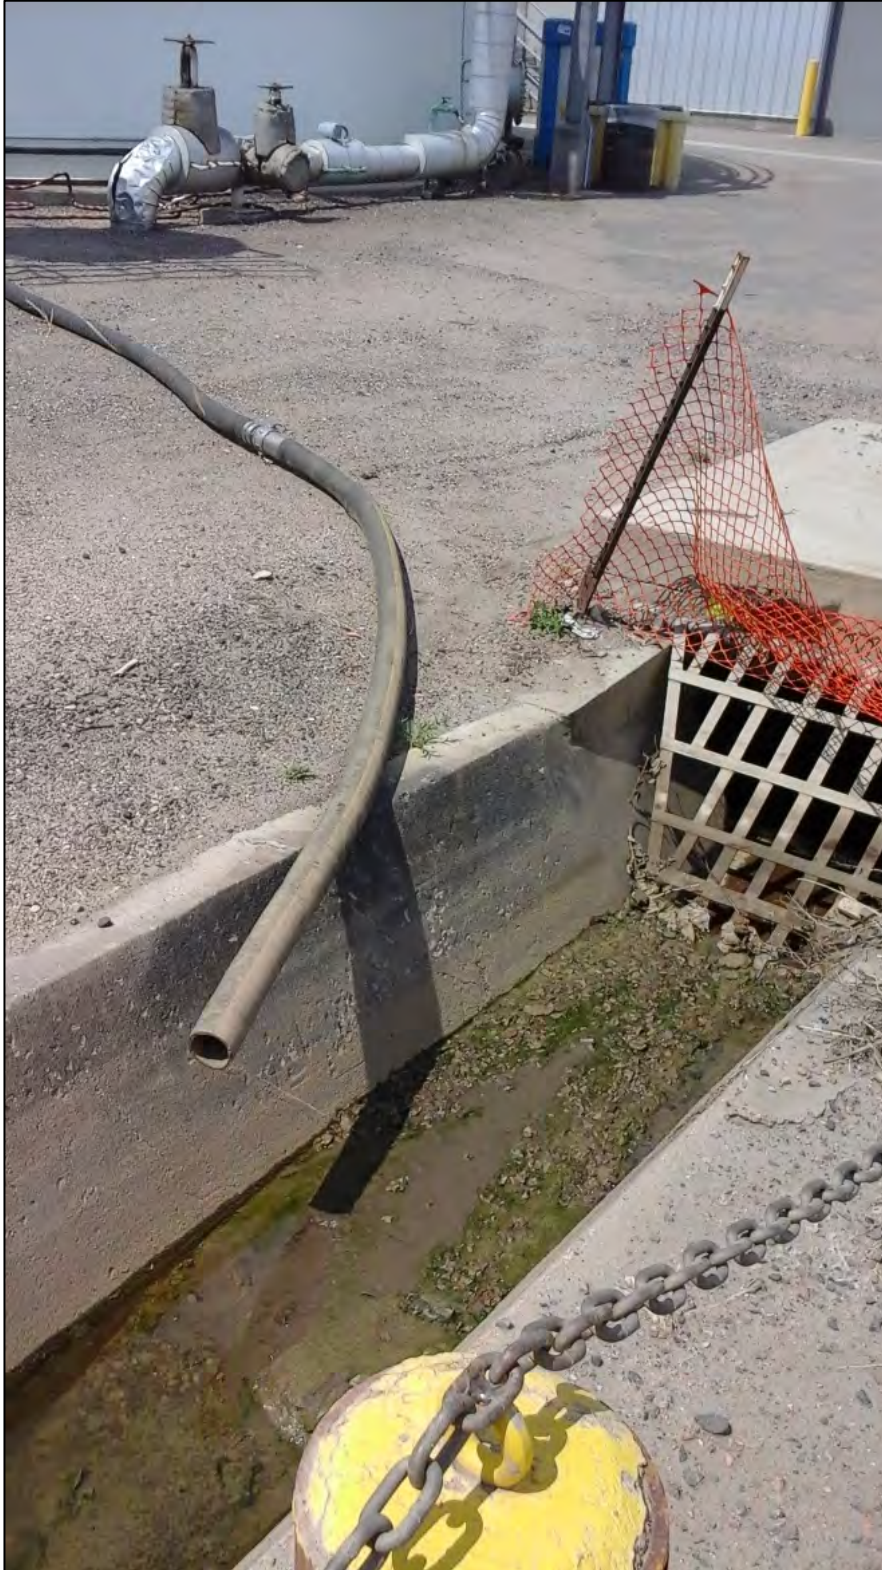
Photograph 17. Additional view of a decant line from the Tank B clarifier skimming collection tank shown in Photograph 16.

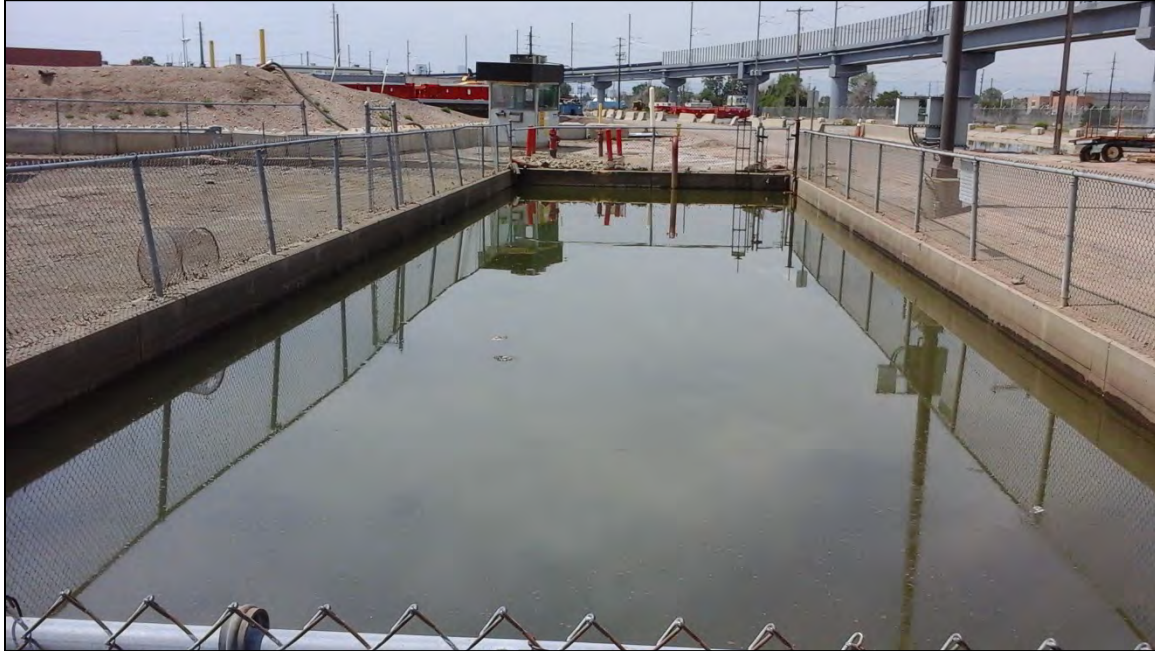
Photograph 18. View, facing south, of Facility's onsite Finger Lake impoundment.

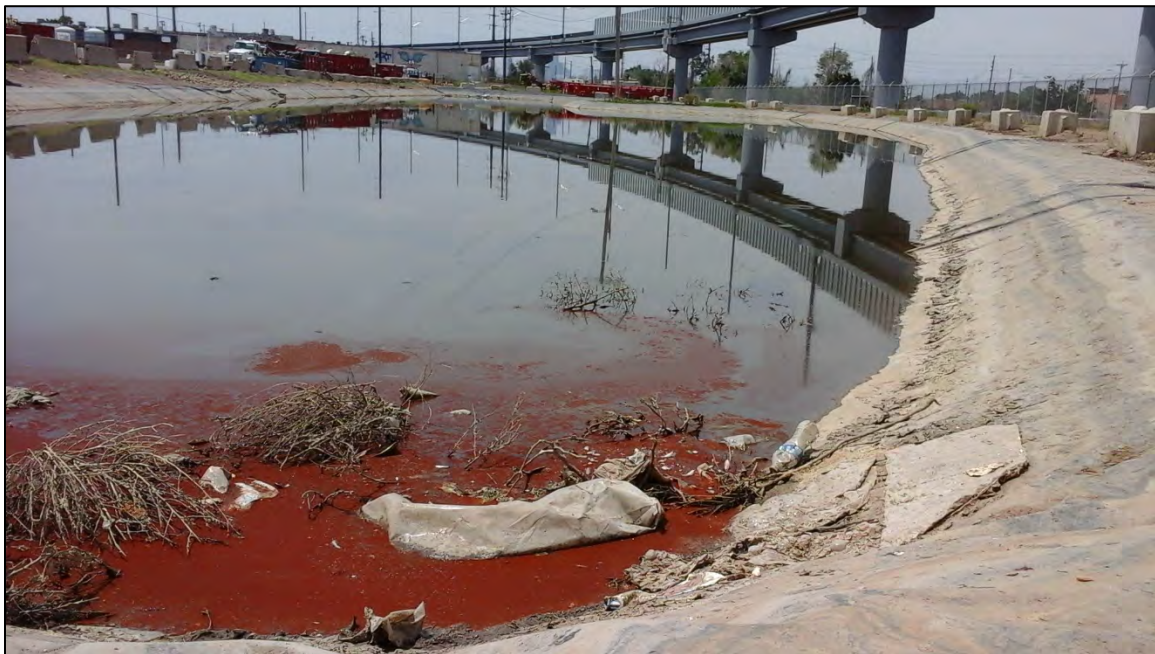
Photograph 19. View, facing south, of Facility's onsite Webber's Pond.

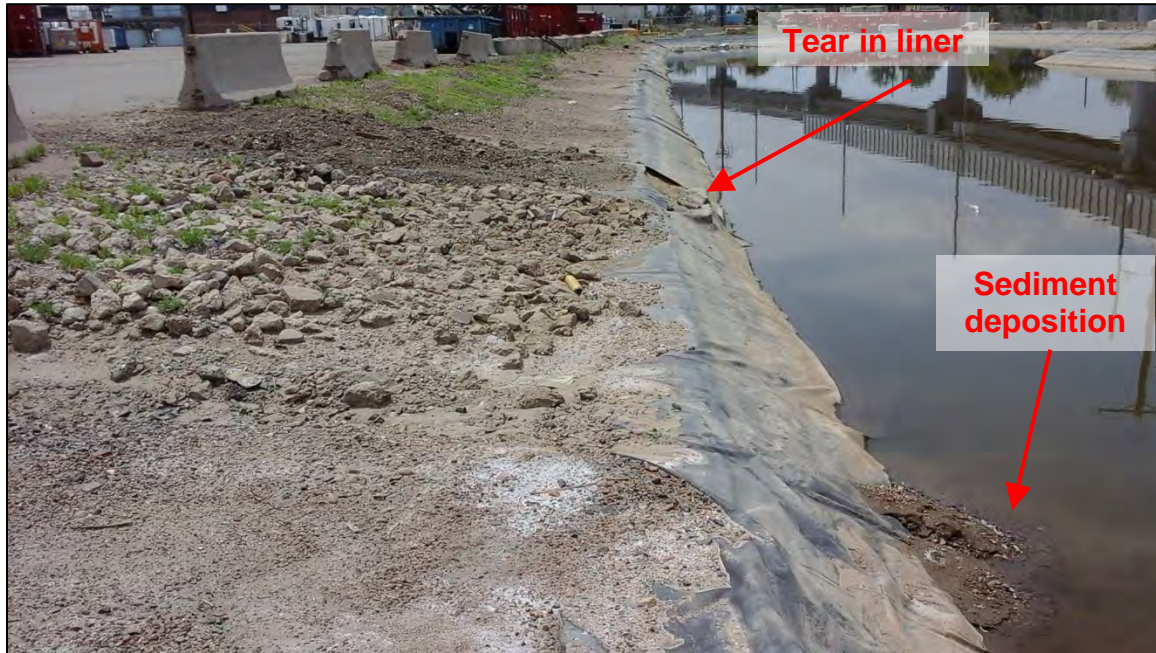
Photograph 20. View, facing south, of rill formations along the eastern embankment of Webber's Pond. Note the sediment deposited in Webber's Pond beneath the rill. Also note the torn poly liner for Webber's Pond, as shown in Photograph 21.

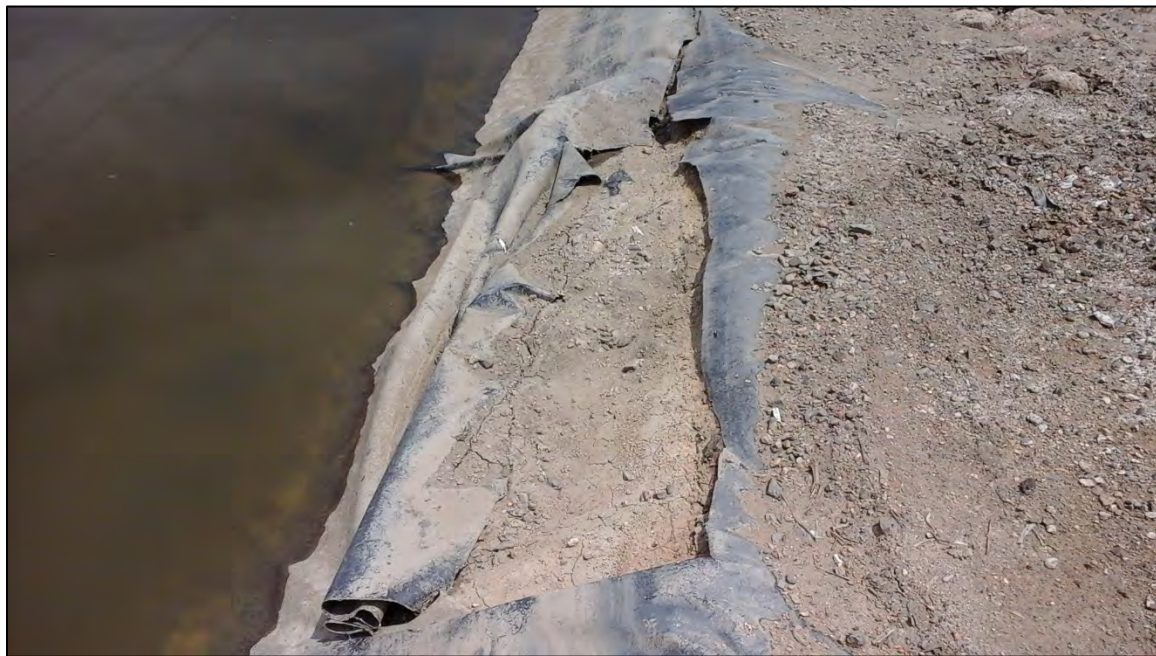
Photograph 21. Close-up view of the torn poly liner of Webber's Pond shown in Photograph 20.

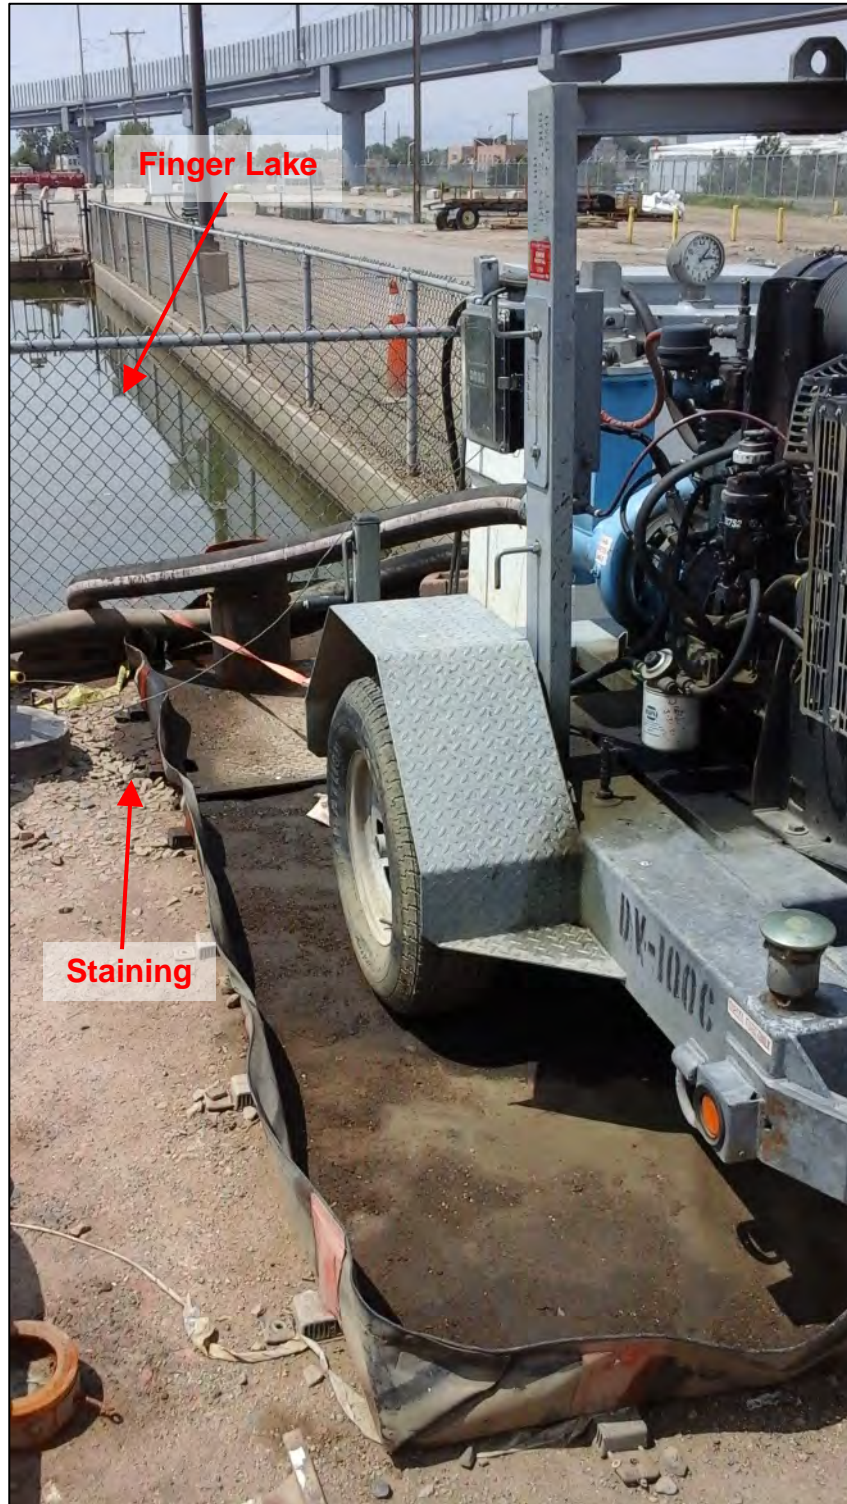
Photograph 22. View of the pump that transfers the contents of Finger Lake into Webber's Pond or to the WWTP. The pump was located within secondary containment; however, petroleum staining was observed on the ground surface outside of the containment.
