## **Appendix A - Photograph Log**

*Inspection Dates: June 22-24, 2021*

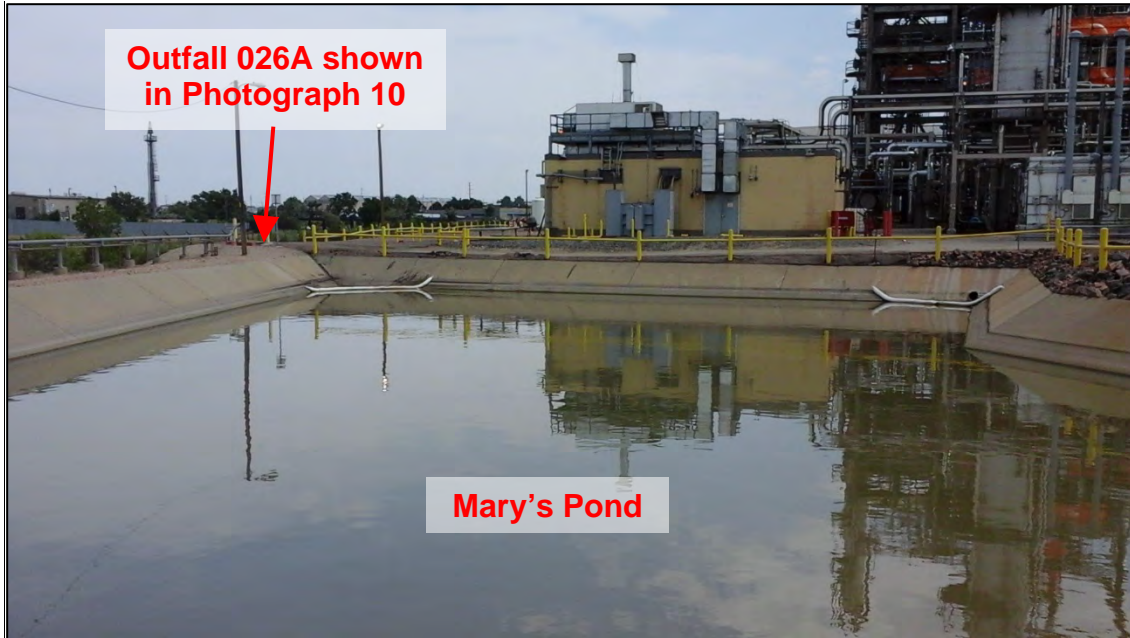
**Photograph 1.** View, facing southeast, of Mary's Pond receiving stormwater runoff from Plant 3 (asphalt plant). Mary's Pond can be pumped to the WWTP or discharged through Outfall 004A.

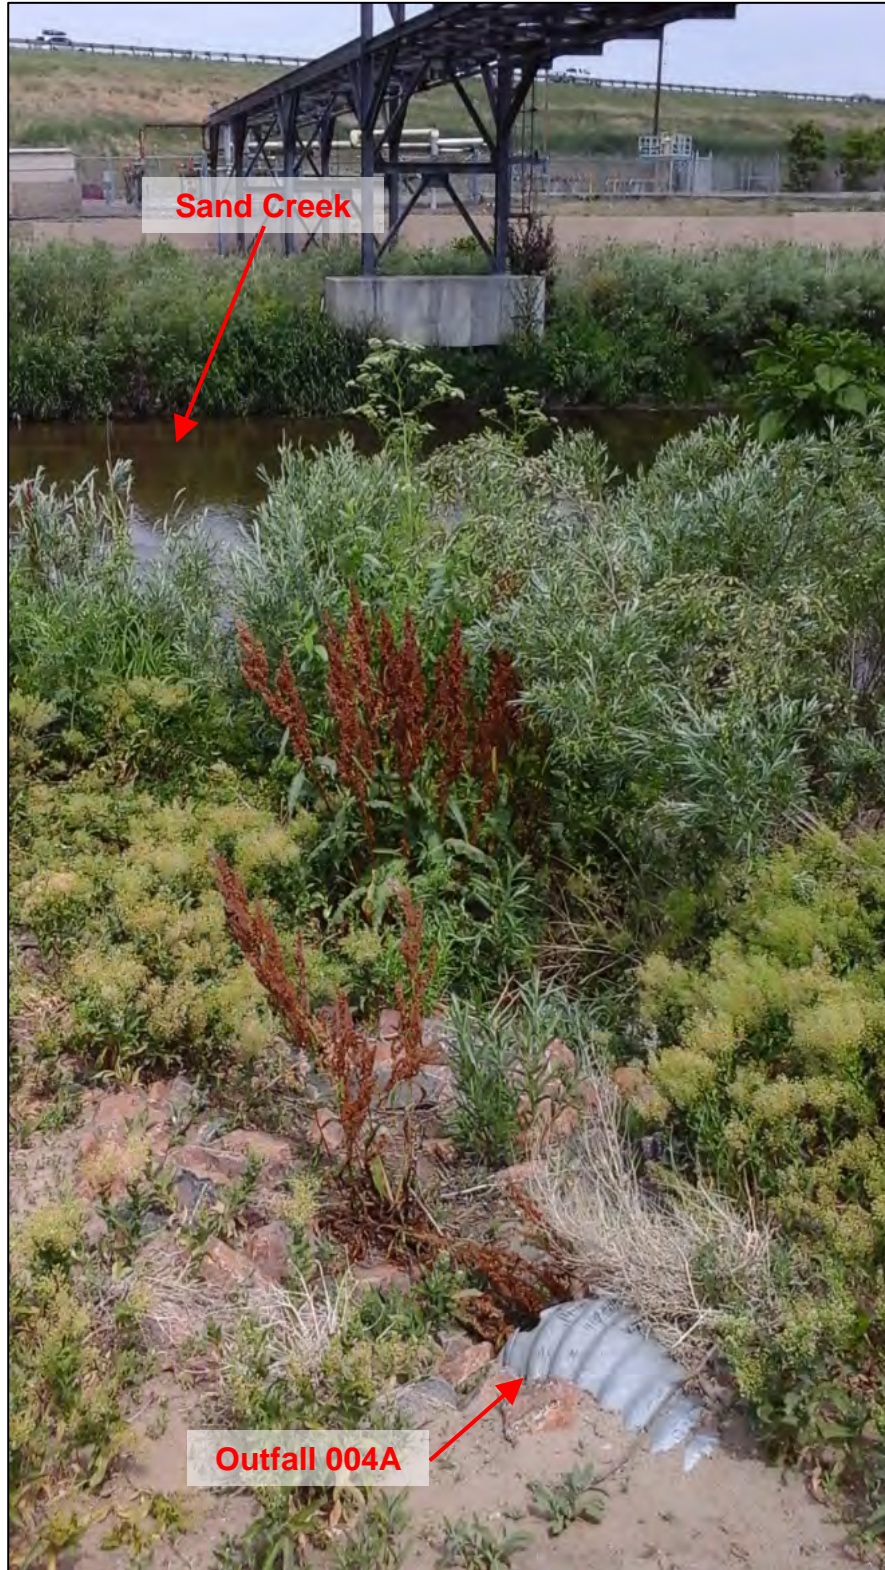
**Photograph 2.** View of Outfall 004A to Sand Creek from Mary's Pond, shown in Photograph 1.

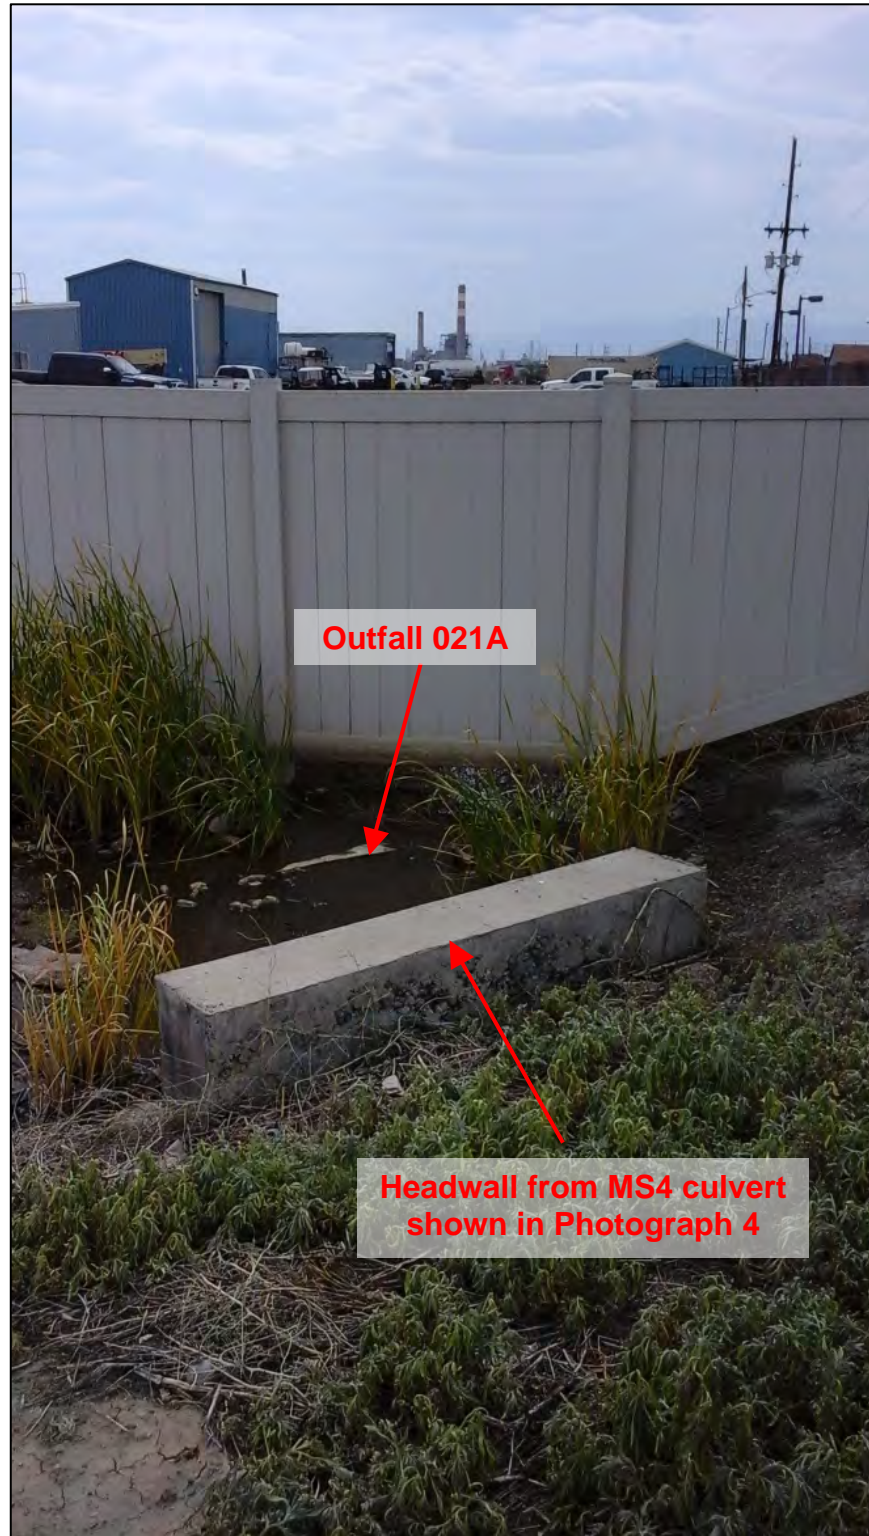
**Photograph 3.** View, facing west, from the Colorado Boulevard right-of-way, of Outfall 021A at the northeast corner of the Nelson Property. The stormwater detention basin on the northeast side of the property is located behind the white fence. Outfall 021A is noted as the location where accumulated stormwater is monitored and also where stormwater is commingled with stormwater runoff from the City of Commerce City’s MS4 from Colorado Boulevard.

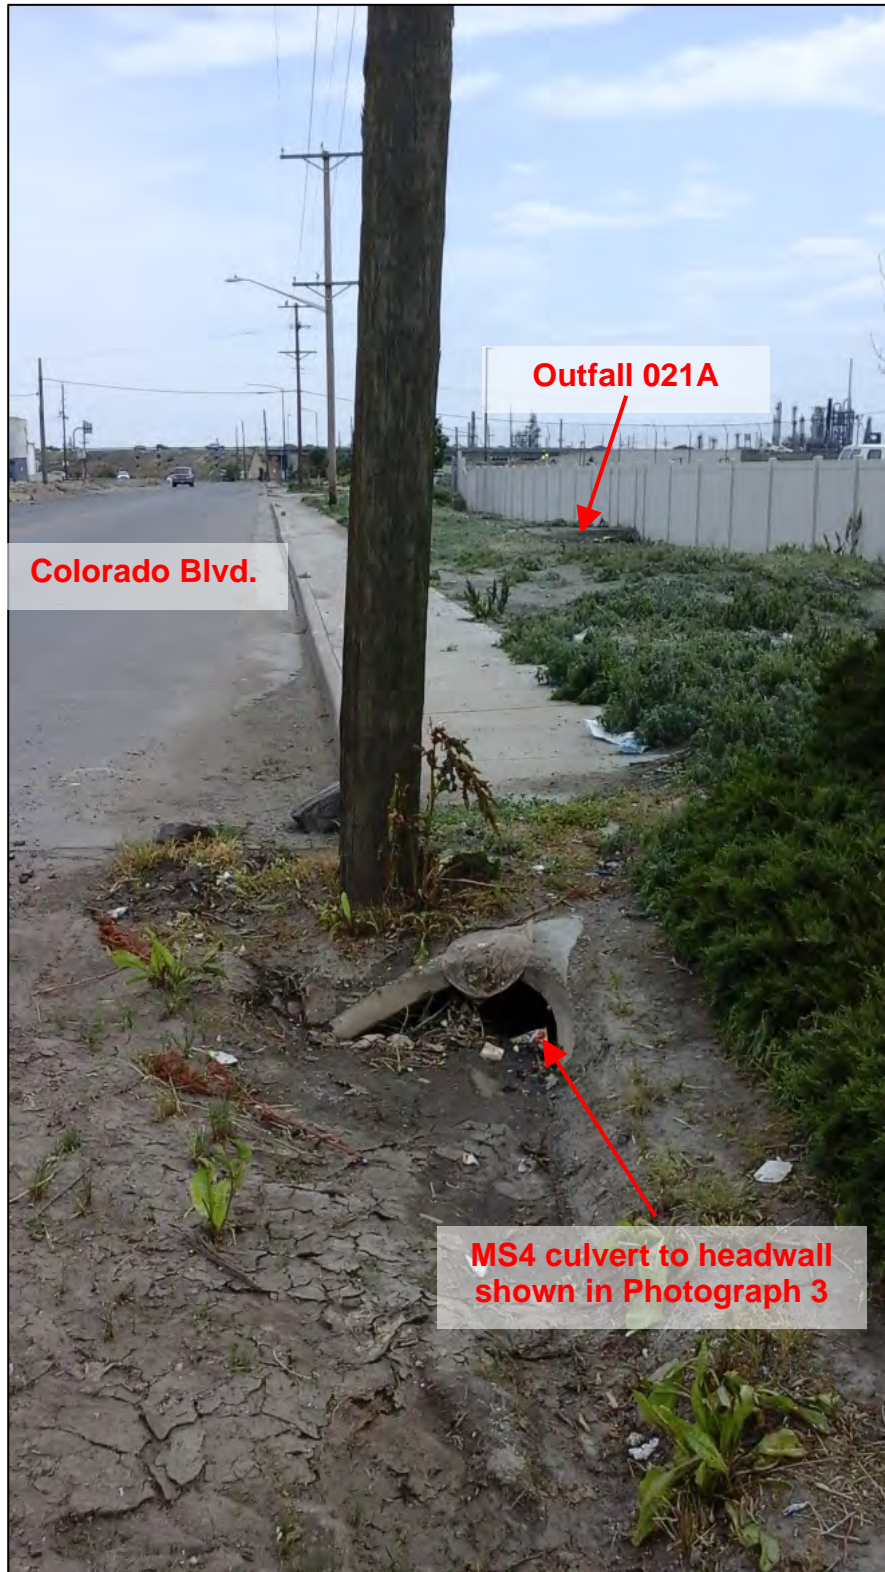
**Photograph 4.** View of a storm drain culvert inlet along Colorado Boulevard adjacent to the Nelson Property. This MS4 culvert outlets at the headwall shown in Photograph 3 at the same location as Outfall 021A from the Nelson Property.

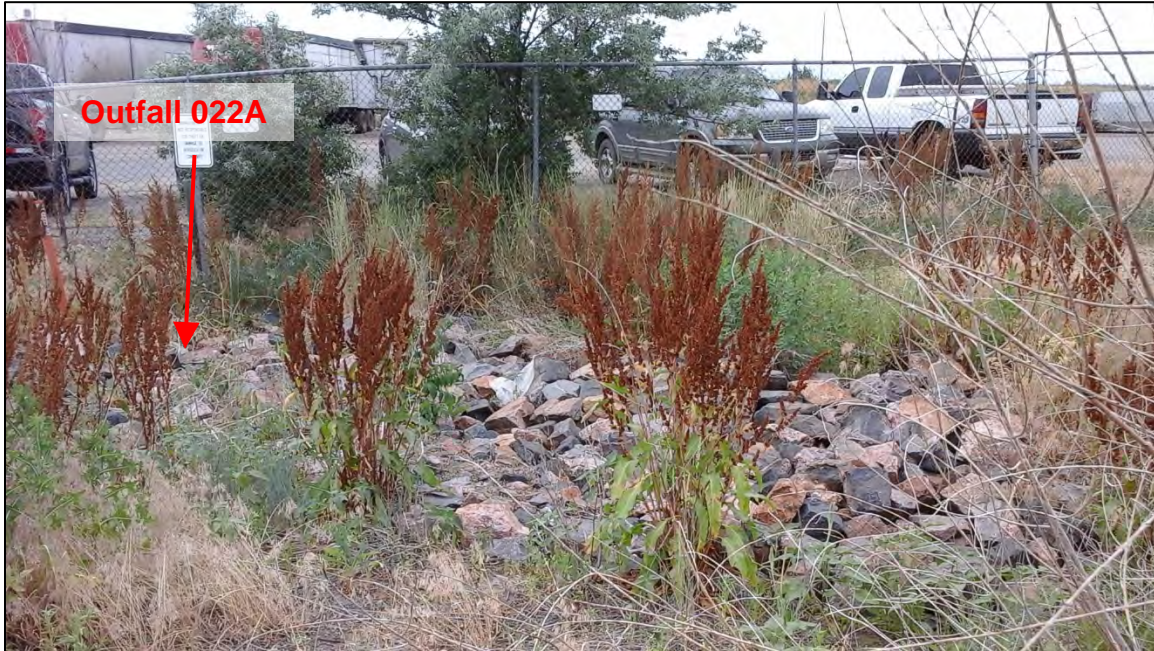
**Photograph 5.** View of Outfall 022A on the northwest side of the Nelson Property. This outfall drains into an adjacent offsite (behind chain link fence) parking lot and potentially to the City of Commerce City MS4.

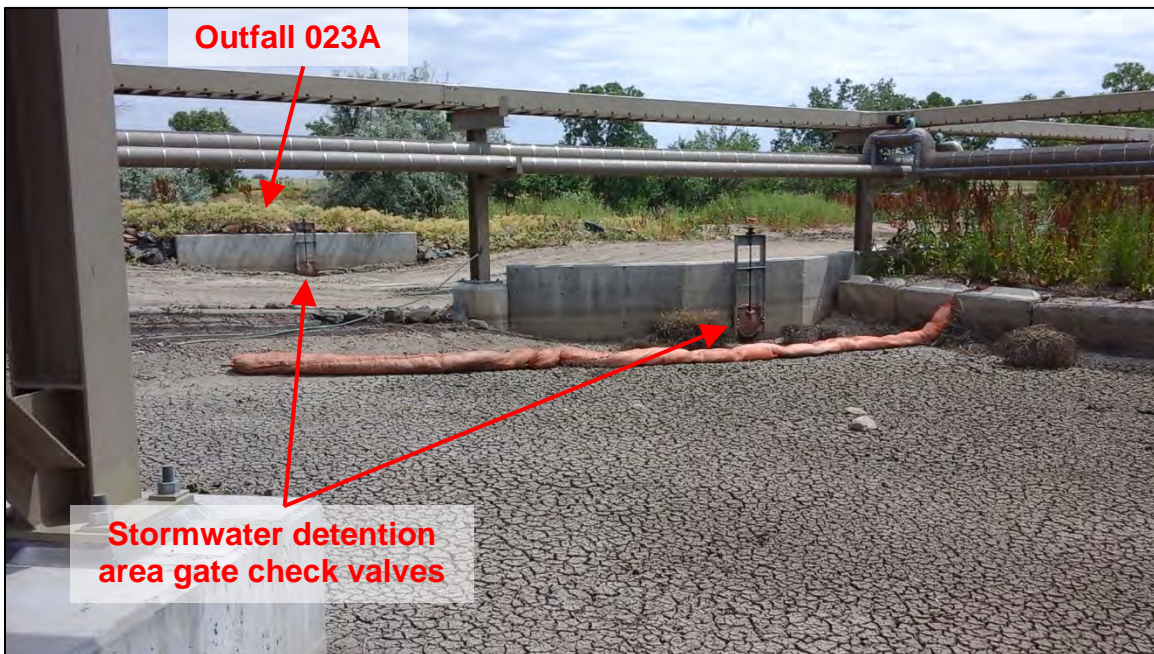
**Photograph 6.** View of Outfall 023A and the two gate check valves for the Outfall 023A stormwater detention area.

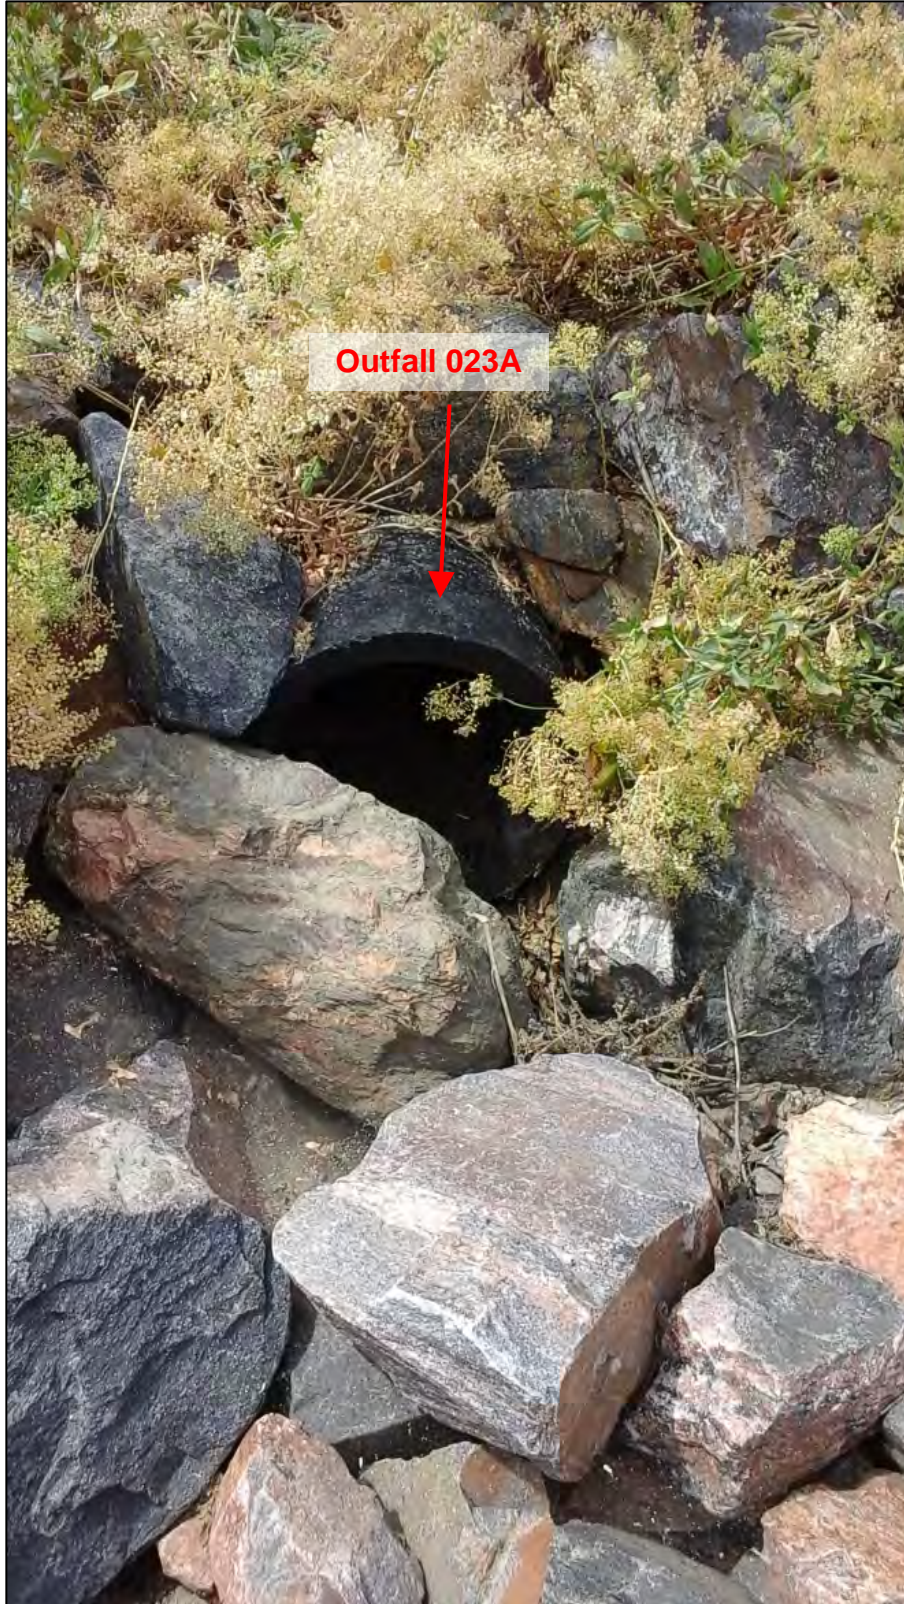
**Photograph 7.** Close-up view of Outfall 023A from stormwater detention area, shown in Photograph 6, which discharges into Sand Creek.

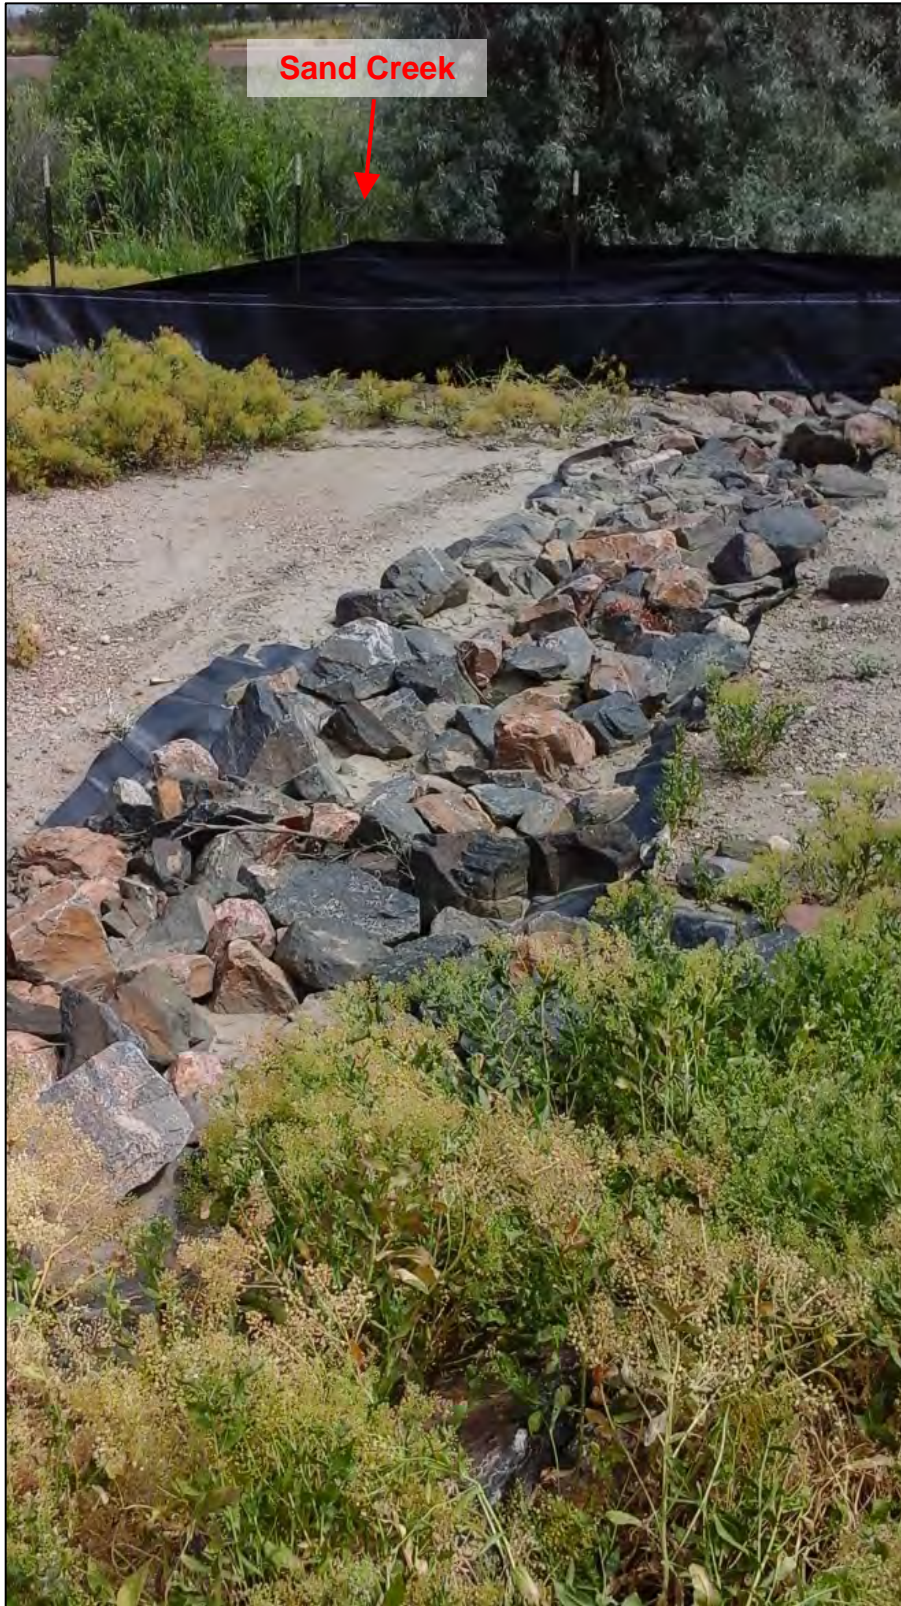
**Photograph 8.** View, facing north, from Outfall 023A towards Sand Creek.

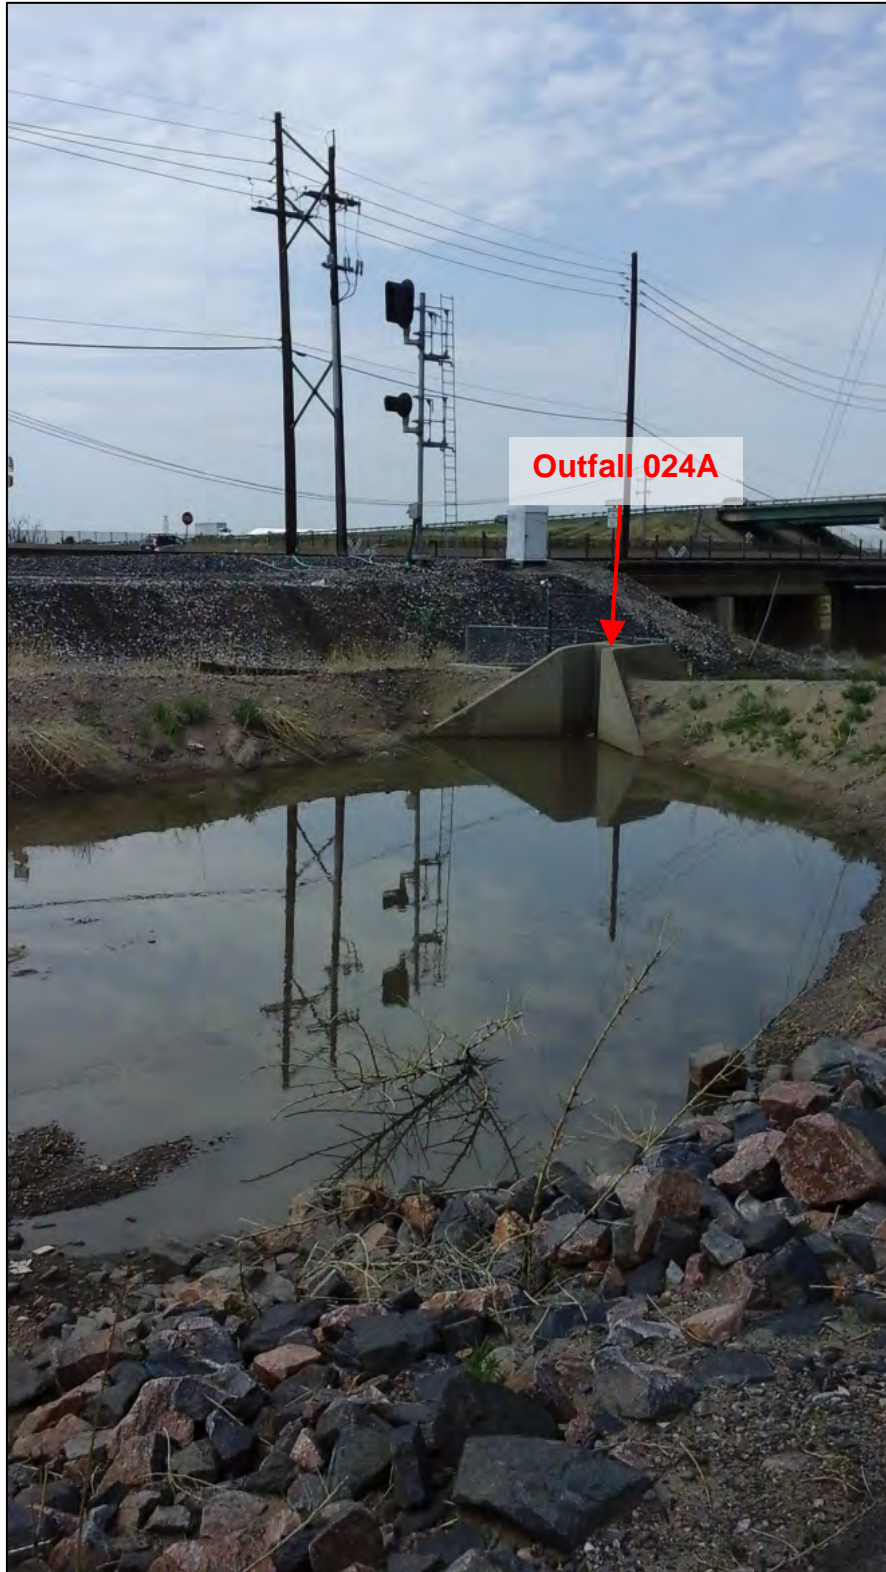
**Photograph 9.** View, facing northwest, of Outfall 024A downgradient of a stormwater detention basin that captures runoff from the Plant 2 employee parking lot.

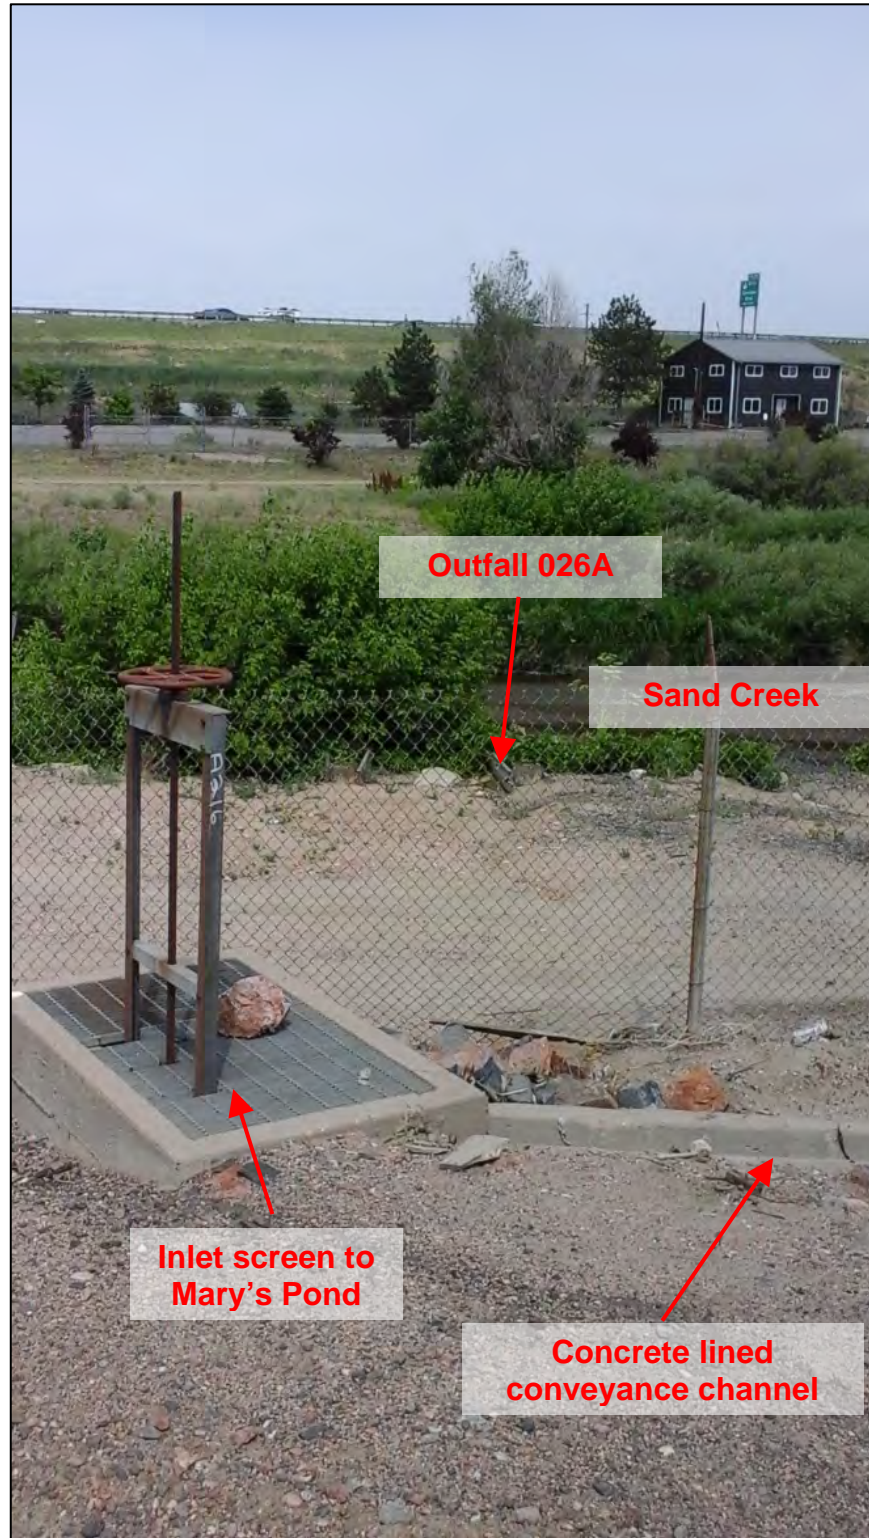
**Photograph 10.** View, facing east, of Outfall 026A which is a high flow contingency (i.e., overflow) discharge point from the Plant 3 east perimeter concrete lined conveyance channel that flows to Mary's Pond (refer to Photograph 1).

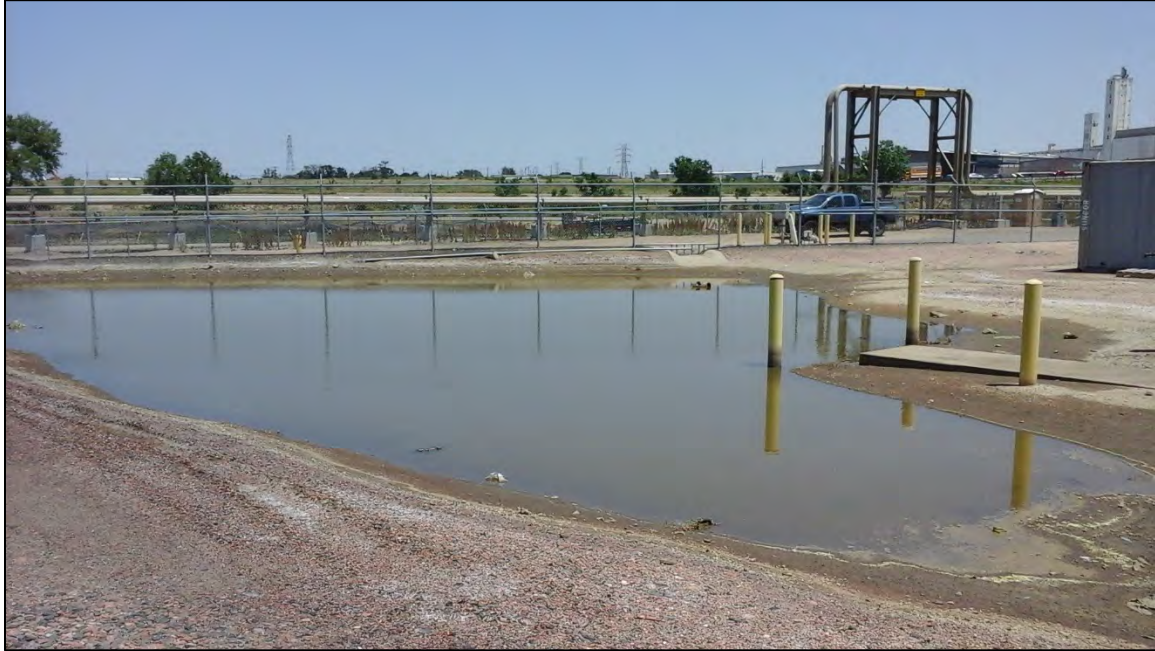
**Photograph 11.** View, facing northeast, of the stormwater detention area located immediately east of the GWTS. This stormwater detention area overflows towards the Sand Creek Swale Pond and to the stormwater detention area before discharges to Outfall 023A. This stormwater detention area is not identified in the SWMP.

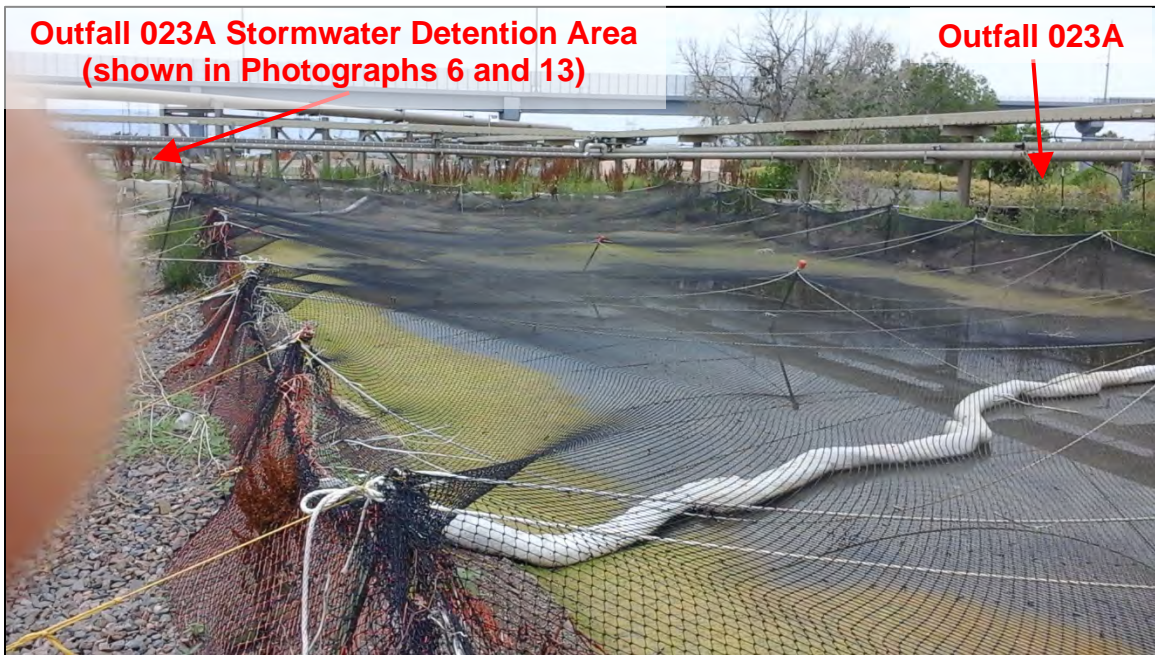
**Photograph 12.** View of the Sand Creek Swale Pond located between Plant 1 and Sand Creek where hydrocarbons during wet weather or times of elevated groundwater levels migrates to the ground surface. Note the black oil staining on the ground surface and netting to restrict wildlife access.

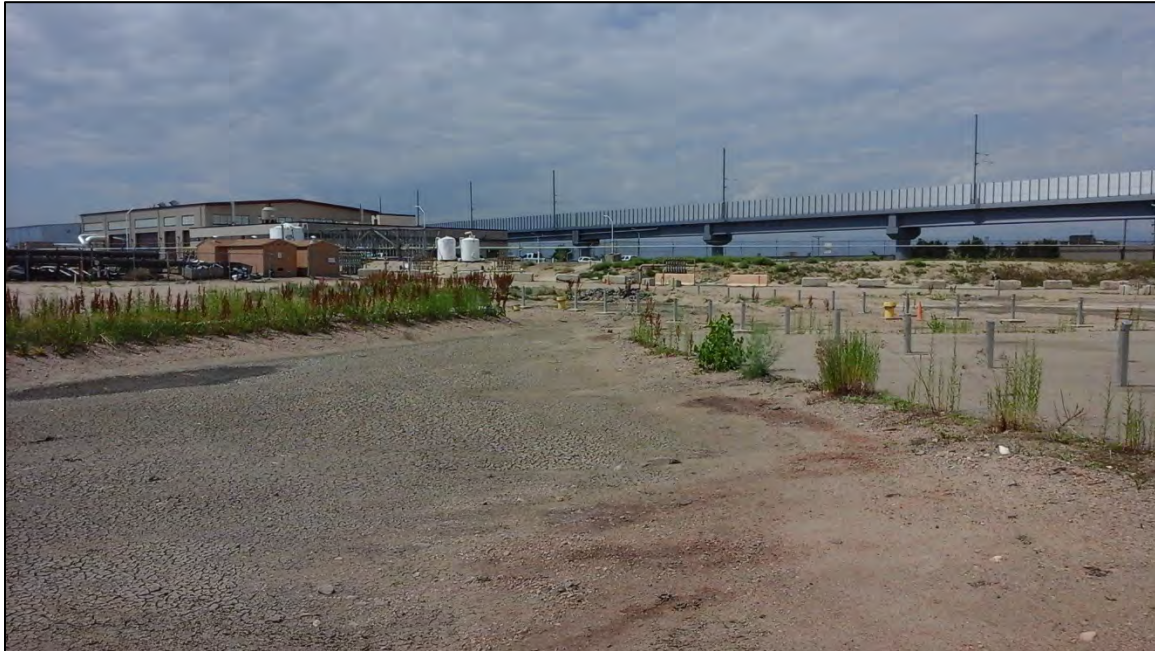
**Photograph 13.** View, facing southwest, of the stormwater detention area upgradient of Outfall 023A.

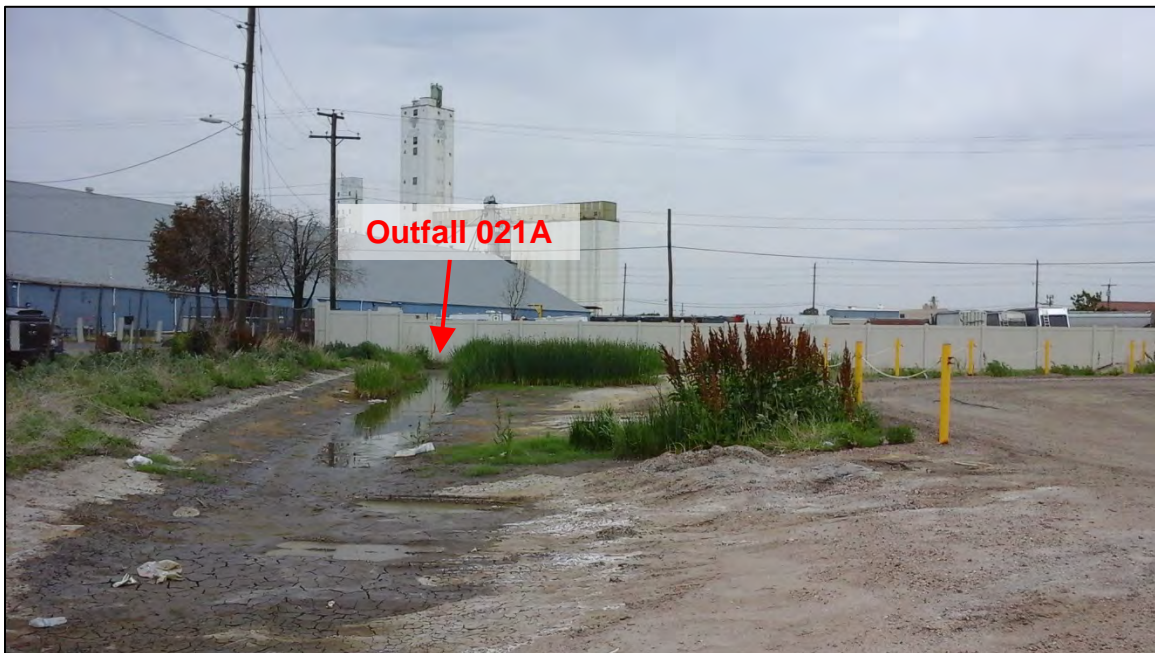
**Photograph 14.** View, facing east, of the stormwater detention basin in the northeast corner of the Nelson Property which discharges to Outfall 021A (refer to Photograph 3). Accumulated sediment and vegetative growth was observed within the basin.

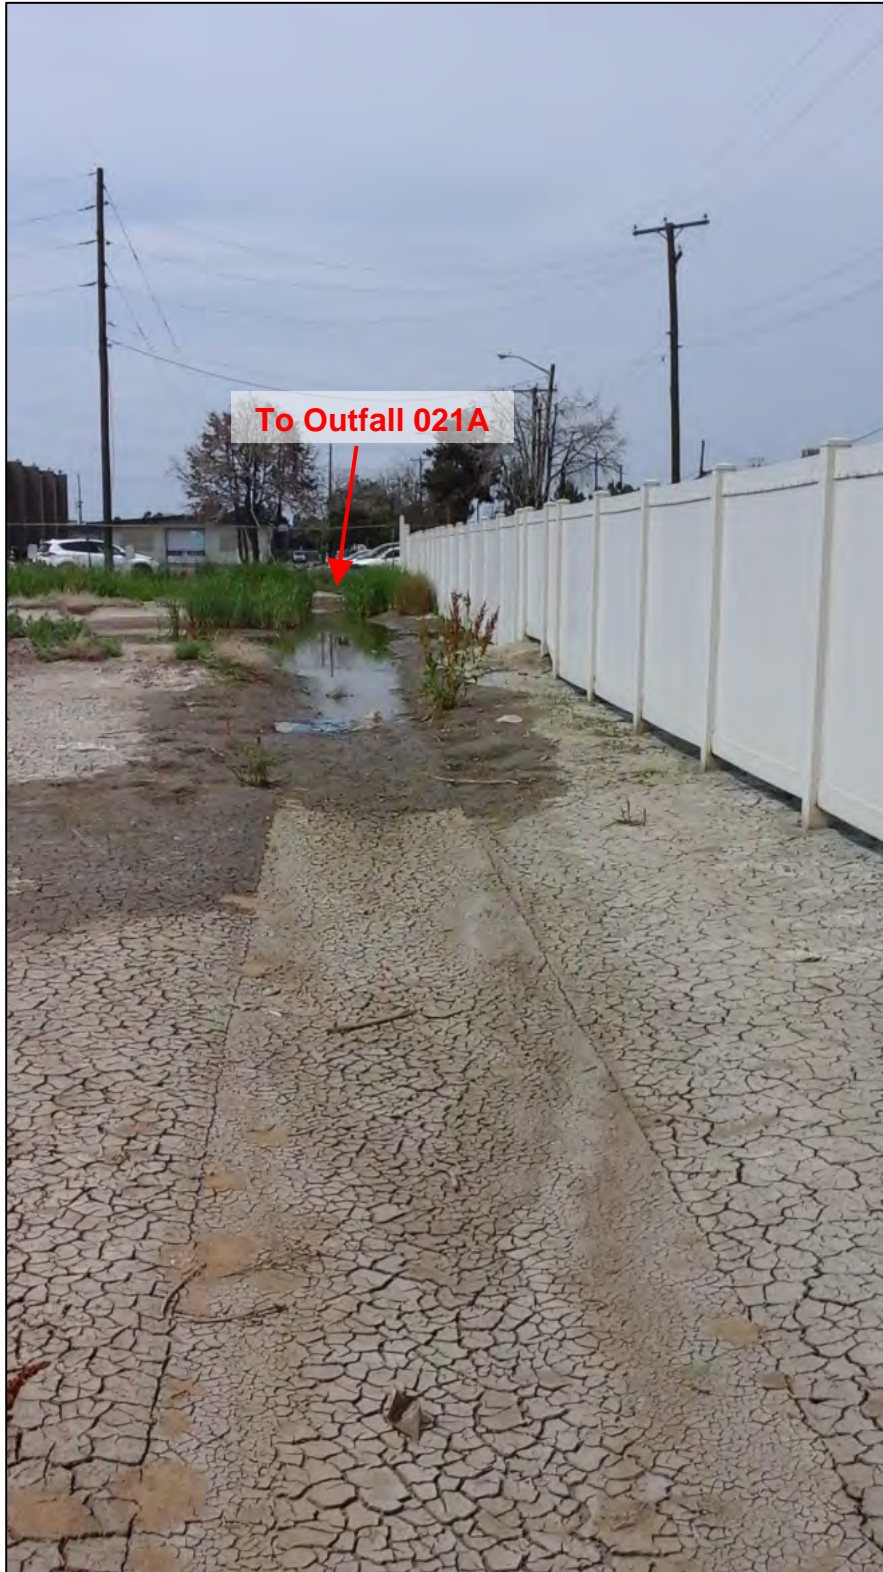
**Photograph 15.** View, facing north, of a valley gutter leading into the stormwater detention basin shown in Photograph 14. Note the accumulated sediment in and around the valley gutter.

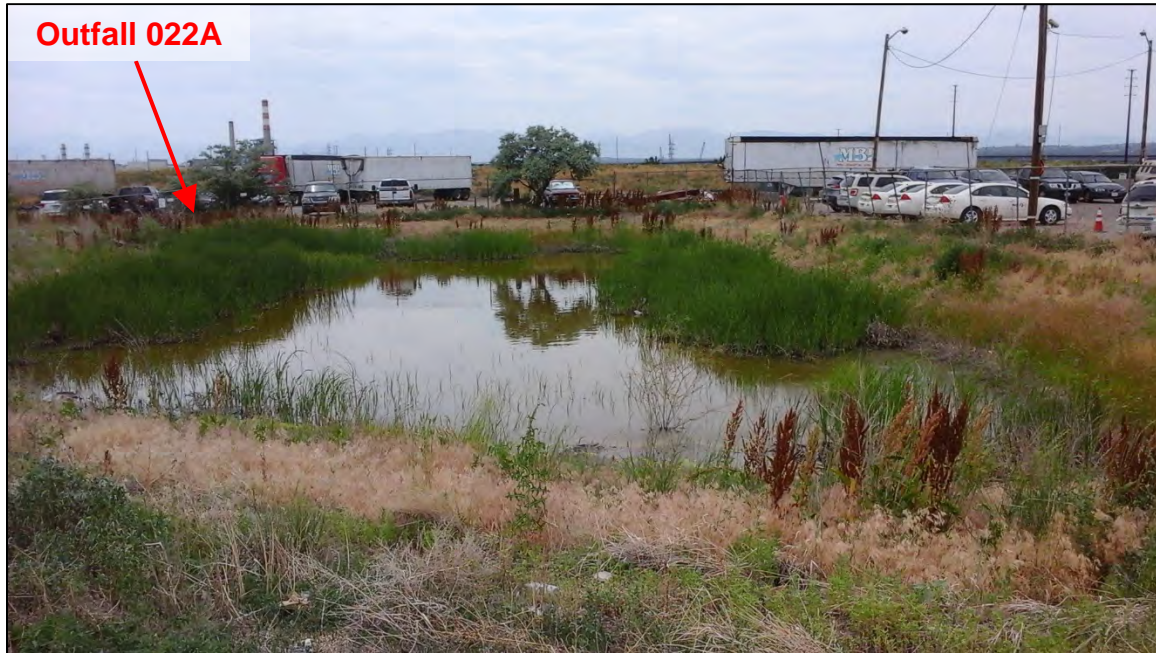
**Photograph 16.** View, facing west, of the stormwater detention basin located in the northwest corner of the Nelson Property. This basin discharges through Outfall 022A shown in Photograph 5. Note the significant vegetative growth potentially diminishing the capacity and effectiveness of this stormwater control.

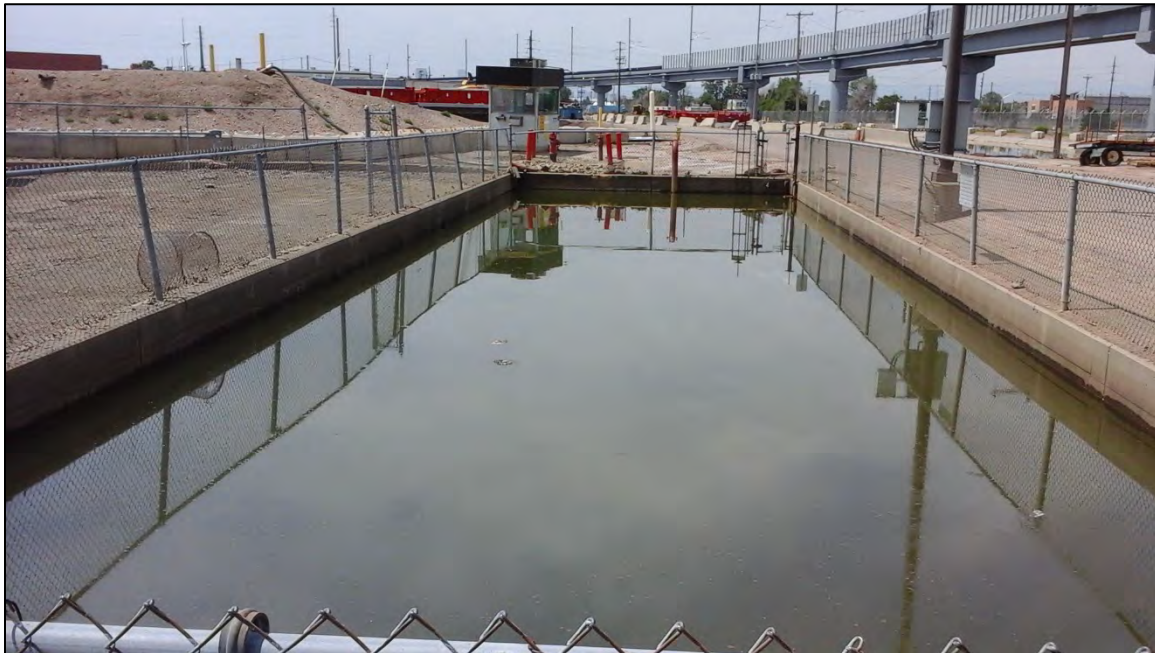
**Photograph 17.** View, facing south, of Facility's onsite Finger Lake impoundment.

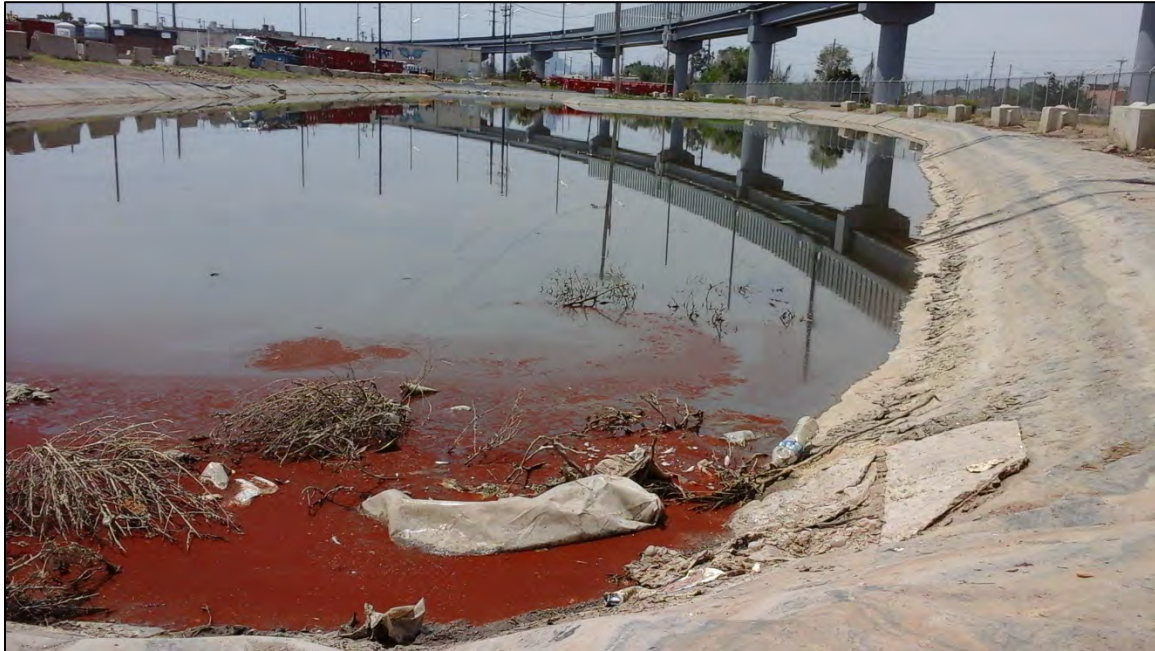
**Photograph 18.** View, facing south, of the Facility's onsite Webber's Pond. Note the accumulated trash and debris within the pond itself.

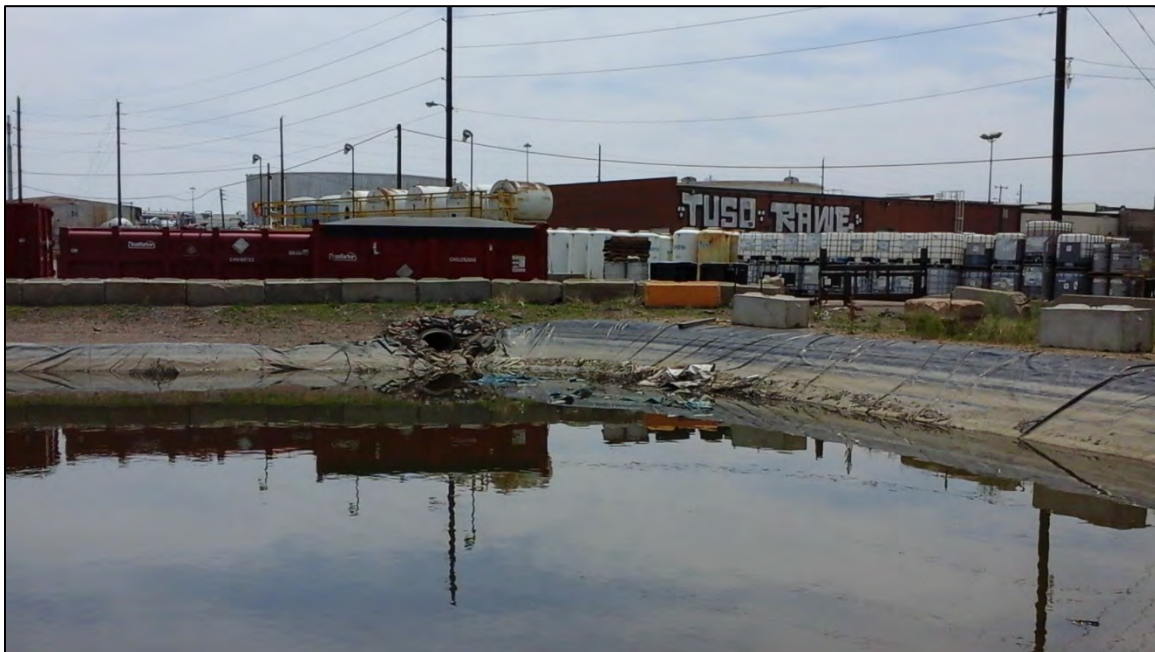
**Photograph 19.** View, facing southeast, of an inlet into the southeast corner of Webber's Pond. Not the trash and debris in the pond adjacent to this inlet.

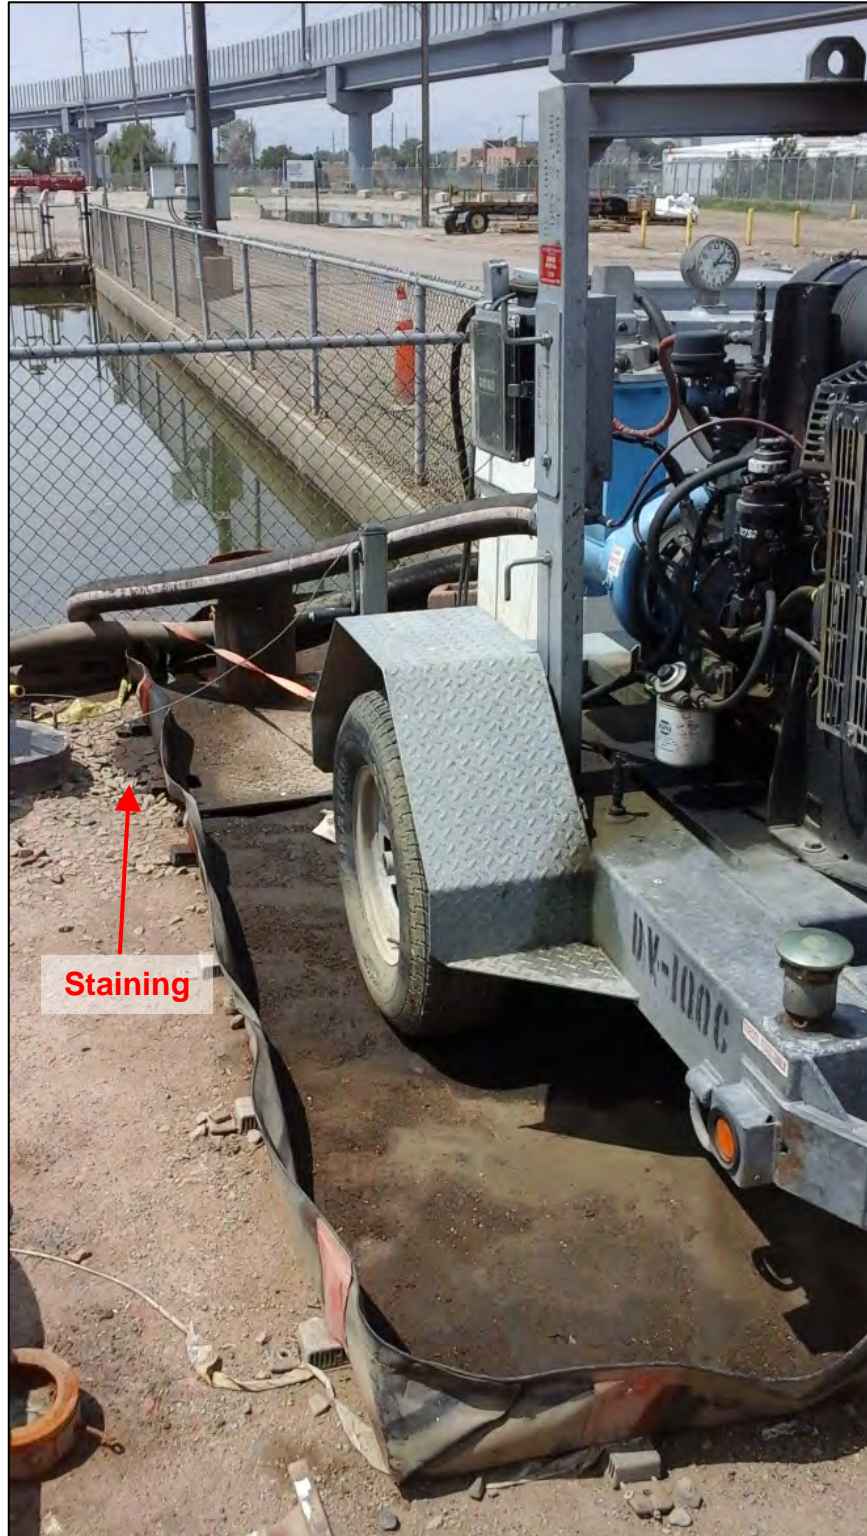
**Photograph 20.** View of the pump that transfers the contents of Finger Lake into Webber’s Pond or to the WWTP. The pump was located within secondary containment; however, petroleum product staining was observed on the ground surface outside of the containment.

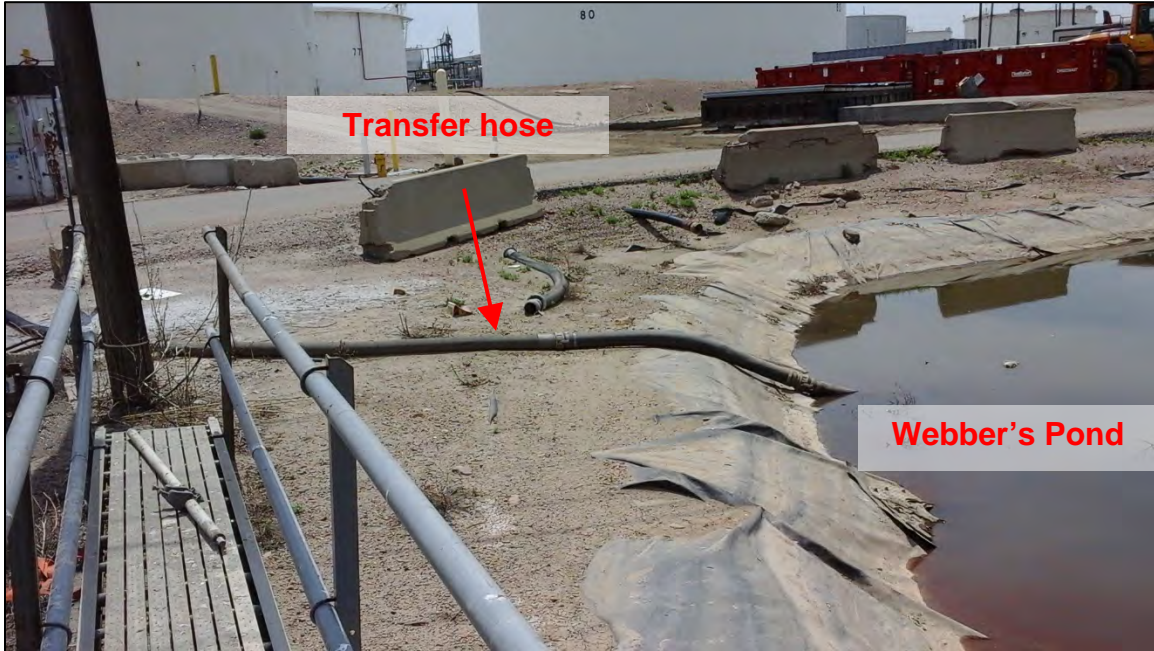
**Photograph 21.** View of transfer hose that connects Finger Lake and Webber's Pond.
