## **Appendix A - Photograph Log**

*Inspection Dates: June 22-24, 2021*

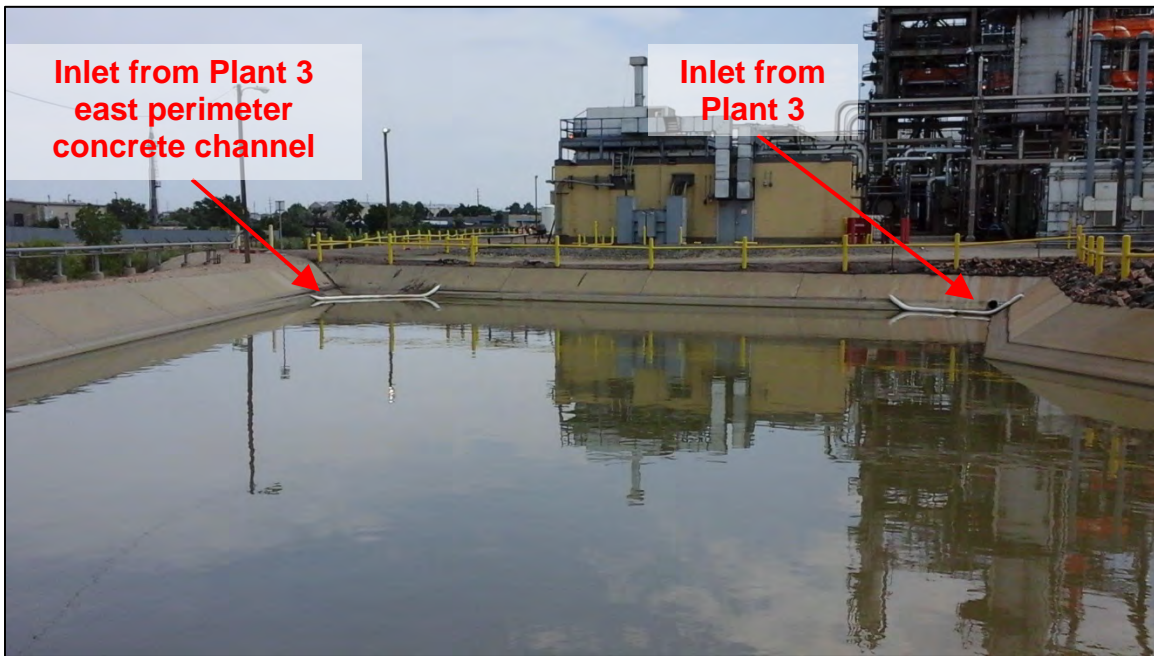
**Photograph 22.** View of Mary's Pond. This pond contained three inlets and one outlet to Outfall 004A. However, pumping equipment was also installed to pump the contents of Mary's Pond to the WWTP during normal conditions, as shown in Photograph 23.

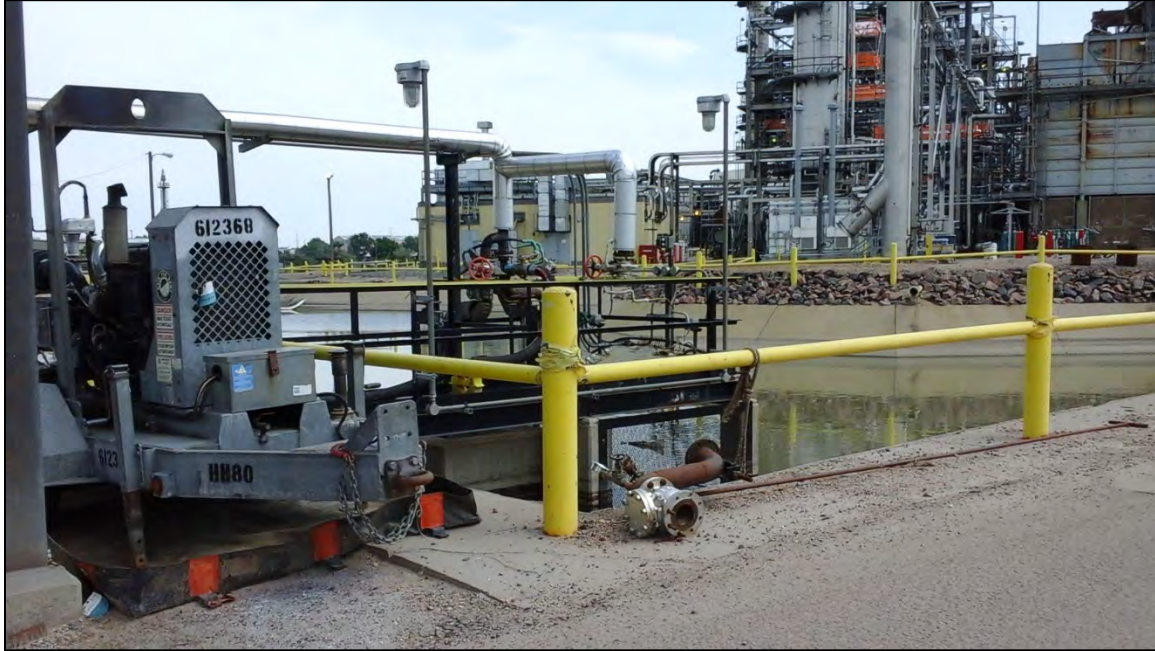
**Photograph 23.** View of the pump that transfers the contents of Mary's Pond to the WWTP during normal conditions.

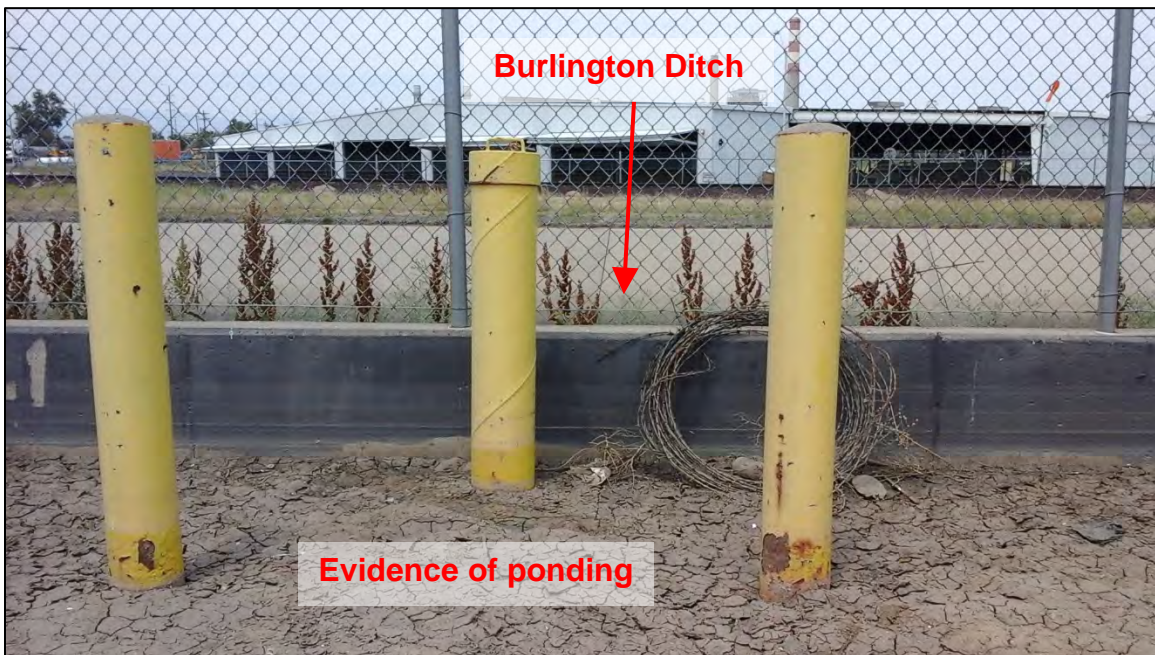
**Photograph 24.** View, facing south, of evidence of ponding between Webber's Pond and the western Facility wall adjacent to the Burlington Ditch. Mr. Marler explained that the 2015 overflow and discharge event from Webber's Pond to the Burlington Ditch occurred near this location.

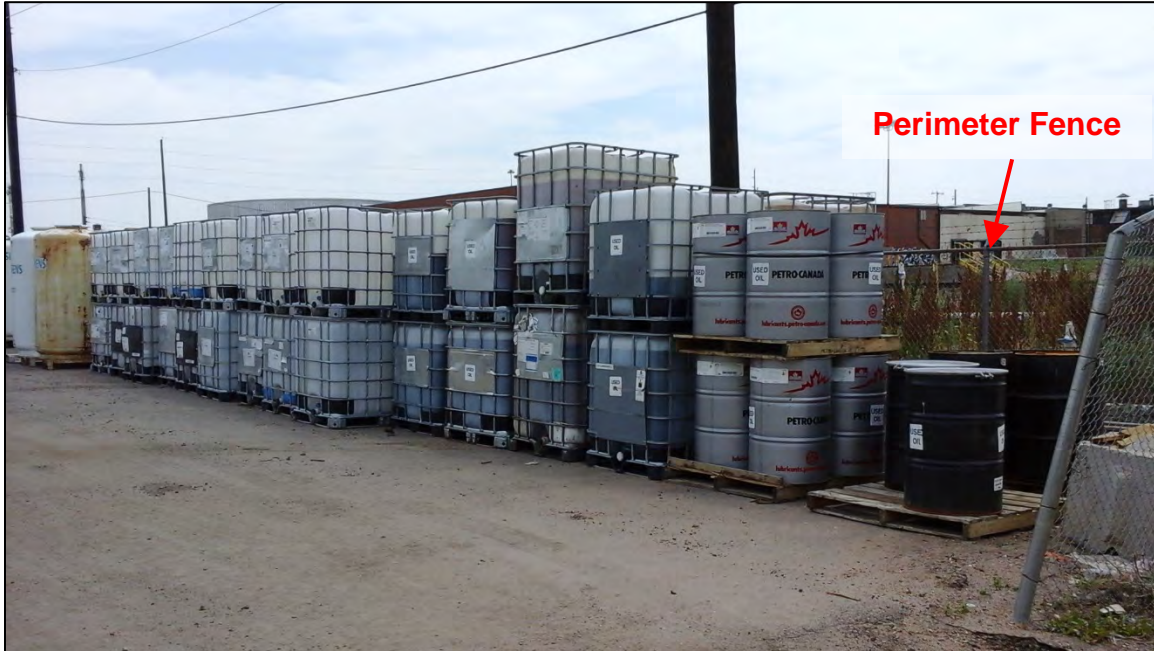
**Photograph 25.** View of waste chemical and used oil totes and drums storage area to the southeast of Webber's Pond. Secondary containment was not provided for these materials. Note the Facility's perimeter chain link fence.

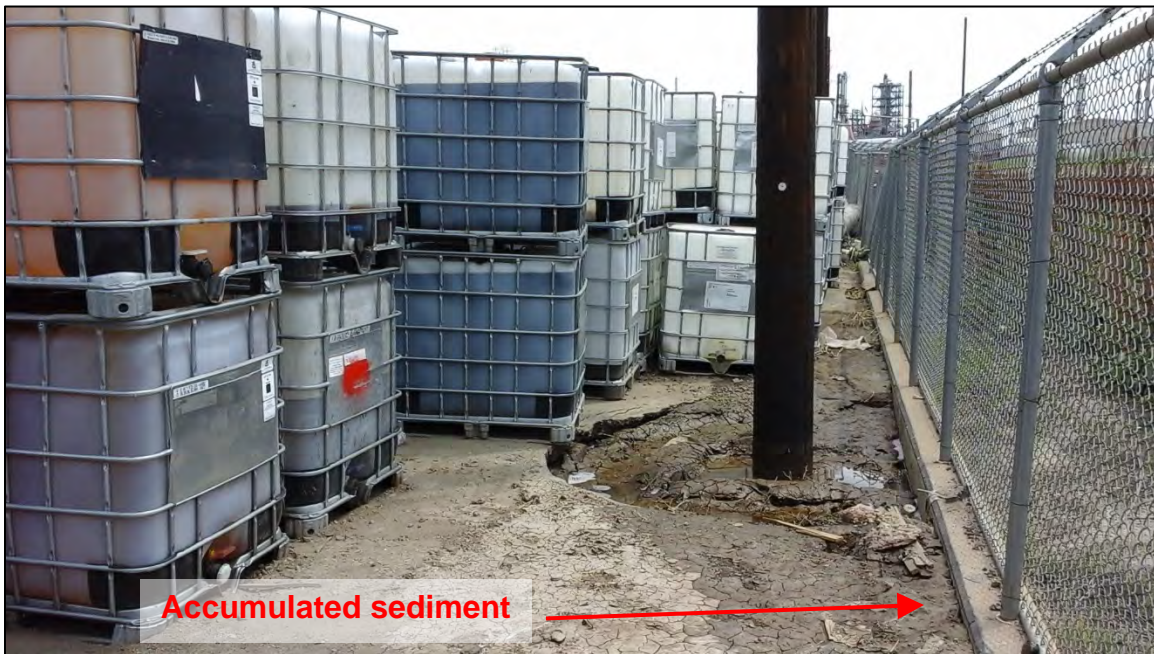
**Photograph 26.** View, facing north, of sediment accumulation against the Facility's south perimeter wall at the waste chemical and used oil storage area shown in Photograph 25. Note secondary containment was not provided for these totes of waste fluids.

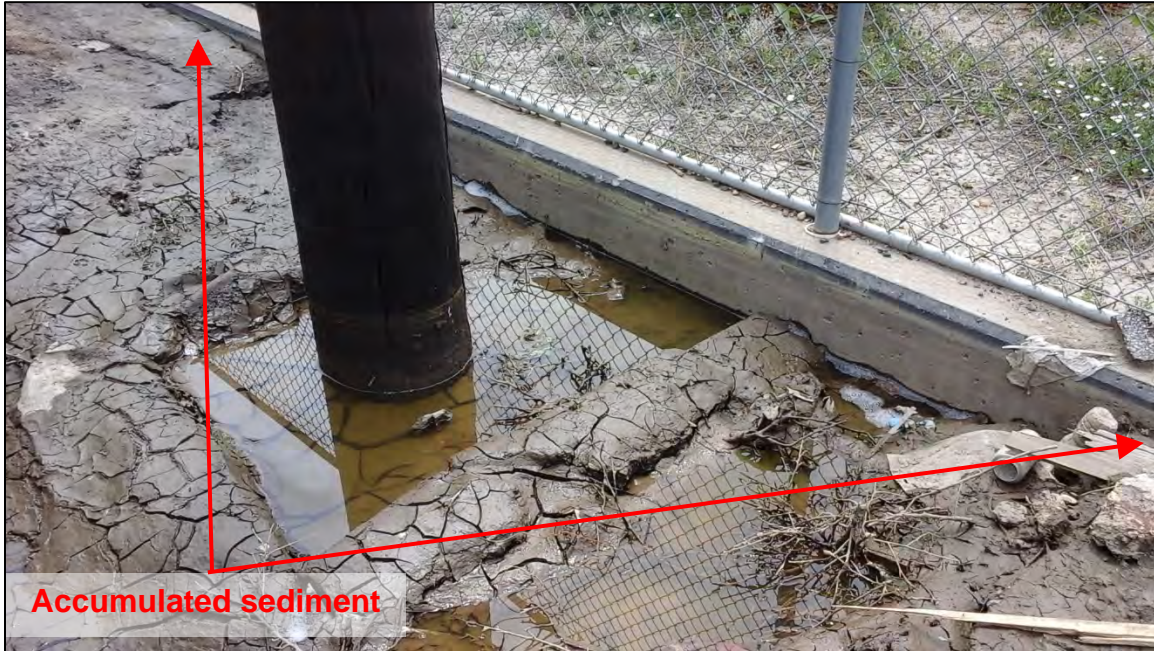
**Photograph 27.** Additional view of accumulated sediment along the south perimeter wall shown in Photograph 26. Note the depth of sediment varied along this perimeter wall.

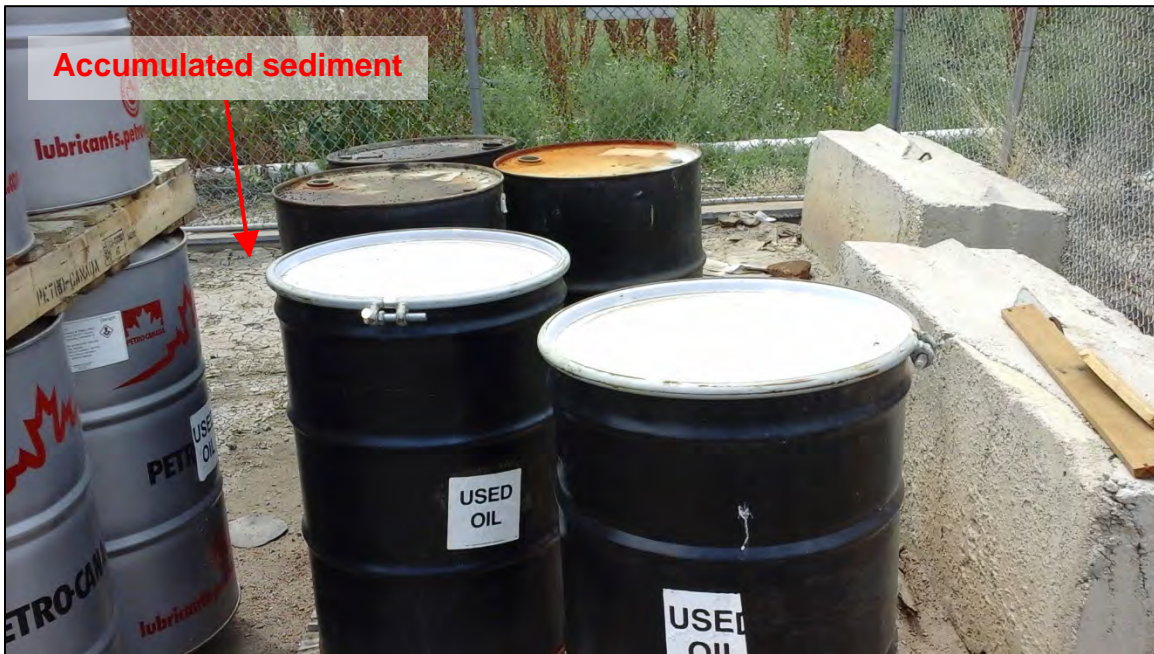
**Photograph 28.** Additional view of accumulated sediment along the south perimeter wall. Also note secondary containment was not provided for the 55-gallon drums of used oil.

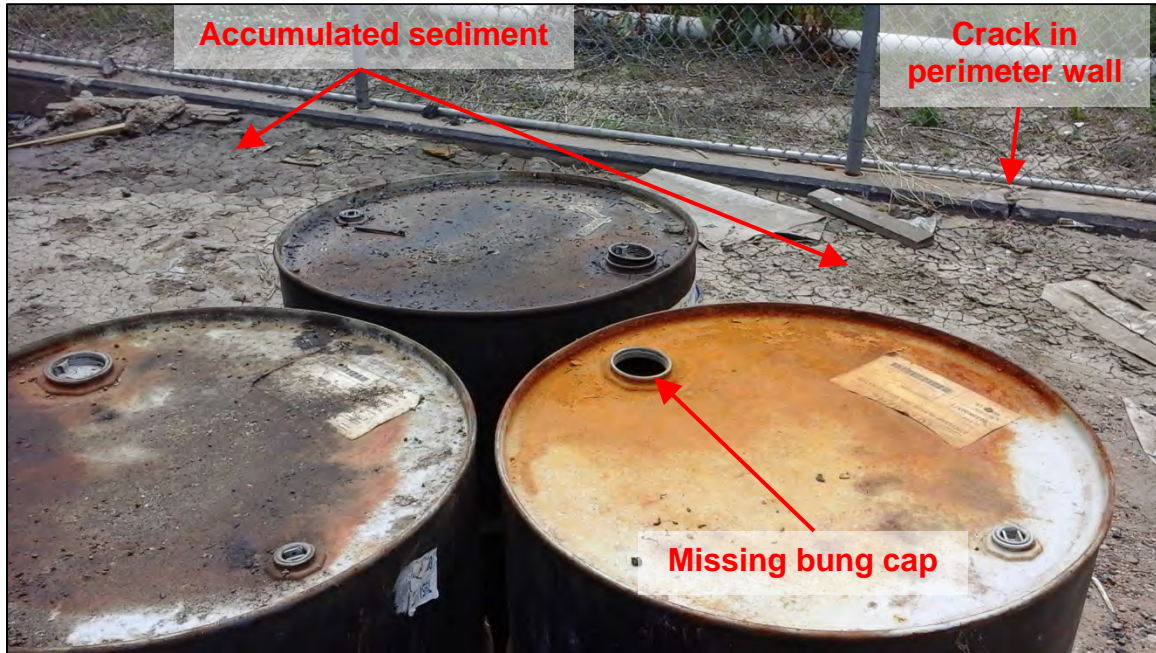
**Photograph 29.** Additional view of accumulated sediment along the south perimeter wall as shown in Photograph 28. Note one of the 55-gallon drums of used oil was missing a bung cap. Also note the crack in the perimeter wall (also shown in Photograph 30).

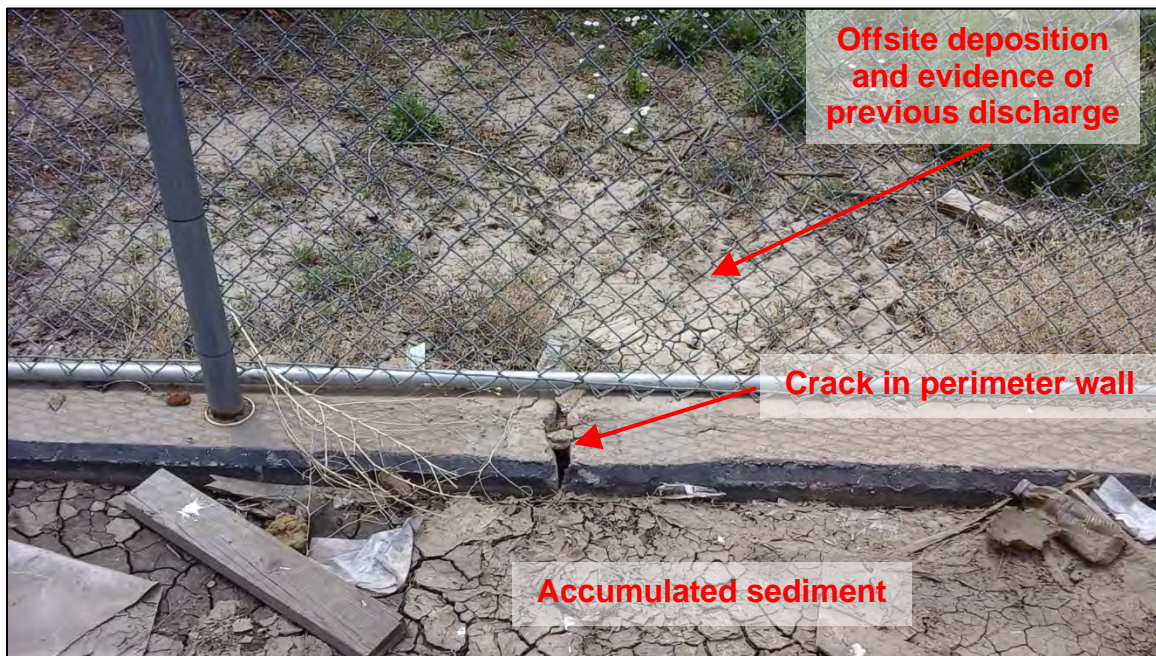
**Photograph 30.** View of a crack in the southern perimeter wall shown in Photograph 29. Evidence of previous stormwater and sediment discharges from this location were observed (e.g., deposition of sediment offsite on the opposite side of the wall).

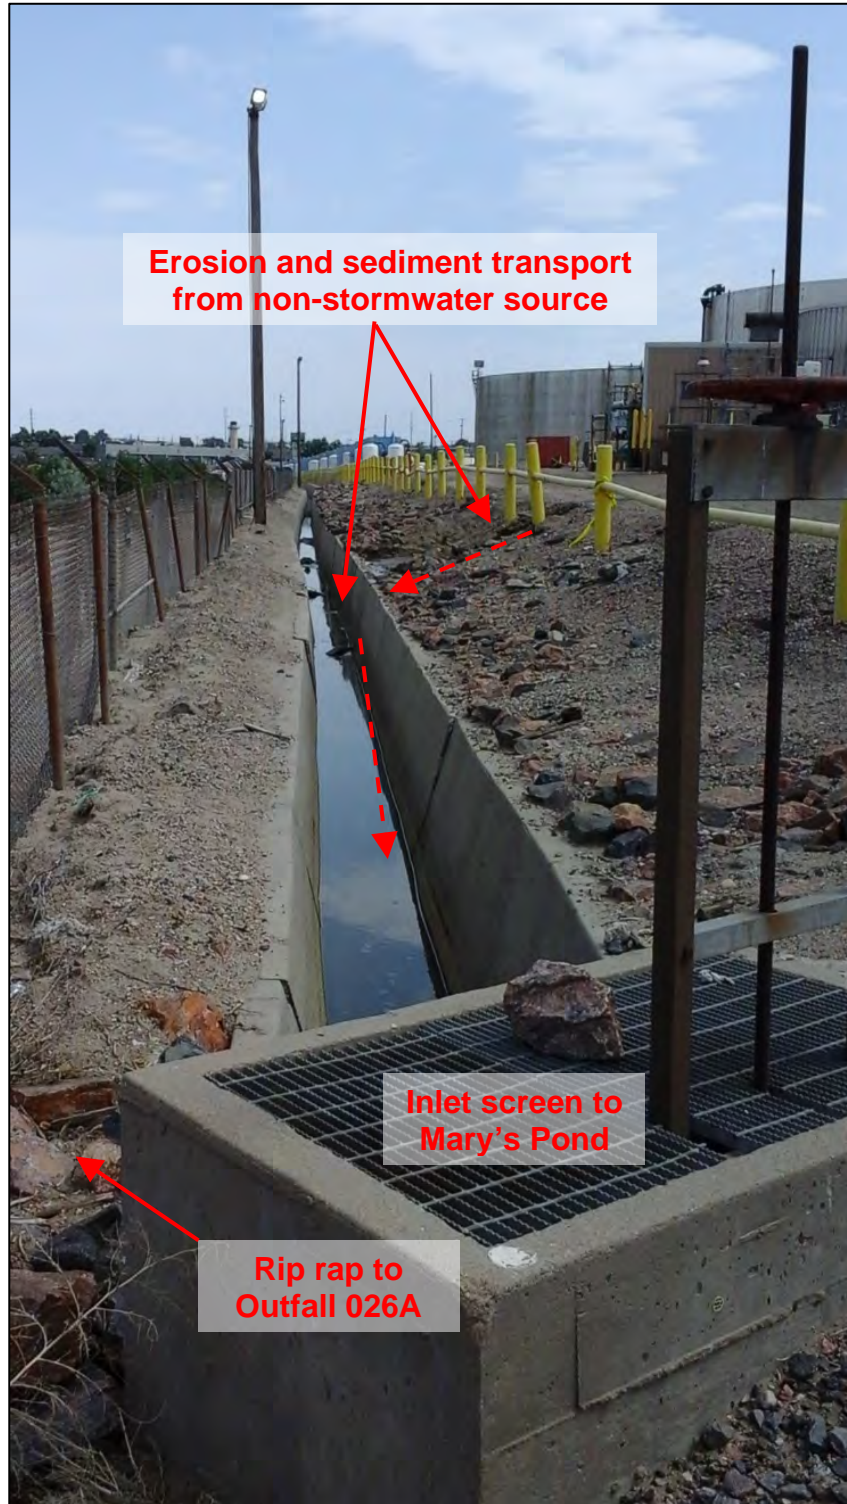
**Photograph 31.** View, facing south, of evidence of erosion occurring upgradient of the Plant 3 east perimeter concrete channel that leads to Mary's Pond (Outfall 004A) or to Outfall 026A during high flow events. Red dotted arrow indicates flow direction. According to Facility representatives this continual flow was from non-contact cooling water in Plant 3 into this channel. Note the slope above the channel was eroded due to the continual flow.

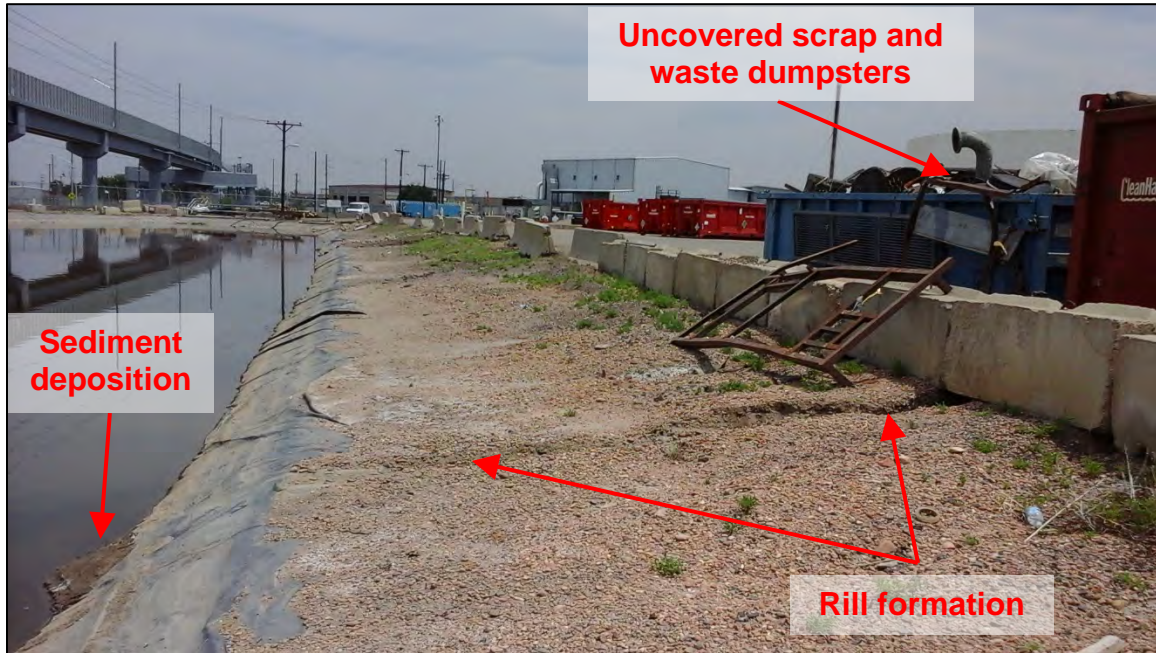
**Photograph 32.** View, facing north, of rill formation on the east embankment of Webber's Pond. Note the sediment deposited in Webber's Pond below the rill. Also note the uncovered scrap and waste dumpsters located upgradient of Webber's Pond.

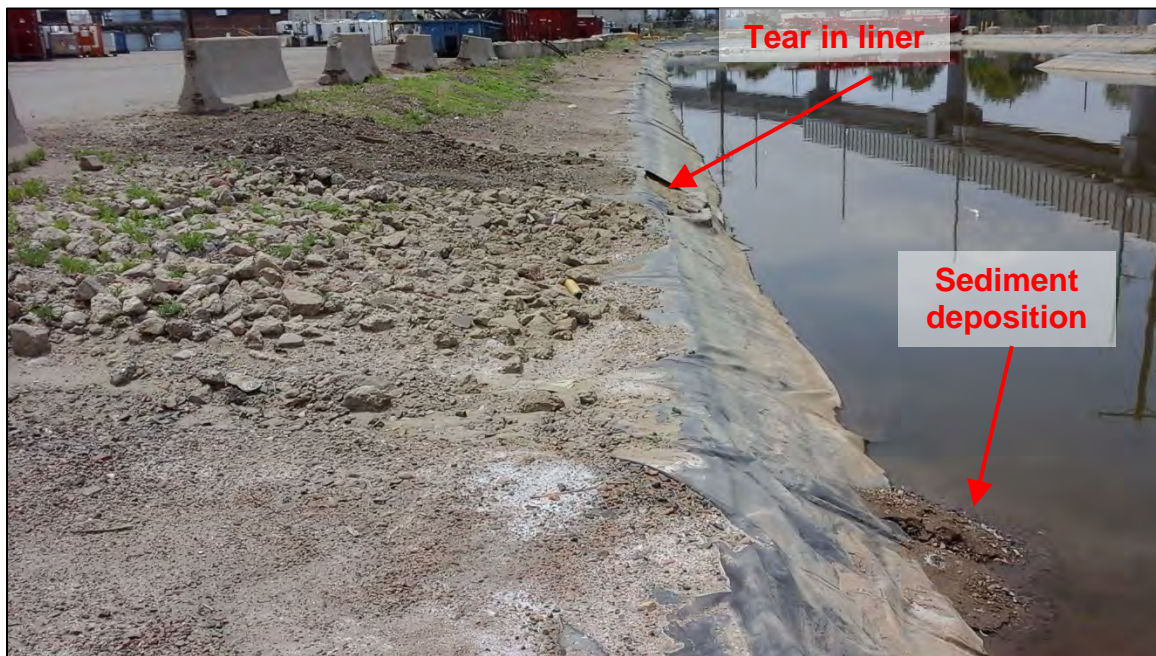
**Photograph 33.** View, facing south, of additional rill formations along the eastern embankment of Webber's Pond. Note the sediment deposited in Webber's Pond beneath the rill. Also note the torn poly liner for Webber's Pond, as shown in Photograph 36.

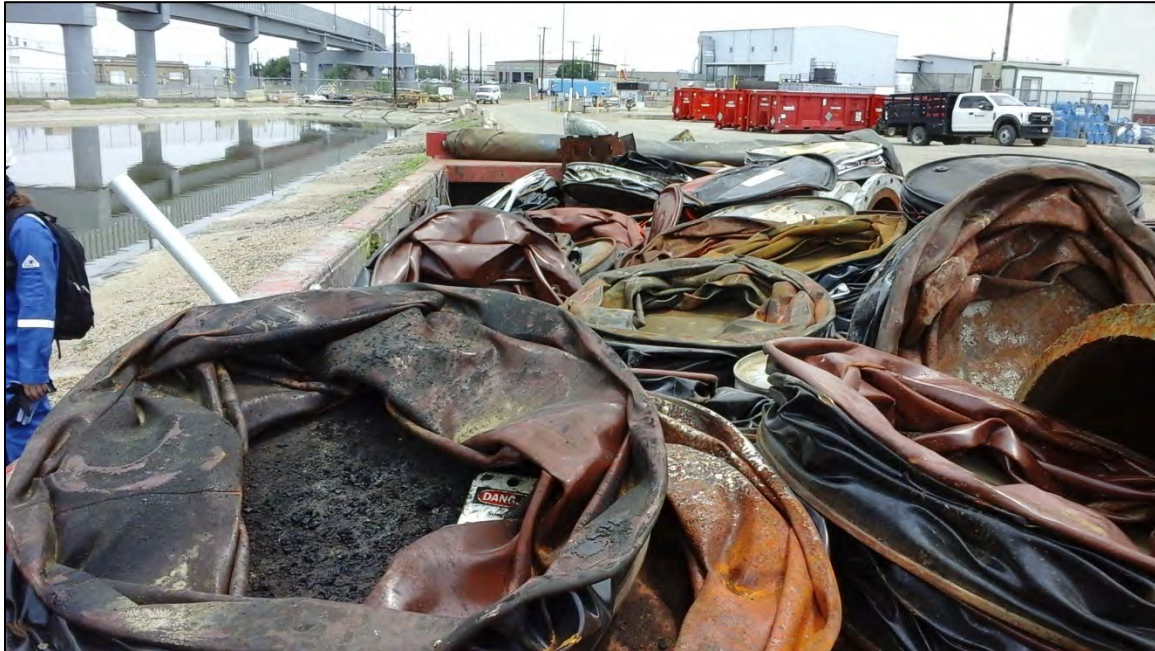
**Photograph 34.** View of crushed 55-gallon drums in one of the uncovered scrap and waste dumpsters located adjacent to Webber’s Pond, shown in Photograph 32.

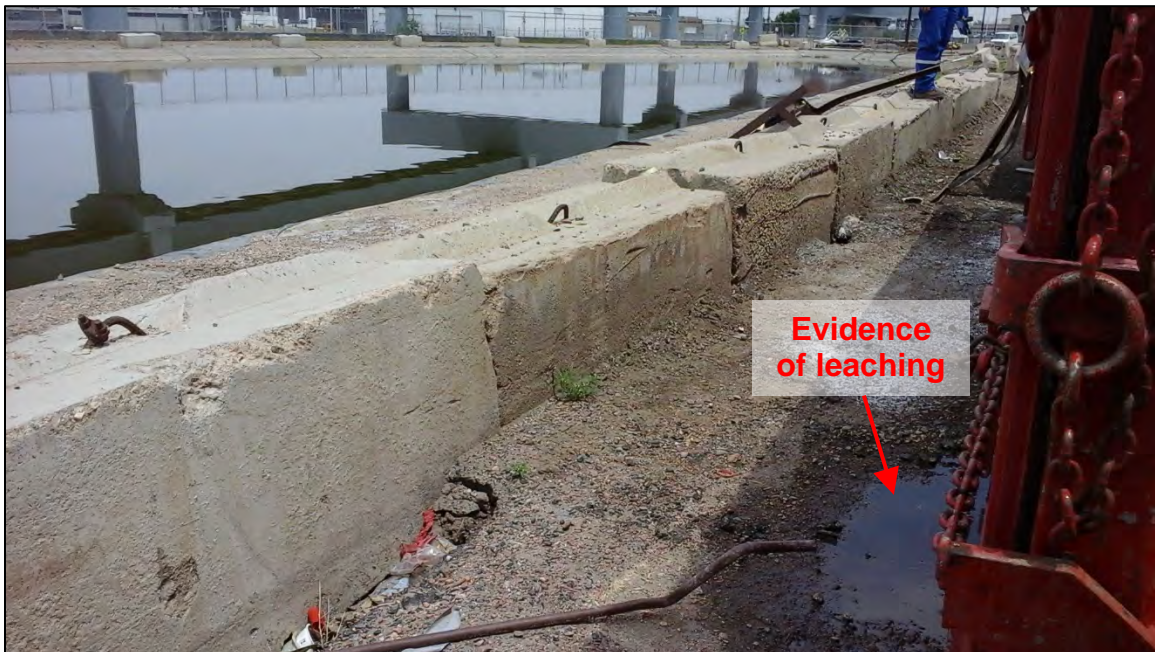
**Photograph 35.** View of leachate on the ground surface beneath the uncovered scrap and waste dumpsters shown in Photographs 32 and 34.

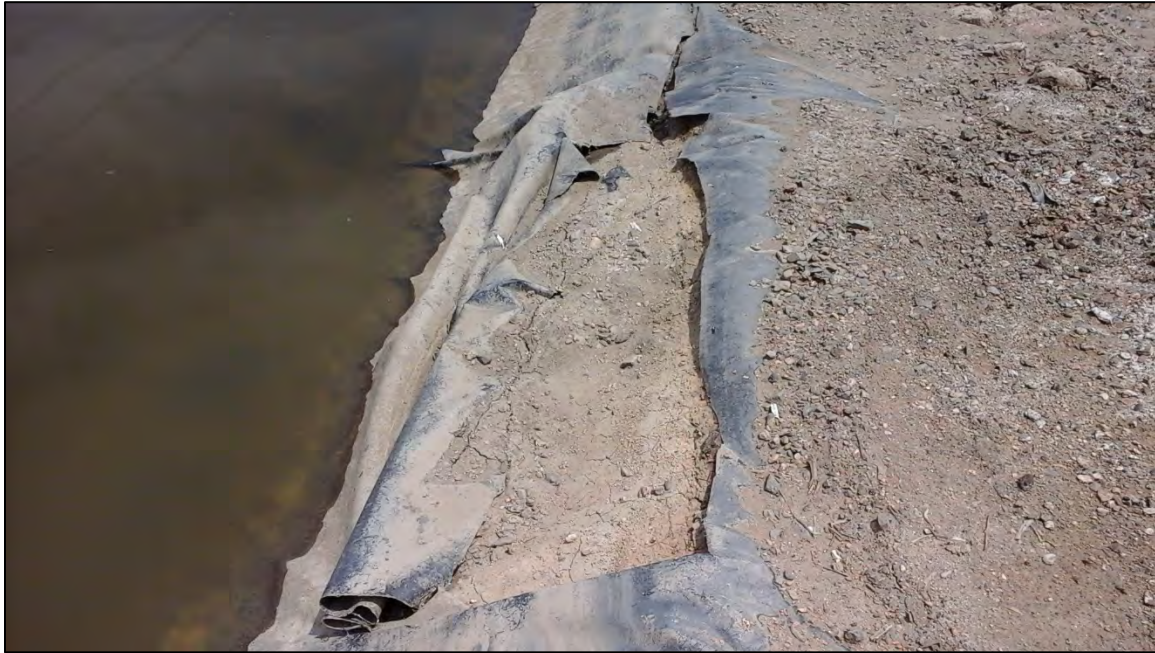
**Photograph 36.** Close-up view of the torn poly liner of Webber’s Pond shown in Photograph 33.

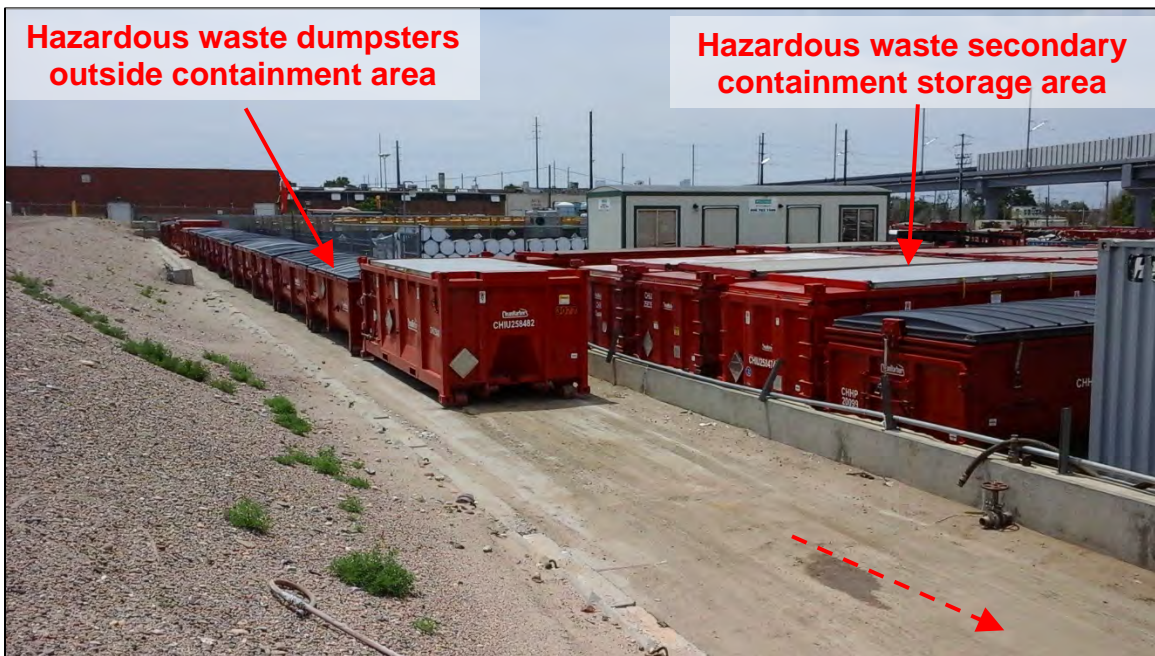
**Photograph 37.** View, facing southwest, of the hazardous waste storage area located in Plant 1, east of Webber’s Pond. Note six (6) red hazardous waste dumpsters were stored outside of this designated hazardous waste storage area and lacked secondary containment. Red dotted arrow indicates flow direction; refer to Photographs 38 and 39 for the observed flow pathway.

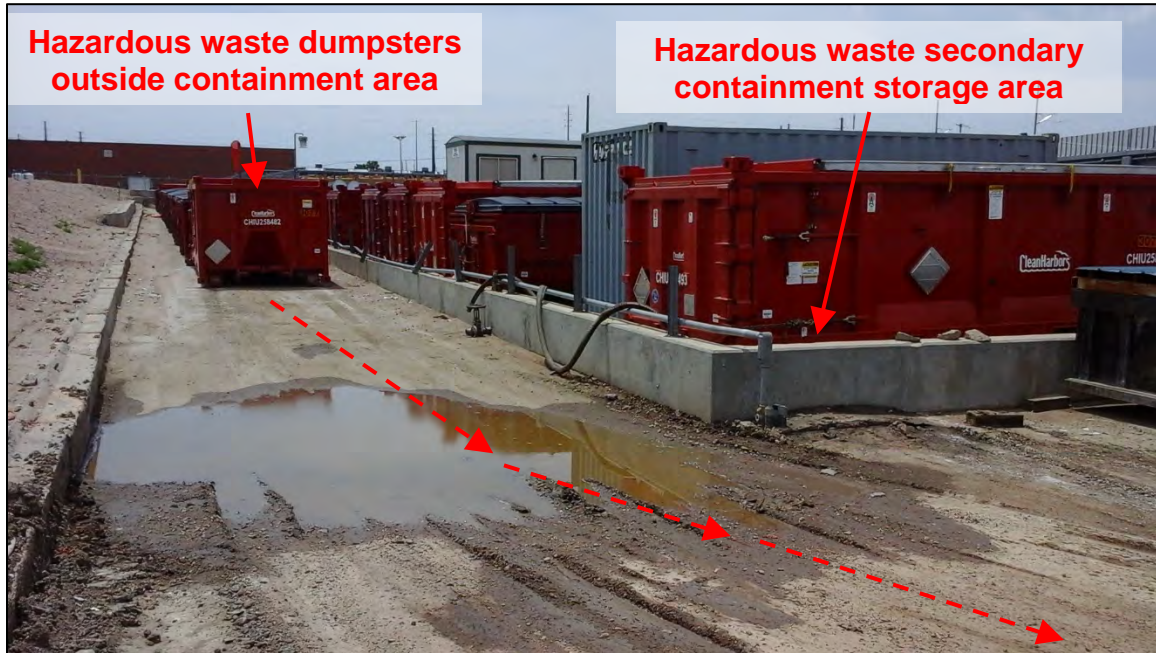
**Photograph 38.** View, facing south, of the hazardous waste storage area located in Plant 1, east of Webber's Pond. Red dotted arrow indicates flow direction; refer to Photograph 39 for observed flow pathway to Webber's Pond.

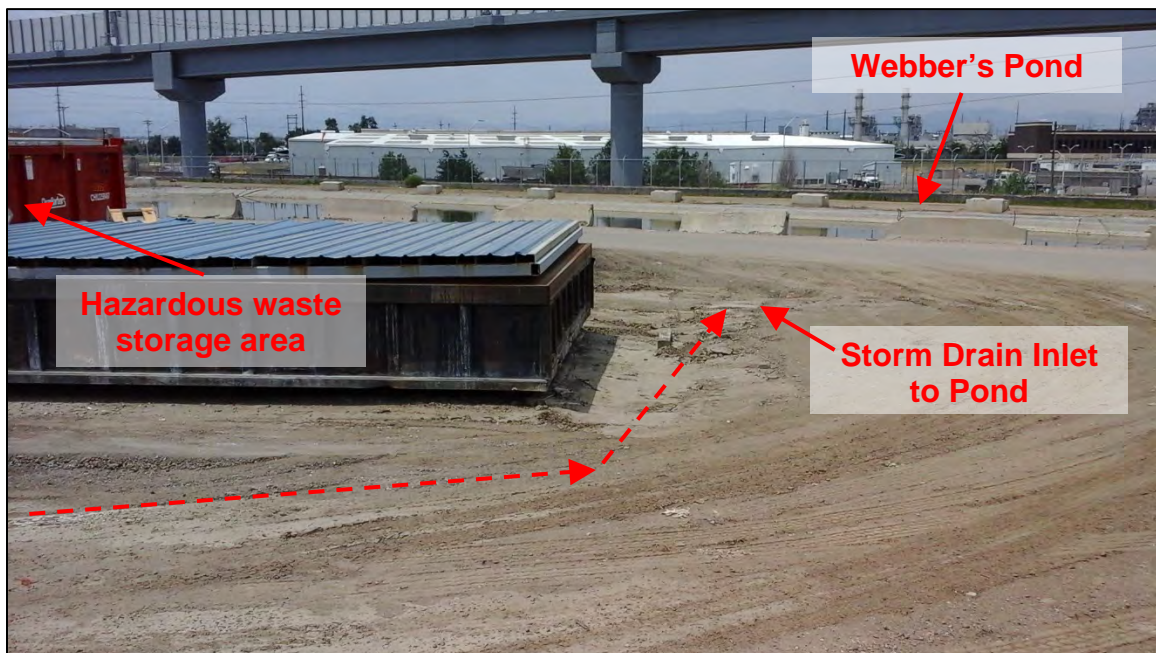
**Photograph 39.** View of the observed flow pathway from the area with the six (6) red hazardous waste dumpsters to Webber's Pond, as shown in Photographs 37 and 38. Stormwater runoff from this area enters a storm drain which flows to the adjacent Webber's Pond.
