Appendix B
Exhibit Log

Suncor Commerce City Refinery (COS000009)
 Compliance Evaluation Inspection Appendix B

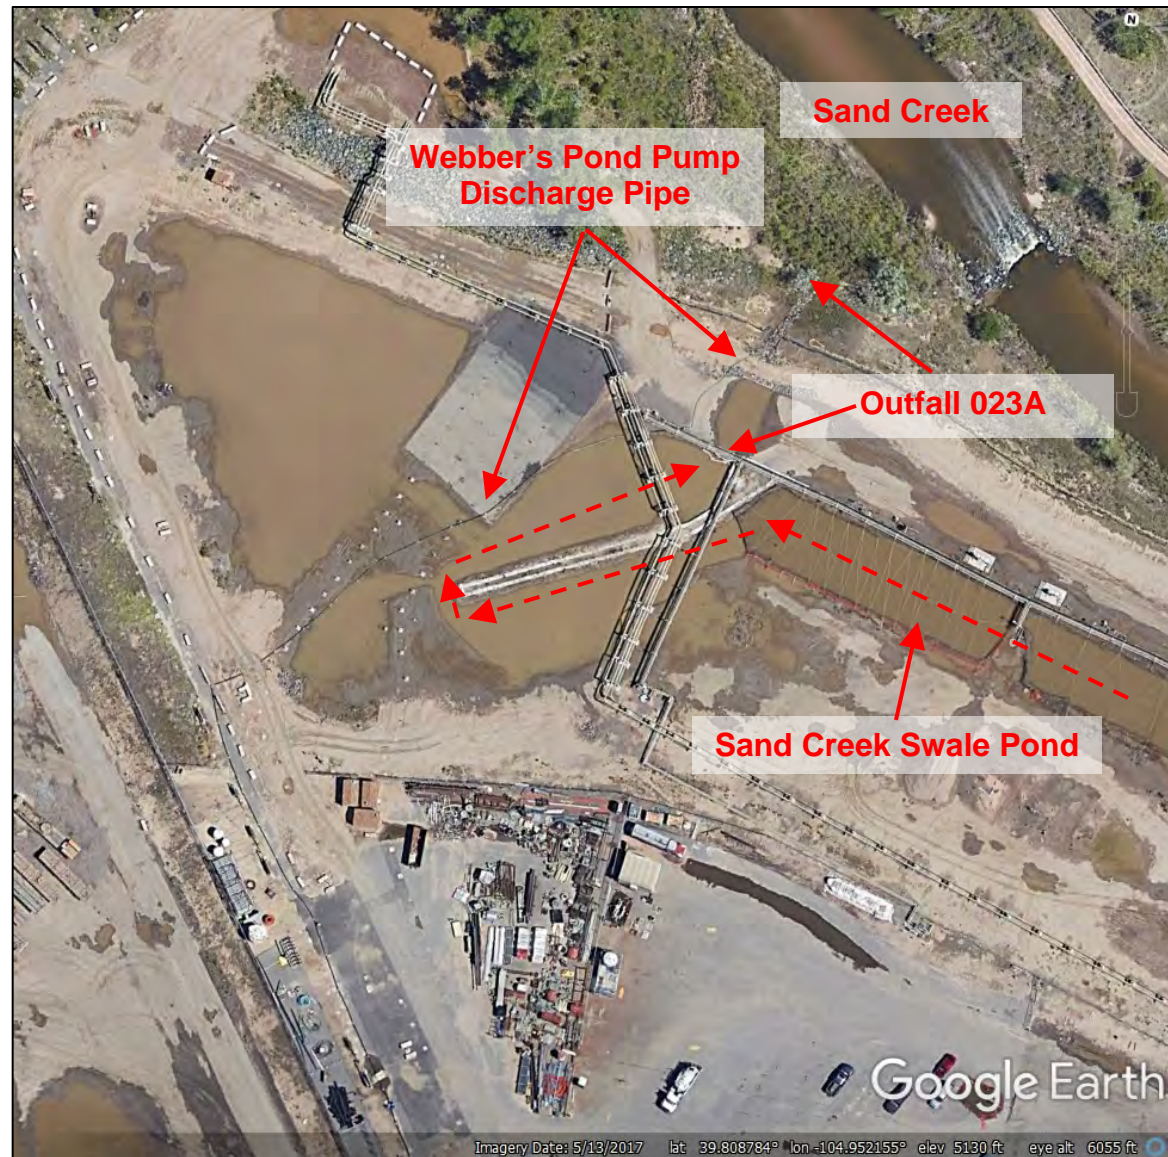
Exhibit 4
GoogleEarth Aerial Imagery Outfall 023A
May 13, 2017

**Sand Creek Swale Pond
Hydraulically Connected
to Stormwater Detention
Area and Outfall 023A**

In reviewing historic GoogleEarth imagery of the facility, we observed potential hose lines leading to Outfall 023A and Sand Creek visible in May 13, 2017, June 9, 2017, and May 31, 2018 imagery (see attached). A second potential hose line is also visible in vicinity of Outfall 023A in the May 31, 2018 imagery. Do you know if the lines visible at the outfall in these images are actual stormwater discharge lines and if they were installed for the March 2016 discharge event? Can you confirm the number of instances and dates when Webber's Pond was discharged to Outfall 023A since the March 2016 pumping event discussed in the corrective action.

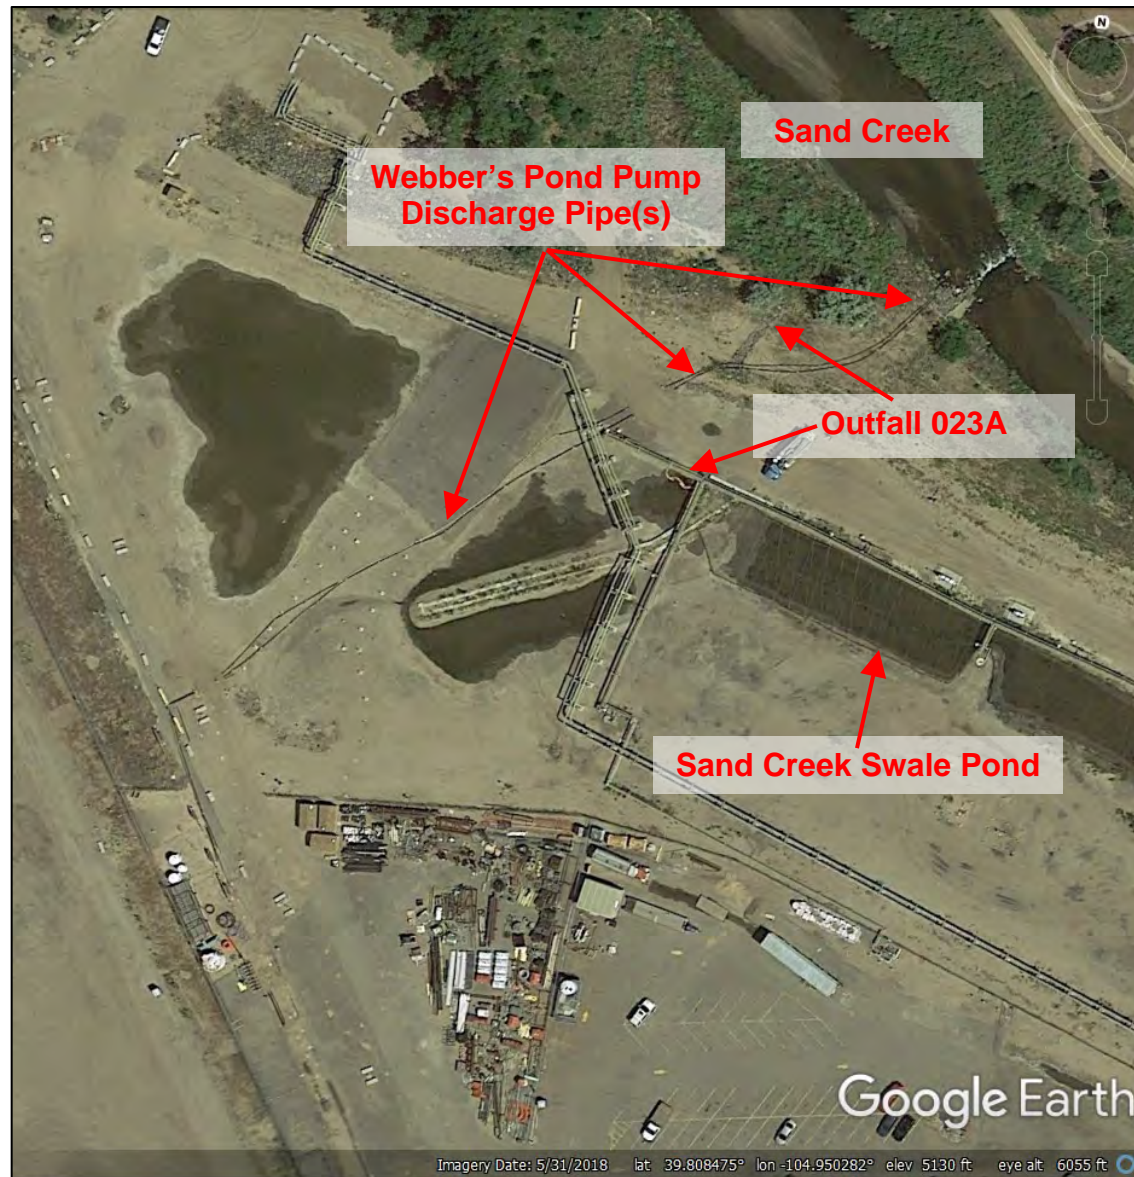
Exhibit 6
GoogleEarth Aerial Imagery Outfall 023A
May 31, 2018

The Google Earth image from May 2018 shows the line between Webber's Pond and Outfall 023A was disconnected upstream of the outfall. This is because earlier in that year we needed to pump the area of Webber's Pond again to avoid discharge into Burlington Ditch. However, there was plenty of capacity in the pond associated with 023A, so the water was pumped into the pond rather than the outfall, and no discharge was necessary.

The second line shown in the image from May 2018 extending to Sand Creek was used for bypass of the wastewater line between Outfall 020A and Sand Creek. This was used to allow tie in to the new flume associated with Outfall 020A in late 2017 and again in May 2018 to replace a reducer downstream of the flume to correct an issue with flow out of the flume. By the time of the Google Earth image on May 31, 2018, the line was no longer in use and had been partially removed. By the time of the 2019 Google Earth image, all the temporary piping had been removed and has not put into place again, since.

Completion of the Membrane Bioreactor (MBR) project and combination of outfalls in 2018 has resulted in additional hydraulic capacity through Outfall 002B. Therefore, Suncor does not anticipate the need to reinstall these temporary lines in the future.
