**U.S. ENVIRONMENTAL PROTECTION AGENCY
 REGION VIII WATER BRANCH, ENFORCEMENT
 AND COMPLIANCE ASSURANCE DIVISION
 CLEAN WATER ACT
 COMPLIANCE INSPECTION REPORT**

Name of Facility: Suncor Energy (USA) Inc. Commerce City Refinery
Facility Address: 5801 Brighton Blvd., Commerce City, CO 80022
Mailing Address: 5801 Brighton Blvd., Commerce City, CO 80022

Type of Inspection: Industrial Stormwater CEI
Owner: Suncor Energy (USA) Inc.
Operator: Suncor Energy (USA) Inc.
Permittee: Suncor Energy (USA) Inc.
NPDES Permit No: COS000009
NPDES Permit Effective Date: September 27, 2012
NPDES Permit Expiration Date: October 31, 2017 (administratively extended)
SIC Codes: 2911, 3599
Number of Outfalls: 9
Receiving Water: Sand Creek; Unnamed tributary to the South Platte River
Latitude and Longitude: 39.75 N, -104.883333 W

Inspection Dates: June 22, 23, and 24, 2021
Approximate Entry Time: 9:00 a.m. (MDT) on June 22, 2021
Approximate Exit Time: 3:40 p.m. (MDT) on June 24, 2021

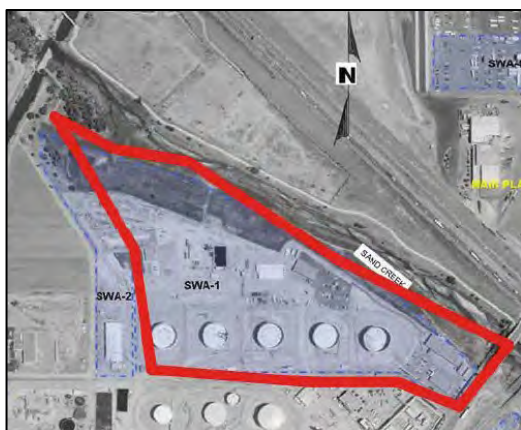
Figure 1. SWA Nos. 1 and 2.

Stormwater runoff from SWA Nos. 1 and 2 (areas within Plant 1 where stormwater runoff is not treated by the WWTP; see Figure 1) is collected in the stormwater detention area upgradient of Outfall 023A (refer to [Appendix A, Photographs 6 and 13](#)). This stormwater detention area also receives runoff from the contaminated groundwater swale (referred to as the Sand Creek Swale Pond, see Figure 2) located between Plant 1 and Sand Creek during significant storm events (refer to [Appendix A, Photograph 12](#)). Additionally, stormwater runoff from an unnamed stormwater detention area located immediately east of the groundwater treatment systems (GWTS) (refer to [Appendix A, Photograph 11](#)) also drains to the stormwater detention area at Outfall 023A. Stormwater runoff from SWA No. 2 first collects in a concrete conveyance channel that runs north and northwest along the boundary of Plant 1 and adjacent to Metro Wastewater Reclamation District property and ultimately conveyed by culvert into the stormwater detention area at Outfall 023A.

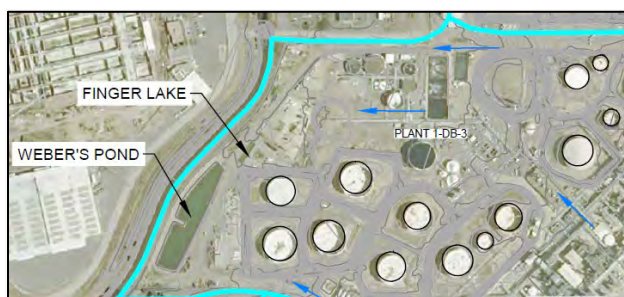
Figure 3. Plant 1 drainage and location of Finger Lake and Webber's Pond.

Stormwater runoff from the remaining portions of Plant 1 that does not flow to the stormwater detention area at Outfall 023A or to Outfall 025A and is not captured and conveyed to the Facility's oily water and non-oily water sewer systems which flow to the WWTP, drains to two impoundments referred to as Finger Lake and Webber's Pond located on the western portion of the Facility (refer to [Appendix A, Photographs 17 and 18](#) and Figure 3). Finger Lake is a concrete lined rectangular impoundment which collects both stormwater runoff and non-stormwater sources, including firefighting training waters. Webber's Pond is a poly-lined impoundment located approximately 50 feet east of the Burlington Ditch waterway. According to Facility representatives, stormwater that accumulates in the tank farm secondary containment areas may also be pumped to Webber's Pond to promote evaporation. Mr. Marler (Suncor's Sr. Environmental Advisor) explained that stormwater and non-stormwater that collects in these two impoundments is not discharged through any stormwater Permit (CDPS Permit No. COS0000009) outfalls. He explained that Finger Lake may be pumped to the WWTP for treatment after being sampled for WWTP effluent parameters (CDPS Permit No. COS0001147). If the samples show compliance with Permit conditions, it is pumped (refer to [Appendix A, Photograph 23](#)) directly to Lagoon 1 of the WWTP (bypassing the majority

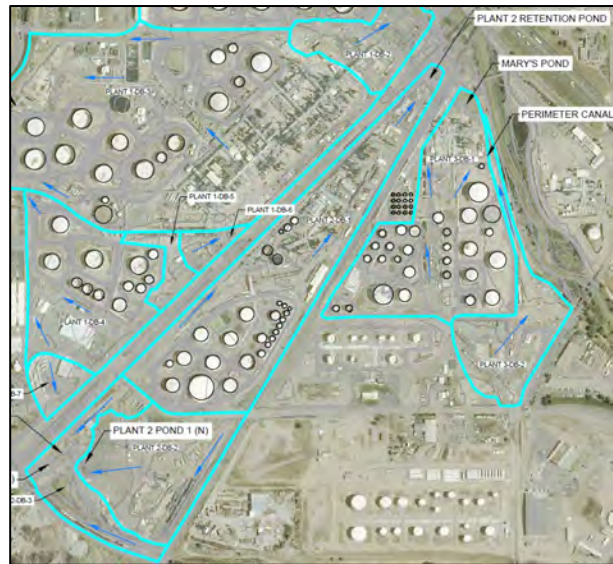
Figure 5. Plant 2 drainage.

Runoff at Plant 2 generally flows north and northeast toward Sand Creek; however, the south side of Plant 2 drains to the south and southwest into an unnamed tributary to the South Platte that follows a railroad right-of-way to the west along the Facility's southern boundary (see Figure 5). Stormwater runoff from Plant 2 that is not captured (primarily employee parking area) by the oily water and non-oily water sewer systems collects in a stormwater detention basin located upgradient of Outfall 024A (refer to Appendix A, Photograph 9). According to Facility representatives, this basin is normally pumped back to the WWTP headworks for treatment but can discharge to Outfall 024A via gate valve, as needed.

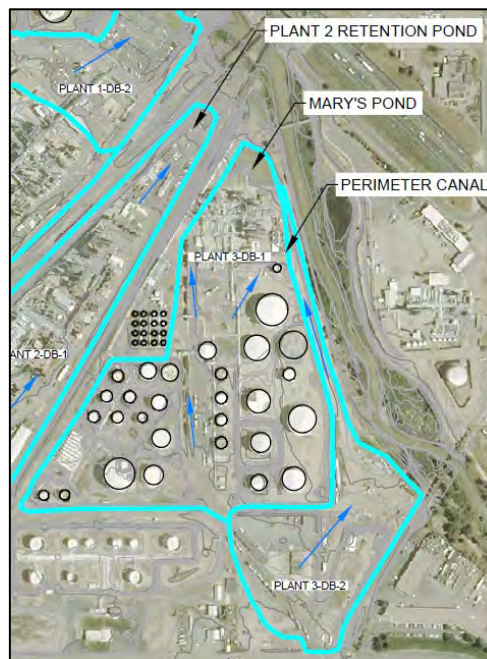
Figure 7. Plant 3 drainage.

Runoff at Plant 3 generally flows to the north towards Mary's Pond or Sand Creek via the north entrance road (see Figure 7). During the inspection, Facility representatives explained that Outfall 027A, a manual release outfall associated with SWA No. 6, is no longer utilized for stormwater discharges. Stormwater runoff from Plant 3 is captured in Mary's Pond, a concrete lined stormwater retention basin. According to Facility representatives, during normal conditions, all stormwater runoff captured in this pond is pumped to the WWTP headworks for treatment (refer to Appendix A, Photographs 22 and 23). During significant storm events, Mary's Pond is discharged to Sand Creek through a manually controlled valve to Outfall 004A (refer to Appendix A, Photograph 2). During significant storm events, a concrete conveyance channel flowing northwest along the eastern perimeter of Plant 3 into Mary's Pond may overtop the channel wall upstream of the inlet into Mary's Pond. Stormwater that overtops this channel overland flows north into Sand Creek (refer to Appendix A, Photograph 10). This high flow contingency discharge point has been permitted by CDPHE as Outfall 026A.
