**RCRA FACILITY ASSESSMENT
REPORT**

**PRC Environmental Management, Inc.
October 1993**

**RCRA FACILITY ASSESSMENT REPORT
SOUTHERN PACIFIC
TRANSPORTATION COMPANY
HOUSTON, TEXAS
TXD000820266**

October 1993

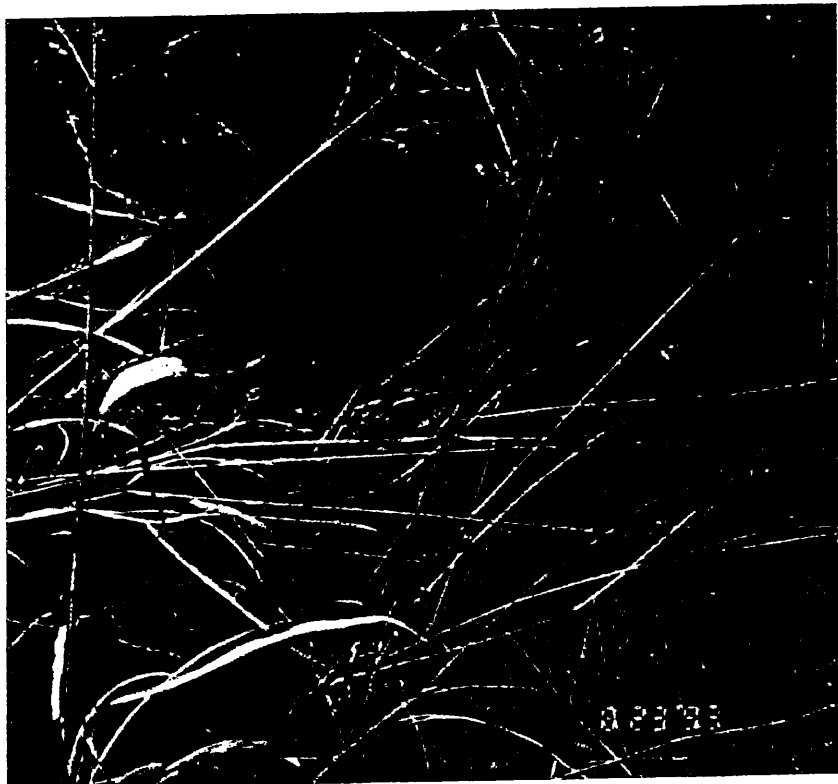
PHOTOGRAPH NO. 3

In 1986, TWC representatives observed dark standing water and stressed vegetation in the NDD. Sap wastewater contaminated with naphtha and creosote had been discharged directly into the SDD. According to facility representatives, TDWR had installed a weir downstream of the site, during the 1970's, to prevent contaminated runoff from the SDD from entering Buffalo Bayou. The weir prevented drainage of the natural ditch, which increased the level of ponding in the low inactive wastewater lagoon.

en by: K. Matherne Direction Facing: North
ainage ditch (SWMU No. 2), west of the facility boundary.

PRC recommends an RFI of the drainage ditches.

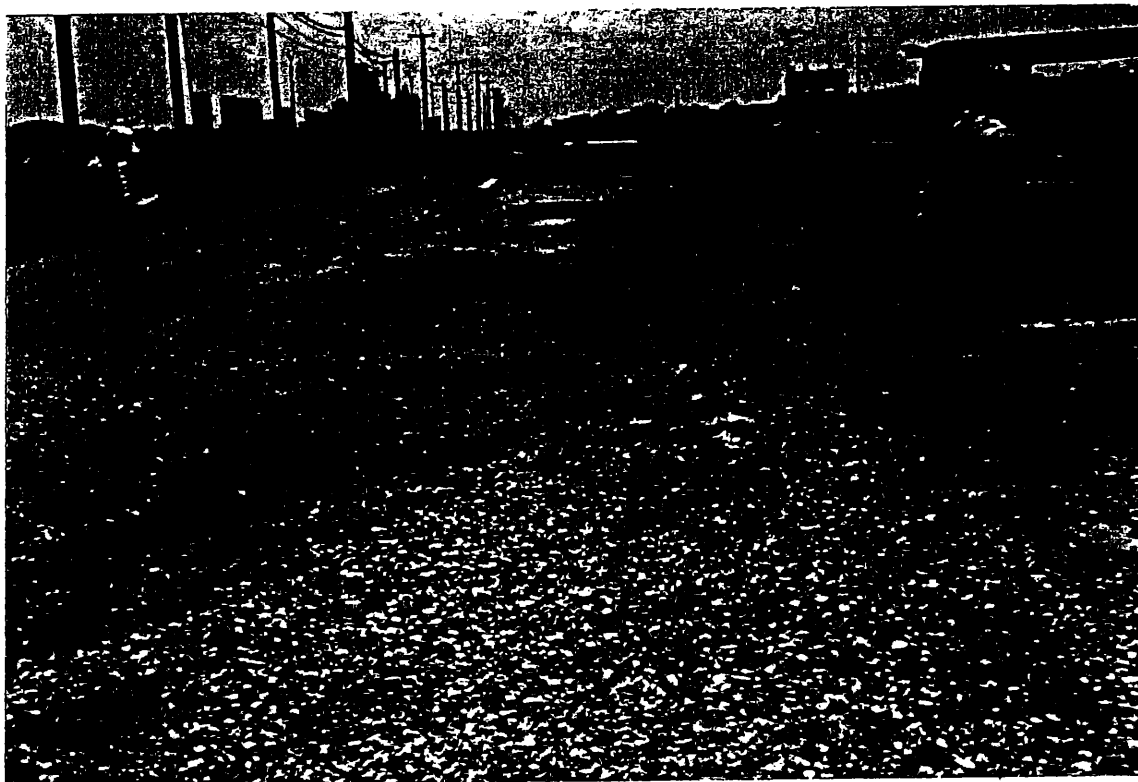
PHOTOGRAPH NO. 5

No information concerning environmental releases was available for the original process area. In 1990, during closure procedures for the UST, surface soil contamination was encountered in the vicinity of UST No. 44-023-05. SPTCo representatives assumed that the contamination did not originate from UST releases, but from previous activity in the original process area, where the UST was located. The diesel storage tank (AOC No. 1), is also located within the SWMU, showed evidence of stained gravel and soil during the VSI.

Contaminated soils encountered during the closure of UST No. 44-023-05, which was located in the original process area, indicate possible releases from the original process area or UST 44-023-05. Stained gravel and soil below the diesel storage tank indicated a possible release. In addition, no information is available concerning the treatment process or waste management activities at the original process area.

Date: 08/23/93 Picture Taken by: K. Matherne Direction Facing: Southwest
Picture Description: Location of Former UST no. 44-023-05 (SWMU No. 9), which is within the
original process area (SWMU No. 5)

PRC recommends an RFI of the original process area.

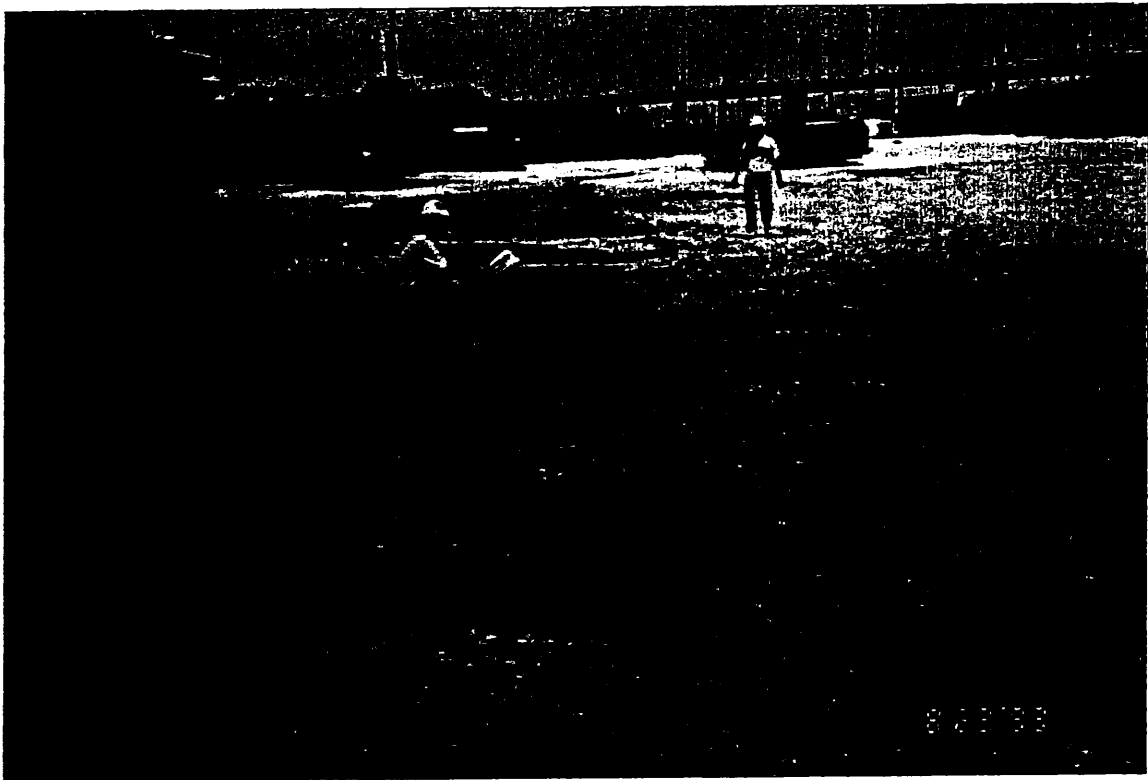
Date: 08/23/93 Picture Taken by: K. Matherne Direction Facing: East
Picture Description: Concrete pad, believed to have been the location of the boiler (SWMU No. 6);
the area is now used for material storage.

PRC recommends an RFI of the water treatment and boiler system, including the former cooling tower.

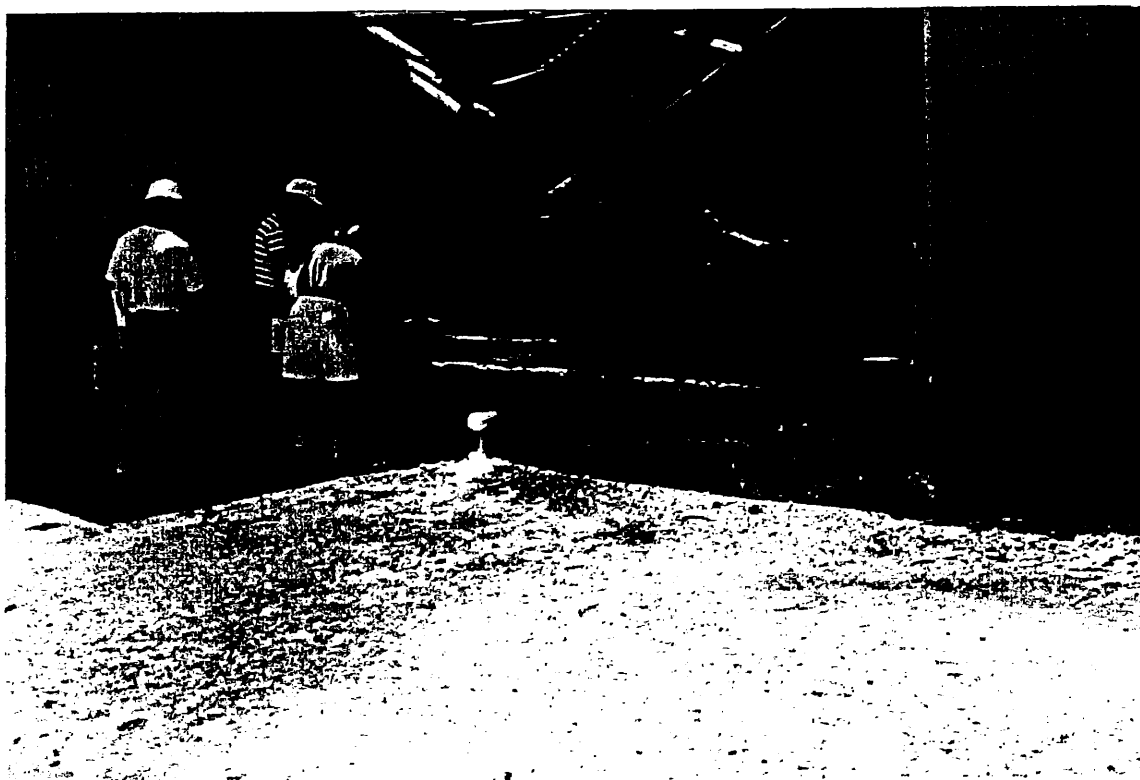
Next and east of the treatment building was a concrete tank enclosed in a metal building. The tank was rectangular, measuring about 30 by 15 feet. The tank was above ground. It had cinder block walls, about 3 feet tall by 1 foot wide. The tank opening was covered with wooden planking; rolls of chain-link fencing were stored on top. The view inside the tank was obscured, but standing water and wood debris were observed inside the tank. PRC could not determine whether the tank extended below grade. A 2- to 4-inch-diameter pipe was observed extending from the south wall of the tank. A hard, white, granular accumulation of an unknown substance was observed around the open end of the pipe. SPTCo representatives did not know the nature or cause of the accumulation and did not have any information concerning the function of the tank in the water treatment system.

Date: 08/23/93 Picture Taken by: K. Matherne Direction Facing: Northwest
Picture Description: Above-grade concrete tank in the former water treatment area (SWMU No. 6);
note the white crystalline powder in the pipe protruding from the side of the wall (center of
photograph).

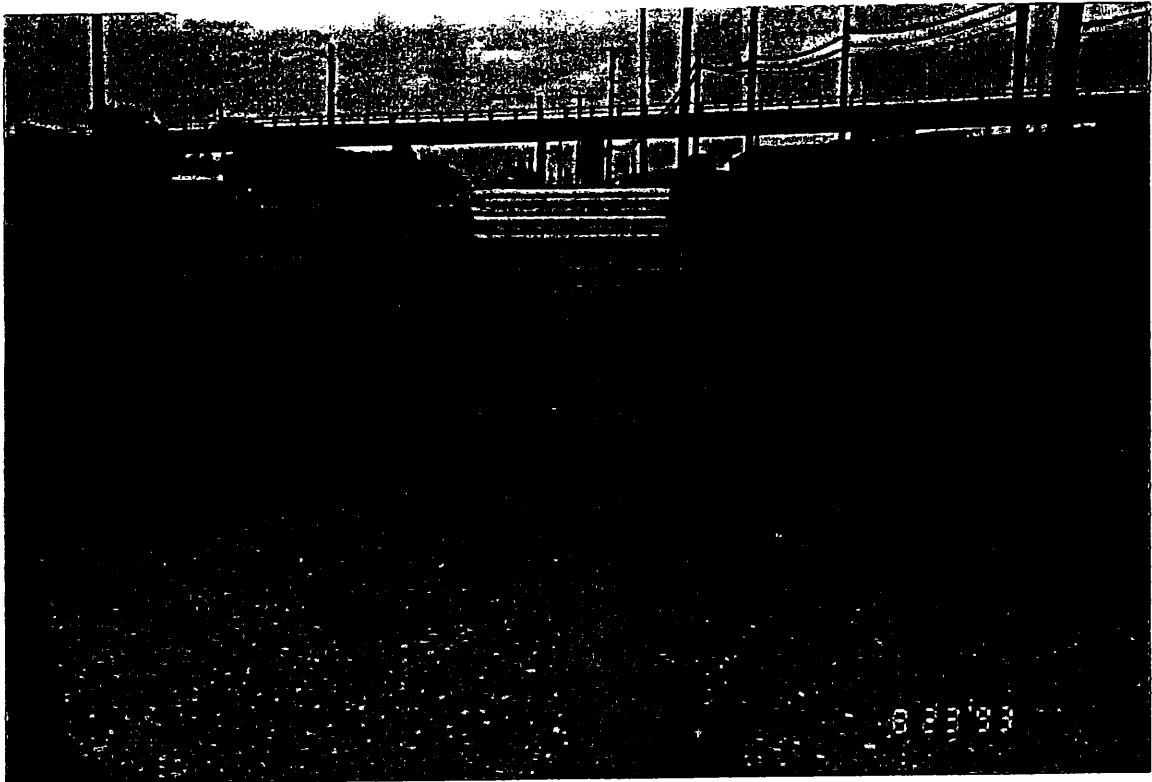
PHOTOGRAPH NO. 9

Picture Description: Former aboveground storage tank (AST) area (SWMU No. 8); the base of a former AST is visible in the bottom center of the photograph.

PRC recommends an RFI of the former AST area.

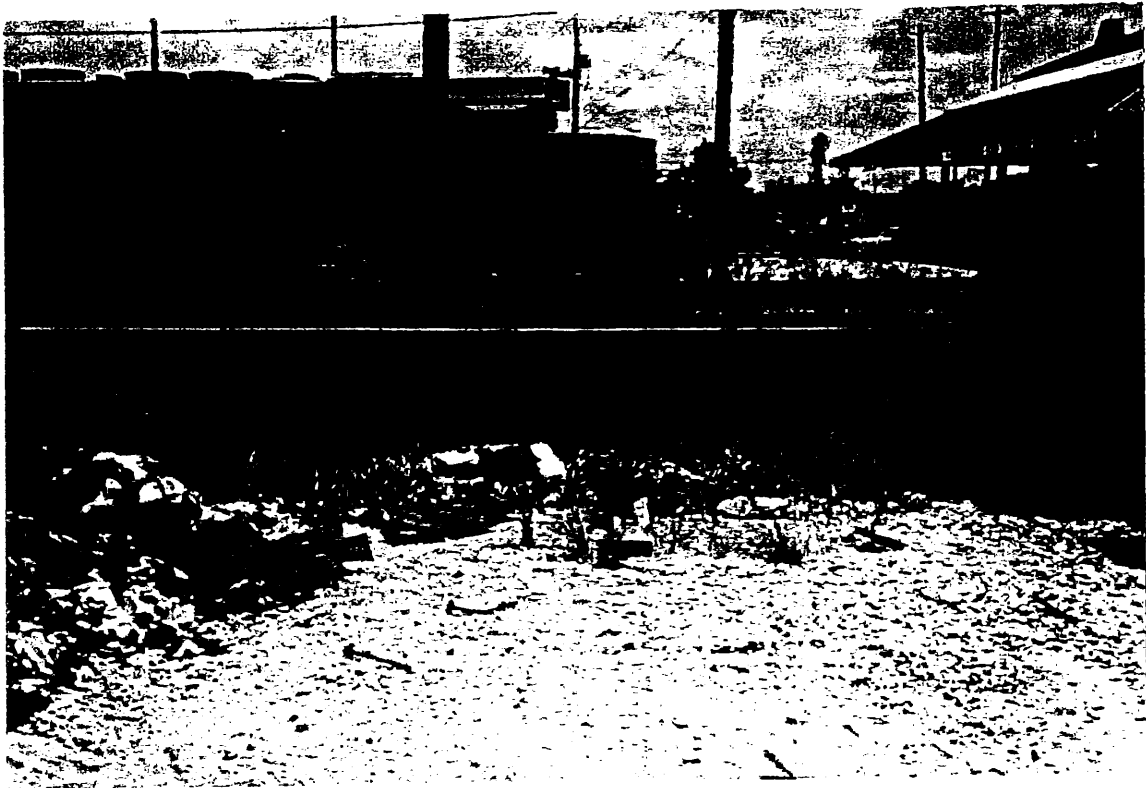
PHOTOGRAPH NO. 10

Date: 08/23/93 Picture Taken by: K. Matherne Direction Facing: Southeast
Picture Description: A portion of the retaining wall that originally surrounded the entire AST
(SWMU No. 8); wall is now limited to the southeast side of the SWMU.

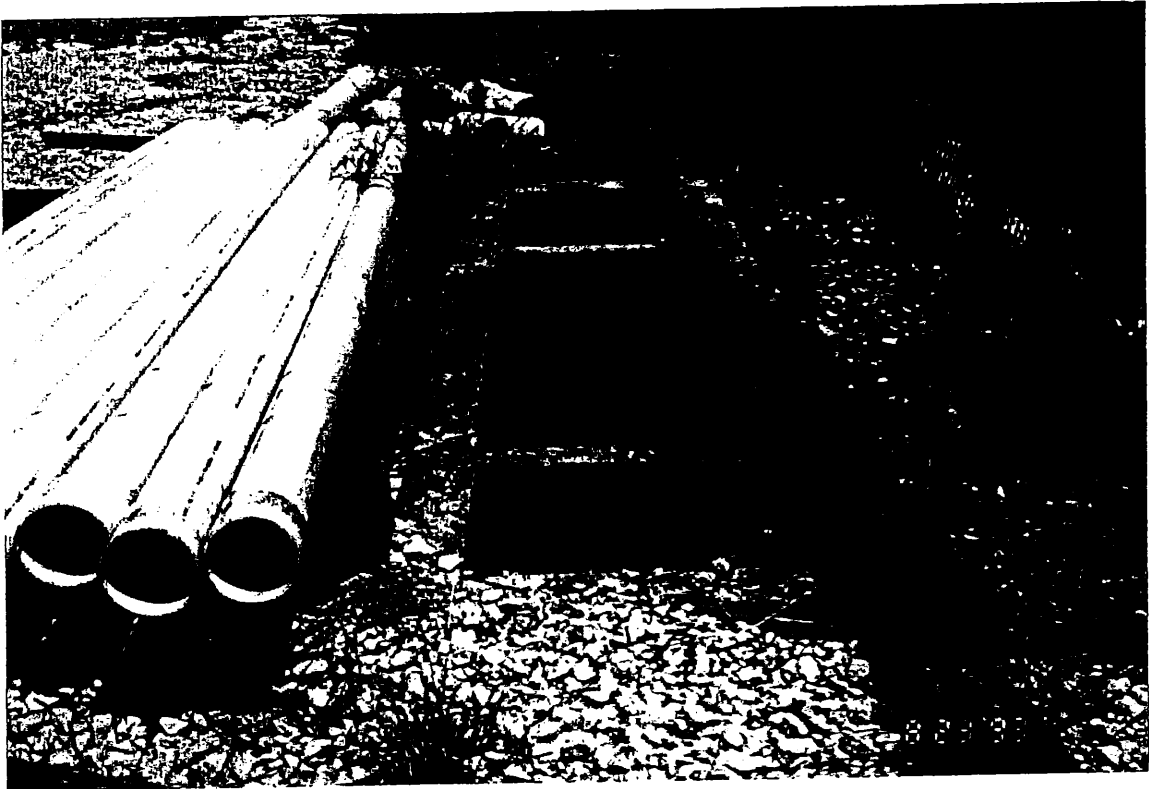
Date: 08/23/93 Picture Taken by: K. Matherne Direction Facing: East
Picture Description: An oil/water separator (SWMU No. 11) used in sap water treatment; this separator was located next to the location of the former sap water treatment tank area (SWMU No. 10), which is partially covered by the white PVC pipe visible on the left edge of the photograph.

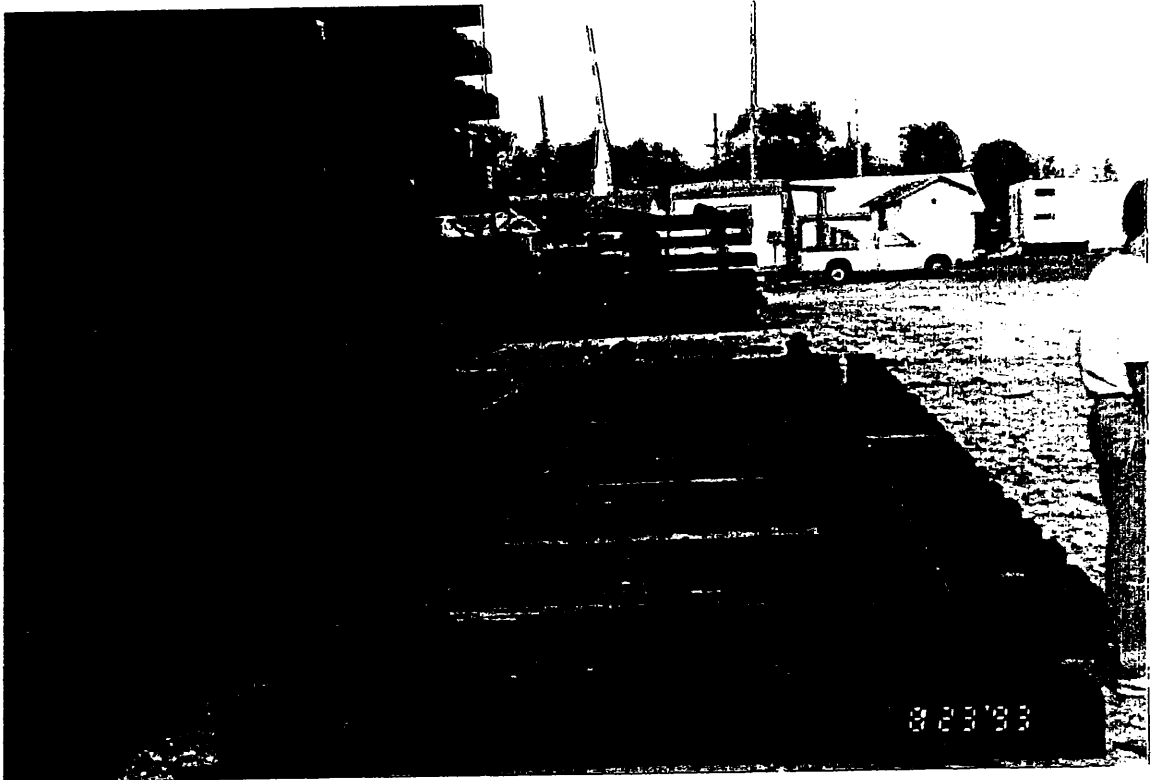
PHOTOGRAPH NO. 15

Date: 08/23/93 Picture Taken by: K. Matherne Direction Facing: Northeast
Picture Description: Close-up of the switch panel plant in the railroad tie storage area
(SWMU No. 12); the switch panel plant now assembles sections of track and treated ties, and stores
them in this area.

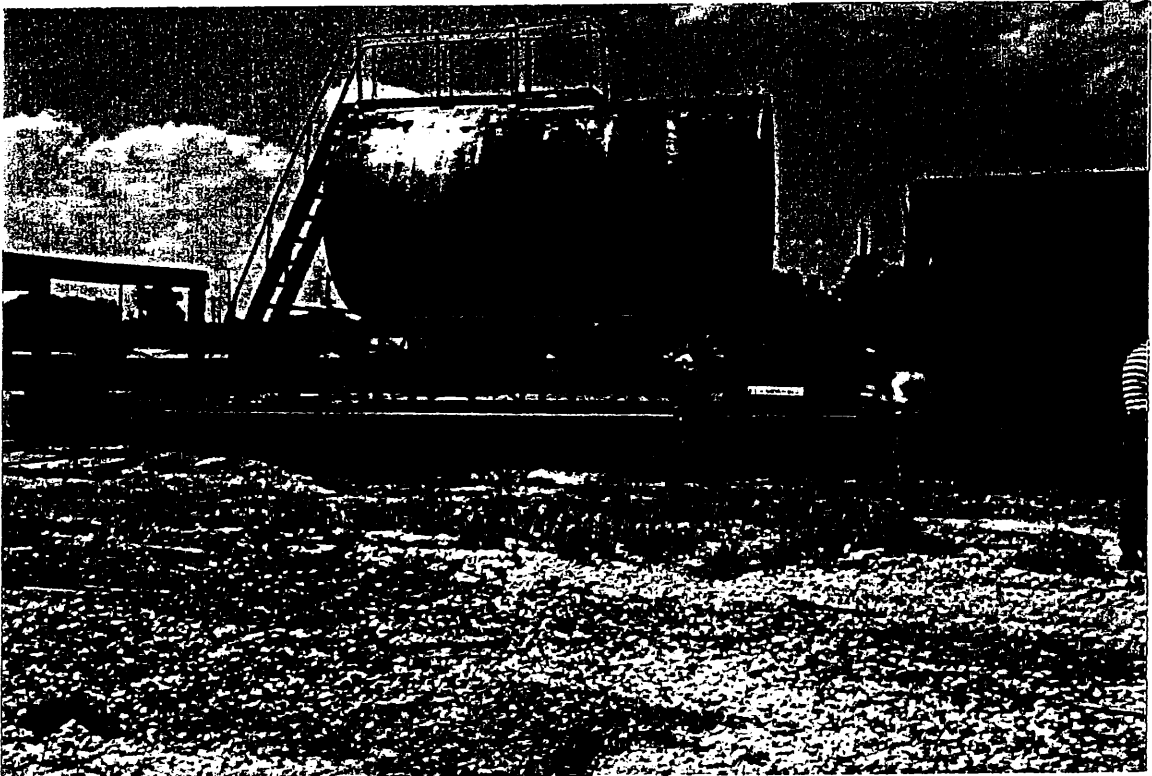
PHOTOGRAPH NO. 16

Date: 08/23/93 Picture Taken by: K. Matherne Direction Facing: North
Picture Description: Diesel storage tank (AOC No. 1); note the concrete containment wall around the tank area.

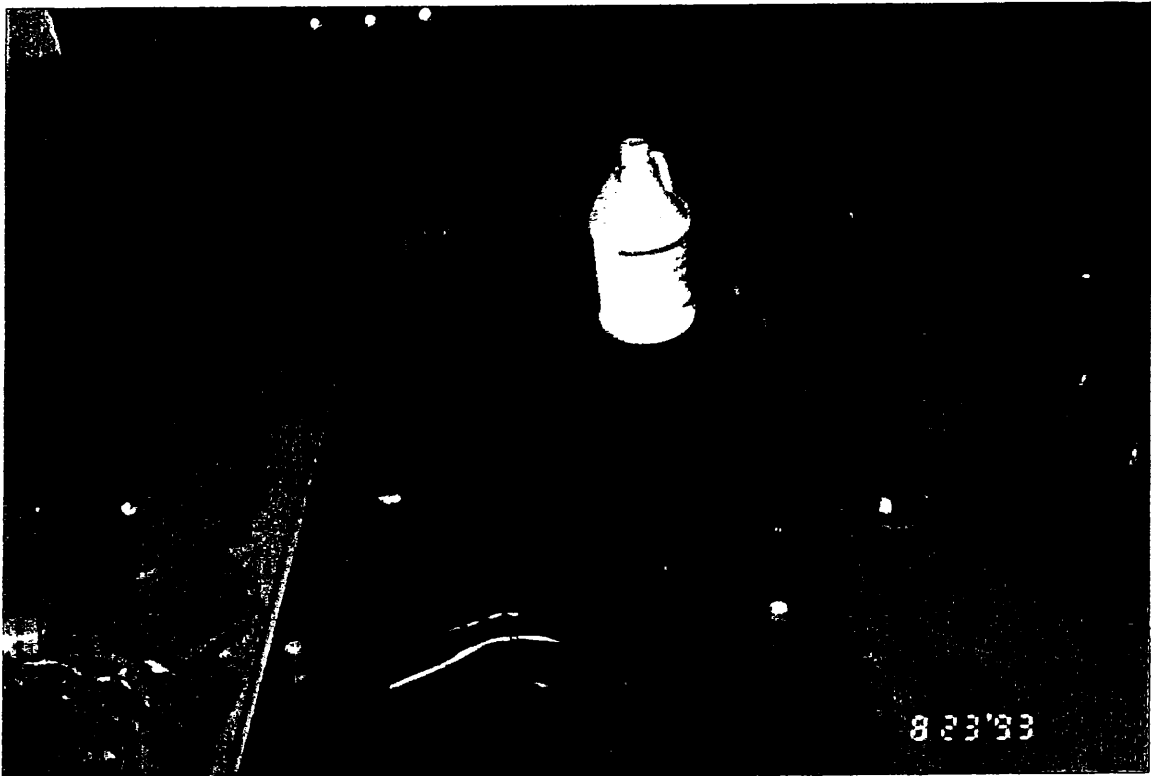
Date: 08/23/93 Picture Taken by: K. Matherne Direction Facing: Southeast
Picture Description: Inside the hose house (AOC No. 2); note recent oil staining (center) and floor
drain cap (upper right).
