**DEPARTMENT OF NATURAL RESOURCES AND ENVIRONMENTAL CONTROL**

**RCRA CORRECTIVE ACTION  
LONG-TERM STEWARDSHIP INSPECTION**

**FACILITY:** (Former) Atlantic Coast Environmental, Inc.  
225 (State) College Road  
Dover, Delaware 19904

**DATE OF ASSESSMENT:** October 29, 2021

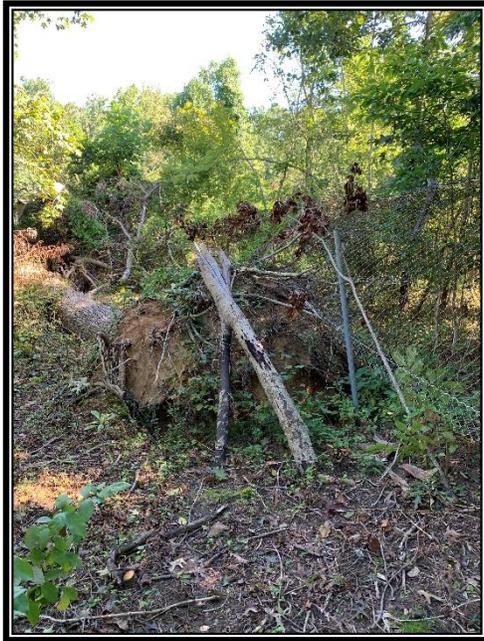
**Observations:** During the September 27, 2021, site visit, the Facility fence line was observed in several locations (four to five) to have been elevated above the ground surface sufficiently to allow

access beneath the fence and into the Facility. This occurred where trees growing proximal to the fence line were wind-felled during past storm events. When the trees fell, their associated root mass lifted the fence. At the time of the LTS Inspection on October 29, these elevated lengths of fence had been repaired by slightly re-routing new fencing around the wind-felled tree root masses. Compliant signage was observed posted at each of the Facility entry gates.

**Photograph No. 1:** Wind-felled tree damage to Facility security fencing on September 27, 2021.

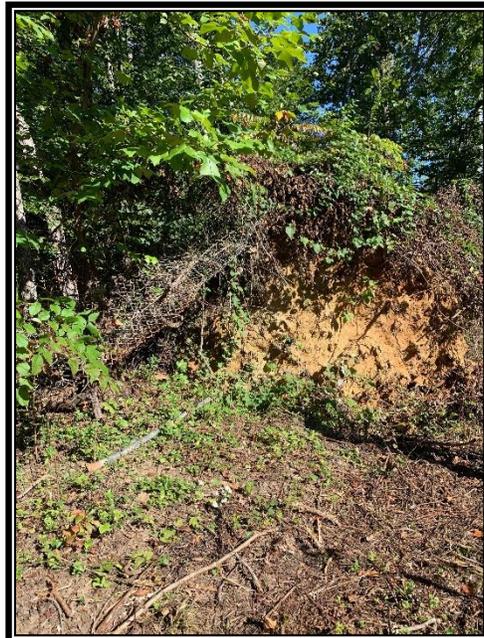
**Photograph No. 2:** Wind-felled tree damage to Facility security fencing on September 27, 2021.

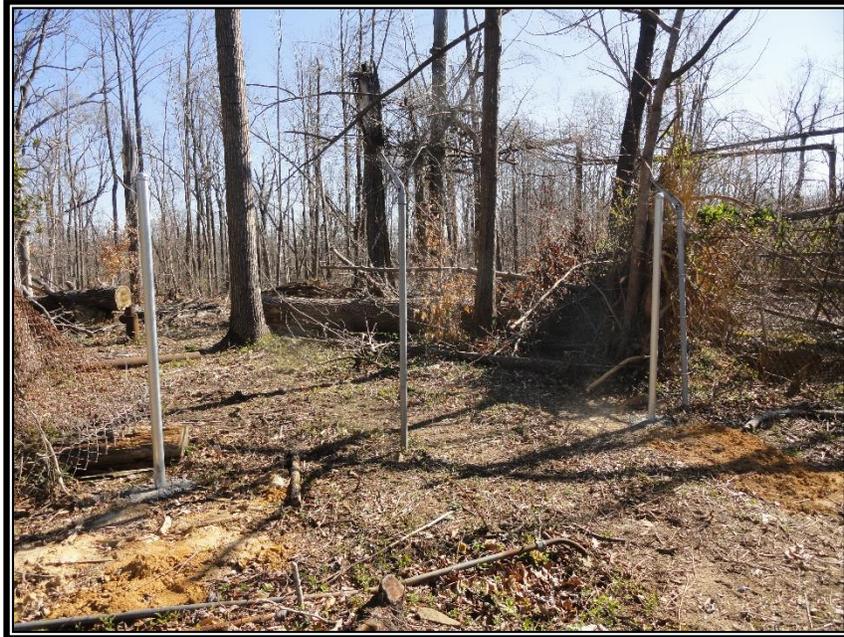
However, an approximate 12- to 16-foot gap in the Facility fence line was observed during the LTS inspection. This gap was not due to treefall, but rather the fencing was intentionally removed to provide access to the monitoring wells located exterior to the Facility fence line. The gap was located approximately southwest of monitoring wells MW-5 and MW-5D (old) and east of monitoring wells MW-2 (old) and MW-2R, as depicted on Attachment 2.

**Photograph No. 3:** Northeasterly view of the 12- to 16-foot gap in the Facility Security fence on March 29, 2022.

- *Replace the 12- to 16-foot gap in the fence with a chain-link gate, thus securing the Facility while also providing access (as needed) to the wells outside the Facility fence line; or*
- *Replace the 12- to 16-foot gap with fencing (no gate), then clear vegetation outside of the fence line to provide access from the access road to the exterior wells.*

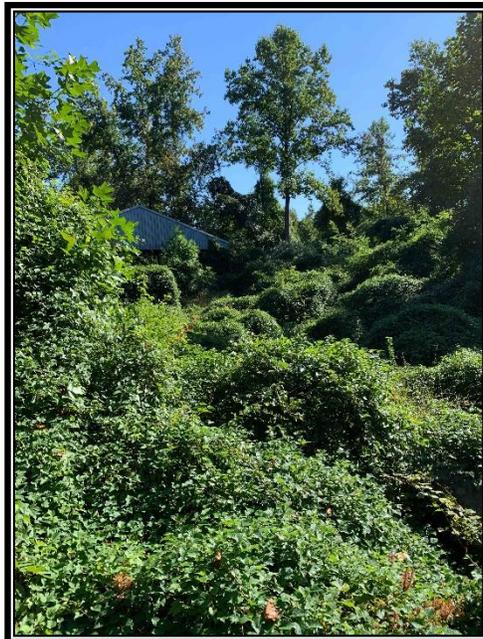
**Observations:** During the September 27, 2021 site visit, the engineered hazardous waste landfill cap was obscured from observation due to an excess of vegetative growth. During the LTS inspection, the observed location, elevation, slopes, and overall general condition of the engineered hazardous waste landfill cap visually appeared to be consistent with reported design specifications suggesting that the structural integrity of the engineered hazardous waste cap system has persisted. However, in preparing the Facility for inspection, the contractors had completely denuded the cap of vegetation.

**Photograph No. 4:** Northeasterly view of the engineered hazardous waste landfill on September 27, 2021.

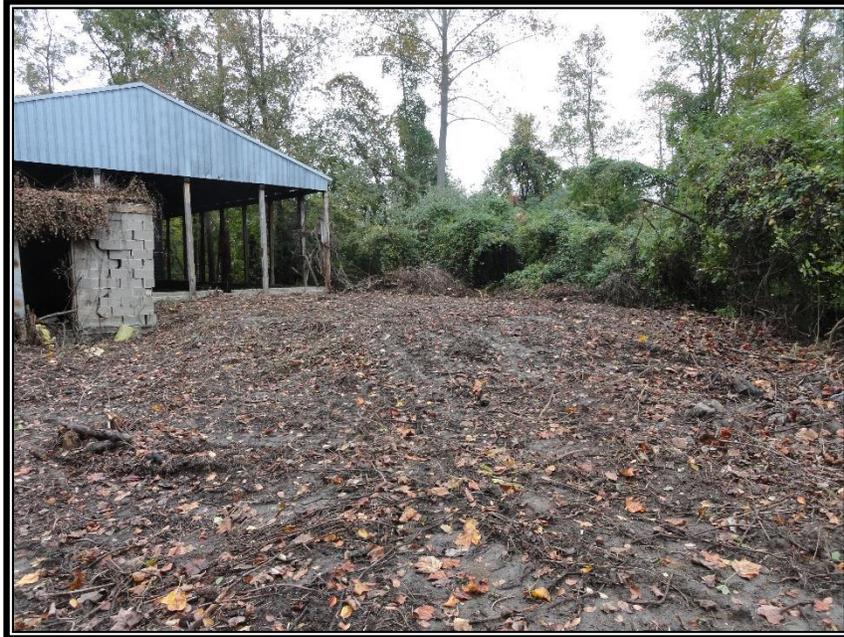
**Photograph No. 5:** Easterly view of the engineered hazardous waste landfill cap on October 29, 2021.

- *Please provide an approximately eight-foot (8-ft.) wide margin free of significant, potentially intrusive vegetation along the southeast margin of the engineered hazardous waste landfill cap as a protective buffer area to proactively minimize the potential for intrusive woody vegetation growth into the cap.*
- Cap re-vegetation:
  1. *Lightly grade or "dress" the cap to ensure positive drainage from the cap (may require the import of soil)*
  2. *Appropriately re-vegetate the cap to minimize erosion (may require the import of top soil)*

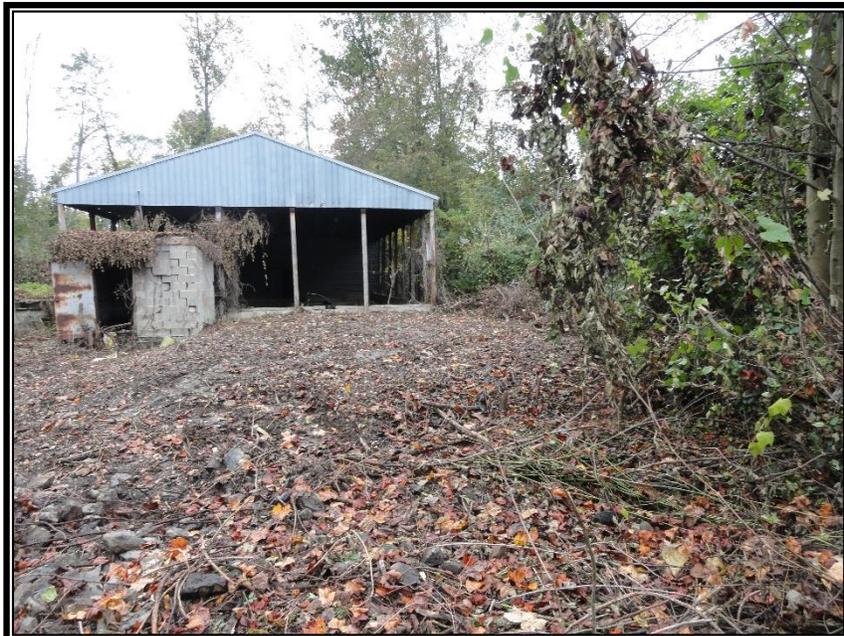
**Photograph No. 6:** Northerly view of the engineered hazardous waste landfill cap on October 29, 2021.

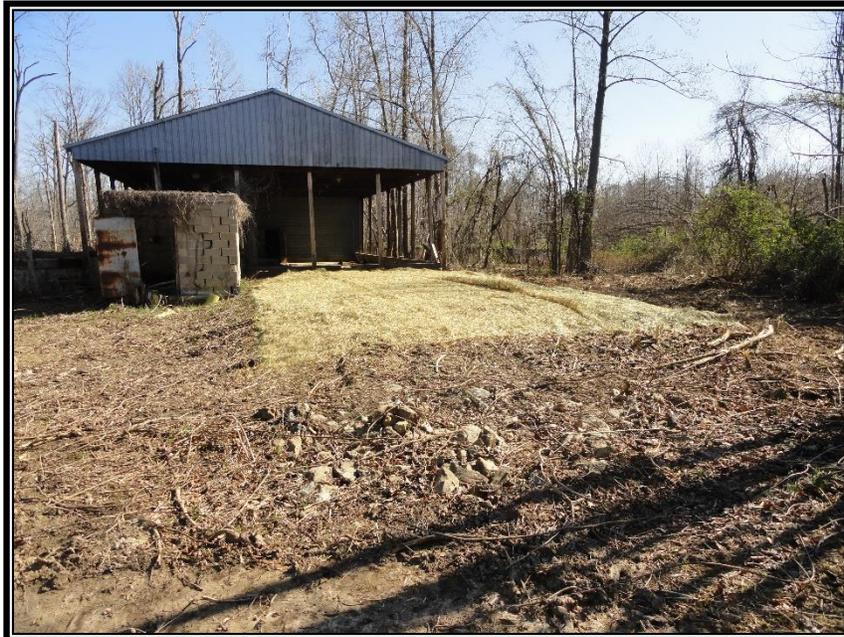
**Photograph No. 7:** Northeasterly view of the hazardous waste landfill cap on March 29, 2022, with erosion control blankets applied.

To date, the tasks associated with the fencing have been completed, and the top of the engineered hazardous waste landfill cap was re-seeded and erosion control blankets were applied. Tasks pending completion include seeding and application to the slopes of the engineered cap and restoration of the functionality of the storm water conveyance swale. The Facility Owner representative has been provided a deadline of May 13, 2022, to complete these pending tasks.

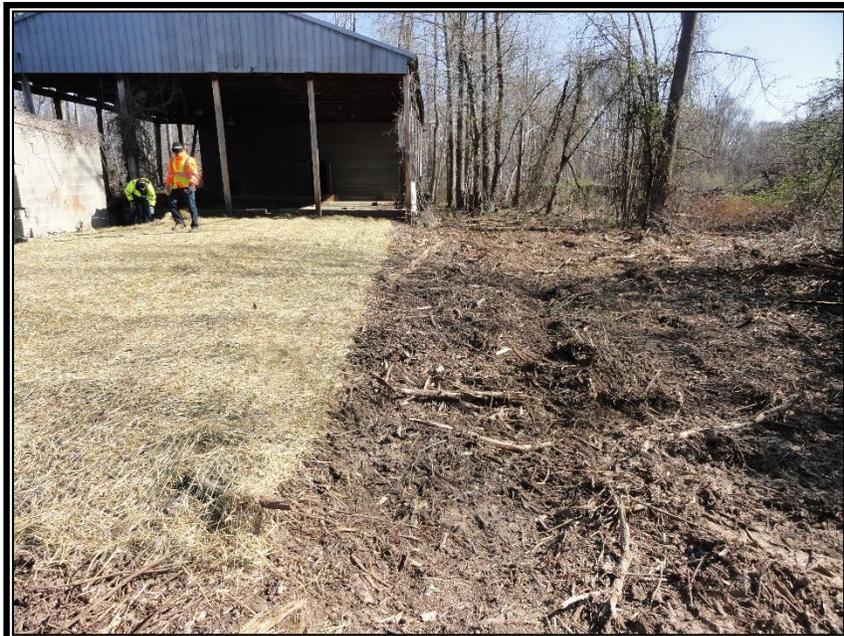
**Photograph No. 8:** Northern view of the hazardous waste landfill cap on March 29, 2022, with erosion control blankets applied.

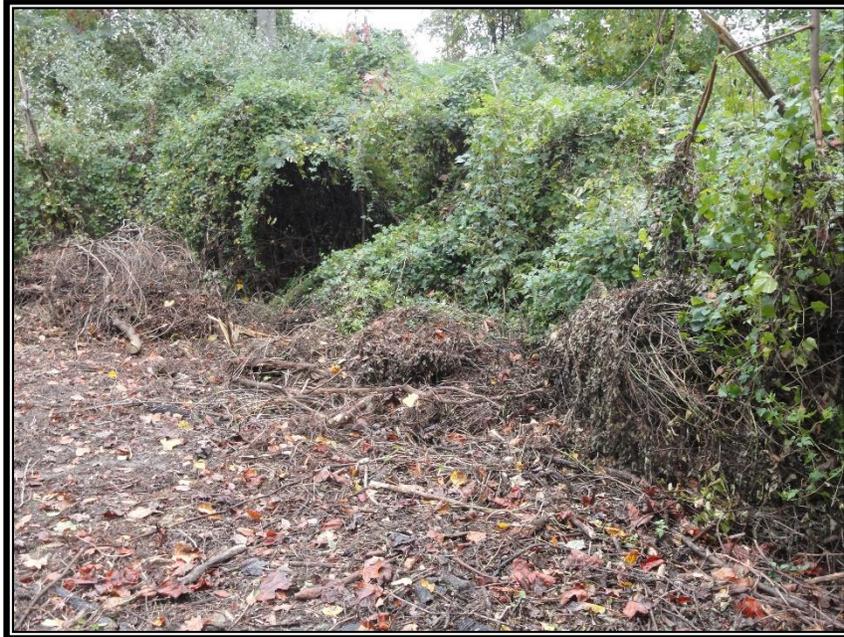
**Observations:** During the September 27, 2021 site visit, the storm water conveyance swale associated with the engineered hazardous waste landfill cap was obscured from observation due to an excess of vegetative growth. During the LTS inspection, the associated storm water conveyance swale was nearly unlocatable due to excessive vegetation and excessive accumulation of sediments in the swale. The swale was approximately located based the intermittent presence of rip-rap exposed through the accumulated sediments; its location appeared consistent with that presented in Attachment 4. For its intended purpose, the swale appeared non-viable.

**Photograph No. 9:** Northeasterly view of the swale location along the southeasterly margin of the landfill on October 29, 2021.

- *Please remove accumulated sediments and vegetation from the drainage swale to allow for the efficient conveyance of stormwater away from the cap area.*
  - *The rip-rap currently comprising the swale (excluding the associated sediments and vegetation) may be re-used to protect the swale from erosion. The import of additional rip-rap may be necessary.*

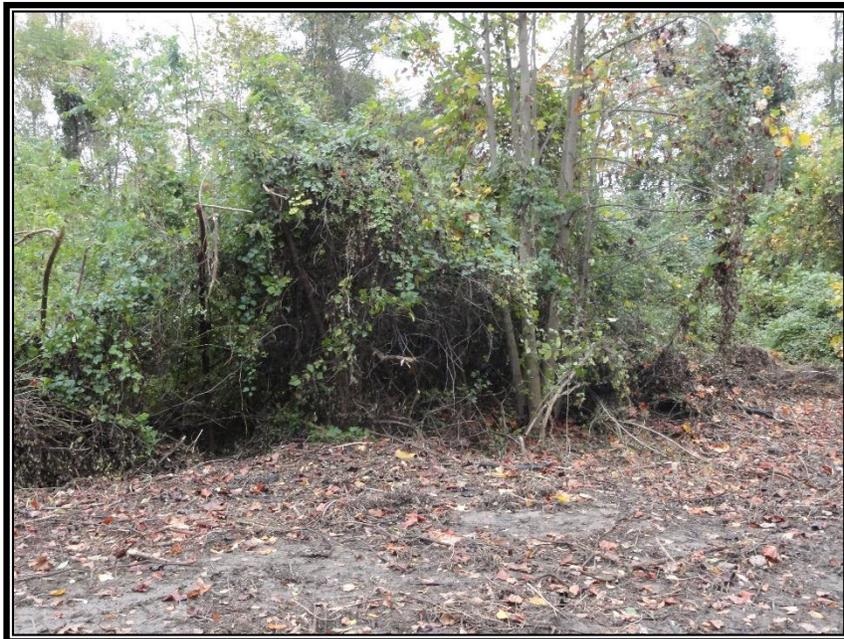
**Photograph No. 10:** Easterly view of the swale at the easterly corner of the landfill on October 29, 2021.

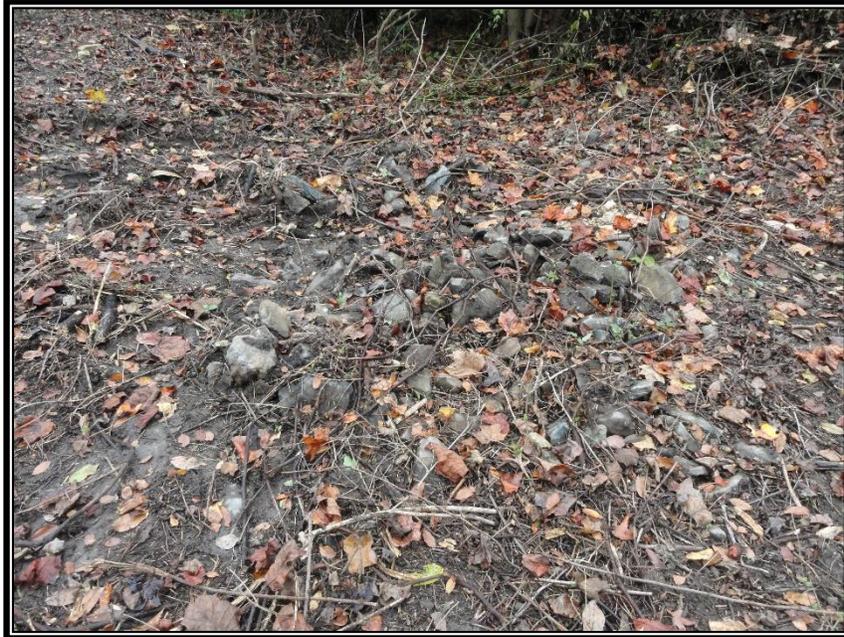
**Photograph No. 11:** View of the sediment accumulated within the swale along the southwesterly margin of the landfill on the October 29, 2021.

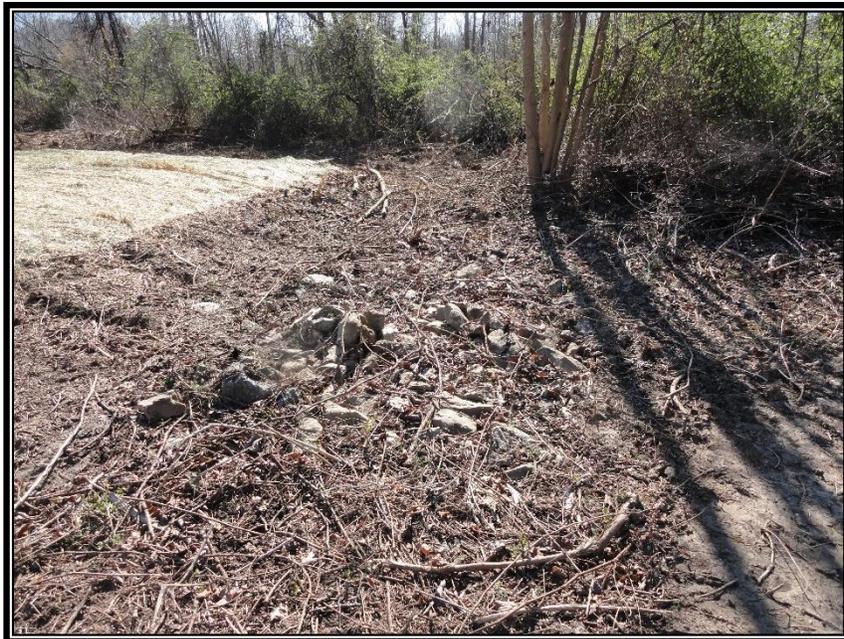
**Photograph No. 12:** Easterly view of the swale along the southwesterly margin of the landfill on March 29, 2022.
