DEPARTMENT OF THE NAVY
VICE CHIEF OF NAVAL OPERATIONS
2000 NAVY PENTAGON
WASHINGTON DC 20350-2000

FINAL ENDORSEMENT on RDML Christopher J. Cavanaugh, USN ltr 5830 of 14 Jan 22

Subj: COMMAND INVESTIGATION INTO THE 6 MAY 2021 AND 20 NOVEMBER 2021
INCIDENTS AT RED HILL BULK FUEL STORAGE FACILITY

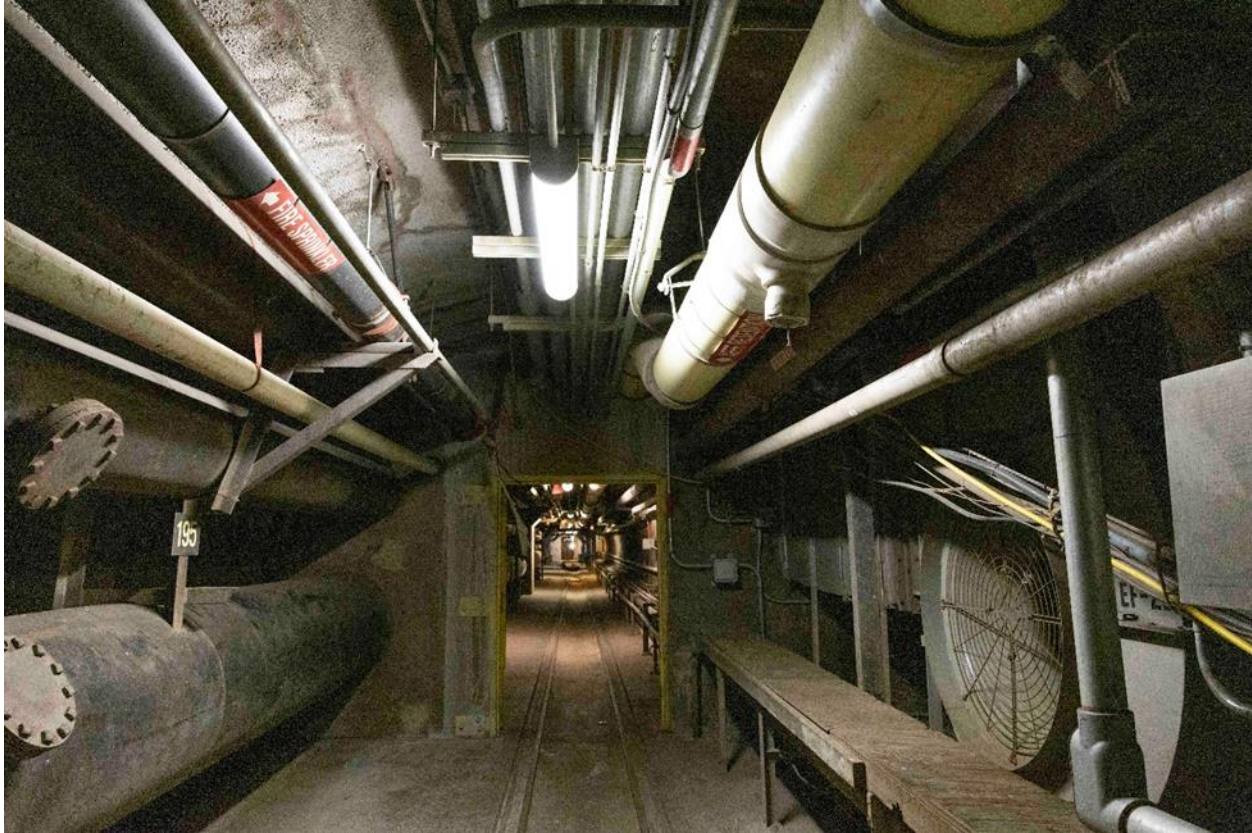
Lower Access Tunnel with AFFF retention line in top right (PVC pipe)

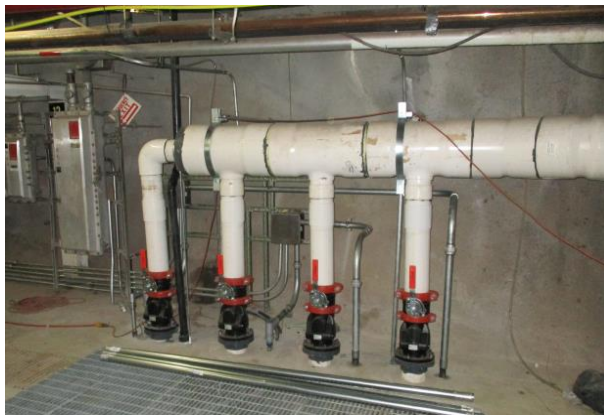
383. On 13 Mar 17, the construction contractor formally notified NAVFAC PAC, in writing, that they constructed the entire AFFF retention line with PVC vice Steel pipe. [Encl (353)]

Original AFFF Retention Line Piping in Immediate Area of an AFFF Sump

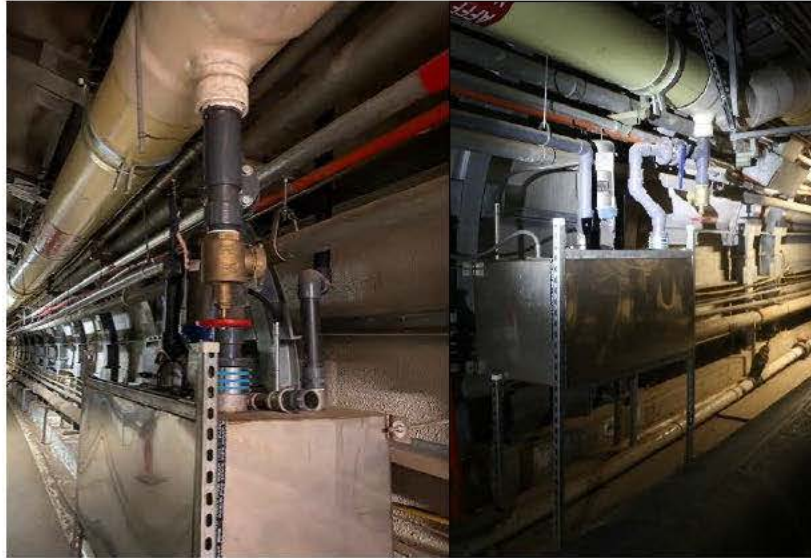
drainage out to a new manual hose connection at the Adit 3 entrance via new 3" PVC piping. This system does not utilize the groundwater sump system. This is the installed configuration today and is in close proximity to the Adit 3 groundwater sump, but does not connect with that sump. This system was not used to drain the AFFF retention line following the November spill. [Encl (354)]

Final Installed Low Point Drain System with PVC Retention Line

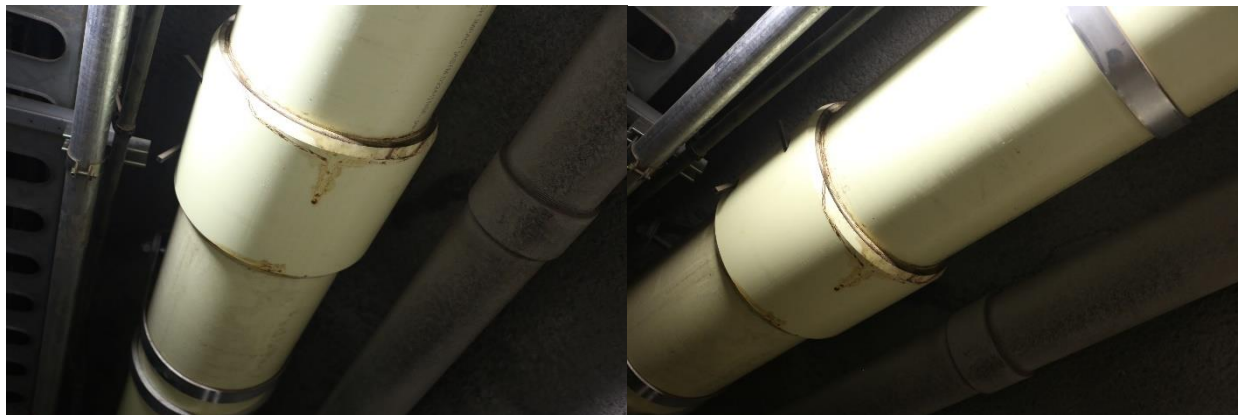
414. On 17 Mar 22, during a walkthrough of Red Hill, the supplement investigation team noted visual evidence of a foreign substance on the outside of the PVC AFFF retention line piping joints that appears to have seeped out.

Installed PVC AFFF Retention Line with Joint Seepage

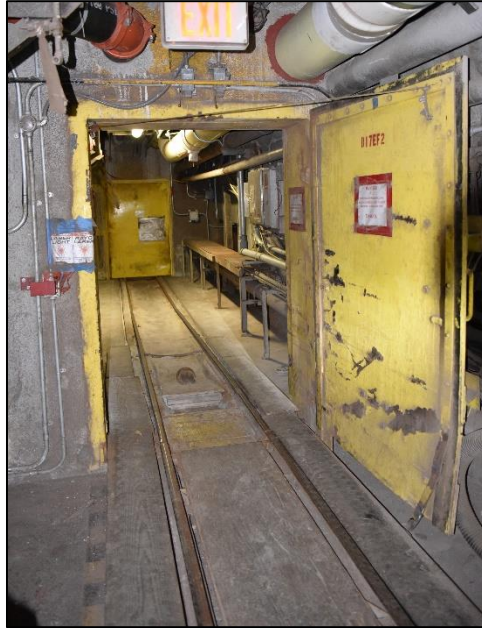
Figure 1: Image of open oil-tight door (foreground) and closed ventilation door on either side of the damaged fire suppression system low point drain valve. [Encl (169)]

178. After driving through the doorway, he again stopped the train and disembarked to close the ventilation control door. As he turned to close the door, he discovered liquid spraying from the low point drain of the fire suppression system retention line. He reported the leak immediately to the CRO. He recognized the source was a non-fuel system, first reporting it was from a sewage line, then fire suppression agent, then water. Finally, he reported the leak as water with a fuel smell. This line should have been empty. [Encls (83), (173)-(186)]
