SUBJECT: Long-Term Stewardship Assessment
U.S. Bronze Foundry & Machine, Inc.
EPA ID: PAD004318416
18649 Brake Shoe Road
Meadville, PA 16335

DATE: September 25, 2023

September 14, 2023
Long Term Stewardship Inspection
Photolog

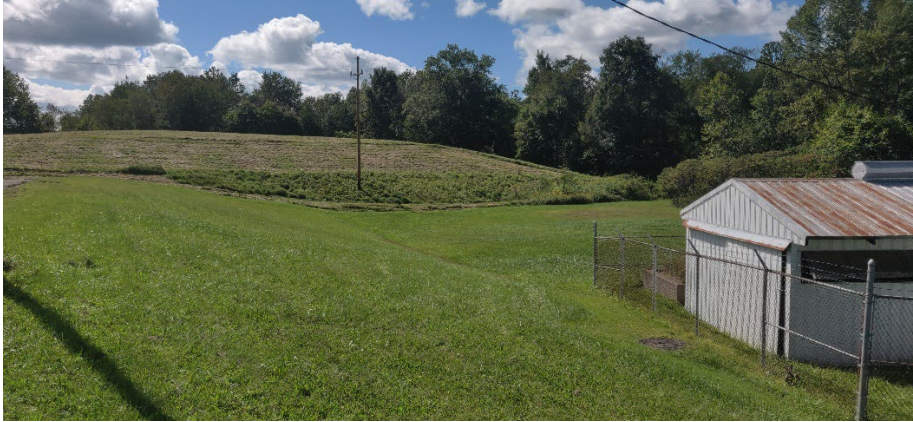
After leaving the conference room, the meeting attendees went outside to visit the South Parking Lot Area and capped portion of the MISS Area. The asphalt covered portion of the South Parking Lot was in good condition. Some cracks were observed but none that penetrated the full thickness of the asphalt. The vegetation over the geomembrane sloped portion of the containment area just north of the parking lot was clearly maintained and not stressed. Photos 1 and 2 in the Photolog contained in Attachment 1 of this report show views looking southwest from the South Parking Lot Area towards the closed landfill. The landfill vegetative cover had been mowed to the extent possible with the riding mower equipment. Areas inaccessible to that equipment were scheduled to be mowed shortly. From the South Parking Lot, the meeting attendees visited the capped portion of the MISS Area. Photos 3 and 4 show views of the northern boundary of the capped portion of the MISS Area to the east and west, respectively. The entire capped area is vegetated and is adequately maintained with no stressed vegetation or tree/shrub growth on the cap. No evidence of excavation or disturbance of the cap was observed. The LTS site visit concluded after the inspection of this area.

Photo No. 1 (142656): View looking southwest at capped portion of South Parking Lot Area and closed landfill.

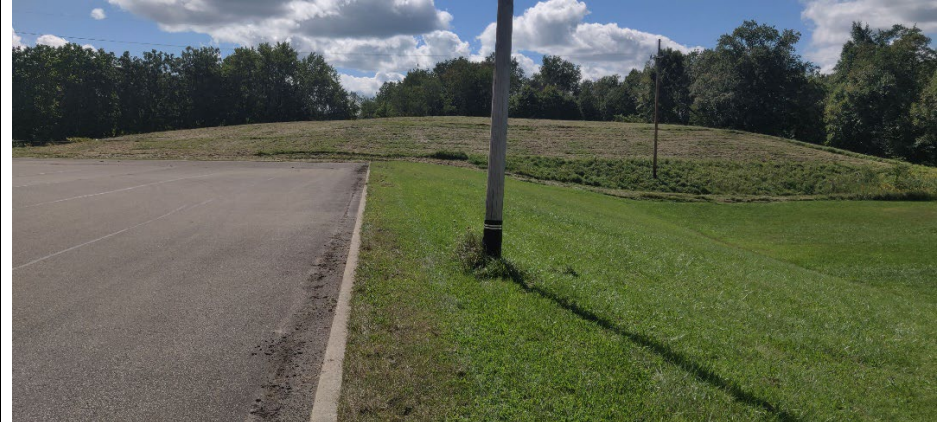
Photo No. 2 (142707): View looking southwest at asphalt and geomembrane capped portions of South Parking Lot Area with closed landfill in background.

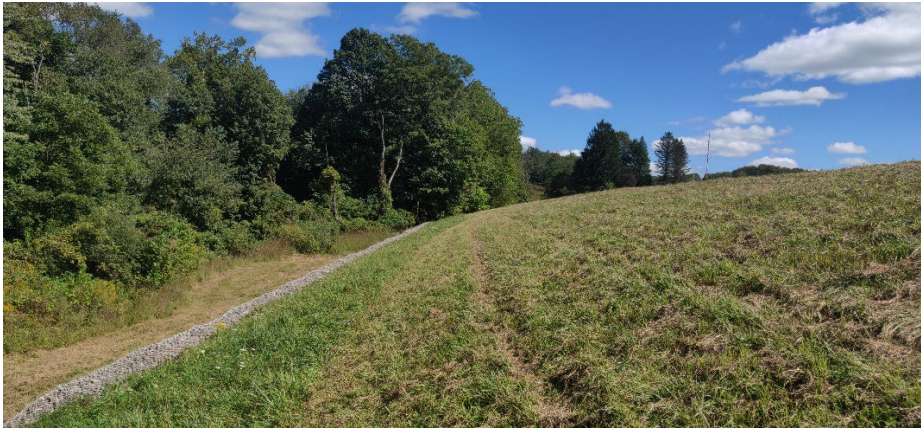
Photo No. 3 (143230): View looking east along northern boundary of capped portion of the Metals Impacted Soils and Sediments (MISS) Area.

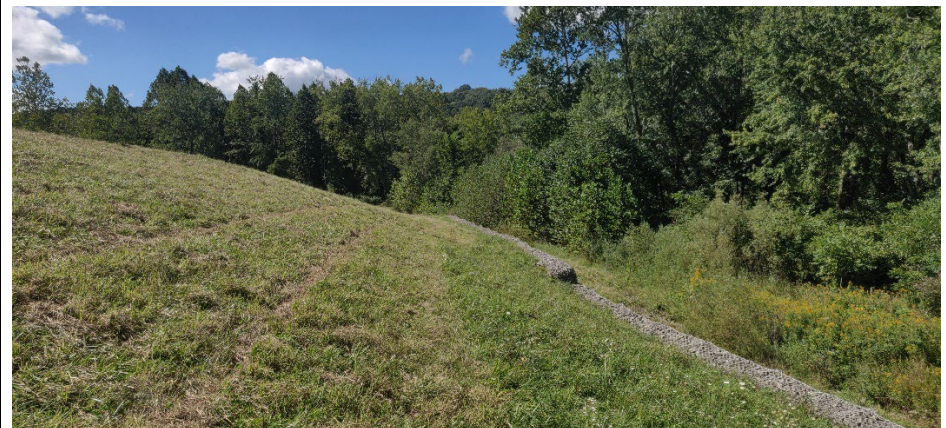
Photo No. 4 (143233): View looking west along northern boundary of capped portion of the Miss Area.
