OCTOBER 14, 2022

MUNICIPALITY OF TOA ALTA SEPTEMBER 2022 MONTHLY REPORT
Civ. No. 3:21-01087-DRD

N. AYALA
TERRATEK ENGINEERING GROUP, PSC
P.O. Box 367445 San Juan, PR 00936

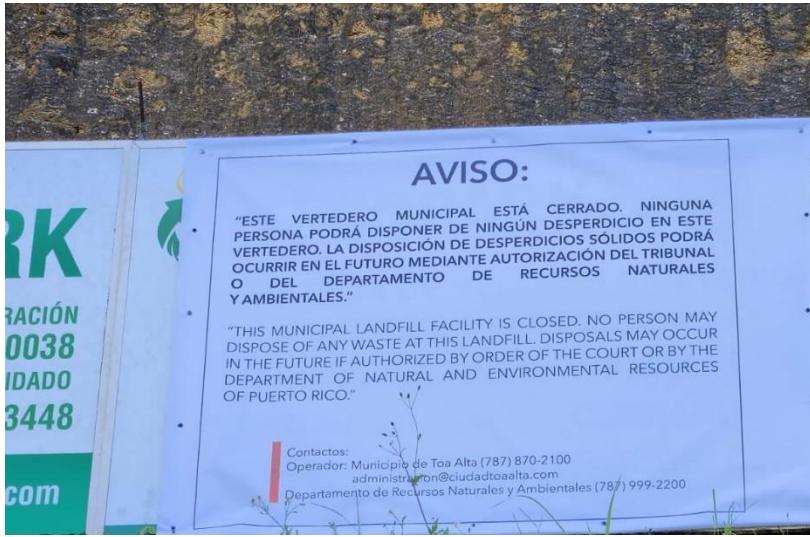
A sign with a size of four foot by five foot was installed at the landfill entrance. See the attached picture.

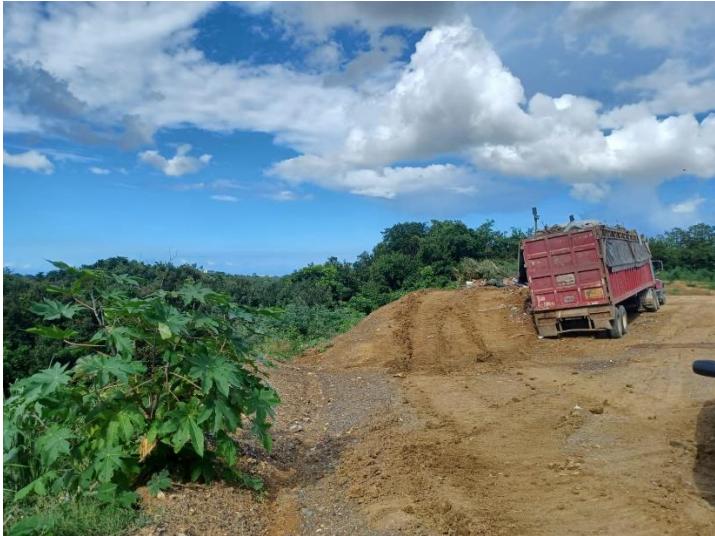
9/9/2022 14:30:00

To make sure MTA does not jeopardize the Public Assistance Grant from FEMA. MTA need to wait for FEMA to quantify the amount of debris removed and after that procedure the debris can be finally disposed at a permitted facility.
