JULY 18, 2023

MUNICIPALITY OF TOA ALTA JUNE 2023 MONTHLY REPORT
Civ. No. 3:21-01087-DRD

NIVIA I. AYALA, PE
TERRATEK ENGINEERING GROUP, PSC
P.O. Box 367445 San Juan, PR 00936

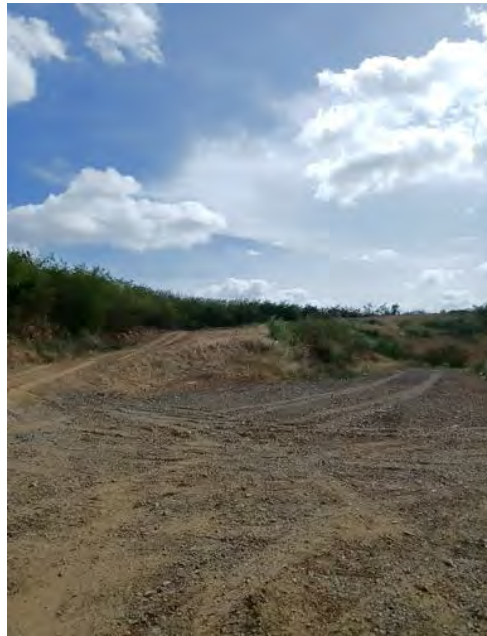
Figure 1 Daily Cover June 2023

Daily Cover at the facility was completed on April 30, 2022. All areas of exposed waste were covered by Daily Cover.

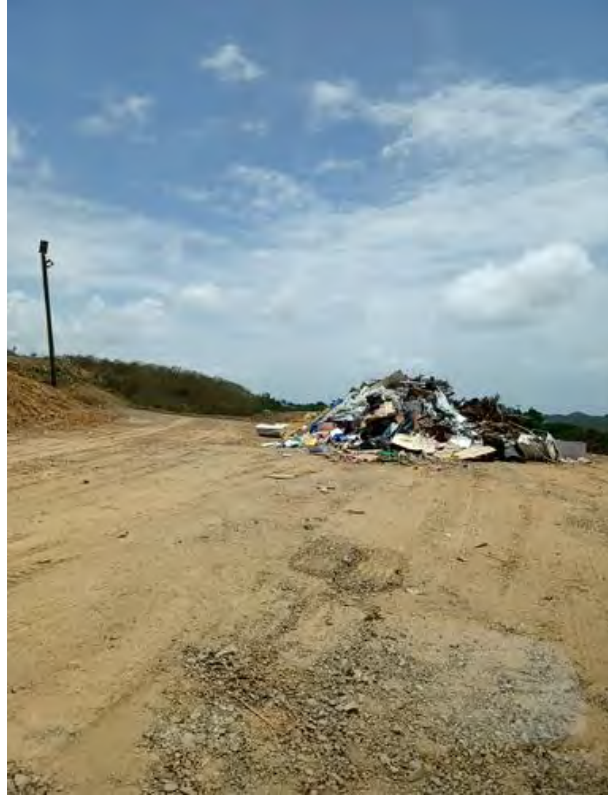
Figure 2 Transfer Area for C&D, Metals, and Bulk Materials.

The cessation of waste disposal at the facility was completed by March 30, 2022. However, as agreed in the Stipulation, the temporary storage of construction and demolition (C&D) waste, bulk household waste (durable goods such as mattresses, furniture, and appliances), or yard waste (vegetation waste generated by land maintenance) for final disposal at a different landfill is active and been performed daily.

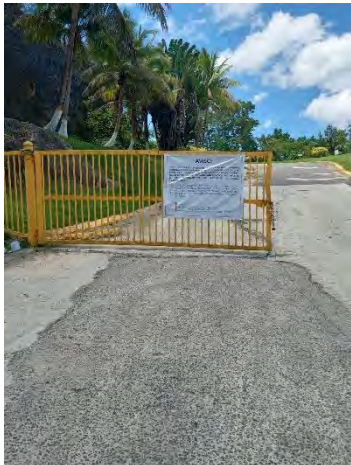
Figure 4 Outside Gate

A sign with a size of four feet by five feet was installed at the landfill entrance. See the attached pictures.

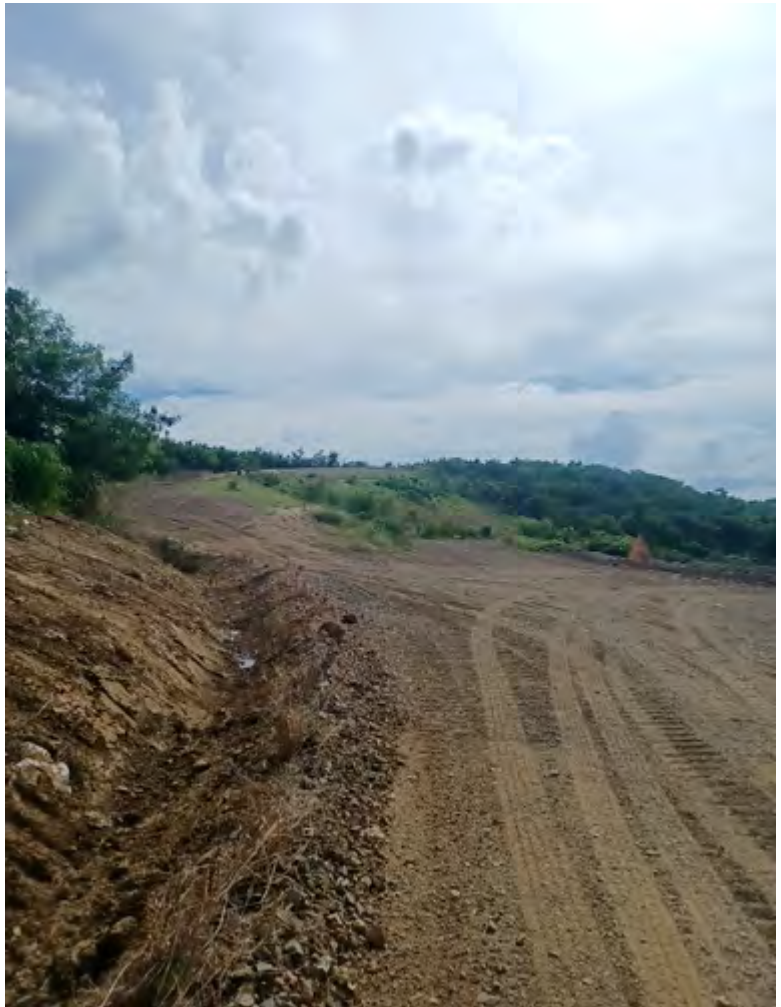
Incluir foto

Condicion de Cubierta Talud Norte

Excelentes condiciones

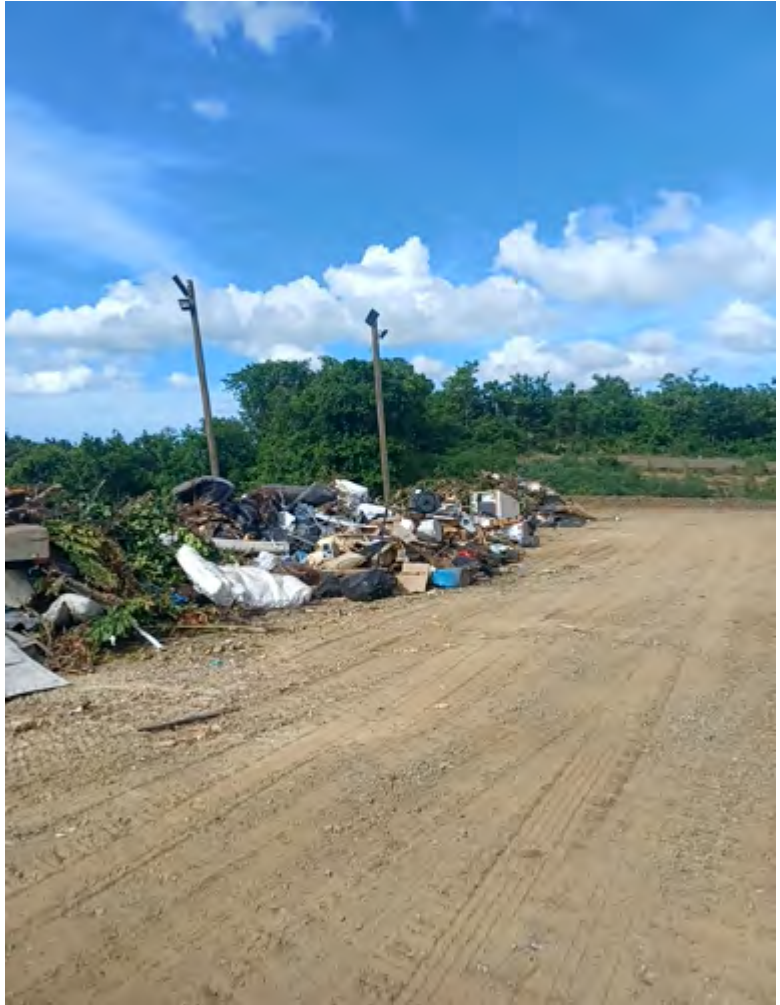
Tomar foto

Condicion Operacion Recibo de Escombros

Necesita Limpieza

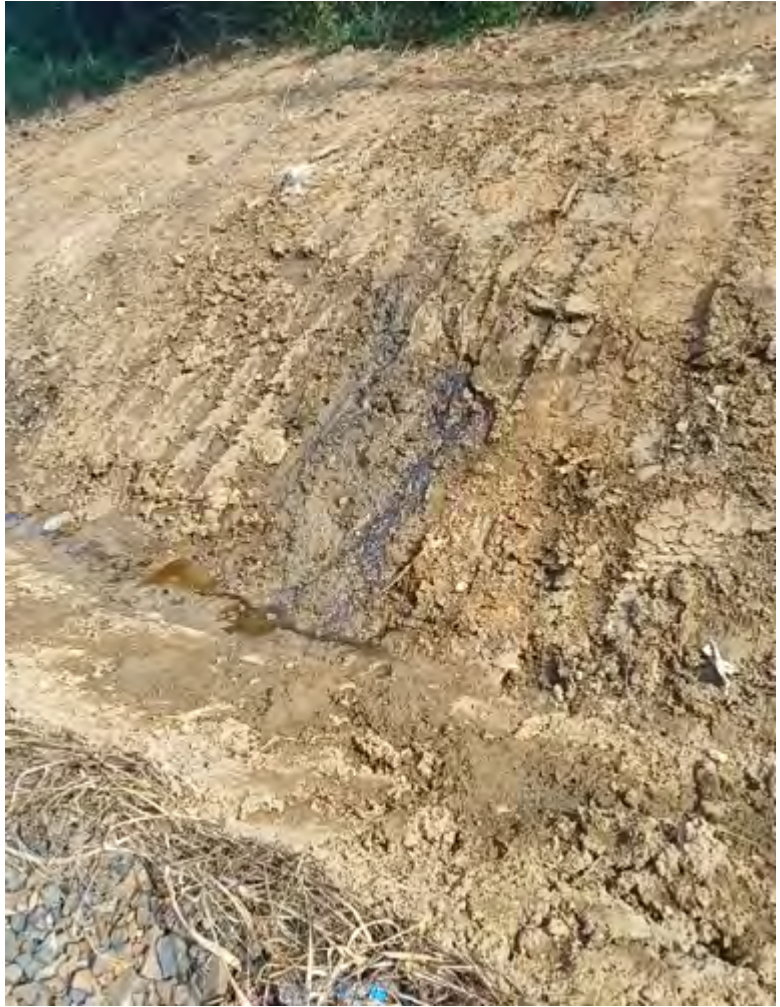
Añadir fotos deal area de brotes visibles

Se pueden notar brotes de lixiviado?

SI

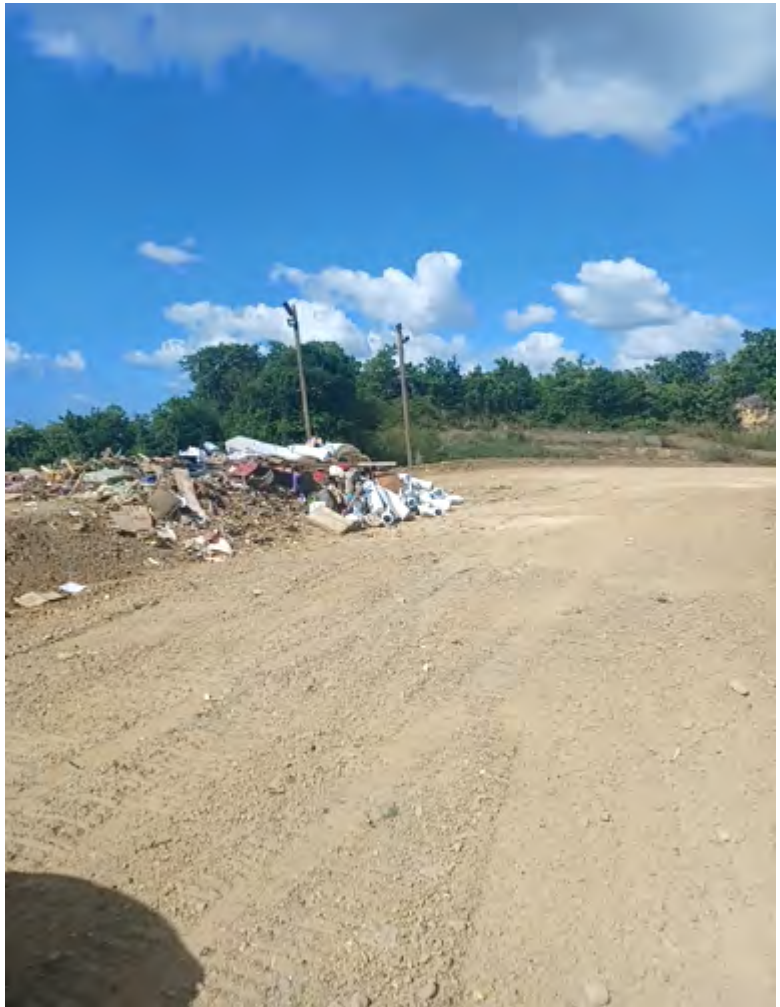
Tomar foto

Condicion Operacion Recibo de Escombros

Necesita Limpieza

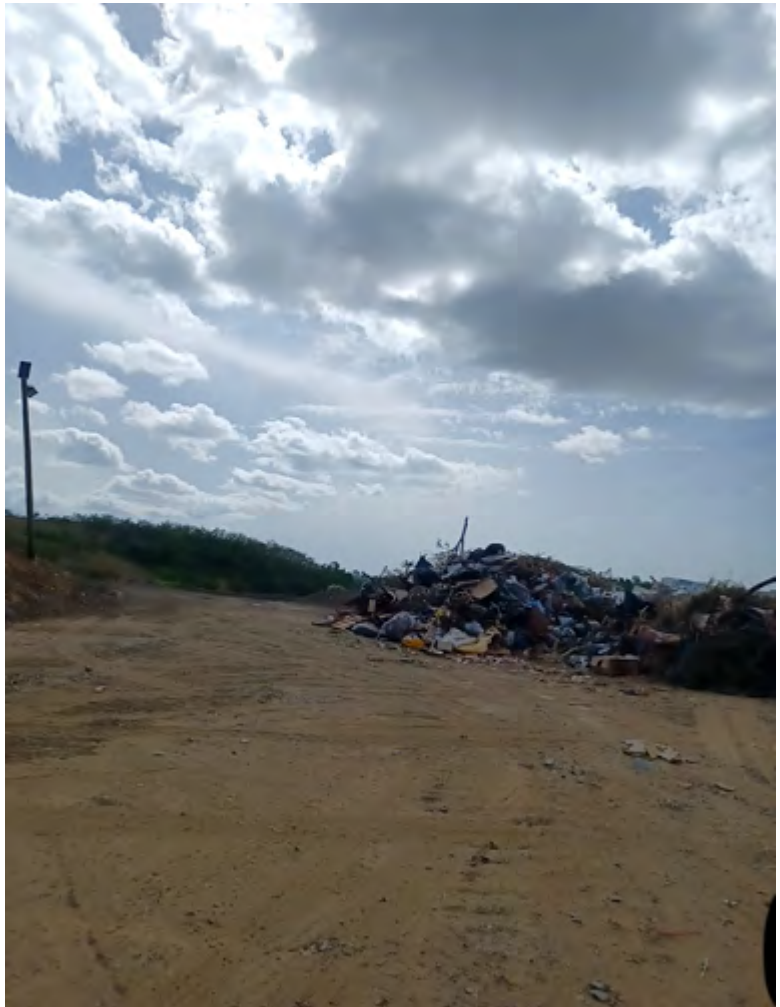
Tomar foto

Condicion Operacion Recibo de Escombros

Necesita Limpieza

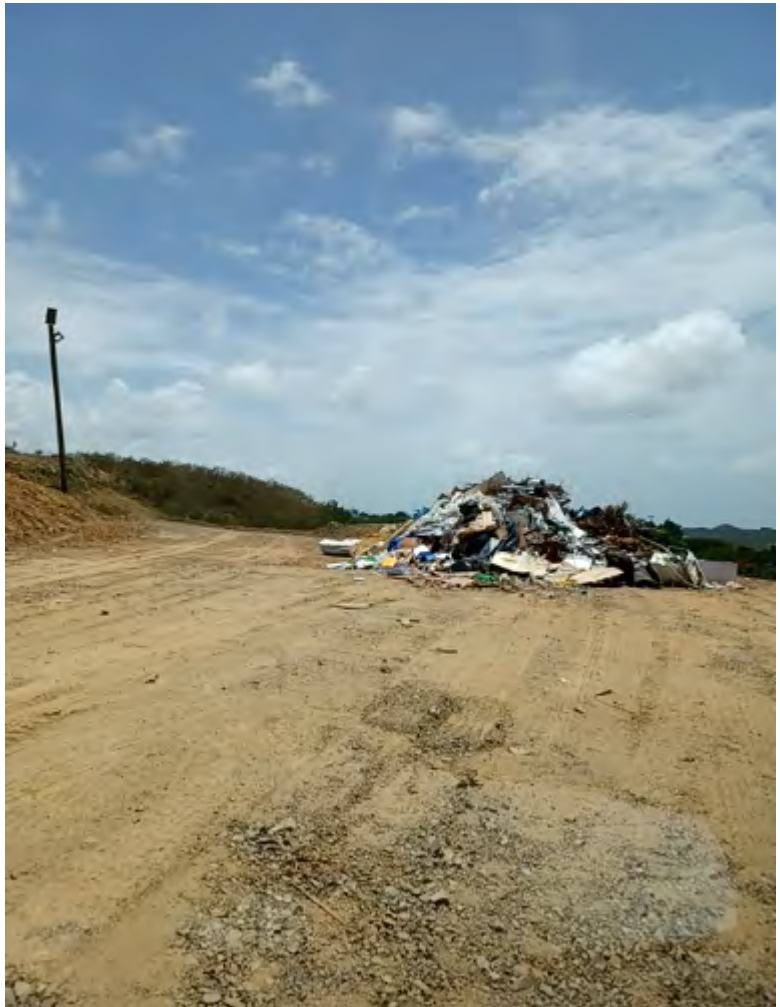
Tomar foto

Condicion Operacion Recibo de Escombros

Necesita Limpieza

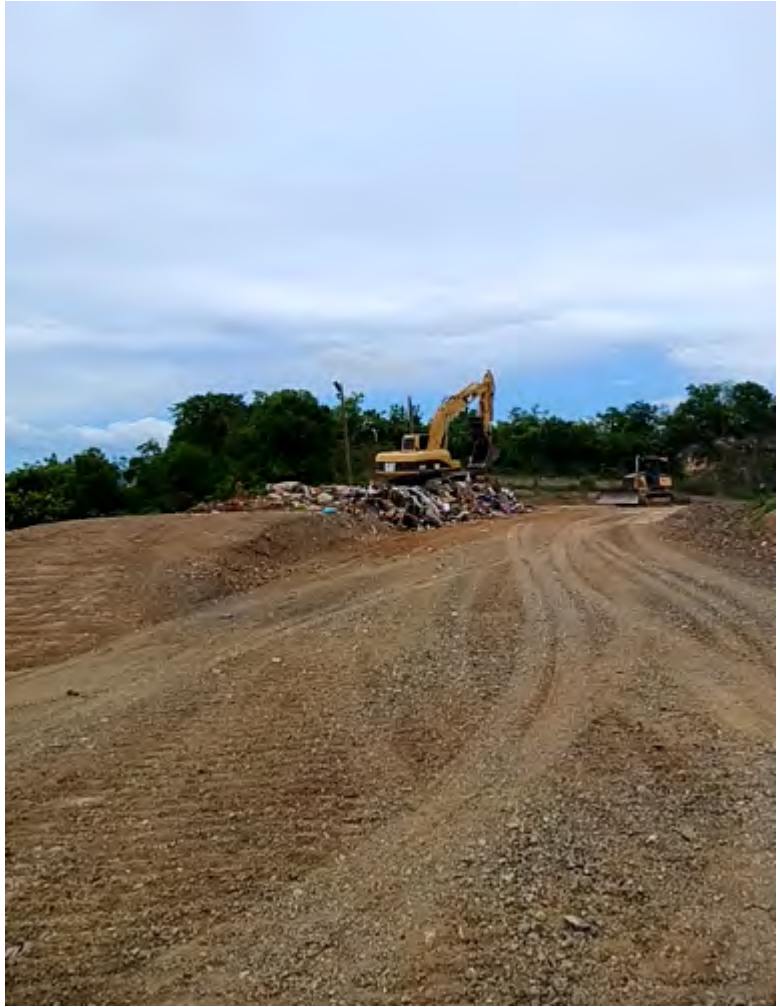
Tomar foto

Condicion Operacion Recibo de Escombros

Necesita Limpieza
