FEBRUARY 15, 2023

MUNICIPALITY OF TOA ALTA JANUARY 2023 MONTHLY REPORT
Civ. No. 3:21-01087-DRD

N. AYALA
TERRATEK ENGINEERING GROUP, PSC
P.O. Box 367445 San Juan, PR 00936

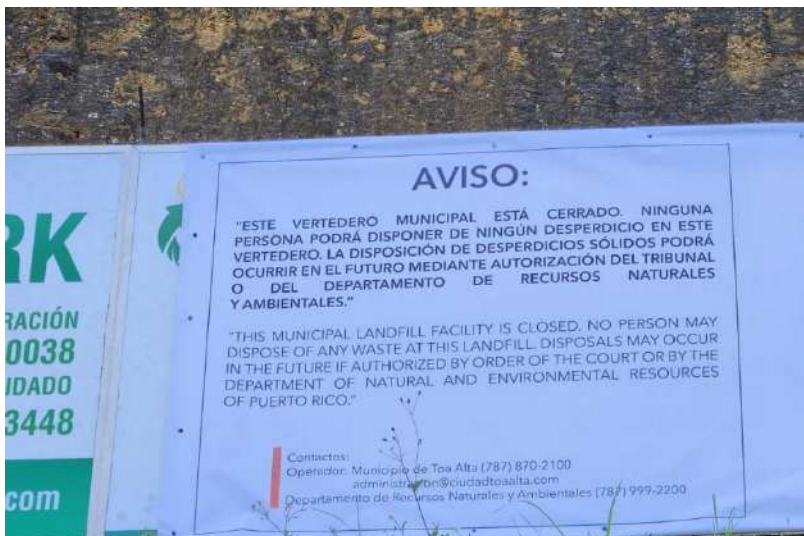
A sign with a size of four feet by five feet was installed at the landfill entrance. See the attached picture.

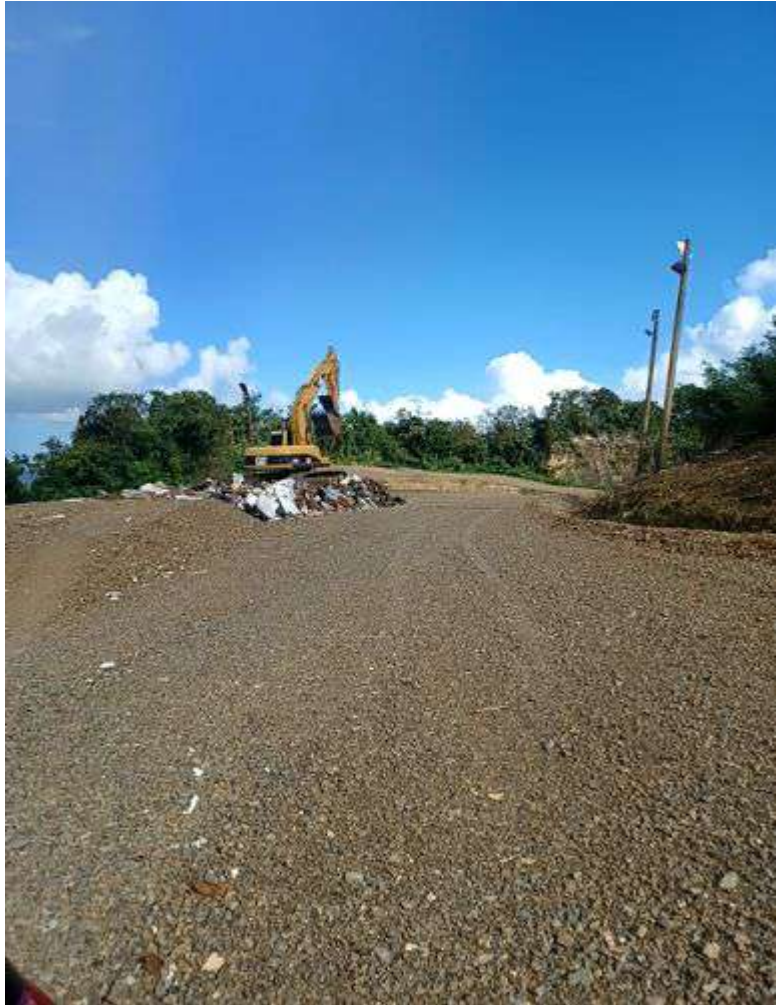
Tomar foto

Condicion Operacion Recibo de Escombros

Necesita Limpieza

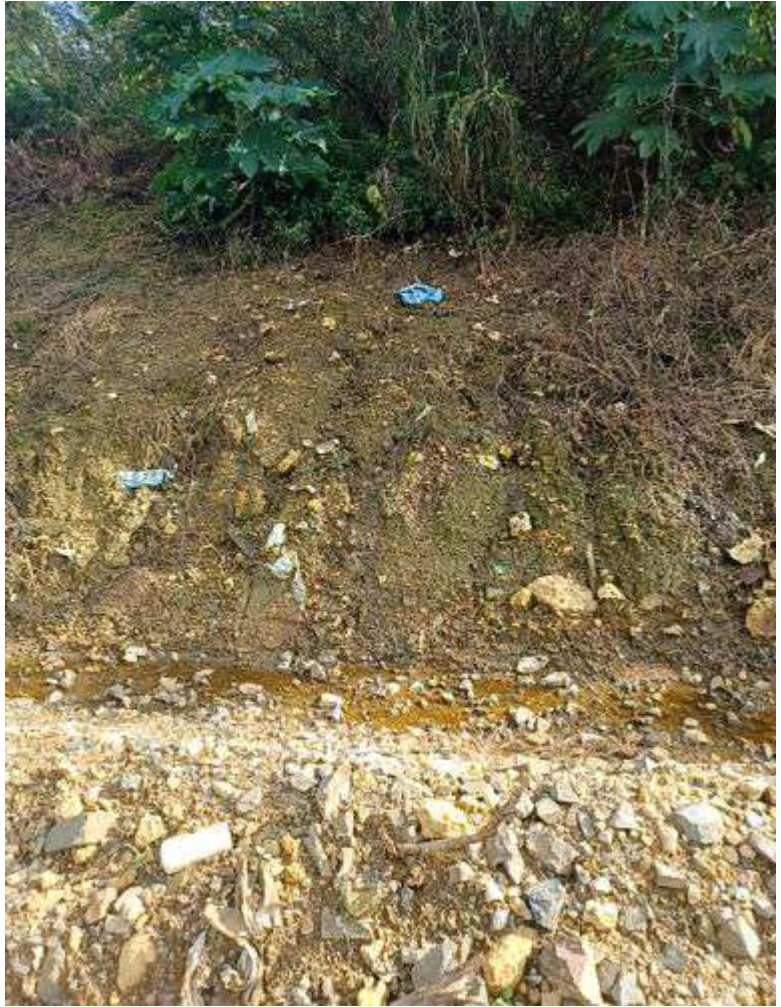
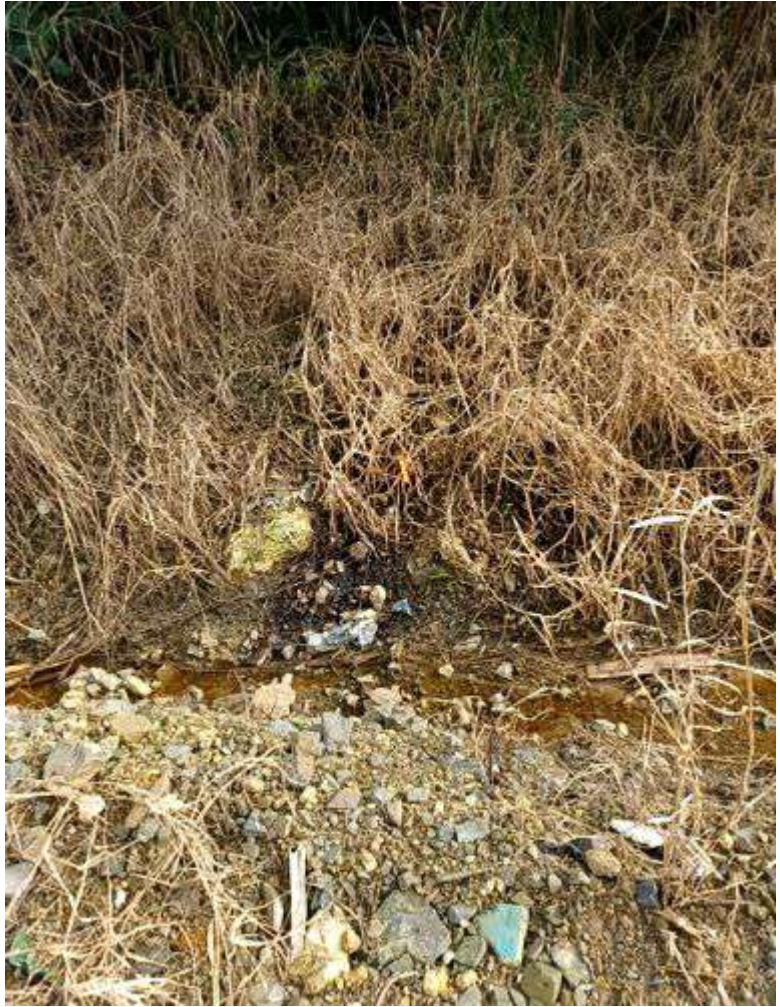
Añadir fotos deal area de brotes visibles

Se pueden notar brotes de lixiviado?

SI

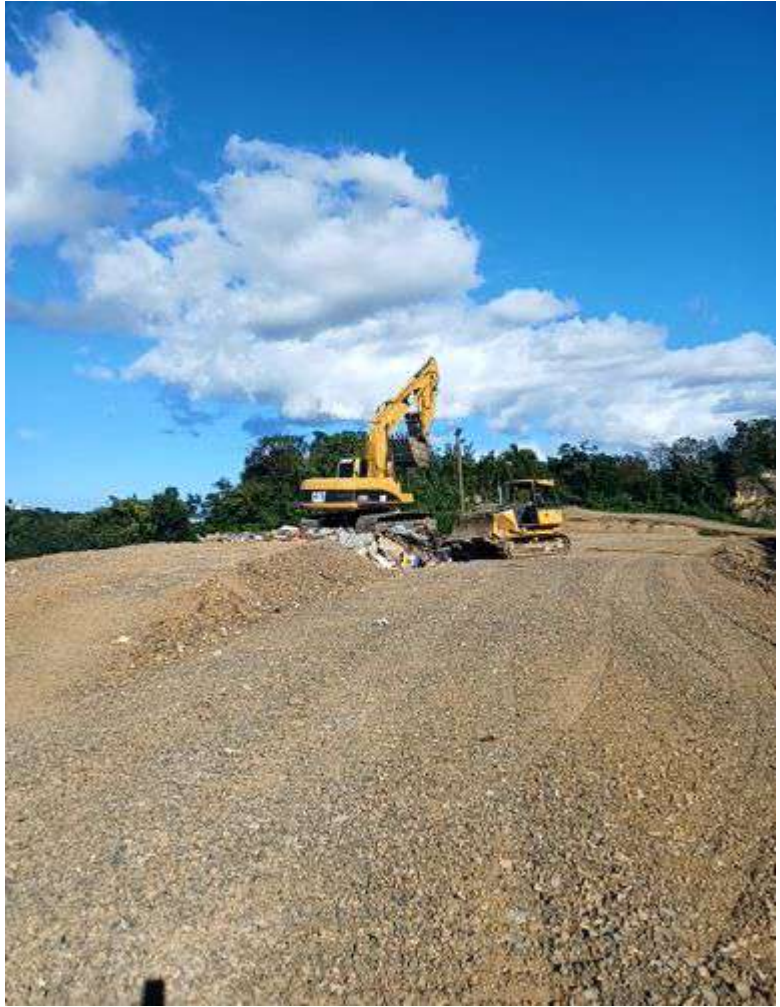
Tomar foto

Condicion Operacion Recibo de Escombros

Necesita Limpieza

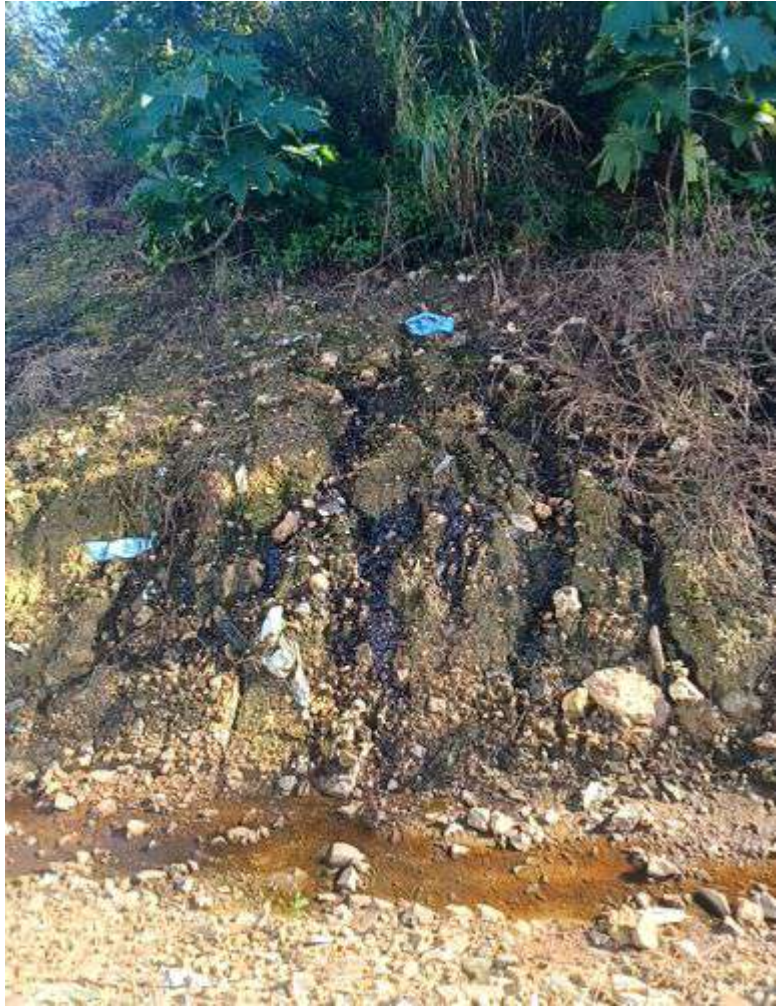
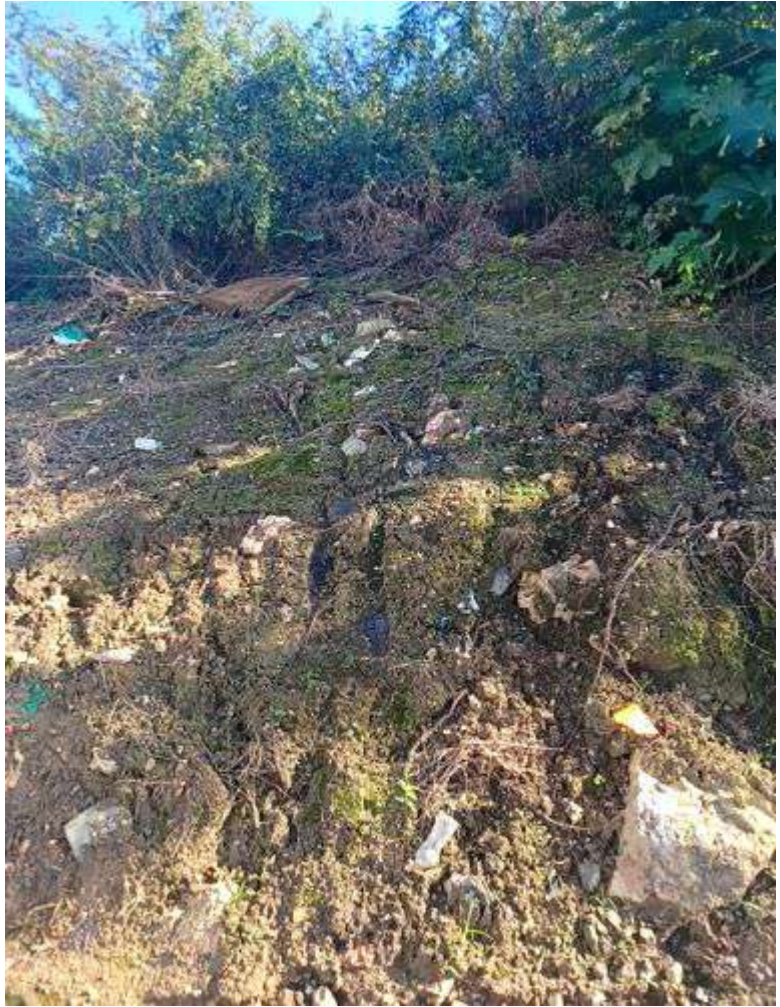
Añadir fotos deal area de brotes visibles

Se pueden notar brotes de lixiviado?

SI

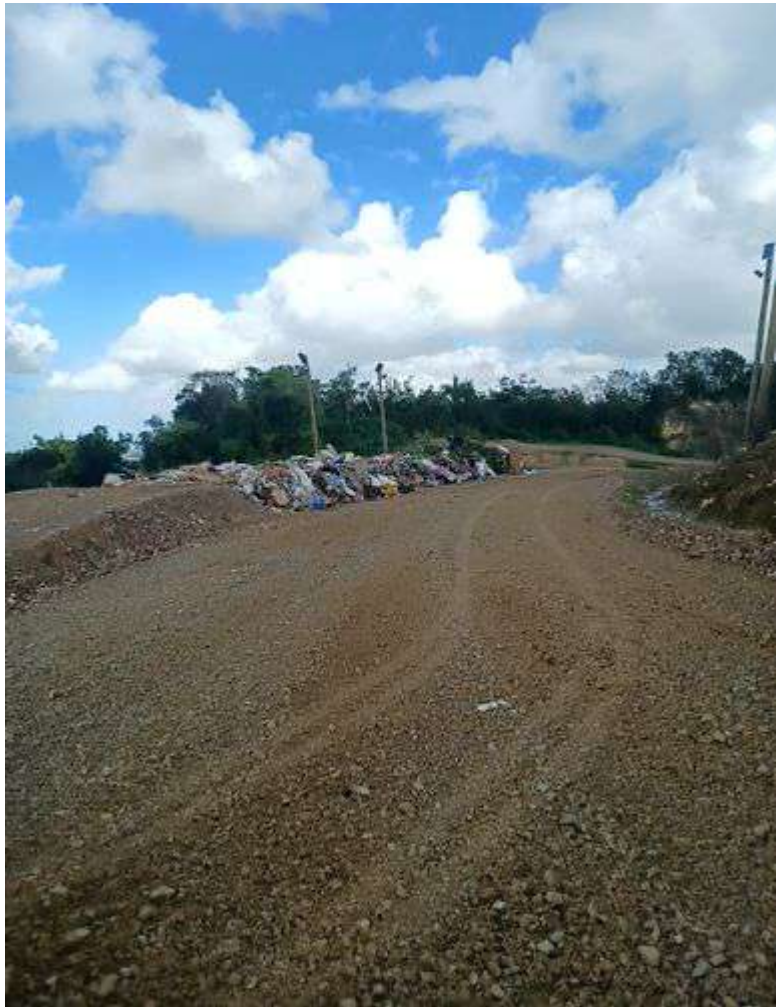
Tomar foto

Condicion Operacion Recibo de Escombros

Necesita Limpieza

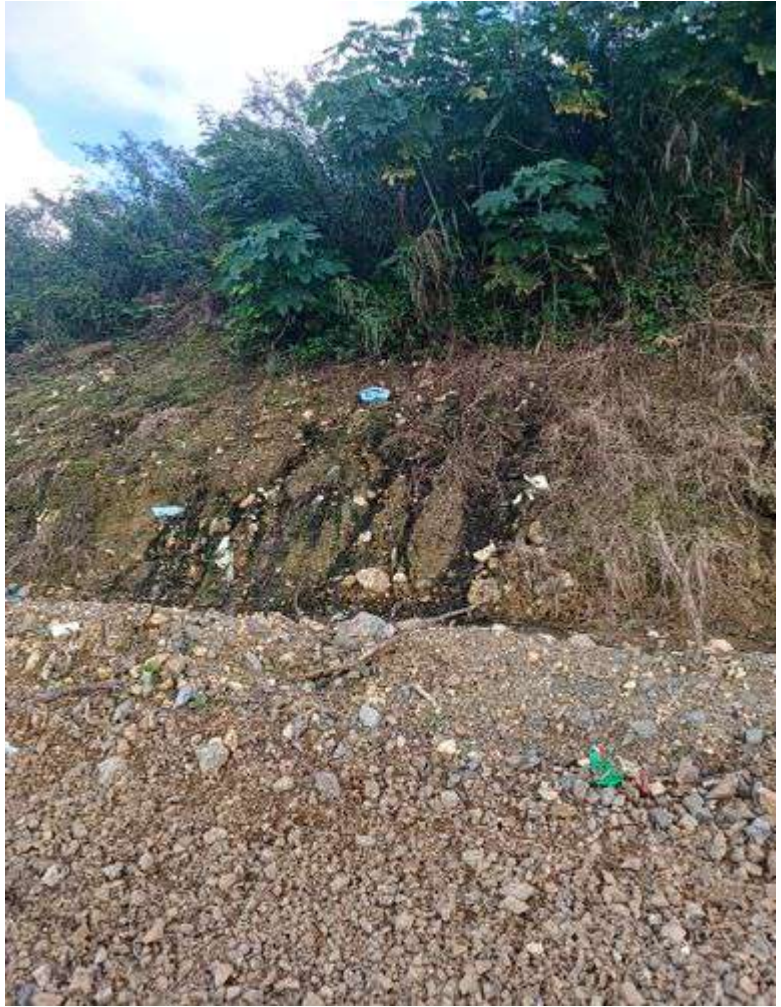
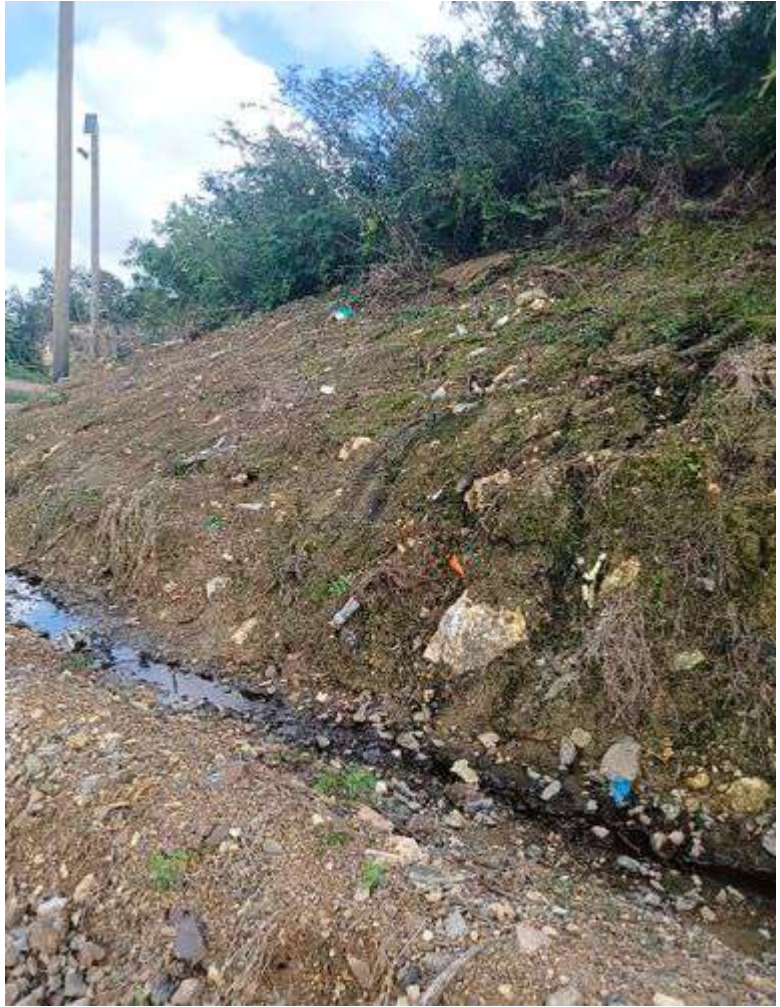
Añadir fotos deal area de brotes visibles

Se pueden notar brotes de lixiviado?

SI

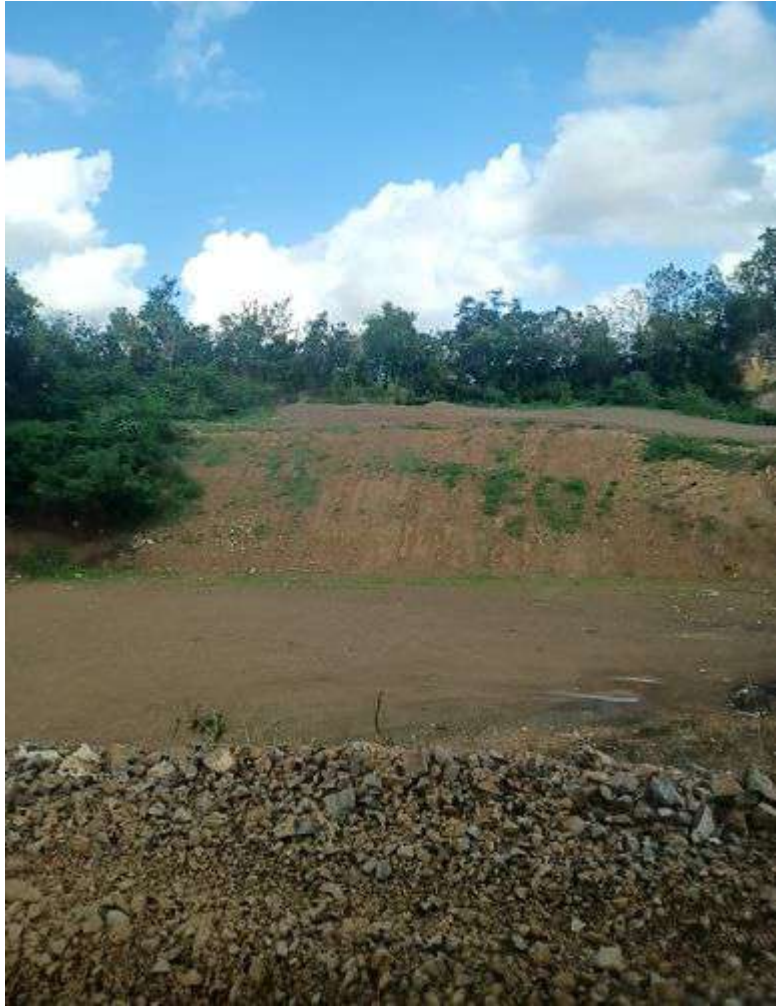
Tomar Foto de haber condiciones que necesiten mejoras

Condicion de areas de desvio de materiales

Esta area estaba llena de White Goods! y se limpió.

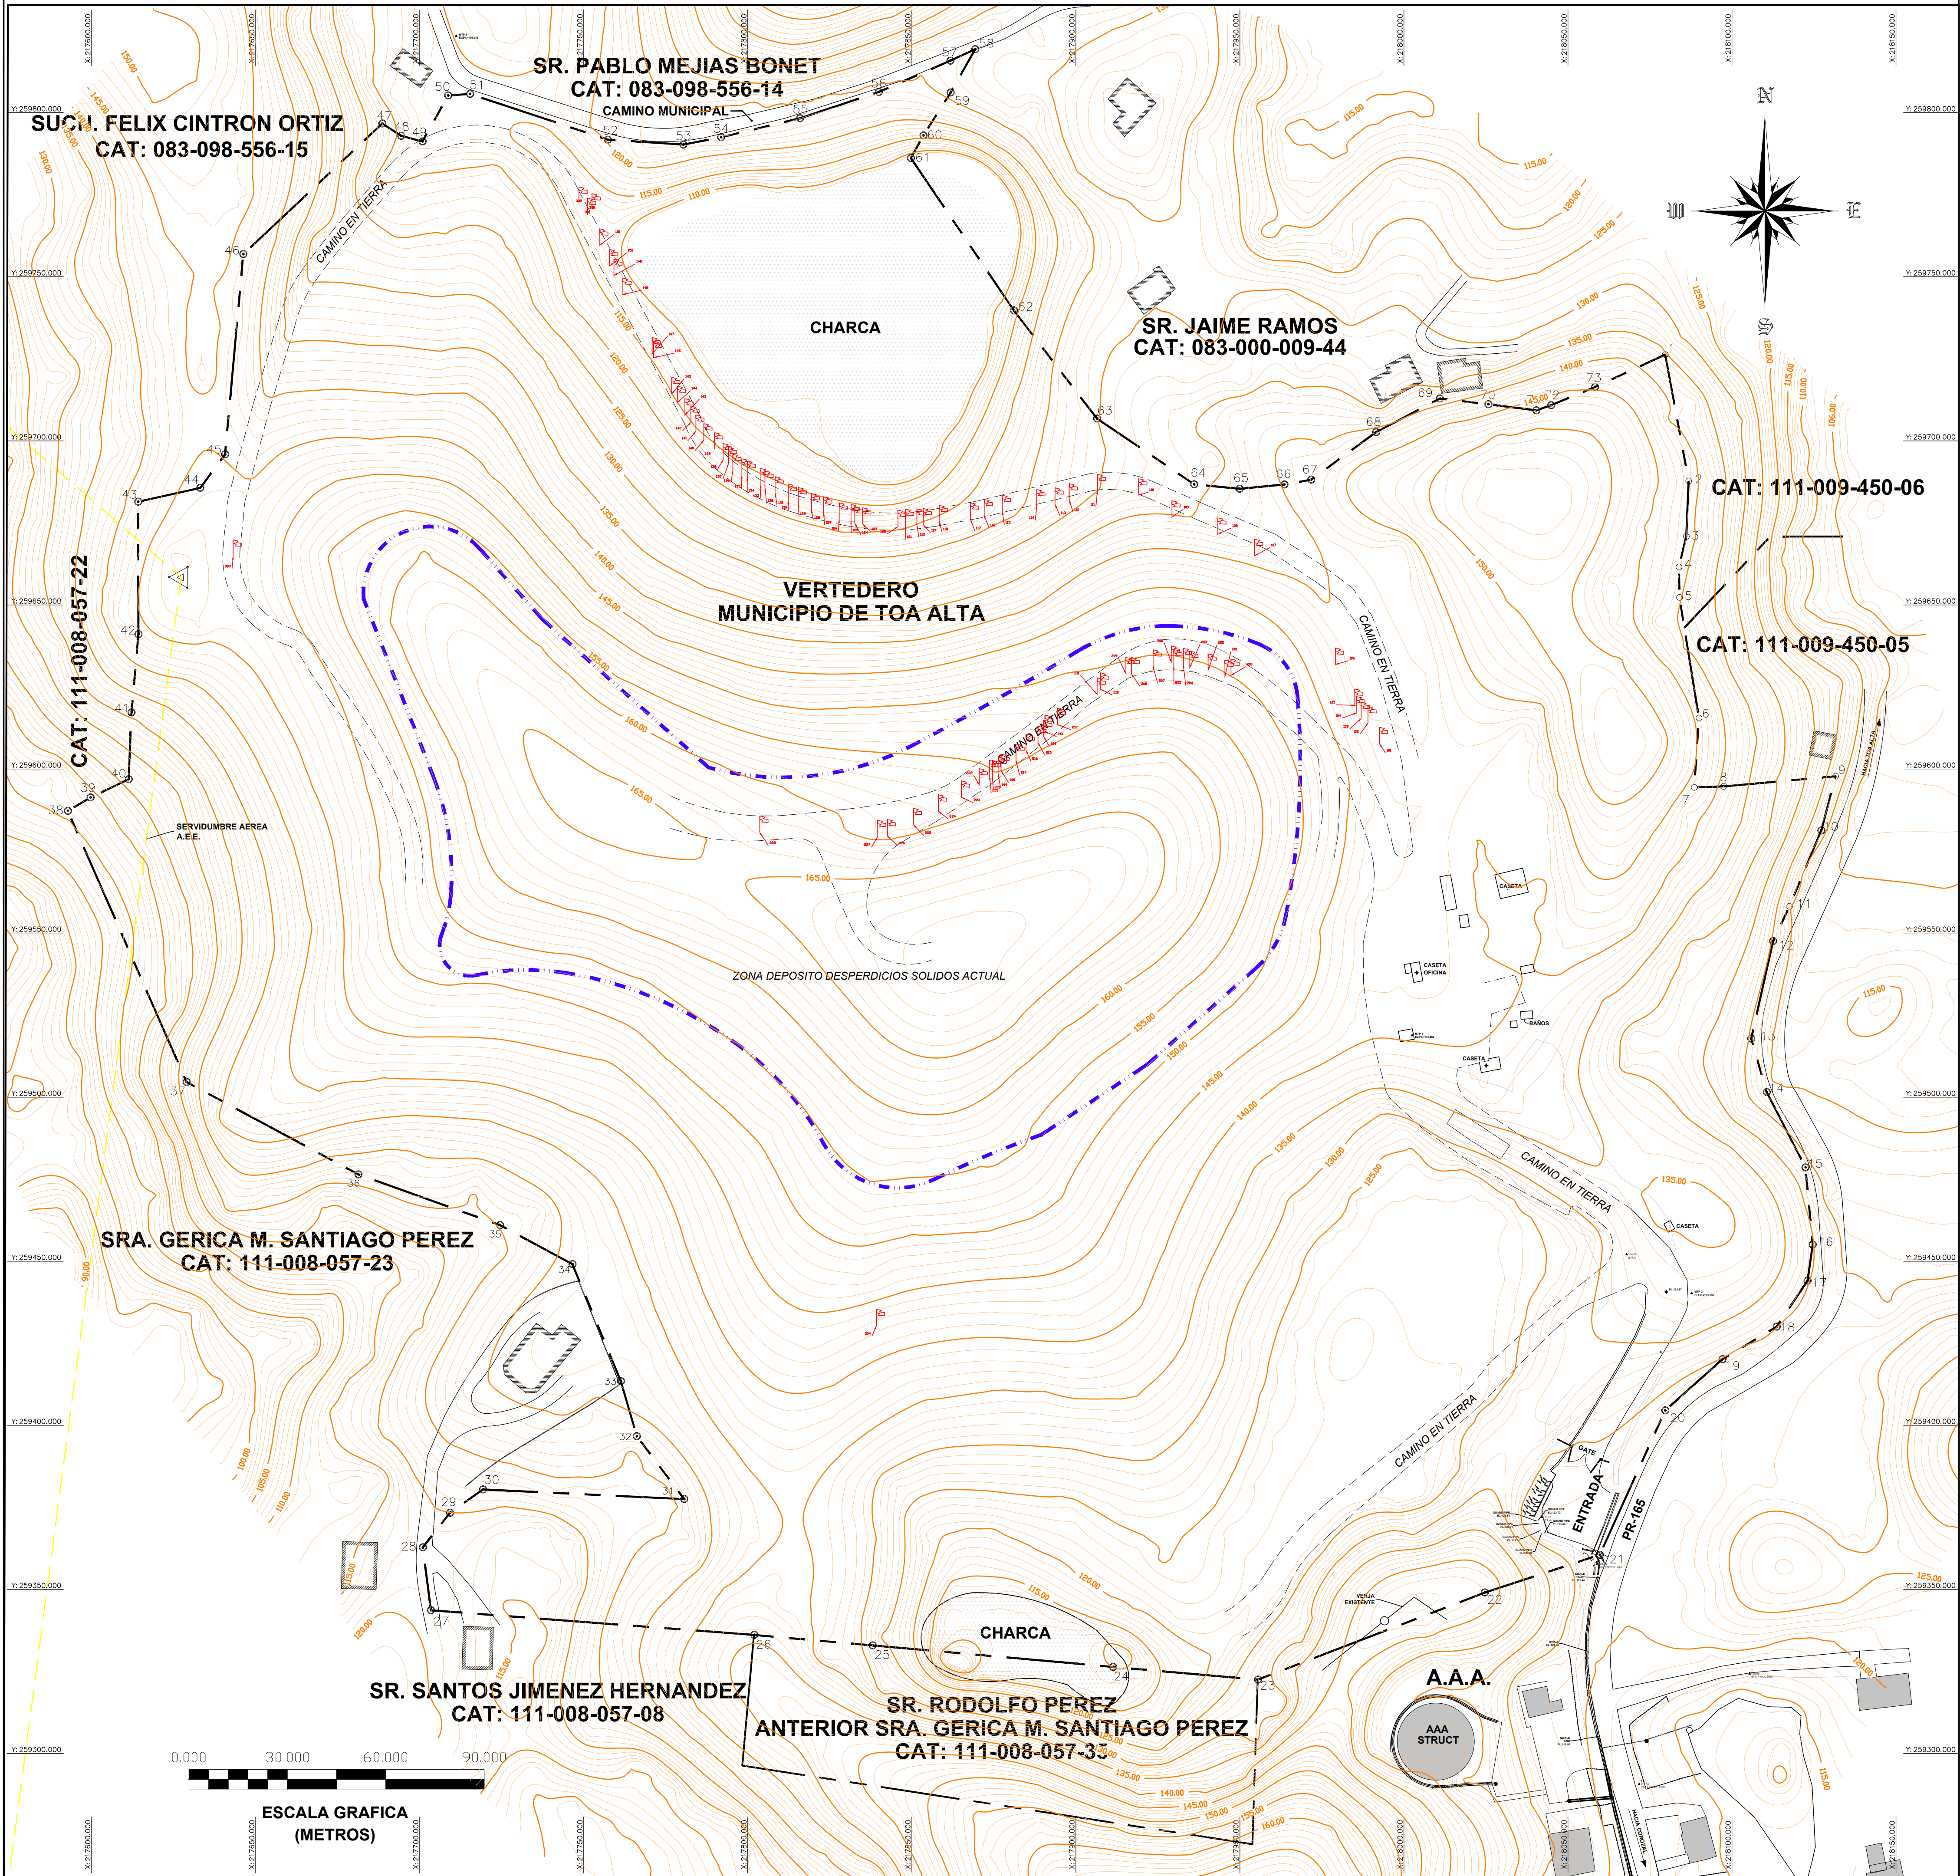
PLANO TOPOGRÁFICO "ASBUILT" CONDICIONES EXISTENTES
IDENTIFICACIÓN SUMIDEROS LIXIVIADOS EXISTENTES
 FINCA PROPIEDAD DEL MUNICIPIO DE TOA ALTA
 VERTEDERO RESIDUOS SÓLIDOS
 SITA: EN CARRETERA PR-165, KM. 9.0, Bo. MAMEY
 TOA ALTA, PUERTO RICO

CONDICIONES EXISTENTES PARA DICIEMBRE 17, 2022
