MUNICIPALITY OF TOA ALTA JANUARY 2023 MONTHLY REPORT  
Civ. No. 3:21-01087-DRD

N. AYALA  
TERRATEK ENGINEERING GROUP, PSC  
P.O. Box 367445 San Juan, PR 00936

Municipality of Toa Alta Civ. No. 3:21-01087-DRD		
Reporting Period:	February 01 to 28, 2023	
Reporting Number:	07	
Reporting Official:	Nivia Ayala, PE/TerraTek	
Reporting Date:	3/18/2023	
Description of Compliance with each requirement of the Order		
ID	Requirement	Compliance Status
1	Daily Cover	Daily cover was completed prior to April 30, 2022.
2	Cessation of Waste Disposal	In-Compliance
3	Posting of Signs	In Compliance
4	Intermediate Cover	Intermediate cover was scheduled to start by October 1, 2022. In a meeting with DNER, MTA agreed to start intermediate cover task by July 01, 2023, to the top deck and including stormwater runoff chutes. After DNER approves, or approves with modifications or conditions, any MTA revised permanent closure plan, and if the approved plan includes a schedule for completion of Intermediate Cover, that schedule shall control. Please see Additional comment for ID 4 item.

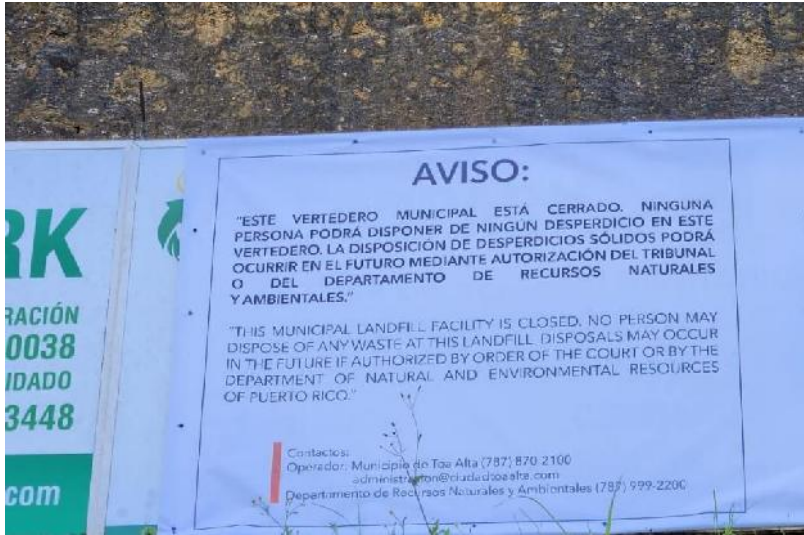
A sign with a size of four feet by five feet was installed at the landfill entrance. See the attached picture.

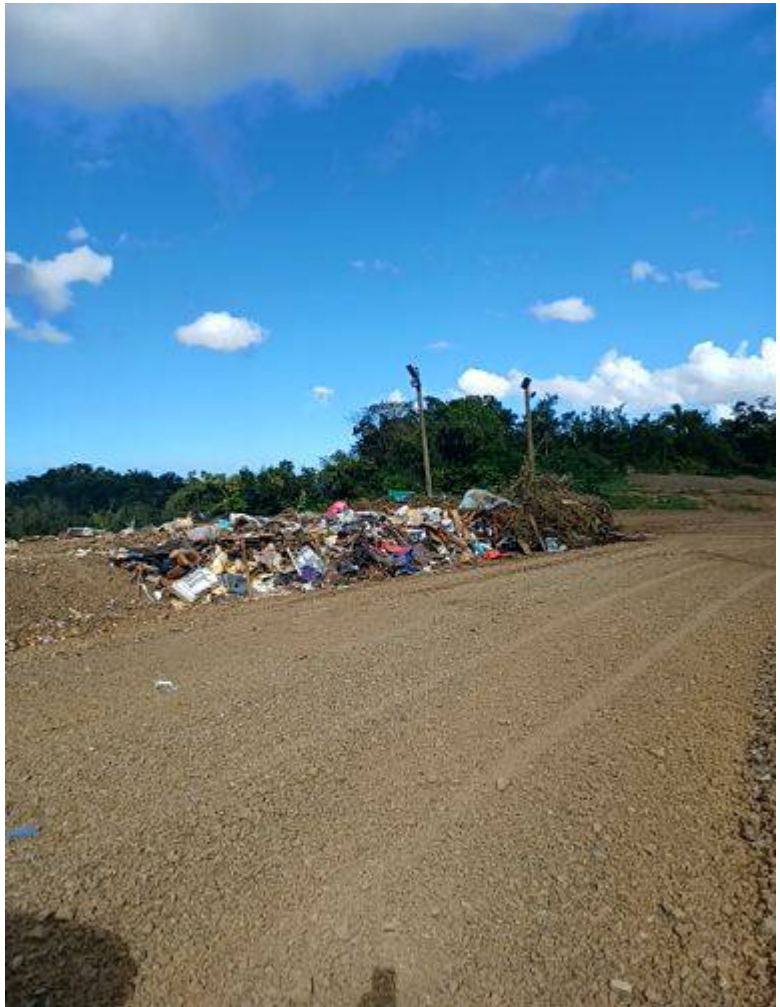
**Tomar foto**

**Condicion Operacion Recibo de Escombros**

Necesita Limpieza

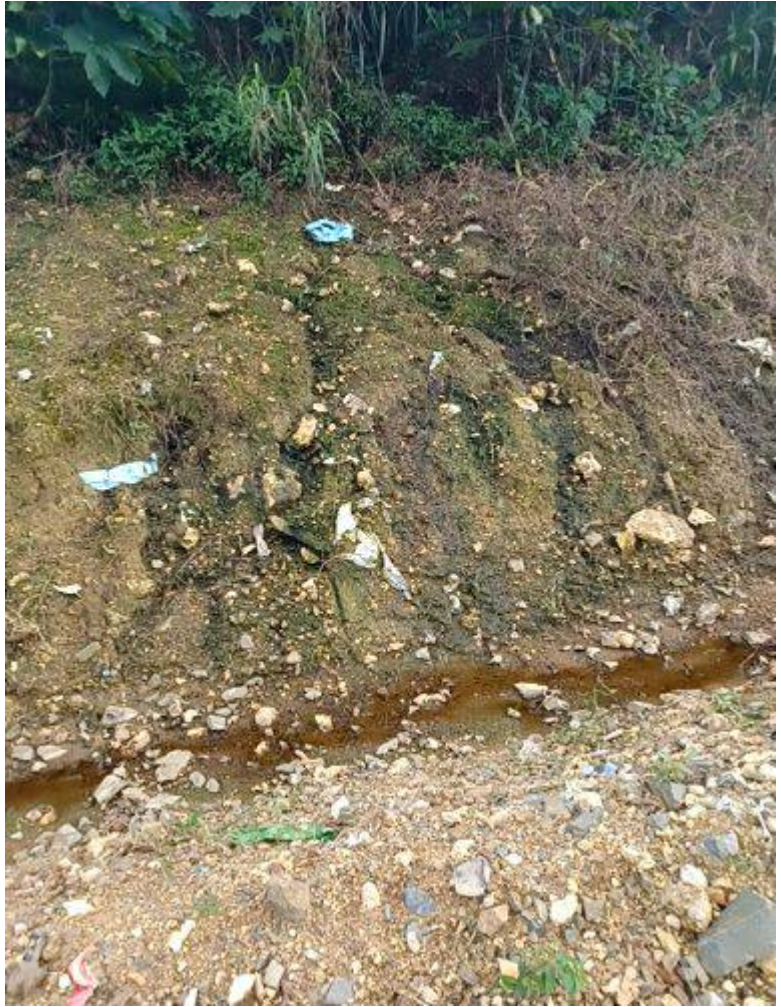
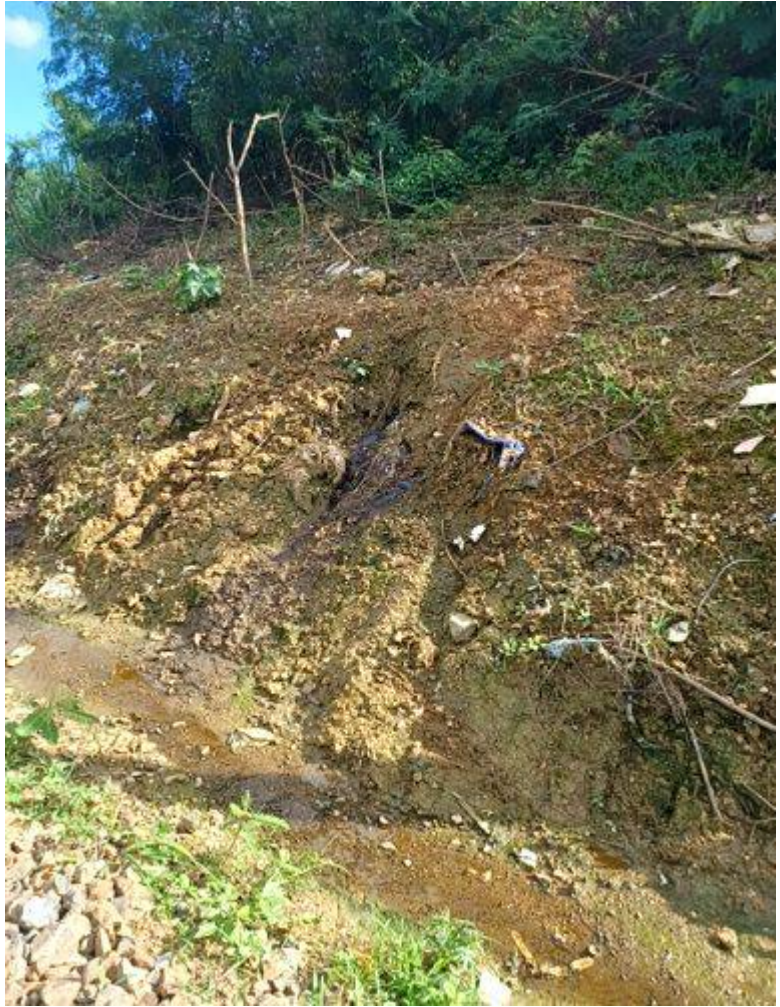
**Añadir fotos deal area de brotes visibles**

**Se pueden notar brotes de lixiviado?**

SI

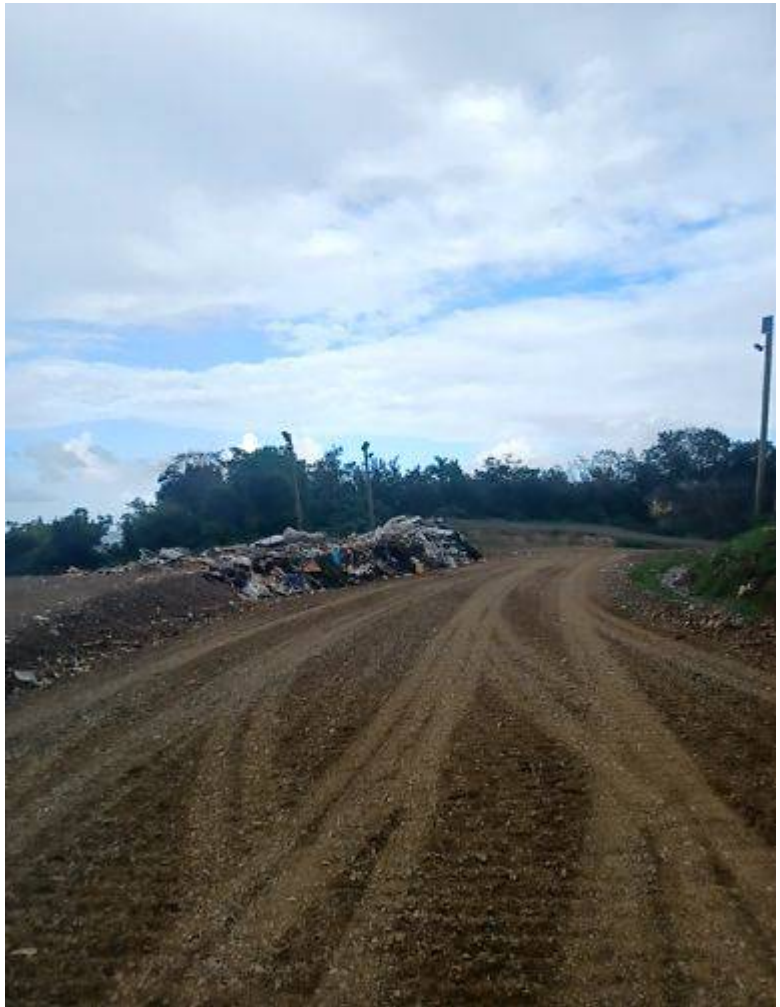
**Tomar foto**

**Condicion Operacion Recibo de Escombros**

Necesita Limpieza

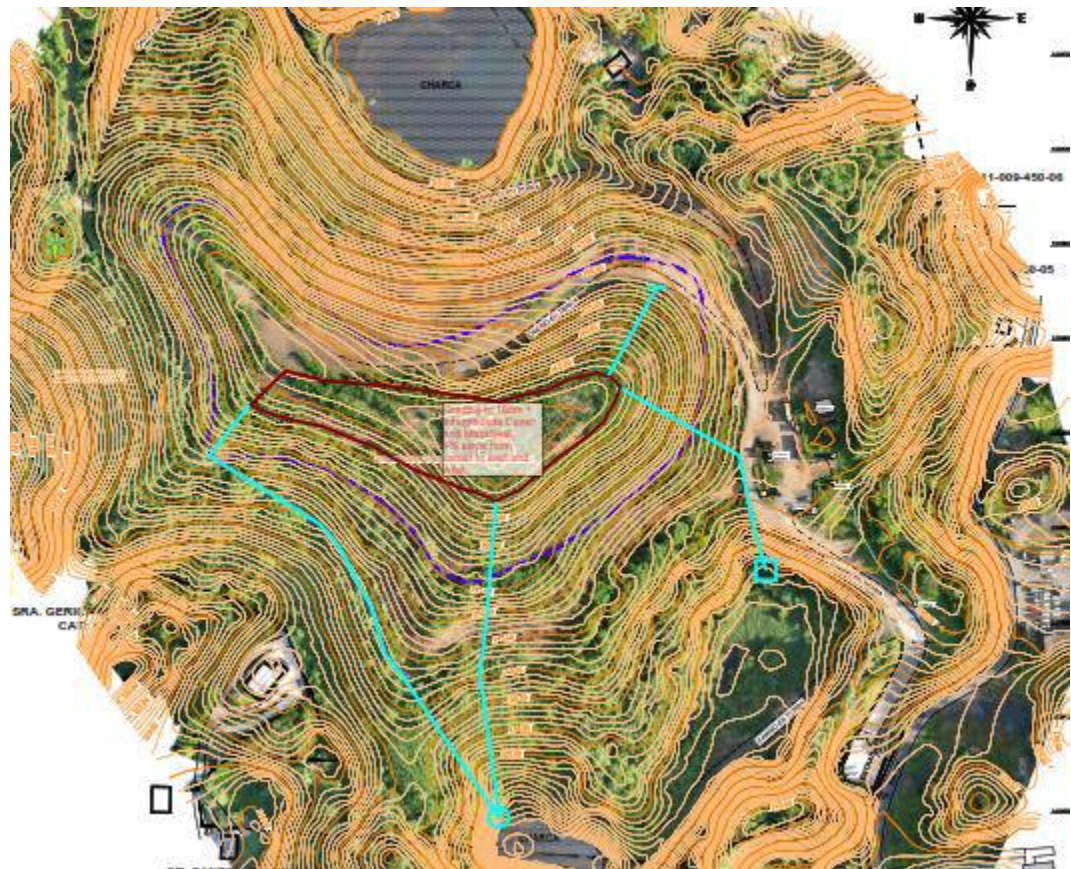
Figure 3 Top Deck and Stormwater Down Chutes

The Site Top Deck has an area of approximately 4 acres, by applying a Styrene Acrylic Liquid Stabilizer after proper grading, we can achieve a temporary impermeability effect prior to final capping of the Site. We can reduce approximately 19397 gallons of leachate generation in 1 year. **Adding a 13% reduction of leachate generation.**

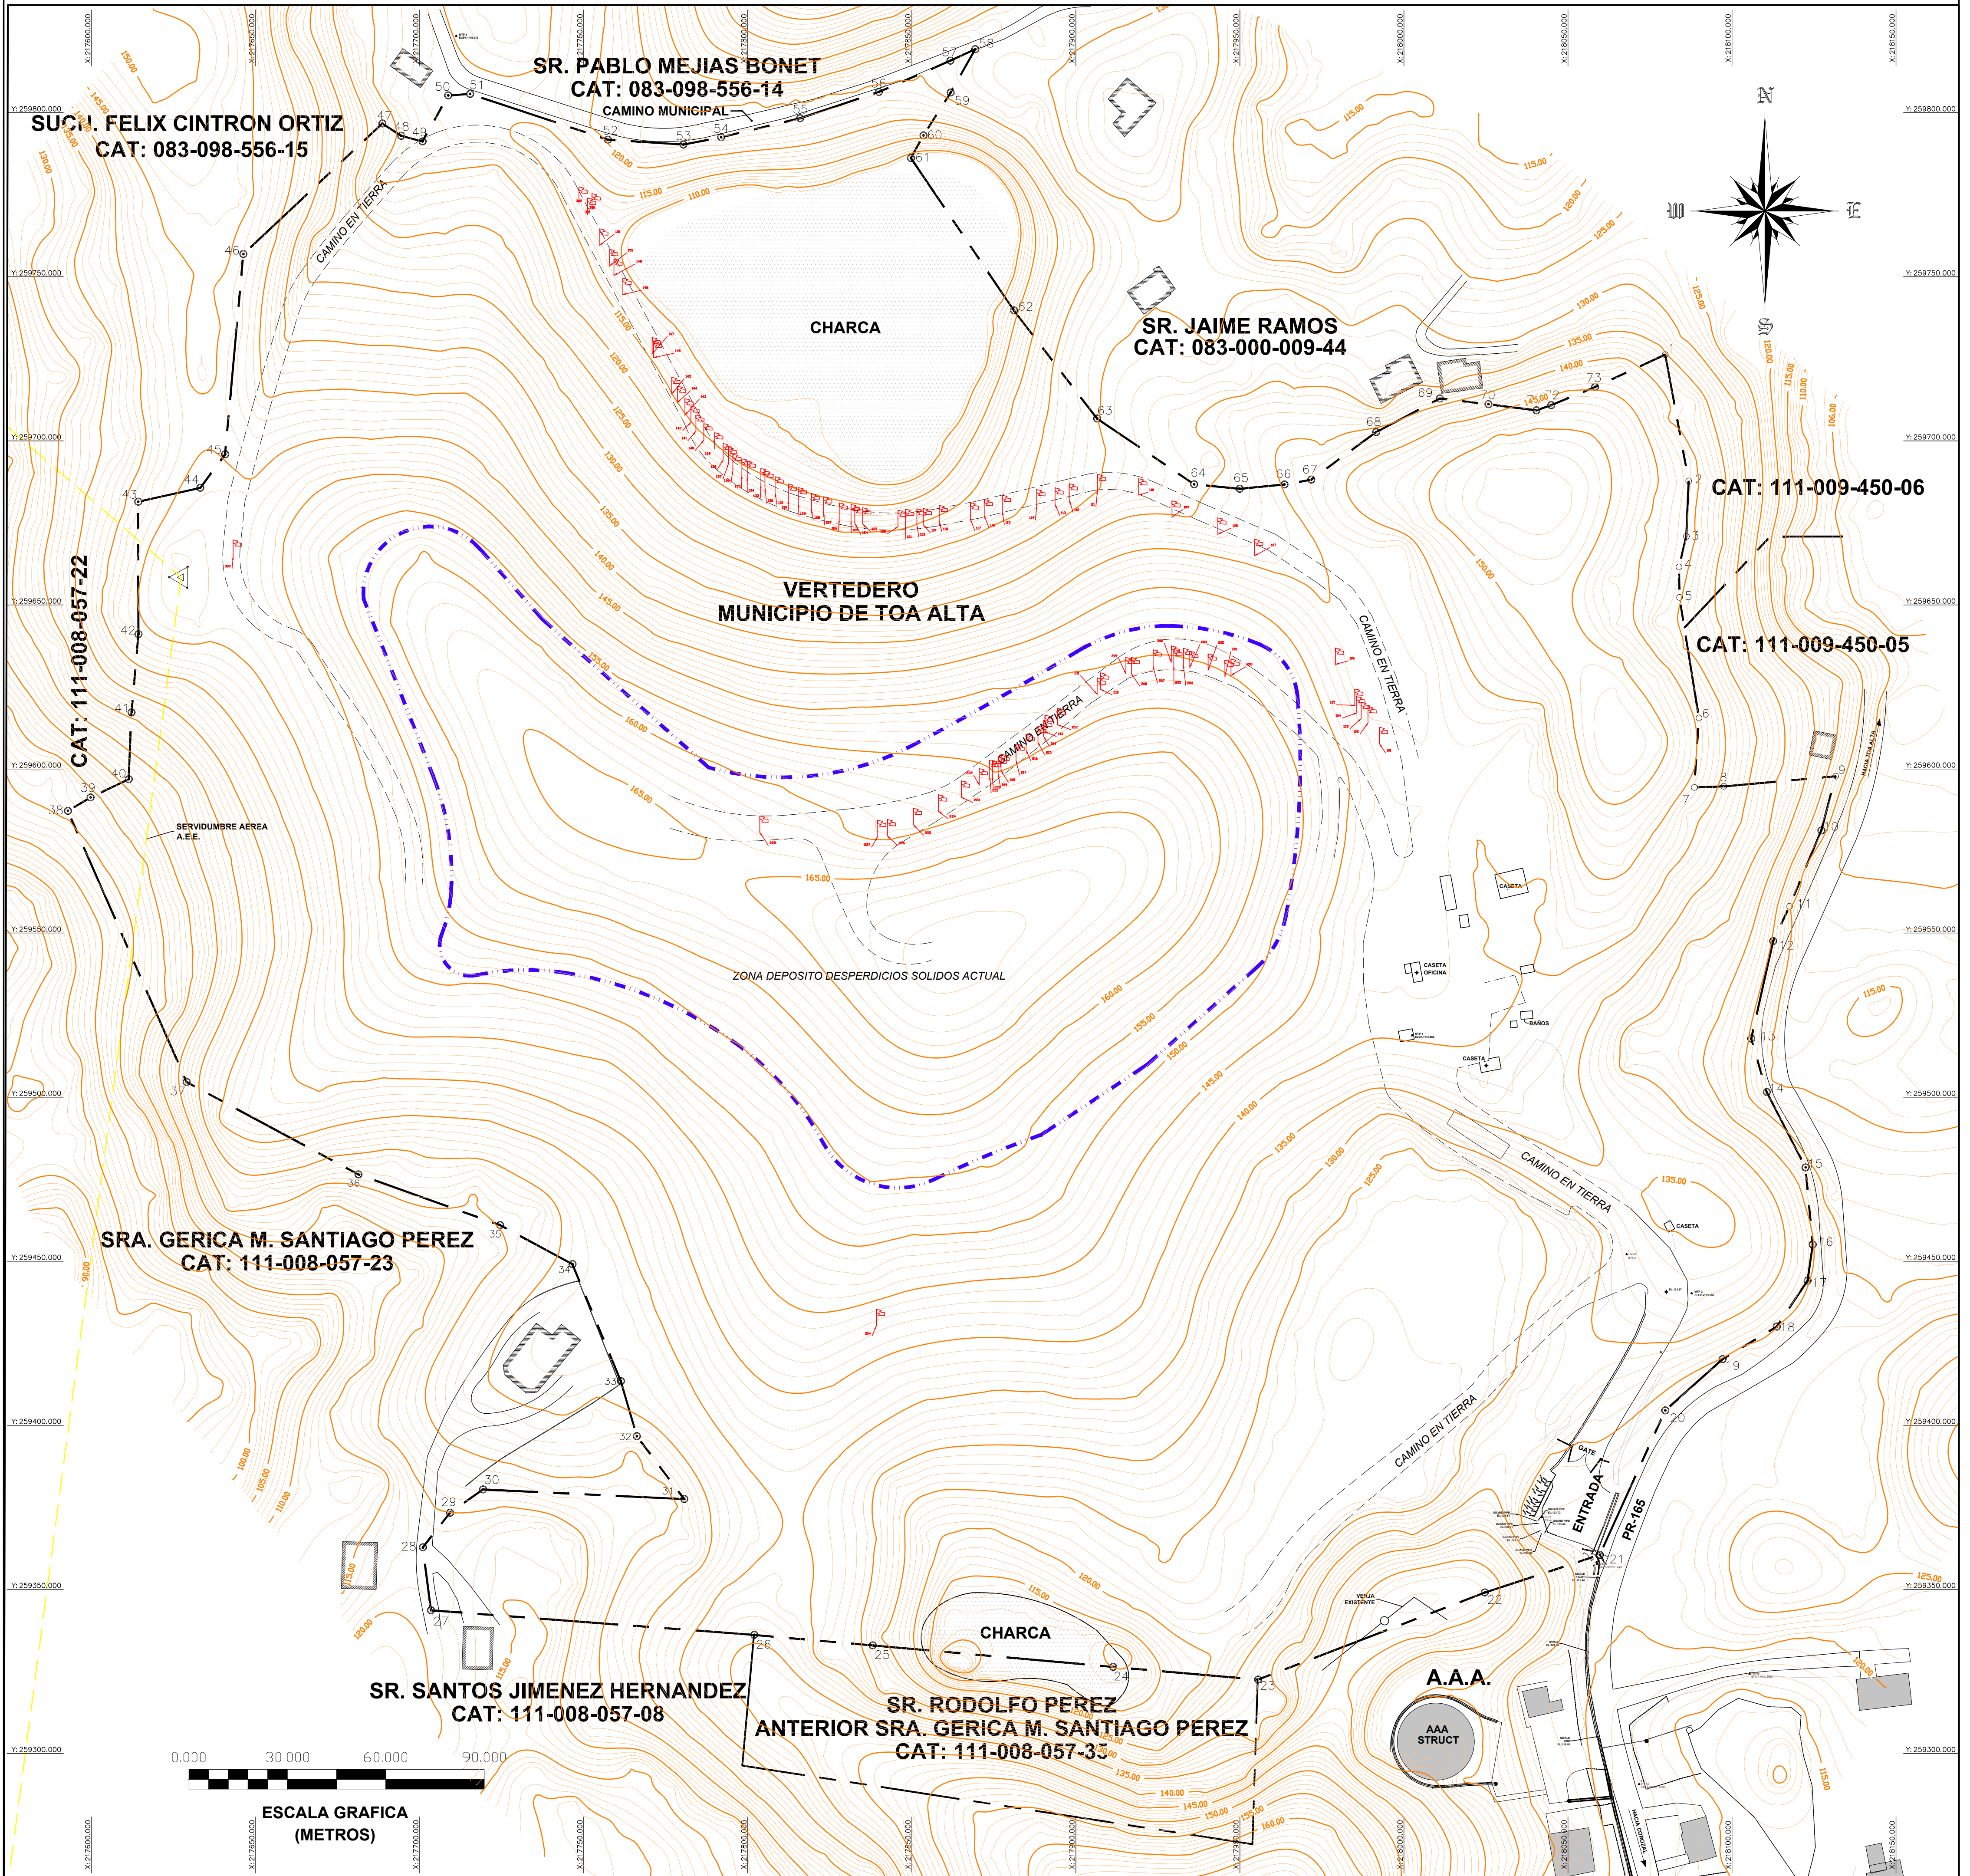
**PLANO TOPOGRÁFICO "ASBUILT" CONDICIONES EXISTENTES**  
**IDENTIFICACIÓN SUMIDEROS LIXIVIADOS EXISTENTES**  
 FINCA PROPIEDAD DEL MUNICIPIO DE TOA ALTA  
 VEREDERO RESIDUOS SÓLIDOS  
 SITA: EN CARRETERA PR-165, KM. 9.0, Bo. MAMEY  
 TOA ALTA, PUERTO RICO

CONDICIONES EXISTENTES PARA DICIEMBRE 17, 2022 COORD. LAMBERT NAD-83 X= 217,876.00 Y= 259,575.00
