ATTACHMENT NILES-C

File Number: 24TA006	Company Name: ACCEL Schools Ohio, LLC	Company Address, City, State, Zip Code: 45 S Chestnut Avenue, Niles, Ohio 4446
Date of Inspection: April 3, 2024	Inspector-Photographer: Brandon Brewster	Number of Photographs Taken: 49
Camera Used: Canon PowerShot SX740 HS	Digital Recording Media: SD CARD	Notes: All photos date and time stamped, except Photo #1. All photos were taken at Niles Preparatory Academy located at 45 S Chestnut Avenue, Niles, Ohio 44446.

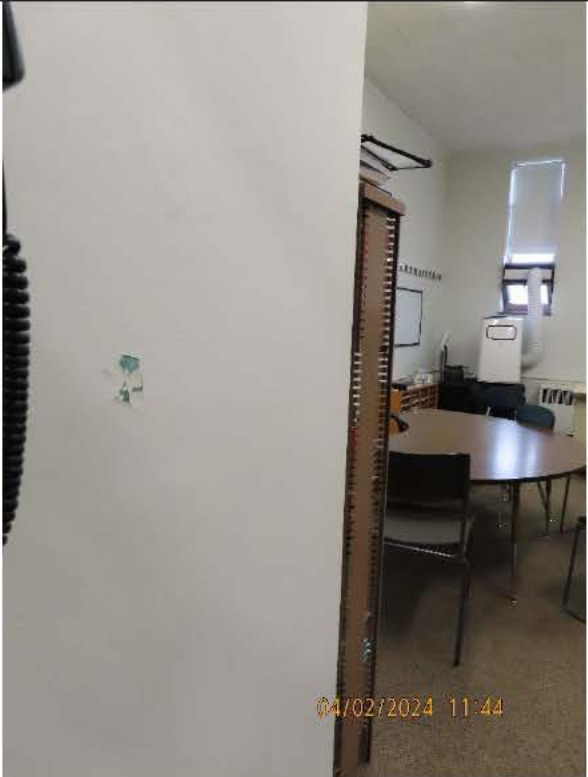
6.	Date Taken: 04/03/2024	Time Taken: 11:44 AM ET

Sample No.: 6-IMG100-00546.JPG		
	Description of Digital Image: Upper Level – Room 302/Resource Room		
	<p>The Resource Room contained 1x1 acoustical ceiling tile and minor wall paint damage near the room's entrance.</p> <p>Modifications: Reduced scale of photo by 50% for the purpose of inspection report.</p>

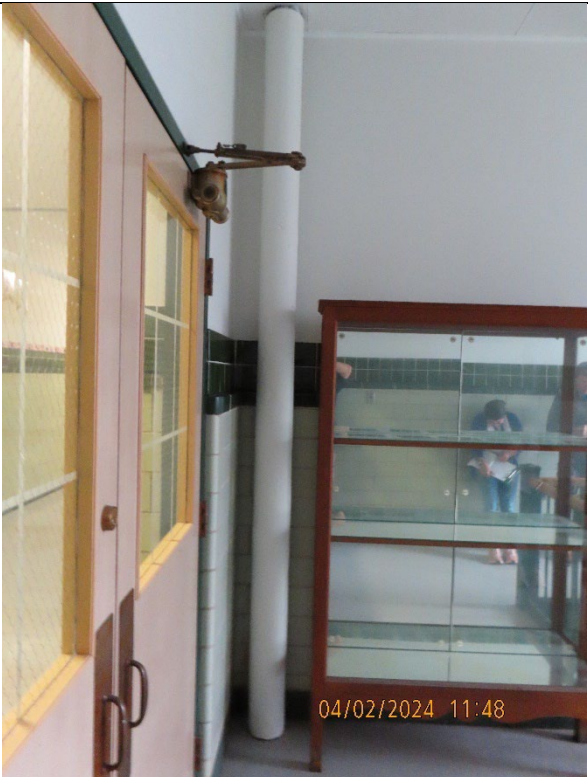
9.	Date Taken: 04/03/2024	Time Taken: 11:48 AM ET

Sample No.: 9-IMG100-00549.JPG		
	Description of Digital Image: Upper Level – Eastern Stairwell		
	<p>The stairwell contained a vertical pipe that appear to be a water supply riser and continued to the Main Level. The vertical pipe's insulation wrapping to be firm and hard in texture. 1x1 acoustical ceiling tile continued from the Upper Level Hallway to the Upper Level Eastern Stairwell.</p> <p>Modifications: Reduced scale of photo by 50% for the purpose of inspection report.</p>

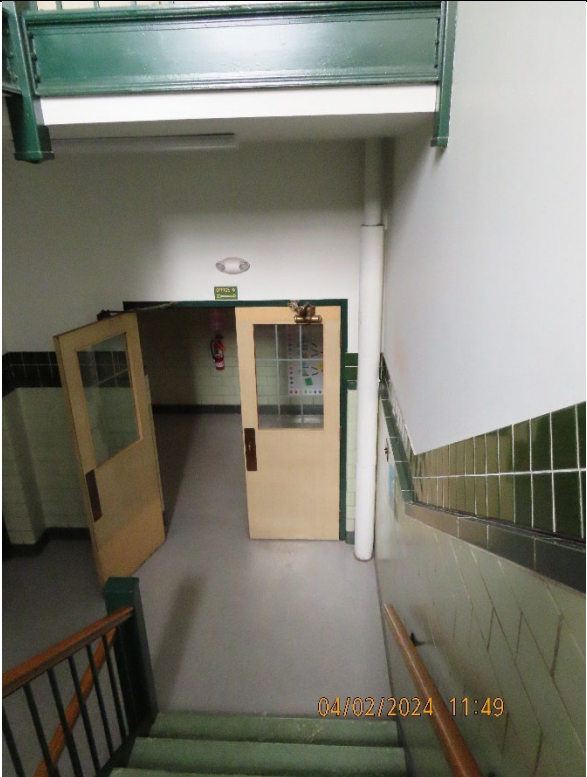
10.	Date Taken: 04/03/2024	Time Taken: 11:49 AM ET

Sample No.: 10-IMG100-00550.JPG		
	Description of Digital Image: Main Level – Eastern Stairwell The water supply riser continued from the Upper Level Easter Stairwell to the Main Level Eastern Stairwell. The vertical pipe’s insulation wrapping to be firm and hard in texture.		
Modifications: Reduced scale of photo by 50% for the purpose of inspection report.

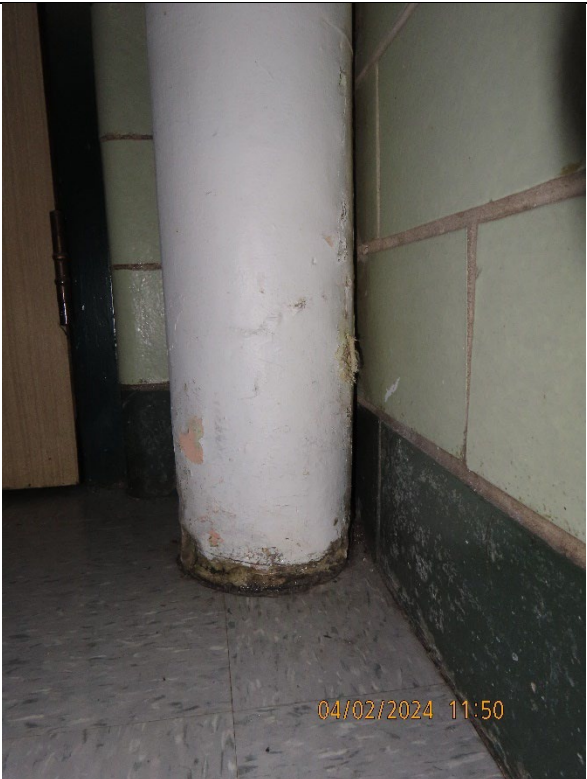
11.	Date Taken: 04/03/2024	Time Taken: 11:49 AM ET

Sample No.: 11-IMG100-00551.JPG		
	Description of Digital Image: Main Level – Eastern Stairwell The water supply riser continued from the Upper Level Easter Stairwell to the Main Level Eastern Stairwell. The bottom of the vertical pipe’s insulation wrap appear to have signs of deterioration.		
Modifications: Reduced scale of photo by 50% for the purpose of inspection report.

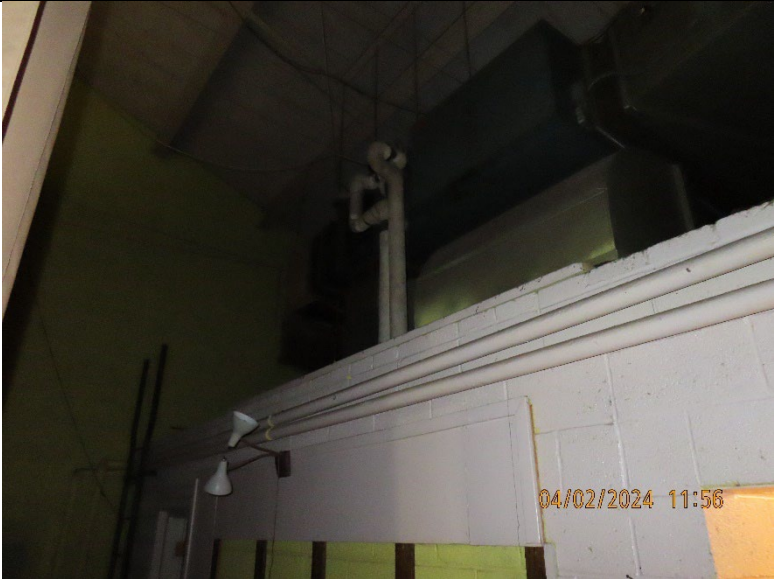
14.	Date Taken: 04/03/2024	Time Taken: 11:56 AM ET

Sample No.: 14-IMG100-00554.JPG		
	Description of Digital Image: Main Level – Gymnasium		
	<p>The back of the stage contained a boiler and heat transfer system that was closed off by a brick wall partition. The EPA Representatives were not able to access the boiler and heat transfer system due to the wall partition. Horizontal and vertical piping were observed to be accessible and inaccessible due to the brick wall partition.</p>		
Modifications: Reduced scale of photo by 50% for the purpose of inspection report.

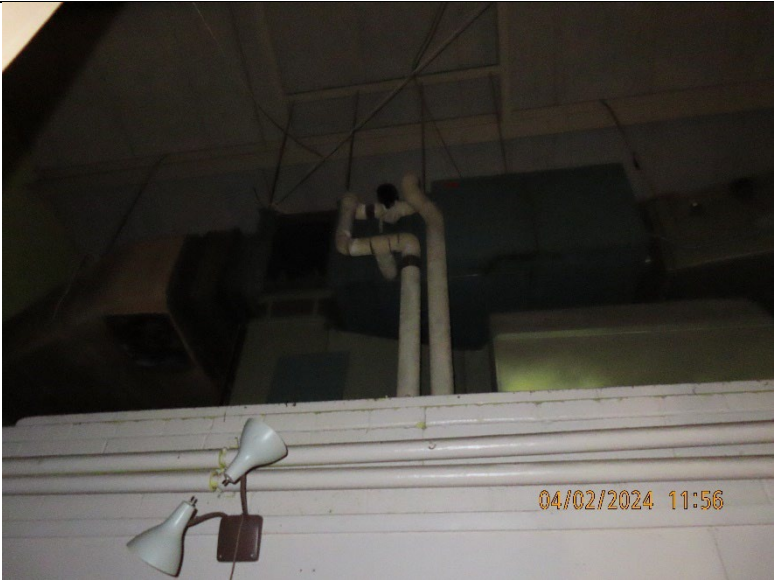
15.	Date Taken: 04/03/2024	Time Taken: 11:56 AM ET

Sample No.: 15-IMG100-00555.JPG		
	Description of Digital Image: Main Level – Gymnasium		
	<p>The back of the stage contained a boiler and heat transfer system that was closed off by a brick wall partition. The EPA Representatives were not able to access the boiler and heat transfer system due to the wall partition. Horizontal and vertical piping were observed to be accessible and inaccessible due to the brick wall partition.</p>		
Modifications: Reduced scale of photo by 50% for the purpose of inspection report.

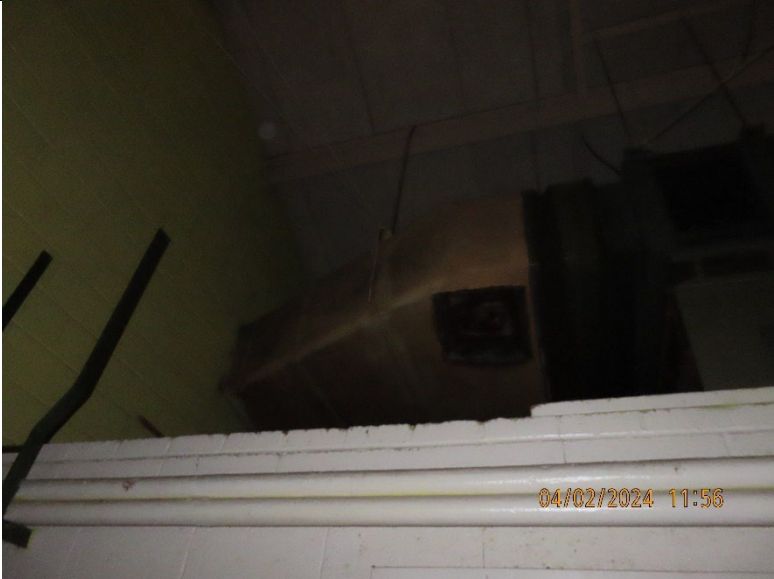
16.	Date Taken: 04/03/2024	Time Taken: 11:56 AM ET

Sample No.: 16-IMG100-00556.JPG		
	Description of Digital Image: Main Level – Gymnasium		
	<p>The back of the stage contained a boiler and heat transfer system that was closed off by a brick wall partition. The EPA Representatives were not able to access the boiler and heat transfer system due to the wall partition. Horizontal and vertical piping were observed to be accessible and inaccessible due to the brick wall partition. An insulation jacket to the heat transfer system appeared to be in a deteriorating condition.</p>		
Modifications: Reduced scale of photo by 50% for the purpose of inspection report.

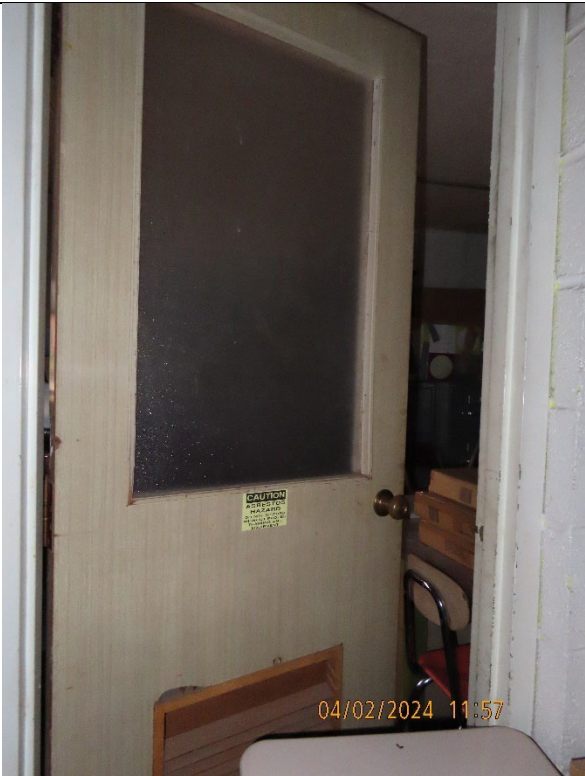
17.	Date Taken: 04/03/2024	Time Taken: 11:57 AM ET

Sample No.: 17-IMG100-00557.JPG		
	Description of Digital Image: Main Level – Gymnasium		
	<p>Two storage rooms located in the back of the stage had an asbestos caution sign posted on the entrance doors.</p>		
Modifications: Reduced scale of photo by 50% for the purpose of inspection report.

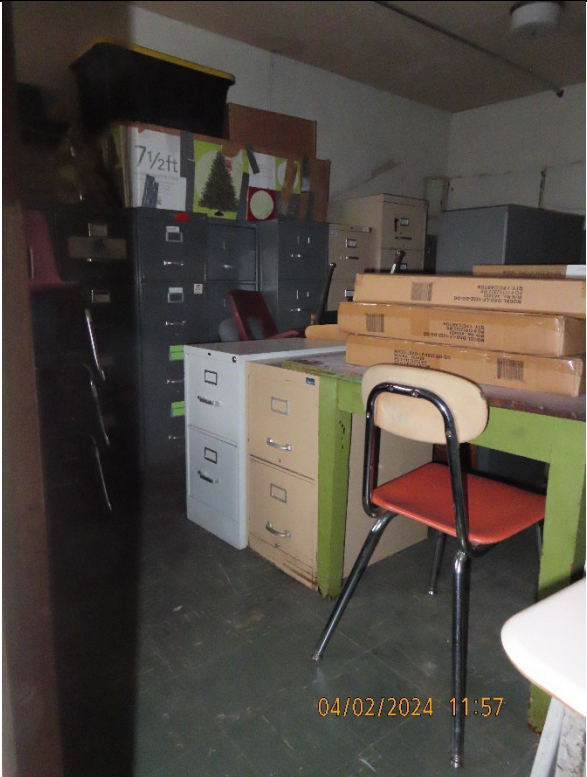
18.	Date Taken: 04/03/2024	Time Taken: 11:57 AM ET

Sample No.: 15-IMG100-00558.JPG		
	Description of Digital Image: Main Level – Gymnasium		
	<p>Two storage rooms located in the back of the stage contained deteriorating 1x1 acoustical ceiling tiles, scratched green floor tiles, deteriorating wall plaster and paint exposing the wall's concrete base. Both storage rooms stored various school furniture and educational material.</p>		
Modifications: Reduced scale of photo by 50% for the purpose of inspection report.

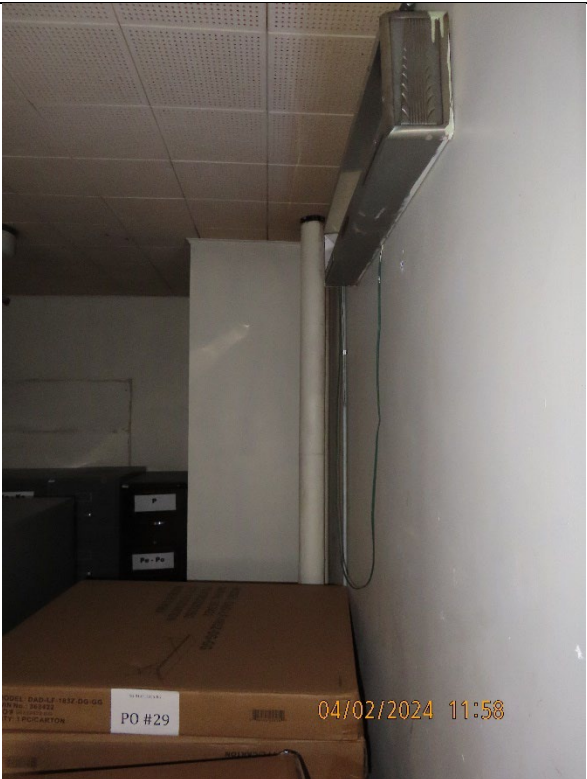
19.	Date Taken: 04/03/2024	Time Taken: 11:58 AM ET

Sample No.: 19-IMG100-00559.JPG		
	Description of Digital Image: Main Level – Gymnasium		
	<p>Two storage rooms located in the back of the stage contained deteriorating 1x1 acoustical ceiling tiles, scratched green floor tiles, deteriorating wall plaster and paint exposing the wall's concrete base. Both storage rooms stored various school furniture and educational material.</p>		
Modifications: Reduced scale of photo by 50% for the purpose of inspection report.

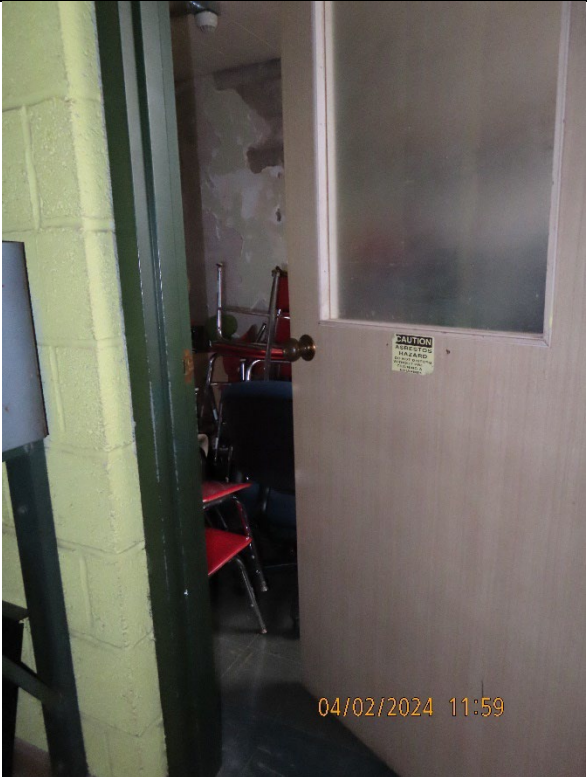
20.	Date Taken: 04/03/2024	Time Taken: 11:59 AM ET

Sample No.: 20-IMG100-00560.JPG		
	Description of Digital Image: Main Level – Gymnasium		
	<p>Two storage rooms located in the back of the stage contained deteriorating 1x1 acoustical ceiling tiles, scratched green floor tiles, deteriorating wall plaster and paint exposing the wall's concrete base. Both storage rooms stored various school furniture and educational material.</p>		
Modifications: Reduced scale of photo by 50% for the purpose of inspection report.

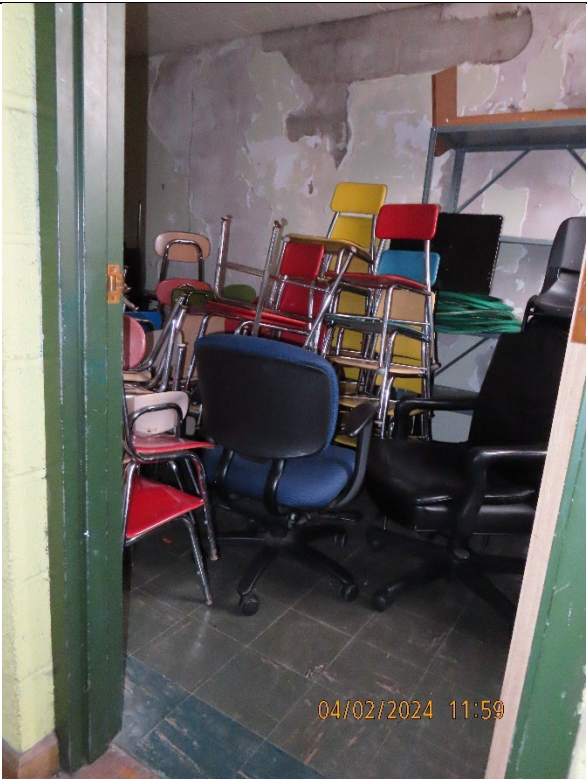
21.	Date Taken: 04/03/2024	Time Taken: 11:59 AM ET

Sample No.: 21-IMG100-00561.JPG		
	Description of Digital Image: Main Level – Gymnasium		
	<p>Two storage rooms located in the back of the stage contained deteriorating 1x1 acoustical ceiling tiles, scratched green floor tiles, deteriorating wall plaster and paint exposing the wall's concrete base. Both storage rooms stored various school furniture and educational material.</p>		
Modifications: Reduced scale of photo by 50% for the purpose of inspection report.

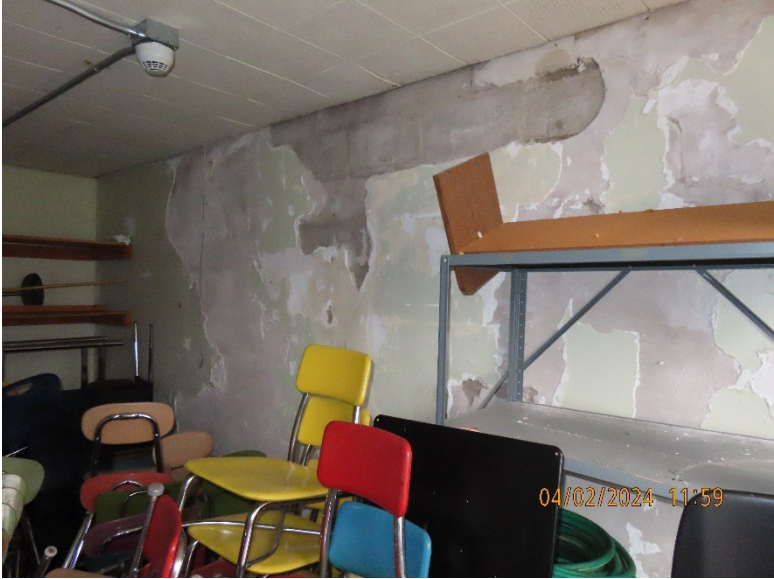
22.	Date Taken: 04/03/2024	Time Taken: 11:59 AM ET

Sample No.: 22-IMG100-00562.JPG		
	Description of Digital Image: Main Level – Gymnasium		
	<p>Two storage rooms located in the back of the stage contained deteriorating 1x1 acoustical ceiling tiles, scratched green floor tiles, deteriorating wall plaster and paint exposing the wall's concrete base. Both storage rooms stored various school furniture and educational material.</p>		
Modifications: Reduced scale of photo by 50% for the purpose of inspection report.

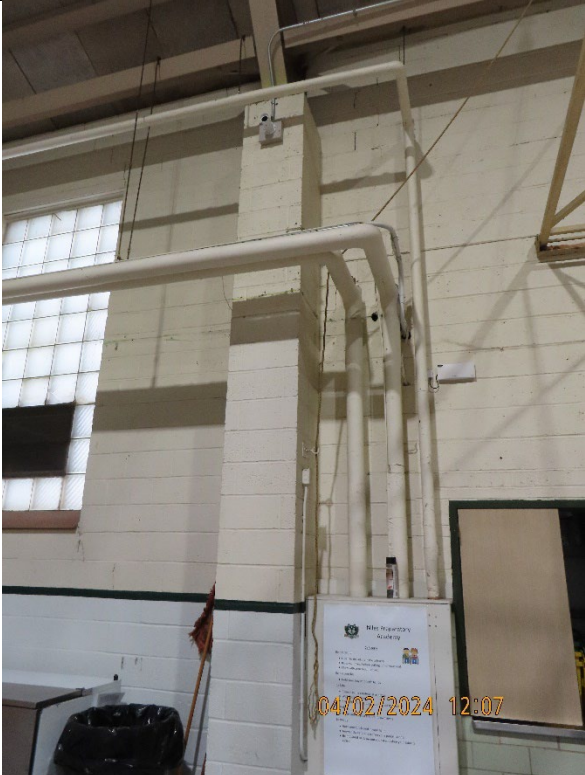
23.	Date Taken: 04/03/2024	Time Taken: 12:07 PM ET

Sample No.: 23-IMG100-00563.JPG		
	Description of Digital Image: Main Level – Gymnasium		
	<p>Various vertical and horizontal piping were observed throughout the gymnasium. A wooden box located at the western wall of the gymnasium that may have been concealing a water heat transfer appliance.</p>		
Modifications: Reduced scale of photo by 50% for the purpose of inspection report.

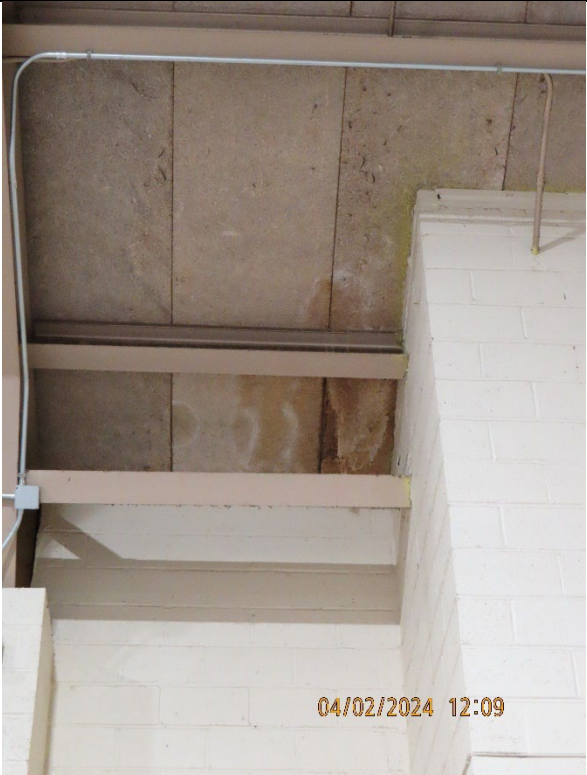
24.	Date Taken: 04/03/2024	Time Taken: 12:09 PM ET

Sample No.: 24-IMG100-00564.JPG		
	Description of Digital Image: Main Level – Gymnasium		
	<p>The ceiling boards with a fibrous texture located at the entrance of the gymnasium contained water damage.</p>		
Modifications: Reduced scale of photo by 50% for the purpose of inspection report.

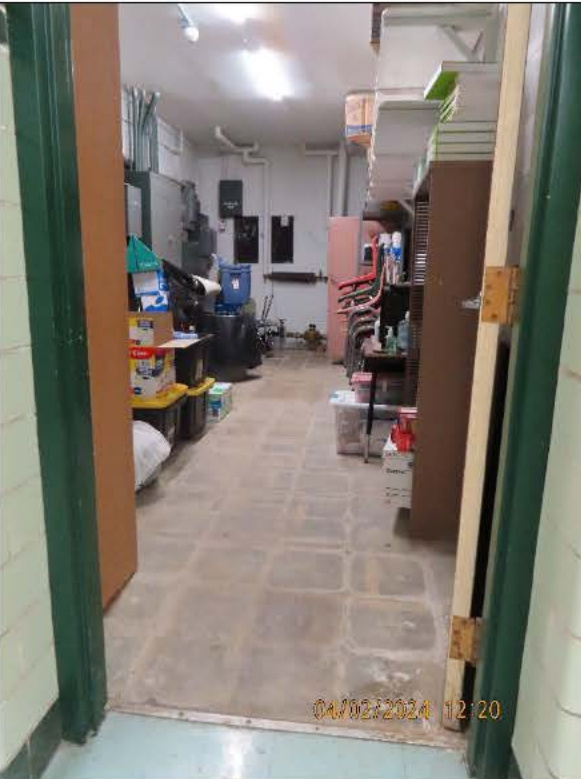
31.	Date Taken: 04/03/2024	Time Taken: 12:20 PM ET

Sample No.: 31-IMG100-00571.JPG		
	Description of Digital Image: Lower Level – Electric Room		
	<p>The electric room contained the school building's electric panels and breaker box, and appeared to be used for storing various school equipment. The floor tile appeared to have been previously removed and the concrete base is exposed. The far end wall of the electric room contained pipe insulation.</p> <p>Modifications: Reduced scale of photo by 50% for the purpose of inspection report.</p>

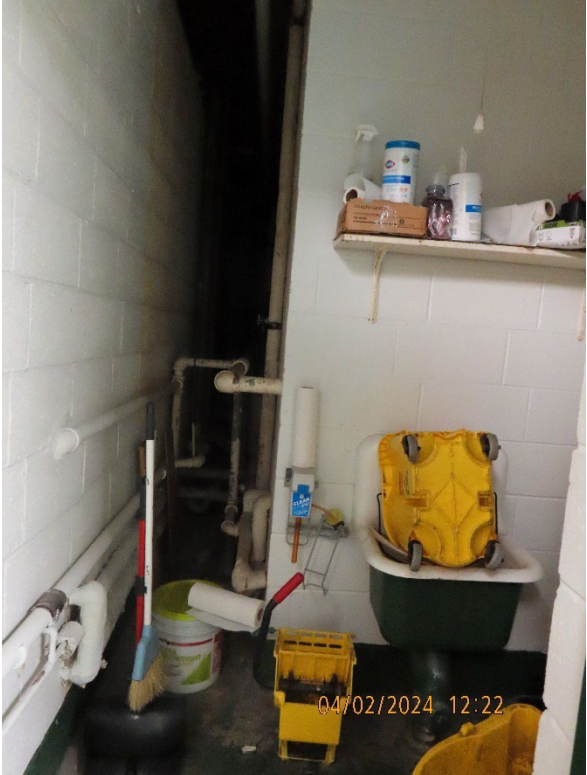
32.	Date Taken: 04/03/2024	Time Taken: 12:22 PM ET

Sample No.: 32-IMG100-00572.JPG		
	Description of Digital Image: Lower Level – Custodial Closet. The custodial closet stored various custodial equipment and had a small narrow hallway occupied by thermal system insulation.		
Modifications: Reduced scale of photo by 50% for the purpose of inspection report.

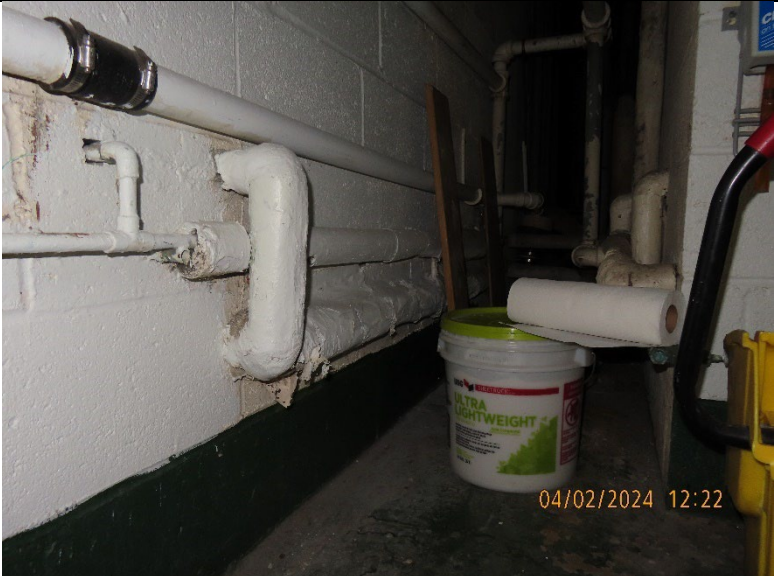
33.	Date Taken: 04/03/2024	Time Taken: 12:22 PM ET

Sample No.: 33-IMG100-00573.JPG		
	Description of Digital Image: Lower Level – Custodial Closet. The custodial closet stored various custodial equipment and had a small narrow hallway occupied by thermal system insulation.		
Modifications: Reduced scale of photo by 50% for the purpose of inspection report.

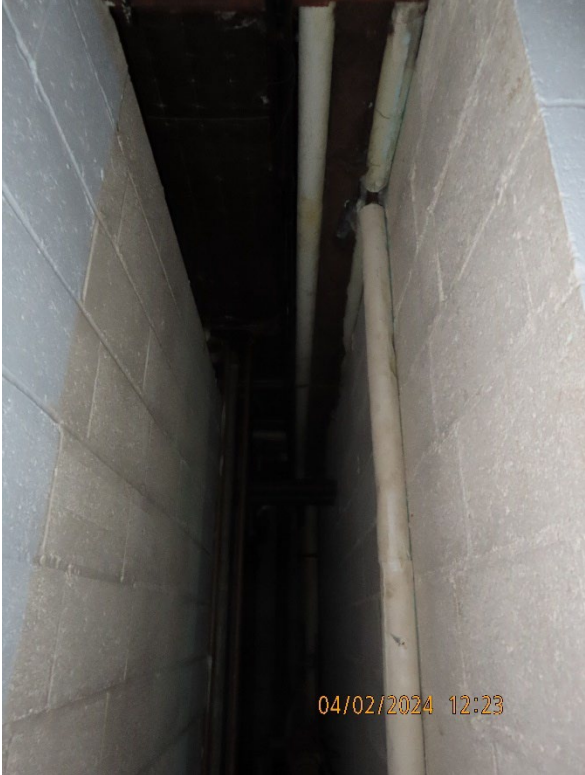
34.	Date Taken: 04/03/2024	Time Taken: 12:25 PM ET

Sample No.: 34-IMG100-00574.JPG		
	Description of Digital Image: Lower Level – Custodial Closet. The custodial closet contained a small narrow hallway occupied by thermal system insulation.		
	Modifications: Reduced scale of photo by 50% for the purpose of inspection report.

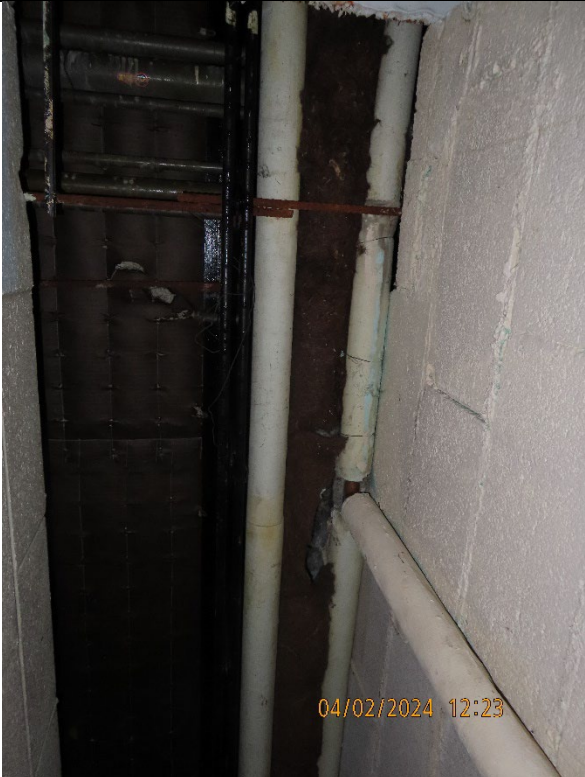
35.	Date Taken: 04/03/2024	Time Taken: 12:25 PM ET

Sample No.: 35-IMG100-00575.JPG		
	Description of Digital Image: Lower Level – Custodial Closet The ceiling in the custodial closet's small hallway appear to have a brown fiber insulation that may be fiberglass or another fiber material.		
	Modifications: Reduced scale of photo by 50% for the purpose of inspection report.

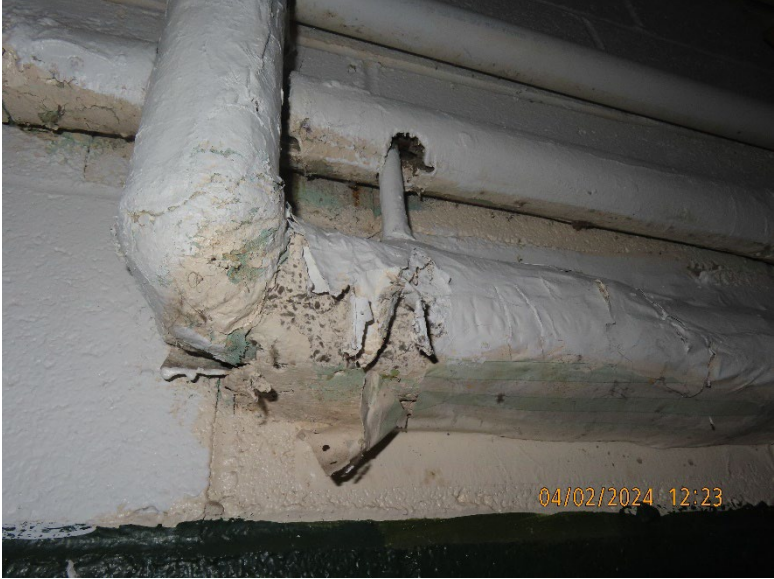
36.	Date Taken: 04/03/2024	Time Taken: 12:25 PM ET

Sample No.: 36-IMG100-00576.JPG		
	Description of Digital Image: Lower Level – Custodial Closet		
	<p>The custodial closet’s small hallway contained an elbow with insulation appearing to be deteriorating and exposing the mudding that is in a friable condition.</p>		
Modifications: Reduced scale of photo by 50% for the purpose of inspection report.

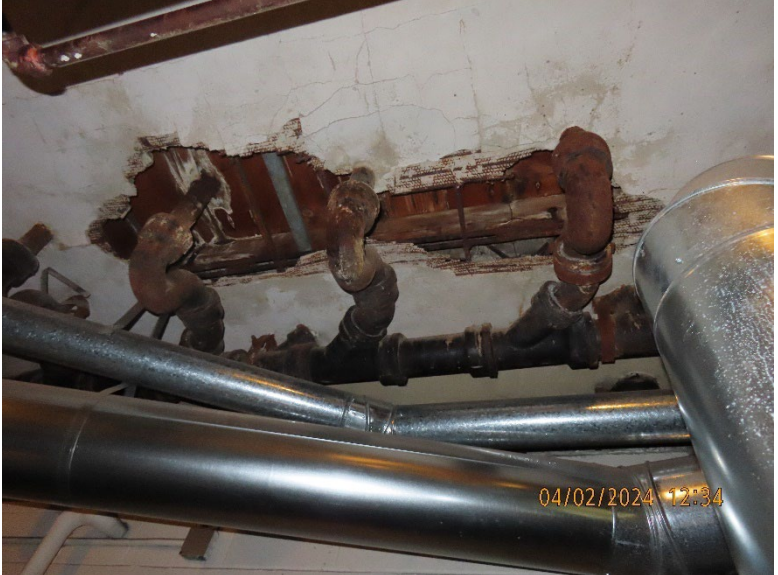
44.	Date Taken: 04/03/2024	Time Taken: 12:34 PM ET

Sample No.: 44-IMG100-00584.JPG		
	Description of Digital Image: Lower Level – Boiler Room		
	<p>The northwest side of the boiler room’s ceiling plaster was deteriorating and falling onto the ground.</p>		
Modifications: Reduced scale of photo by 50% for the purpose of inspection report.

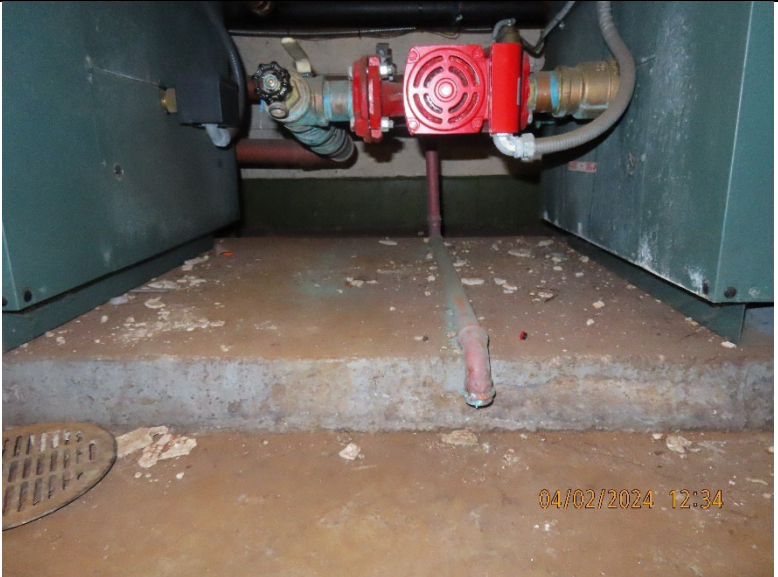
45.	Date Taken: 04/03/2024	Time Taken: 12:34 PM ET

Sample No.: 45-IMG100-00585.JPG		
	Description of Digital Image: Lower Level – Boiler Room		
	<p>The northwest side of the boiler room’s ceiling plaster was deteriorating and falling onto the ground. Dust and debris of the ceiling plaster was present throughout the boiler room’s floor.</p>		
Modifications: Reduced scale of photo by 50% for the purpose of inspection report.

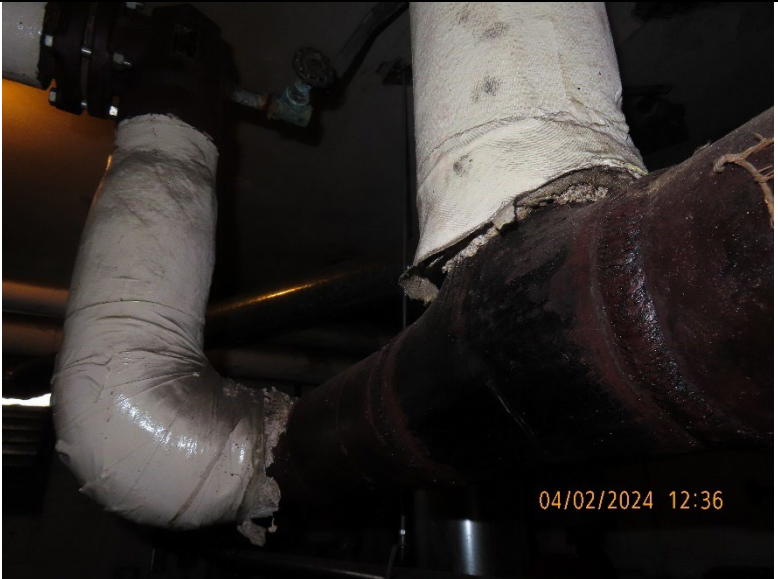
46.	Date Taken: 04/03/2024	Time Taken: 12:36 PM ET

Sample No.: 46-IMG100-00586.JPG		
	Description of Digital Image: Lower Level – Boiler Room		
<p>The northwest side of the boiler room contained a pipe insulation elbow was deteriorating and its mudding appeared friable. It appears that the pipe insulation elbow may have been patched in the past.</p>			
<p>Modifications: Reduced scale of photo by 50% for the purpose of inspection report.</p>

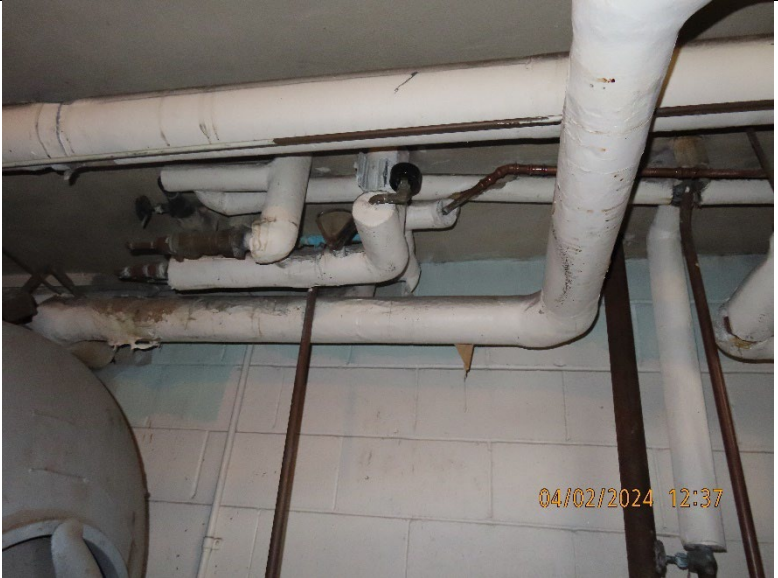
47.	Date Taken: 04/03/2024	Time Taken: 12:37 PM ET

Sample No.: 47-IMG100-00587.JPG		
	Description of Digital Image: Lower Level – Boiler Room		
<p>The southeast side of the boiler room's ceiling contained horizontal piping with insulation wrapping that appear to be deteriorating and becoming friable.</p>			
<p>Modifications: Reduced scale of photo by 50% for the purpose of inspection report.</p>
