YAE - ATTACHMENT B

File Number: 24TA002	LEA Name: ACCEL Charter Schools	LEA Address, City, State, Zip Code:
School Name: Youngstown Academy of Excellence	School Address: 1408 Rigby Street Youngstown, Ohio 44506	1650 Tysons Boulevard, Suite 600 McLean, Virginia 22102
Date of Inspection: 4/2/2024 to 4/3/2024	Inspector Names: Michael Todd, Christina Saldivar and Brandon Brewster	Number of Photographs Taken: 67

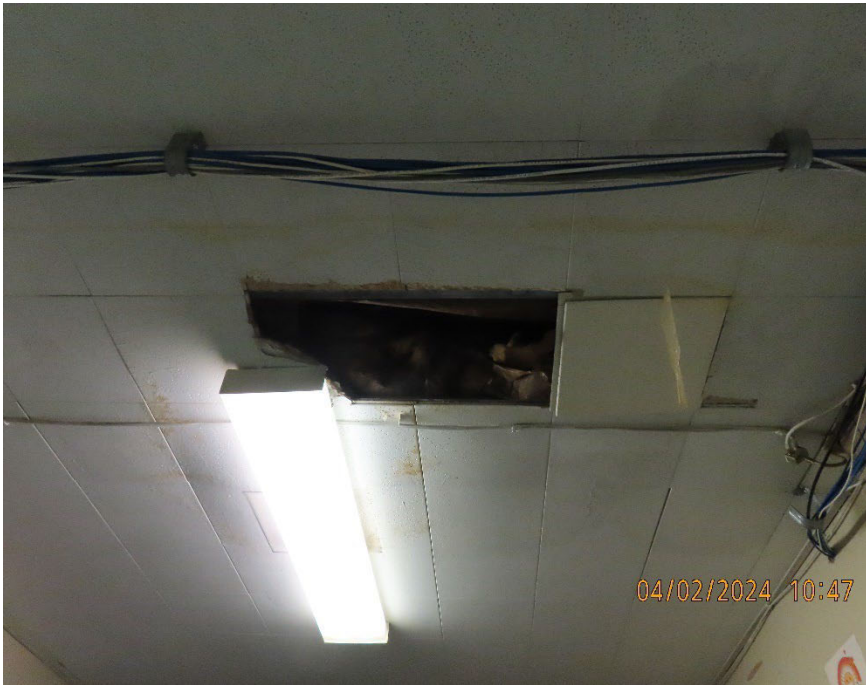
7.	Date Taken: 4/2/24	Time Take: 10:47 AM EST	
	Sample No.: B-7

Description of Digital Image:  YAE Hallway outside Kindergarten Classroom.  Significantly damaged suspect ACBM ceiling tile.		
8.	Date Taken: 4/2/24	Time Take:

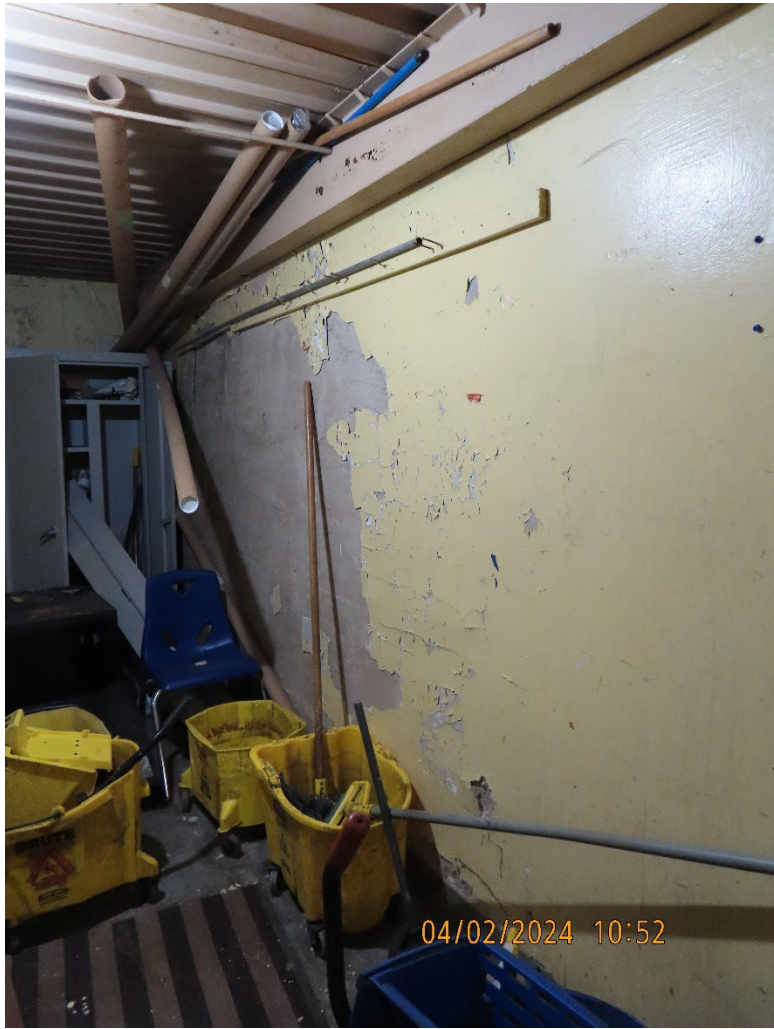
11	Date Taken: 4/2/24	Time Taken: 10:52 AM EST

<p>Sample No.: B-11</p> <p>Description of Digital Image:</p> <p>Custodial closet in 1<sup>st</sup> grade Hallway, located on the 1<sup>st</sup> floor.</p> <p>Peeling and chipping paint on the walls.</p>

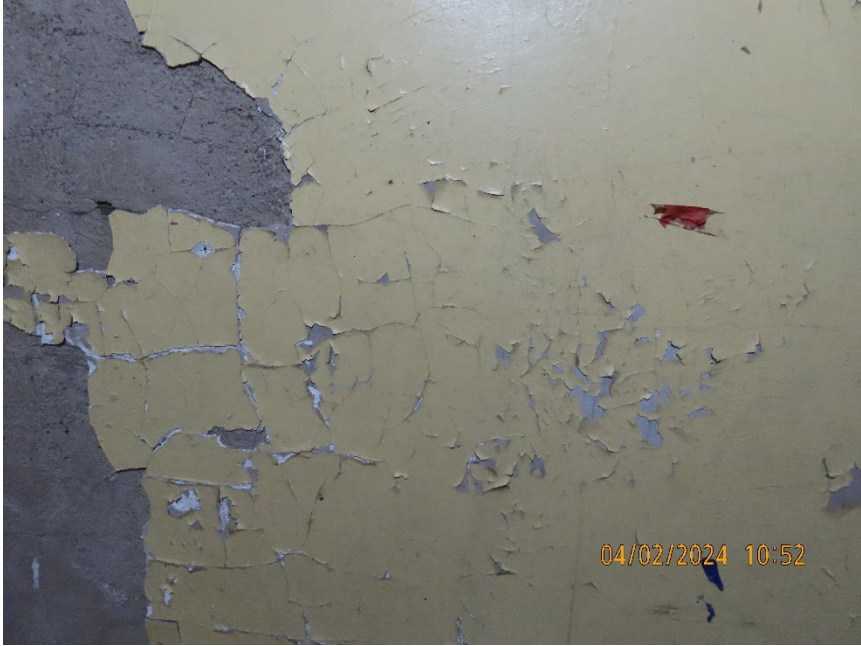
12.	Date Taken: 4/2/24	Time Taken: 10:52 AM EST

Sample No.: B-12	Description of Digital Image:  Custodial closet in 1 <sup>st</sup> grade Hallway, located on the 1 <sup>st</sup> floor.  Peeling and chipping paint on the walls.

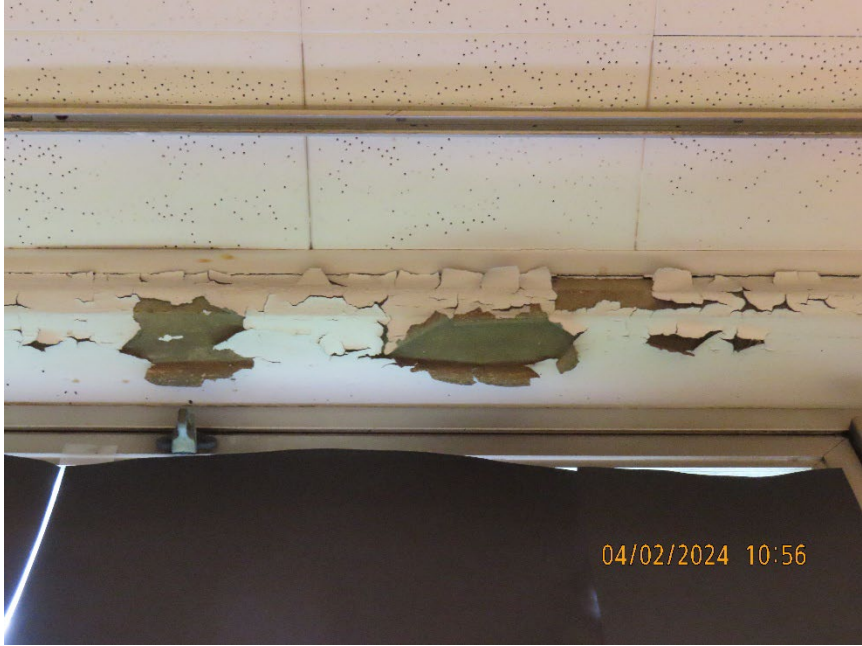
14.	Date Taken: 4/2/24	Time Taken: 10:56 AM EST

Sample No.: B-14 Description of Digital Image:  1 <sup>st</sup> Floor, Second Grade Classroom  Significantly damaged peeling and chipping paint

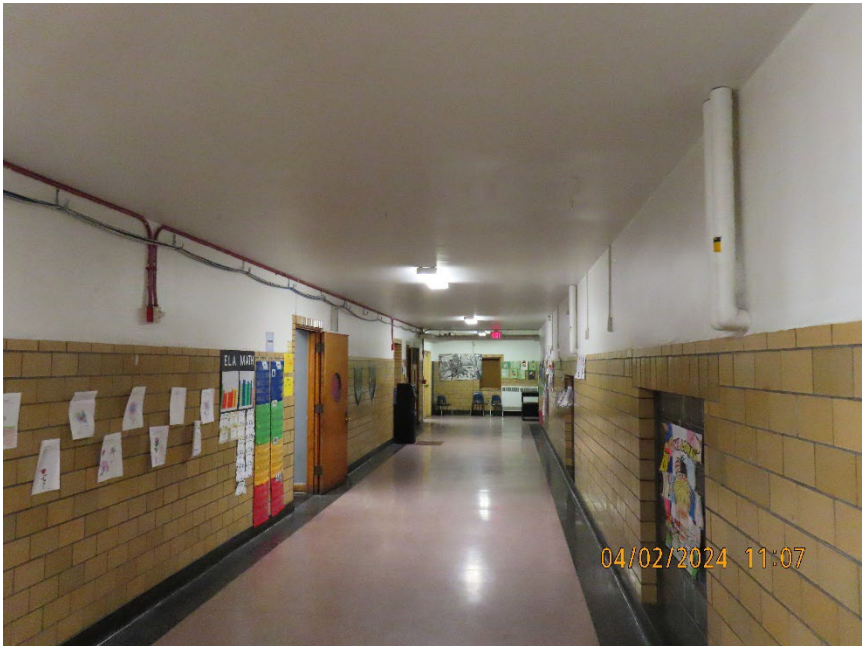
19.	Date Taken: 4/2/24	Time Taken: 11:07 AM EST

<p>Sample No.: B-19</p> <p>Description of Digital Image:</p> <p>4<sup>th</sup> Grade Hallway, Outside Teachers Lounge</p> <p>ACBM Piping TSI with warning label.</p>

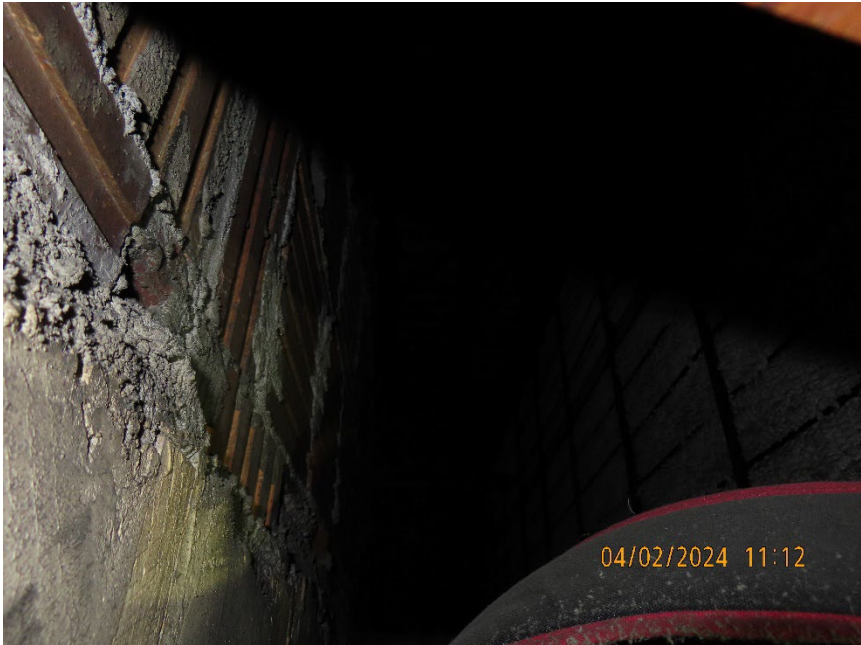
Sample No.: B-25	Description of Digital Image:  4 <sup>th</sup> Grade Classroom  Opening to closet and wall.  Wall Cavity

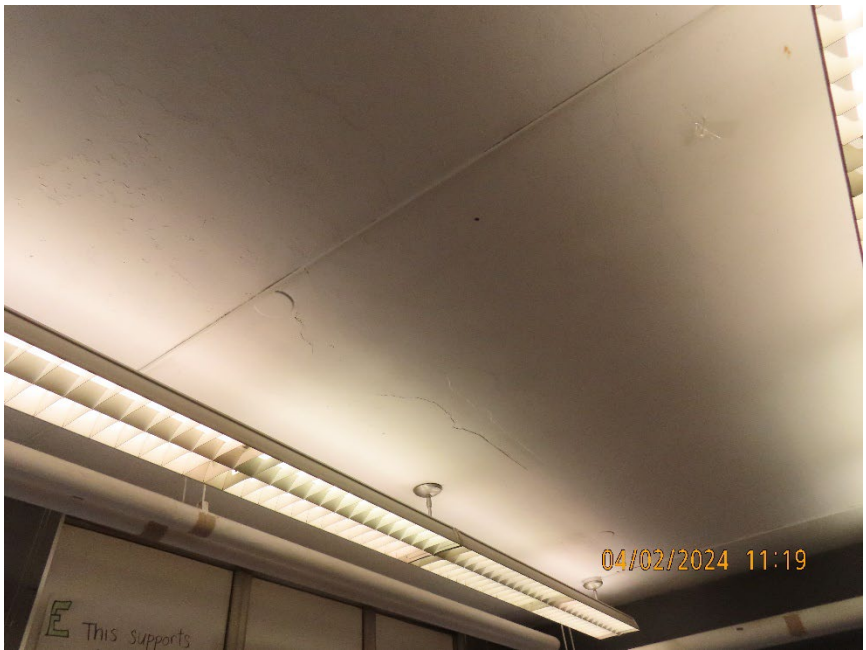
27	Date Taken: 4/2/24	Time Taken: 11:19 AM EST

Sample No.: B-27 Description of Digital Image:  Room 209, 5 <sup>th</sup> Grade Classroom  Peeling and Chipping paint noted on the ceiling

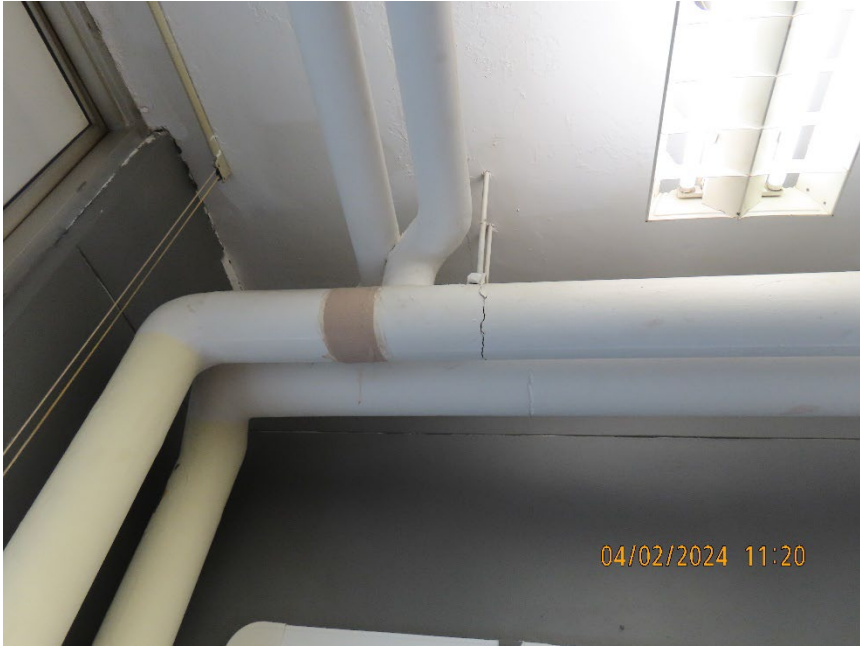
28.	Date Taken: 4/2/24	Time Taken: 11:20 AM EST

Sample No.: B-28 Description of Digital Image:  Room 209, 5 <sup>th</sup> Grade Classroom  Peeling and Chipping paint noted on the ceiling  Suspect ACM TSI with evidence of O&M Activities (Brown Patchwork)

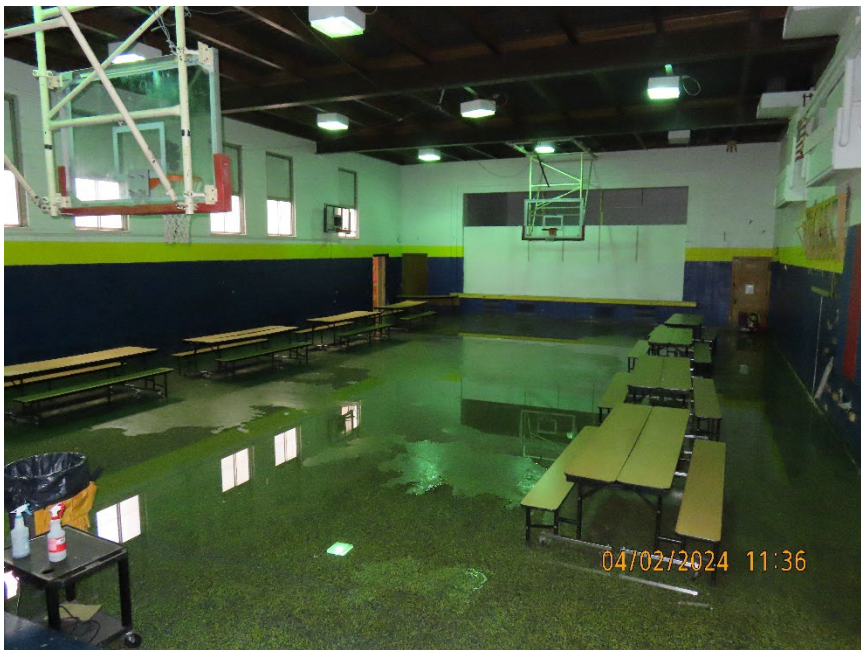
38.	Date Taken: 4/2/24	Time Taken: 11:36 AM EST

Sample No.: B-38 Description of Digital Image:  1 <sup>st</sup> Floor, Gymnasium  Gymnasium is flooded with rain water

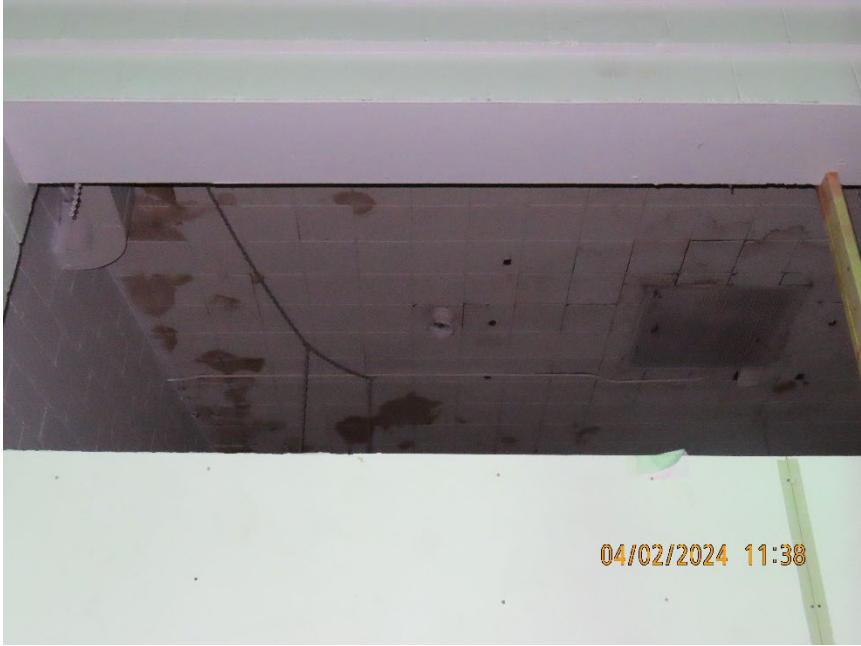
41.	Date Taken: 4/2/24	Time Taken: 11:38 AM EST

Sample No.: B-41	Description of Digital Image:  1 <sup>st</sup> Floor, Gymnasium, Above the Stage  Suspect Damaged ACM Ceiling Tile

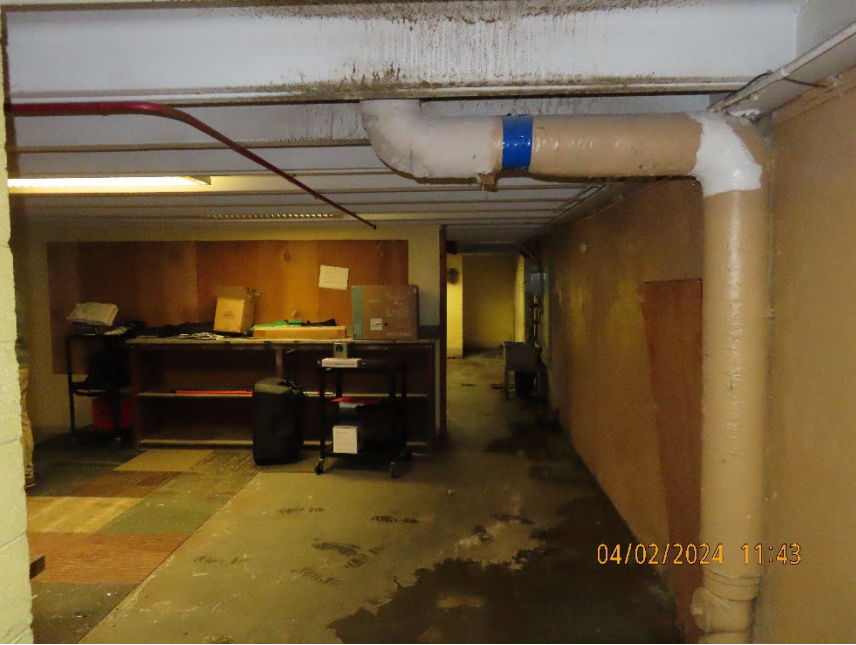
43.	Date Taken: 4/2/24	Time Taken: 11:43 AM EST

Sample No.: B-43	Description of Digital Image:  Basement Boiler Room  Suspect ACM TSI on Roof Drain Line  Water Seepage Observed at the Floor Level of the Pipe.

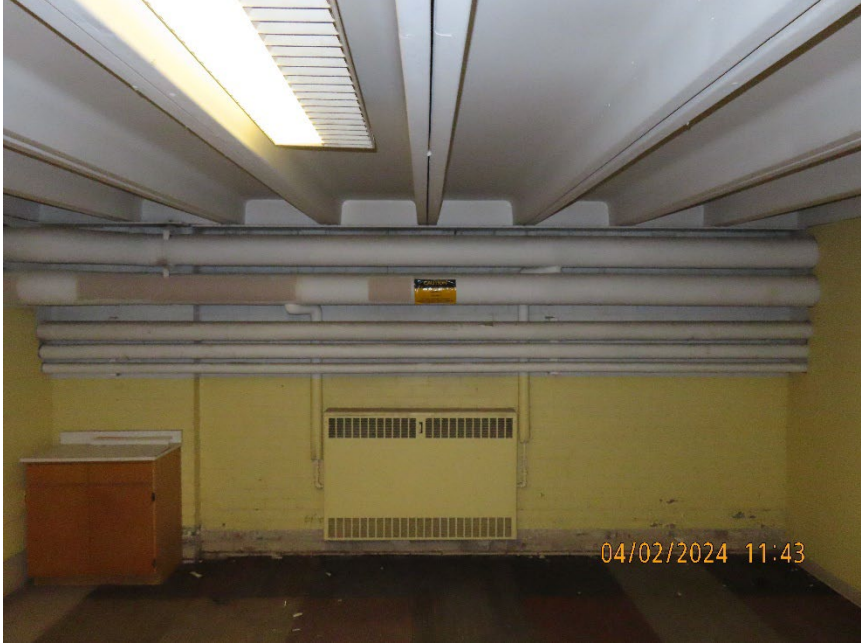
45.	Date Taken: 4/2/24	Time Taken: 11:43 AM EST

Sample No.: B-45	Description of Digital Image:  Basement Boiler Room  ACM TSI  Piping has a label attached stating 'Caution Asbestos Hazard, Do Not Disturb'

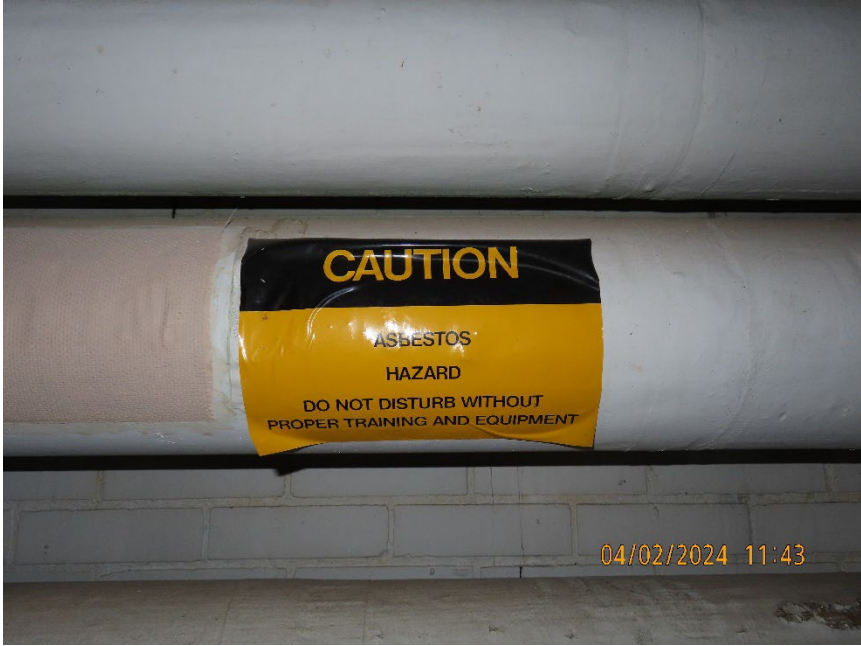
46	Date Taken: 4/2/23	Time Taken: 11:34 AM EST

Sample No.: B-46 Description of Digital Image:  Basement Boiler Room  ACM TSI  Piping has a label attached stating 'Caution Asbestos Hazard, Do Not Disturb'

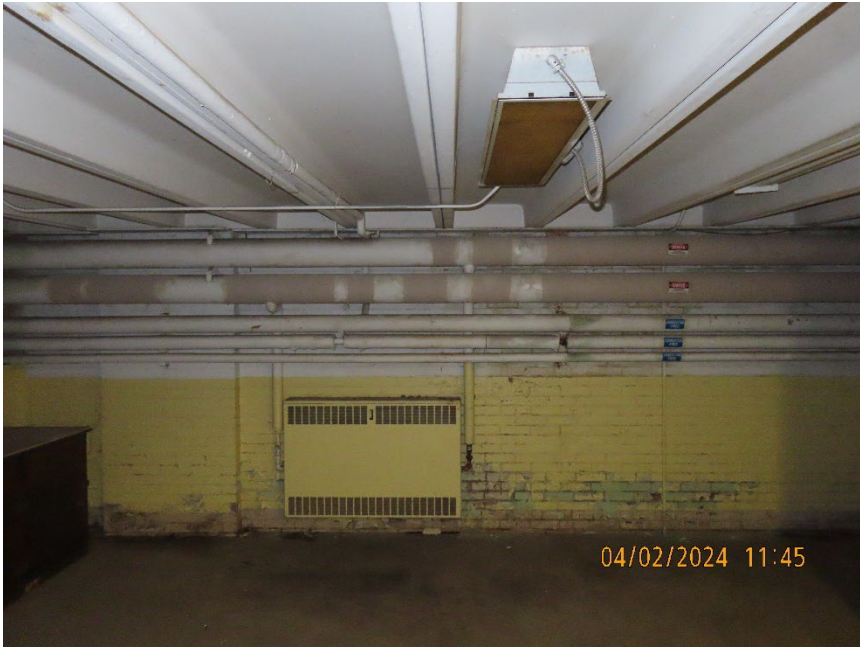
47.	Date Taken 4/2/24	Time Taken: 11:34 AM EST

Sample No.: B-47 Description of Digital Image:  Basement Boiler Room  ACM TSI  Piping has labels attached noting asbestos free (Blue) and Contains Asbestos (Red/Black).

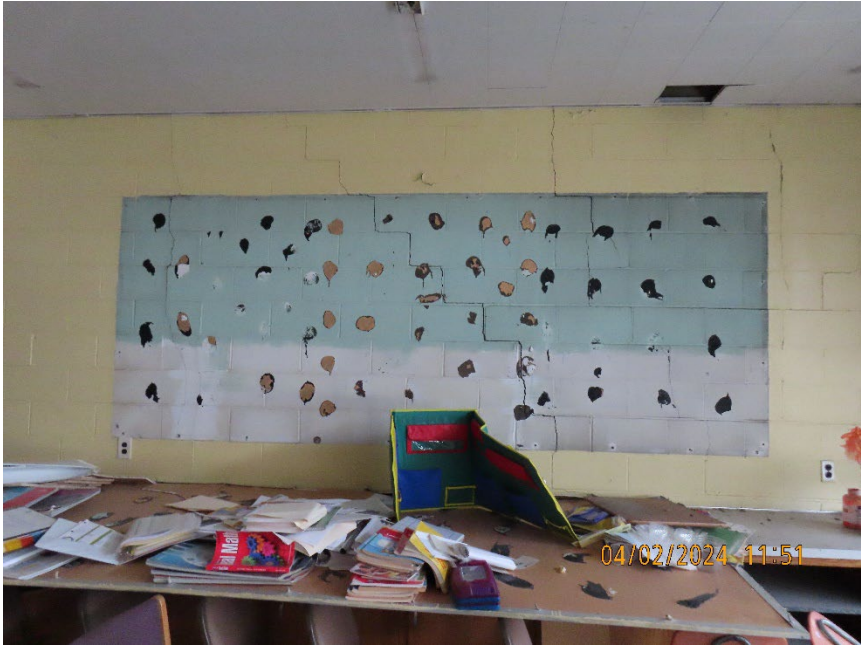
50.	Date Taken: 4/2/24	Time Taken: 11:51 AM EST

<p>Sample No.: B-50</p> <p>Description of Digital Image:</p> <p>3<sup>rd</sup> Floor, Room 300</p> <p>Room 300 is currently not an active classroom. A chalkboard containing suspect ACM Black Mastic is set on a few chairs with school materials stored on top.</p> <p>Suspect ACM Black Mastic is also identified on the wall where the chalkboard once was adhered to the wall.</p>

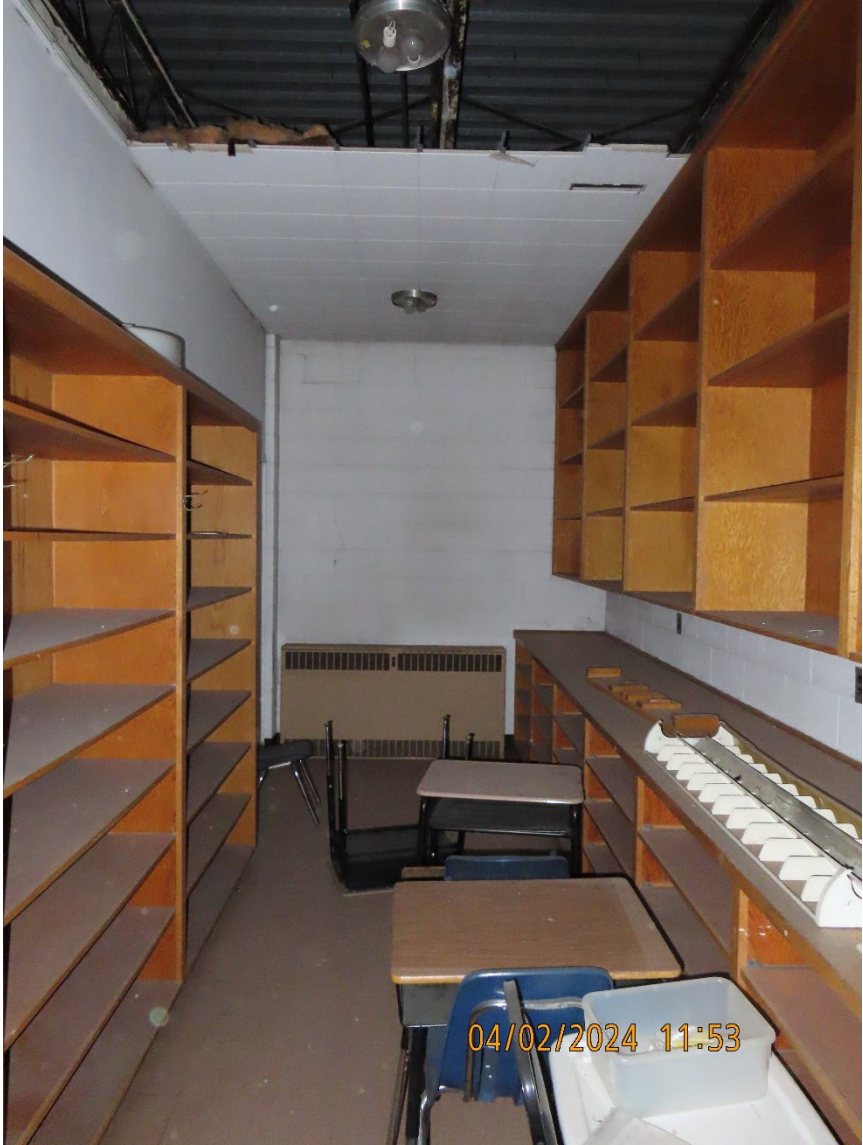
51.	Date Taken 4/2/24:	Time Taken: 11:53 AM EST

Sample No.: B-51 Description of Digital Image:  3 <sup>rd</sup> Floor, Room 300 Storage Closet  Suspect ACM Ceiling Tile Damaged and Missing.

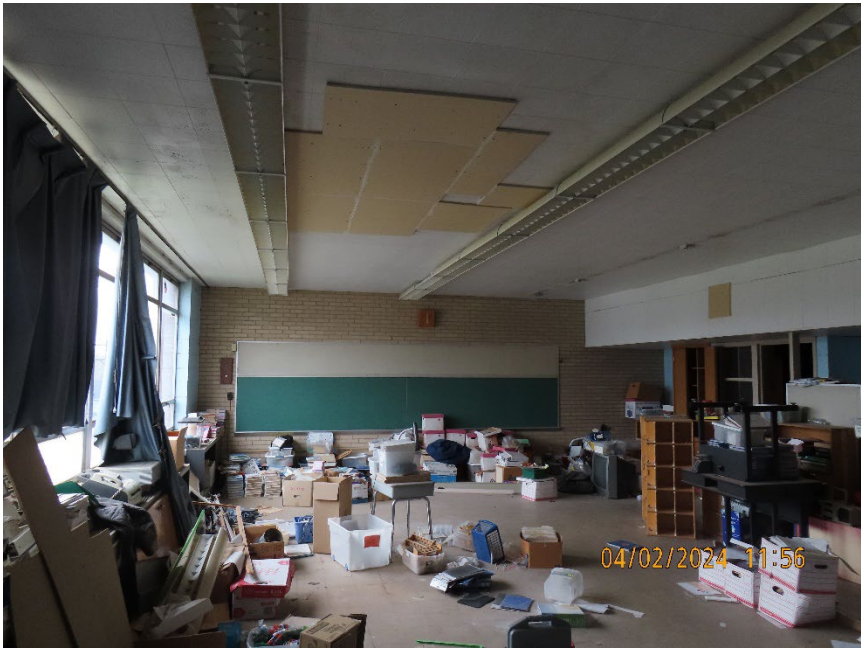
53.	Date Taken 4/2/24:	Time Taken: 11:56 AM EST

Sample No.: B-53	Description of Digital Image:  3 <sup>rd</sup> Floor, Room 301  Inactive Classroom with School Supplies being Stored,  Damaged, Suspect ACM Ceiling Tile. Ceiling Tiles were Repaired with Drywall Sheets.

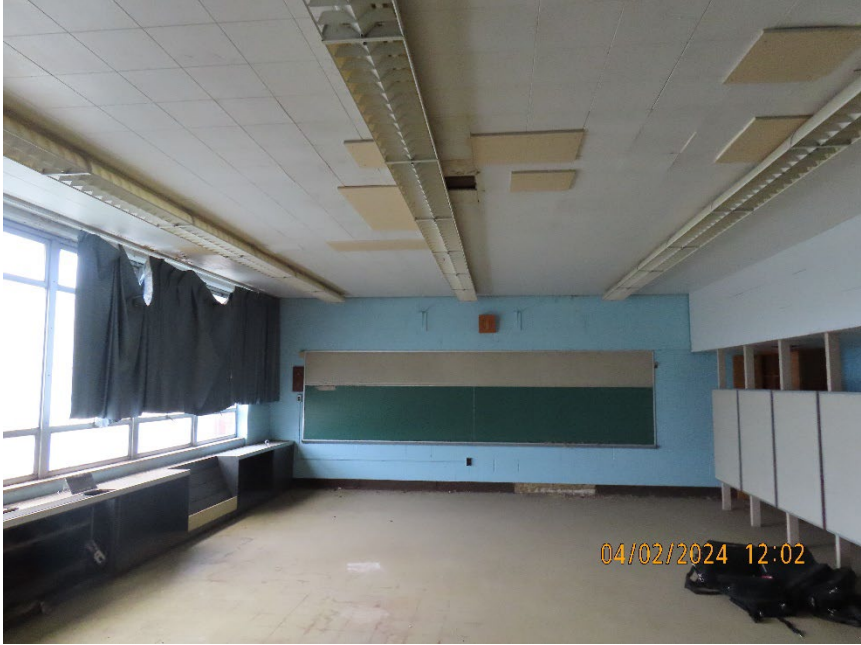
58	Date Taken: 4/2/24	Time Taken: 12:02 PM EST

<p>Sample No.: B-58</p> <p>Description of Digital Image:</p> <p>3<sup>rd</sup> Floor, Classroom 303</p> <p>Damaged Suspect ACM Ceiling Tile.</p> <p>Tan Suspect 9"x9" Floor Tile</p>

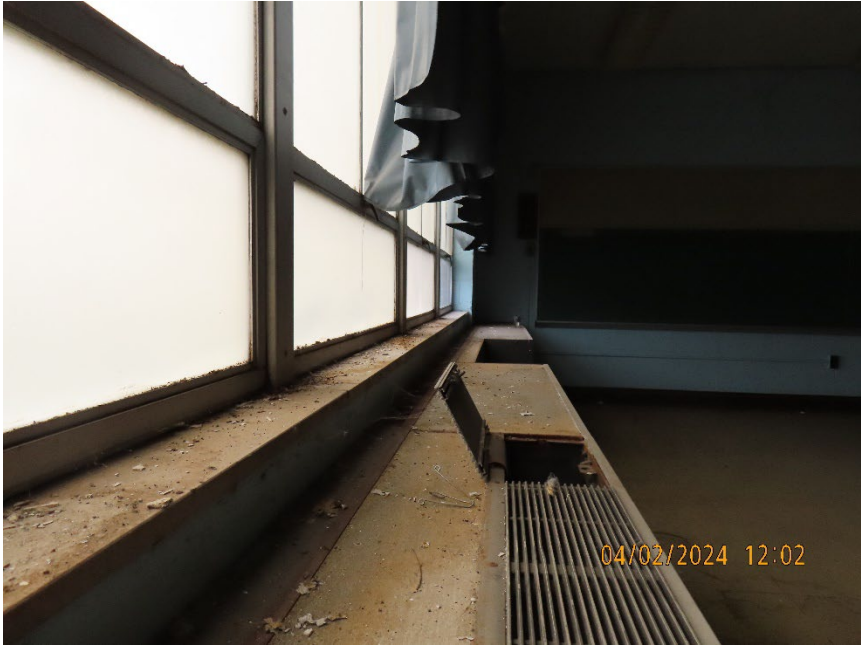
59.	Date Taken: 4/2/24	Time Taken: 12:02 PM EST

Sample No.: B-59 Description of Digital Image:  3 <sup>rd</sup> Floor, Classroom 303  Suspect ACM Ceiling Tile debris, Suspect Lead-Based Paint debris and dead insects located on the classroom radiator.

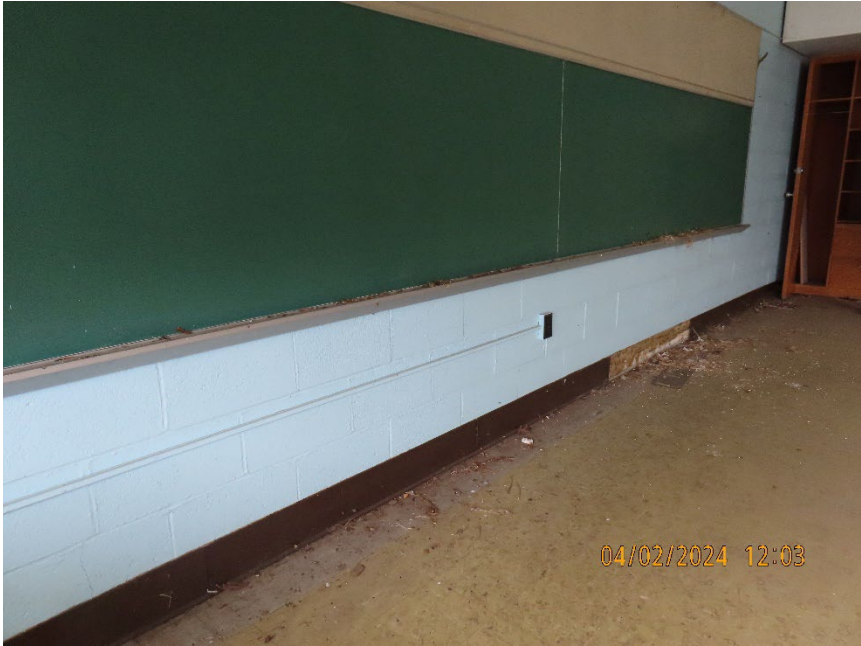
60.	Date Taken: 4/2/24	Time Taken: 12:03 PM EST

Sample No.: B-60	Description of Digital Image:  3 <sup>rd</sup> Floor, Classroom 303  Insect and Rodent carcass and nests located on the chalkboard ledge and floor

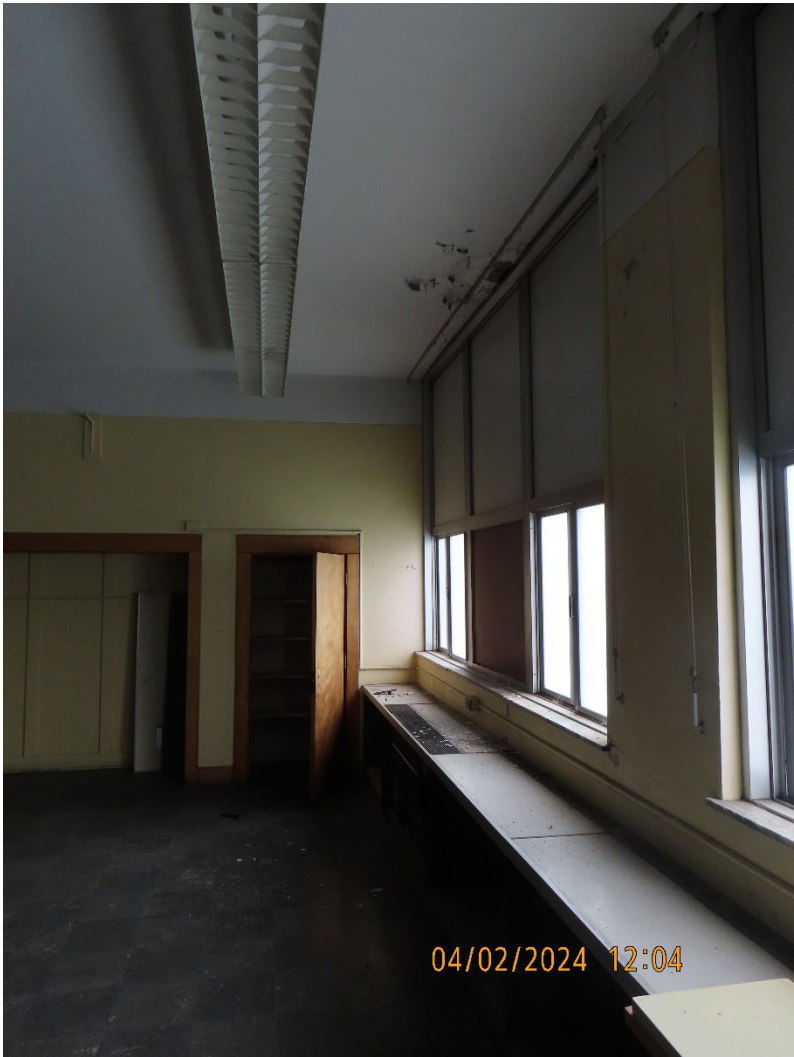
61.	Date Taken: 4/2/24	Time Taken: 12:04 PM EST

Sample No.: B-61		<p>Description of Digital Image:</p> <p>3<sup>rd</sup> Floor, Classroom 306</p> <p>Significantly Damaged and Peeling Paint located above the Windows.</p> <p>Paint chips and debris collecting on the radiator ledge below.</p>

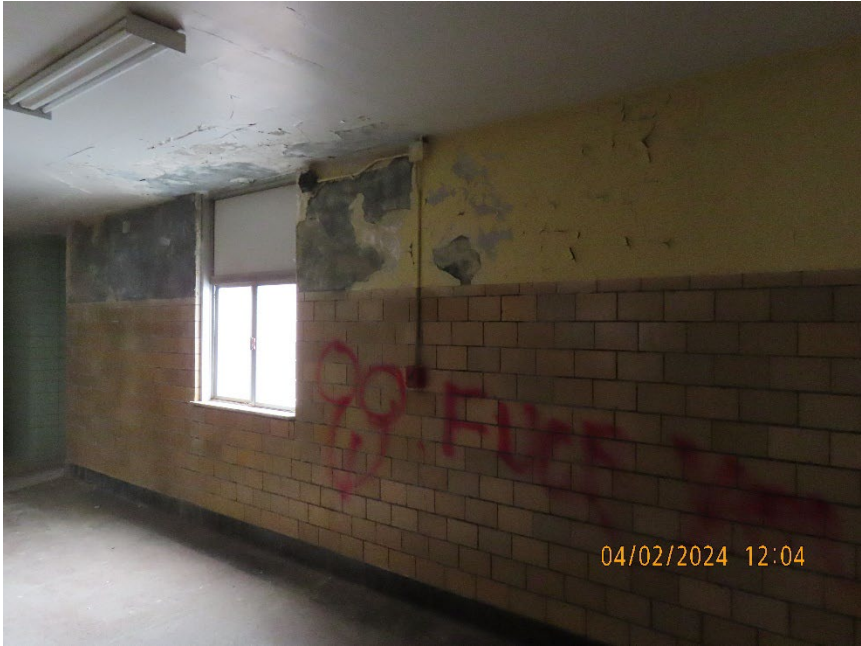
62.	Date Taken: 4/2/24	Time Taken: 12:04 PM EST

Sample No.: B-62		Description of Digital Image:  3 <sup>rd</sup> Floor Hallway  Significantly Damaged Suspect ACM Plaster and Peeling/Chipping Suspect Lead Based Paint

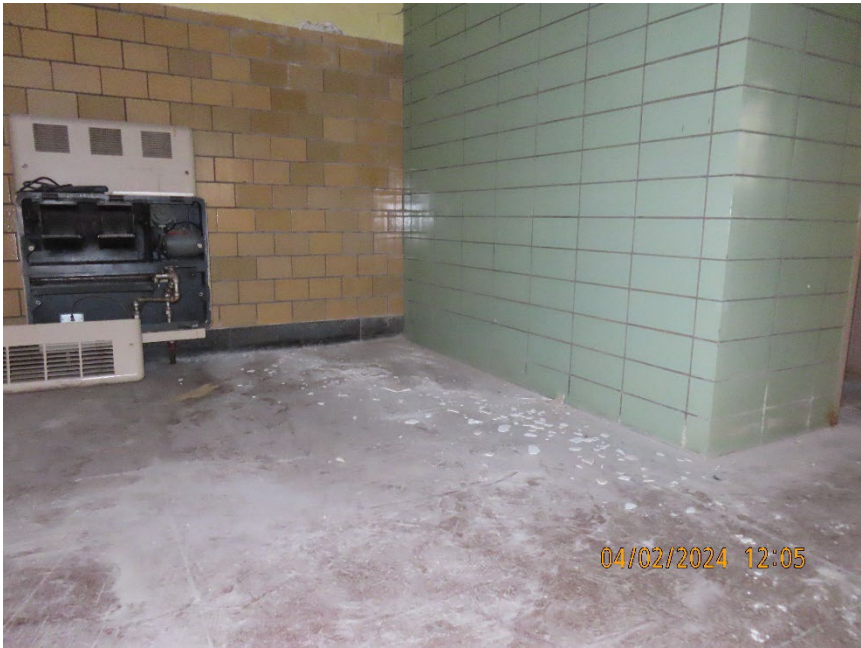
64.	Date Taken: 4/2/24	Time Taken: 12:05 PM EST

Sample No.: B-64 Description of Digital Image:  3 <sup>rd</sup> Floor Hallway  Significantly Damaged Suspect ACM Plaster and Peeling/Chipping Suspect Lead Based Paint Debris on the ground Outside of the Washroom
