AHERA ASBESTOS INSPECTION REPORT

**YOUNGSTOWN ACADEMY OF EXCELLENCE
1408 RIGBY STREET
YOUNGSTOWN, OHIO 44506**

April 19, 2024

NAES Project Number 24209AI

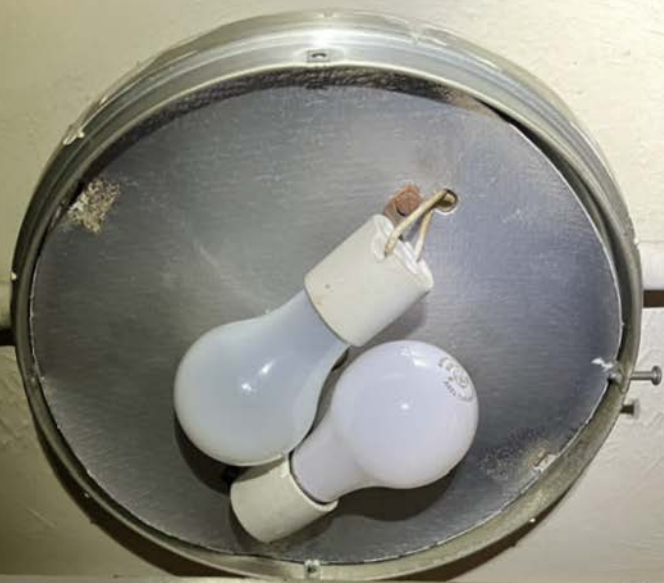
HA # 14

TABLE 3 ASBESTOS MANAGEMENT RECOMMENDATIONS Youngstown Academy of Excellence 1408 Rigby Street Youngstown, Ohio					
Material	Location of Material	Condition	Friable Yes/No	Quantity	Recommendations
(HA-14) Mud Joint Packing (Fiberglass Lines)	Throughout	Good	Yes	275 Each (Multiple HA's Included)	O&M
(HA-15) Light Fixture Heat Shield	Library Maintenance Closet Hall Closet, 2 nd Floor Classroom 301 Closet Restrooms in Classroom: 100, 101, 102, 202, 203, 204, 205, & 206	Good	Yes	40 SF (20 Fixtures)	O&M
(HA-17) Hard Pipe Insulation	Throughout	Good	Yes	1,138 LF (Exposed)	O&M
(HA-19) Tan & Brown Mottled 12" Floor Tile (Mastic Only)	Classrooms 200 & 201	Good	No	2,580 SF	O&M
(HA-20) Black 12"x 24" Floor Tile	Classrooms: 207, 208, 209, 304, 305, & 306	Good	No	624 SF (Boarder Tile)	O&M
