APPENDIX 6 FIVE-YEAR REVIEW SITE INSPECTION CHECKLIST

APPENDIX 6-1 FIVE-YEAR REVIEW SITE INSPECTION CHECKLIST OU1

Five-Year Review Site Inspection Checklist – OU1

I. SITE INFORMATION			
Site name: Hudson River PCBs Superfund Site, OU1: Remnant Deposit Sites	Date of inspection: August 30, 2022		
Location and Region: New York, Hudson Falls and Fort Edward	EPA ID: NYD980763841		
Agency, office, or company leading the five-year review: EPA Region 2	Weather/temperature: Partly cloudy; 80° F		
Remedy Includes: (Check all that apply)			
Attachments: Inspection team roster attached	☑ Site map attached		
II. INTERVIEWS (Not Applica	able - See Part 4 Other Interviews)		
1. System Operations Site Manager Name Title Interviewed □ at site □ at office □ by phone Phone	Date		
Problems, suggestions; Report attached	IIO		
2. System Operations Staff	Title Date

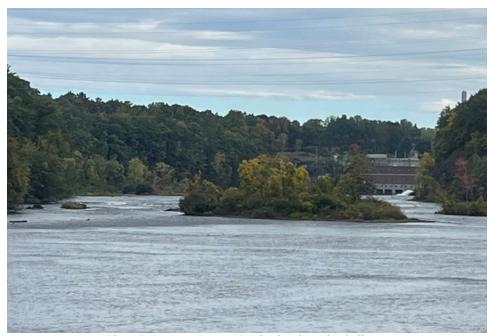
Photo 1. Remnant Deposit 1 (island and nearby shallows).

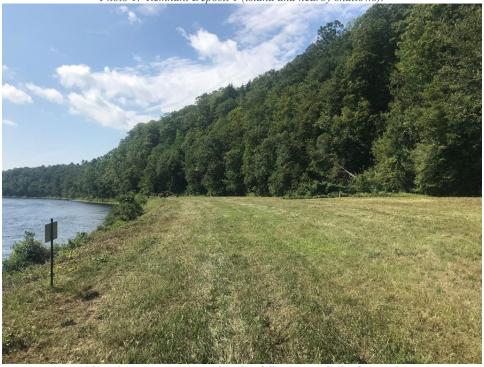
B. Other Site Conditions				
Remarks: A downed tree from a landslide was observed on the land-side edge of the cap for Remnant Deposit 2. The tree was subsequently removed, and GE reported no significant damage to the cap.				
Inspection Roster				
Organization EPA	Name Michael Cheplowitz			
EPA Arcadis on behalf of General	Matt Wiener

Photo 2. Remnant Deposit 2 with a fallen tree in the background.

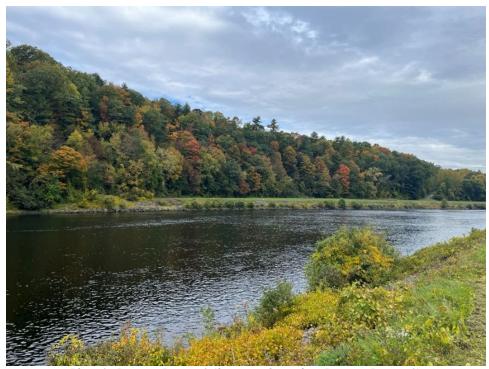
Photo 3. Remnant Deposit 2 (facing northwest from Remnant Deposit 3).

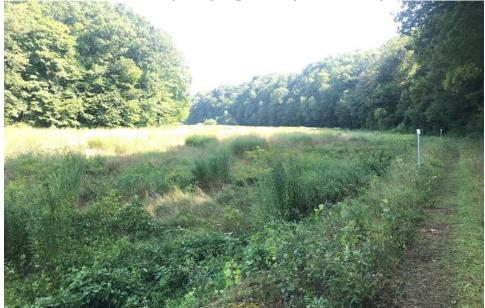
Photo 4. Remnant Deposit 3 (facing north).

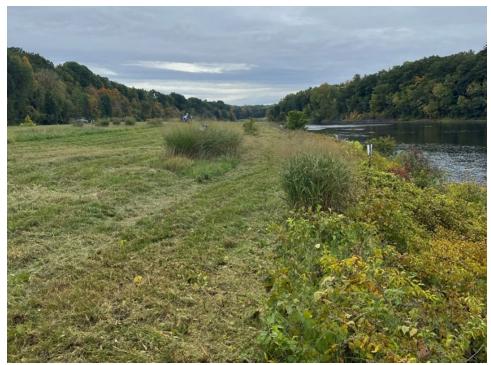
Photo 5. Remnant Deposit 3 (facing south).

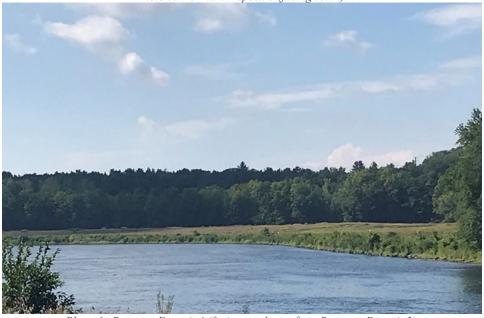
Photo 6. Remnant Deposit 4 (facing southwest from Remnant Deposit 3).

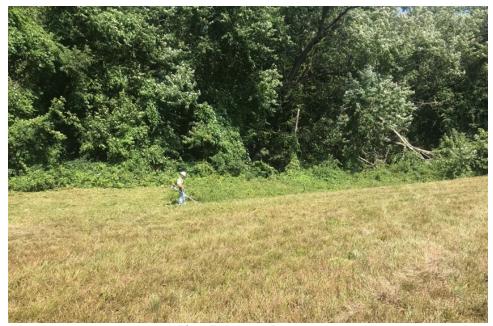
Photo 7. Remnant Deposit 4.

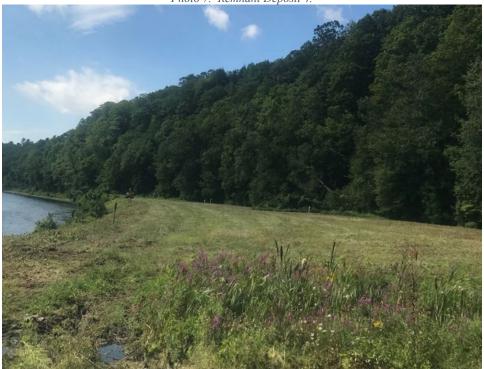
Photo 8. Remnant Deposit 4 (facing south).

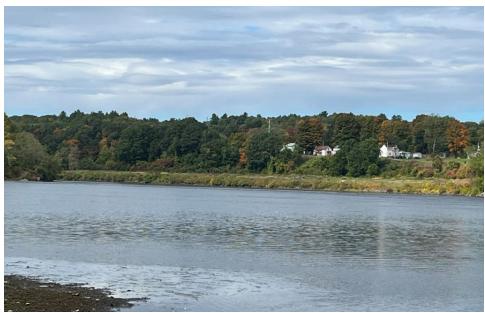
Photo 9. Remnant Deposit 5 (facing northeast from Rogers Island).

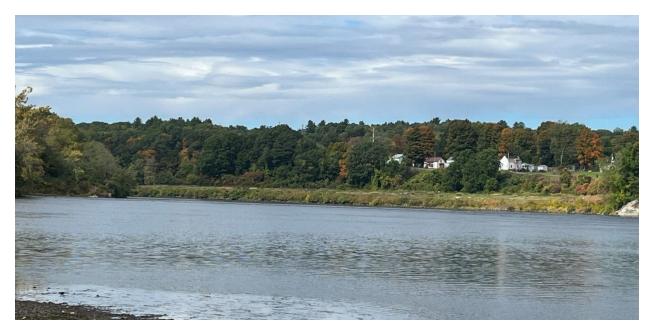
Photo 1. Water column sampling location north of Rogers Island. Remnant Deposit 5 is visible in the background.

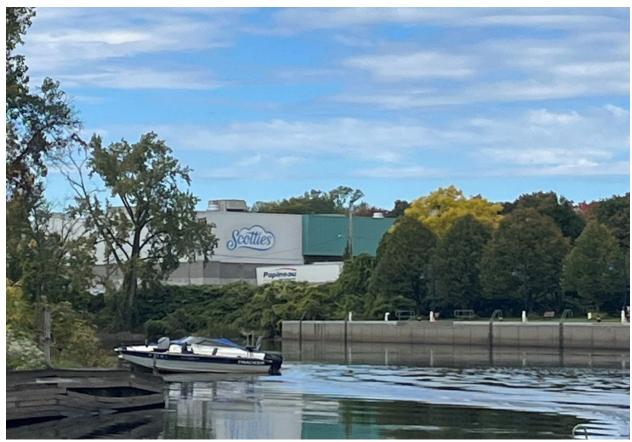
Photo 2. Location of CUs 0 and CU 1, where silting in after dredging was observed.

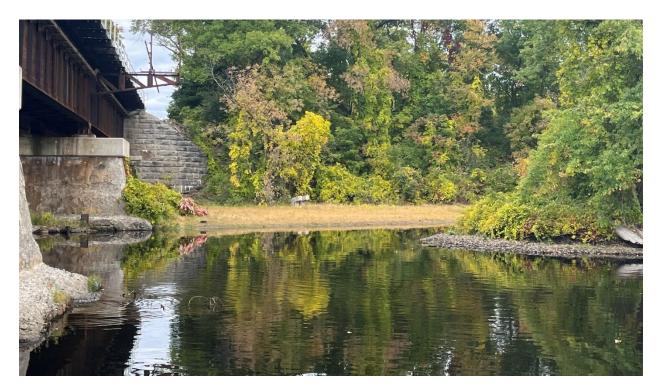
Photo 3. Cove in CU8 that is included in the TD1 fish sampling area.

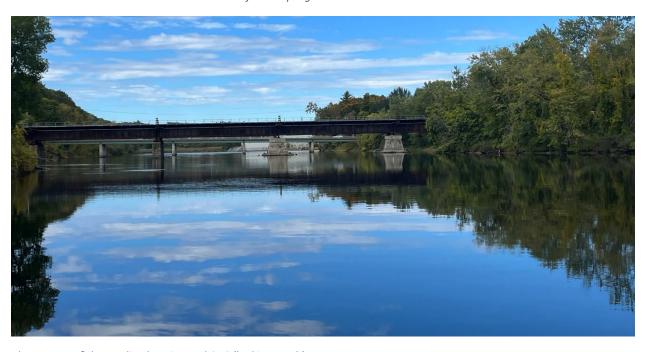
Photo 4. TD1 fish sampling location and CU6 (looking south).

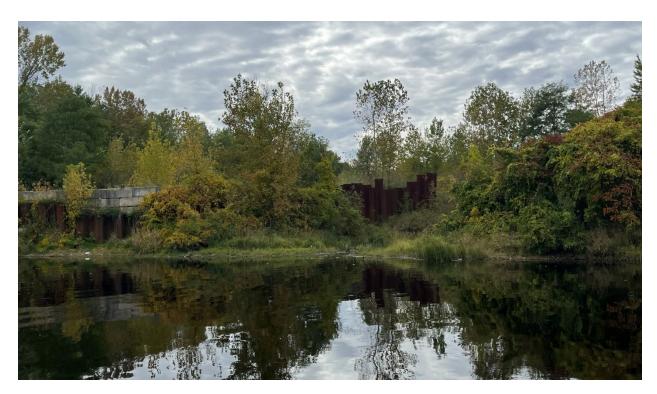
Photo 5. NYSDEC Moreau launch and loading area during dredging (Reach 8).

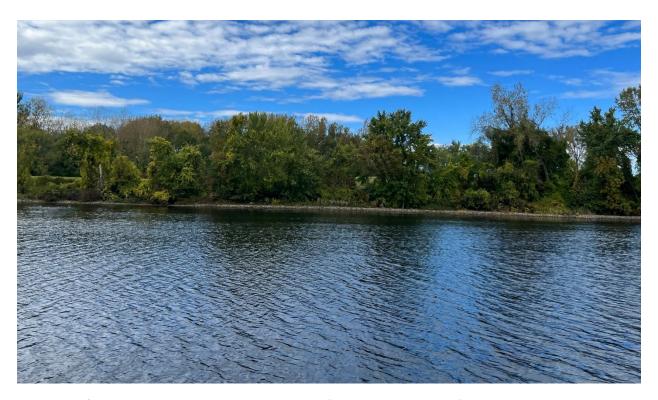
Photo 6. TD2 fish sampling area. A short-term response action (shoreline stone placement) is visible along the shoreline in the background as part of the Hudson River floodplain program.

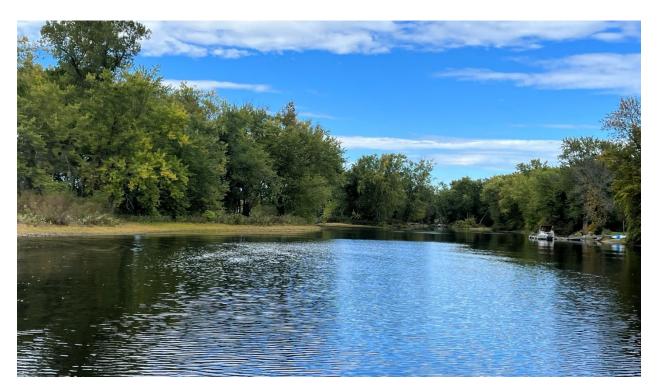
Photo 7. TD3 fish sampling location near the confluence with Snook Kill.

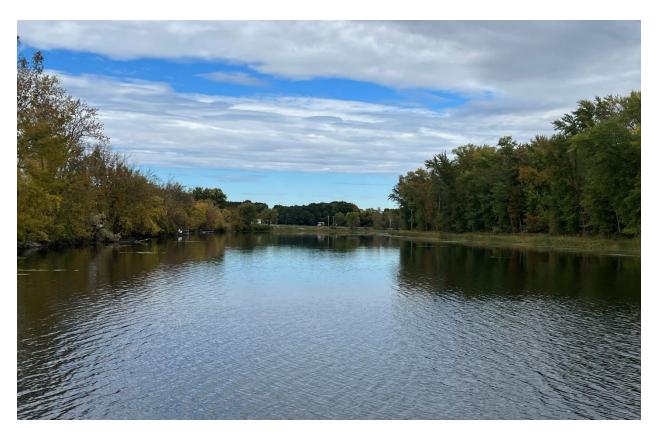
Photo 8. Fish sampling location TD4.

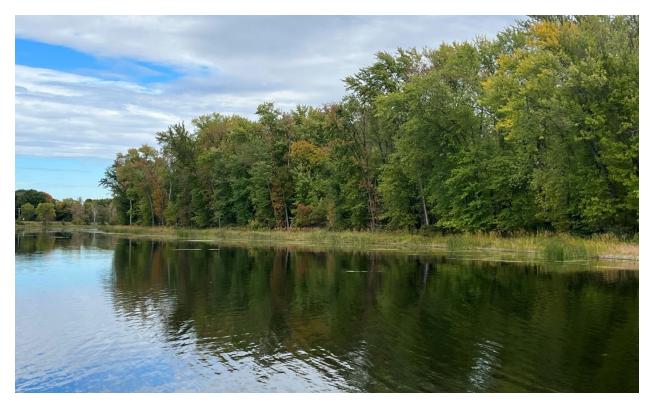
Photo 9. Fish sampling location TD5 along West Griffin Island.

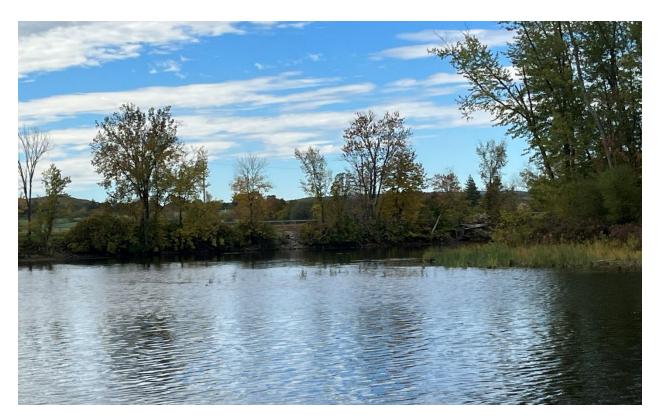
Photo 10. Reconstructed wetland at the southern tip of Griffin Island.

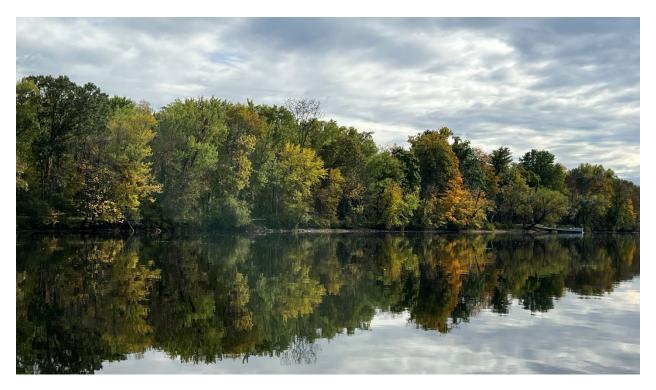
ND3 Fish station	10/5/22	Annual fish sampling location	None	N/A
NYSDEC Hotspot 28	10/5/22	Habitat reconstruction area.	None	N/A

Photo 11. Fish sampling location ND3.

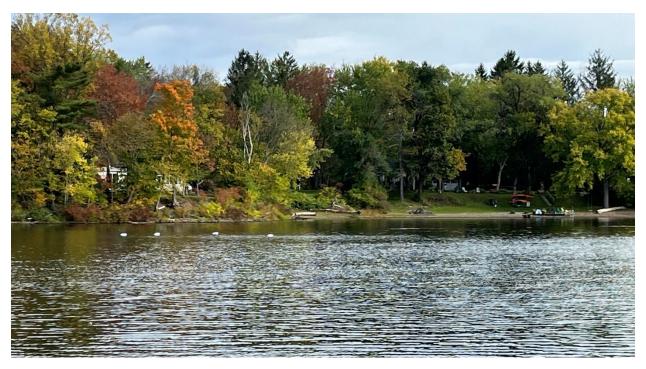
Photo 12. NYSDEC Hotspot 28, which was identified as a high-priority dredging area. A monitored habitat construction area was established on top of the fill.

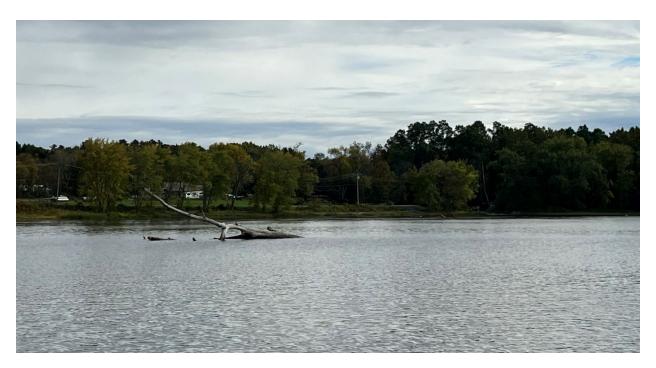
Photo 13. The southern extent of NYSDEC Hotspot 28.

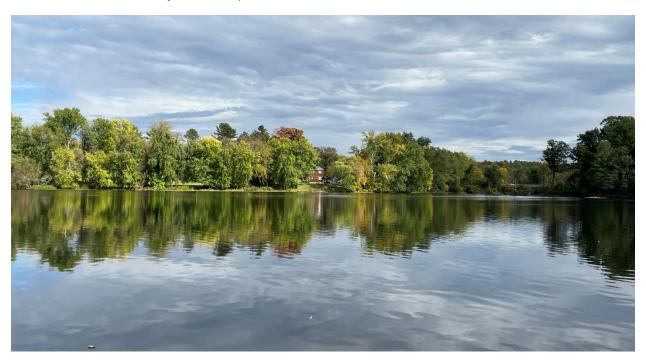
Photo 14. Fish sampling location ND4.

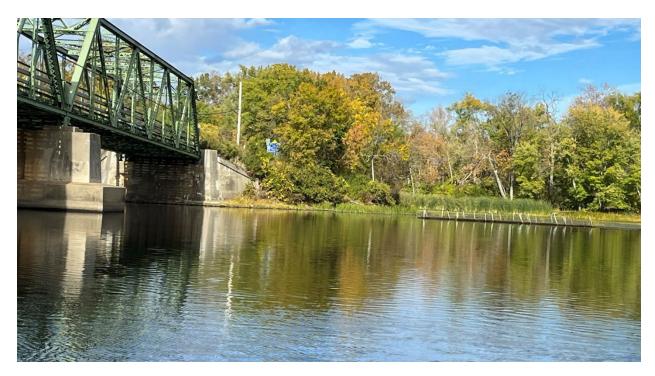
Photo 15. Fish sampling location ND5 with a wetland reconstruction area in the background.

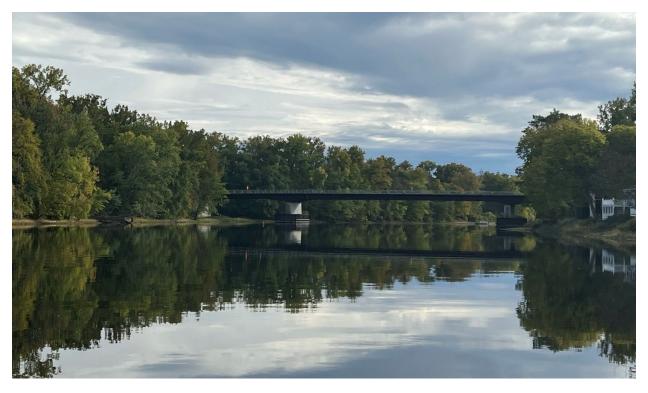
Photo 16. The Schuylerville Dix Bridge water column sampling location.

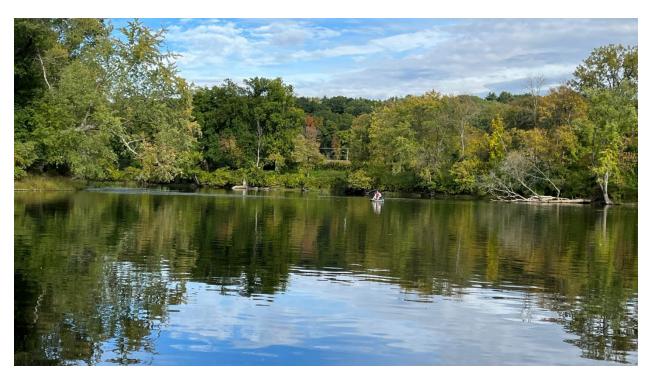
Photo 17. Fish sampling location SW1.

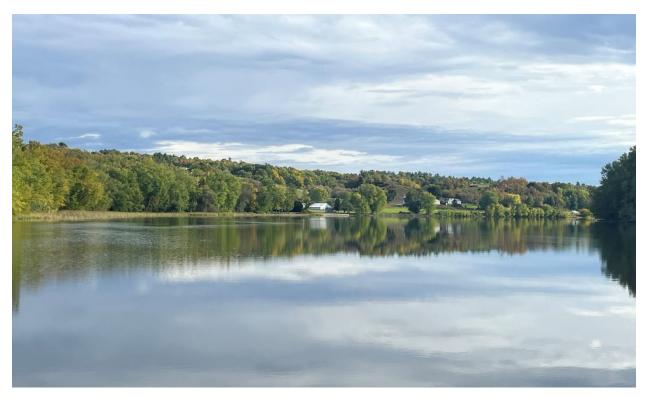
Photo 18. Fish sampling location SW2.

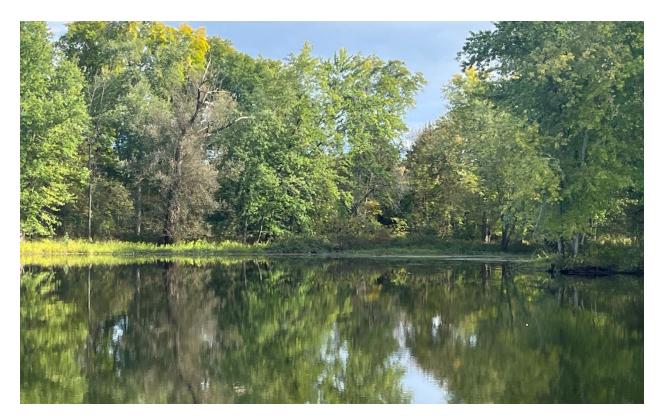
Photo 19. Fish sampling location SW3.
