MUNICIPALITY OF TOA ALTA MAY 2024

MONTHLY REPORT

Civ. No. 3:21-01087-DRD

TERRATEK ENGINEERING GROUP, PSC  
P.O. Box 367445 San Juan, PR 00936

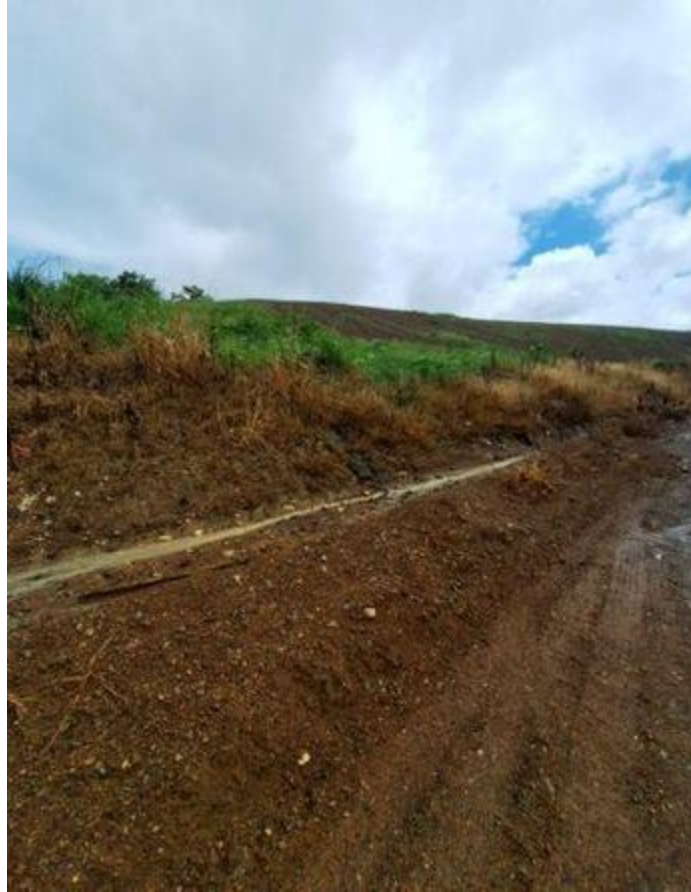
Daily Cover at the facility was completed on April 30, 2022. Daily Cover covered all areas of exposed waste.

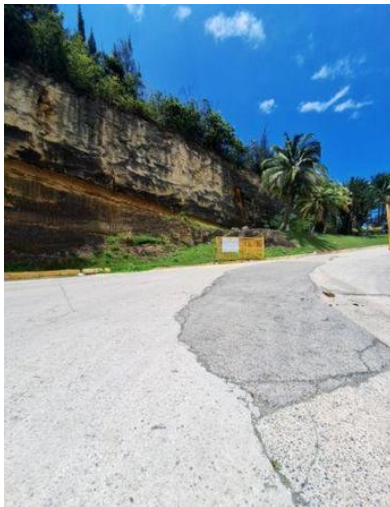
A sign size of four feet by five feet was installed at the landfill entrance. See the attached pictures.

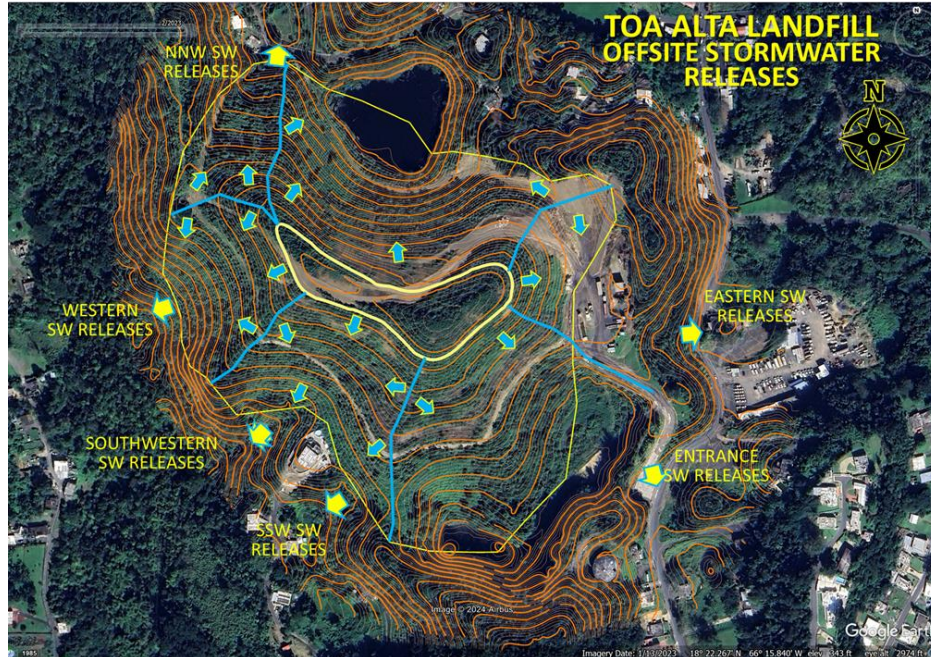
Needs to be reviewed and corrected

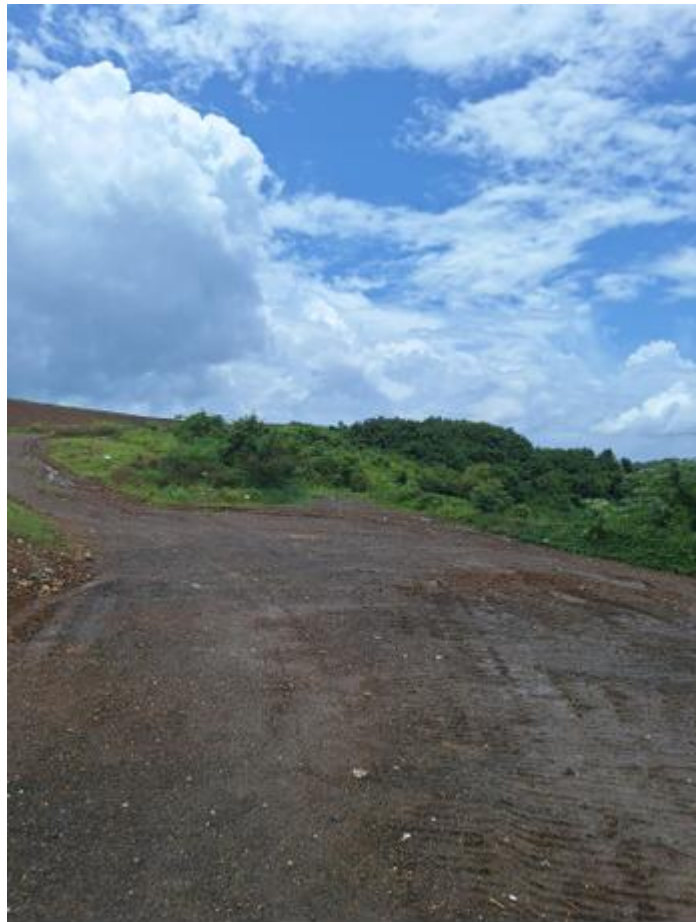
Condicion de Cubierta Talud Norte **Excelentes condiciones**

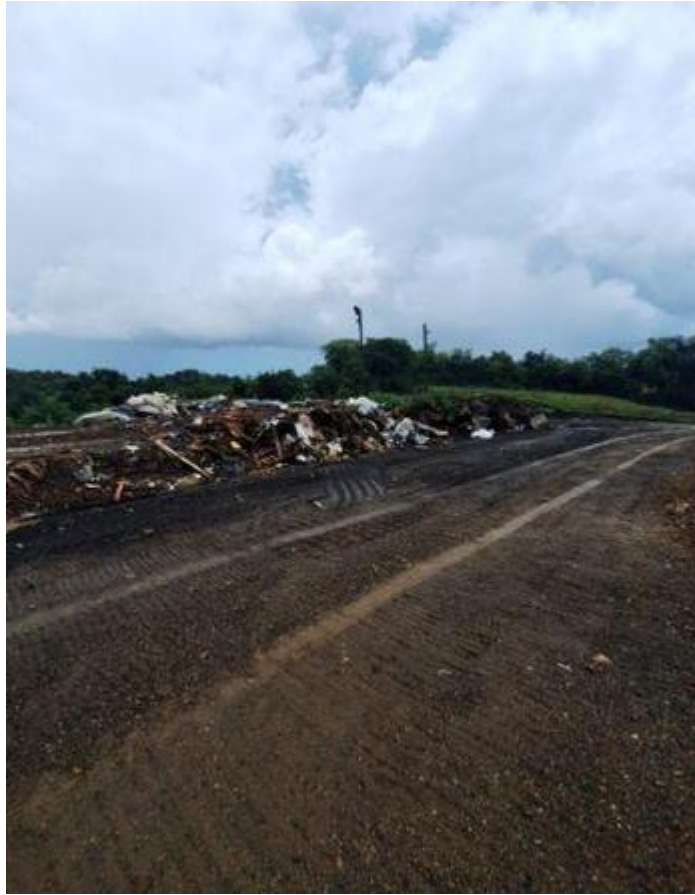
Necesita Limpieza

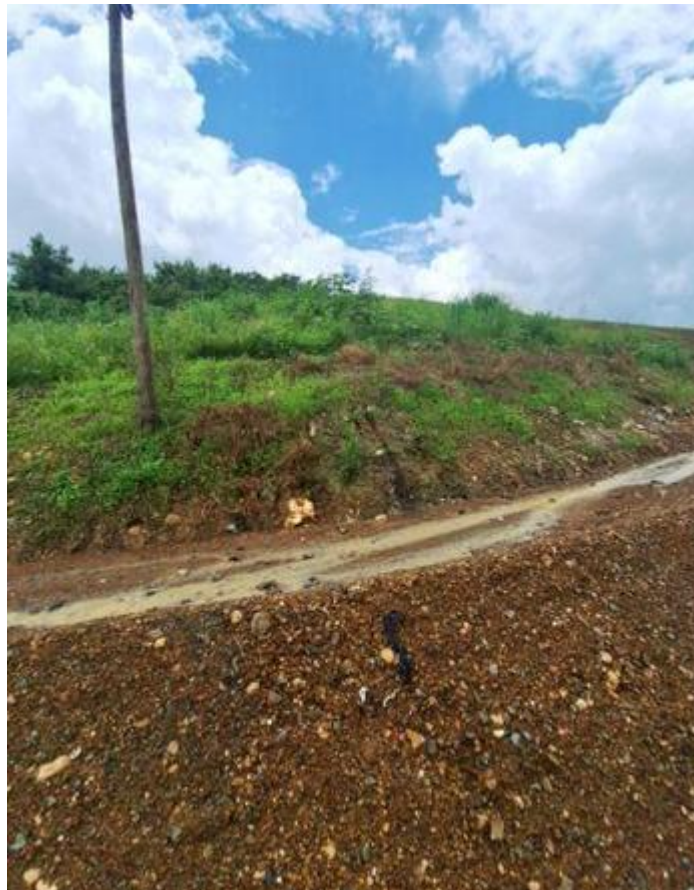
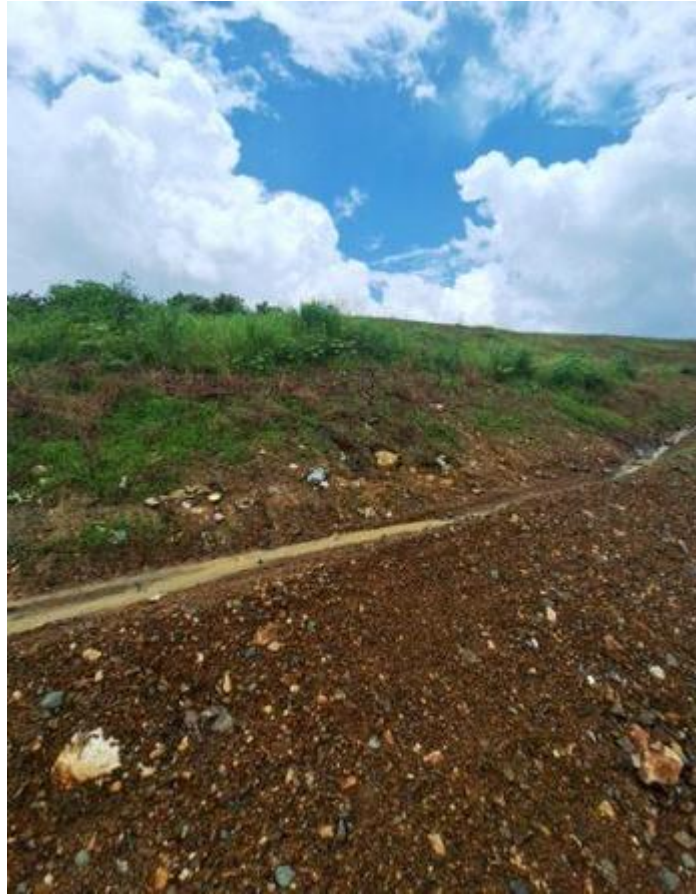
Se pueden notar brotes de lixiviado?

SI

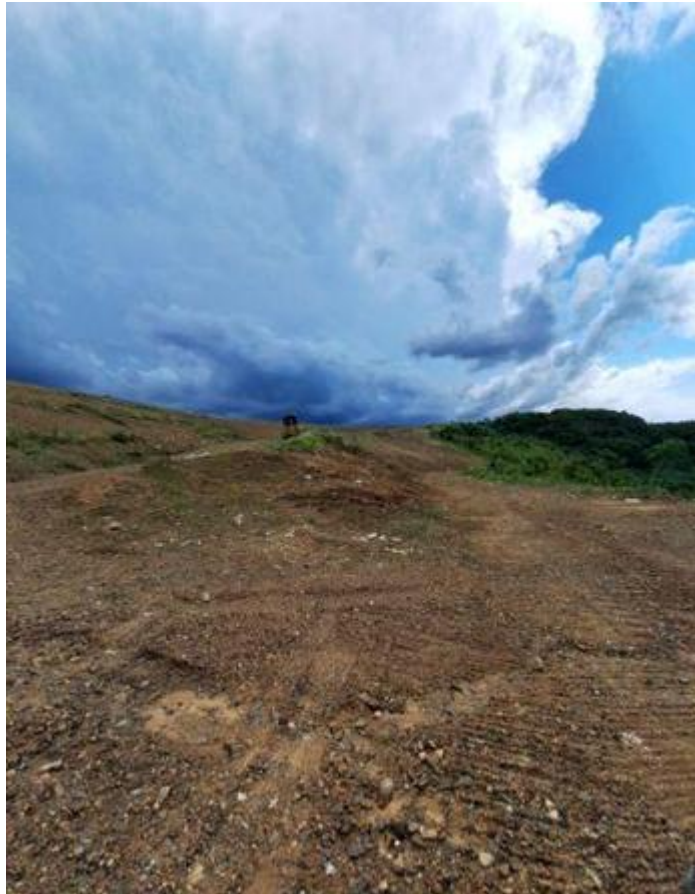
Excelentes condiciones

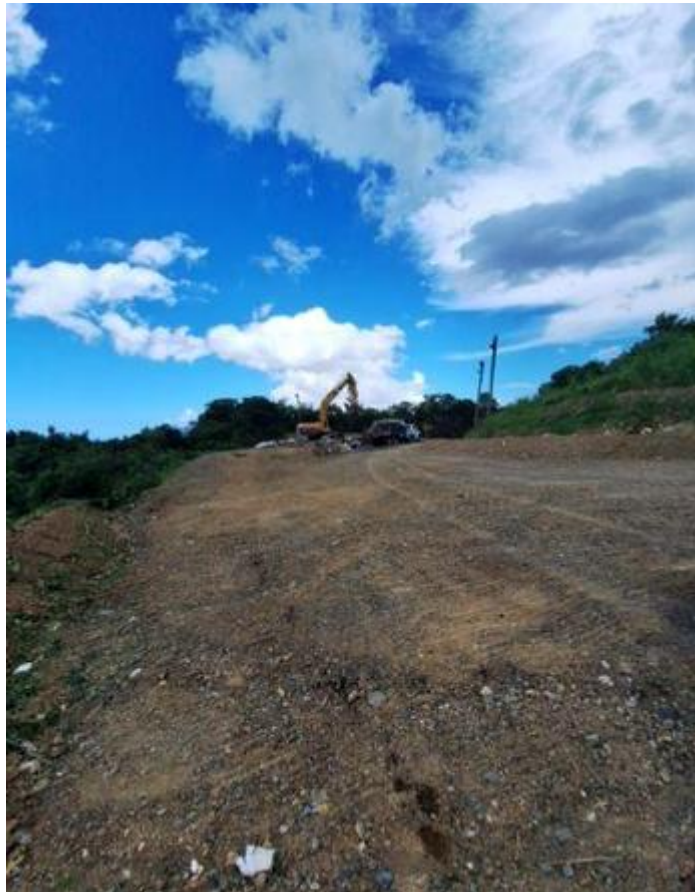
Necesita Limpieza

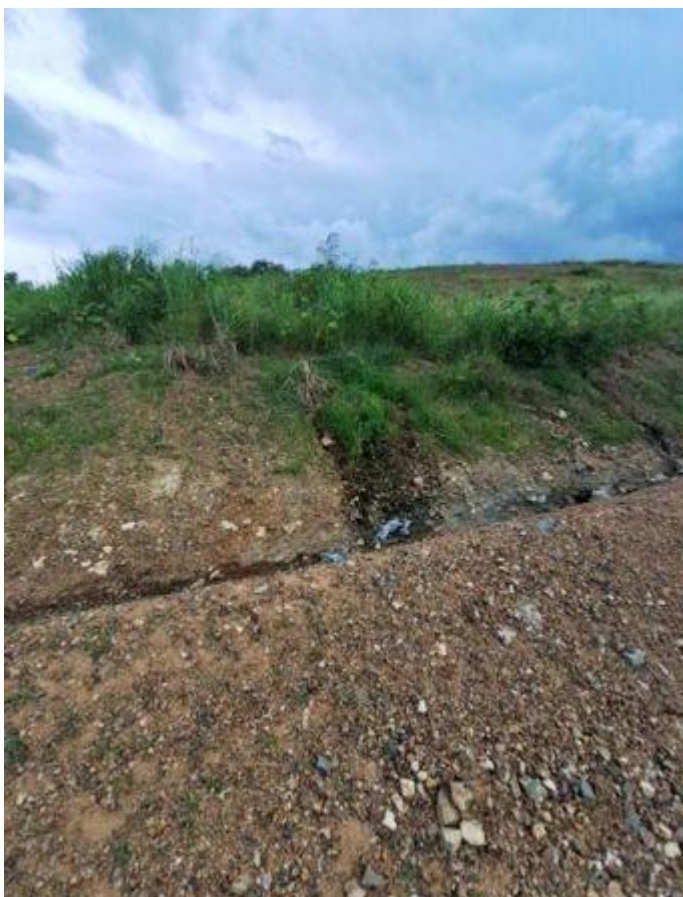
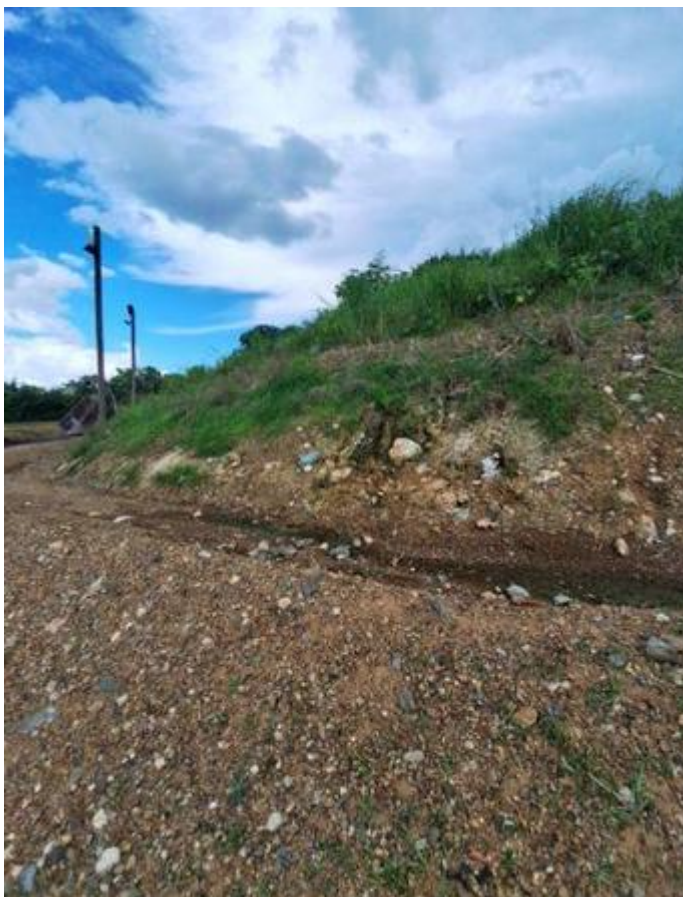
Se pueden notar brotes de lixiviado?

SI

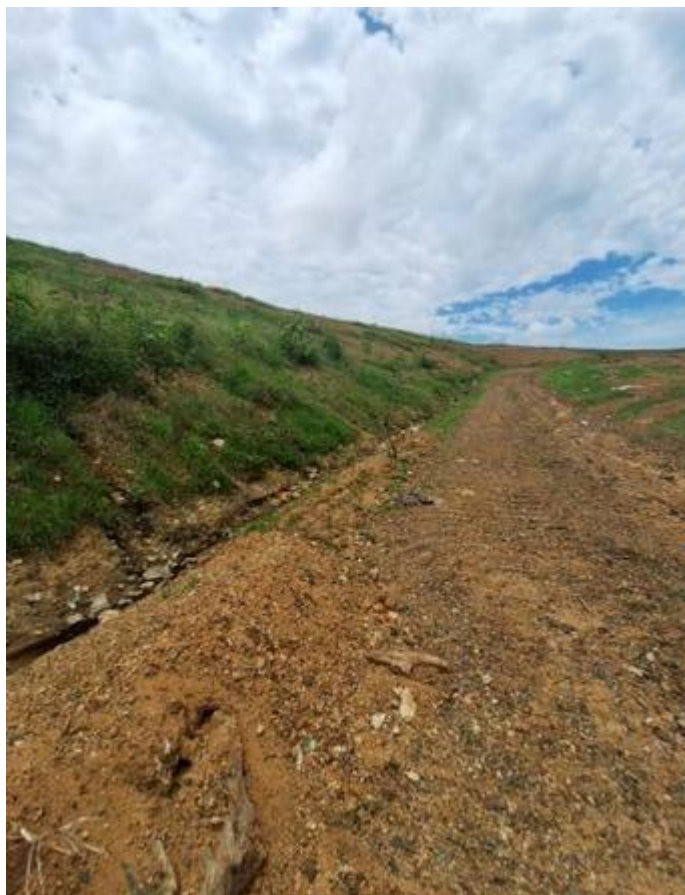
Tomar foto de bermas y canales o cualquier medida de control que necesite mantenimiento.

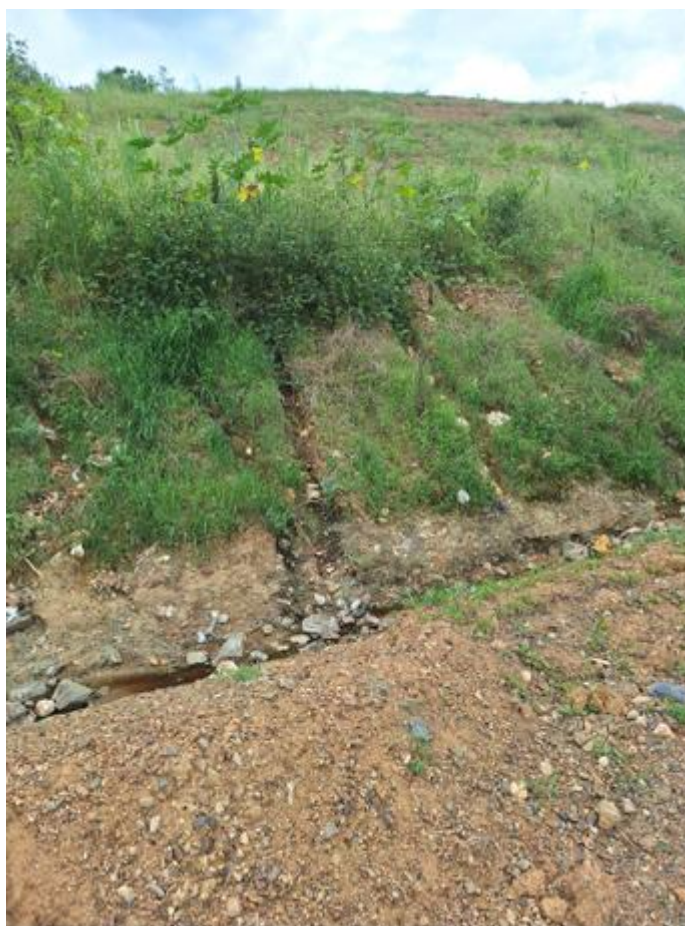
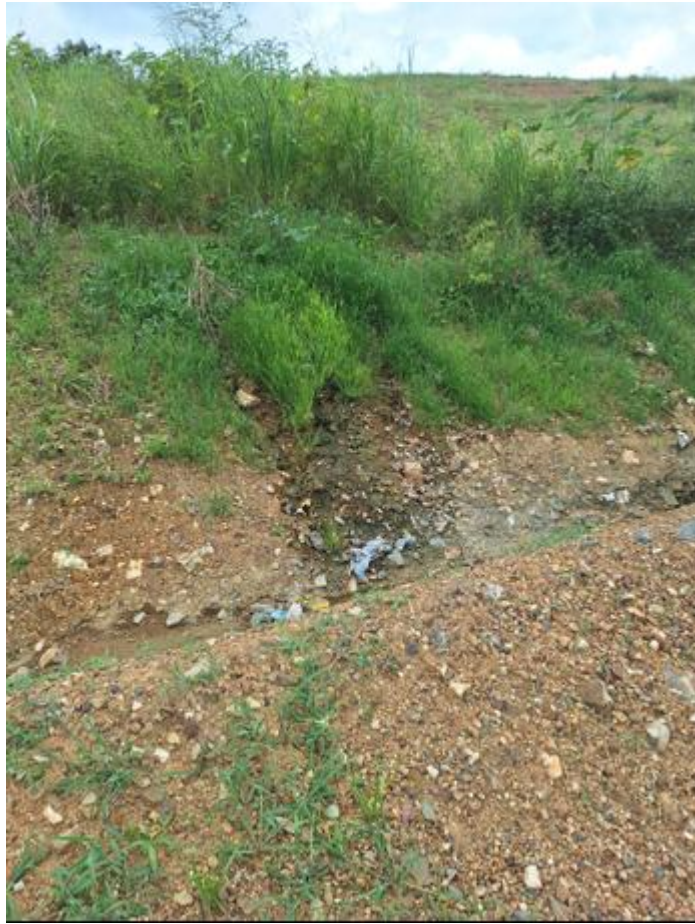
Se pueden notar brotes de lixiviado?

SI
