MUNICIPALITY OF TOA ALTA JULY 2024
MONTHLY REPORT
CIV. No. 3:21-01087-DRD

NIVIA I. AYALA, PE
TERRATEK ENGINEERING GROUP, PSC
P.O. Box 367445 San Juan, PR 00936

Municipality of Toa Alta Civ. No. 3:21-01087-DRD		
Reporting Period:		July 01 to July 31, 2024
Reporting Number:		22
Reporting Official:		Nivia Ayala, PE/TerraTek
Reporting Date:		08/30/2024
Description of Compliance with Each Requirement of the Order		
ID	Requirement	Compliance Status
1	Access	In-Compliance
2	Daily Cover	In Compliance
3	Cessation of Waste Disposal	In-Compliance
4	Posting of Signs	In Compliance
5	Intermediate Cover	A new intermediate cover phase spanning approximately 4.5 acres is currently underway, with robust clearing and grubbing activities commencing this month.
6	Maintenance of Cover	In-Compliance
7	Slope Stability	In compliance with agreed short-term controls, safety barrier fencing, and H&S program.
8	Leachate Management	
8a	Leachate Management Plan	A formal Leachate Management Plan was submitted with the Preliminary Closure Plan on October 31, 2023.
8b	Management of Leachate Collected from Landfill	Permit Approved GDG-24-706-001

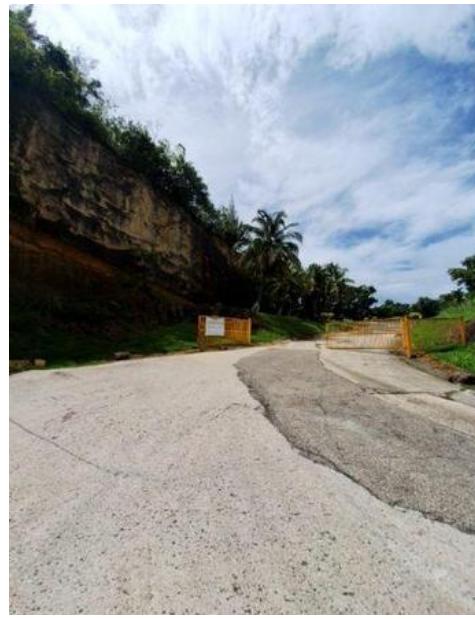
A sign size of four feet by five feet was installed at the landfill entrance. See the attached pictures.

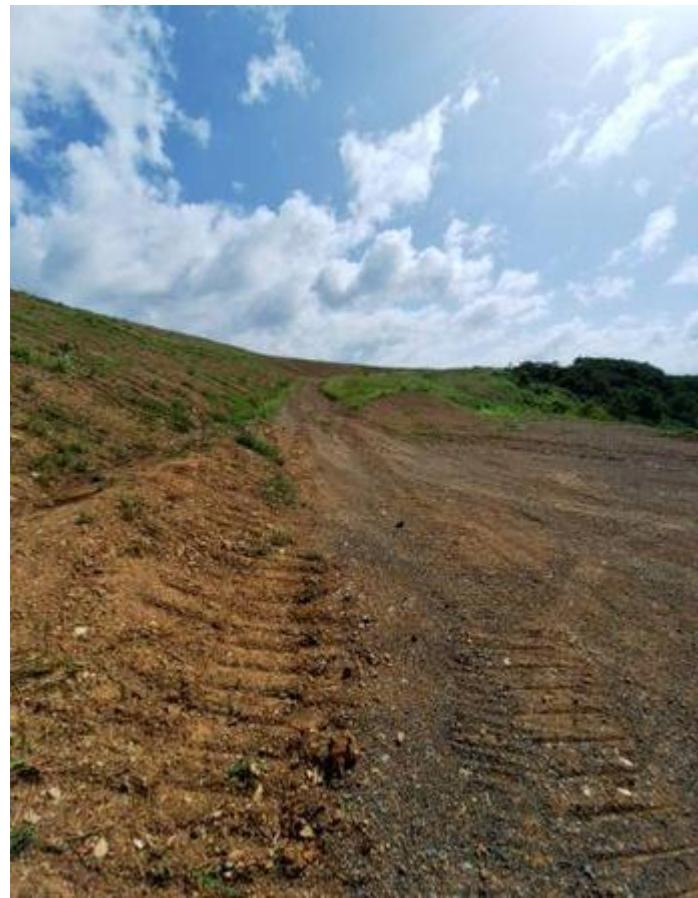
Excelentes condiciones

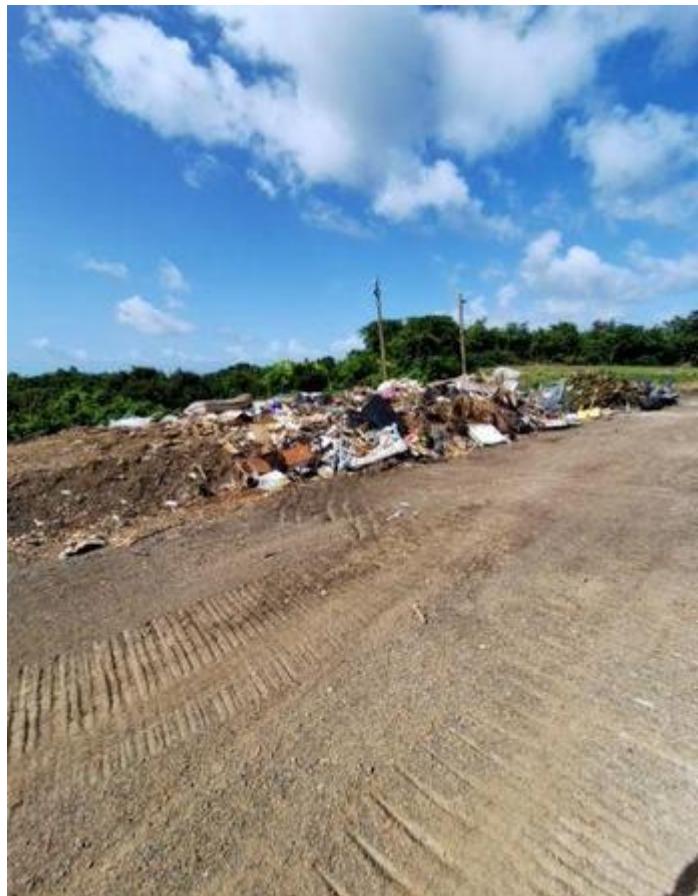
Necesita Limpieza

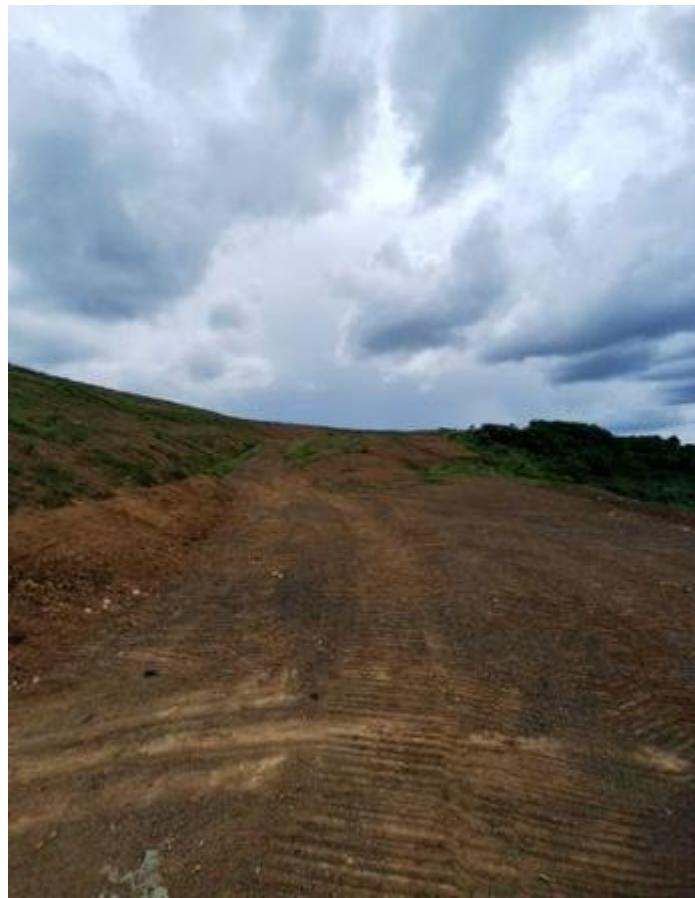
Excelentes condiciones

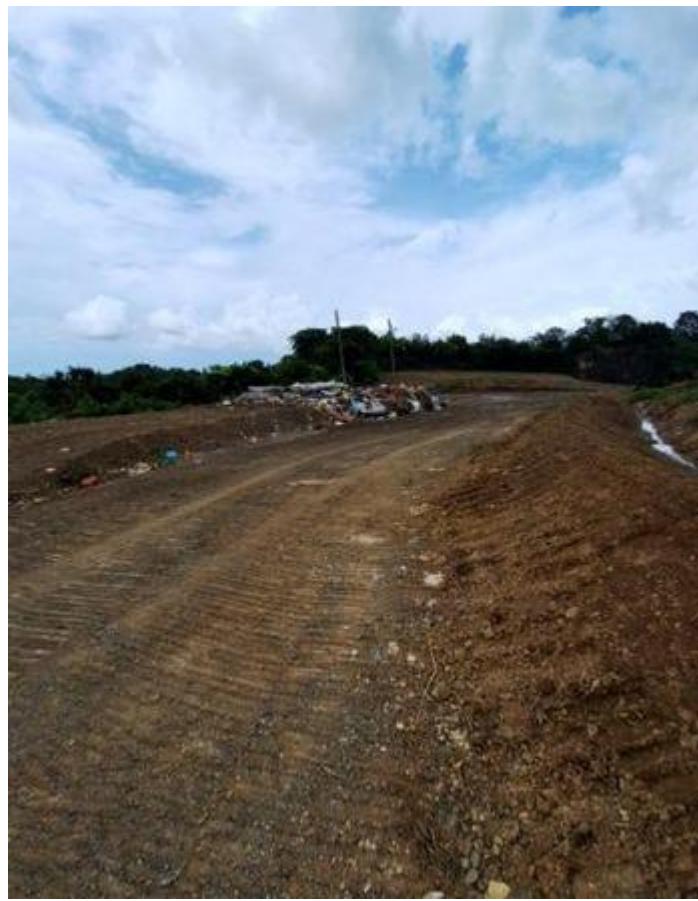
Necesita Limpieza

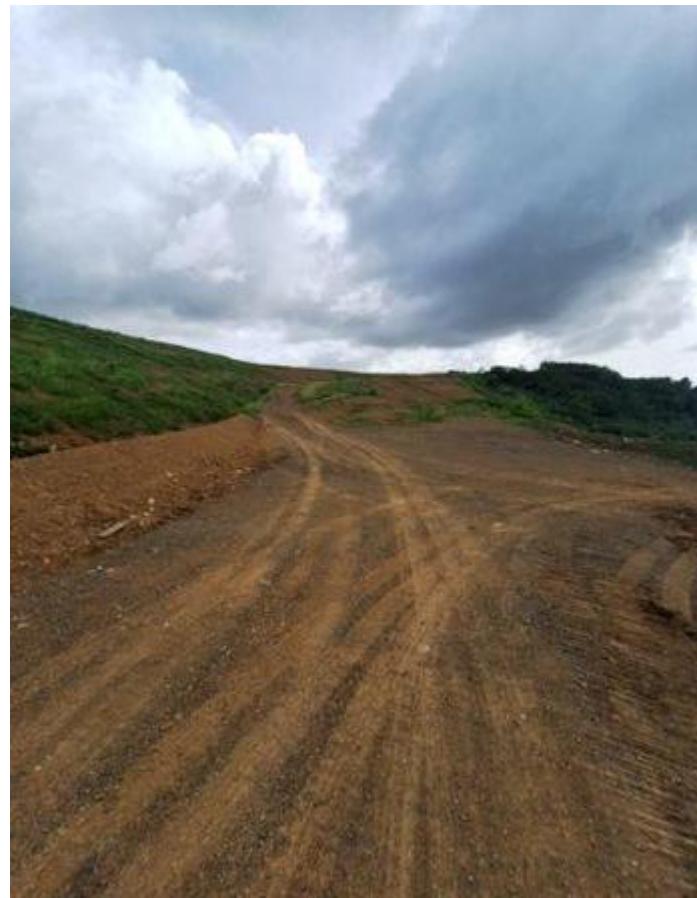
Excelentes condiciones

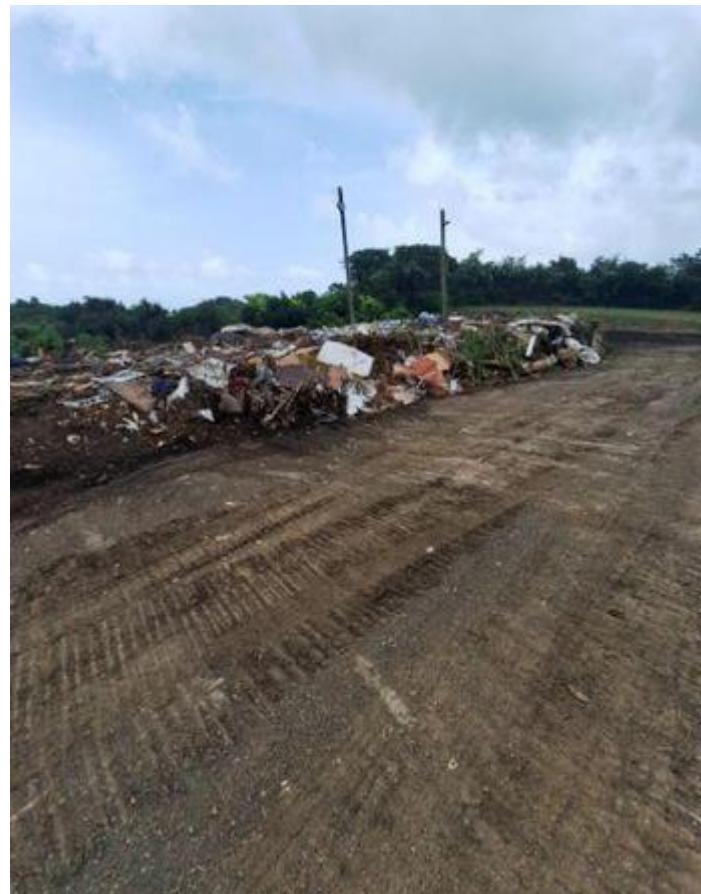
Necesita Limpieza
