U.S. EPA Construction Inspection Training Course

Module 5: 2022 Construction General Permit (CGP)

Site Inspections

Site 1, Part 1

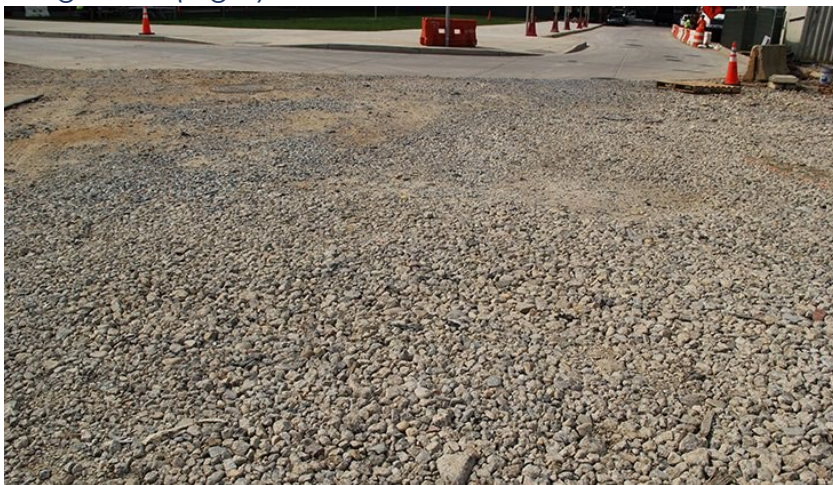
Figure 10-4. View of stone aggregate on the stabilized construction entrance.

This construction entrance is stabilized with a commonly used technique: aggregate stone over underlying geotextile. As a reminder, when inspecting controls, you must look for signs that the control needs maintenance. For example, for this type of control, you need to see if the stones are packed down, sediment-laden, or displaced. If this is the case, it may indicate that the sediment-laden stone needs to be removed and replaced with clean stone, and possibly new underlying geotextile, to effectively remove sediment from the wheels of vehicles. At this site, the construction entrance appears to be in working condition and there isn't a significant amount of sediment track-out on the paved road. There are a few areas with visibly accumulated

sediment or displaced stones, but they do not appear to impact the construction entrance. During future inspections, continue to inspect the condition of the stabilized construction site entrance.

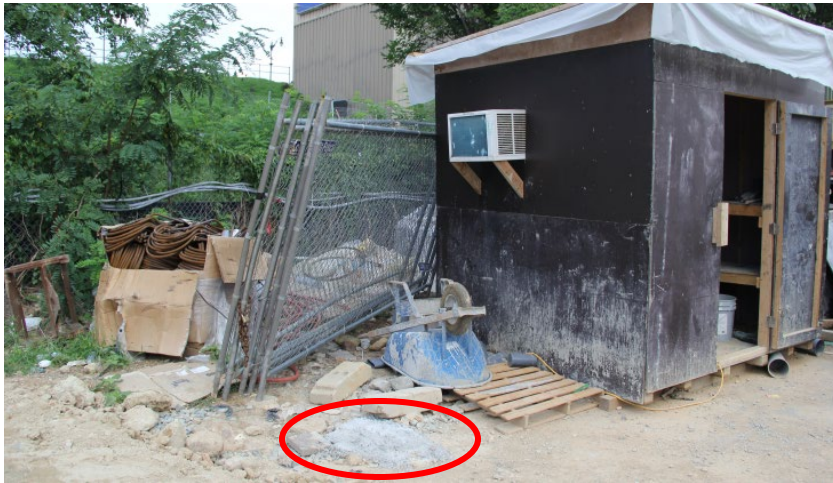
Figure 11-4. Improper concrete washout next to a storage shed.

On the left side of the storage shed, it appears that a small amount of concrete has been washed onto the ground. The operator must remove and dispose of the hardened concrete appropriately. Furthermore, the operator must ensure that concrete is washed out into a leak-proof container or pit and properly disposed. If by the end of the inspection you do not observe a designated concrete washout area on-site, then you must document this finding in your inspection report as a corrective action because a required stormwater control was never installed, which is one of the conditions triggering corrective actions in the CGP. Keep this in mind during the rest of this inspection. Discuss this finding with the operator after the inspection so they can begin to remedy the situation immediately.

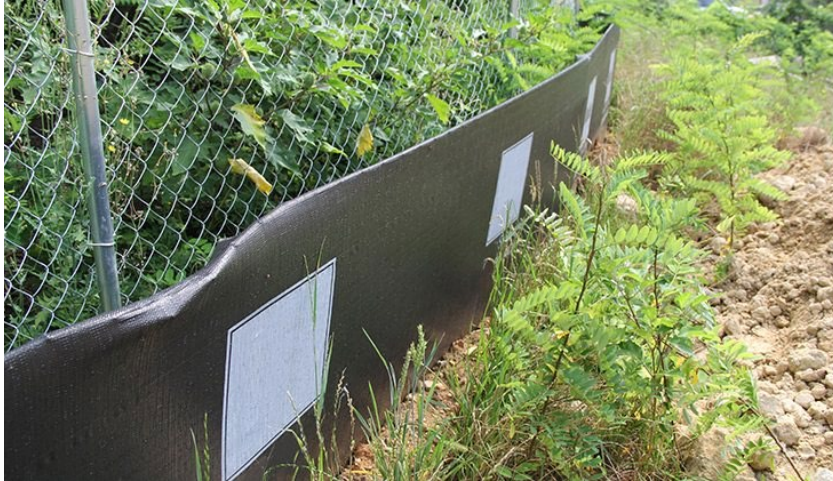
Figure 12-5. View of a different section of the silt fence upgradient of the stockpile.

This image shows a view of the super silt fence perimeter control. This super silt fence appears to be in good condition—there isn't much sediment accumulated, there are no tears in the fabric, and the fence appears to be entrenched into the ground. However, the super silt fence appears to be installed incorrectly. This perimeter control is intended to reduce run-on, or in other words, to reduce off-site stormwater entering the construction site. The front of the super silt fence, shown here, needs to be installed facing the direction of flow. Therefore, it needs to be facing out, toward the chain link fence. Document this finding in your inspection report and state that a corrective action is triggered because the control was installed incorrectly. You need to discuss this finding with the operator immediately after the inspection so the operator can re-install the silt fence properly. During a typical site inspection, you need to walk along the length of all perimeter controls to assess their condition, but for the sake of time, we won't do that during this virtual inspection.

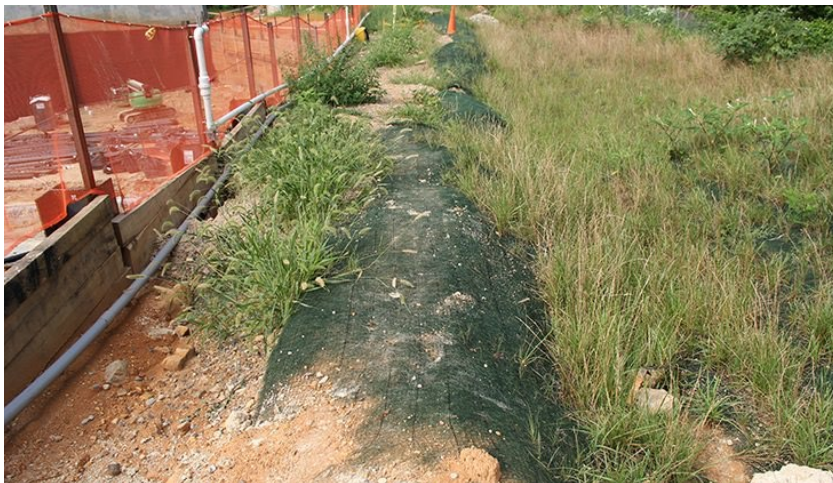
Figure 14-4. View of the diversion berm along the perimeter of the active construction area.

Unfortunately, the erosion control matting at this spot on the berm is damaged and needs to be repaired. Include the damaged matting as a finding that requires routine maintenance in your inspection report. This finding is considered routine maintenance because it can be resolved with a minor repair, rather than replacing the control in its entirety. Present this finding to the operator after your inspection so they can immediately initiate routine maintenance.

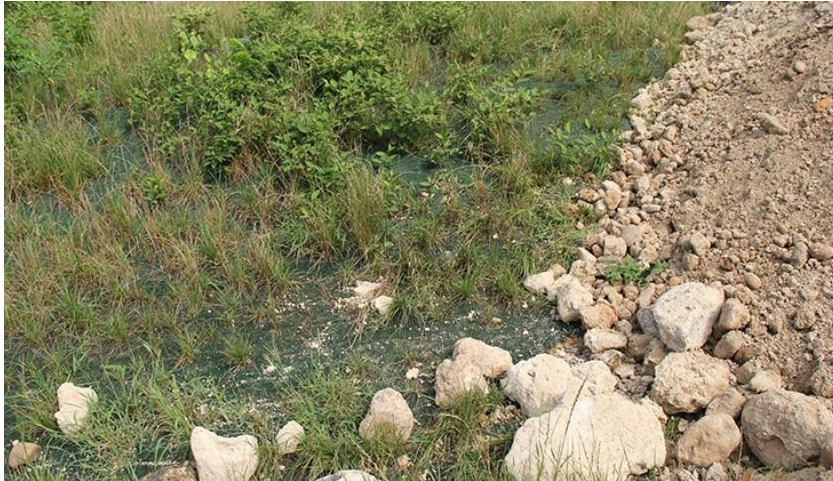
Figure 14-5. View of erosion control matting and vegetation on the slope adjacent to the soil stockpile.

This sloped area next to the stockpile is stabilized with erosion control matting and vegetation. During site inspections, you must inspect all areas where stabilization measures have been implemented. You must check for signs of damage, erosion, or sediment accumulation. By the looks of it, the erosion control matting here appears to be in good condition.

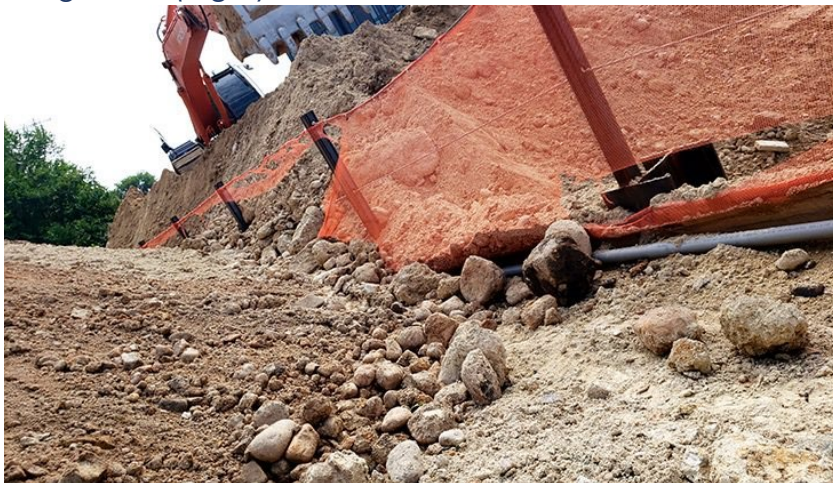
Figure 14-6. View of orange safety fence immediately downgradient of the soil stockpile, above the active construction area.

This stockpile doesn't have a downgradient sediment barrier, which is required by the permit. This damaged orange fence is not a sufficient sediment barrier. Any stockpile erosion would cause sediment to fall into the excavated area, which is treated by dewatering controls, but the fallen sediment could lead to damage or additional work for the operator. Document the lack of a downgradient sediment barrier as a finding in the inspection report. This finding triggers a corrective action because a required stormwater control was never installed. Present this finding to the operator after the inspection so they can initiate corrective actions immediately.

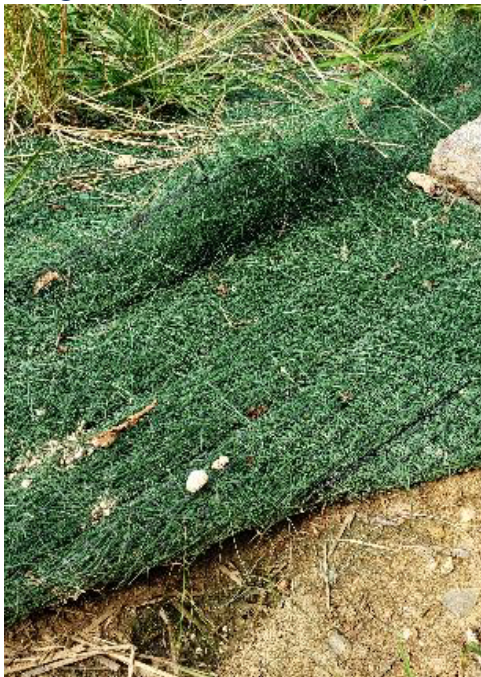
Figure 15-4. Displaced erosion control matting on the diversion berm.

Check out this berm. There are some areas along the berm where the erosion control matting has been displaced and the underlying ground is exposed. During a precipitation event, these exposed areas would be unprotected and could cause erosion and sediment discharge. Because this condition only requires a minor repair, the work can be treated as routine maintenance, as opposed to a corrective action, which would be triggered by more significant repairs or a complete replacement of the control. Include this finding as routine maintenance in your inspection report, and remind the operator to begin work immediately.

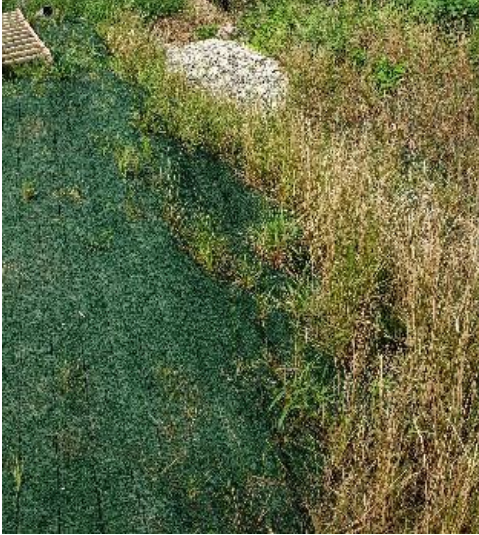
Figure 15-5. View of erosion control matting on the diversion berm.

When inspecting erosion control matting, you need to check that separate sections of material are properly overlapped and joined together. In general, the erosion control matting along this berm appears smooth and well installed.

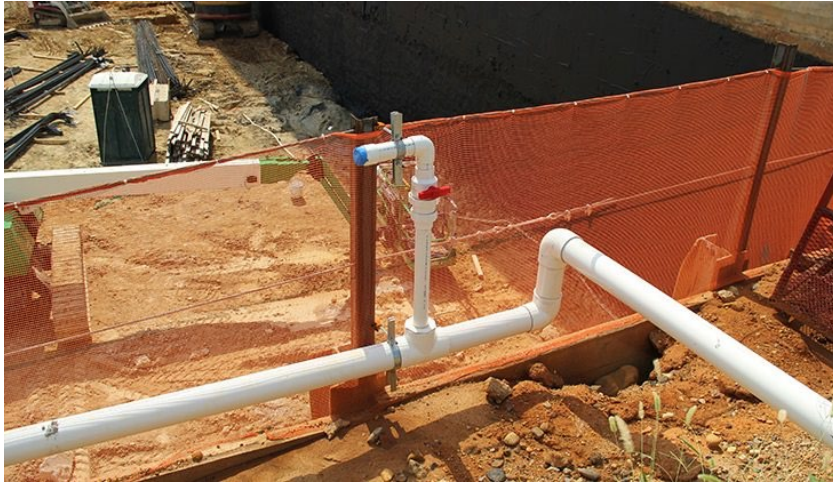
Figure 16-4. Piping and a valve that are part of the dewatering system for the active construction area.

This is the valve closest to the portable sediment tank. The valve and the pipe appear to be free of staining, cracking, leaking, and other signs of wear. During dewatering, the pump needs to have enough power to push water up the hose, through this valve, and up the pipe towards the portable sediment tank.

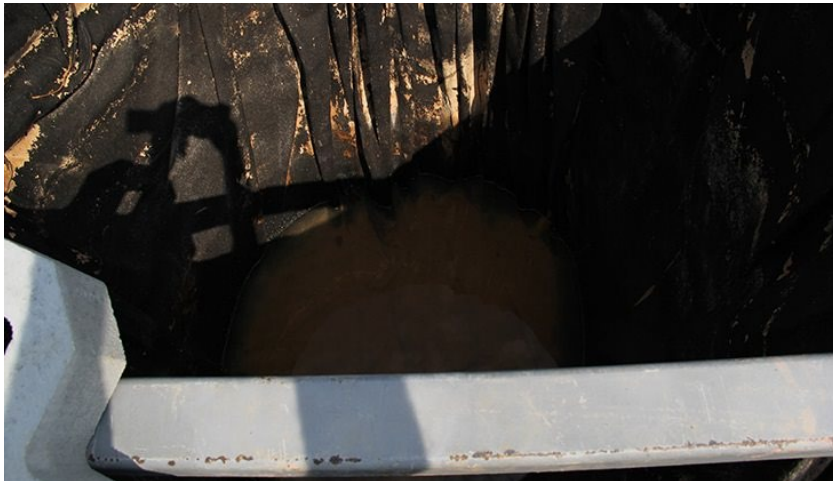
Figure 16-5. View of the inside of the portable sediment tank.

When inspecting a dewatering system, you need to check how much sediment has accumulated inside the control, which in this case is the portable sediment tank. Looking inside, you can see signs of sediment residue on the black filter bag and some sediment accumulated at the bottom, but there is still plenty of capacity to continue dewatering. The filter bag is not damaged and appears to function properly.

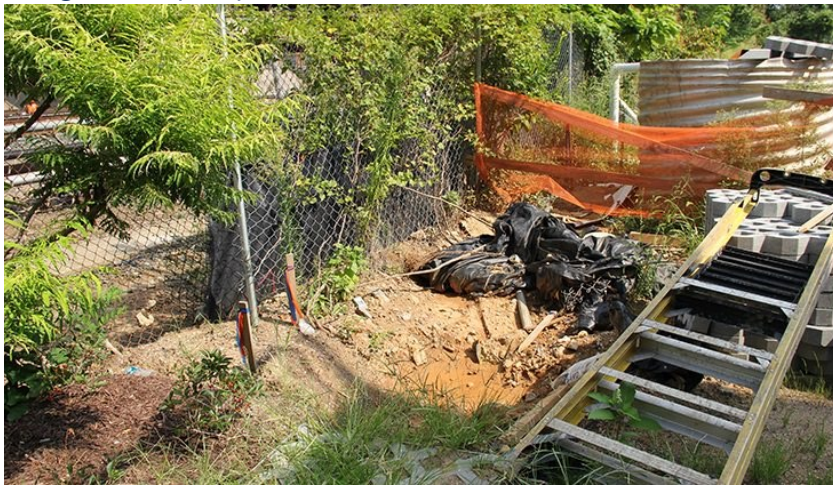
Figure 17-3. Debris and construction materials on the ground near the portable sediment tank.

As you walk the site, it's a good idea to keep an eye out for piles of materials that are uncovered, discarded materials, or other good housekeeping concerns. This area is untidy, but is it a stormwater pollution concern? The ground slopes toward the excavated construction area, so it's unlikely any material or pollutants would be mobilized off-site, as long as effective controls are in place. Still, you may recommend to the operator that they dispose of the debris and cover or stabilize this area. If you see uncovered material like this at a site you inspect in the future, use your best judgment to decide if this counts as a condition that should be addressed through routine maintenance or corrective action.

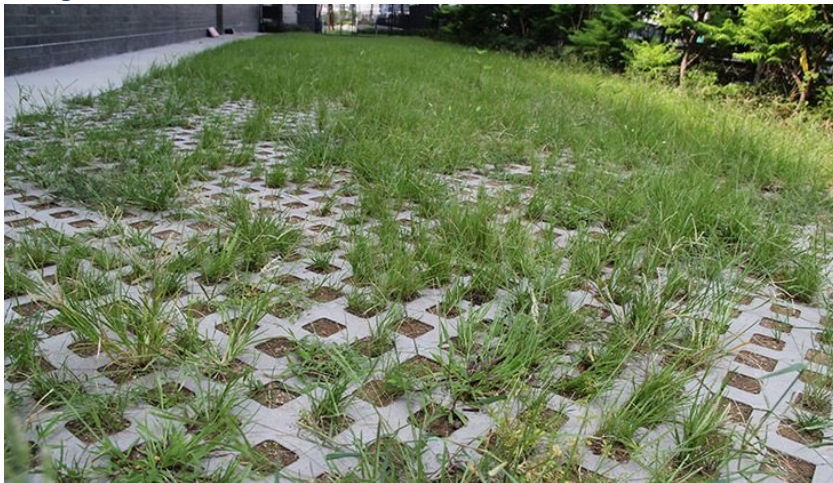
Figure 17-7. View of permeable pavers behind the parking garage.

Check out the pavers in this area. The vegetation appears to be growing in well, and there are no cracks, sediment accumulation, or debris.

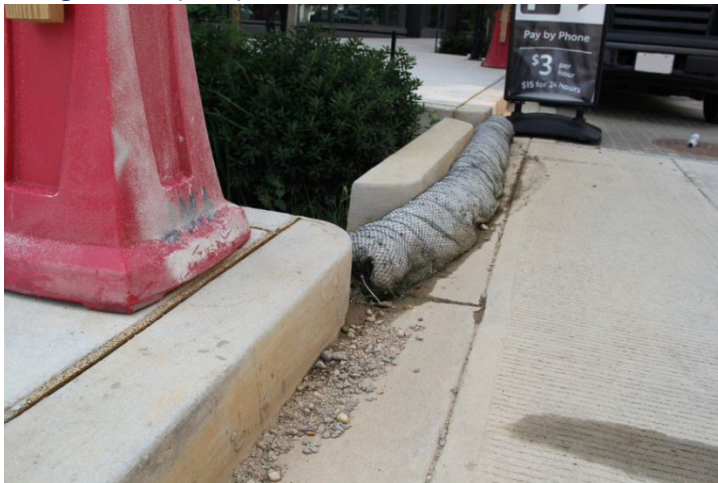
Figure 19-4. View of filter sock covering inlet to bioretention cell along First Street.

You can see some evidence of sediment accumulation on the upgradient side of the filter sock, which means it's doing its job. There is a relatively small amount of sediment; however, the operator must remove any sediment that has accumulated adjacent to the inlet. This finding is considered routine maintenance because removing the sediment is upkeep that ensures the stormwater control remains in effective operating condition. Include a finding to this effect in your inspection report and indicate that routine maintenance is required. Also, make sure to tell the operator so they can remove and properly dispose of the sediment.

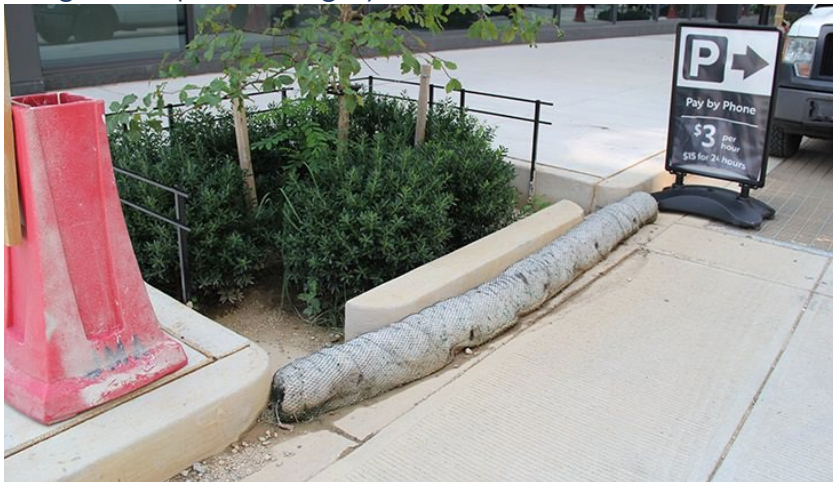
Figure 19-6. View of bioretention cell along first street.

This inlet leads to a small bioretention cell, which is a permanent green infrastructure feature that manages stormwater. Even though it is not a storm drain, it still must be protected so that it continues to function as designed. This filter sock appears to be in good condition, but it needs to be moved so that it fully covers both curb-cut inlets. If the filter sock is not long enough to cover both curb cuts, the operator should use two filter socks. Add this finding to the inspection report and note that routine maintenance is needed. Moving the filter sock to cover both curb cuts or adding a second filter sock is considered a minor repair or upkeep, and therefore is

treated as routine maintenance as opposed to a corrective action, which would be triggered if the repair was more significant. Communicate this finding to the operator after the inspection so they can complete the routine maintenance.

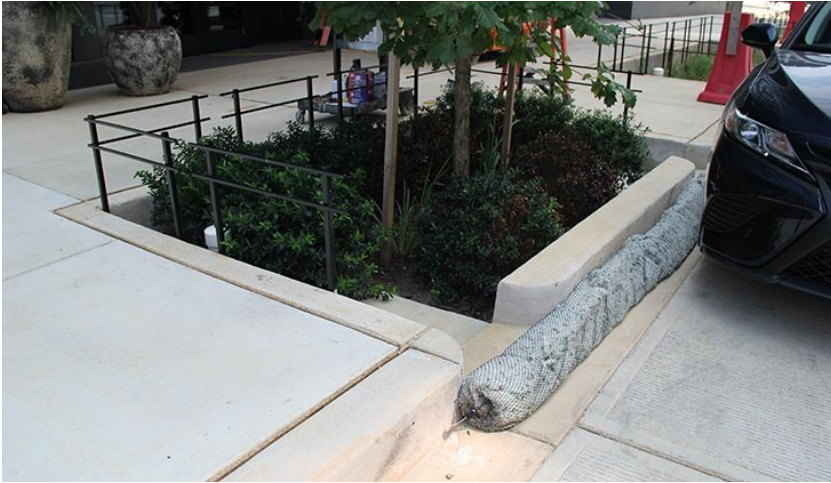
Figure 20-4. View of second bioretention cell along First Street.

Here's another bioretention cell with a filter sock protecting the inlet. This control appears to be in good condition.

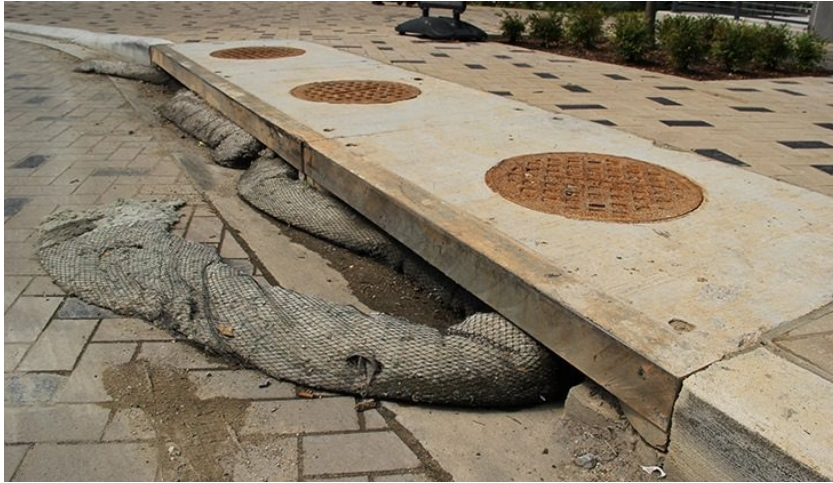
Figure 22-5. View of the filter sock in the curb inlet at the end of First Street.

These filter socks are in bad condition and must be replaced immediately. In their current condition, they are not protecting this curb inlet. Not only are many parts crushed or even sunk into the curb inlet, but there are also several gaps that could allow stormwater discharges to carry pollutants off-site. Because this control needs to be replaced in its entirety, this condition triggers a corrective action. Add this to your inspection report, and present this finding to the operator.

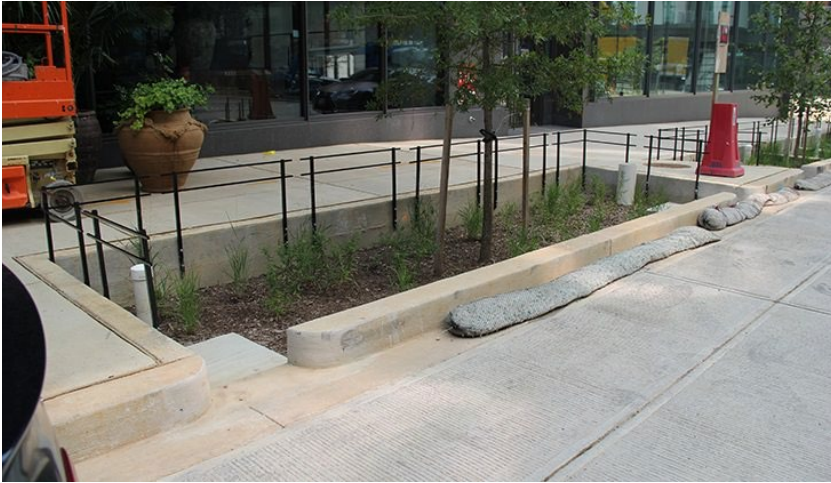
Figure 23-4. View of a third bioretention cell along First Street.

This curb inlet is unprotected because the filter sock has been moved or displaced. Add this finding to the inspection report as a condition that requires routine maintenance, and inform the operator of this finding. Because moving the filter sock to cover the curb cut is considered a minor repair or upkeep, routine maintenance is all that is required here, as opposed to a corrective action.
