U.S. EPA Construction Inspection Training Course

Module 5: 2022 Construction General Permit (CGP)

Site Inspections

Site 1, Part 2

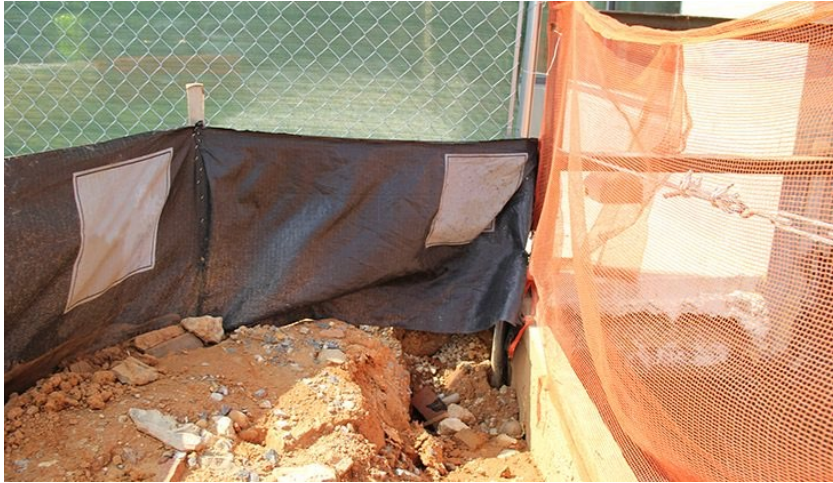
Figure 2-4. View of the silt fence in the area behind the truck.

It's a good thing we walked around the truck to check out this area. The silt fence in the area behind the truck appears to be undercut, or perhaps it was improperly installed. This area is below the curb line, so stormwater will likely pond in this area instead of flowing into the road. Even so, the operator must repair the silt fence or consider implementing another control to reduce the potential for stormwater pollution from turbid water overtopping the curb. Add this finding to your inspection report and note that it requires routine maintenance if the silt fence is repaired, or corrective action if the silt fence is replaced in its entirety or a new type of control is installed. Talk to the operator about this issue and remind them that routine maintenance or corrective action, whichever applies, must be initiated immediately after the inspection.

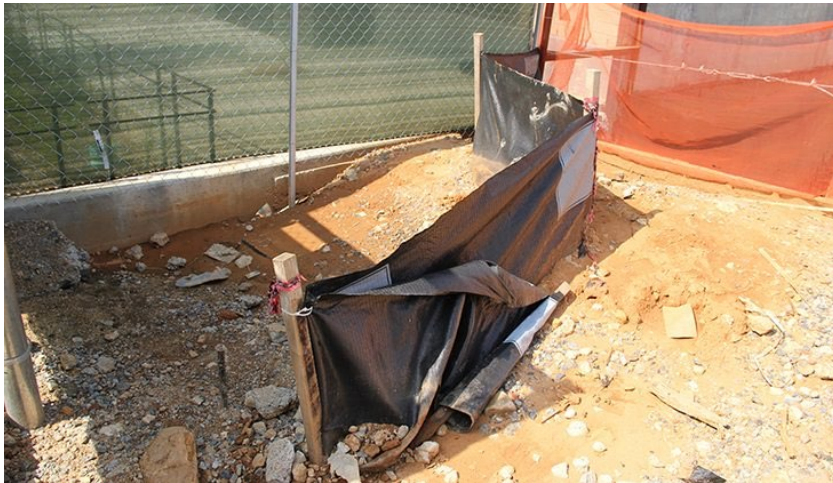
Figure 2-5. Another view of the silt fence in the area behind the truck.

This is a view of the area behind the truck. The silt fence perimeter control is damaged. Because this area is lower than the curb line, it's unlikely that sediment would migrate into the road, but the silt fence helps prevent turbid water from overtopping the curb. So, you must still note this condition in your inspection report as requiring routine maintenance to repair the silt fence.

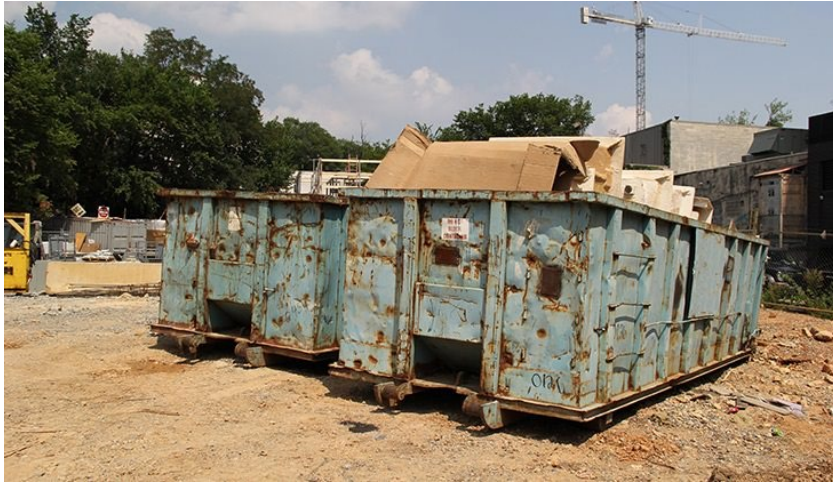
Figure 4-7. View of the front of two dumpsters.

The operator uses these two dumpsters for general construction and domestic wastes. It appears that trash is almost overflowing the dumpster on the right. You should remind the operator to empty the dumpsters before they overflow.

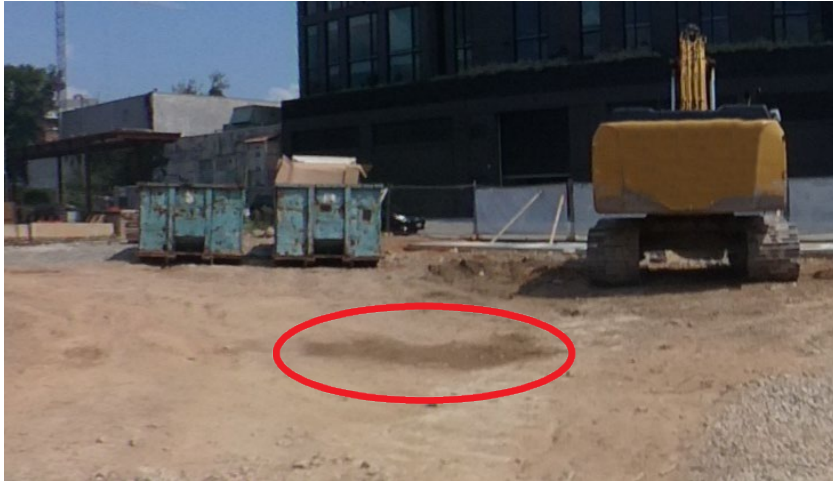
Figure 4-9. There is a grease stain on the ground in the materials storage area.

There is a large grease stain on the ground here circled in red. Document this as a finding in your inspection report and request routine maintenance. The operator must clean up spills immediately using dry clean-up methods where possible. You will also want to make sure that adequate supplies are available, such as a spill kit, to handle the clean-up.”

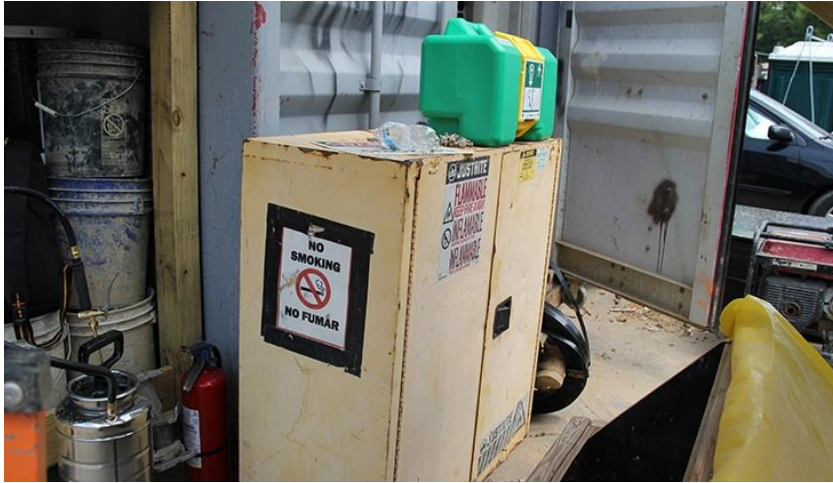
Figure 7-4. Flammables cabinet near subcontractor's trailer.

It's good to see that the operator keeps a flammables cabinet to store flammable materials. Next to the flammables cabinet, you can see a metal pump sprayer on the ground, which may be used for spraying pesticides, fertilizer, or other chemicals. This area is under the stairs of the scaffolding, which does not provide adequate cover for the sprayer since it is partially exposed to precipitation. Include this as a finding in the inspection report and note that it requires routine maintenance. Because moving the sprayer under the cover of the scaffolding is something that can be done quickly and easily, this can be treated as routine maintenance. Corrective action would only be required if cover was not readily available and a new control was necessary.

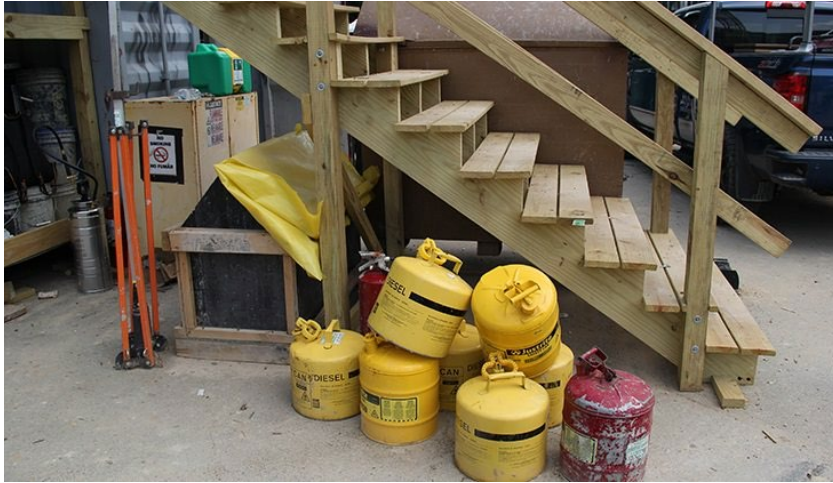
Figure 7-6. Pile of fuel containers near subcontractor's trailer.

This pile of small fuel containers on the ground is a potential pollution source. These containers are empty; however, during future inspections, if you find fuel containers such as these that hold less than 55 gallons and that are not empty, you need to tell the operator to use a spill containment pallet or similar device to capture small leaks or spills. If these containers had not been empty, this finding would have triggered a corrective action because a required control was never installed.

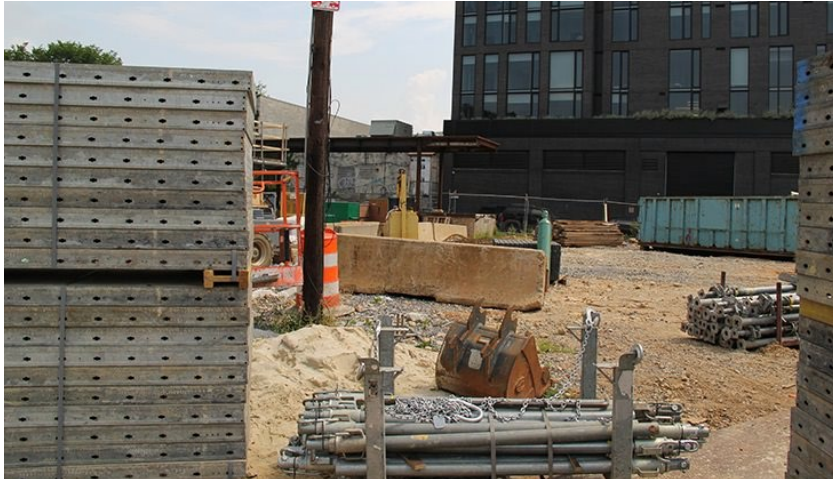
Figure 10-3. View of various building materials in the materials storage area.

The operator stores a variety of building materials here. Keep in mind that the operator must cover or contain any building materials that could release pollutants when exposed to stormwater, such as the pile of sand here. Because there is no sign of a cover or secondary containment, you need to document this as a finding in your inspection report that triggers a corrective action and present it to the operator. Corrective action is required here, as opposed to routine maintenance, because a required control was never installed. Remind the operator that they must initiate the corrective action immediately after the inspection and complete the required corrective action log documentation.

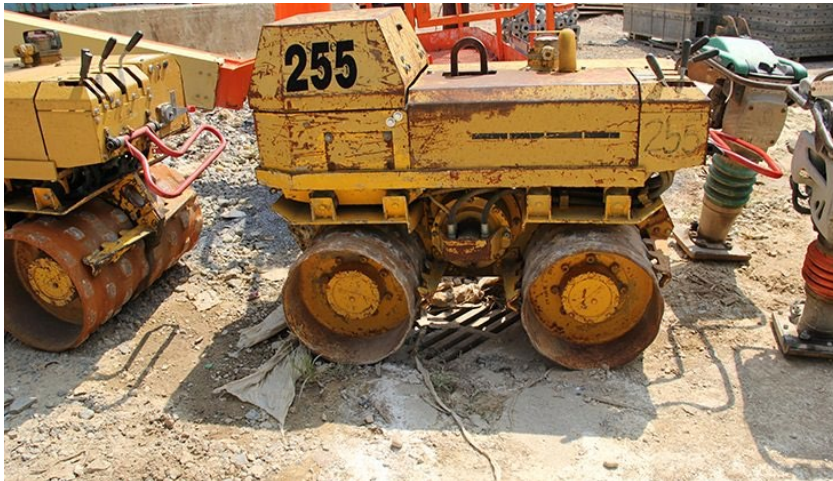
Figure 11-6. View of a compactor parked in the materials storage area.

Here is a problem—there is a compactor parked over a storm drain. It's difficult to see from here, but this storm drain does not have any protection measures. If the compactor leaked pollutants, it would discharge directly into the storm drain inlet. On the site map, this storm drain is labeled as requiring an inlet protection measure. Document this finding as triggering a corrective action because a required stormwater control was never installed and because it's possible that a prohibited discharge has occurred. Raise these concerns with the operator so they can begin implementing the corrective actions immediately after the inspection.

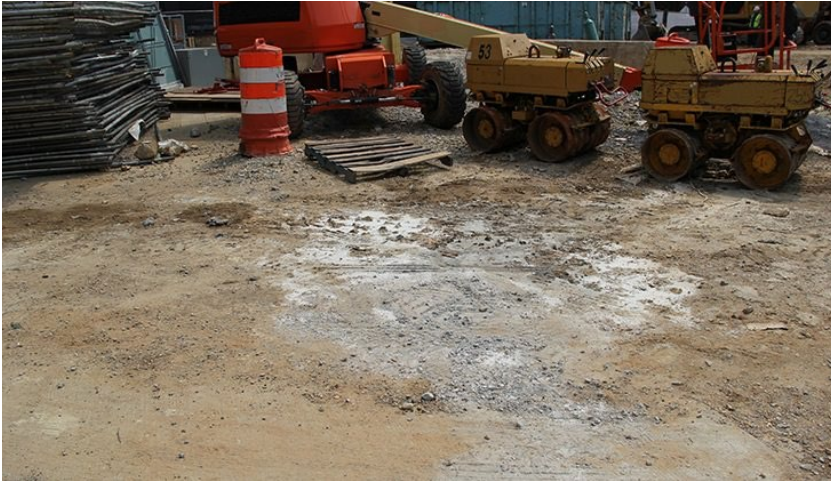
Figure 11-7. Concrete washout on the ground in the materials storage area.

Unfortunately, here is another spot of concrete washout, and this time it's immediately adjacent to the storm drain that's under the compactor. This is the gray staining we saw from a distance earlier. It appears that some of the concrete washout has gone into the storm drain. Document this as a finding in your inspection report and present this finding to the operator after the inspection. This finding triggers a corrective action because the operator does not appear to have an appropriate concrete washout container, and a prohibited discharge appears to have occurred. Corrective actions must include setting up a concrete washout station and properly disposing of any liquid or hardened washout waste. Concrete washout activities must be conducted as far away as possible from storm drain inlets. Raise these concerns with the operator so they can begin implementing the corrective actions immediately after the inspection.

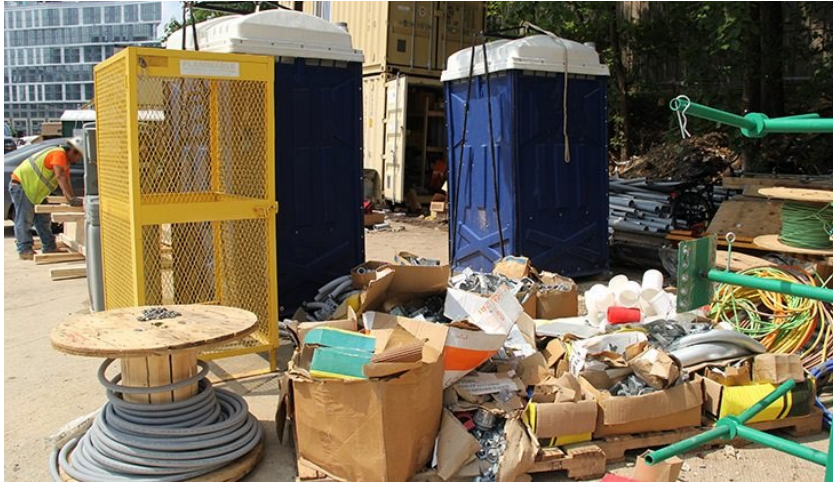
Figure 12-3. Pallet of construction materials behind the portable toilets.

Here is a view of the back of the portable toilets. The boxes stored here are on pallets, but some of the boxes are damaged and pieces are spilling onto the ground. It's difficult to see from this angle, but a closer look reveals that some of these materials are not intended for outdoor use and must be covered when the operator is not actively using them, or the operator must provide a similarly effective means to minimize exposure to precipitation. The operator does not appear to be covering these materials. Document this finding in your inspection report as triggering a corrective action. Corrective action is required here, as opposed to routine maintenance because a required control was never installed, which is a trigger for corrective action under the CGP. Present this finding to the operator after the inspection and remind them that they must initiate corrective actions immediately.

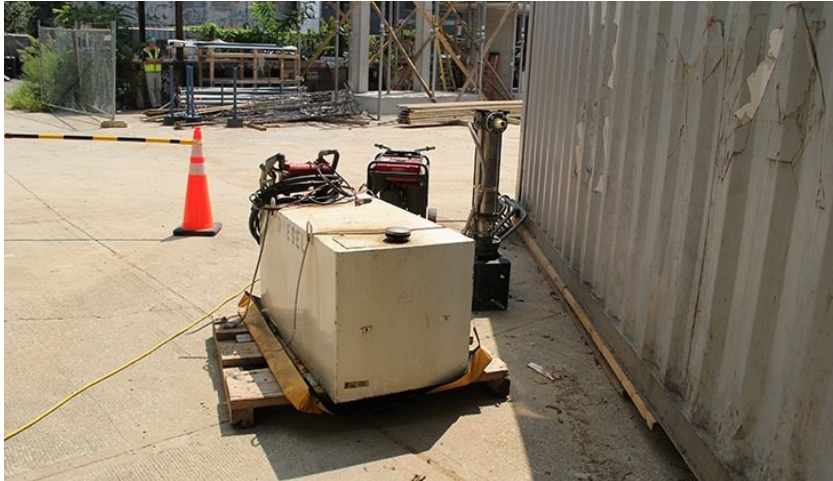
Figure 13-5. View of the back of the large fuel tank.

Remember to always walk all the way around whatever you are inspecting. Now that you're looking at the other side of the fuel tank, you can see that the tank is not placed entirely within the yellow spill containment lining. If this container was not double-walled, any leak from the back left corner would go directly onto the ground. However, this specific tank is double-walled, appears to be in good condition, and the ground appears clean.

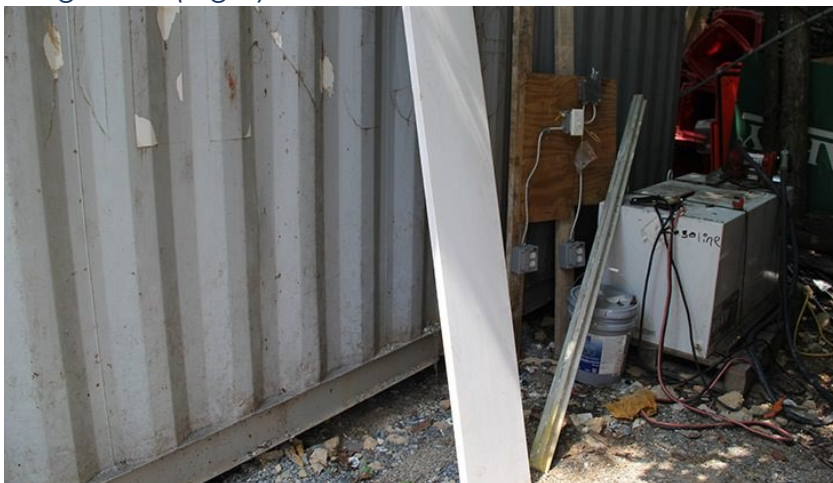
Figure 13-6. Second large fuel tank in a corner by the trailer.

During inspections, it's a good idea to go the extra step and investigate all the nooks and crannies. This area would have been easy to miss, but it's a good thing you checked it out, because there is another fuel tank in the corner that is not identified in the SWPPP or on the SWPPP site map. Ask the operator if the tank is being used. If so, document the lack of controls and the omission of the fuel tank from the SWPPP as findings in your inspection report. The failure to implement required controls would trigger a corrective action. Raise this concern with the operator so they can begin implementing the corrective action immediately after the inspection. The SWPPP would also need to be updated, including the site map, within seven

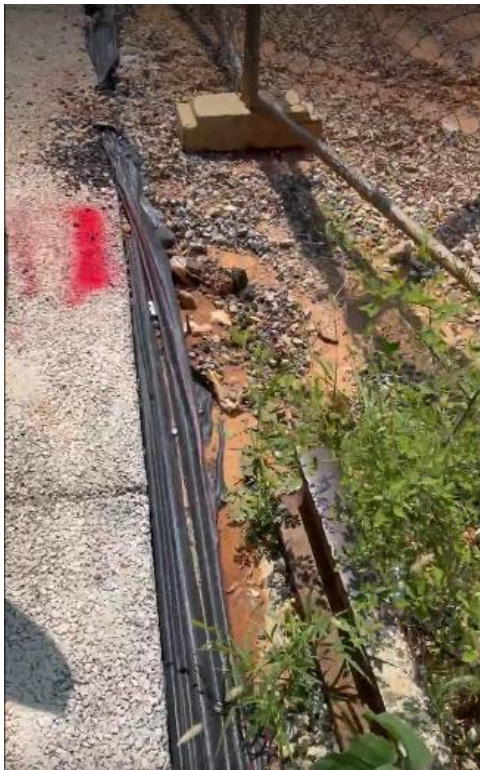
Figure 16-4. Screenshot of video showing collapsed silt fence along Second Street.

After you walk past the freshly disturbed patch of ground from the previous area, there is a section of collapsed silt fence. It does not look like the silt fence can be easily repaired. Because the silt fence needs to be replaced in its entirety, this condition triggers a corrective action. Document this finding in your inspection report and communicate the finding to the operator so they can complete the required corrective action to replace the silt fence.

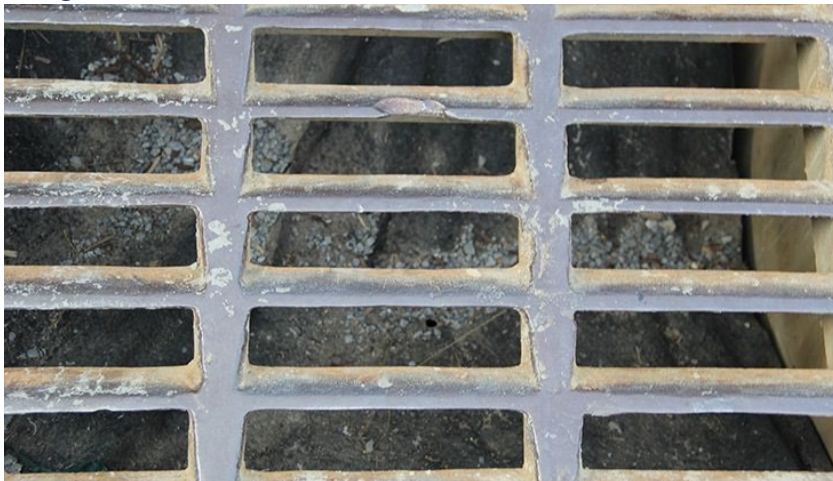
Figure 17-4. Close-up view of storm drain at the intersection of Second Street and Main Street.

Here is a stormwater inlet you did not visit previously. This inlet has filter fabric inside the storm drain inlet that collects sediment from discharged stormwater. There is a gap in the filter fabric coverage on the right side of the inlet that requires routine maintenance, such as repairing or repositioning the filter fabric. Document this finding in your inspection report as a condition that requires routine maintenance. This finding is considered routine maintenance because the control needs minor repair or upkeep. Keep in mind that although there is not a large amount of sediment immediately visible around the stormwater inlet, conditions may still occur where the protection measure is necessary, such as track-out from the active construction area. You need to notify the operator about this finding so they can immediately initiate routine maintenance to repair the control. If the operator chooses to replace the control in its entirety instead of repairing it, the fix would then become a corrective action

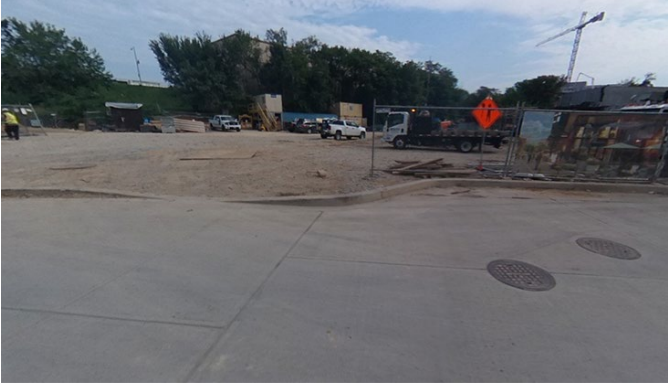
1. Sediment accumulated outside of the construction entrance.

Suggested Fix: Remove the accumulated sediment from the roadway.

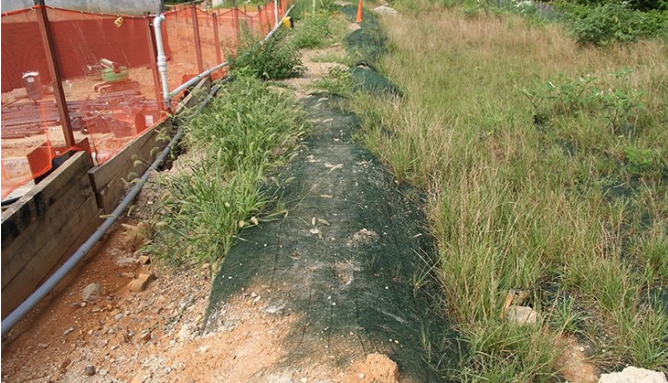
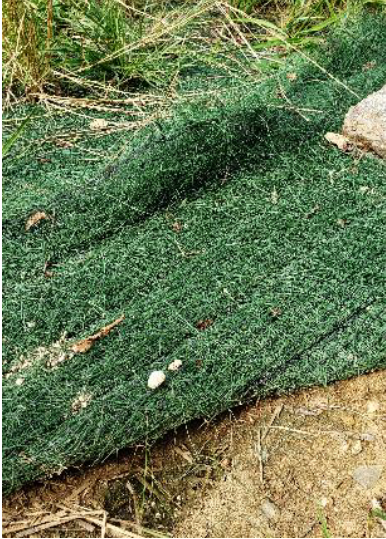
2. Damaged erosion control matting on the diversion berm.

Suggested Fix: Replace or repair areas of erosion control matting that are damaged or displaced.

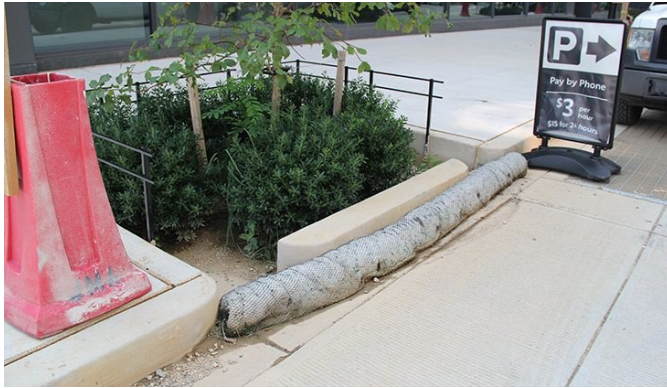
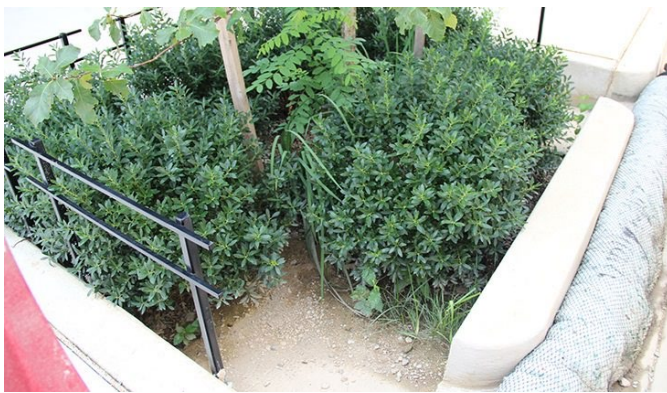
3. Filter sock not fully covering curb cut inlet on First Street, and accumulated sediment in and adjacent to the inlet.

Suggested Fix: Adjust the placement of the filter sock or add another filter sock to cover both openings of the bioretention cell inlets, and remove the accumulated sediment from on top of the bioretention media and adjacent to the inlet protection.

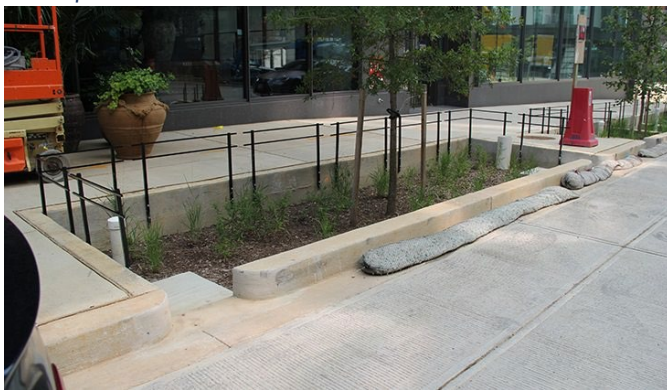
4. Displaced filter sock on First Street.

Suggested Fix: Move the filter sock to cover the curb inlet.

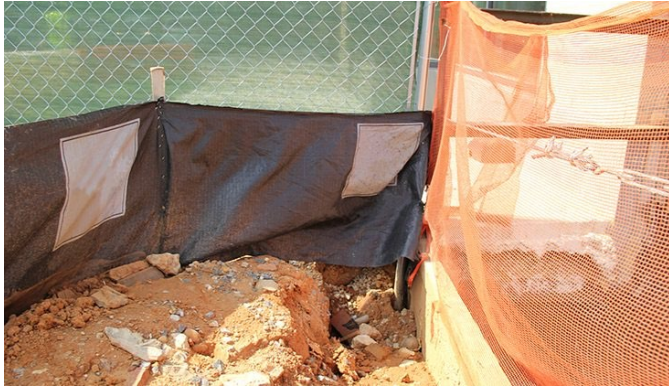
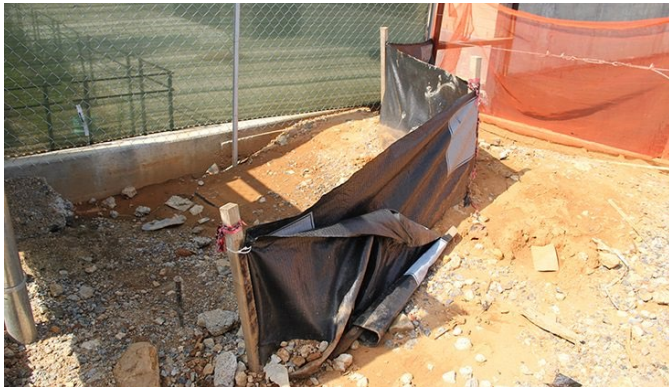
5. Undercut or improperly installed silt fence by garage entrance.

16. Silt fence on First Street, near garage entrance	<input checked="" type="checkbox"/> Yes <input type="checkbox"/> No	Twice	<input type="checkbox"/> Yes <input checked="" type="checkbox"/> No	May 26, 2022	Undercut or improperly installed silt fence by garage entrance. Repair the silt fence by re-trenching the fabric. If the operator decides to replace this with a different control, change this finding to corrective action.

Suggested Fix: Repair the silt fence. If the operator chooses to replace the silt fence in its entirety instead of repairing it, the fix will become a corrective action and require updates to the corrective action log.

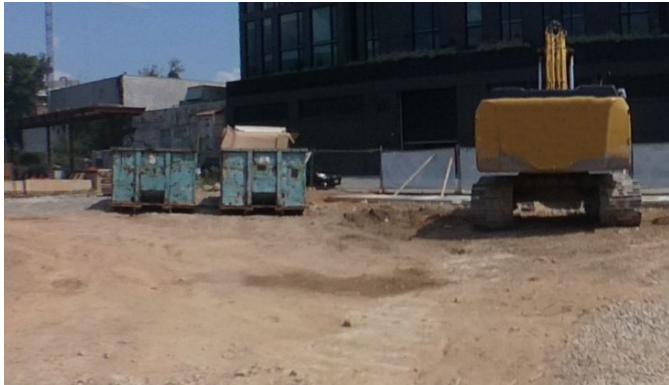
6. A large grease stain in materials storage area.

Suggested Fix: Remove the large grease stain by the dumpsters using a dry clean-up method.

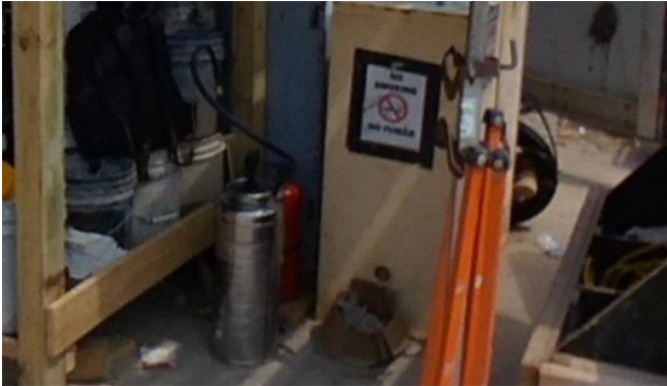
7. An uncovered metal pump sprayer by the subcontractor trailer.

Suggested Fix: Provide a cover or similar means of containment for the metal pump sprayer.

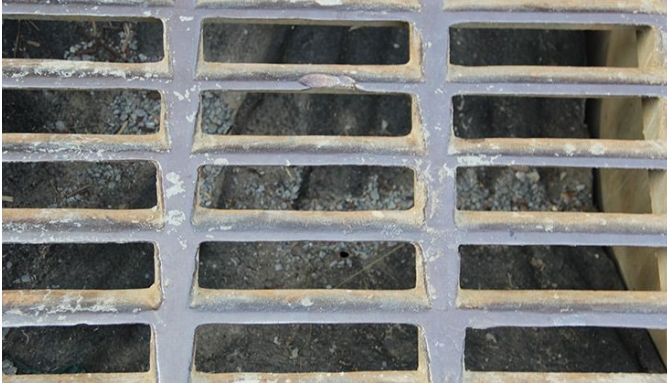
8. A gap in the filter fabric of storm drain inlet protection on Second Street.

Suggested Fix: Repair the filter fabric in the storm drain inlet. If the operator chooses to replace the filter fabric in its entirety instead of repairing it, the fix will become a corrective action and require updates to the corrective action log.

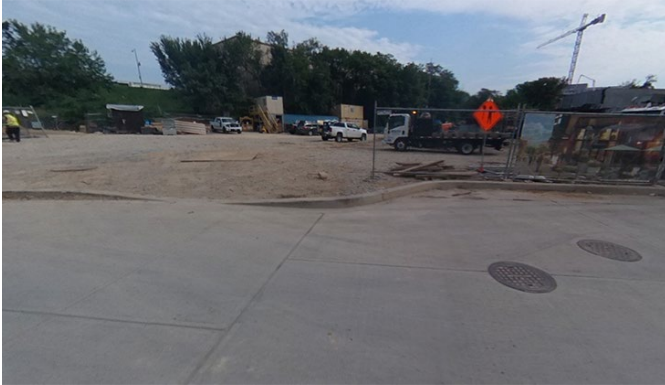
1. Missing perimeter control by the construction entrance.

Suggested Fix: Install perimeter controls at this location.

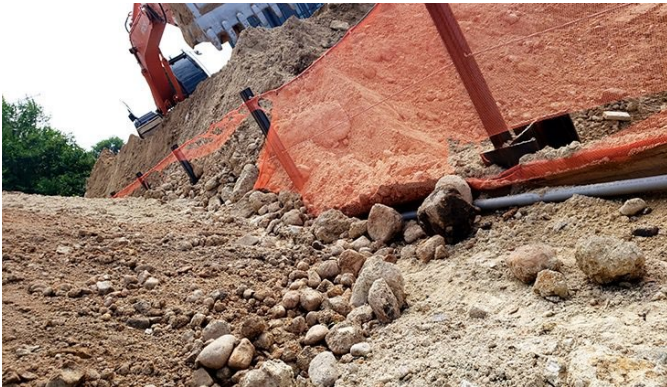
4. No sediment barrier downgradient of the stockpile.

Suggested Fix: Install a sediment barrier downgradient of the stockpile.

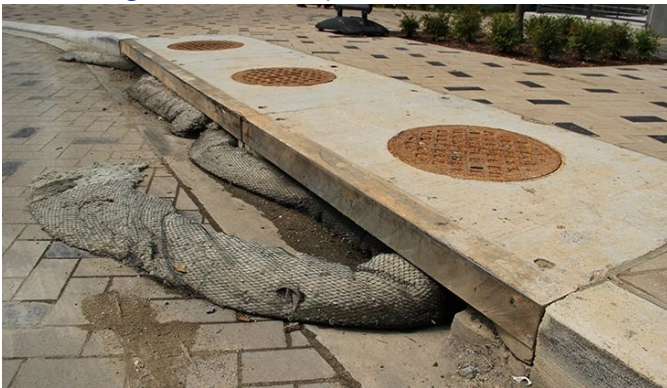
5. Damaged and collapsed filter socks at the end of First Street.

14. Filter socks at the end of First Street	<input type="checkbox"/> Yes <input checked="" type="checkbox"/> No	Once	<input checked="" type="checkbox"/> Yes <input type="checkbox"/> No	July 7, 2022	The filter socks at the end of First Street are crushed and sunk into the curb inlet. Entirely replace these filter socks.

Suggested Fix: Replace the filter socks and sweep up the sediment adjacent to the inlets.

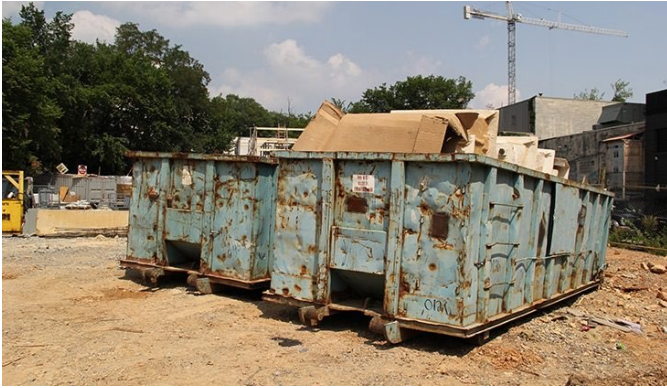
6. *Uncovered dumpsters in the materials storage area.*

Suggested Fix: Cover the dumpsters at the end of the business day and during storm events.

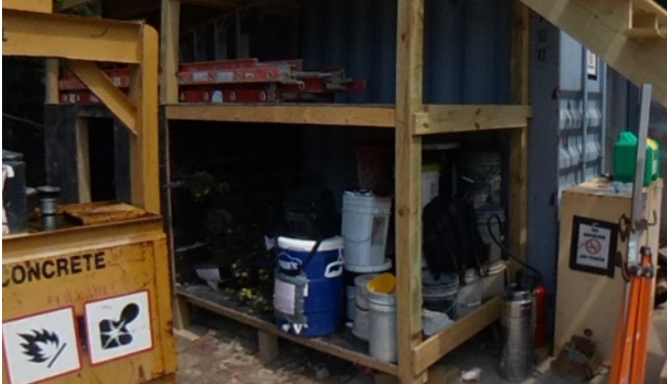
We have not observed a spill kit on-site. The operator must keep a spill kit accessible because it is required by the CGP where fuel tanks are stored on-site, regardless of container size. Record this as a finding that triggers corrective action because a required control is not present at the site.

7. *No spill kit kept on-site.*

Suggested Fix: Place spill kits in key locations around the site to ensure personnel are able to respond quickly in the event of a leak or spill.

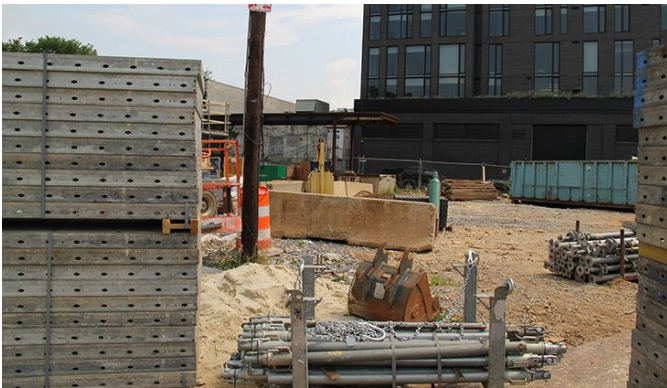
8. *Two occurrences of uncovered materials.*

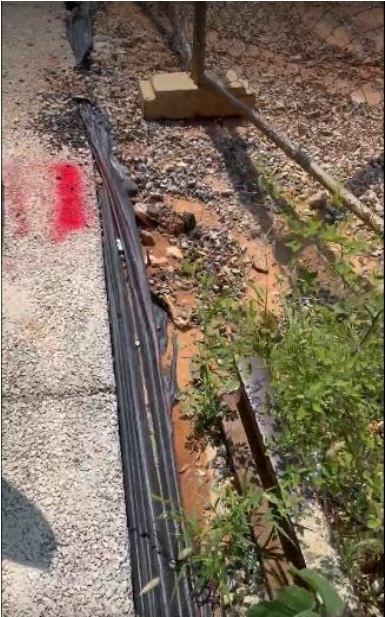
11. A collapsed silt fence along Second Street.

Suggested Fix: Replace the collapsed silt fence at this location.

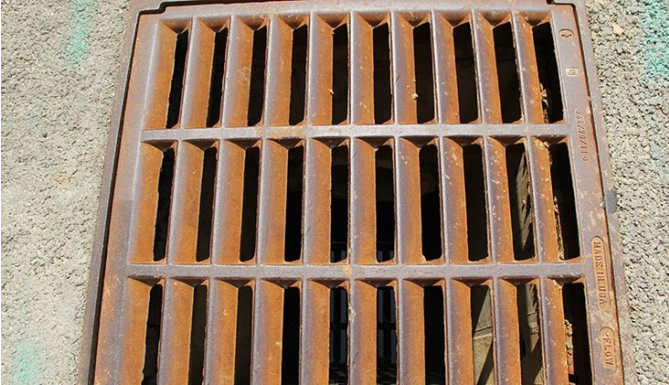
12. An unprotected storm drain inlet on Second Street.

Suggested Fix: Install stormwater inlet protection measures according to the SWPPP and ESC plans.

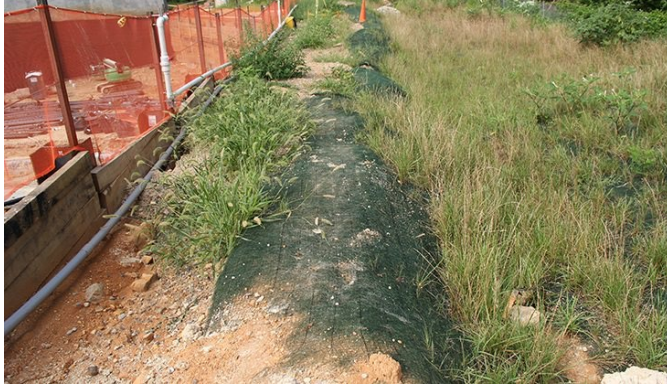
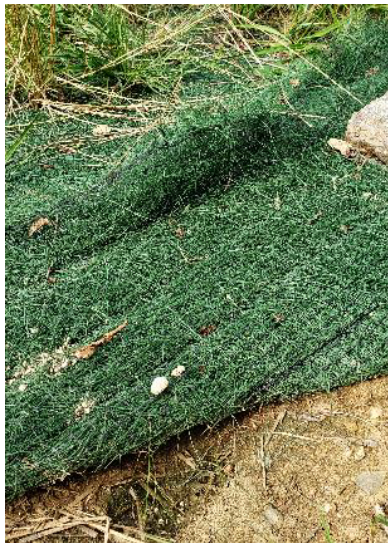
For our virtual inspection of Site 1, let's assume we've reviewed past inspection reports and determined that the second issue in this list, the damaged erosion control matting on the diversion berm, has been observed in the same location two times in the past. Because of these past occurrences, we should elevate our finding from routine maintenance to corrective action. Let's make sure to add this finding to our list of corrective actions.

13. Damaged erosion control matting on a diversion berm. (Observed for the third time)

6. Damaged erosion control matting on berm	<input checked="" type="checkbox"/> Yes <input type="checkbox"/> No	Three times	<input checked="" type="checkbox"/> Yes <input type="checkbox"/> No	May 12, 2022	In general, the erosion control matting on the berm is in good condition, but there are a few sections of matting that are damaged or displaced. This is the third time this condition has been identified on the berm, so the repair of the damaged/displaced sections of matting has been elevated to a corrective action.

Suggested Fix: This is the third time this observation has been made during inspections. Replace or repair areas of erosion control matting that are damaged or displaced on the diversion berm. Consider supplementing it with additional controls to prevent future damage.
