U.S. EPA Construction Inspection Training Course

Module 5: 2022 Construction General Permit (CGP)

Site Inspections

Site 2

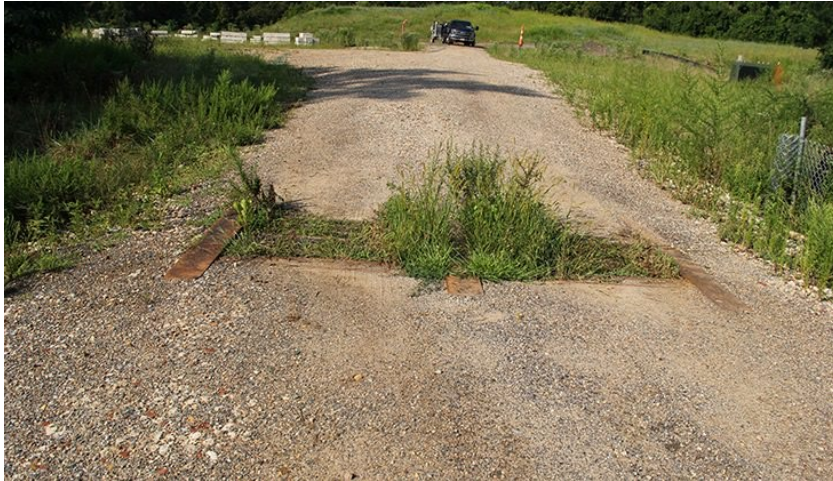
Figure 4-4. View of wash rack in the stabilized construction entrance.

Here is a wash rack at the site's stabilized construction entrance. You must check that the controls are properly installed according to the construction plans and functioning as intended. The stone aggregate used at this construction entrance appears to be smaller than the intended design. In addition, the wash rack is overgrown with vegetation and does not extend as long as designed. The wash rack likely cannot be used as intended to capture sediment washed off from vehicle tires.

Document these issues in your inspection report. That being said, because the site is inactive and mostly stabilized, this entrance is probably not frequently used and there isn't much sediment track-out to be contained. In this kind of situation, it's important to talk to the operator as soon as possible about what controls are necessary based on current activities and then decide whether maintenance or a repair is needed. Remember, if the operator decides to change or remove a control, they must update the project SWPPP and site map accordingly.

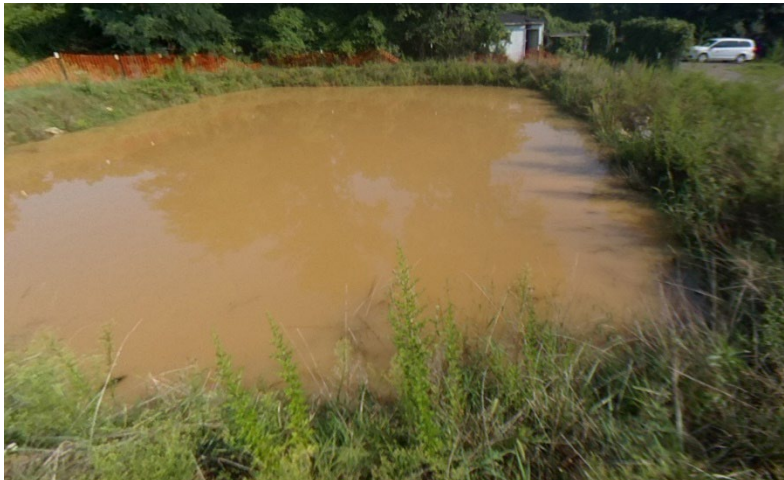
Figure 5-4. View of sediment trap full of turbid water.

When inspecting a sediment trap, you need to check that the operator is removing accumulated sediment from the basin to maintain at least half of the trap's design capacity. This sediment trap is full of turbid water; however, a large storm event passed through this area last night, so this is not surprising and shows that the trap is working as designed by capturing and slowly filtering the sediment laden stormwater.

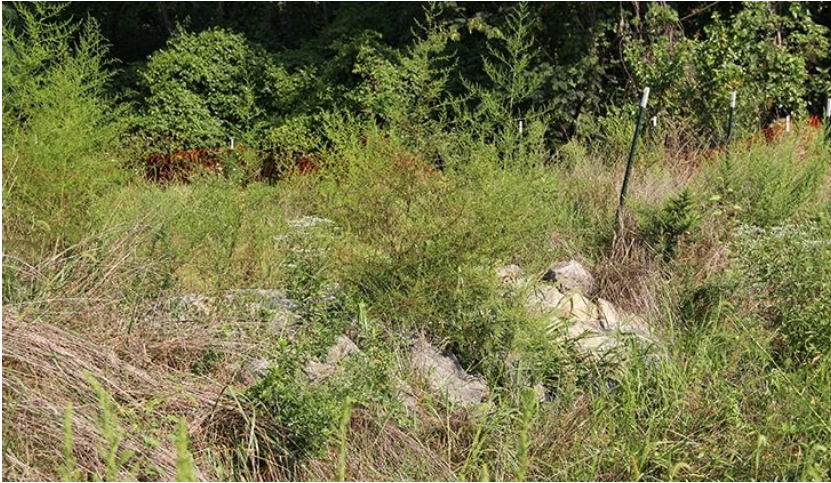
Figure 5-5. View of stone outlet on southern embankment of sediment trap.

It's difficult to see, but the outlet of the sediment trap is on this southern embankment. The outlet is an overflow weir made of riprap that leads to a grassy swale downgradient of the trap. This outlet is obscured by heavy vegetation that may obstruct the flow of stormwater. Removing the overgrown vegetation is considered upkeep that ensures the stormwater control remains in effective operating condition, therefore this work should be handled as routine maintenance as opposed to a corrective action. Document this issue in your inspection report as needing routine maintenance, and present this finding to the operator after the inspection so the operator can begin maintenance immediately. You should walk around to the downgradient side of the outlet to see if you can get a better view of the structure.

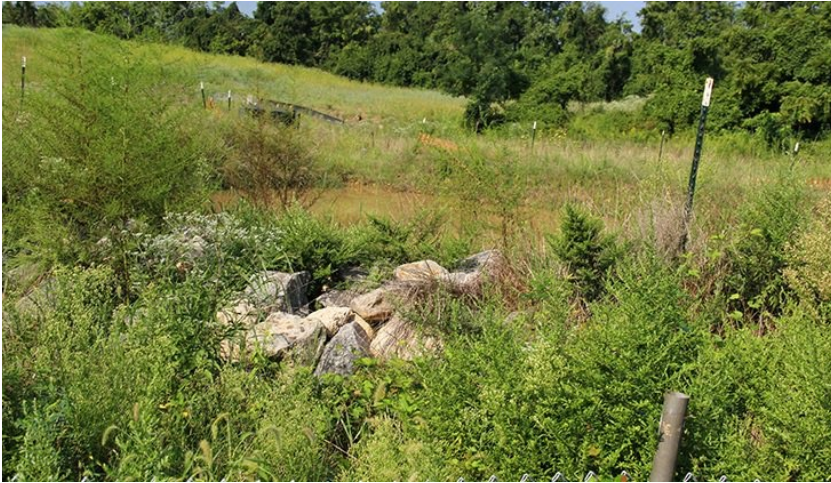
Figure 6-4. View from the downgradient side of the sediment trap's outlet.

We are standing next to the southern embankment of the sediment trap, on the downstream side of the outlet. This provides a slightly better view of the overflow weir, but the structure is still mostly obscured by vegetation. Because of the vegetation, it's difficult to check for evidence of sediment leaving the sediment trap. Let's walk to the downgradient end of the swale and see if there is any sediment leaving the trap.

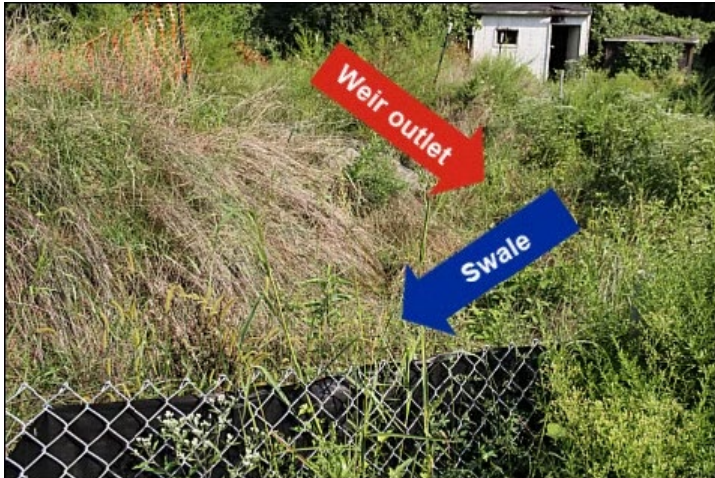
Figure 7-4. View of the sediment trap's outlet and downstream swale.

This image was taken at the downgradient end of the swale, looking upgradient toward the sediment trap's outlet. Because there is so much vegetation growing here, the image is annotated to make clear the locations of the weir outlet and the swale. The segment of super silt fence at the end of the swale filters any sediment leaving the trap.

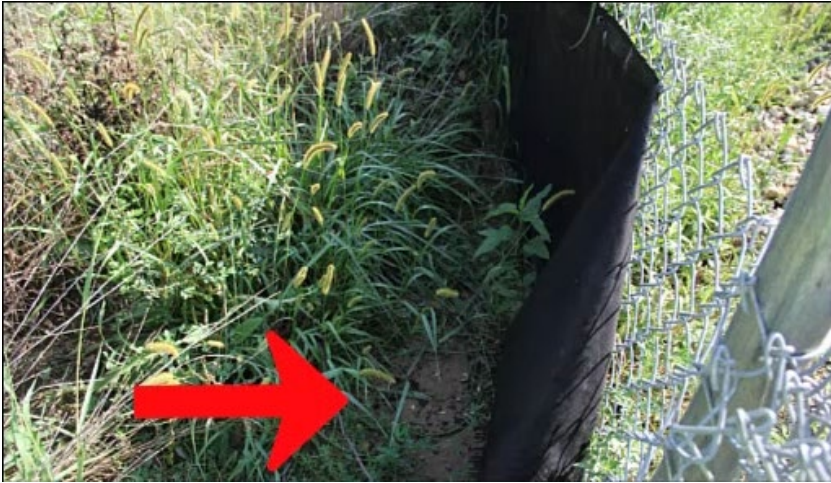
Figure 7-5. View of super silt fence downgradient of the sediment trap outlet.

This is a close-up view of the segment of super silt fence that is downgradient of the sediment trap outlet. This is where any sediment leaving the trap accumulates. The amount of sediment currently accumulated against the fence is minimal and not a concern. However, you can see that a corner of the silt fence fabric has detached and folded over. This can be resolved with routine maintenance because it is a minor repair that ensures the stormwater control remains in effective operating condition. Document this issue in your inspection report and communicate this problem to the operator immediately after the inspection."

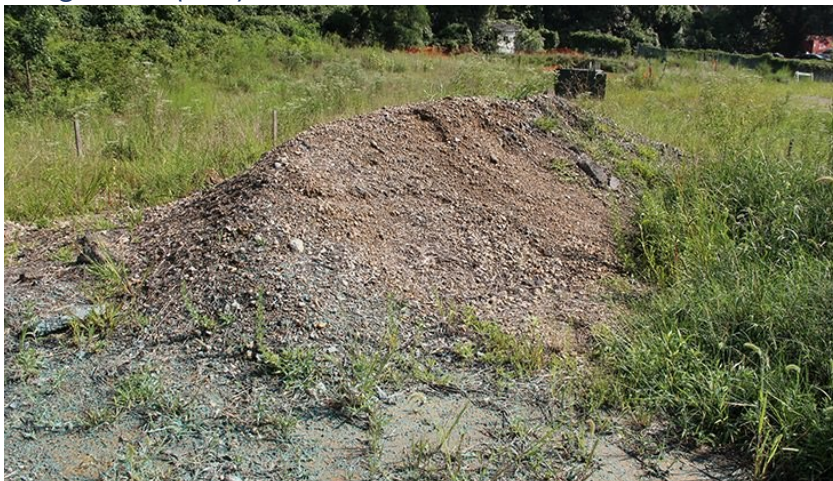
Figure 8-4. Small soil and gravel stockpile near the base of the large soil stockpile.

Here is a small stockpile of soil and gravel that is separate from the big stockpile. It appears to have been here for a little while because there are signs of light rill erosion and vegetation growing on one side. Stockpiles that will be unused for 14 or more days must be covered or otherwise temporarily stabilized. During your site inspections, if you don't know whether a stockpile is actively being used, you need to talk to the operator, check past inspection reports,

and check the SWPPP. Add this finding in your inspection report as a condition triggering corrective action because a required control has not been implemented. Present this finding to the operator and remind them that they must initiate corrective action immediately after the inspection.

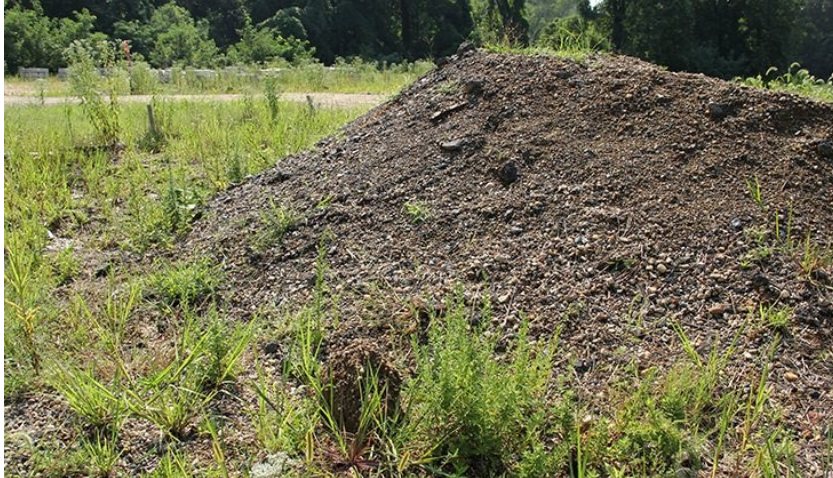
Figure 8-5. View of the back of the small soil and gravel stockpile.

You need to walk all the way around a stockpile to assess the condition of all sides. This side of the little stockpile, facing away from the construction entrance, is in the same condition as the other side. There are no other findings about this stockpile to add to your inspection report.

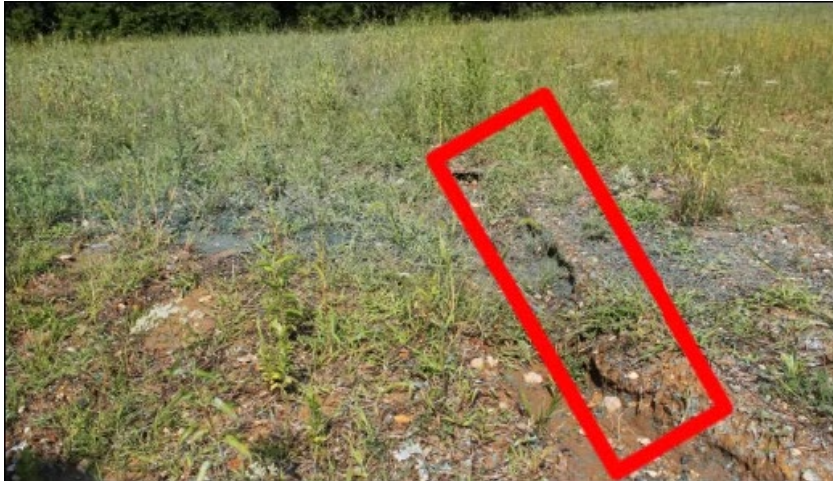
Figure 9-4. Rill erosion on the large soil stockpile.

You can see rill erosion down the entire length of the slope, leading toward the silt fence. The red box in the image highlights the location of the rill erosion. If not addressed, this area will continue to erode, and the rill may widen into a gully. Note this as a finding requiring routine maintenance in your inspection report. The operator must begin the routine maintenance immediately after the inspection. If the operator decides to add supplemental controls such as matting or a check dam to help with the rill erosion, then a corrective action would be triggered because a new control would be installed, and the operator would need to document the repair in a corrective action log. Because the erosion could lead to an accumulation of sediment on-site, you must reinspect this area during each site inspection. You must check the condition of the stabilization and make sure the area doesn't continue to erode.

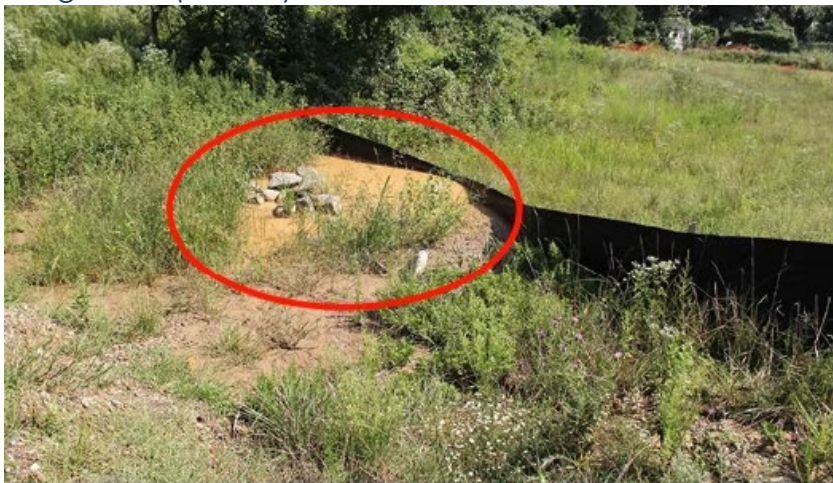
Figure 9-5. View of water ponded against the silt fence at the base of the large stockpile.

There is water ponded against the silt fence, likely from the large storm that passed through the area yesterday. The silt fence is doing its job by holding the sediment back and allowing water to filter through. However, it seems like there may be quite a bit of sediment built up against the silt fence. You need to check the control after the water has drained to assess if the sediment is

In addition, you should include a finding in your inspection report about the ponded turbid water against the silt fence downgradient of the large stockpile. Although this finding does not trigger routine maintenance or corrective action, it is a good practice to include it in your inspection report to document that you have assessed all stormwater controls on-site. You should plan to inspect this control again, after the water has drained, to assess the condition of the silt fence.

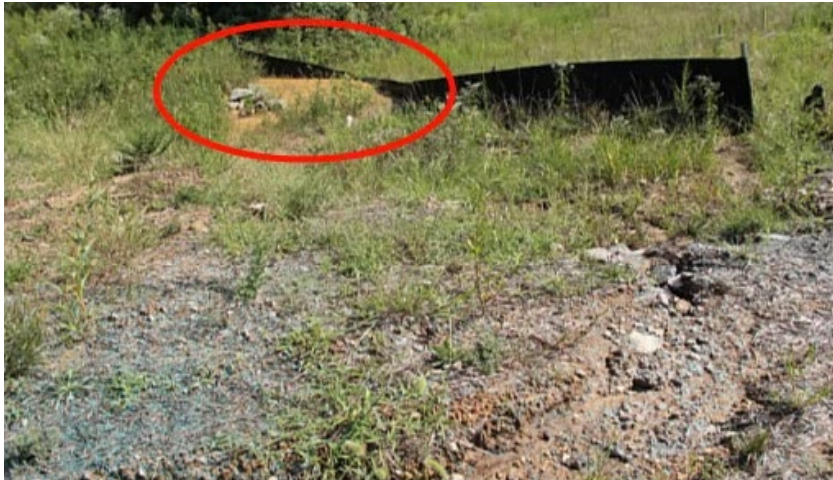
Figure 9-6. View of eroded stockpile slope upgradient of silt fence.

The area upgradient of this section of silt fence is unstabilized and eroded. The unstabilized area is likely contributing to the turbidity of the water ponded against the silt fence, which is circled in red. Note the unstabilized area as a finding that triggers routine maintenance in your inspection report and present the problem to the operator. The operator could fill in and restabilize the eroded area with hydroseed or use an alternative stabilization technique to prevent further erosion. You can write all of the erosion findings related to the stockpile as one finding in the inspection report.

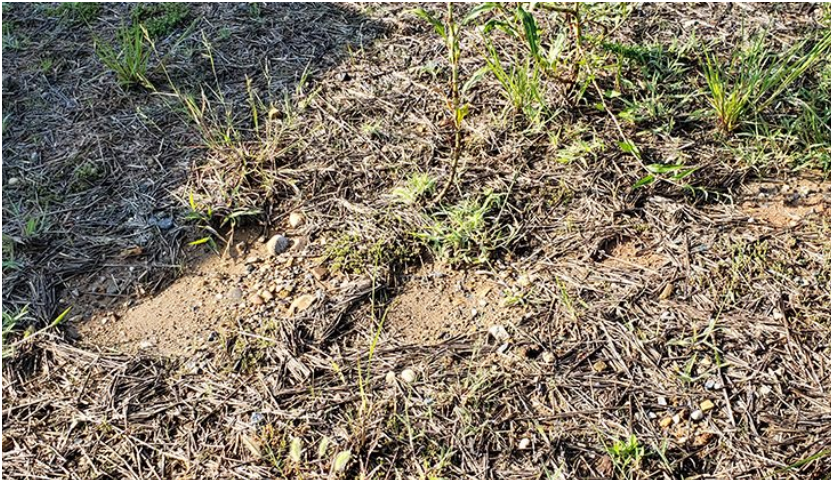
Figure 10-4. Close-up view of bare area on the large stockpile.

There are parts of the stockpile that are bare. It appears that the contractor missed some spots during hydroseeding. Mark this as a finding that requires routine maintenance in your inspection report and present the finding to the operator after the inspection. The operator must immediately begin maintenance as required by the CGP. Again, routine maintenance is appropriate here because the work does not amount to a significant repair of a control, nor does it require the replacement of the entire stabilization measure. This finding can be added to the previous finding about applying hydroseed more consistently across the large stockpile.

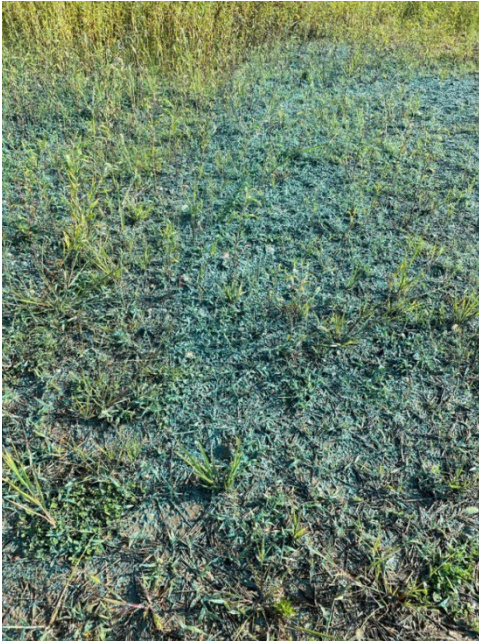
Figure 10-5. Close-up view of hydroseeding on the large stockpile.

This area is very well covered with hydroseed and there are no findings to report.

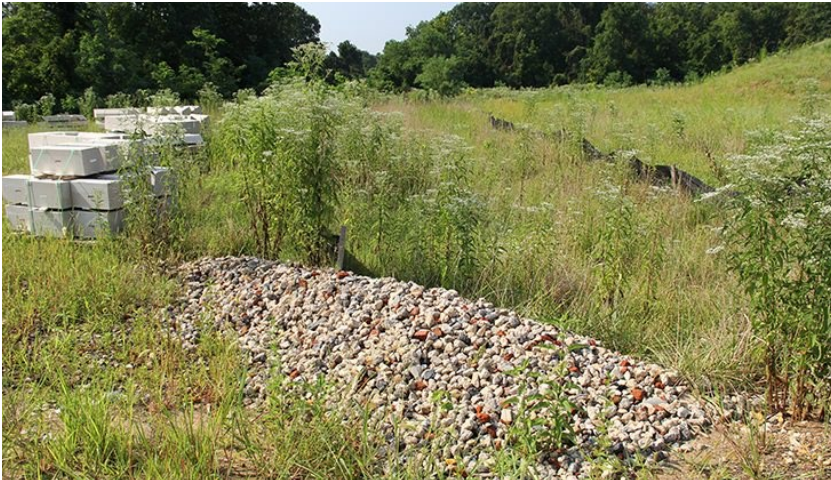
Figure 12-4. Check dam at the upgradient end of the grass swale.

There is a gravel check dam here, at the upgradient end of a grass swale. This check dam control was not included on the site map, but the operator may have decided that it was necessary to install to prevent sediment from moving into the swale. Add this finding to your inspection report and tell the operator to add a description of this control to their SWPPP and include its location on the site map. Similar to how you inspected check dams at the first site, you must ensure that the check dam spans the entire width of the area it is controlling, is well maintained, and is not filled with sediment. This one is in good condition.

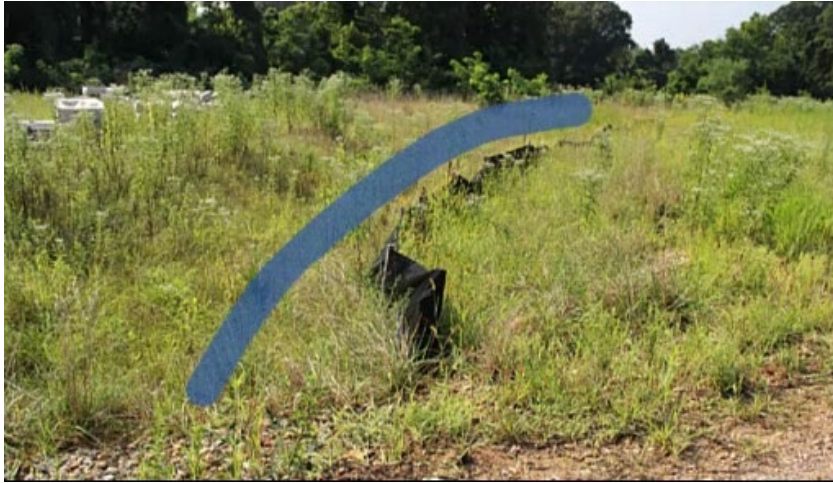
Figure 12-5. Silt fence along the upgradient side of the grass swale.

There is a length of silt fence installed along the upgradient side of a swale. The approximate path of the swale is shown in blue. The silt fence controls stormwater flowing downhill from the stockpile before it enters the swale. You will continue to inspect this silt fence by walking along its length as you move toward the second sediment trap.

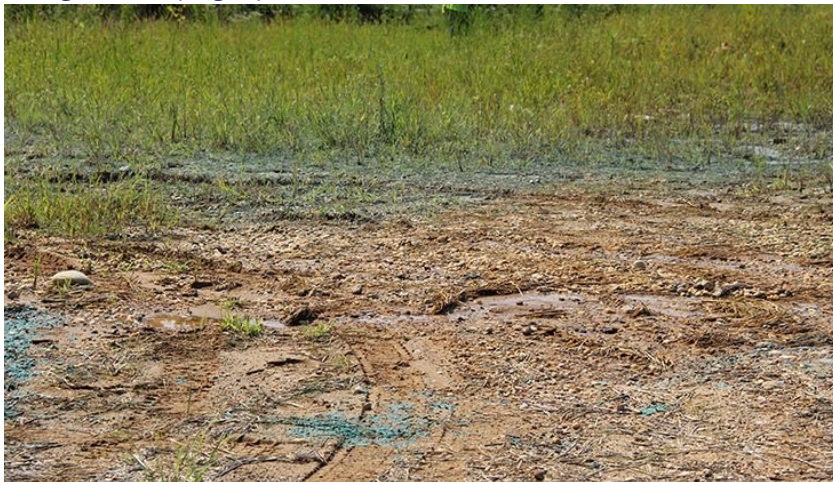
Figure 12-6. View of bare area adjacent to the construction entrance.

Here is another area that is unstabilized because the hydroseed has been applied inconsistently. This finding can be added to the other routine maintenance finding about bare spots on the stockpile. The operator must restabilize the bare area by reapplying hydroseed or another stabilization measure. Similar to the other findings about bare spots, routine maintenance is appropriate here because the work does not amount to a significant repair of a control, nor does it require the replacement of the entire stabilization measure. Remember to communicate this finding to the operator so that work can begin immediately to address this condition. If the

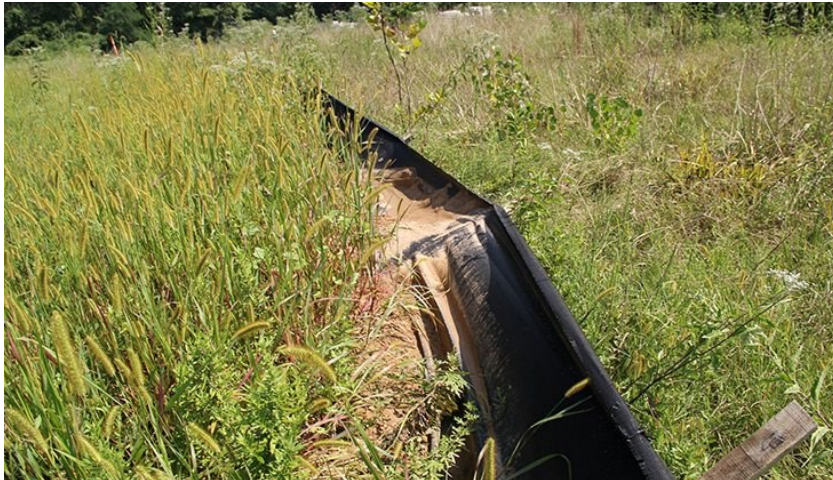
Figure 13-4. View of collapsed silt fence along the grass swale.

Uh-oh. This section of the silt fence has collapsed. It appears to have collapsed due to sediment accumulation and possibly the force of stormwater flow from the stockpile. This is the only downgradient sediment barrier for the stockpile. At a minimum, the operator must remove the accumulated sediment and repair the damaged silt fence at this location. In addition, the operator should consider installing additional controls to manage the expected volume and velocity of stormwater flow. Present this finding to the operator as a corrective action because this is a significant repair and new or replacement controls may be needed. In addition, remind the operator that repairs must be initiated immediately.

9. Silt fence by sediment trap #2	<input type="checkbox"/> Yes <input checked="" type="checkbox"/> No	1	<input checked="" type="checkbox"/> Yes <input type="checkbox"/> No	9. The section of silt fence down gradient of the stockpile has collapsed. Evaluate the cause of the problem, remove the accumulated sediment, and reinstall the silt fence within seven calendar days. Consider installing additional stormwater controls to prevent a recurring finding.

The section of silt fence down gradient of the stockpile has collapsed. The accumulated sediment needs to be removed, and the collapsed silt fence needs to be reinstalled or replaced. Possible causes for the collapse include sediment accumulation and possibly the force of stormwater flow from the stockpile.

Next, the section of silt fence that has collapsed by the second sediment trap triggers a corrective action because it requires a significant repair. The operator should remove the accumulated sediment and repair the damaged section of silt fence. In addition, the operator should consider if additional construction stormwater controls are needed in this area to prevent the silt fence from collapsing again. Routine maintenance is also needed to reattach the filter fabric on a section of the silt fence by the second sediment trap.

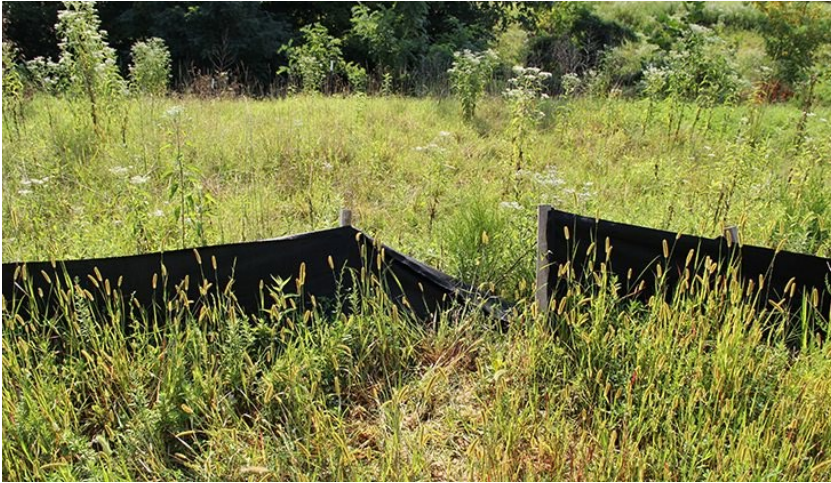
Figure 13-5. View of detached filter fabric on the silt fence along the grass swale.

The filter fabric on this section of silt fence has detached. Note this as a finding that triggers routine maintenance in your inspection report and tell the operator to repair the silt fence. Routine maintenance is sufficient because the work to repair the silt fence is a minor repair to ensure a stormwater control remains in effective operating condition. In addition, remind the operator that repairs must be initiated immediately.

10. Silt fence by sediment trap #2	<input checked="" type="checkbox"/> Yes <input type="checkbox"/> No	1	<input type="checkbox"/> Yes <input checked="" type="checkbox"/> No	10. Near the second sediment trap, the silt fence's filter fabric has detached. Repair the silt fence by the close of the next business day. If infeasible, document why, and complete by no later than 7 days following this inspection.

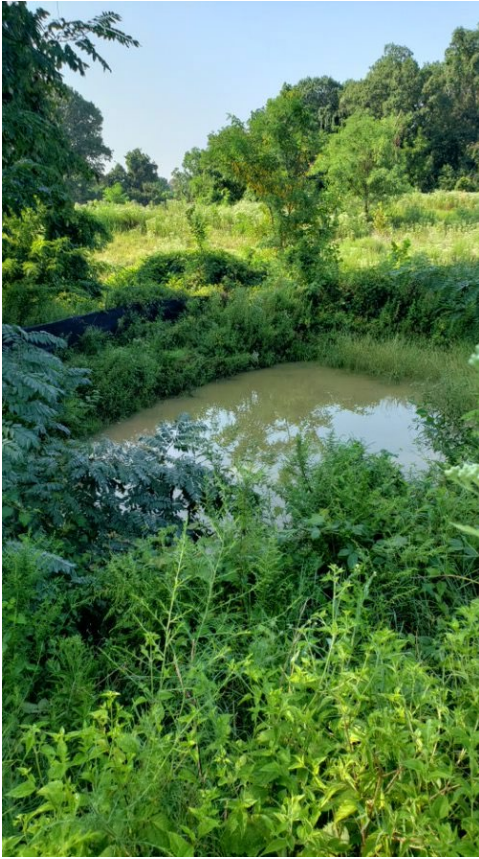
Figure 14-4. View of the second sediment trap at the western perimeter of the site.

The overgrown vegetation makes it difficult to assess the condition of the sediment trap's embankments and outlet. Remember to inspect the entire perimeter of the sediment trap as long as site conditions are safe. This sediment trap is supposed to have a riprap outlet similar to the first sediment trap you inspected. You can see some silt fence from this view, but not the riprap outlet, at least not from this vantage point. You may need to walk around to the downstream side of the sediment trap to assess the condition of the outlet. Although the embankment of the sediment trap appears to be well stabilized, note in your inspection report that the operator needs to trim the vegetation to ensure the sediment trap is in effective operating condition. Document this finding as requiring routine maintenance and discuss it with the operator.

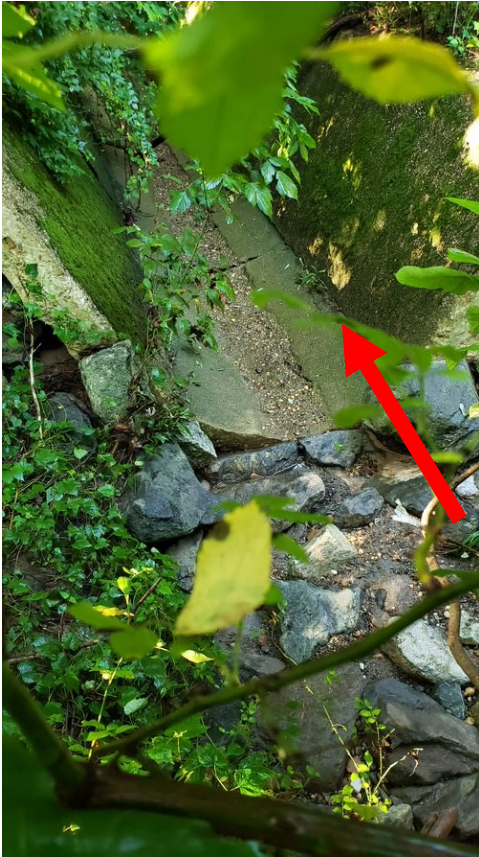
Figure 14-5. View of the downstream side of the sediment trap's outlet, and the concrete channel downgradient of the outlet.

When you inspect a site's discharge point, you must check for signs of erosion and sediment deposition. This image shows the downstream side of the sediment trap's riprap outlet, where stormwater flows into a concrete channel. Accumulated sediment is visible in the concrete channel and needs to be removed so it does not discharge into any downstream waterbodies or storm systems. Document this finding in your inspection report as triggering routine maintenance. This, along with the other issues you've noted during your inspection, shows that despite the site being inactive and mostly stabilized, there is still sediment moving off-site. You shouldn't see this much sediment at this discharge point on your future inspections if the operator completes the various routine maintenance and corrective action items identified across the site during this inspection. If the necessary routine maintenance and corrective actions are complete elsewhere on the site but you continue to observe sediment at this location during future inspections, the operator may need to consider improving the riprap outlet for this sediment trap. Improvements to the outlet could include adding smaller stone or filter fabric to the riprap to help filter out sediment. Improvements could also include ensuring the riprap is not clogged with sediment, which could cause sediment-laden water to overtop the outlet instead of filtering through it.

11. Discharge point from sediment trap #2	<input checked="" type="checkbox"/> Yes <input type="checkbox"/> No	1	<input type="checkbox"/> Yes <input checked="" type="checkbox"/> No	11. Sediment was observed at the discharge point. Remove the sediment from the discharge point by the close of the next business day. If infeasible, document why, and complete by no later than 7 days following this inspection. Continue to monitor after routine maintenance is completed to confirm that sediment is not discharged off-site.

Finally, although you did not observe a discharge occurring during your inspection, the sediment accumulation that you observed at the site's discharge point indicates that a previous discharge may have occurred. You need to ask the operator to remove the accumulated sediment from the discharge point by the close of the next business day.
