NOVEMBER 30, 2023

MUNICIPALITY OF TOA ALTA OCTOBER 2023 MONTHLY REPORT  
Civ. No. 3:21-01087-DRD

NIVIA I. AYALA, PE  
TERRATEK ENGINEERING GROUP, PSC  
P.O. Box 367445 San Juan, PR 00936

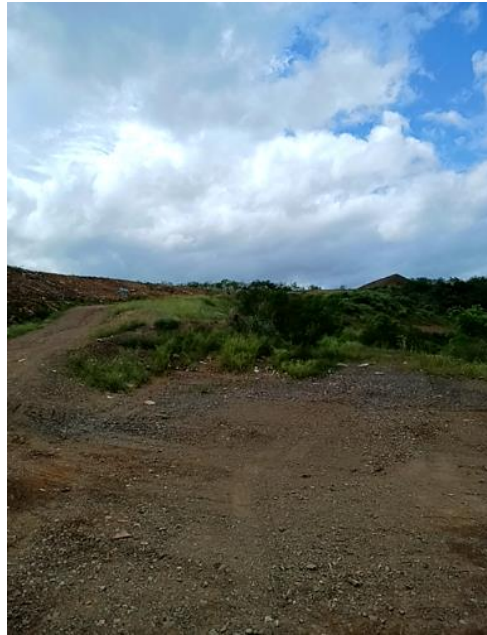
**Daily Cover:**

Daily Cover at the facility was completed on April 30, 2022. Daily Cover covered all areas of exposed waste.

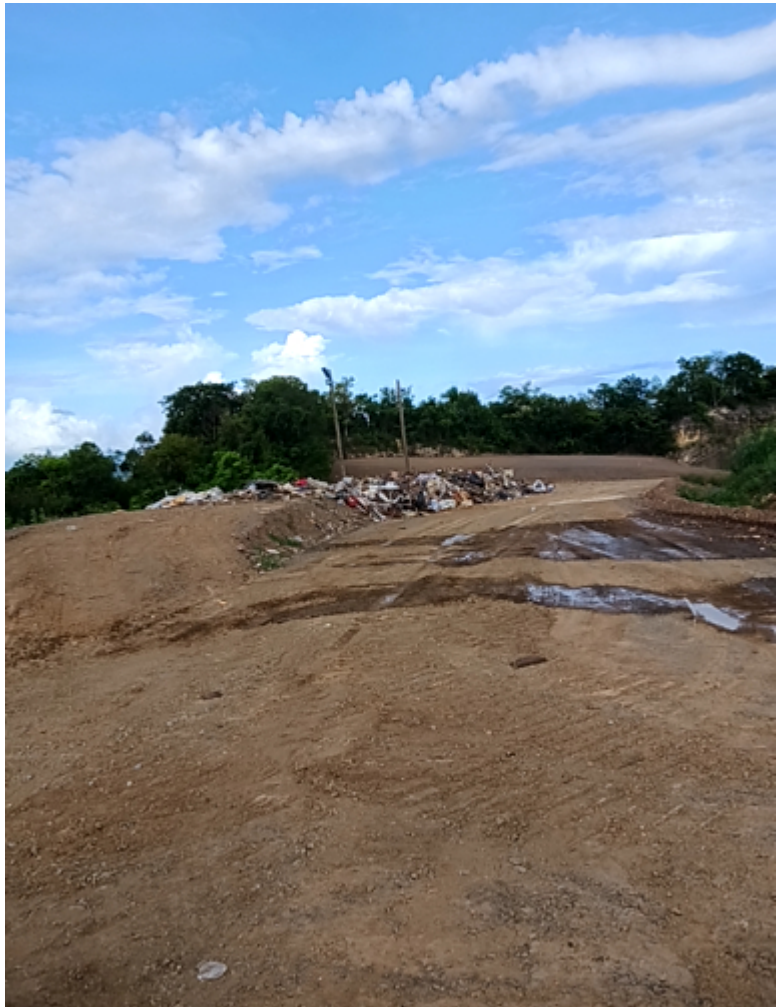
**Tomar foto**

**Condicion Operacion Recibo de Escombros**

Necesita Limpieza

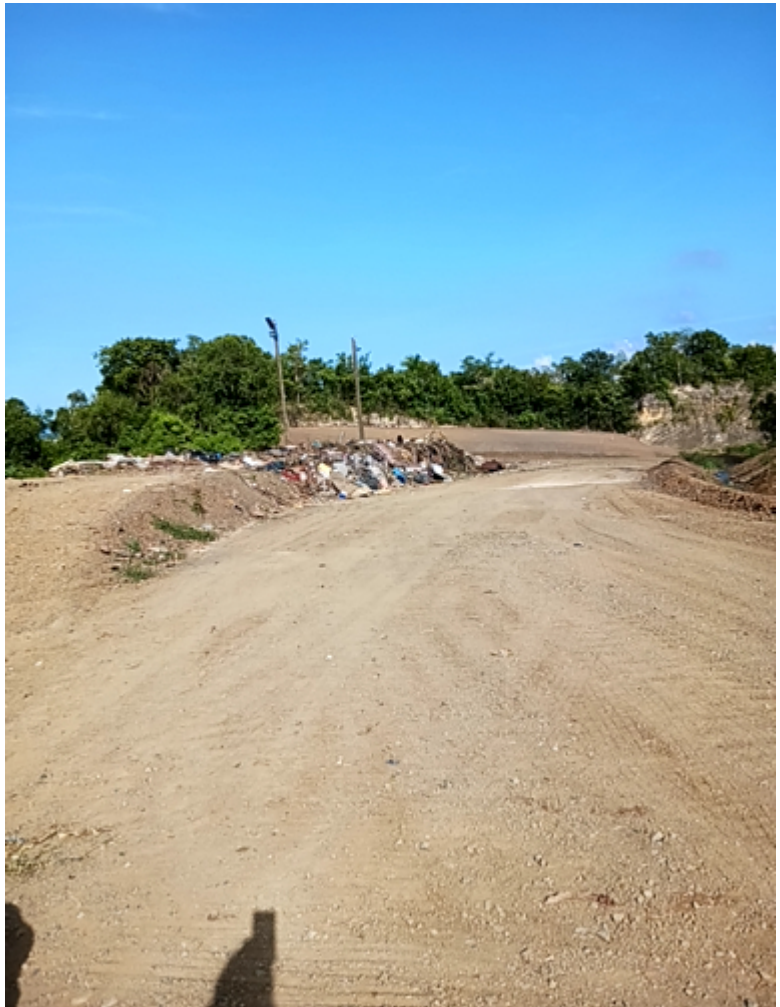
**Tomar foto**

**Condicion Operacion Recibo de Escombros**

Necesita Limpieza

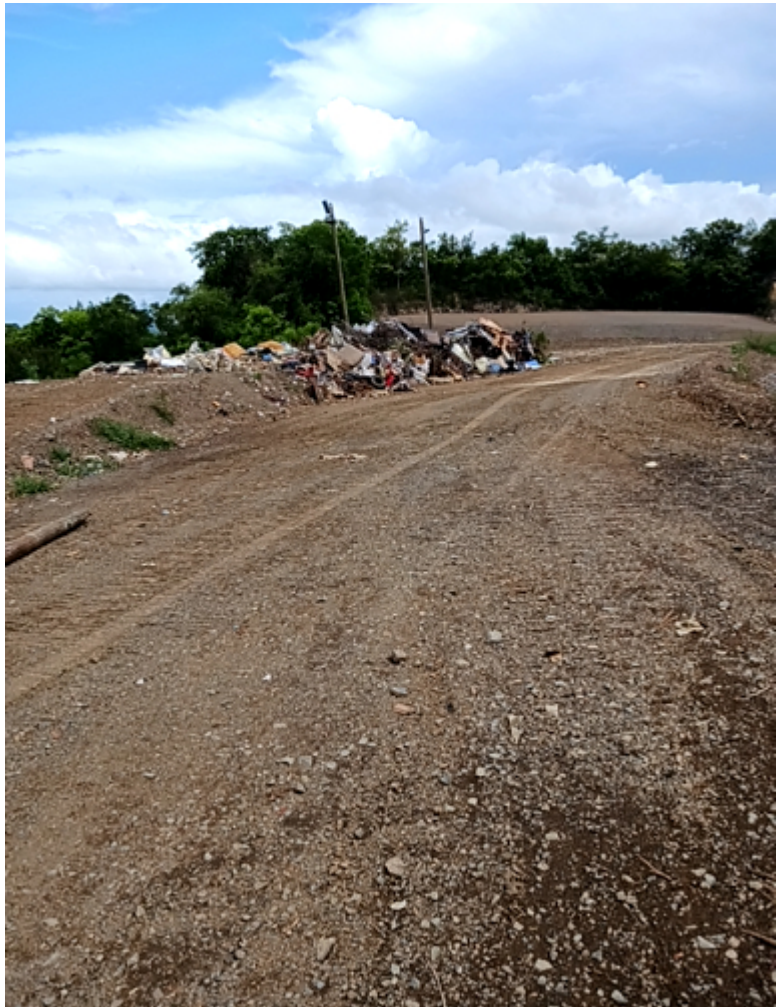
**Tomar foto**

**Condicion Operacion Recibo de Escombros**

Necesita Limpieza

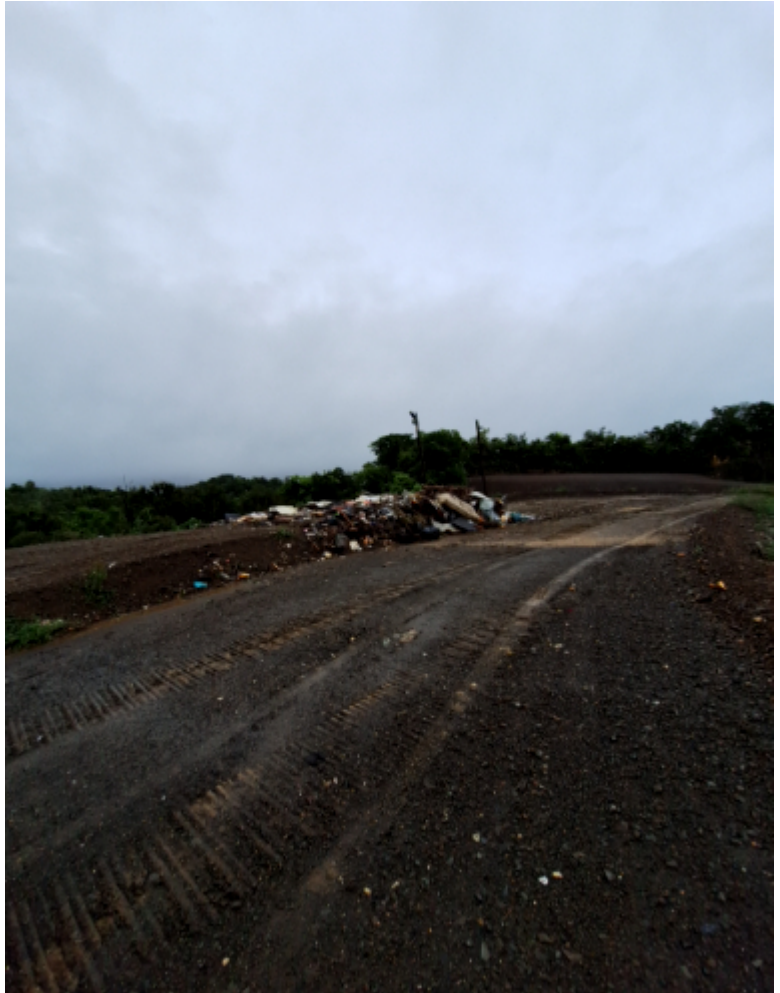
**Tomar foto**

**Condicion Operacion Recibo de Escombros**

Necesita Limpieza
