On-Site Training Case Studies – Two Programs That Work

On-Site Training
Case Studies:
Two Programs That Work

**National Compliance Assistance
Providers Forum 2002**

EPA Region 6 104 (g)
Coordinator : Billy Black, P.E.
Success Stories

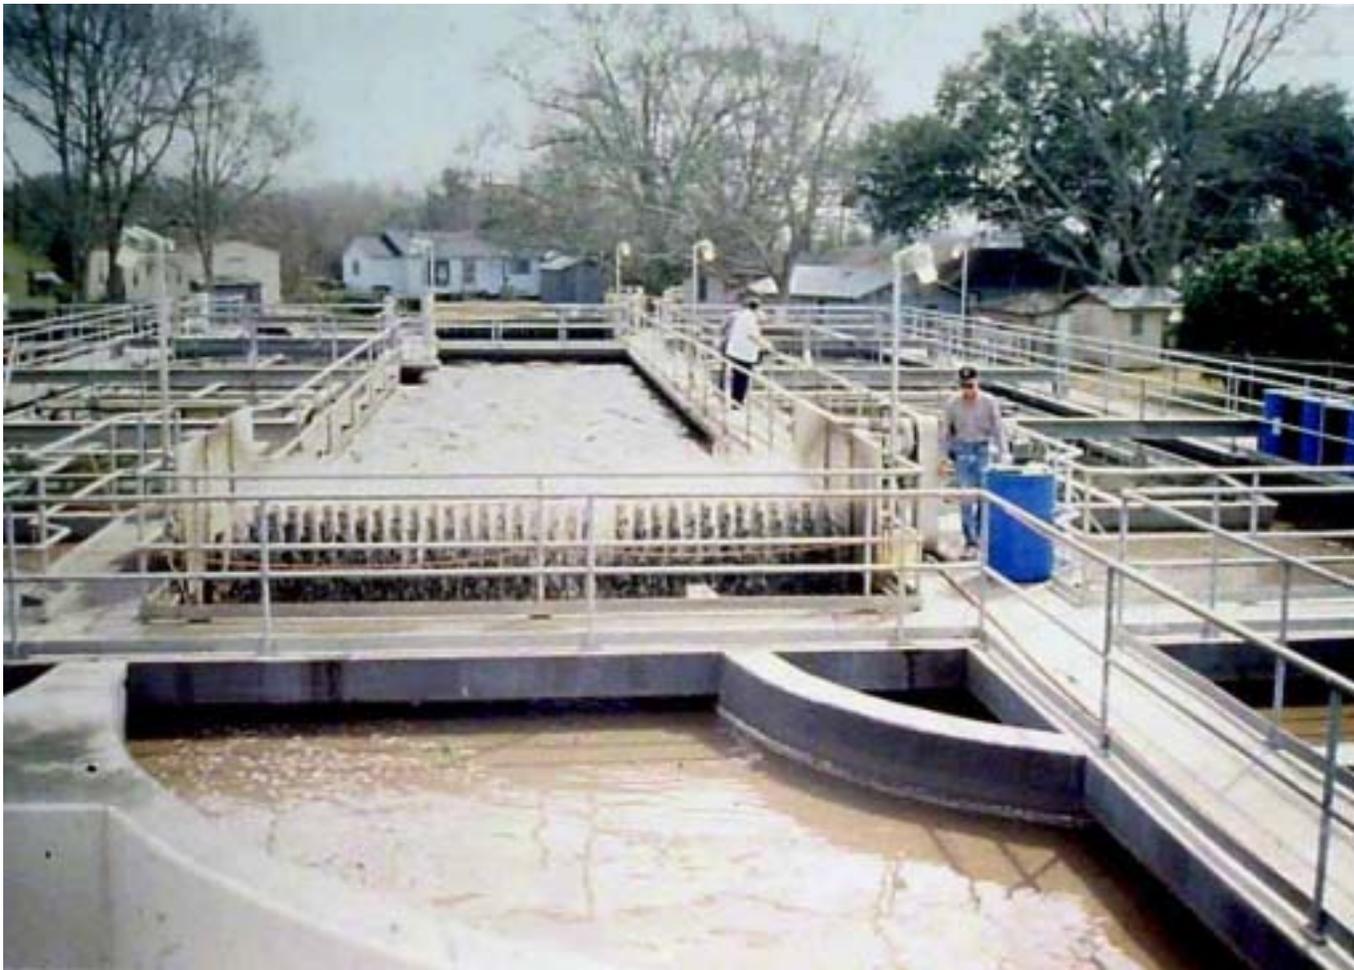
Oxidation ditch;

with a brush rotor on one side &
boat clarifier on the other side

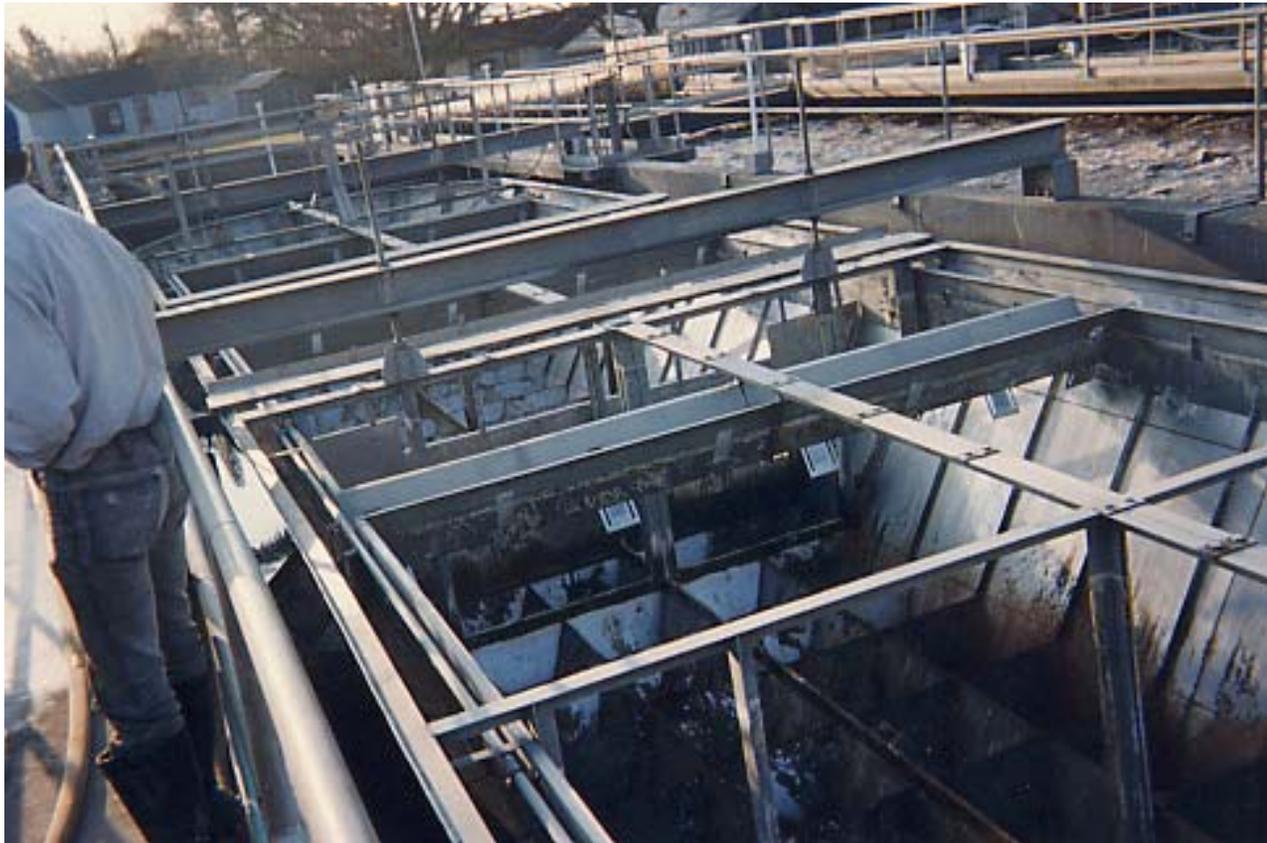
104g Trainer found:

Oxidation Ditch's "Boat Clarifier"
would no longer return activated
sludge.

Clarifier bottom was filled with sludge but more aeration was expected in aeration tank than was occurring

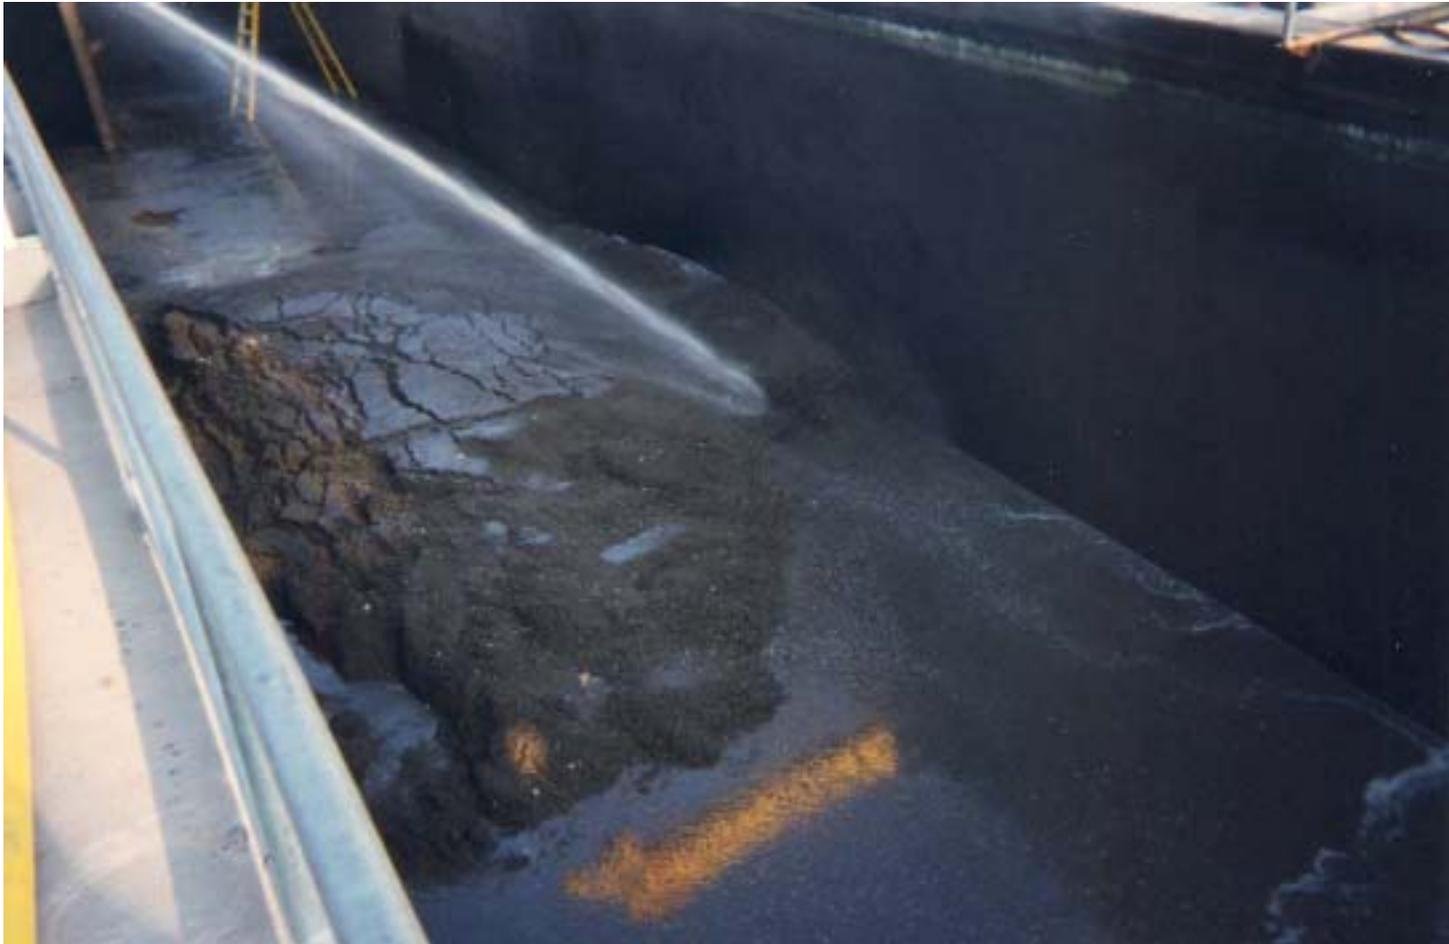
Rice hull sludge was found 6 ft. deep in bottom of aeration ditch

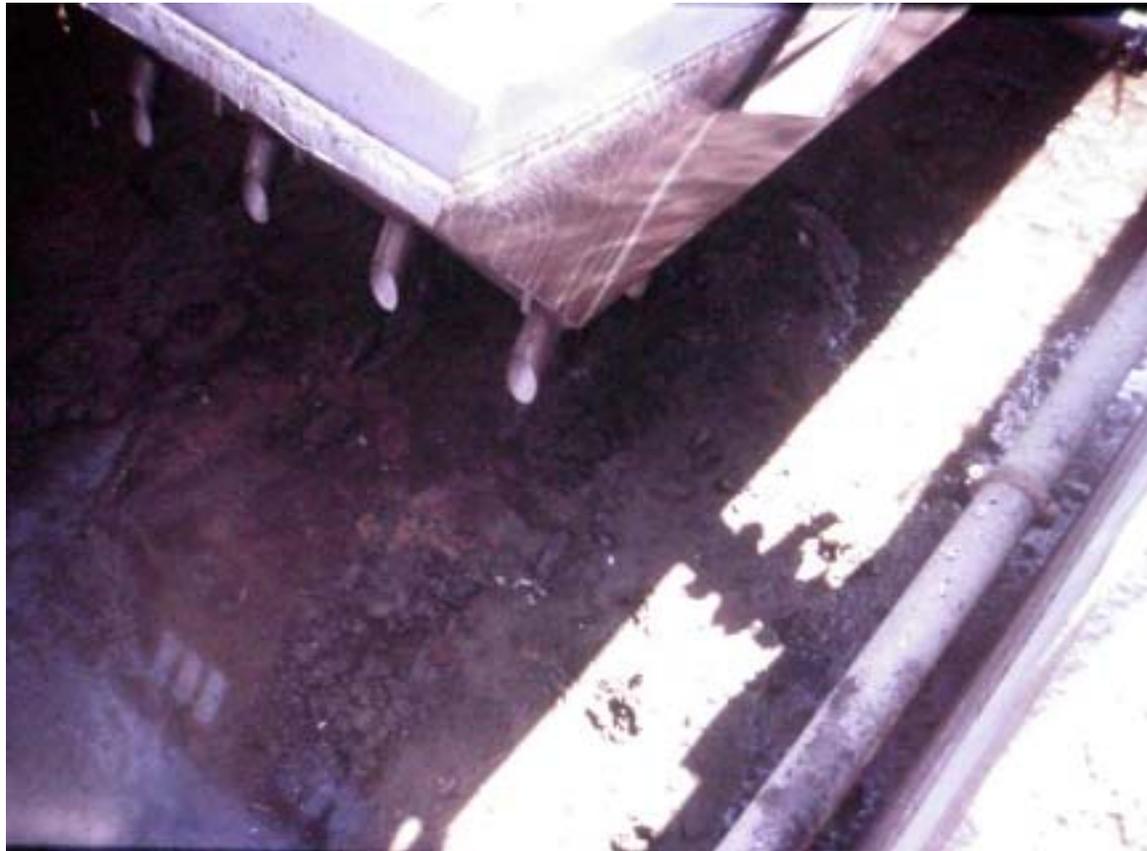
As sludge is removed the bottom of the “Boat Clarifier” appears

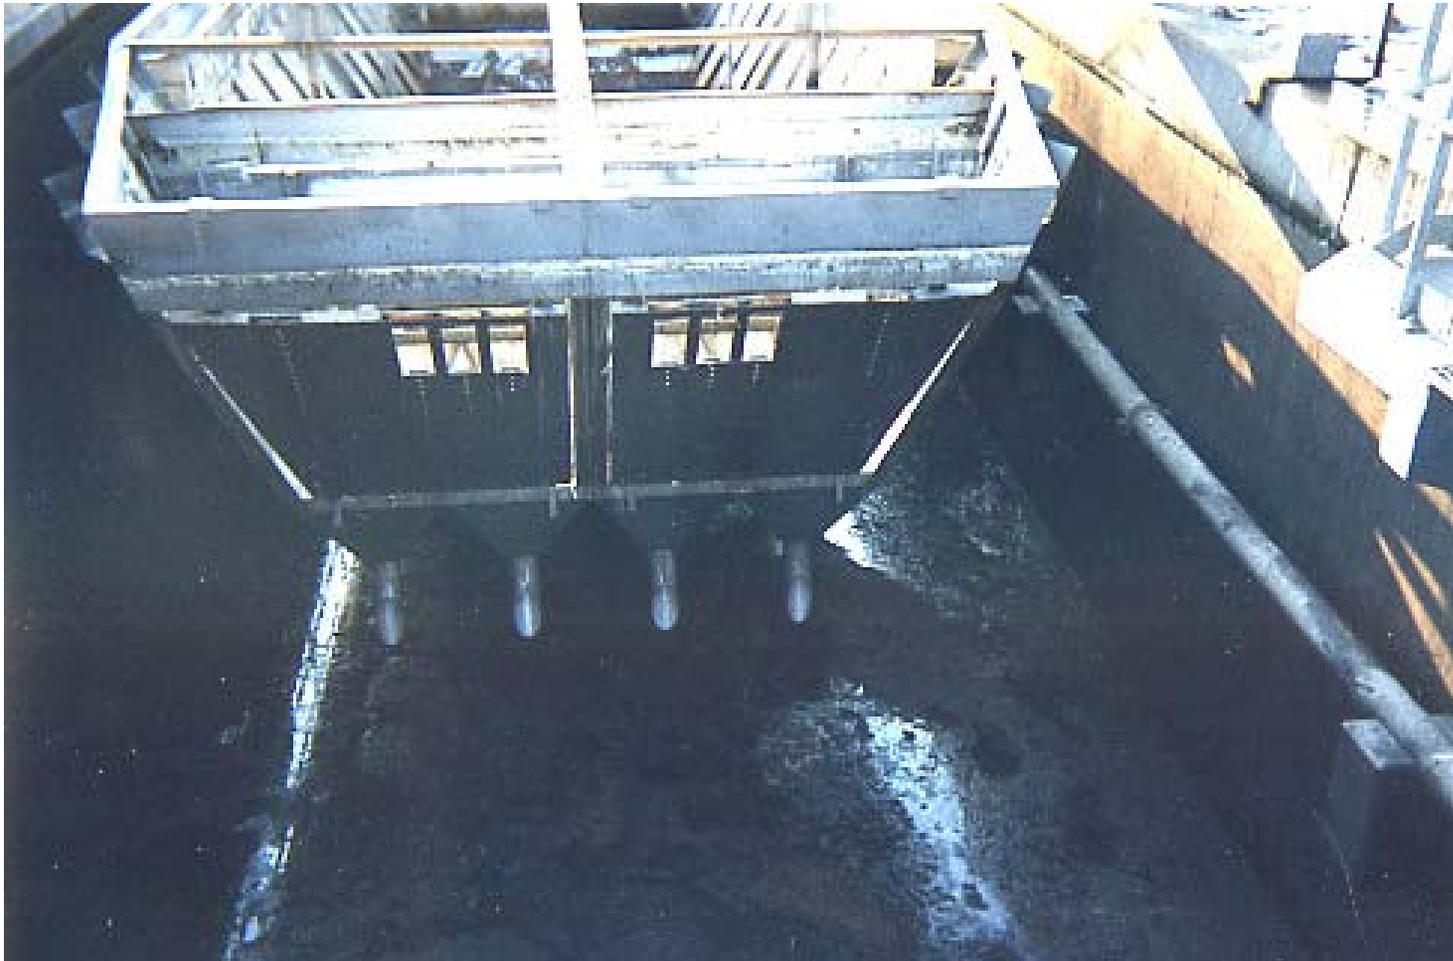
Finally the clarifier draw tubes
are completely free

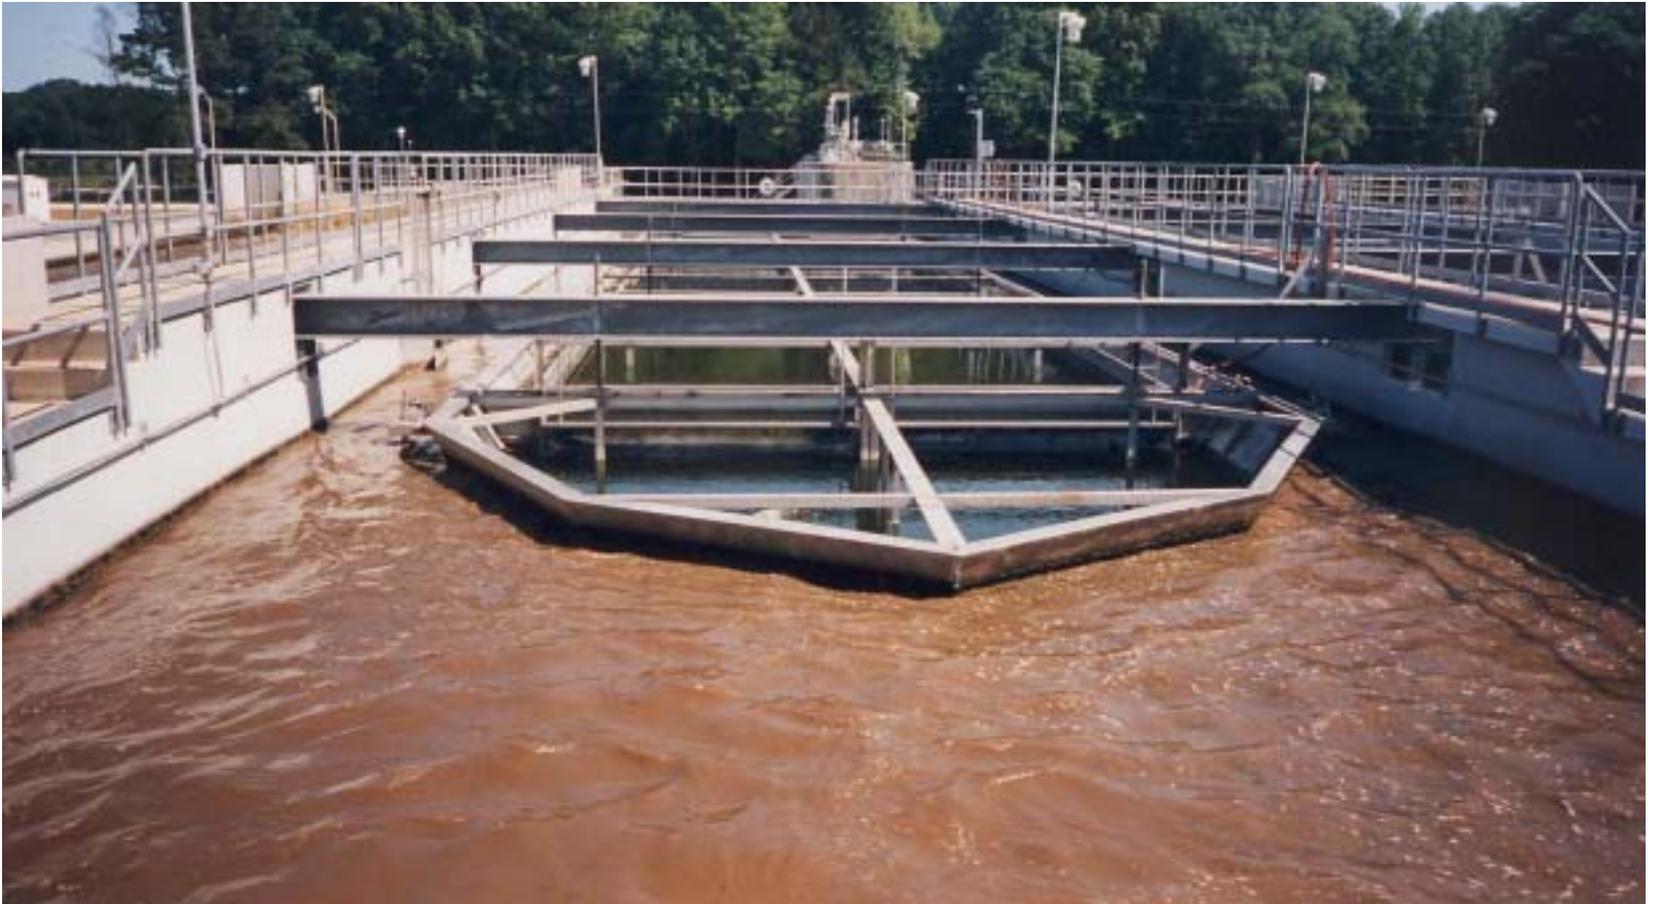
Boat Clarifier is clean, R.A.S.
now flows out of bottom

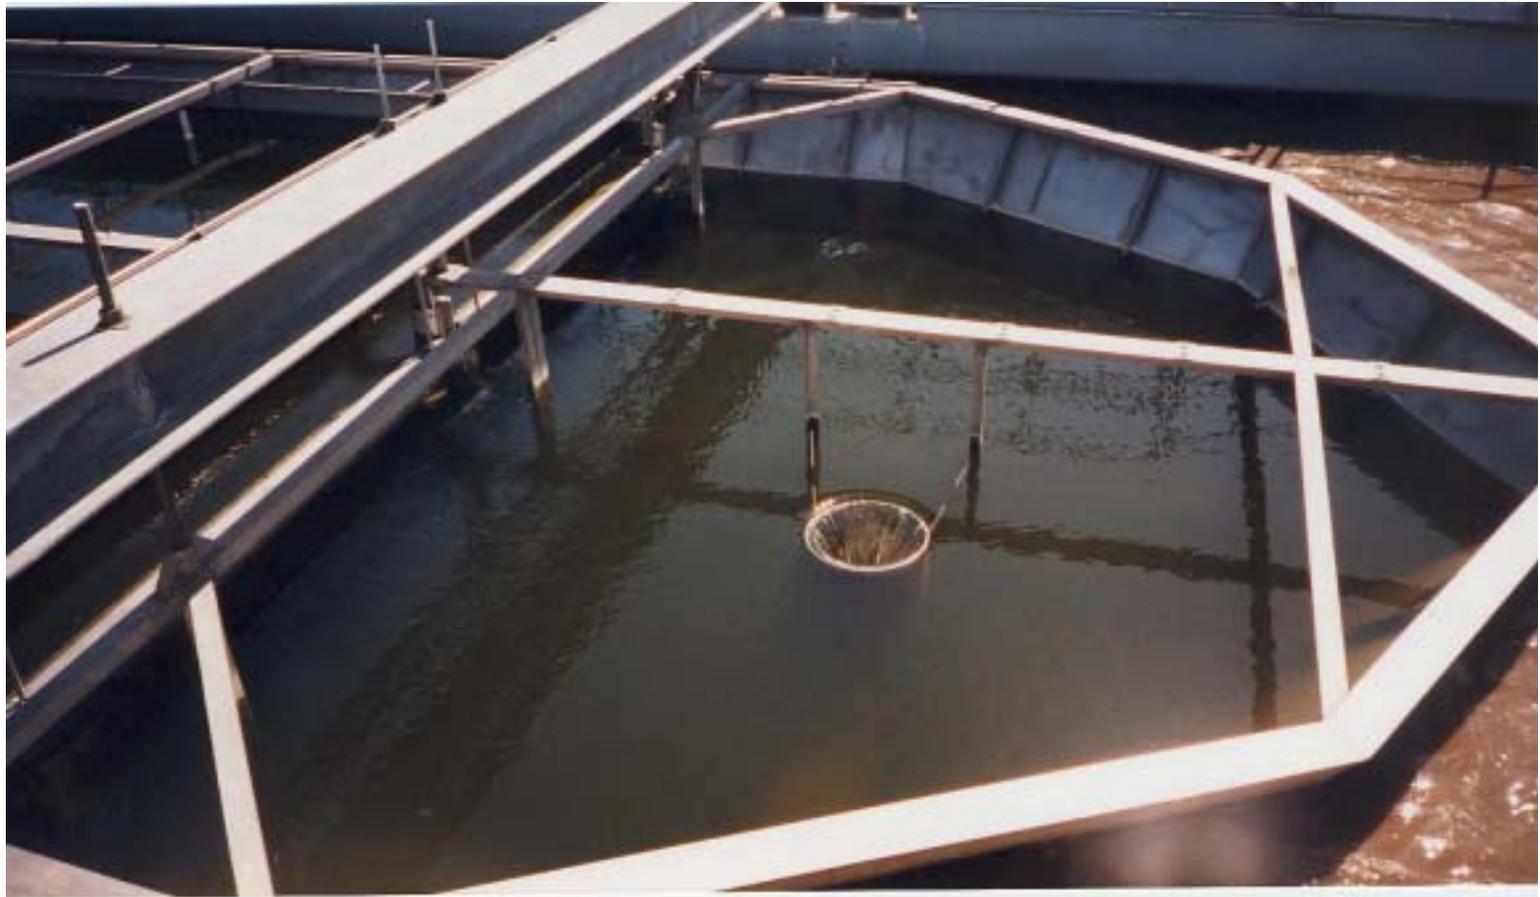
Effluent is clear and meets
discharge limits

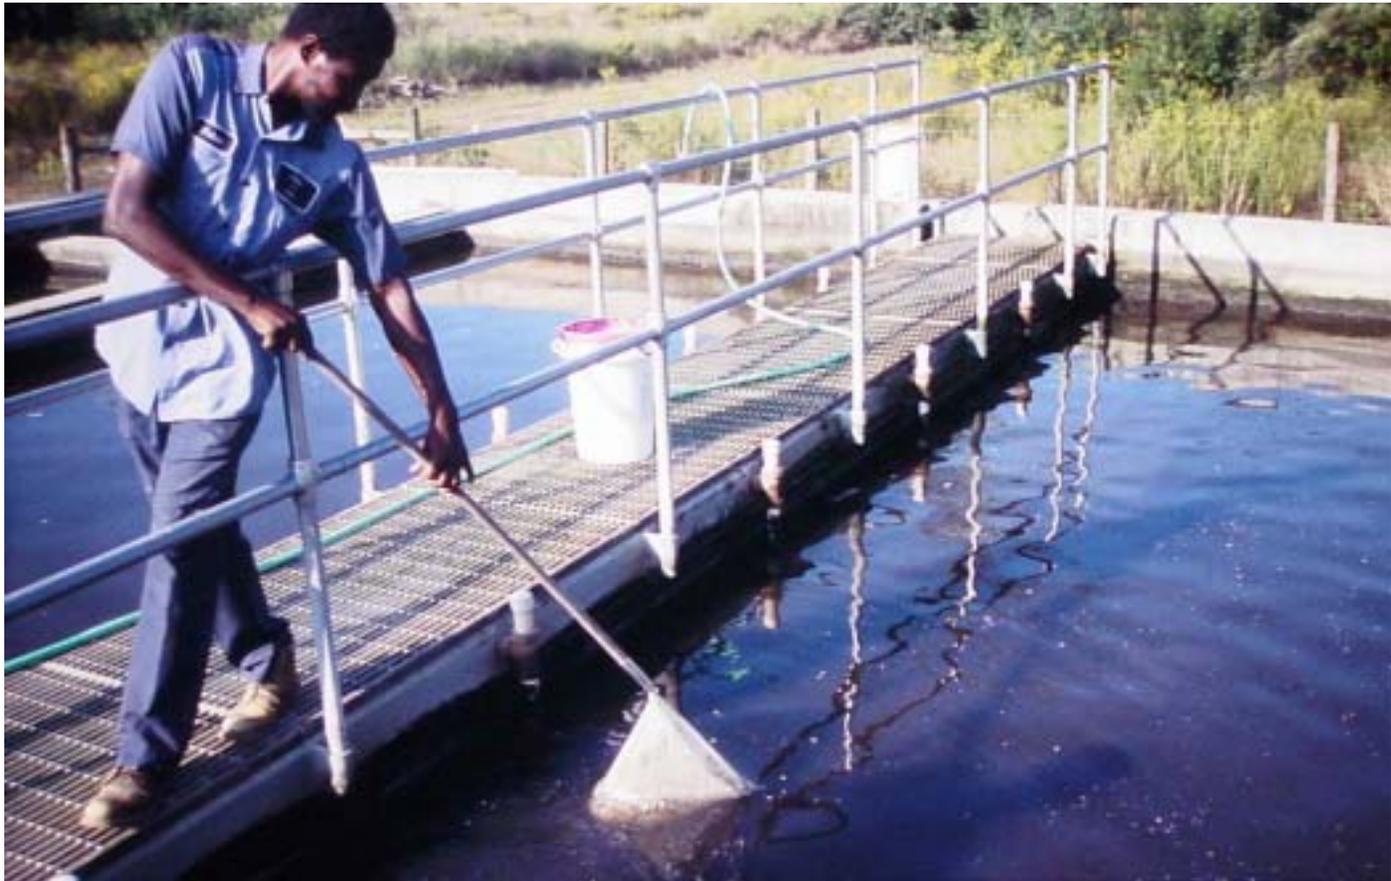
Operator thinks skimming
aeration tank with net is normal

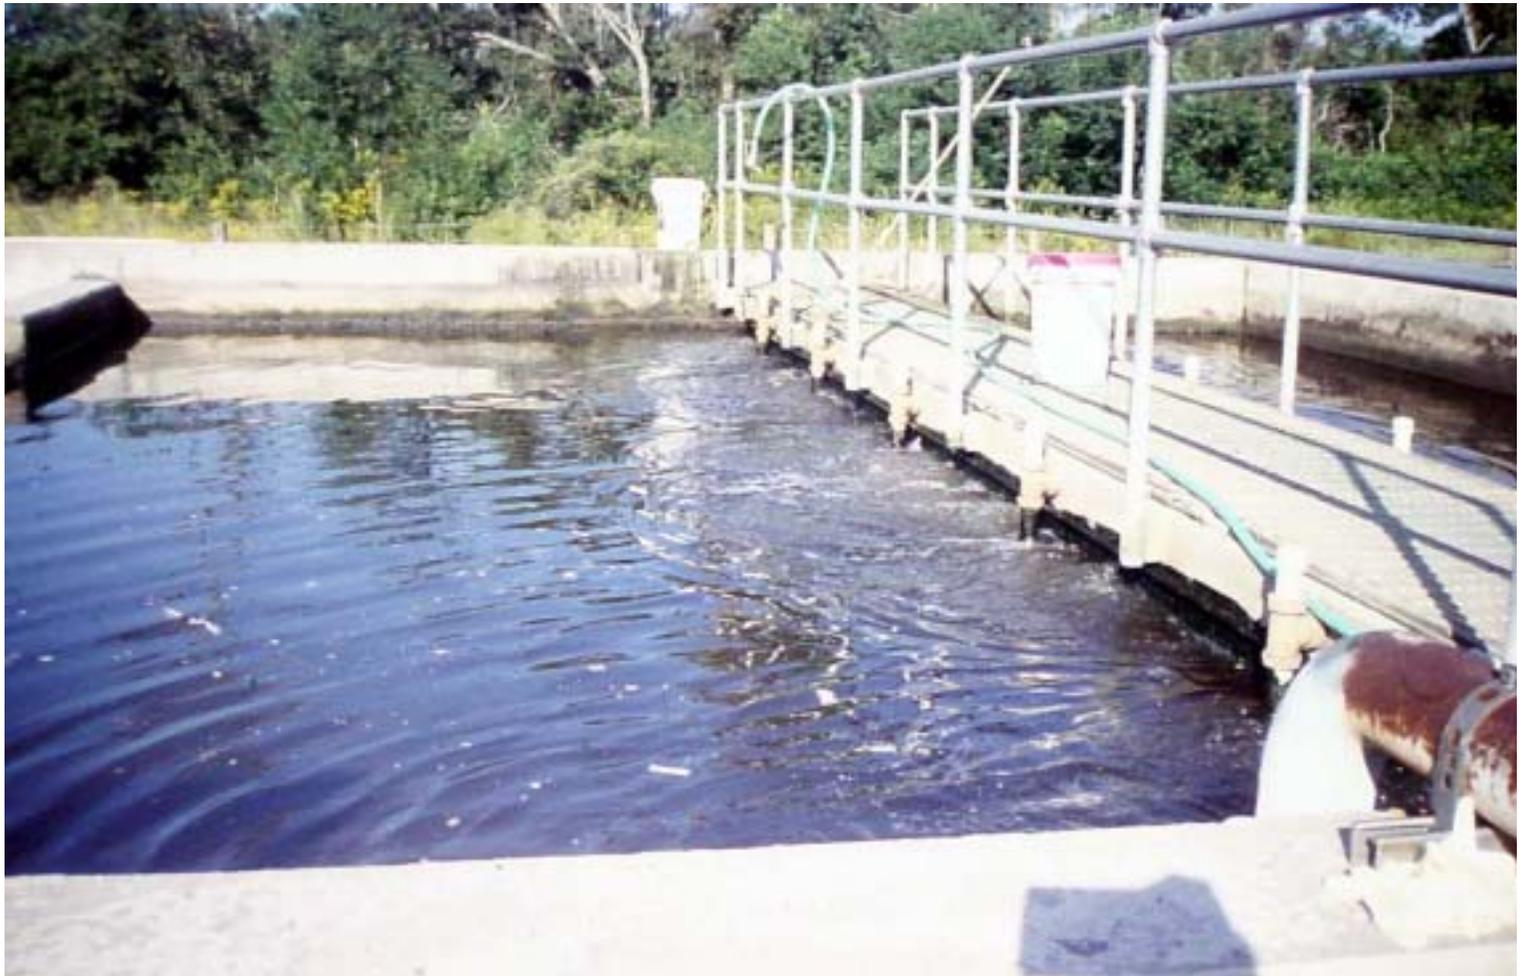
Fine bubble diffusers fail in aeration and mixing

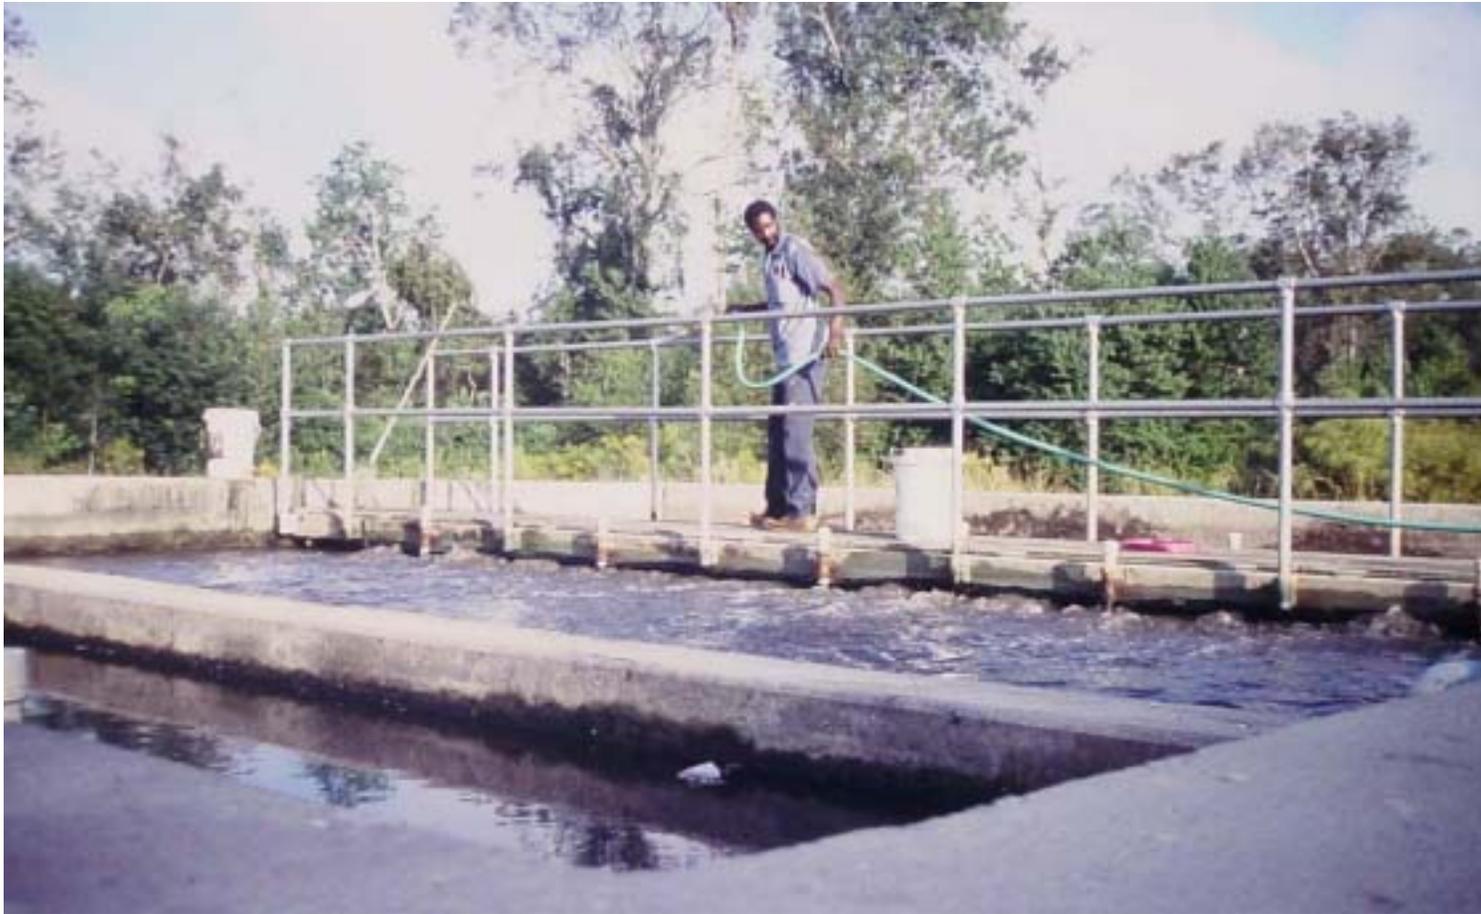
Aeration attained by drilling 1/2 inch holes on bottoms of diffuser

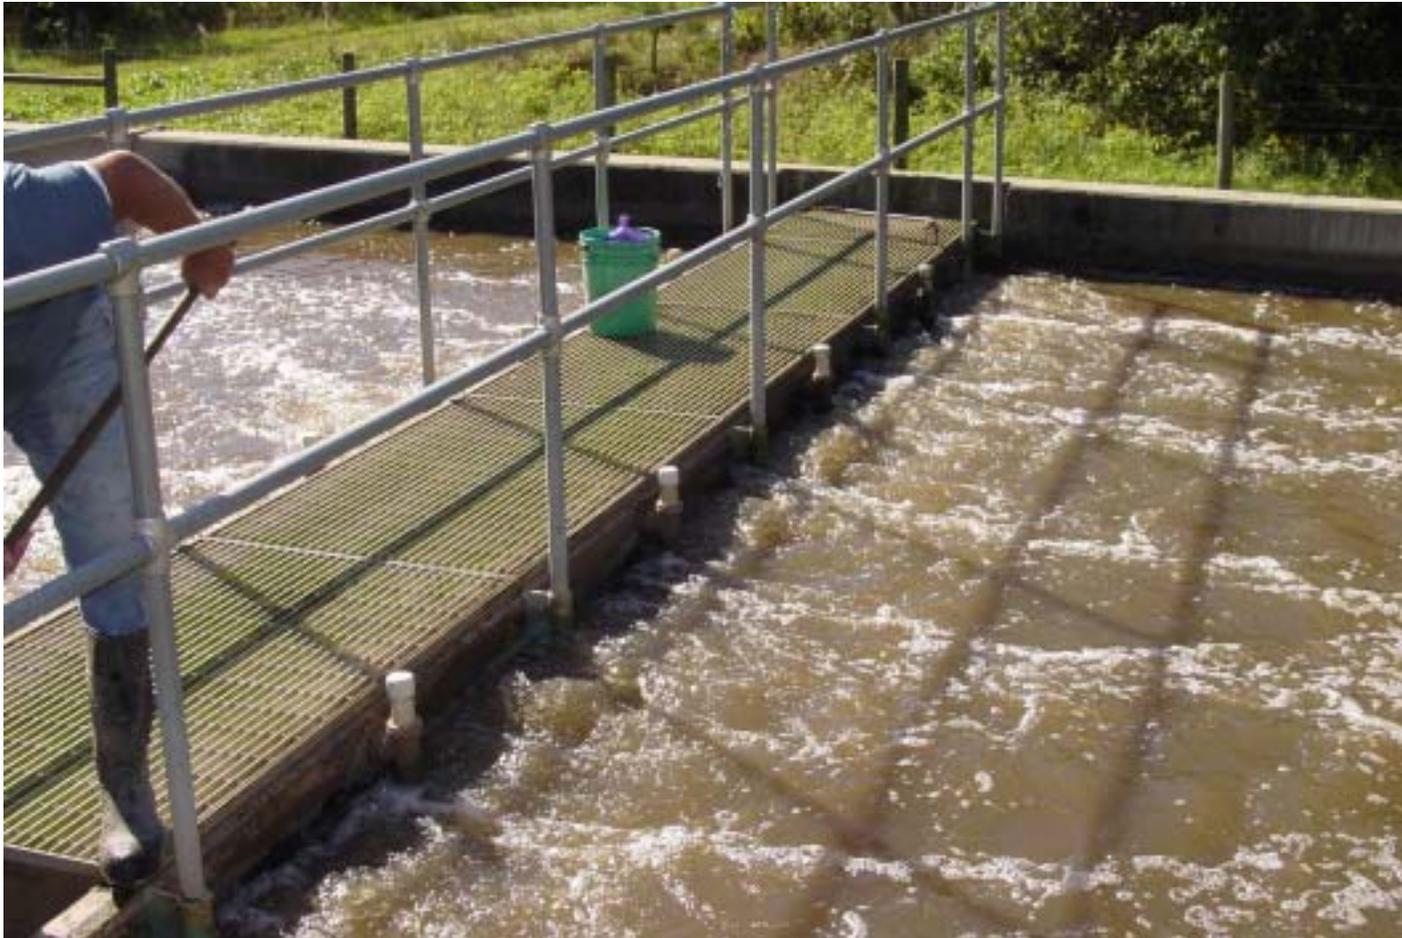
Better aeration starts the growth of activated sludge

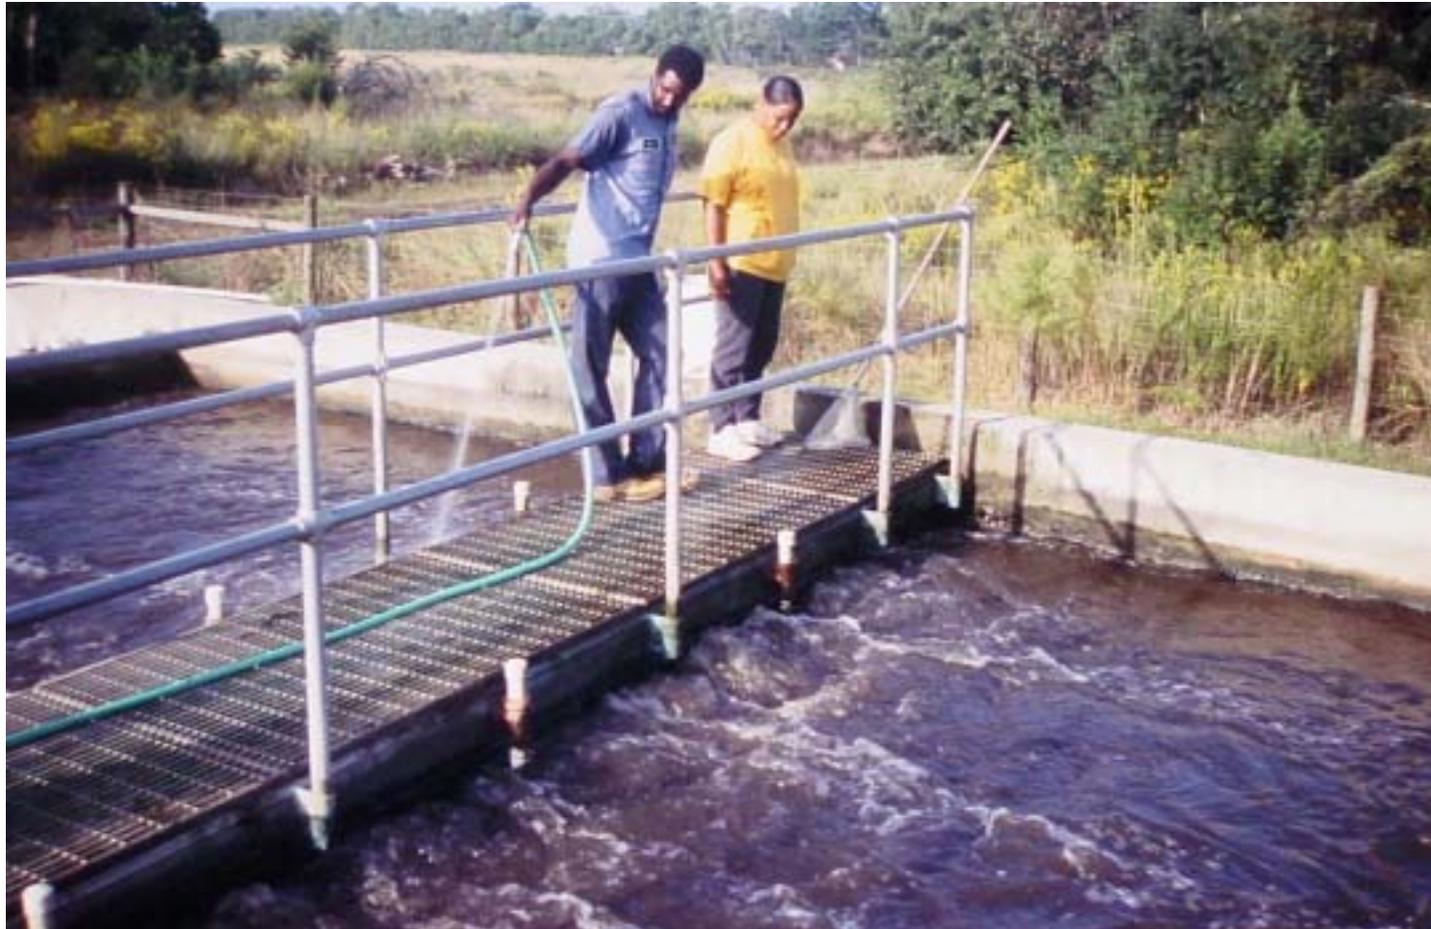
Innovative clarifier under catwalk not working

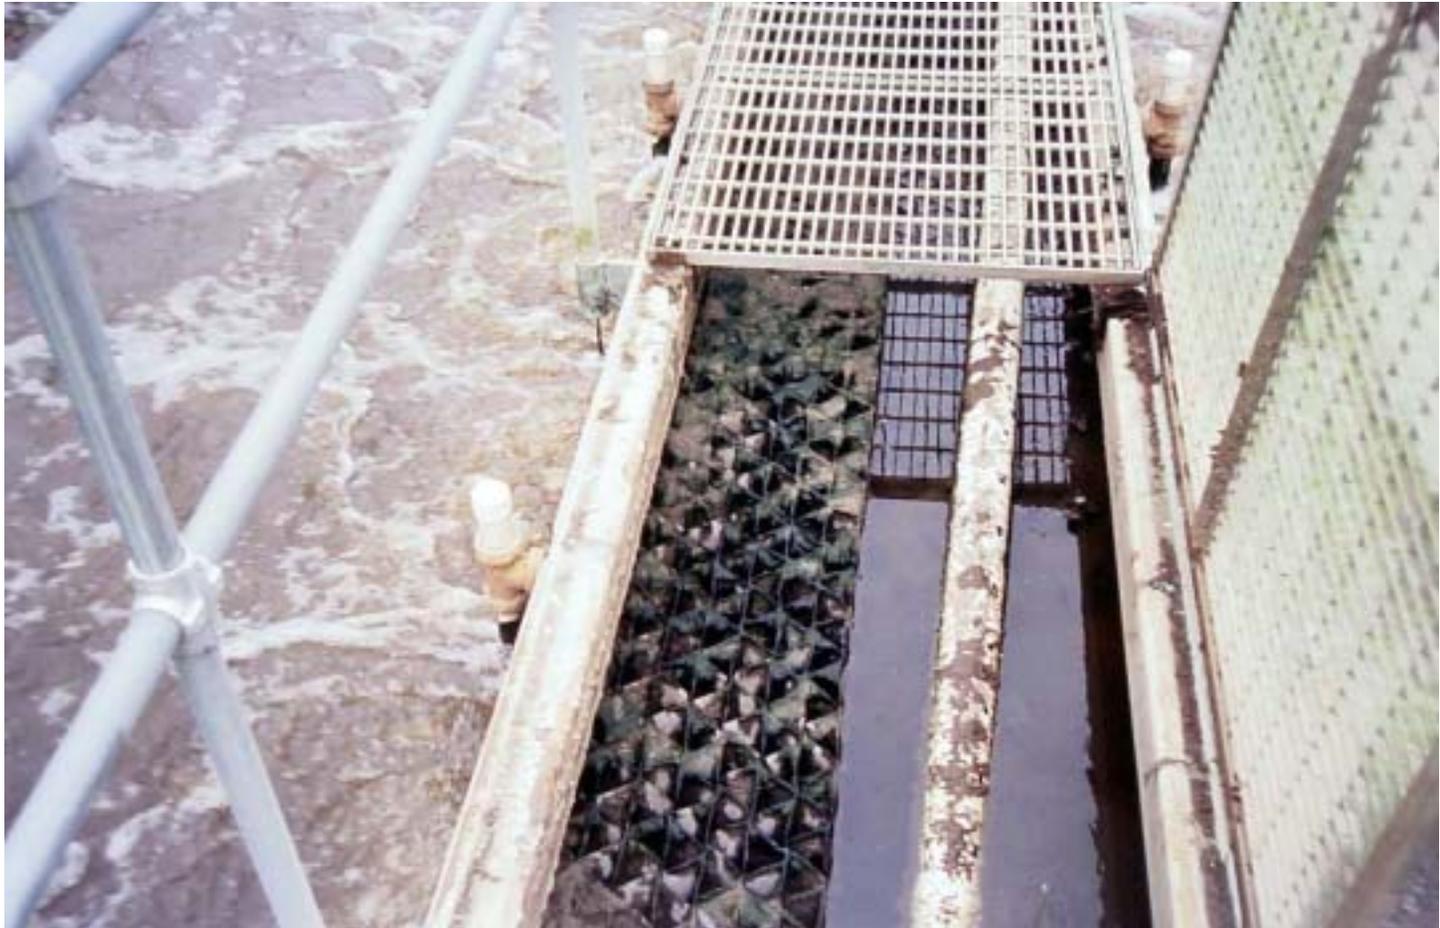
In clarifier, tube settlers clog daily, preventing sludge return

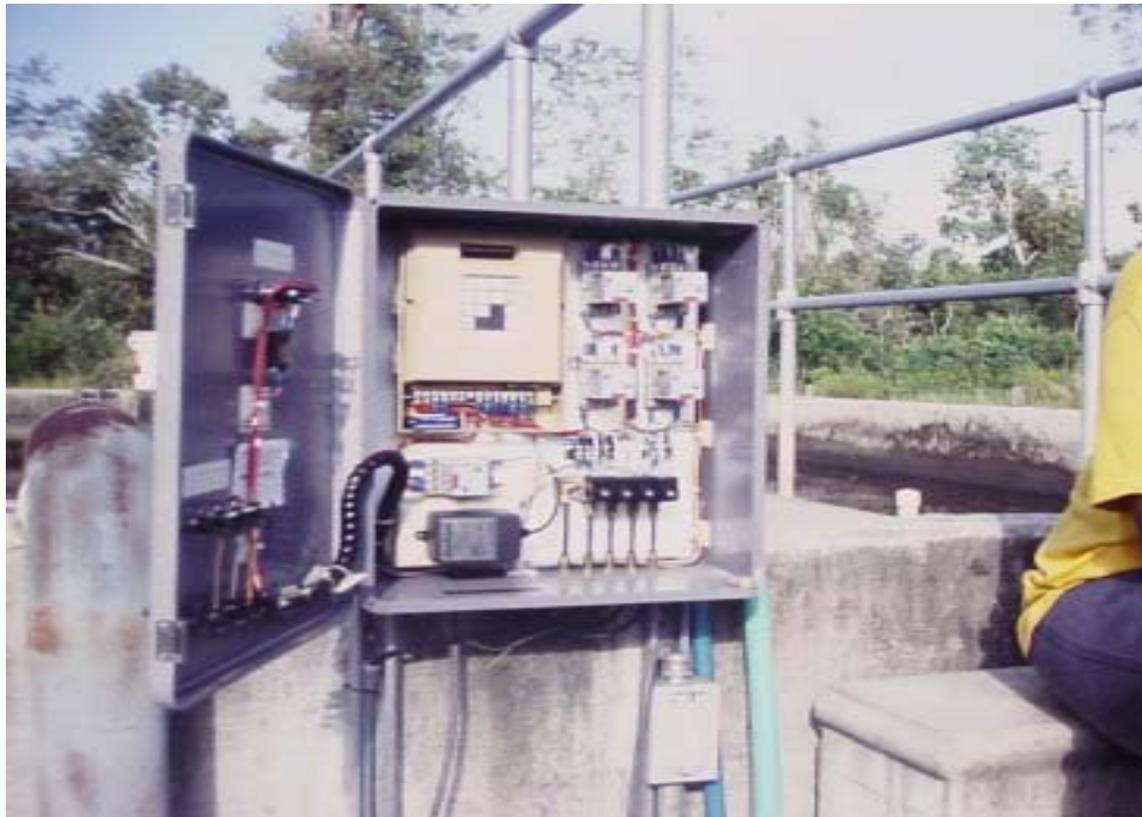
Backwash computer/controller for tube settler is ***NOT*** operator friendly

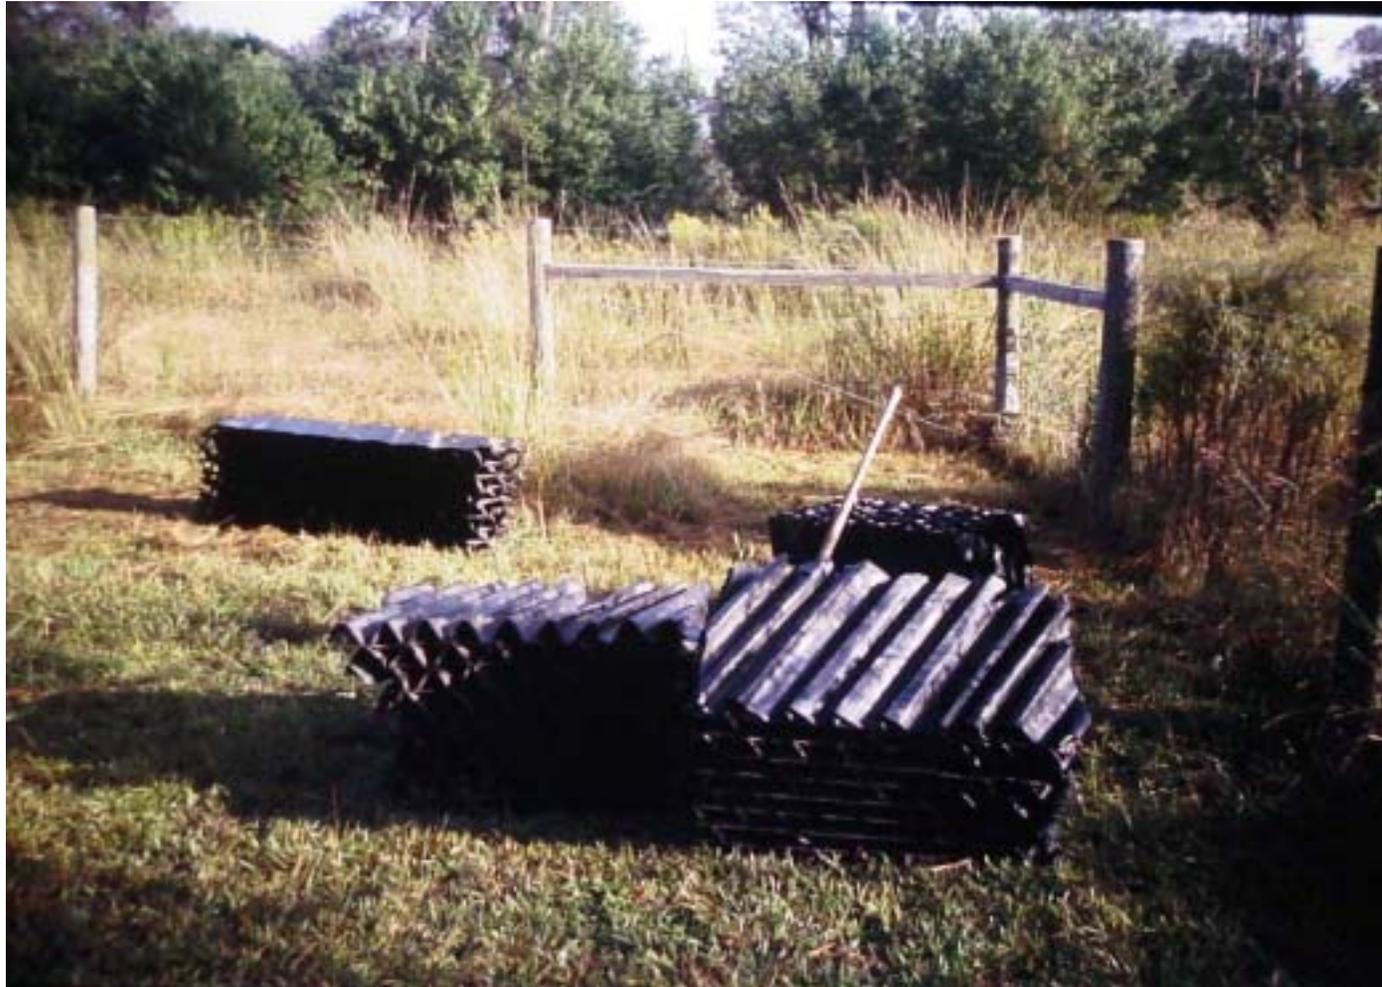
Manufacturer approved removal of tube settlers

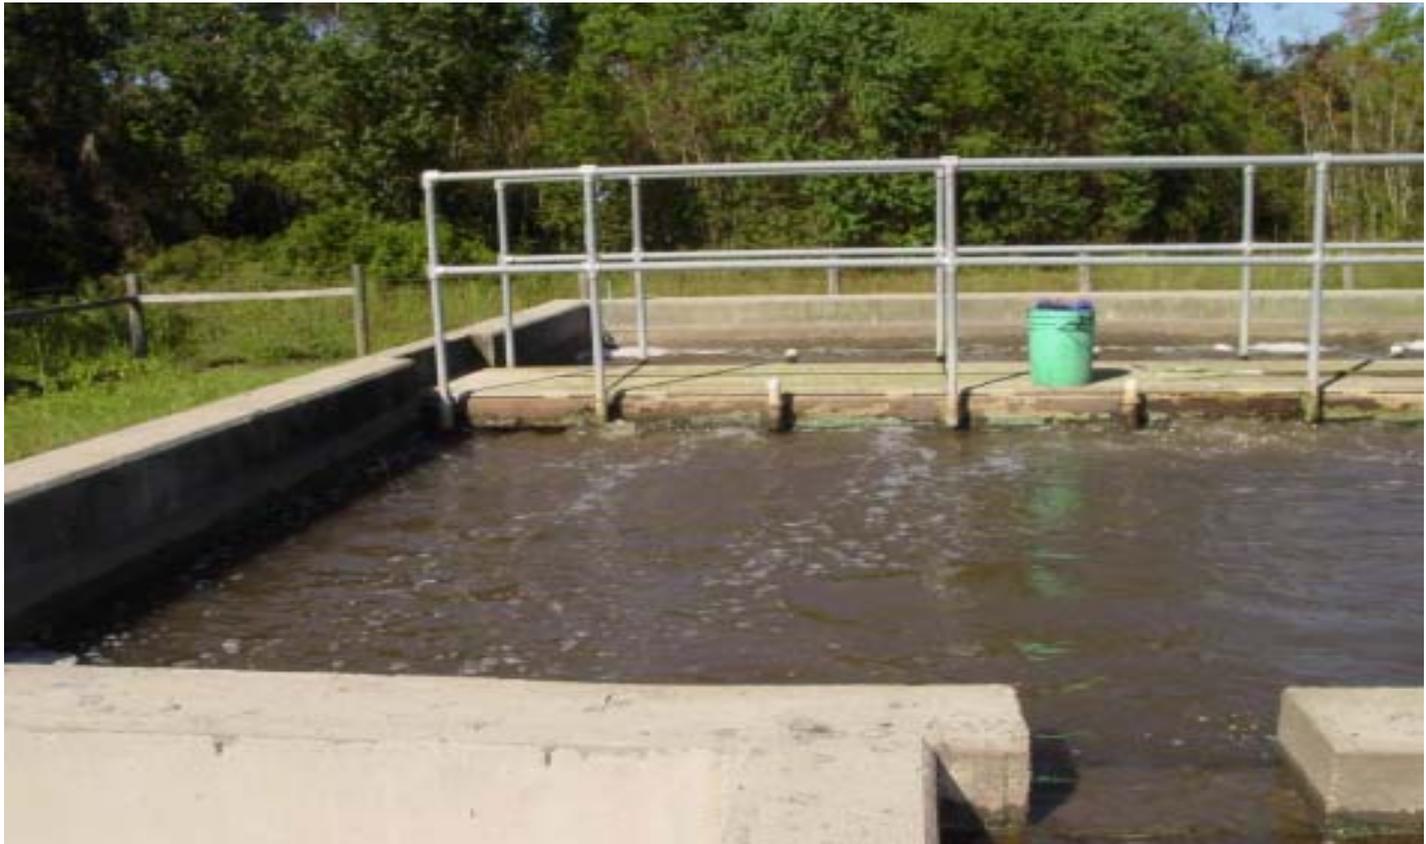
Aeration tank turns brown and
BOD & TSS are in Permit limits

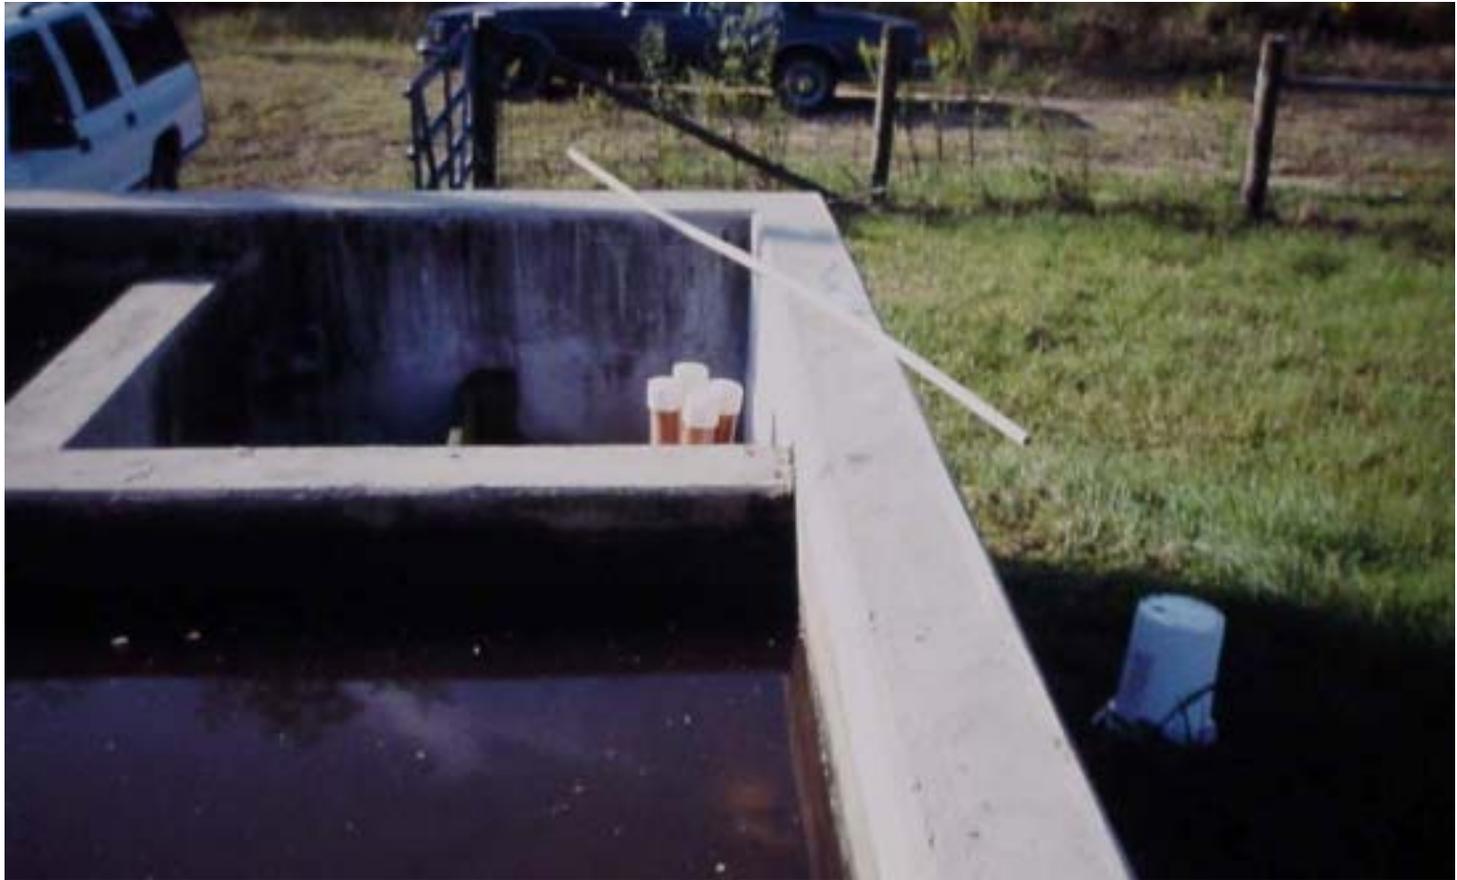
4 tube chlorinator is inadequate
and fecal coliforms are TNTC
