On-Site Training Case Studies – Two Programs That Work

On-Site Training
Case Studies:
Two Programs That Work

**National Compliance Assistance
Providers Forum 2002**

EPA Region 6 104 (g)
Coordinator : Billy Black, P.E.
Success Stories

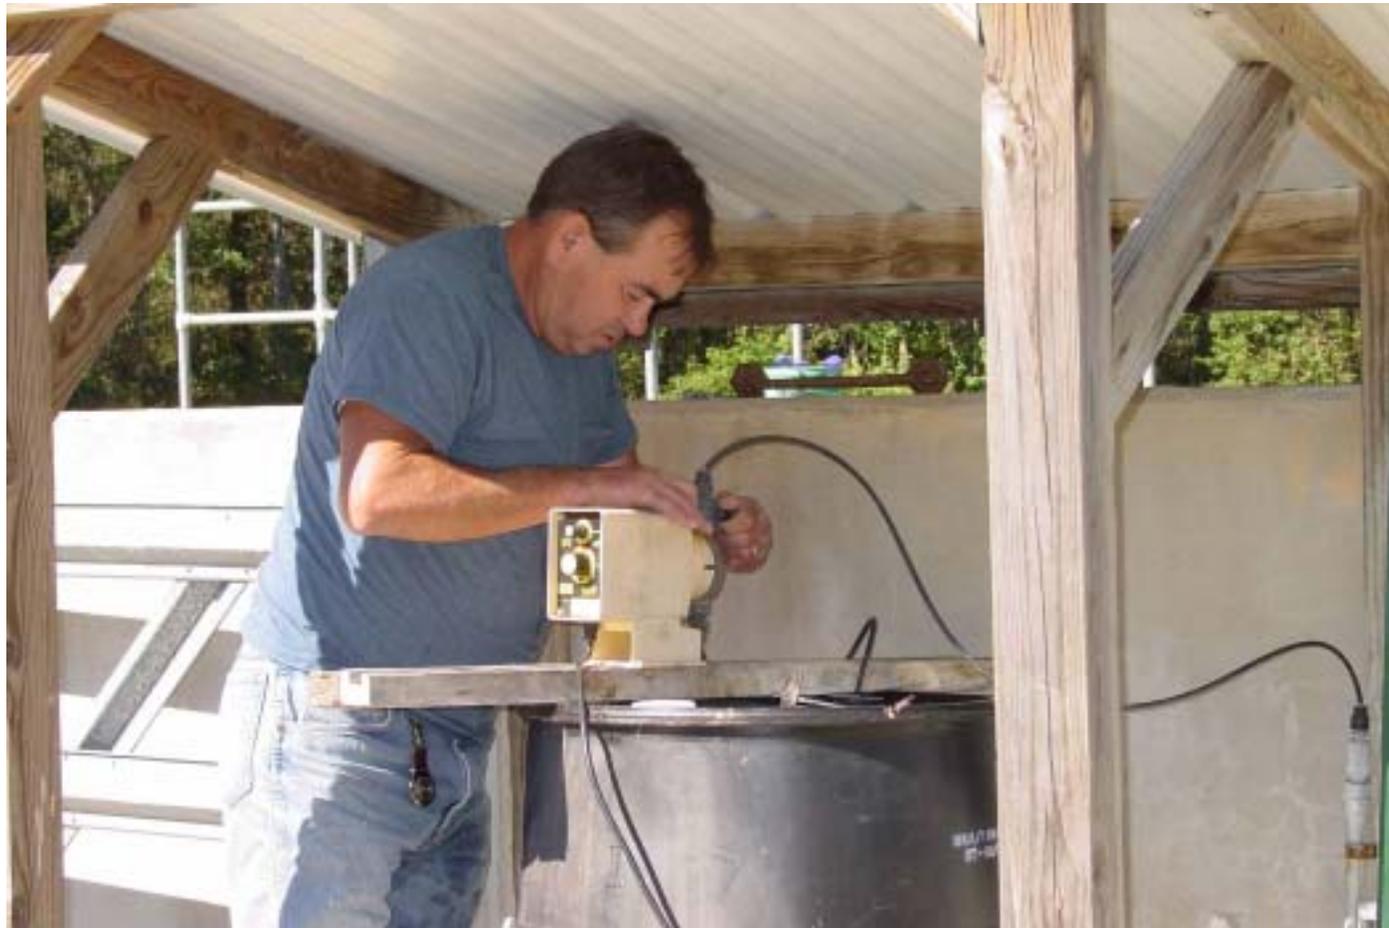
Change disinfection to liquid chlorine & a chemical pump

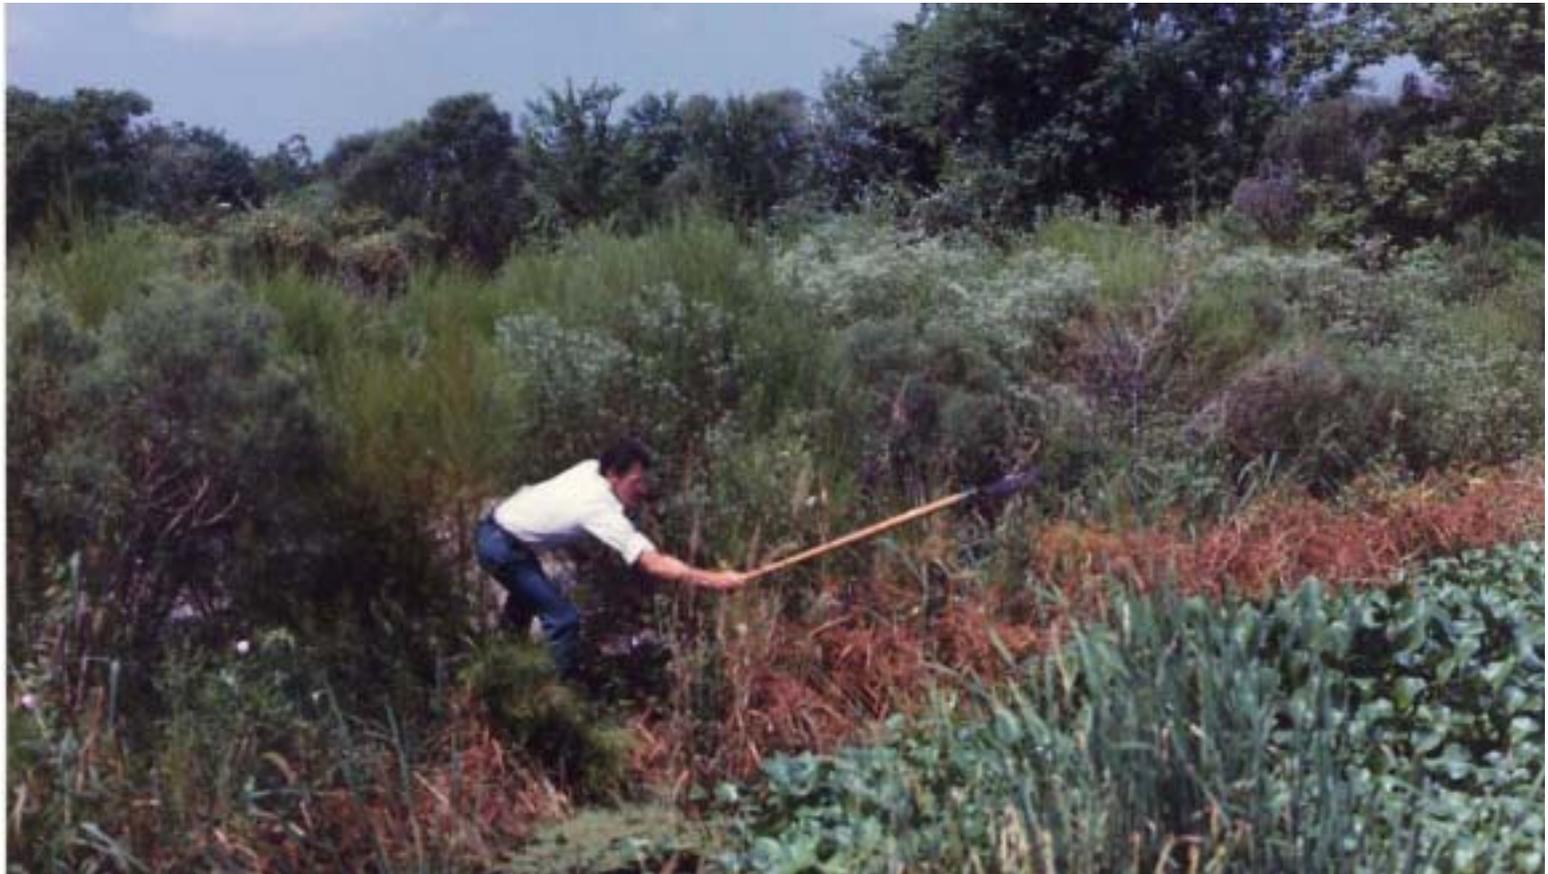
Situation: A 3 cell oxidation pond treats wastewater well but experiences high TSS because of algae. 104g Trainer suggests covering cells #2 & #3 to remove algae

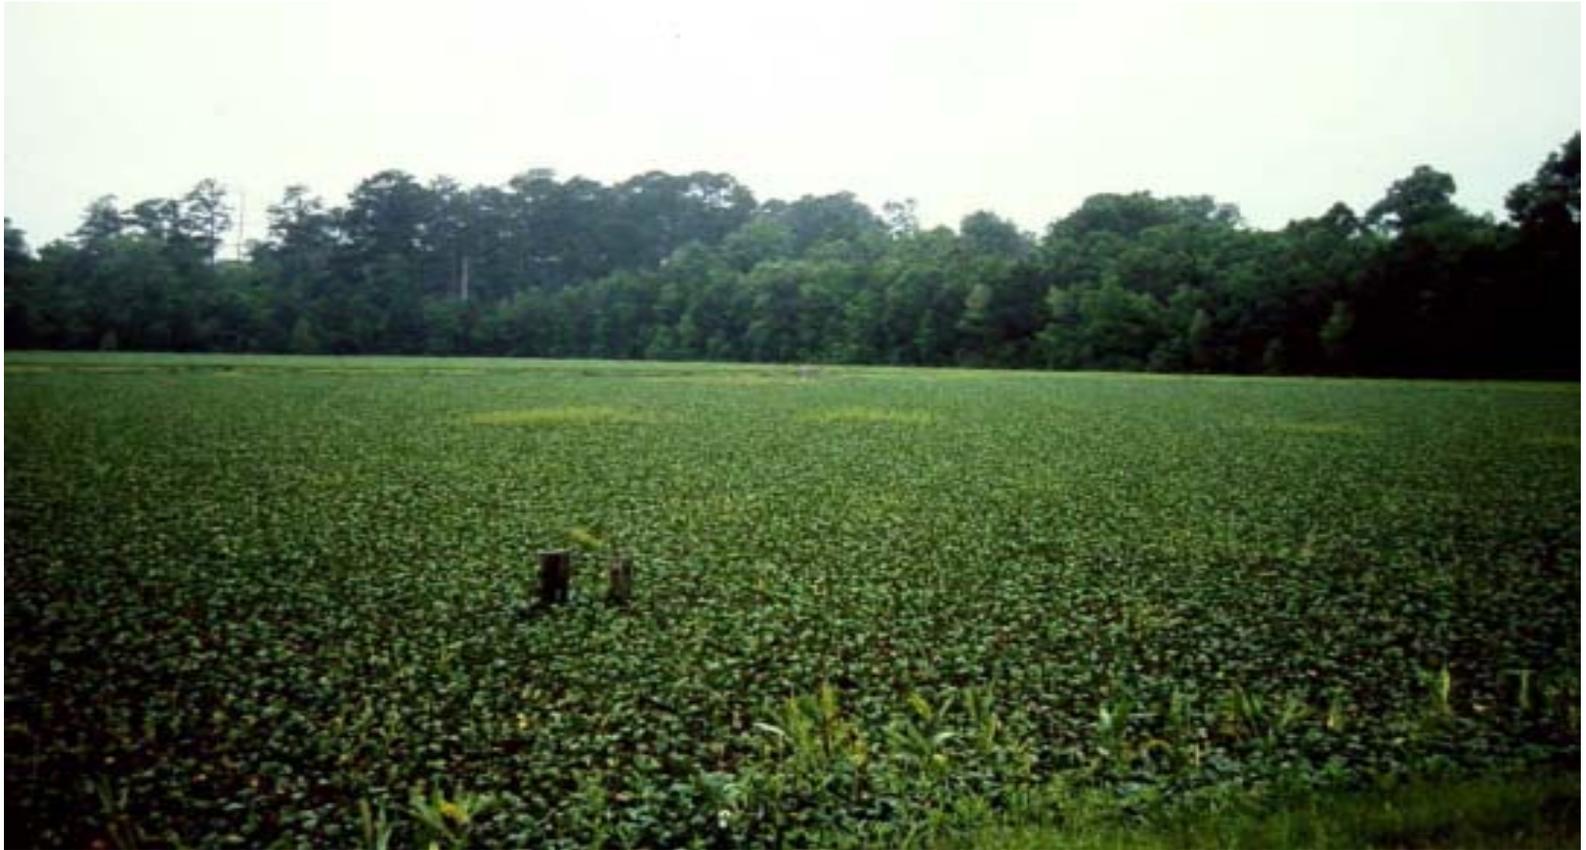
In 90 days the polishing cell#2
and #3 are covered by water
hyacinths which destroys algae

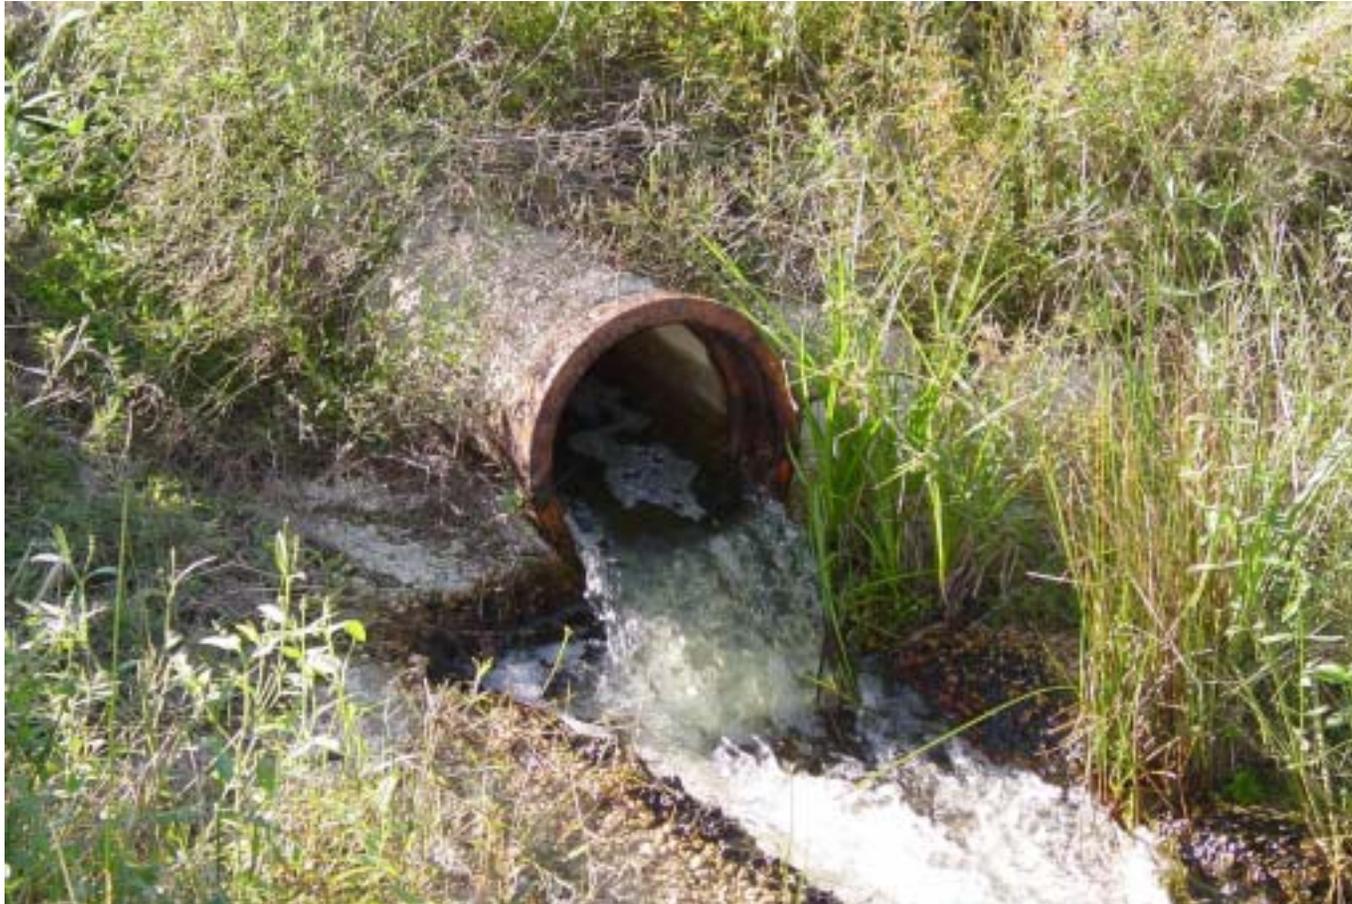
After water hyacinths grow, BOD
& TSS drop to < 10 mg/L

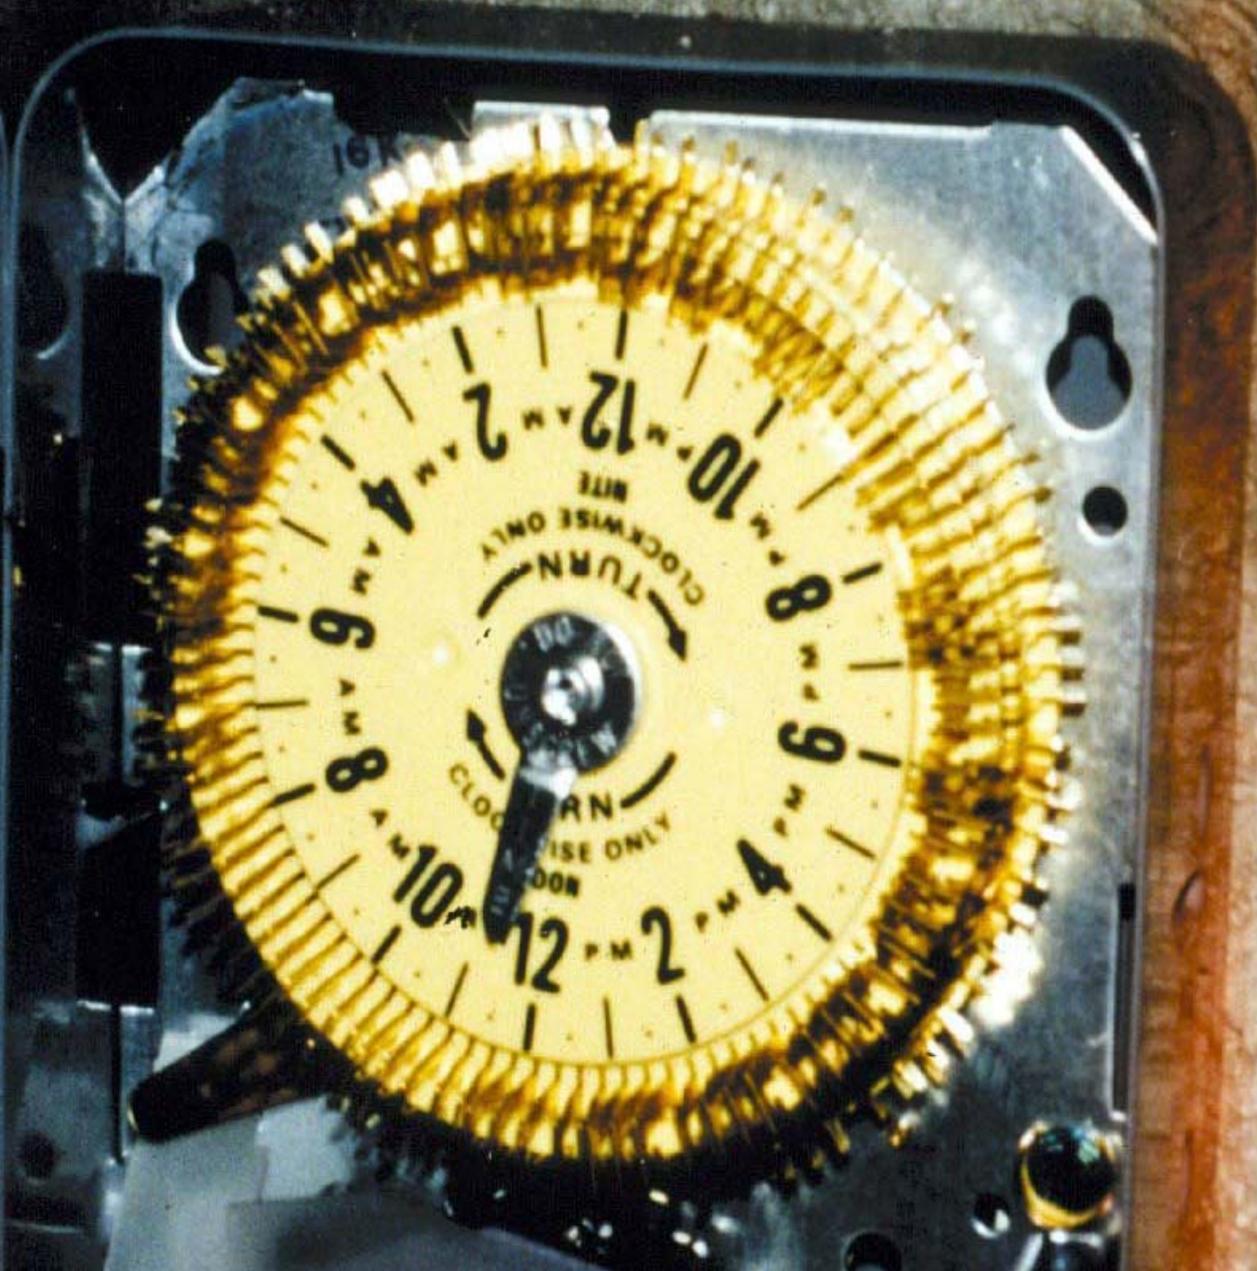
Model T-1905 TIME SWITCH

WIRING DIAGRAM

Control two circuits as Single Pole
Control one circuit as Single Pole Single Throw
Normally closed (NC). To wire switch see

INSTRUCTIONS
Depress tripper(s) into dial at de-
required
on the load for 15-20 minutes
lengthen the on time by 15 minutes
closed position turns off the load for
dial space will lengthen the off time
