**REMOVAL PROGRAM
AFTER ACTION REPORT
FOR THE
DANVERSPORT EXPLOSION SITE
DANVERS, ESSEX COUNTY, MASSACHUSETTS
22 NOVEMBER 2006 THROUGH 9 MARCH 2007**

May 2007

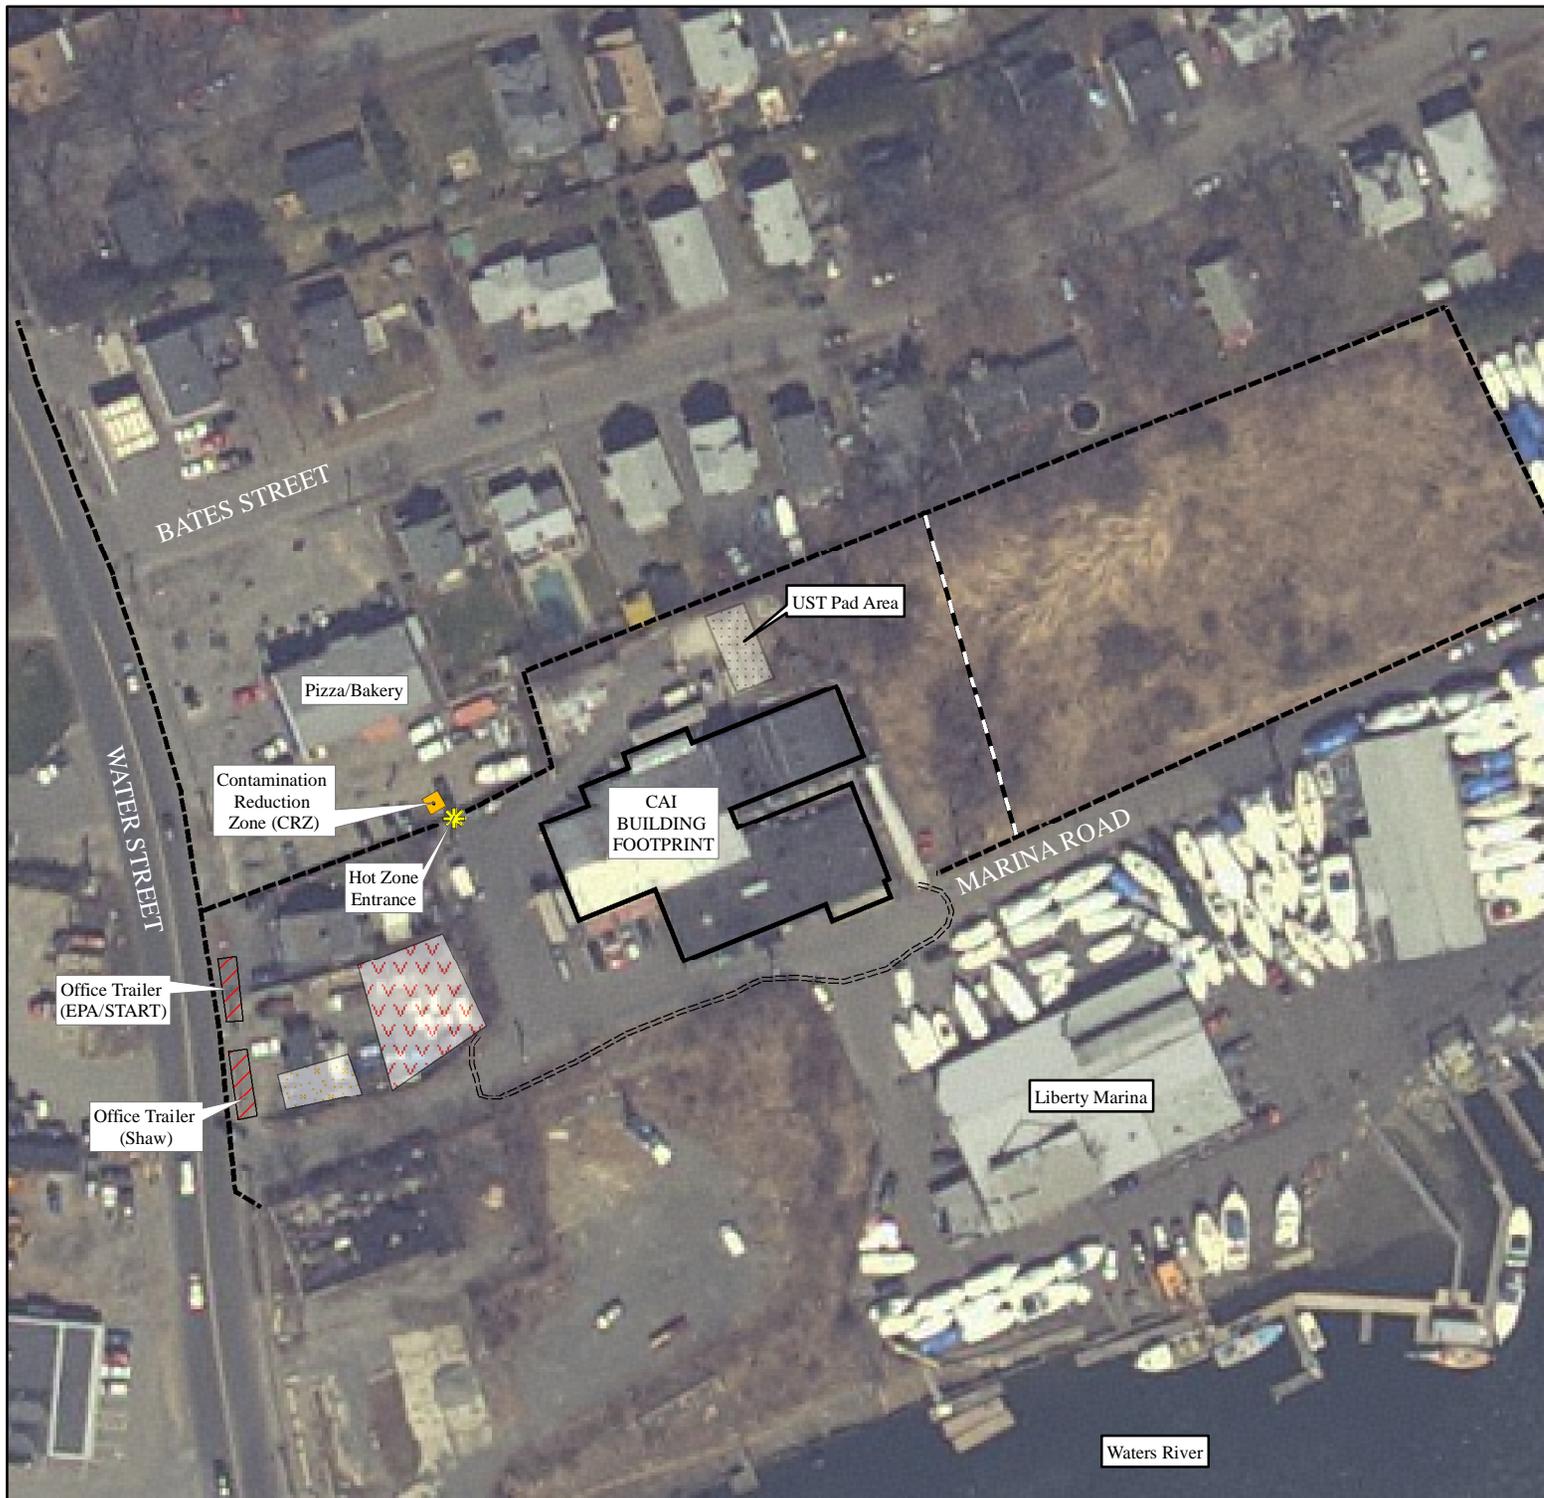
Figure 2

SITE DIAGRAM

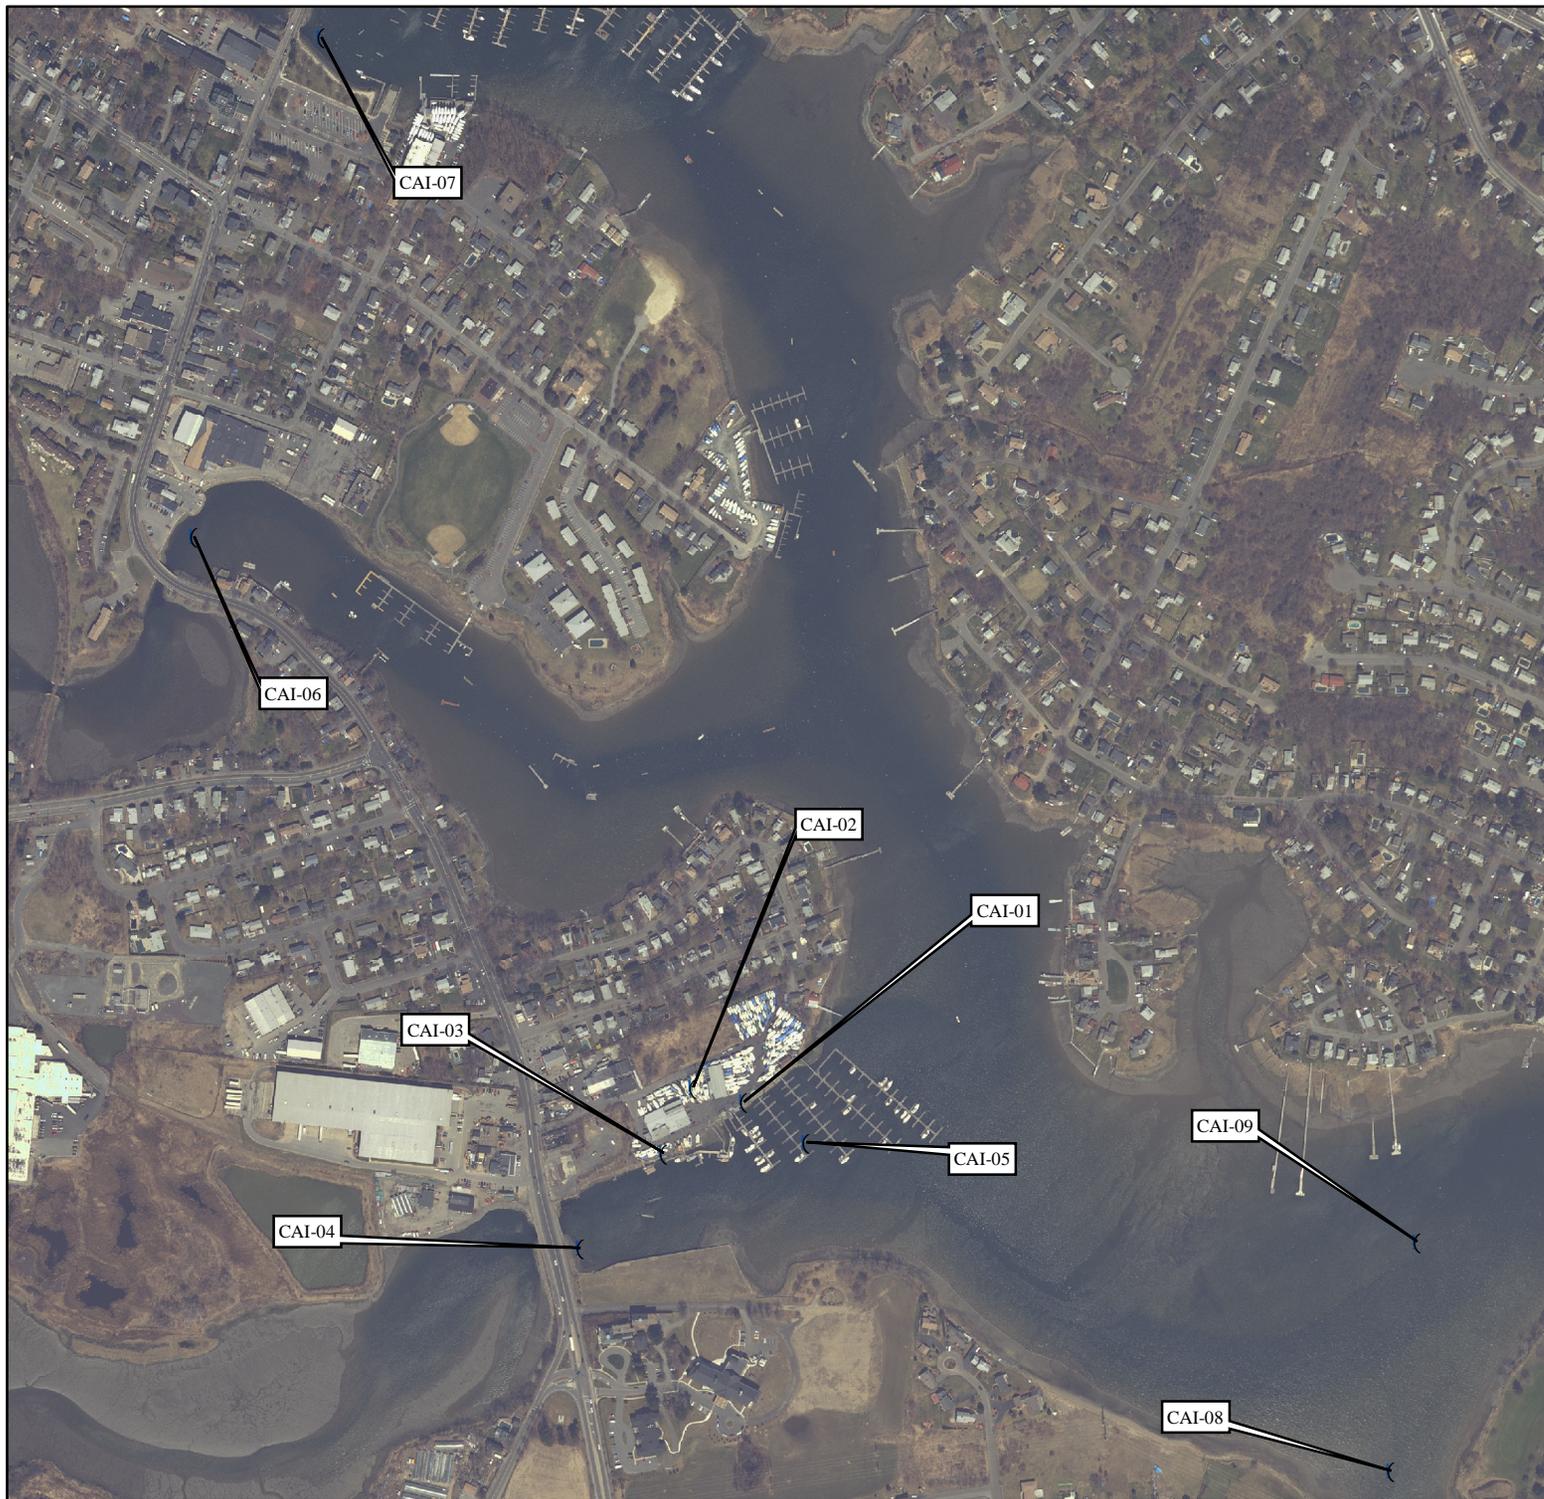
Figure 4
11/22/06
SURFACE WATER
SAMPLE LOCATION MAP
DANVERSPORT EXPLOSION SITE
126 WATER STREET
DANVERS, MASSACHUSETTS

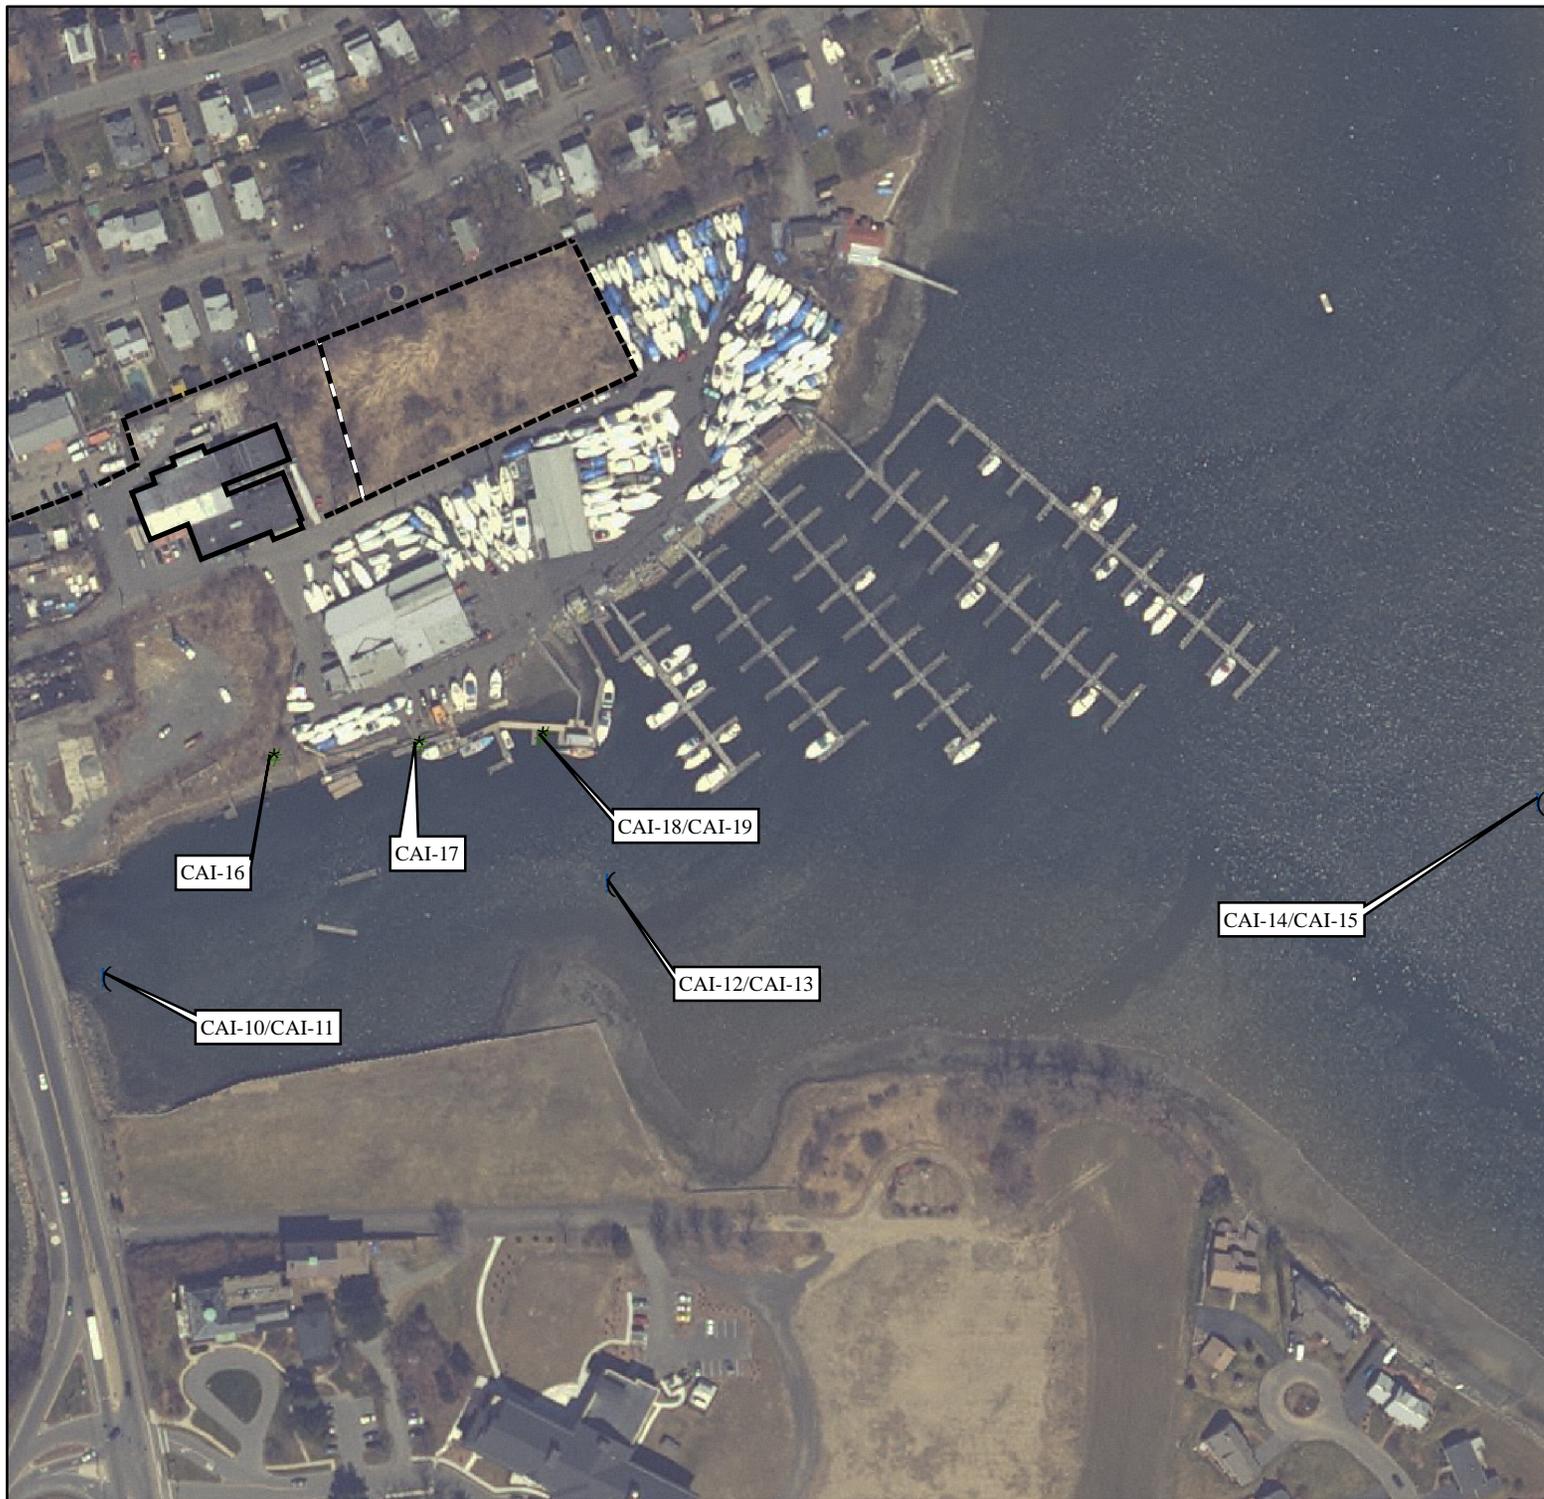
Figure 5
11/24/06
SURFACE WATER AND SEDIMENT
SAMPLE LOCATION MAP
DANVERSPORT EXPLOSION SITE
126 WATER STREET
DANVERS, MASSACHUSETTS

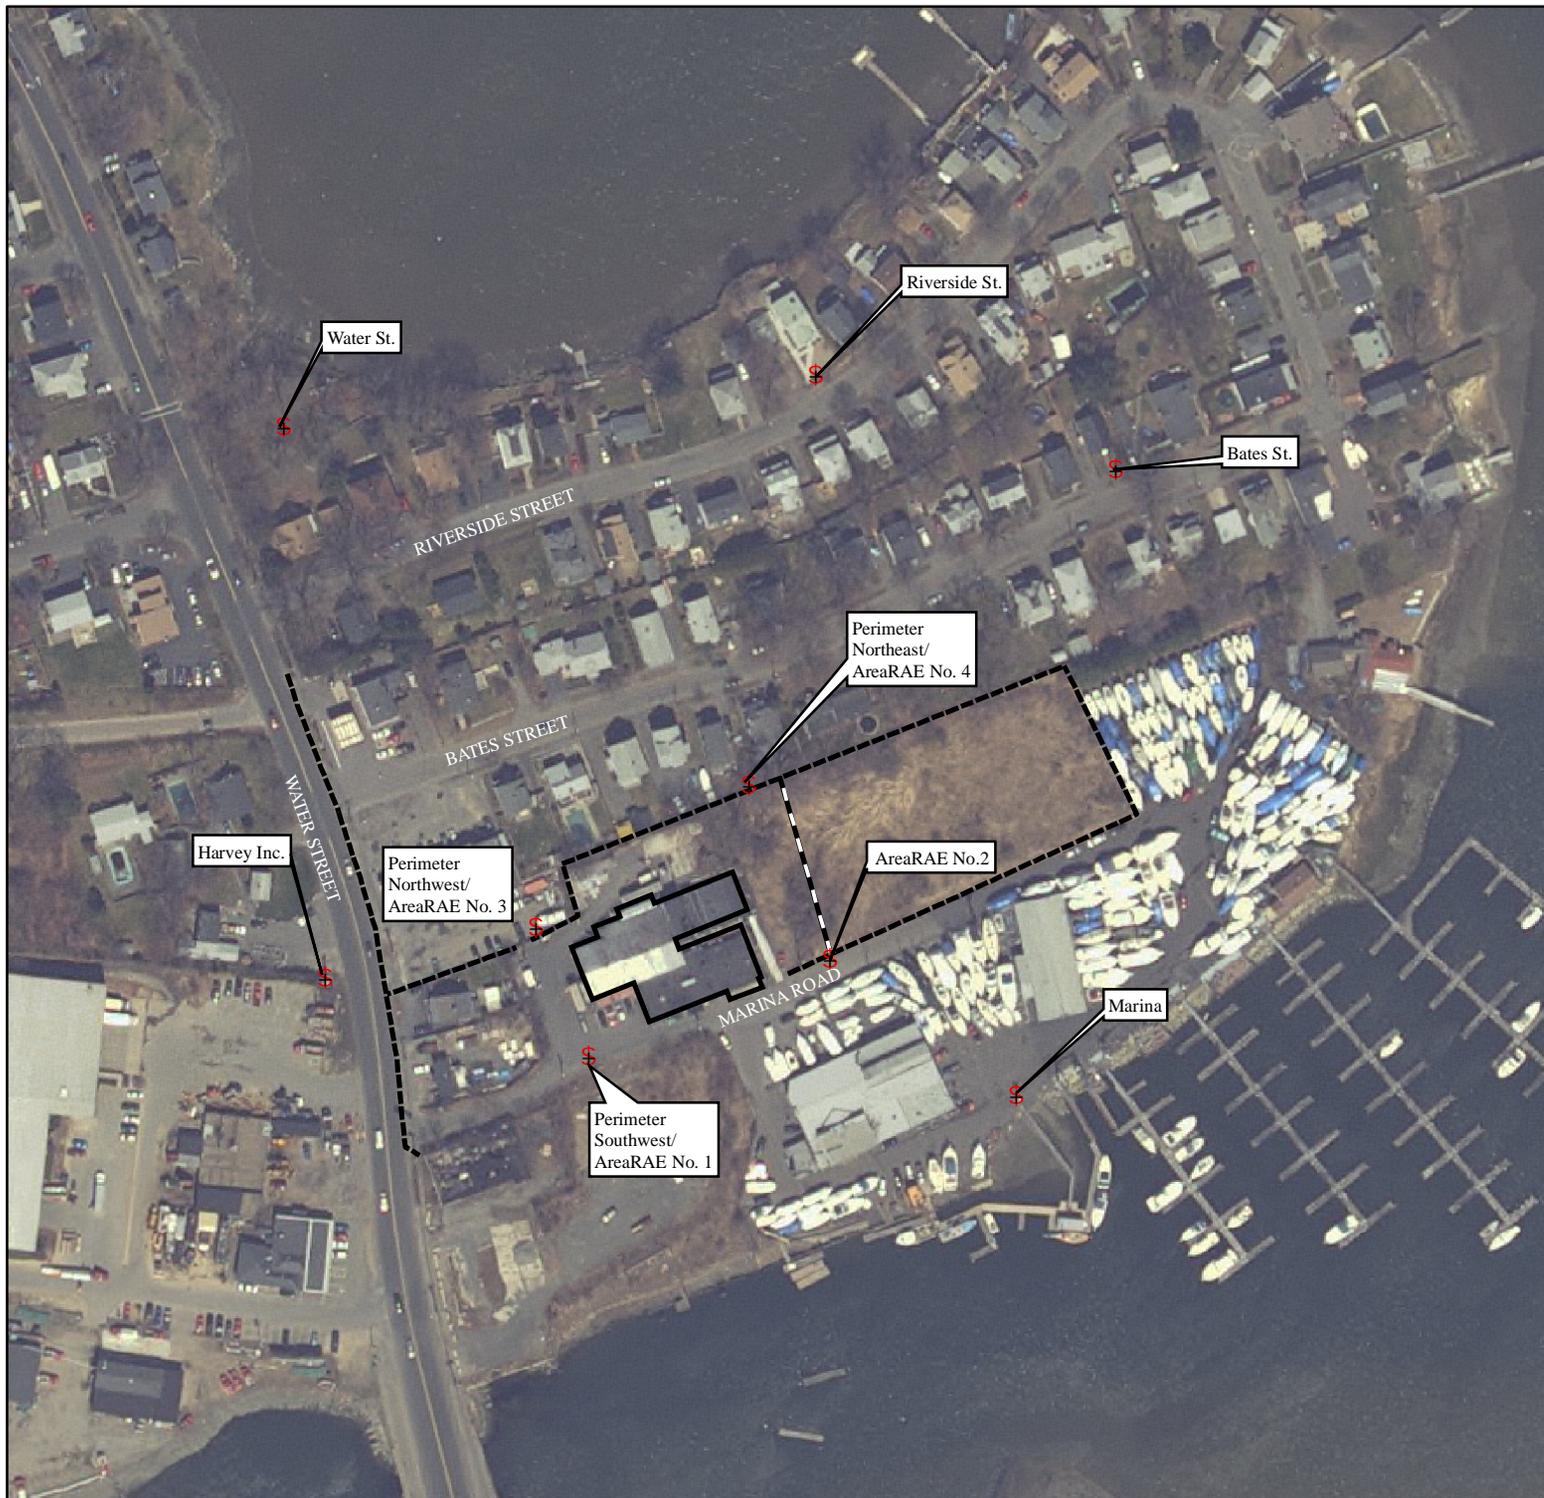
Figure 6

AIR SAMPLE LOCATION MAP

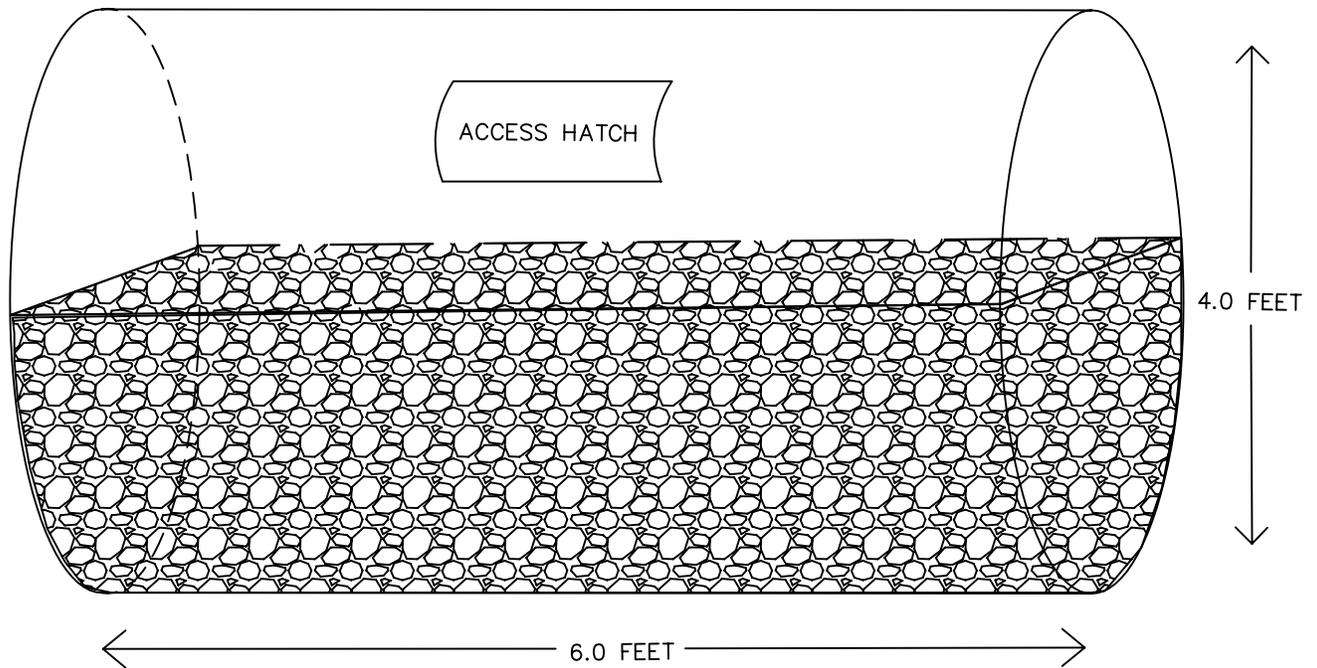
VAT NO. 11 IS AN APPROXIMATELY 250 GALLON PEBBLE TUMBLER. A RECONNAISSANCE OF THE VAT INDICATED THE VAT WAS APPROXIMATELY HALF FULL OF SMOOTH 1-INCH STONE.

NOTE: MEASUREMENTS ARE APPROXIMATE

VAT NO. 11 DIAGRAM
DANVERSPORT EXPLOSION SITE
126 WATER STREET
DANVERS, MASSACHUSETTS

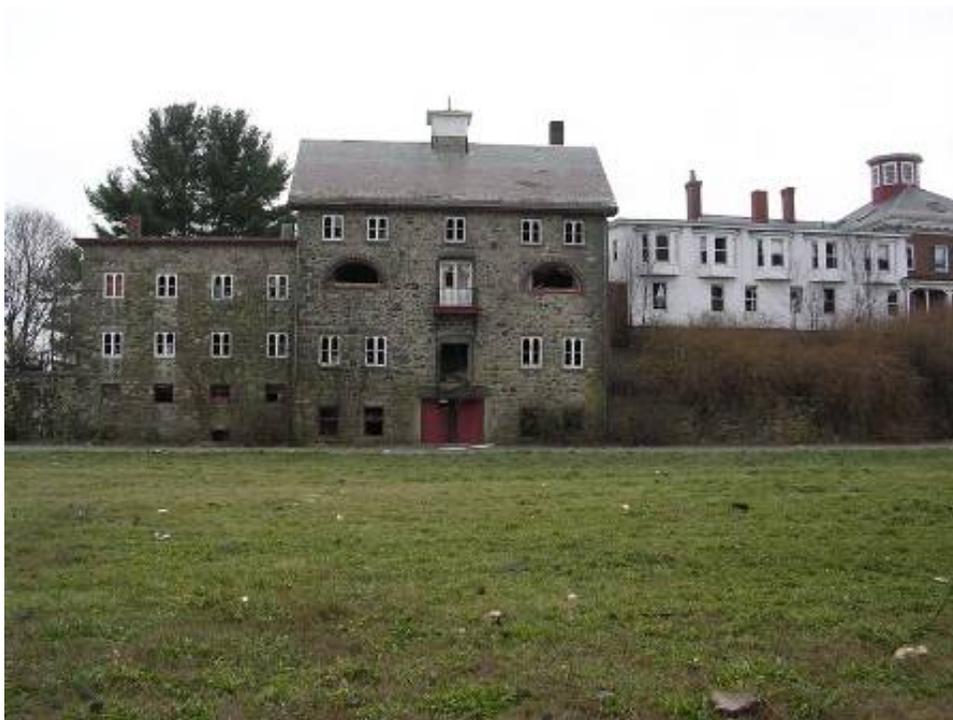
SCENE: View of the blast damaged windows at the Massachusetts School for the Deaf. Photograph taken facing south.

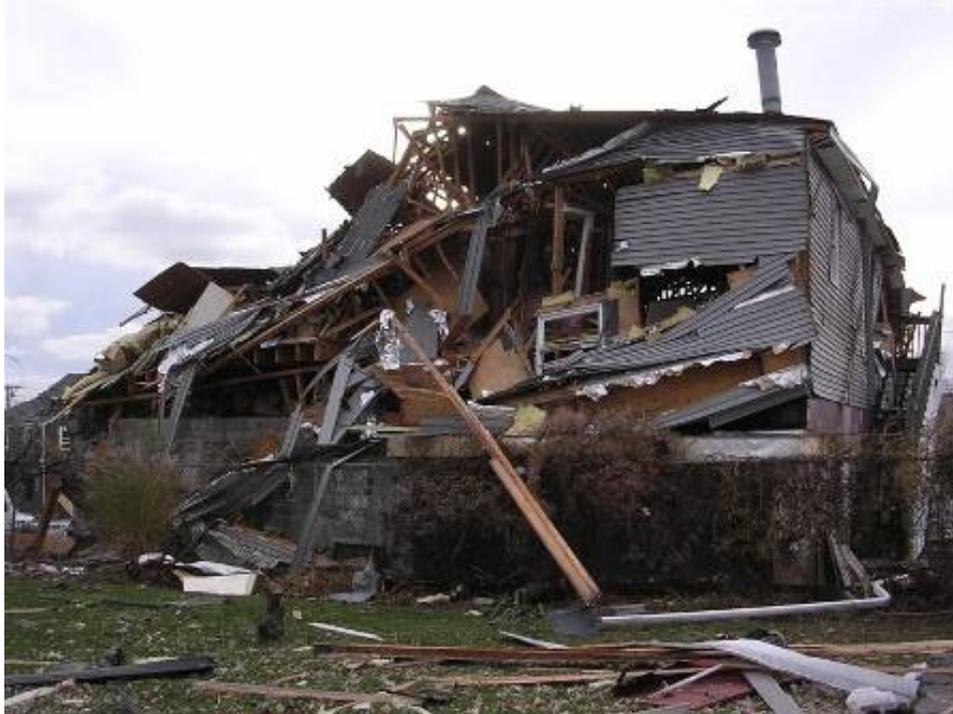
SCENE: View of the damaged pizza/bakery business on Water Street. Photograph taken facing west.

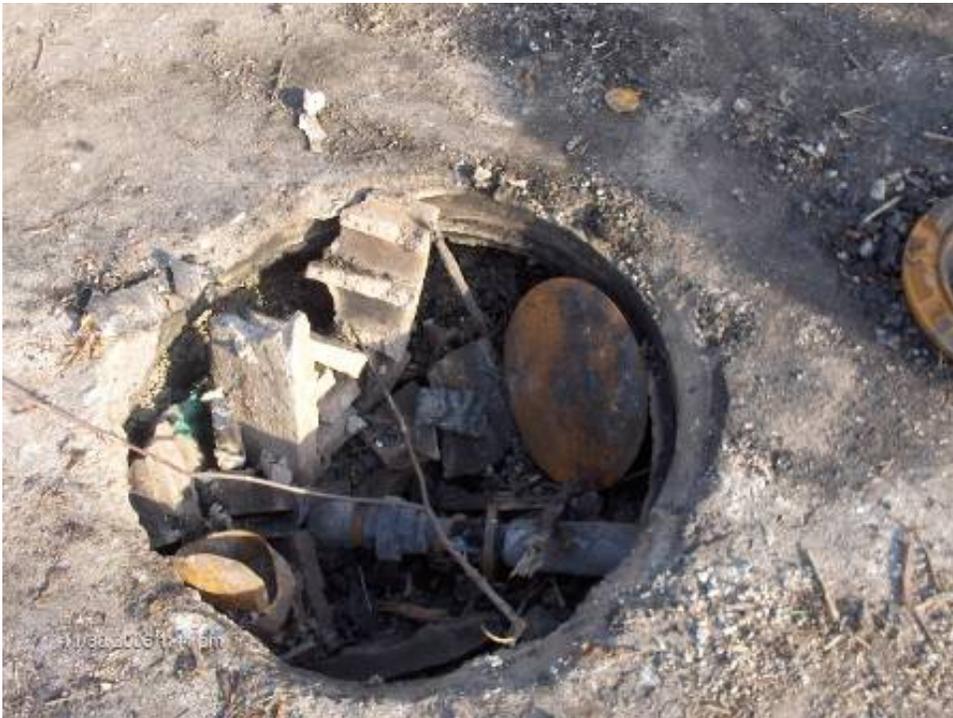
SCENE: View of the center fill port of the n-butyl acetate underground storage tank (UST).

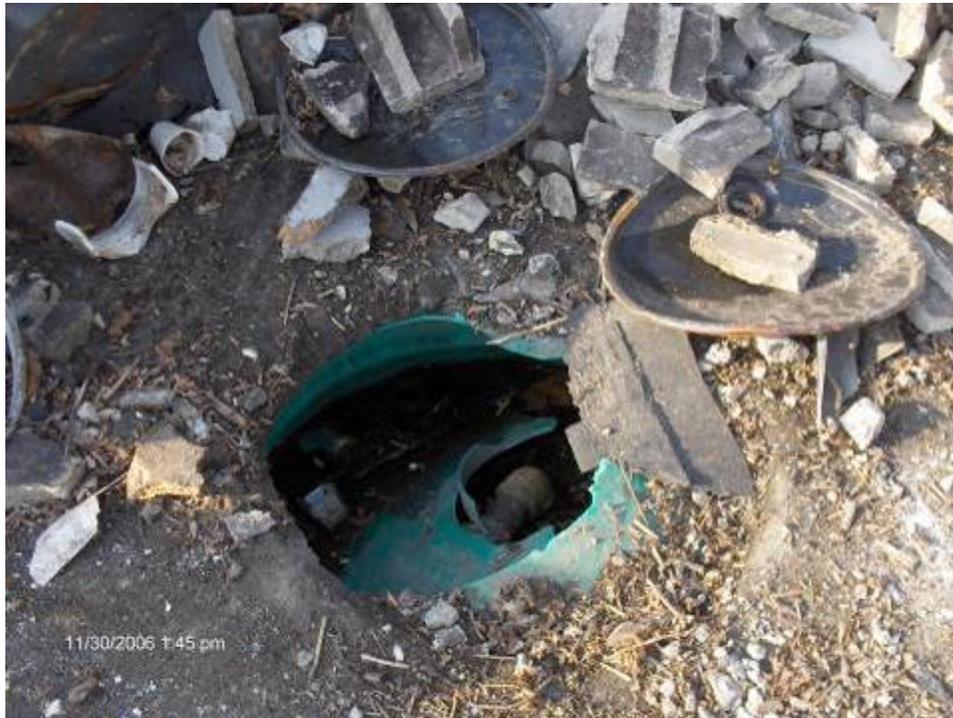
SCENE: View of the western fill port of the acetone UST.

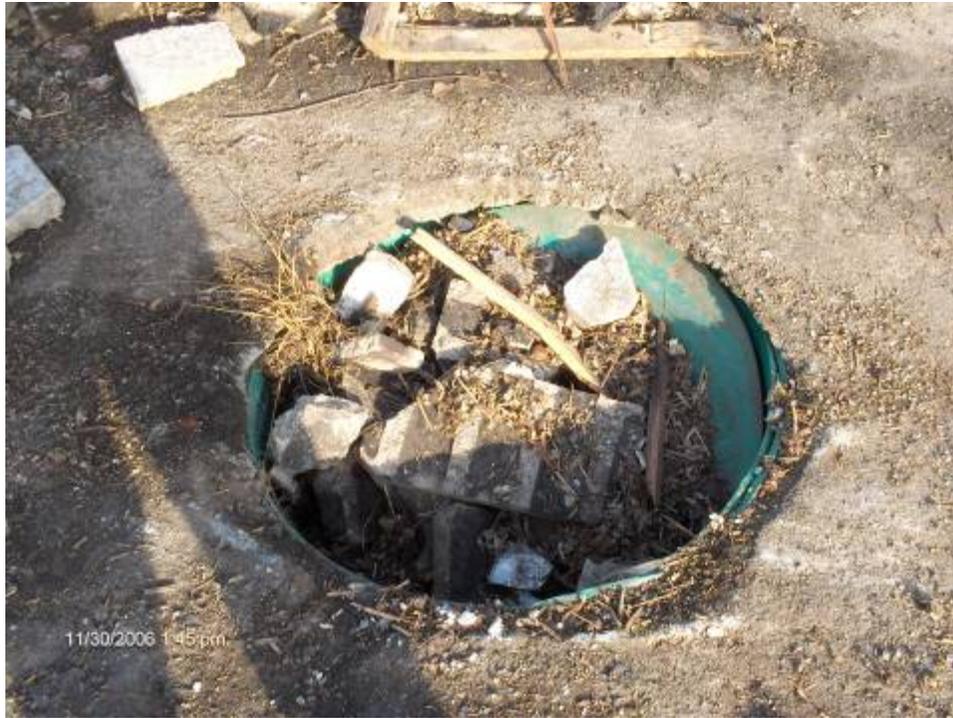
SCENE: View of the center fill port of the acetone UST.

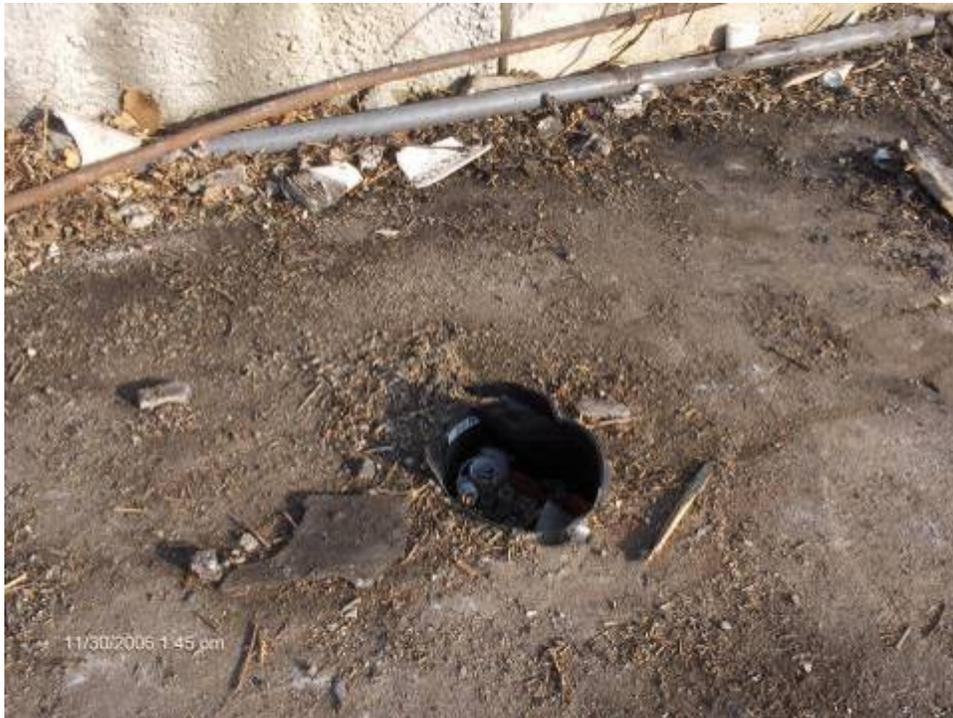
SCENE: View of the eastern fill port of the toluene UST.

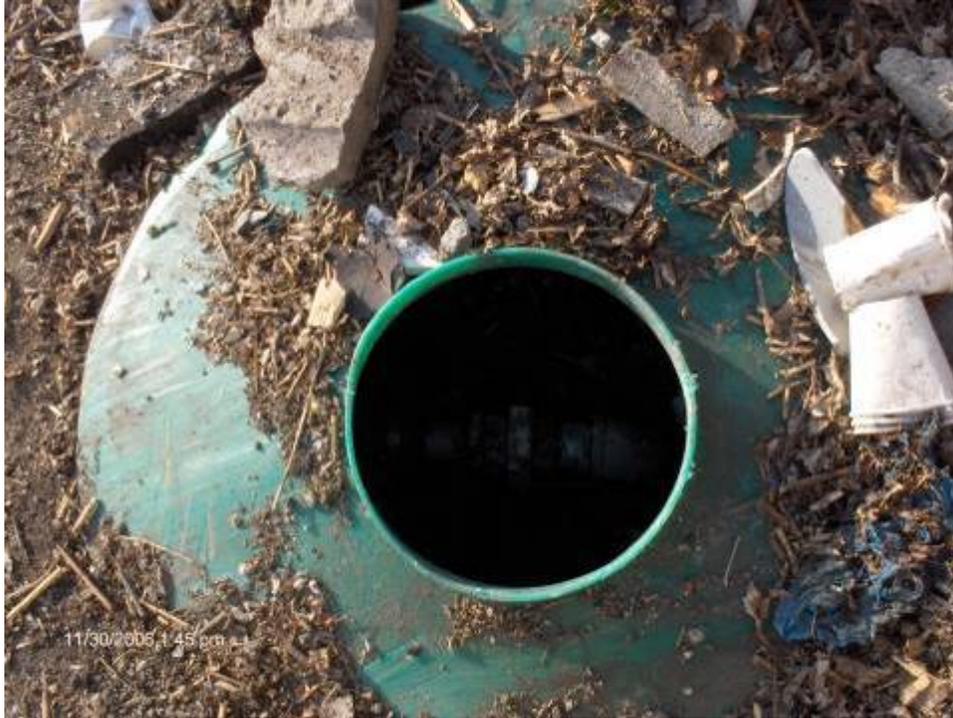
SCENE: View of the eastern fill port of the acetone UST.

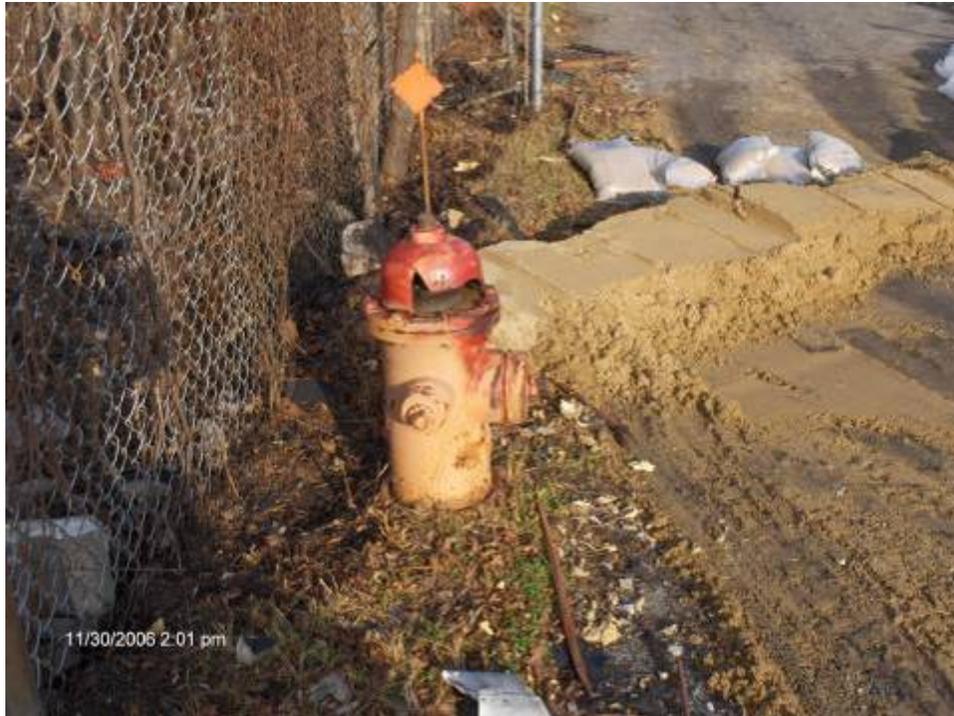
SCENE: View of a damaged fire hydrant at the southeast border of the property adjacent to the marina access road. Photograph taken facing east.

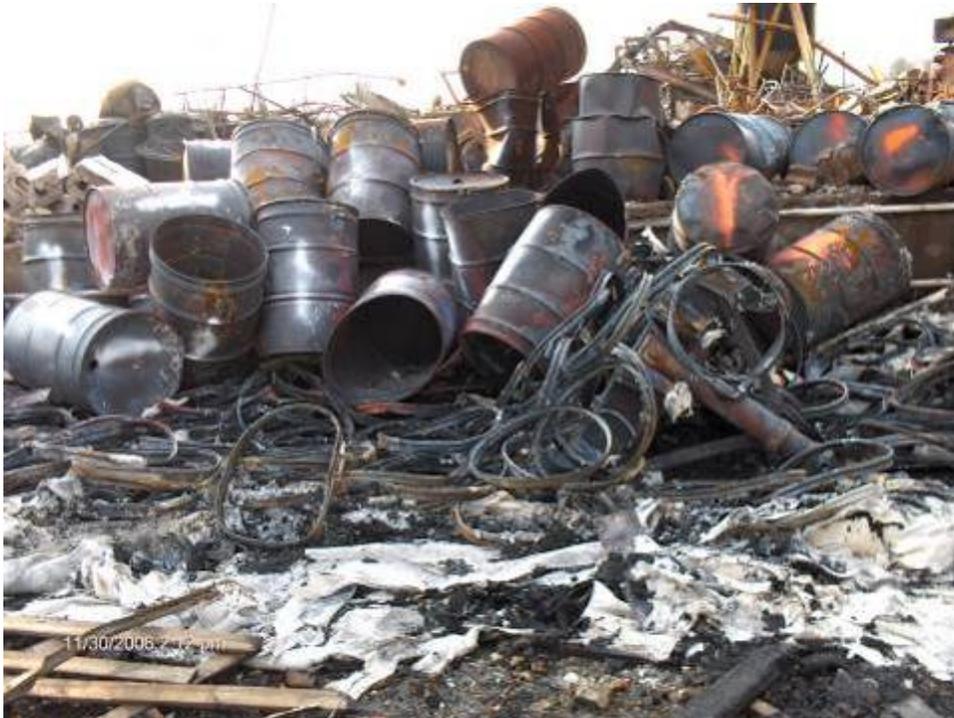
SCENE: View of drums and drum rings on the eastern side of the building footprint. Photograph taken facing west.

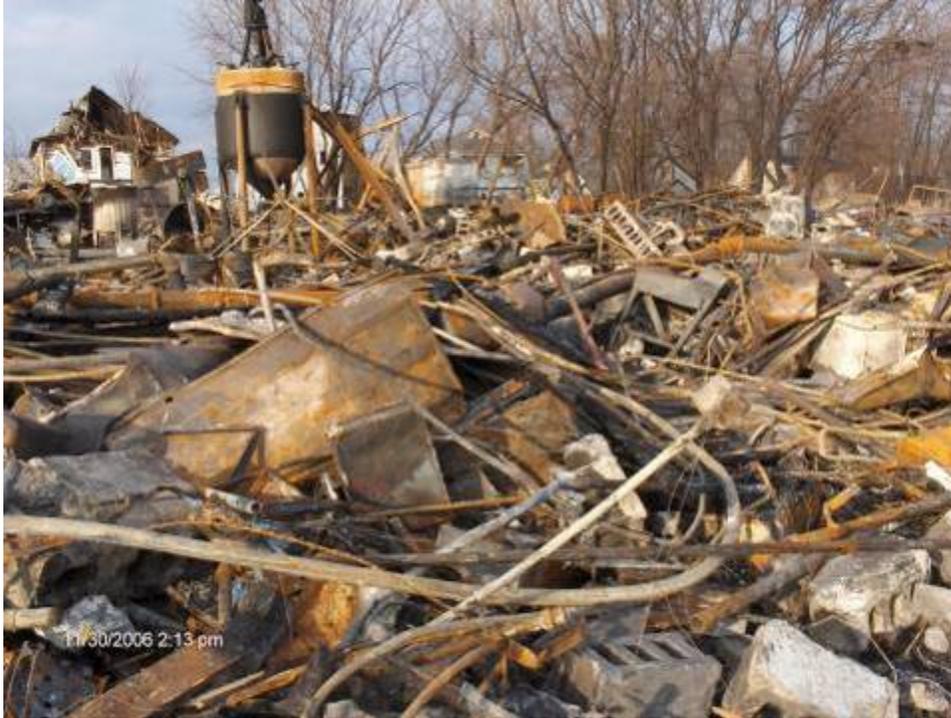
SCENE: View of debris and tanks within the building footprint. Photograph taken facing north.

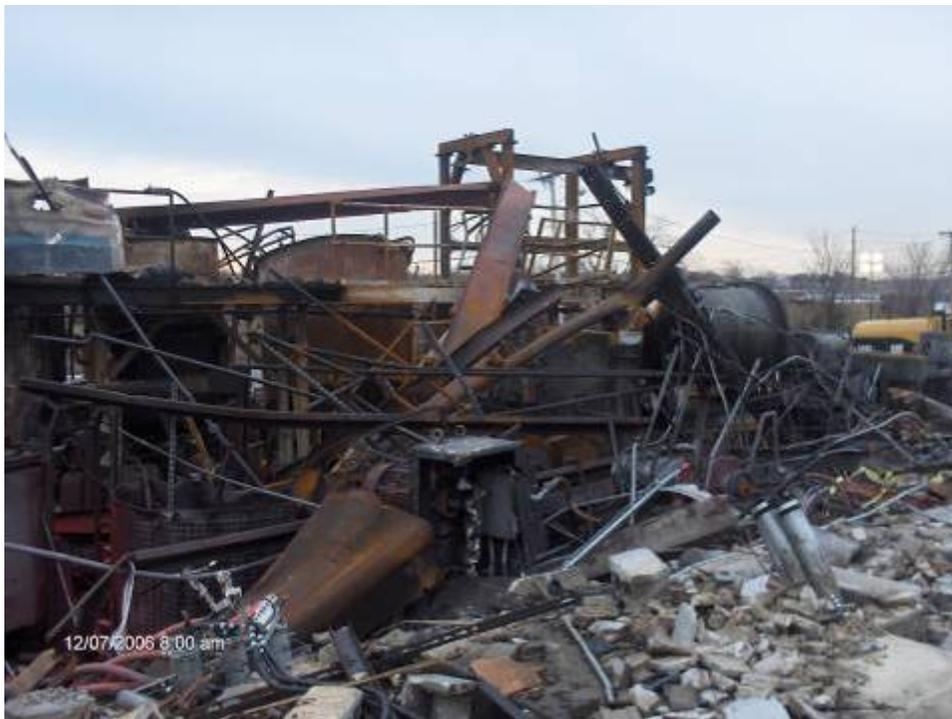
SCENE: View of the building and equipment remains within the building footprint. Photograph taken facing southwest.

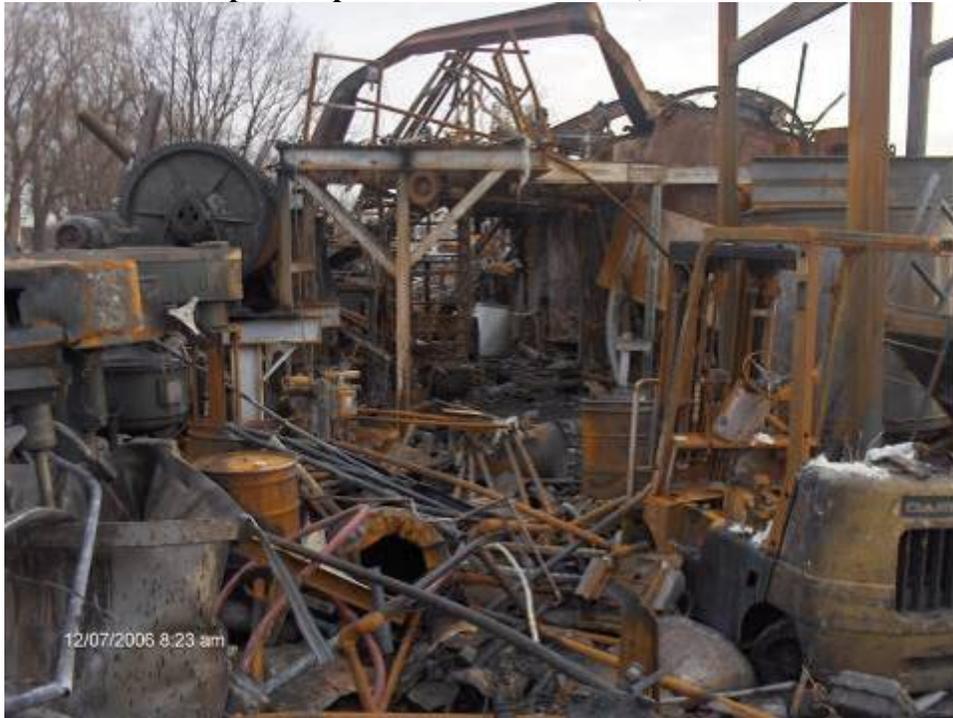
SCENE: View of the building and equipment remains within the building footprint. Photograph taken facing east.

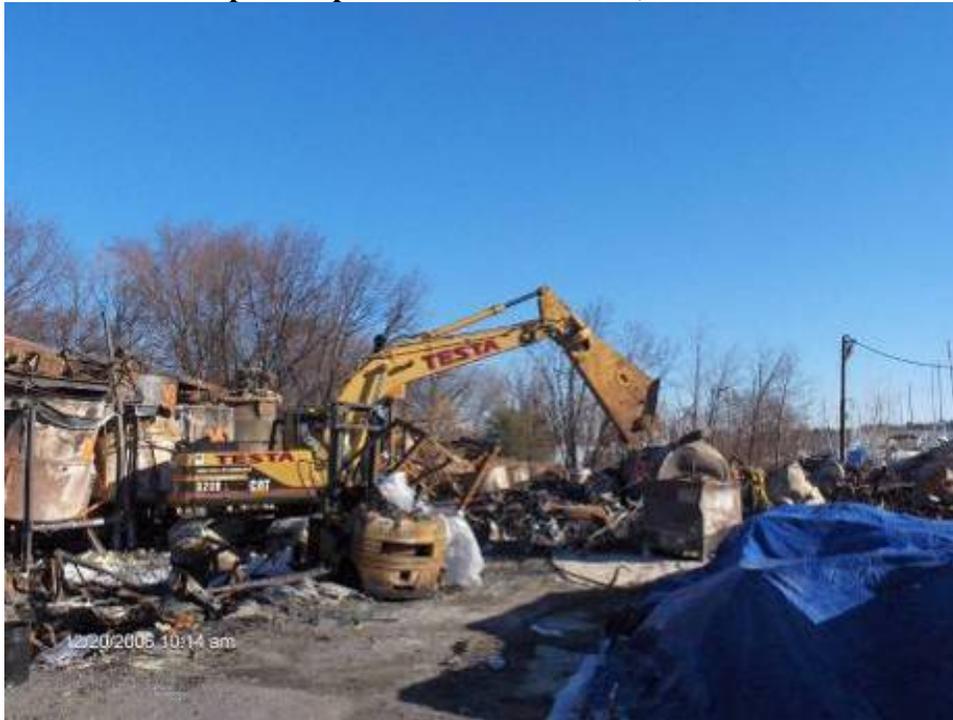
SCENE: View of the excavator shear cutting vats. Photograph taken facing east.

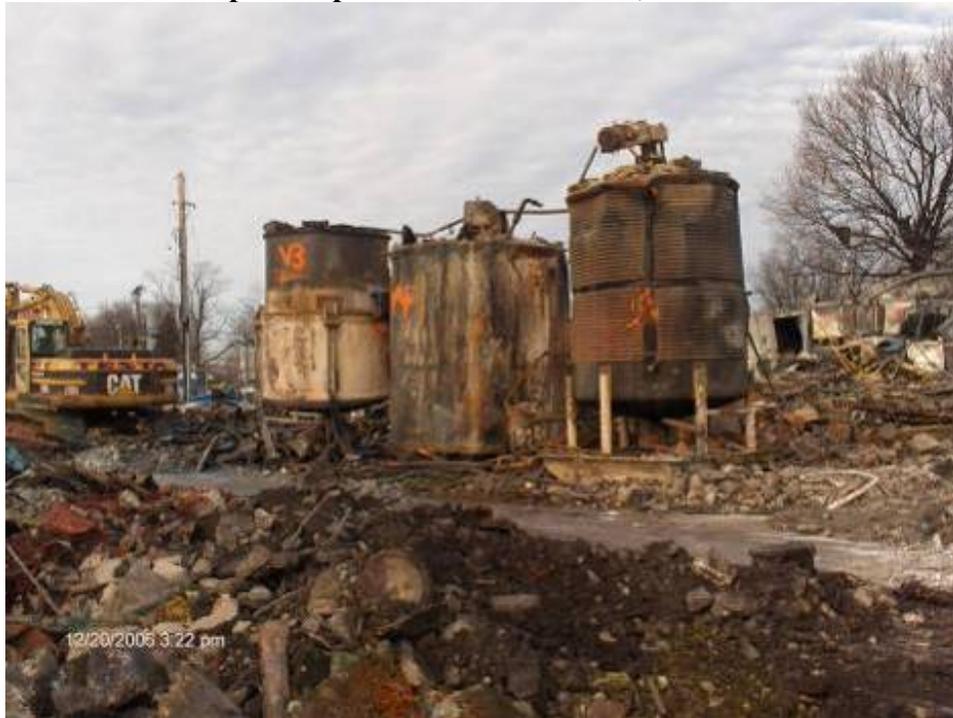
SCENE: View of Vat Nos. 3, 4, and 5. Photograph taken facing northwest.

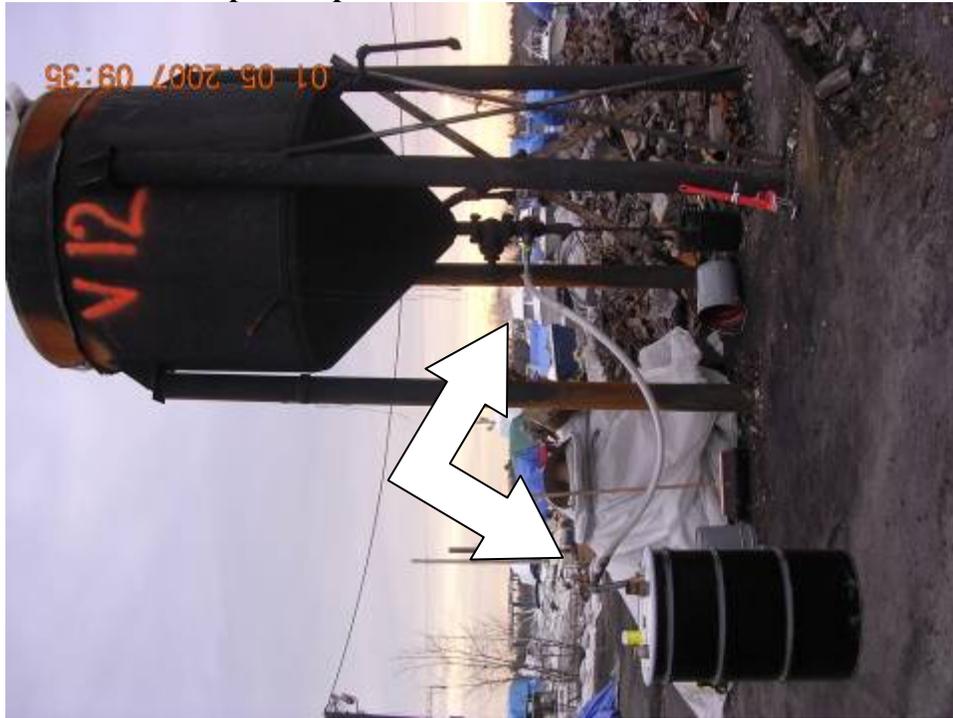
SCENE: View of Vat No. 12, with pipe system set up for product transfer. Photograph taken facing southeast.

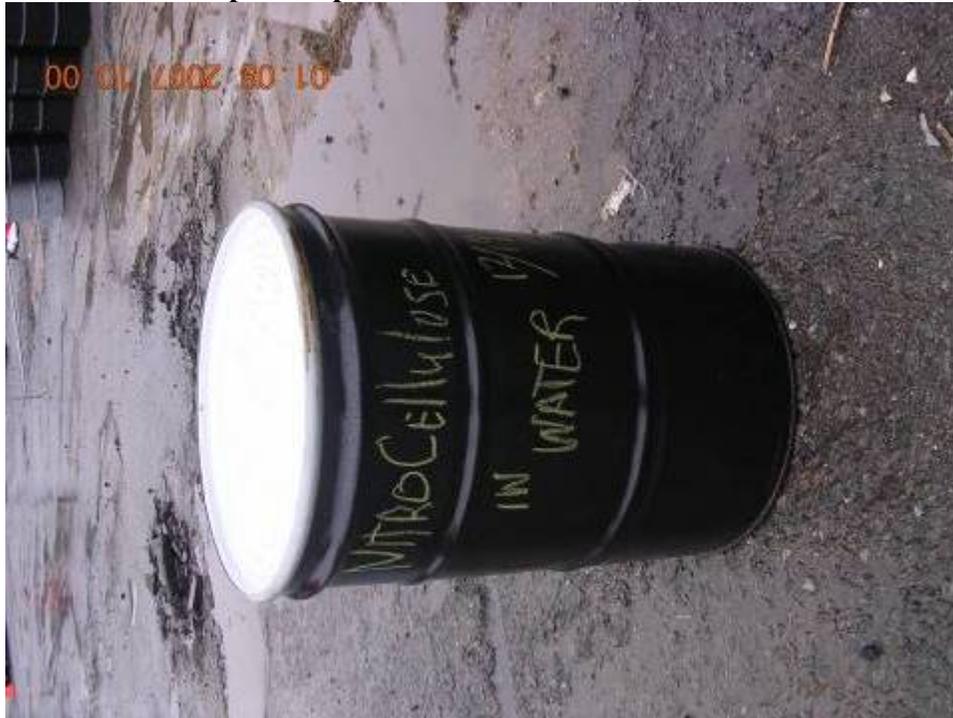
SCENE: View of the nitrocellulose drum ready for disposal. Photograph taken facing northwest.

On 18 December 2006, Arnel representatives conducted a survey of the building footprint. During the survey of the footprint, approximately 3 to 4 pounds of suspected nitrocellulose in the remnants of a fiber drum were observed near Vat No. 7. The nitrocellulose was to be wetted with dihydrous monoxide (DHM), collected using plastic scoops into a container, and covered with DHM to stabilize the nitrocellulose.

On 19 December 2006, ERRS personnel identified additional nitrocellulose and containerized the material. A total of five 5-gallon plastic buckets were filled with a combination of nitrocellulose and tap water. The tap water was used to reduce the fire/explosion hazard and to stabilize the nitrocellulose. The contents of the 5-gallon pails containing hydrated nitrocellulose were transferred to a 55-gallon drum.

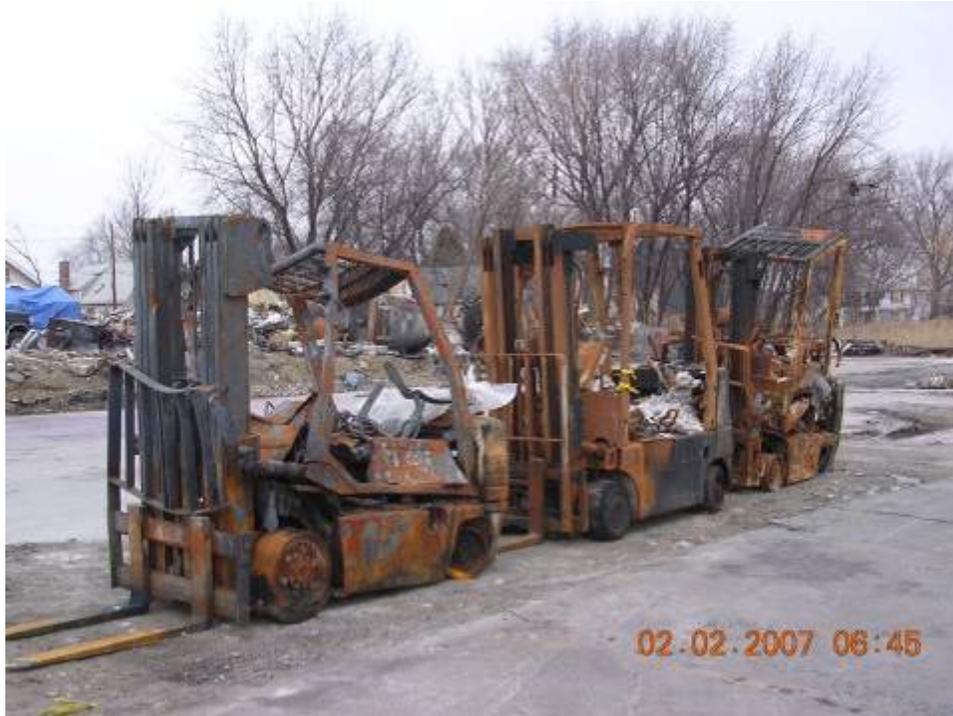
SCENE: View of the damaged forklifts staged on the site. Photograph taken facing northeast.

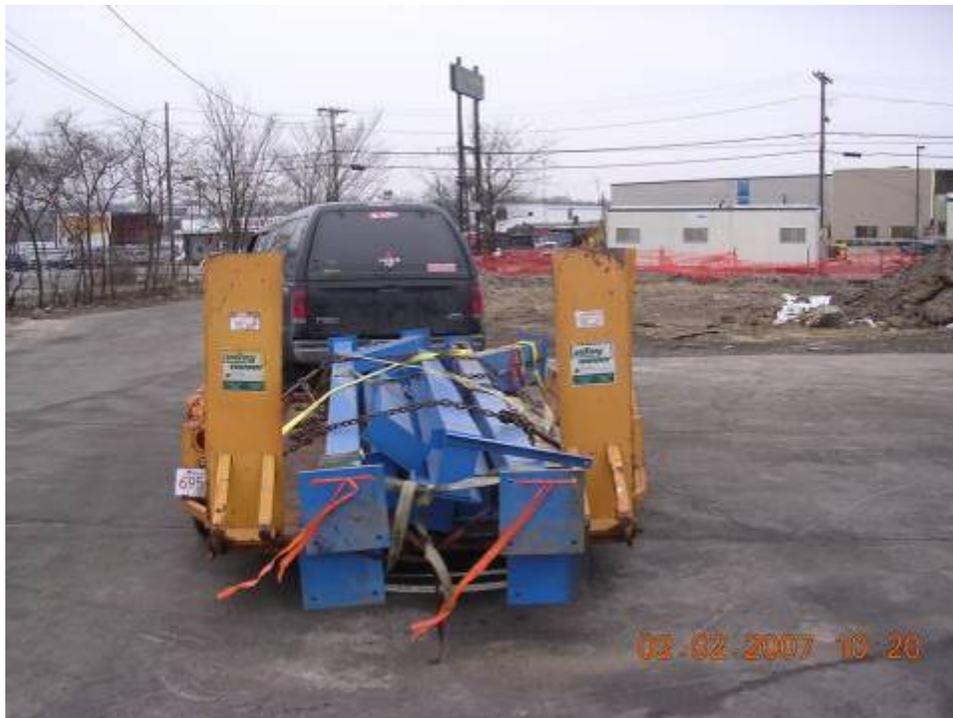
SCENE: View of the dust collection system components that were removed by CAI personnel. Photograph taken facing west.
