Memorandum

To: Joel Lindsay, Weston Solutions, Inc.
From: Todd Chadwell, Woodlot Alternatives
Cc: Izabela Zapisek, Weston Solutions, Inc.
Date: May 31, 2007
Re: 2007 Spring Vegetation Monitoring Report

On May 14 and May 15, 2007, Woodlot Alternatives, Inc. (Woodlot) established additional permanent monitoring plots in Monitoring Area 4 (South of Pomeroy Avenue Bridge) and conducted annual springtime vegetation monitoring and a meander survey in restored areas of the 1½-Mile Reach—GE Pittsfield/Housatonic River Site.

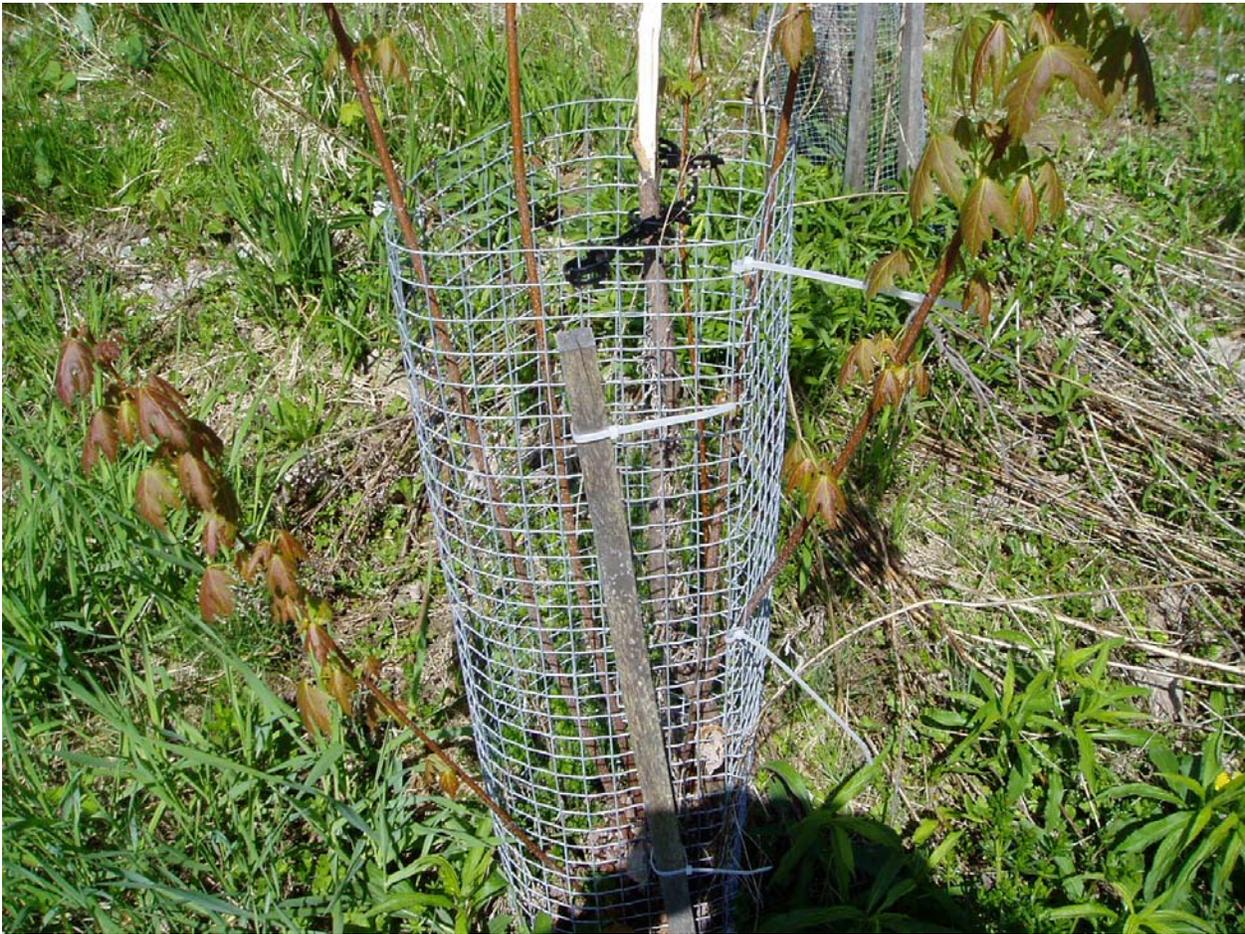
Photo 1. Silver maple requiring pruning due to lateral branching through protective cage.

- Remove protective cages from all shrubs as soon as possible.
- Perform pruning of tree branches growing through protective cages as soon as possible.
- Place tree guards around box elders that are shorter than tree cages.

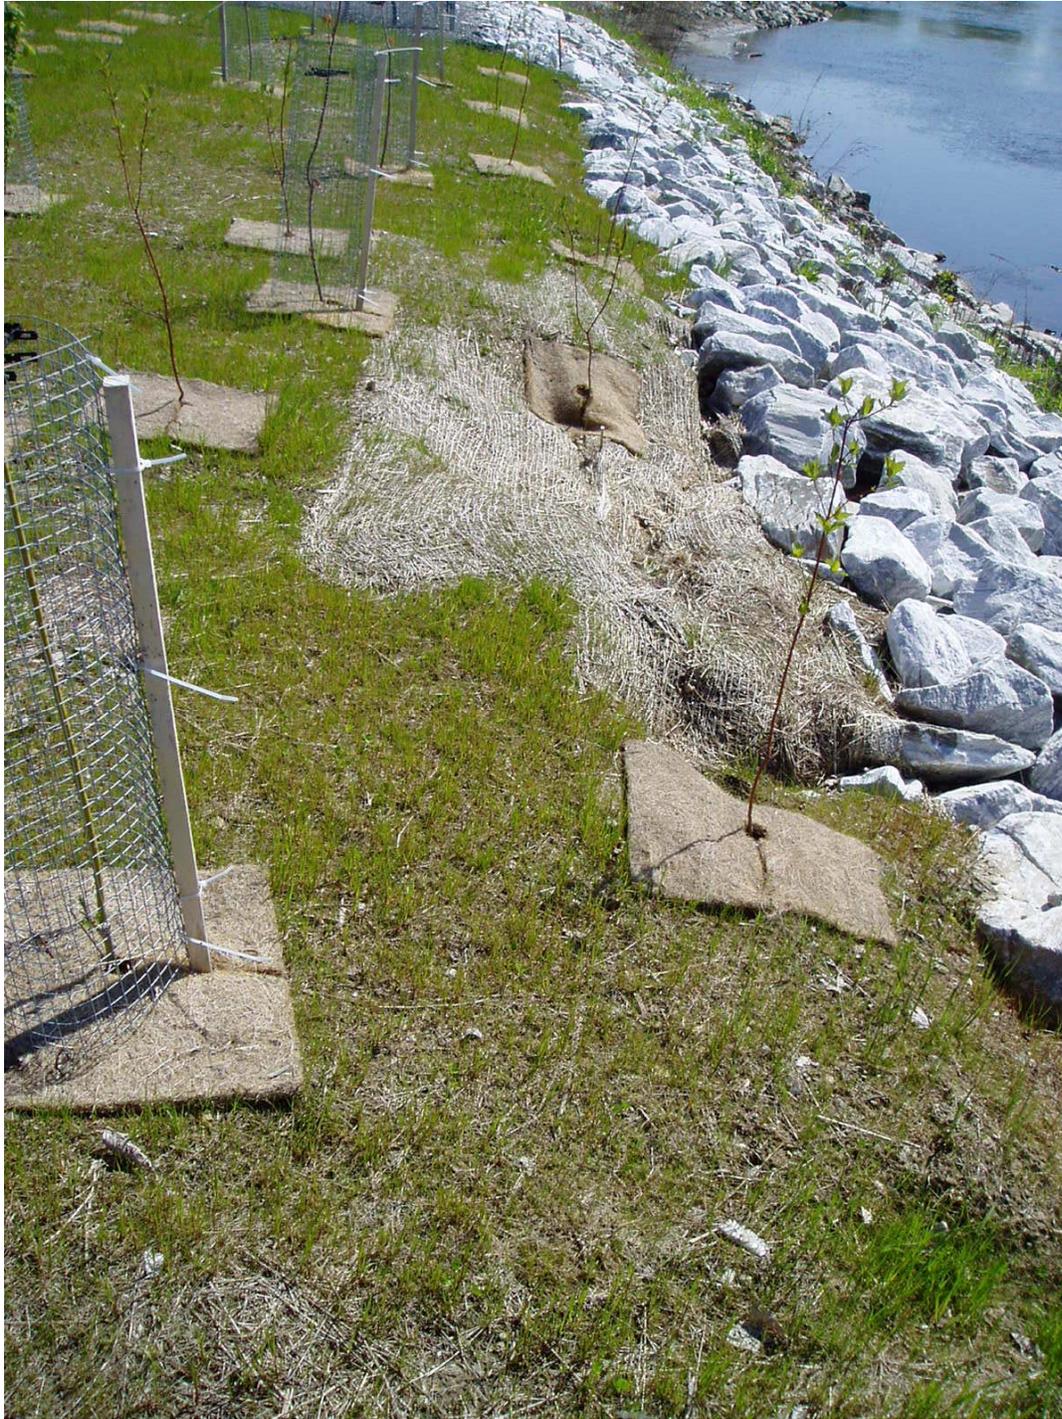
Minor erosion was noted at the top of bank behind the auto dealership on East Street (see photo 2). Erosion was also noted on the east bank across from the Silver Lake outfall and at STA 502+30. Forest tent caterpillars (*Malacosoma disstria*) were evident on one individual choke cherry shrub on the west bank within this reach. Damage caused by an unknown insect boring into woody growth of larger black willow trees was noted primarily on the east bank within this reach (see photo 3).

Photo 2. Erosion under erosion control mat on west bank south of Lyman Street.

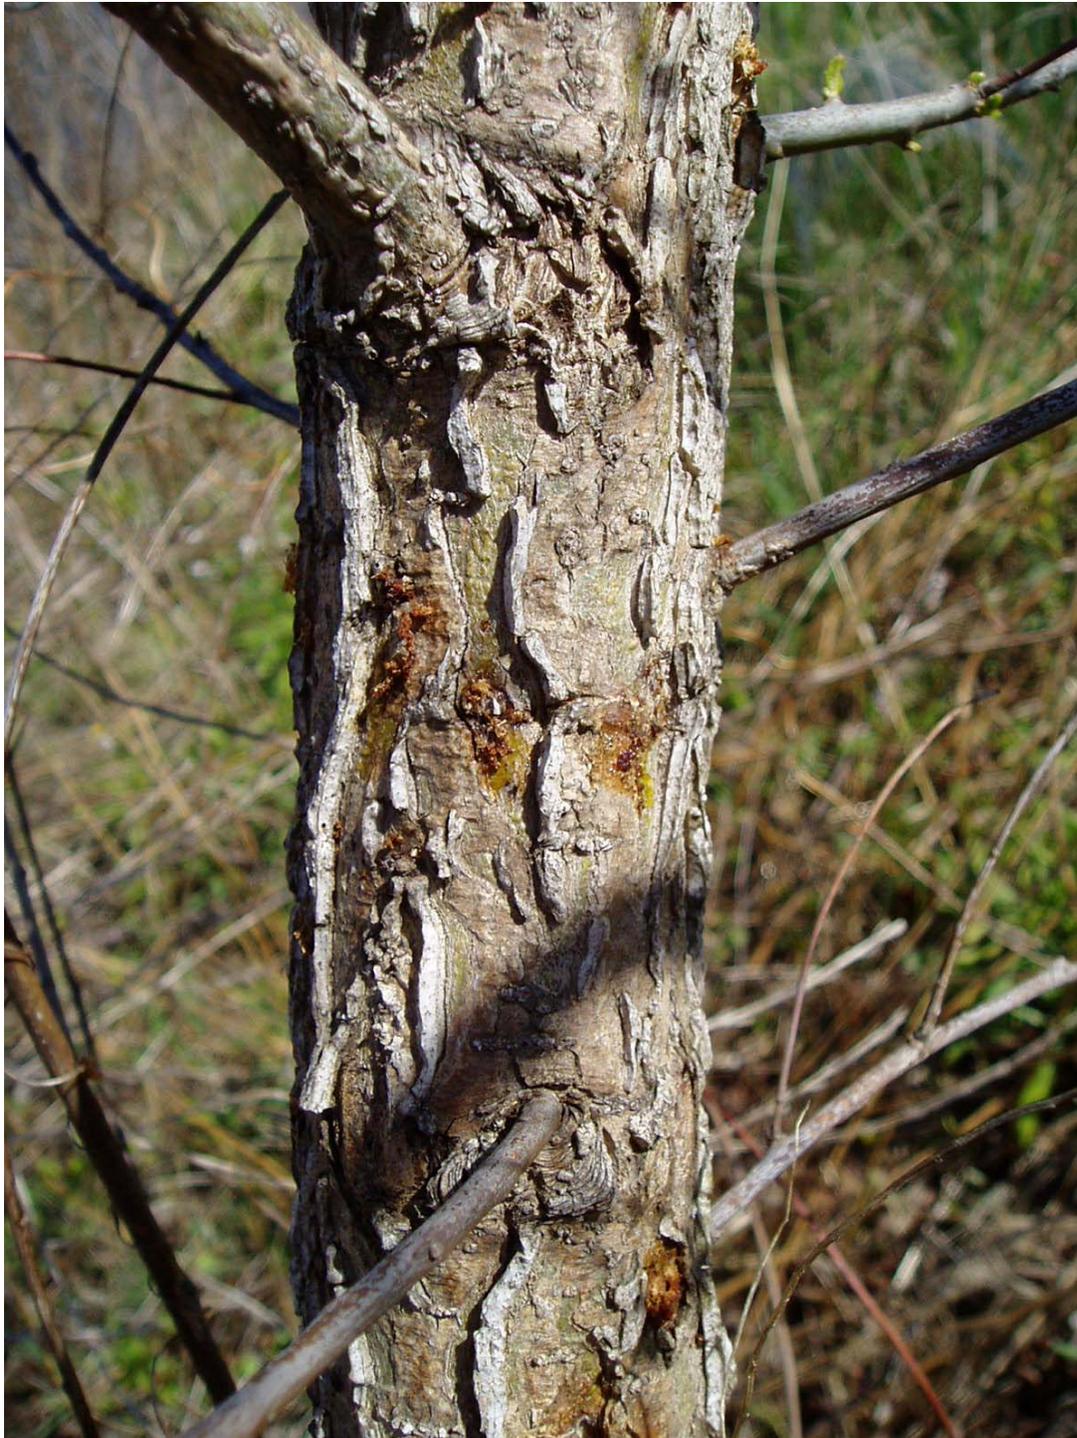
Photo 3. Wounds in black willow caused by insect boring into woody growth.
