**RE: Interim Post-Removal Site Control Plan  
1 ½-Mile Reach Removal Action  
GE-Pittsfield/Housatonic River Site, Pittsfield, Massachusetts**

**INTERIM POST - REMOVAL SITE CONTROL PLAN  
1½-MILE REMOVAL REACH  
GENERAL ELECTRIC (GE)-PITTSFIELD/HOUSATONIC  
RIVER SITE**

**DCN: GE-051908-ADWJ  
May 2008**

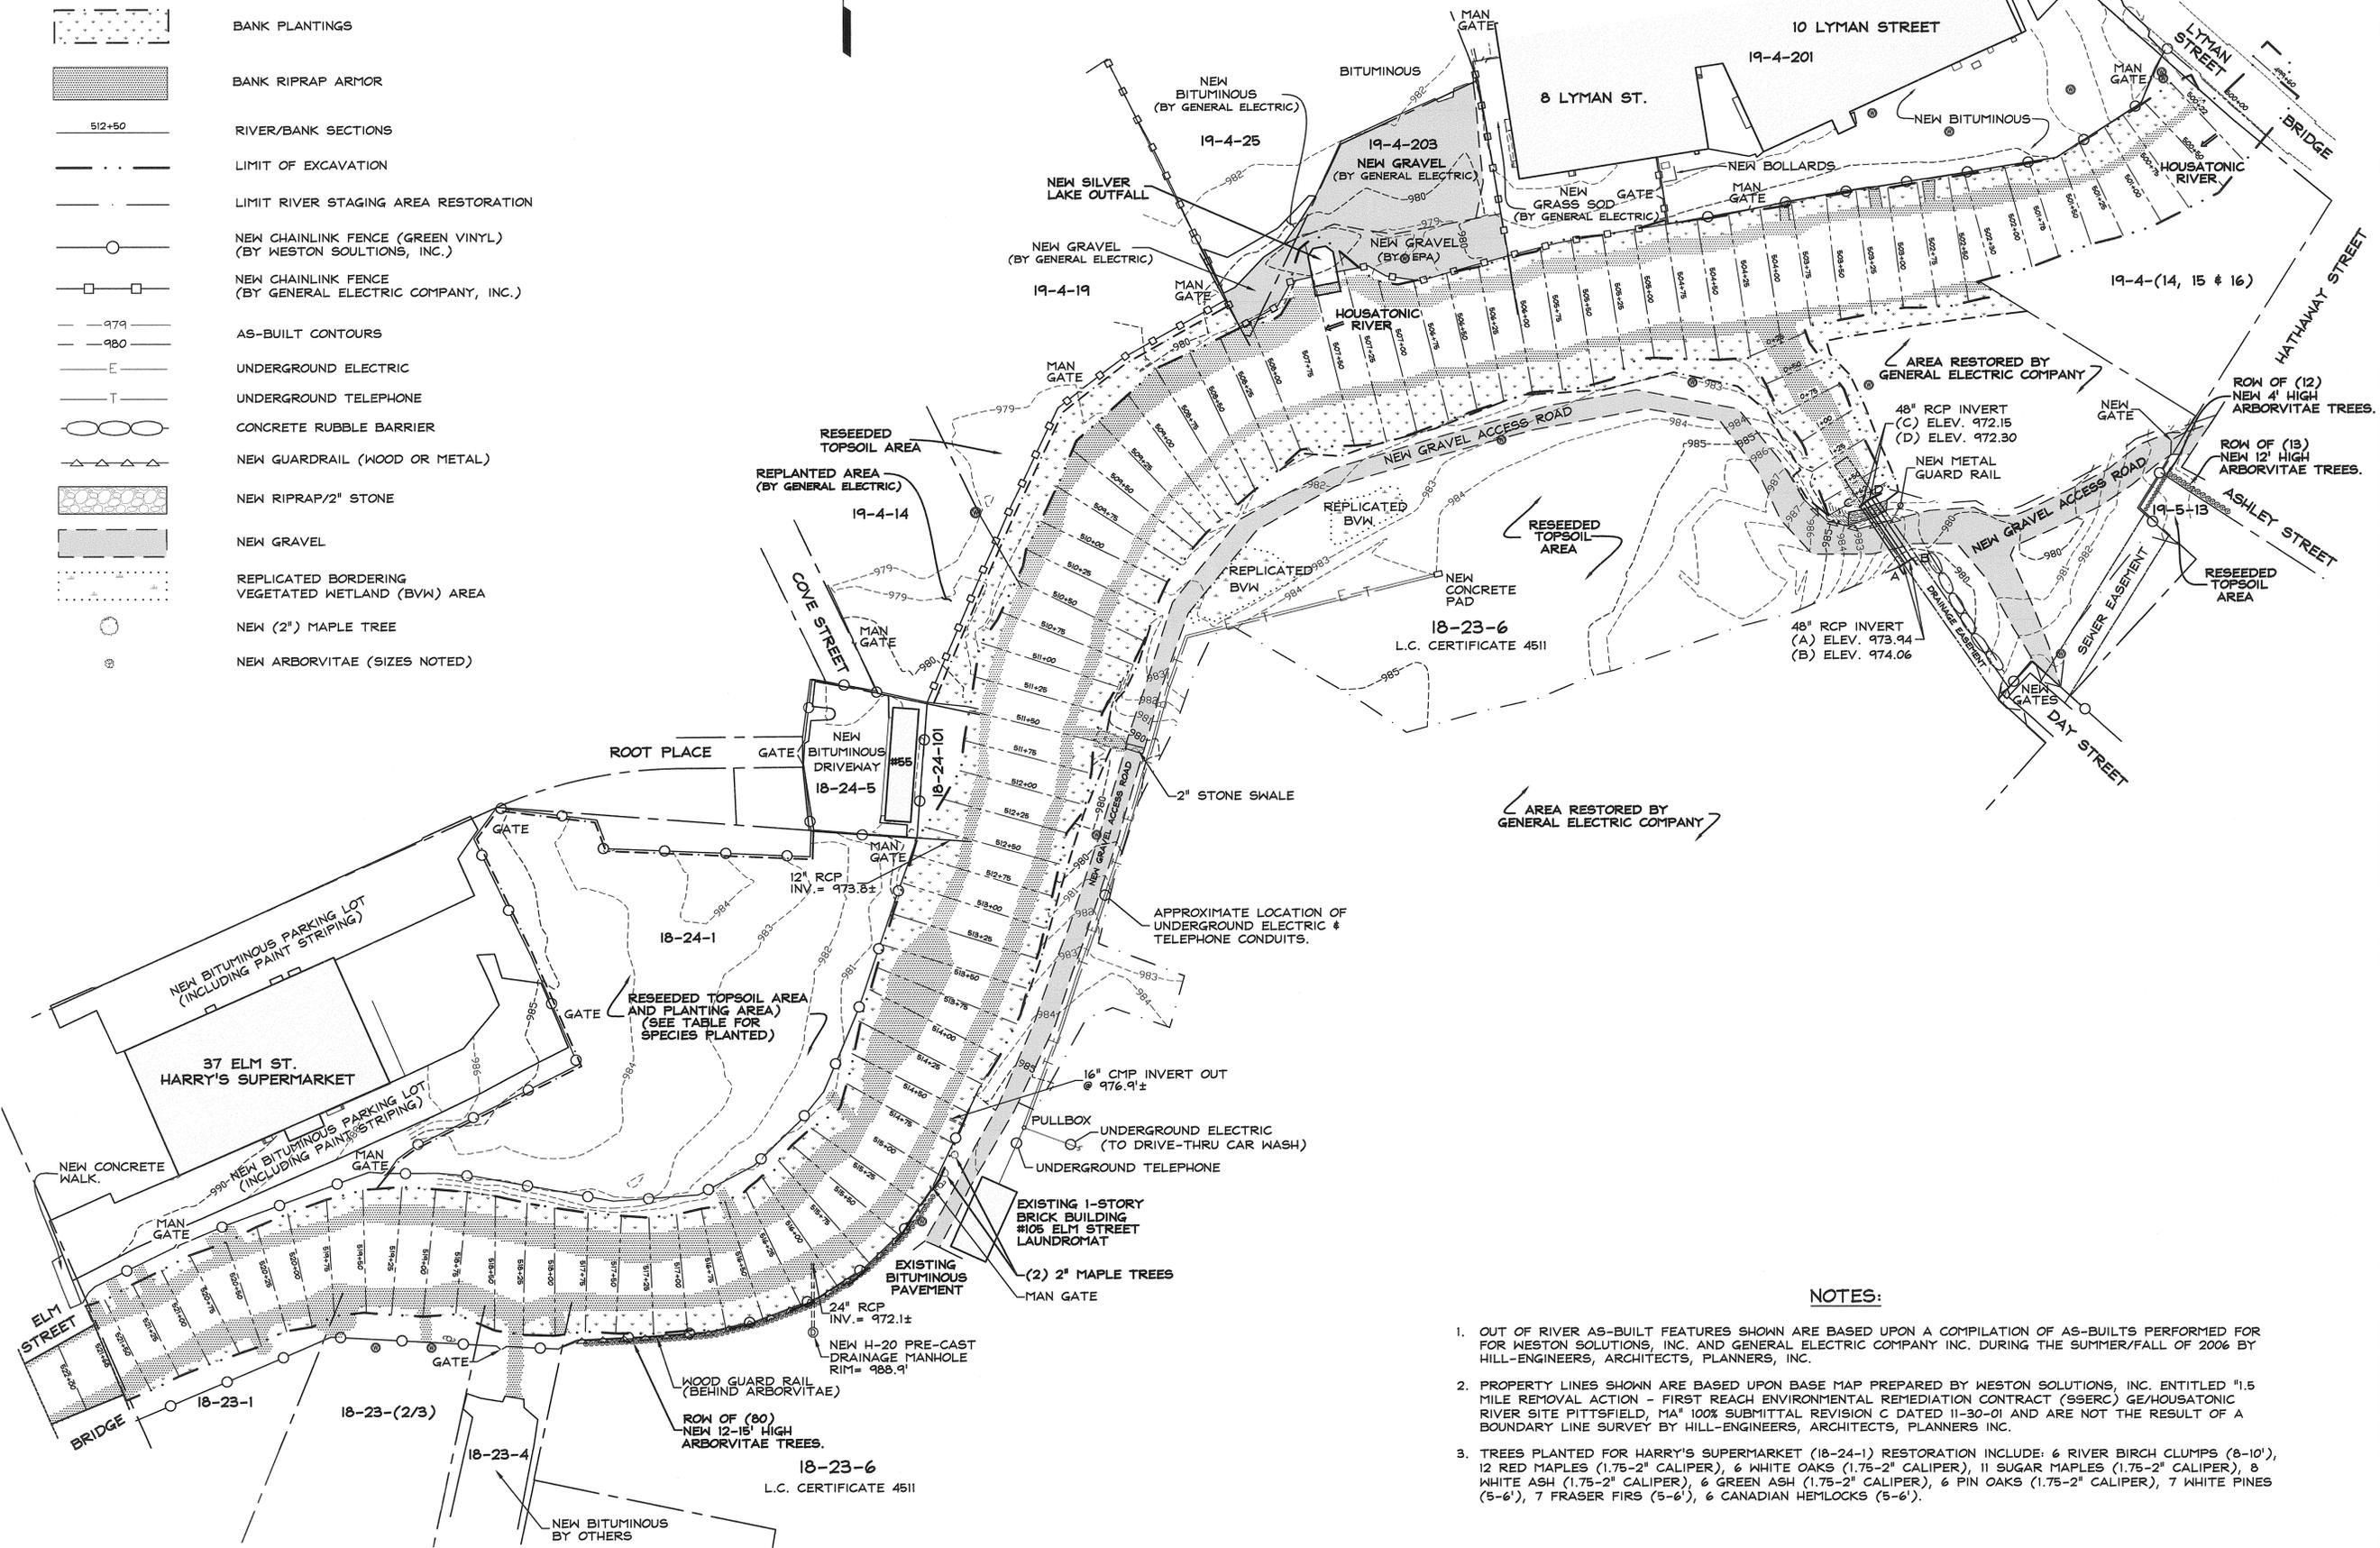
**AS-BUILT SITE PLAN**  
OUTSIDE RIVER REMEDIATION  
LIMITS

1. OUT OF RIVER AS-BUILT FEATURES SHOWN ARE BASED UPON A COMPILATION OF AS-BUILTS PERFORMED FOR WESTON SOLUTIONS, INC. AND GENERAL ELECTRIC COMPANY INC. DURING THE SUMMER/FALL OF 2006 BY HILL-ENGINEERS, ARCHITECTS, PLANNERS, INC.

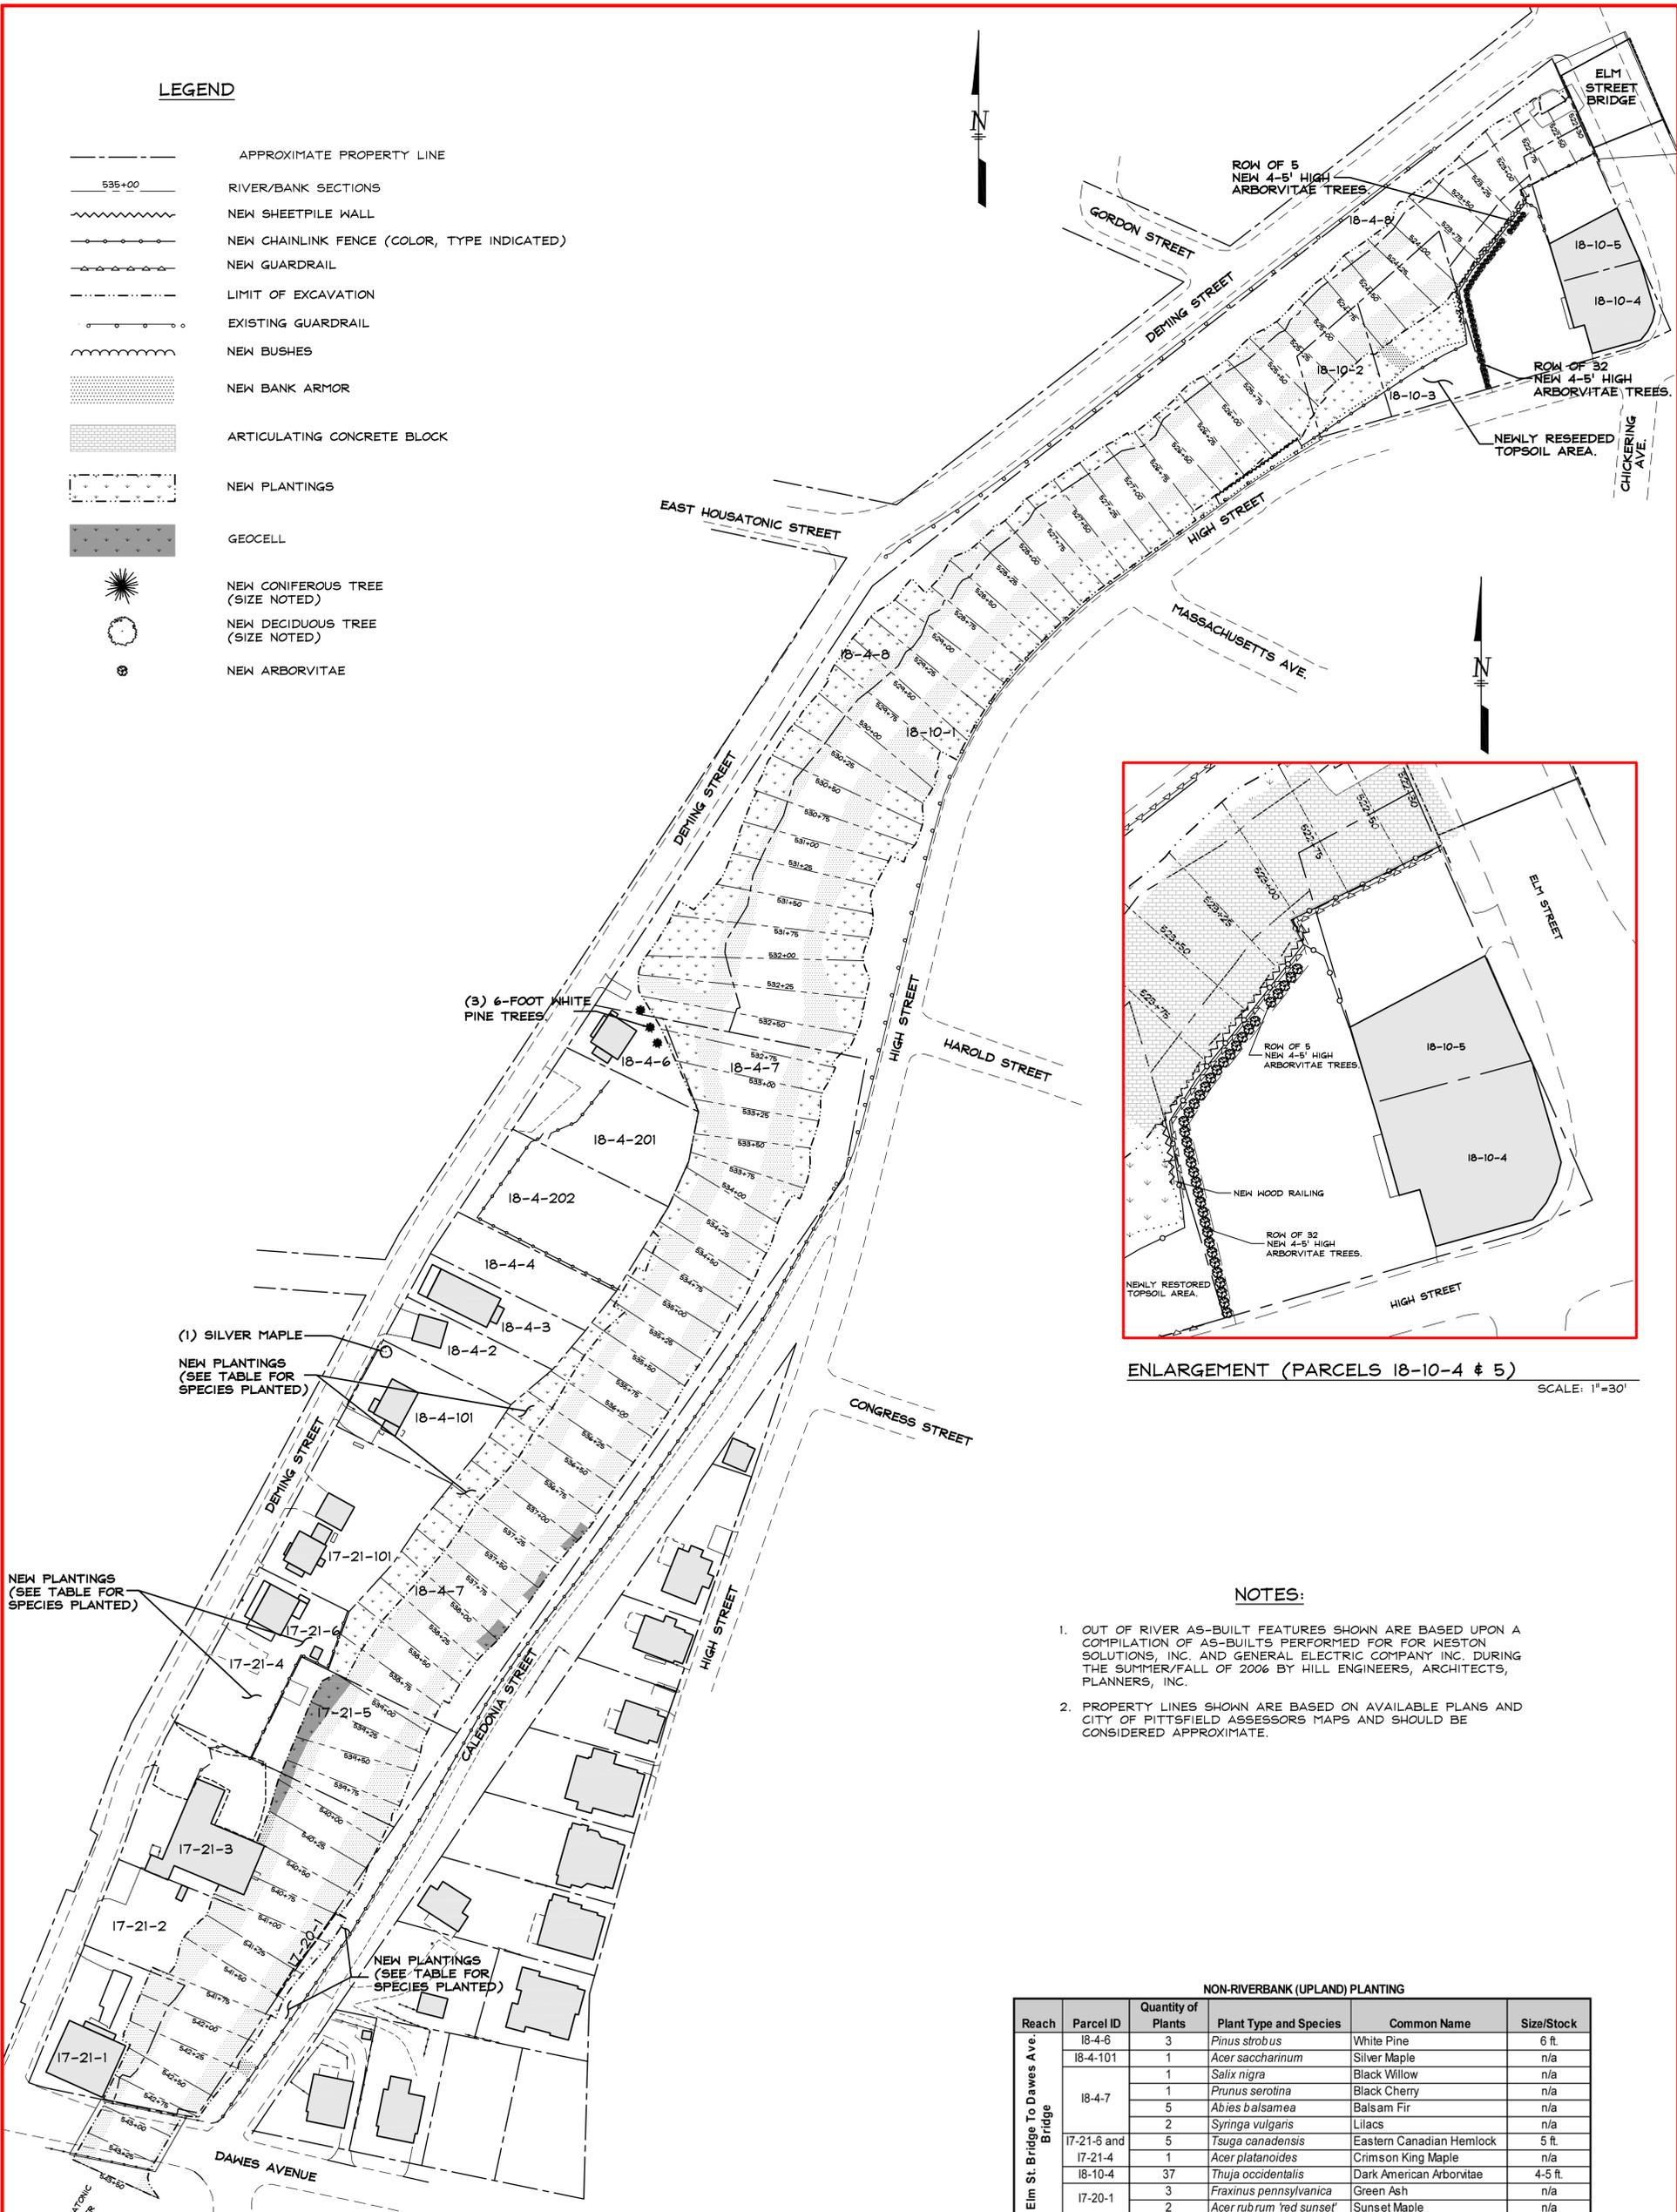
**AS-BUILT NON-RIVERBANK (UPLAND) PLANTING PLAN**  
SCALE: 1"=60'

**ENLARGEMENT (PARCELS 18-10-4 & 5)**  
SCALE: 1"=30'
