RE: July 2005 Monthly Report
1.5 Mile Reach Removal Action
GE-Pittsfield/Housatonic River Site

**GE-Pittsfield/Housatonic River Project 1.5 Mile Removal Action
Pittsfield, MA**

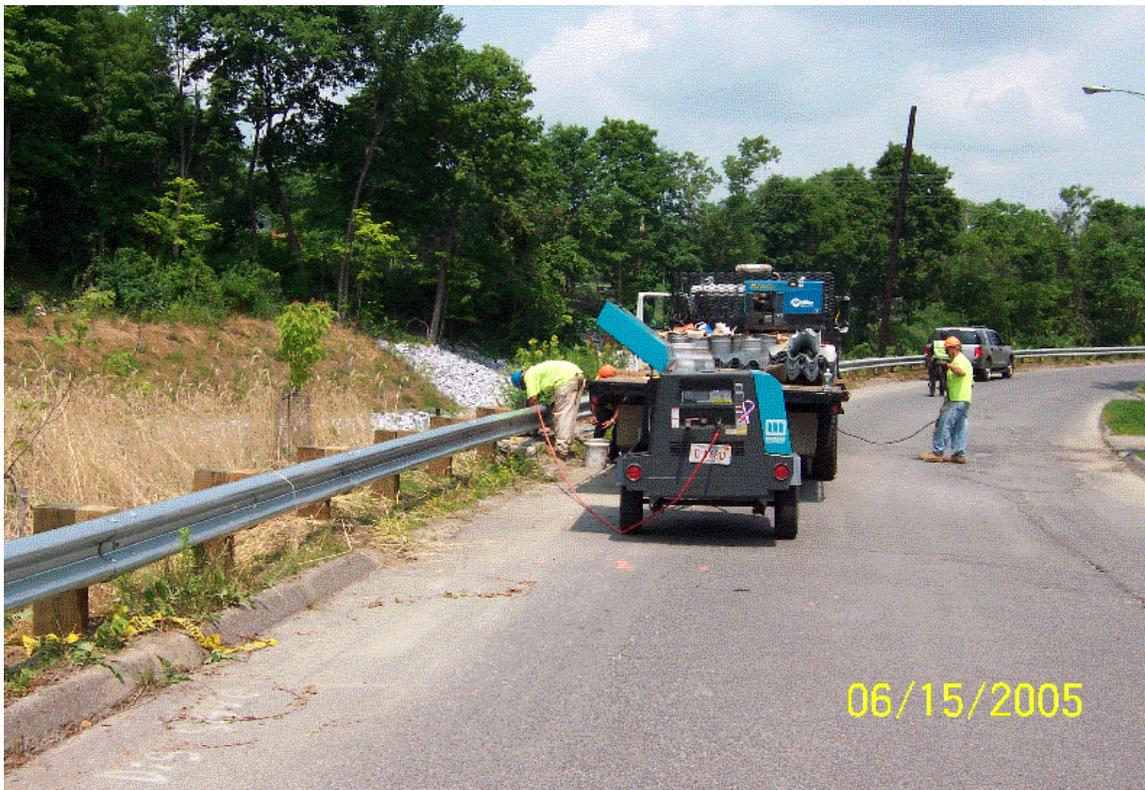
Photograph 1 – Installation of Guard Rail on High Street

Other activities during the third week of July included the removal of the security site fencing along High Street in Phase 2B. In addition, repairs and installation of new guard rail was completed along the riverbank where the security fence was removed. A guard rail was also installed along Deming Street in areas where there previously was no guard rail. The guard rail now extends all the way from Elm Street Bridge to Parcel I8-4-6.

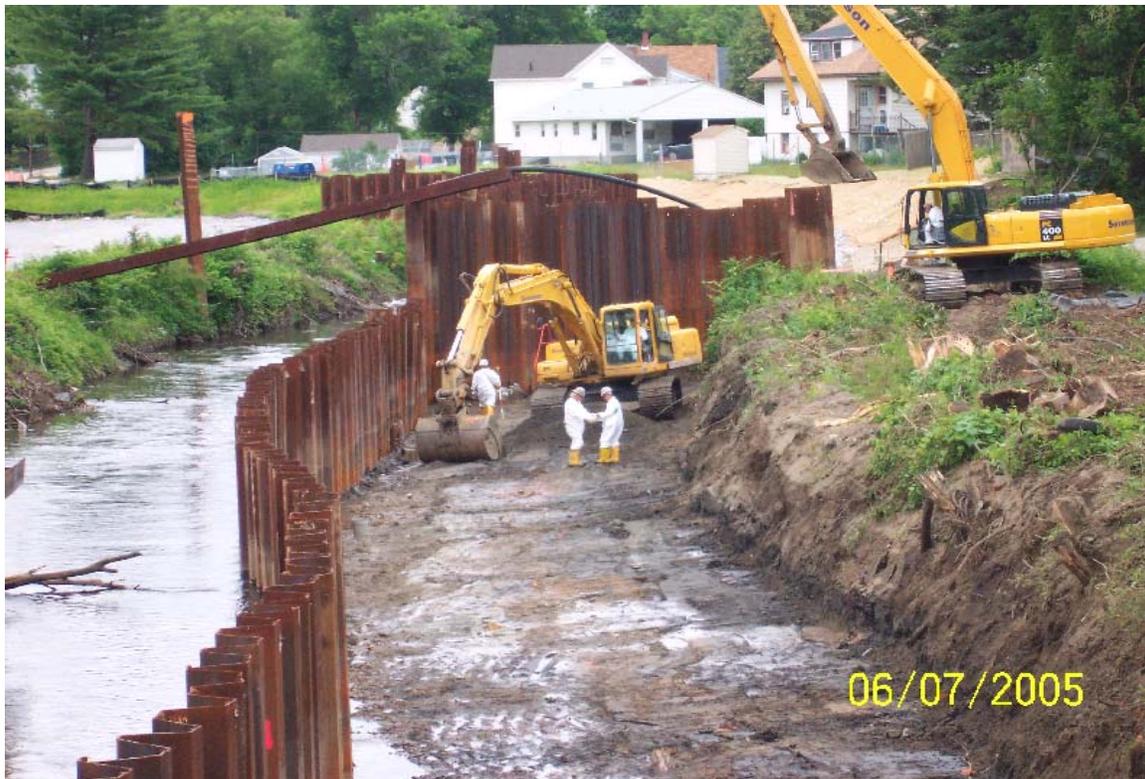
Photograph 2 – Excavation Activities in Cell 32

During the third week of July excavation activities in Cell 32 were completed. A 36-inch reinforced concrete sewer main pipe was uncovered during the riverbank excavation on the downstream end of the cell. The sewer pipe was located approximately 2.5 to 3 feet below grade. The design excavation grade in this area was 3 to 3.5 feet deep. To avoid adversely affecting the structural integrity of the sewer main, some material adjacent to and below the sewer main that was designated for removal was left in place. However a minimum of 3 feet of excavation and backfill was completed within the sewer main area. Most of the excavated TSCA material was transported to Building 63 stockpile management area. Some of the excavated TSCA material was transported directly to the Building 71 OPCA. The non-TSCA material characterized for off-site disposal was transported to Building 65 and the non-TSCA material not characterized for off-site disposal was transported to Area 64B stockpile management area.

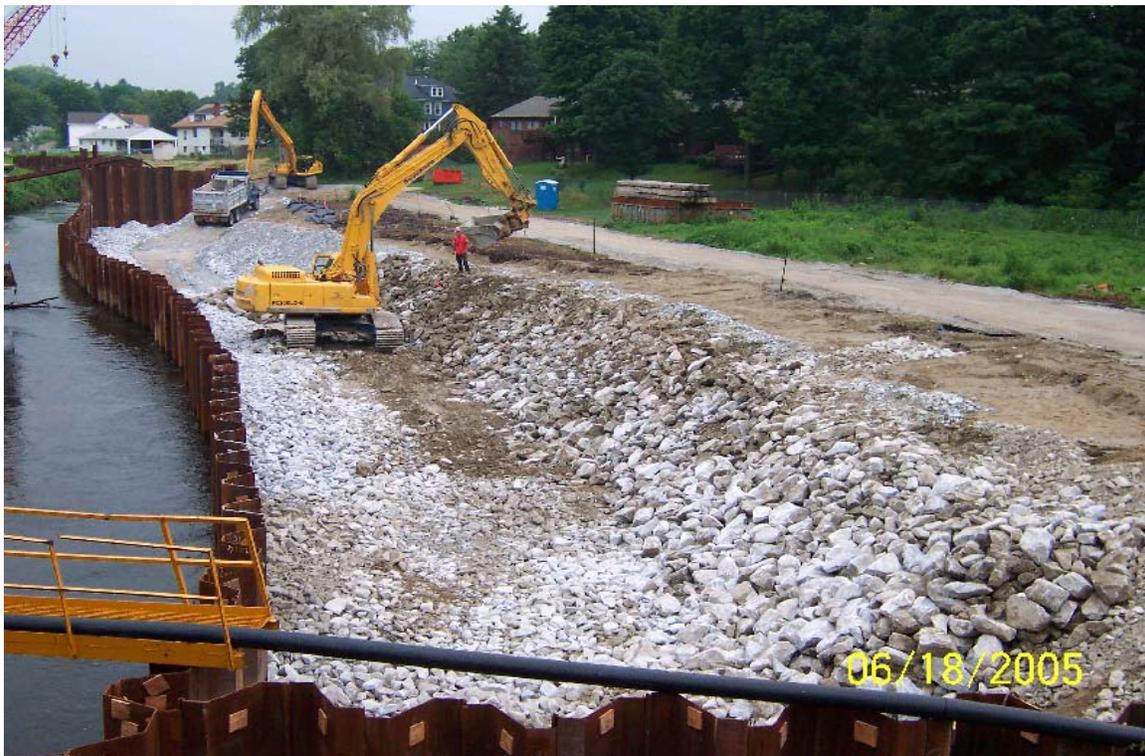
Photograph 3 – Backfilling Activities in Cell 32

First, a backfill access ramp was built on the riverbank of Cell 32. The ramp was built from common fill. The riverbed and riverbank of Cell 32 will be backfilled as follows: The riverbed will be backfilled with a layer of common fill to the design grade, followed by a nine-inch layer of filter material Type II, and a fifteen-inch layer of 9-inch riprap. The riverbanks will be backfilled with common fill to the design grade, a nine-inch layer of filter material Type II and a twenty four-inch layer of 18-inch riprap up to the top of the riverbank, which is at approximately elevation 966.0 feet to 967.0 feet above mean sea level (AMSL).

During the fourth week of July, backfilling activities in Cell 32 were completed in accordance with the backfill configurations described above. The surveyors monitored the backfilling activities in Cell 32 to ensure appropriate design backfill grades were achieved. Once the backfilling was completed, the final restoration verification survey was completed. A layer of 12-inch temporary erosion control riprap was placed at the downstream end of Cell 32, at the interface between Cell 32 and the unexcavated area under the Pomeroy Avenue Bridge, to avoid any potential erosion when the cutoff sheetpile walls are removed and the river channel is open for full river flow.

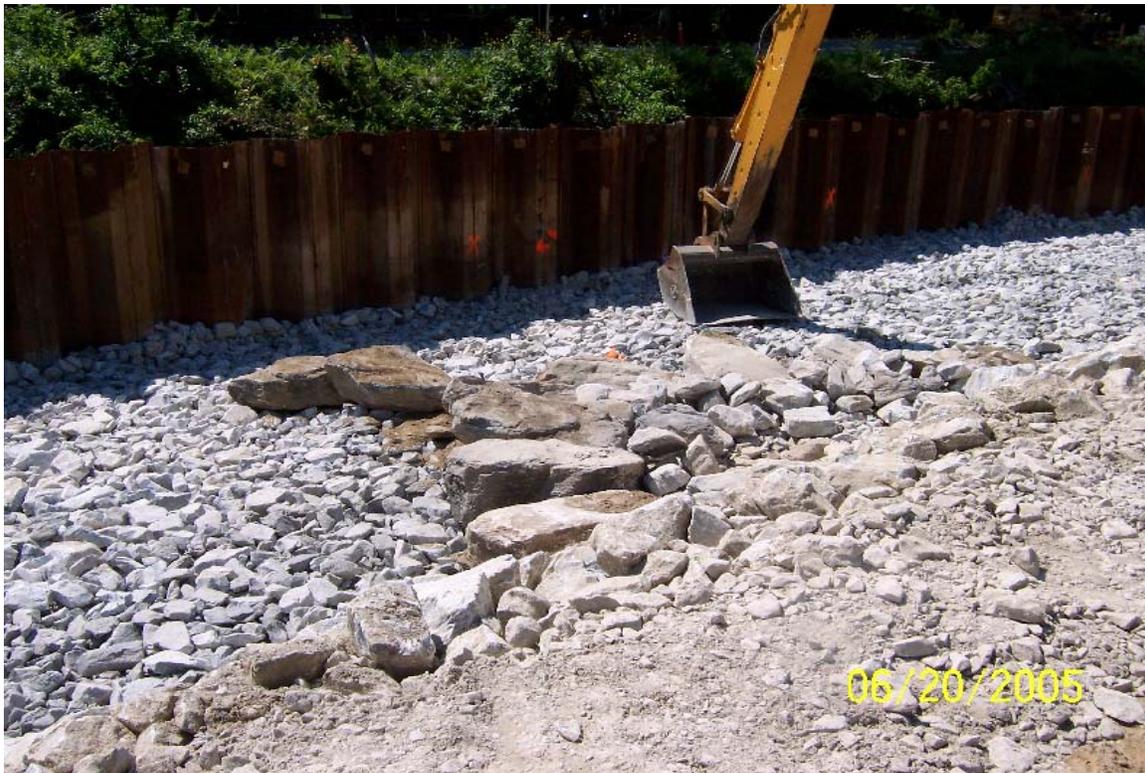
Photograph 4 – Placement of River Enhancement Structures (Wing Deflector) in Cell 32

The installation of some of the river enhancement structures in Cells 29 and 32 was performed. Additional aquatic enhancement structures will be placed at a later date.

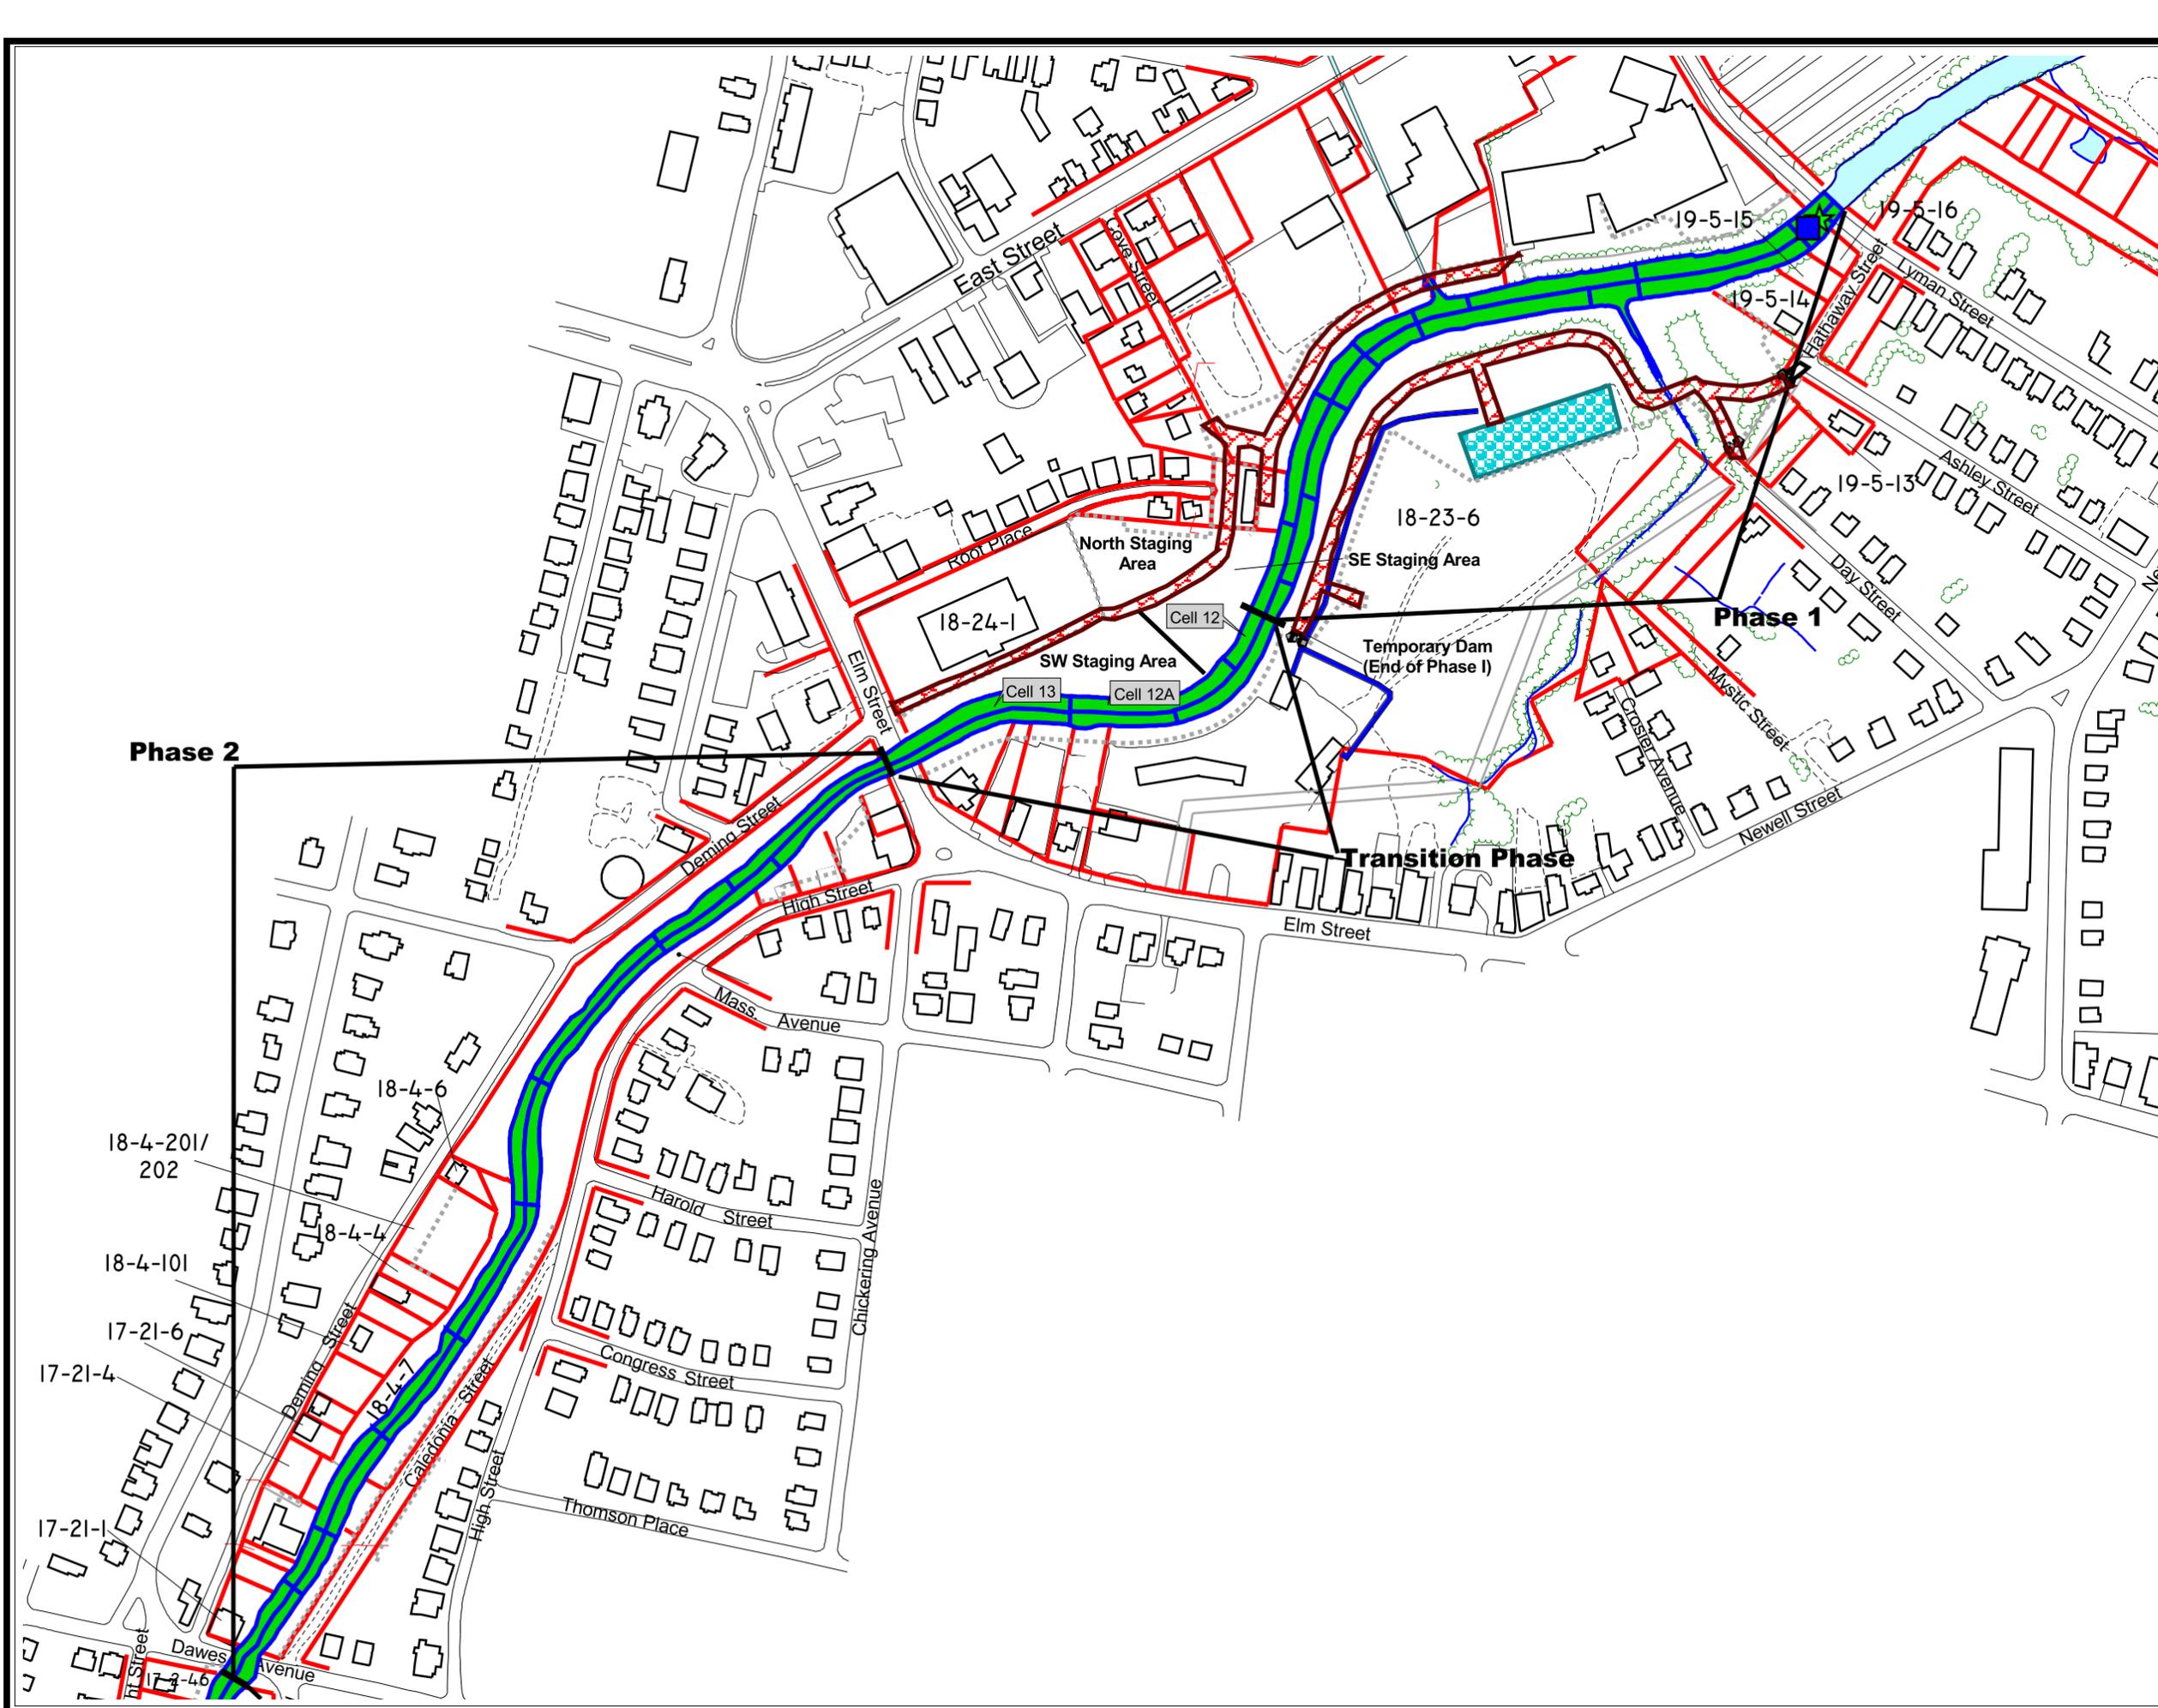
Figure 1
1.5 Mile Removal Action
Site Map (Map 1 of 2)
July 2005 Monthly Report

Figure 1 (2 maps) includes the layout of all excavation cells, the temporary dam, water monitoring locations, air sampling locations, vibration monitoring locations, access road locations, excavation load-out locations, staging area locations, fence line location, and the new and the old water treatment system pad locations.

Refer to Figure 1 (2 maps) for an orientation of the excavation cells and their respective locations.
