RE: May Monthly Report
1.5 Mile Reach Removal Action
GE-Pittsfield/Housatonic River Site

**GE-Pittsfield/Housatonic River Project 1.5 Mile Removal Action
Pittsfield, MA**

Figure 1
1.5 Mile Removal Action
Site Map (Map 1 of 2)
May 2006 Monthly Report

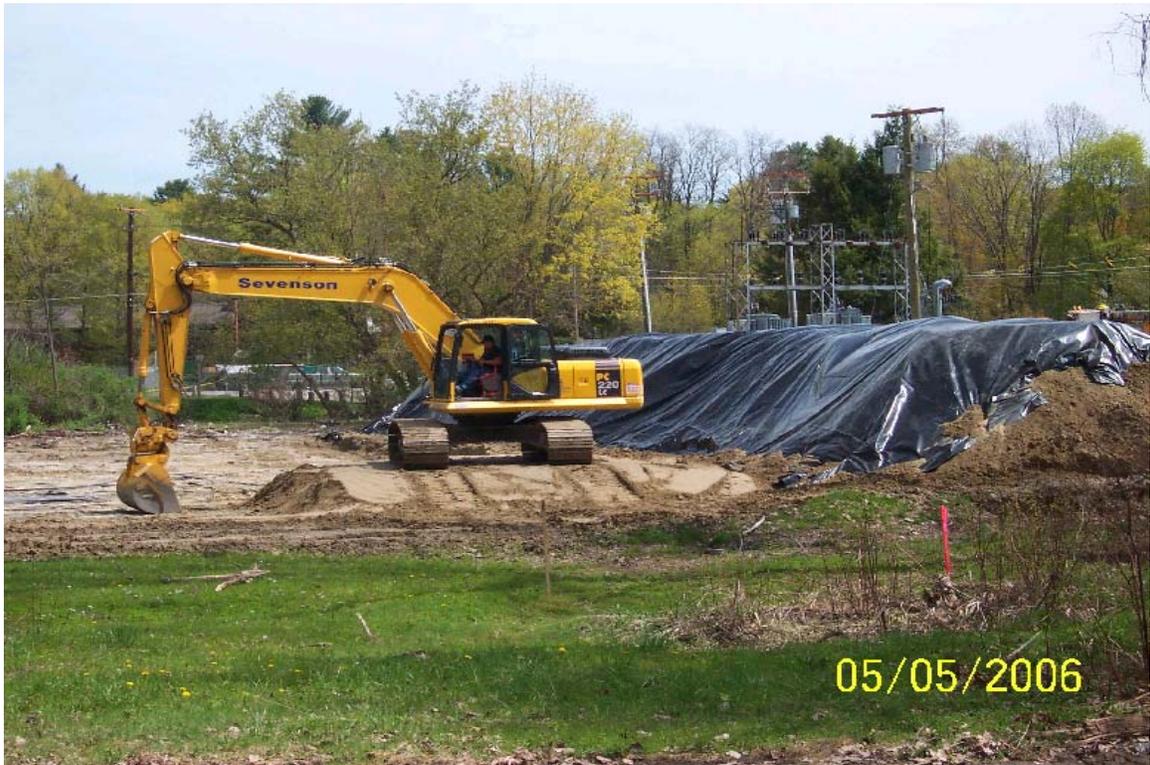
Photograph 1 – Activities Associated with the Removal of the Water Treatment System Pad at Fred Garner Park

By the end of April, the demobilization of the WTS was on going. During the month of May the demobilization of the WTS was completed. The removal of the concrete bin blocks that were on the perimeter of the WTS pad was completed. The blocks were moved to the Lyman Street parking lot staging area, where they will be decontaminated and bulk concrete samples will be collected. The secondary electrical service panel and electric power pole were removed by the Western Mass Electric Company (WMECO). Also, the removal of the miscellaneous WTS equipment and supplies was completed. The equipment was moved to Lyman Street parking lot staging area or the staging area located on GE property adjacent to Building 68, where the decontamination activities were performed. The equipment was then wipe sampled and once the wipe sample results were received and approved, the equipment was slated for transportation offsite.

Once all of the equipment was removed from the WTS area, silt fencing was installed along the perimeter of the WTS area and the removal and stockpiling of the WTS pad was completed. First, the common fill was removed from the WTS area very carefully so that the geotextile layer underneath the common fill was not disturbed. The WTS pad common fill material was stockpiled at the Fred Garner Park. Characterization sampling was performed on the stockpile. The stockpiled material was covered with poly as a dust control measure. The sample results will determine the potential of re-use of this material as clean fill.

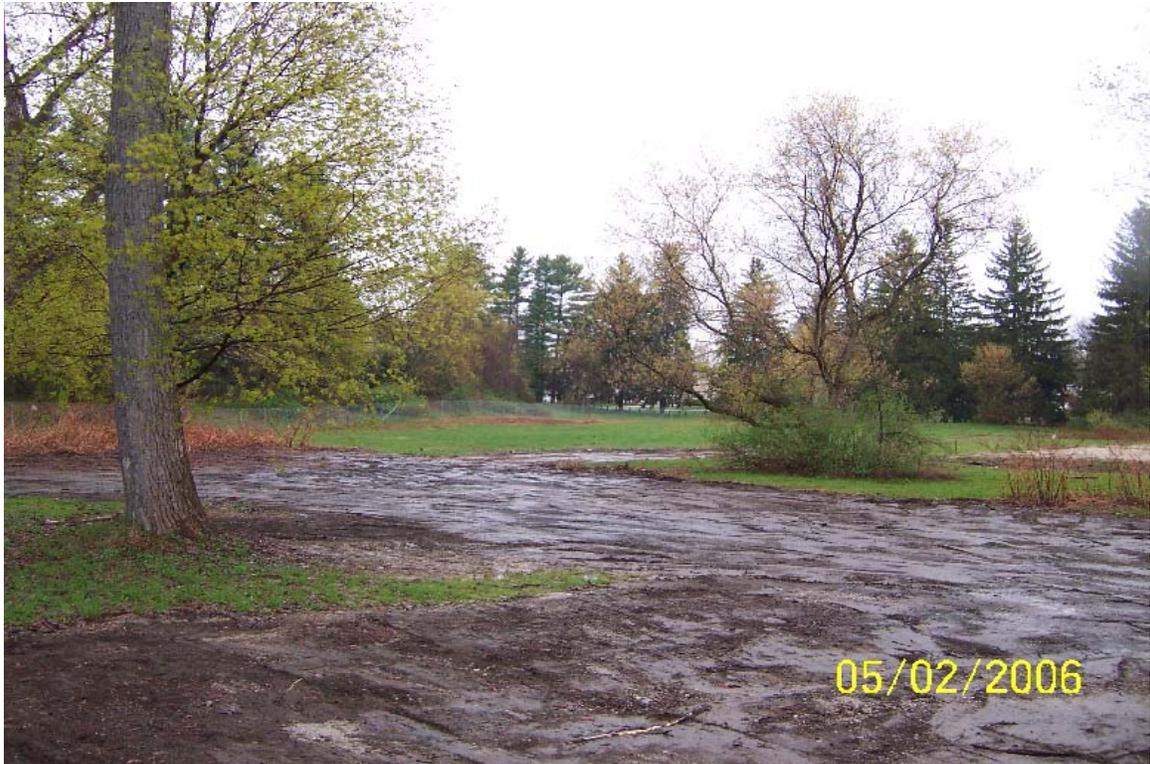
Photograph 2 – Staging Area after Removal of sub-grade material at Fred Garner Park

Also, the removal of the staging area on Fred Garner Park where the construction trailers were located was completed. The dense grade/airport mix material was removed and transported to Area 64E north stockpile management area. Characterization sampling will be performed on the dense grade and sample results will determine the potential of re-use of this material as clean fill. The sub-grade material was also removed and transported to Area 64 stockpile management area. The area where the staging area was located will be re-graded so that appropriate drainage can be achieved and final restoration will be completed at a later date as part of the final restoration work on Fred Garner Park.

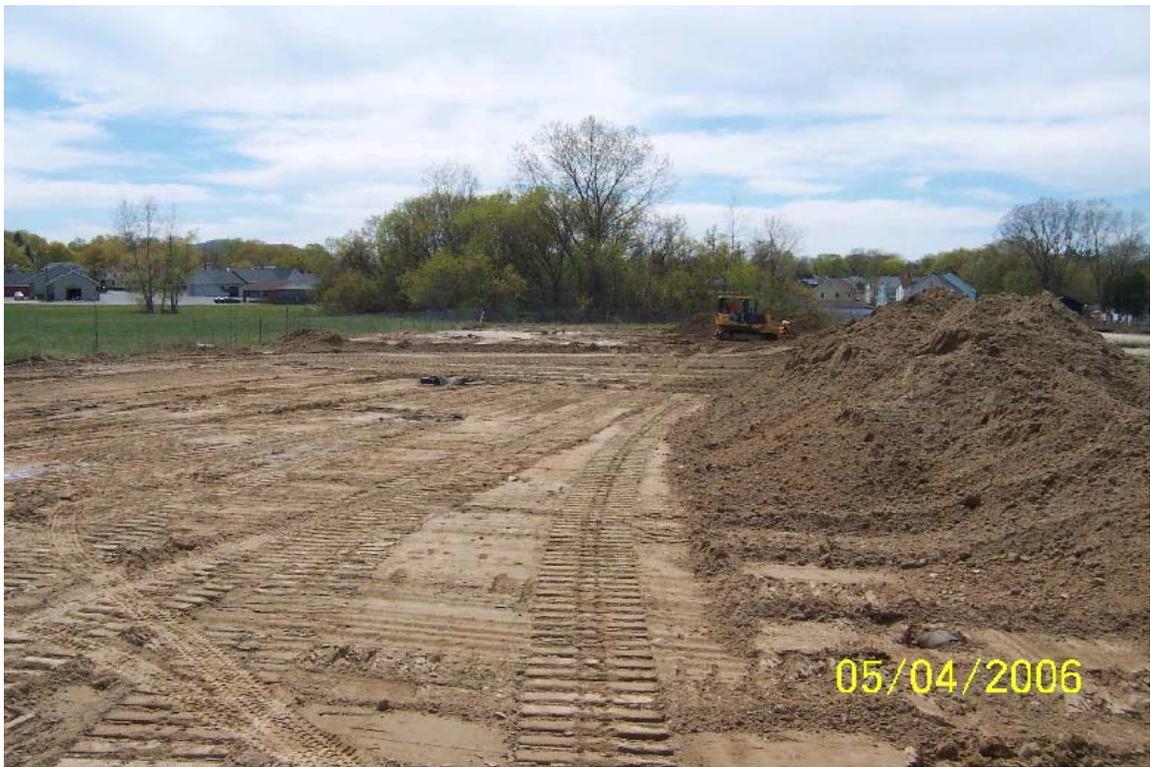
Photograph 3 – Activities Associated with the Removal of the Old Water Treatment System Pad on Parcel I8-23-6

Also, during the month of May, activities associated with the removal of the old WTS pad on Parcel I8-23-6 were initiated. First, the two electrical panels were removed and the wires were pulled. Next, the removal and stockpiling of the WTS pad sand was completed. The sand material was pushed up and stockpiled at the WTS pad. Also, the removal of the staging area adjacent to the WTS pad, where the construction trailers were located during the Phase 1 and Phase 2 construction activities was completed. That material (sand and dense grade mix) was also removed and stockpiled on Parcel I8-23-6. Characterization sampling of the WTS sand material and the staging area sand and dense grade mix were then performed. All of the stockpiled material was covered with poly as a dust control measure. Next, the removal of the staging area sub-grade material was completed. The material was then transported to Area 64 stockpile management area.

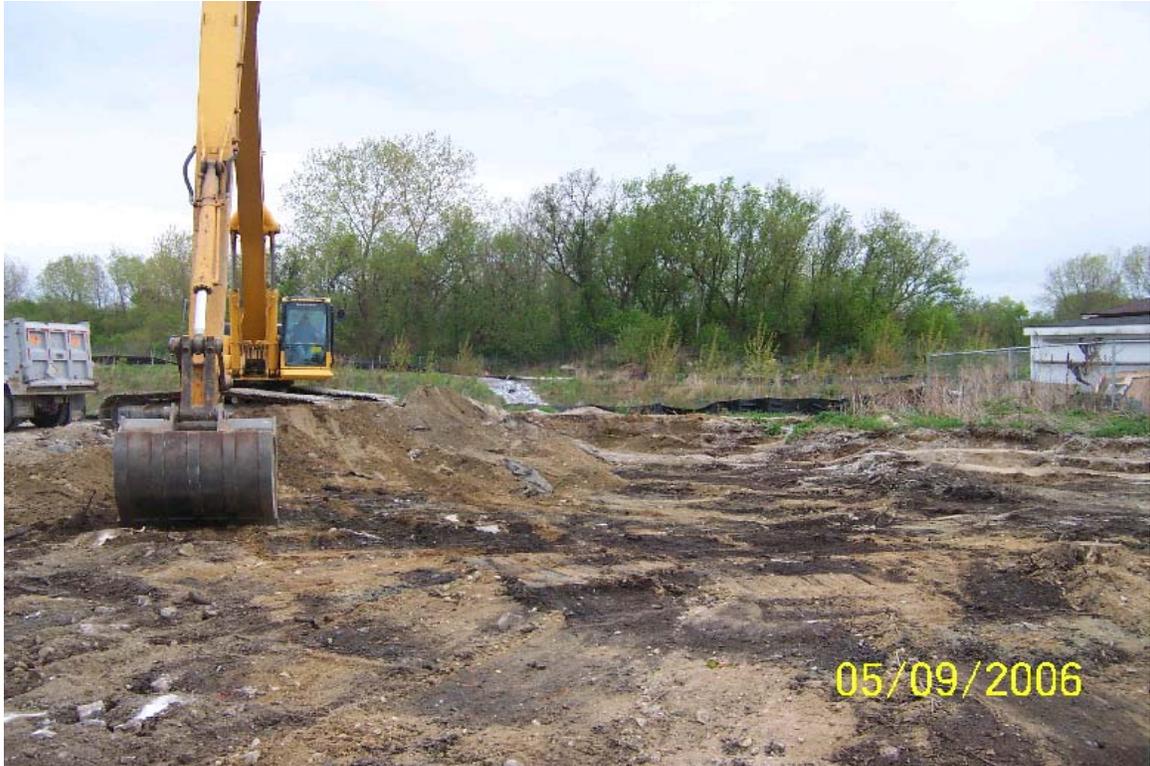
Photograph 4 – Activities Associated with the Removal of the Phase 1 Access Road/Staging Area on the West Riverbank on Parcel I9-4-14

Also, by the end of April, the removal and stockpiling of the access road and staging area materials in Phase 1 was initiated. The access road/staging area on Parcel I8-24-1 was the first to be removed. Next, the removal of the Phase 1 west access road, starting on Parcel I8-24-5 and working upstream towards Parcel I9-4-201 was initiated. During the month of May, the removal of the Phase 1 west access road was completed. The dense grade/airport mix material was removed and transported to Lyman Street parking lot staging area. The sub-grade material was also removed and transported to Area 64 stockpile management area. Once the removal of the access roads was completed, one to four-inch layer of topsoil was placed to return the area to its pre-construction grade. Topsoil was installed on Parcels I9-4-14 and I9-4-19 in the areas where there will be no additional excavation performed by GE. Black stone driveway mix will be placed on Parcels I9-4-25 and I9-4-203 at a later date.

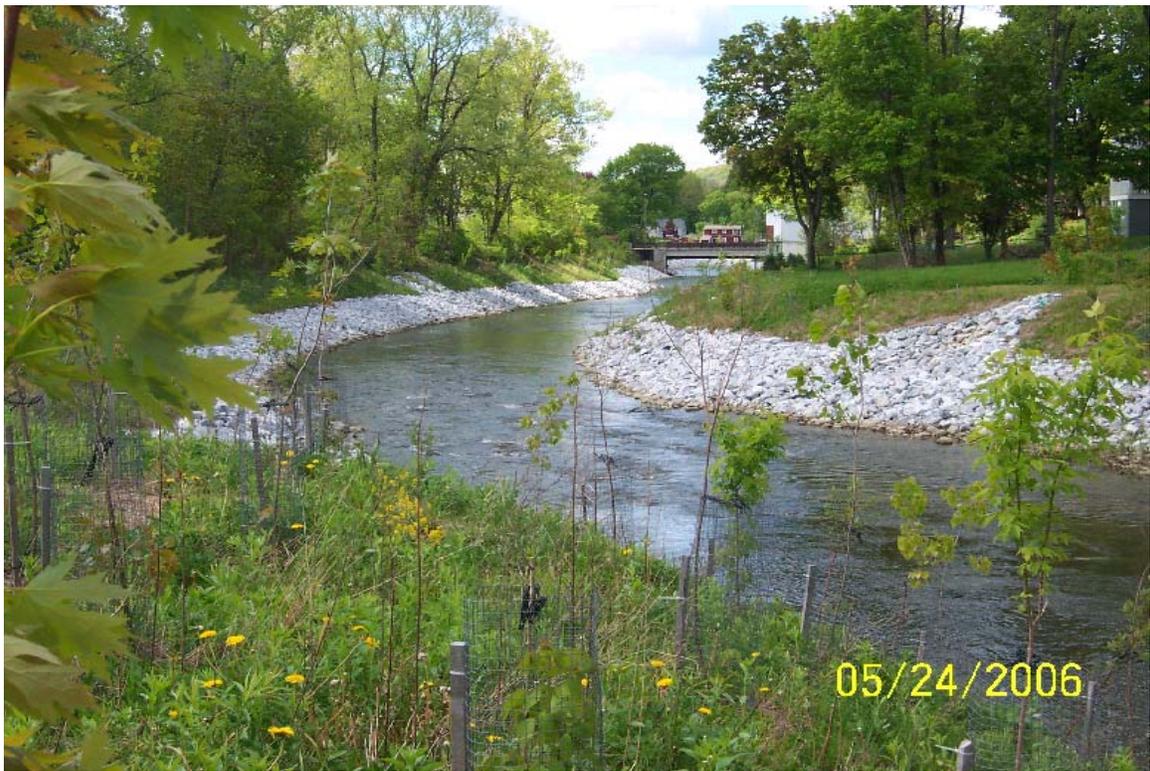
Photograph 5– Overview of Restored Area in Phase 2

Activities associated with repairs of the minor erosion on the riverbank in Phase 2 former Cell 16 and at the location of the former dam trash rack area were completed. Twelve-inch riprap and topsoil were placed to repair the erosion in Cell 16 and topsoil only was placed to repair the washout in the former temporary dam trash rack location.

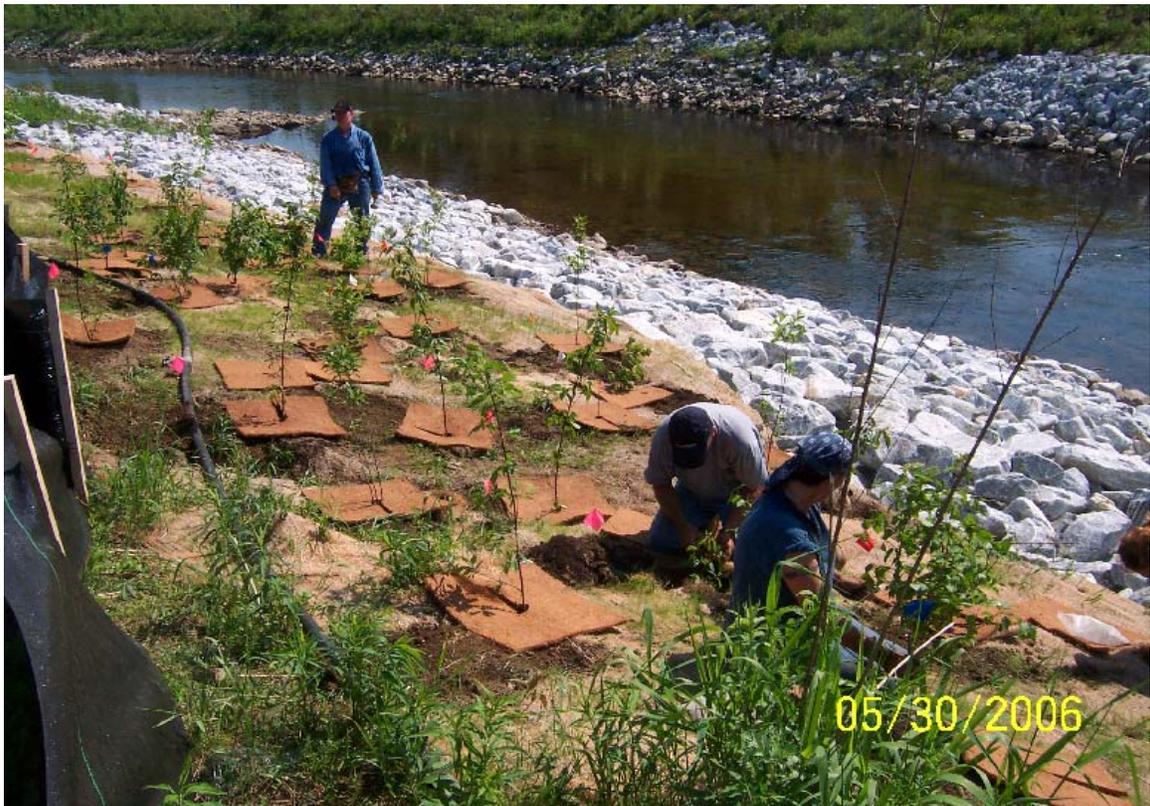
Photograph 6 – Activities Associated with Riverbank Restoration Planting at the Former River Diversion Dam Location

The riverbank planting activities in the temporary river diversion dam areas and on the east riverbank on the first 2 properties downstream of Pomeroy Bridge in Phase 3C were initiated.

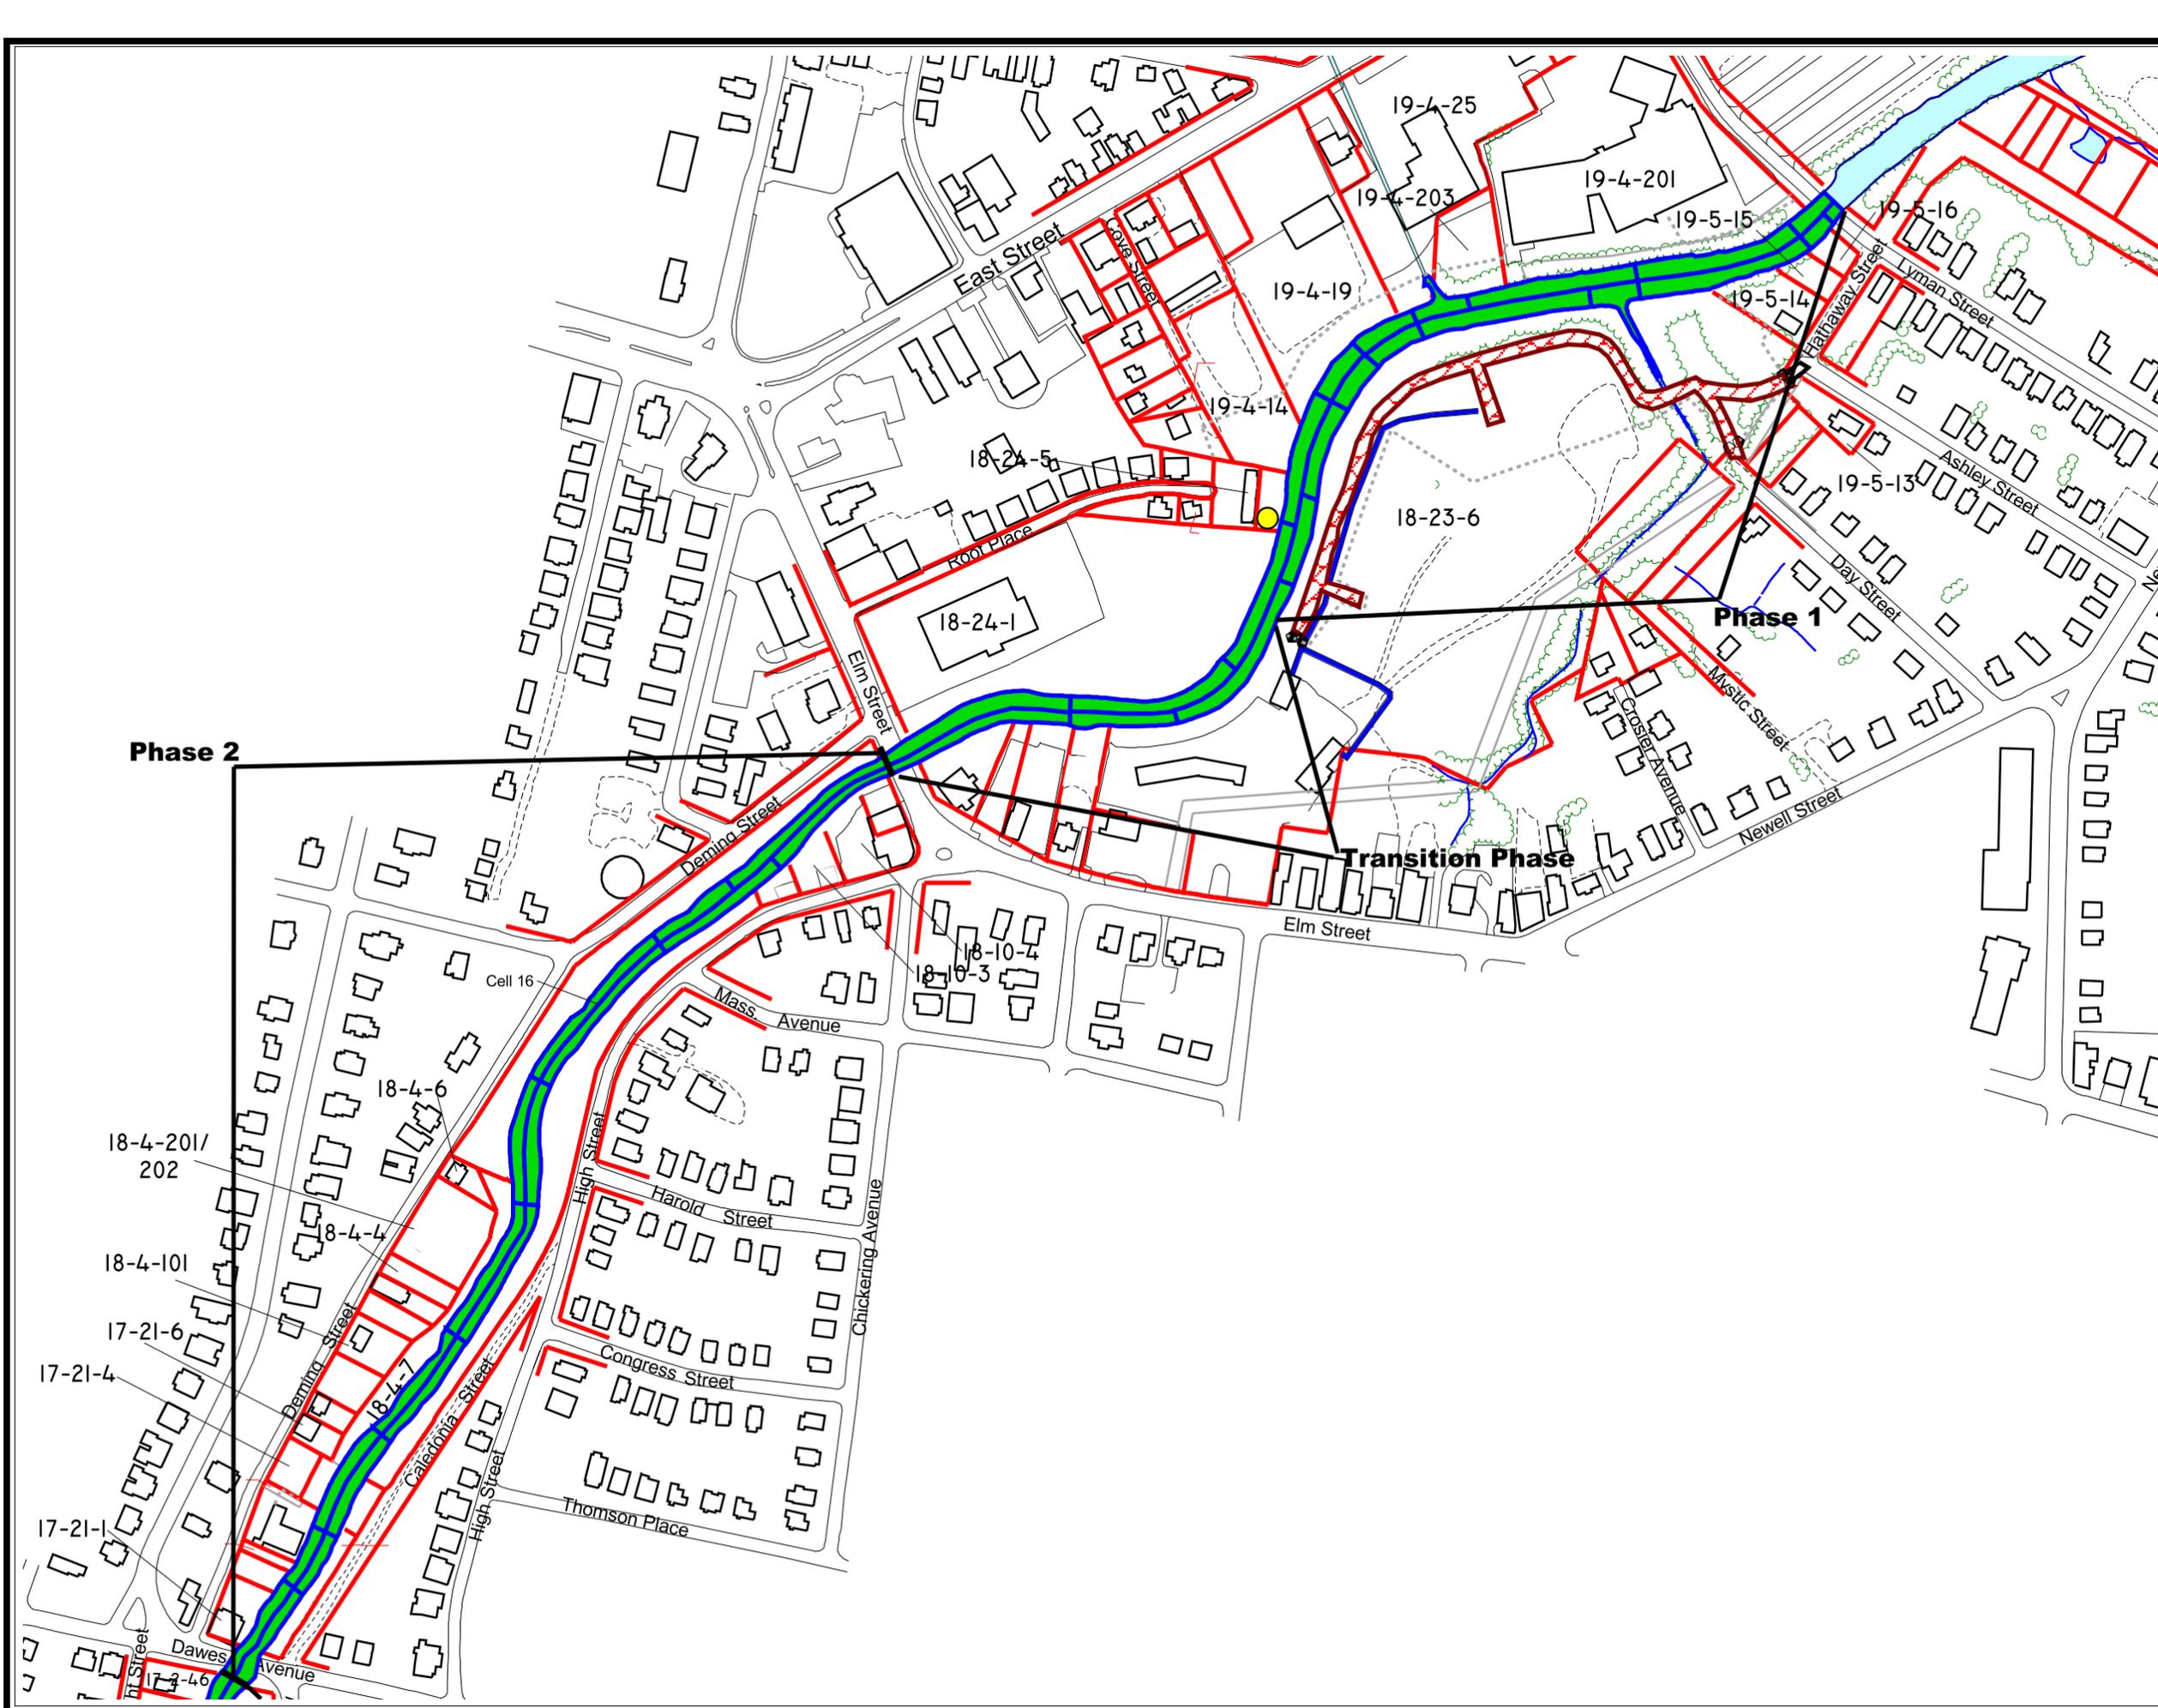
Figure 1 (2 maps) includes the layout of all excavation cells, vibration monitoring locations, access road locations, excavation load-out locations, staging area locations, fence line location, the water treatment system pad locations and the floating river barge crossing.
