RE: August Monthly Report
1.5 Mile Reach Removal Action
GE-Pittsfield/Housatonic River Site

**GE-Pittsfield/Housatonic River Project 1.5 Mile Removal Action
Pittsfield, MA**

Figure 1
1.5 Mile Removal Action
Site Map (Map 1 of 2)
August 2006 Monthly Report

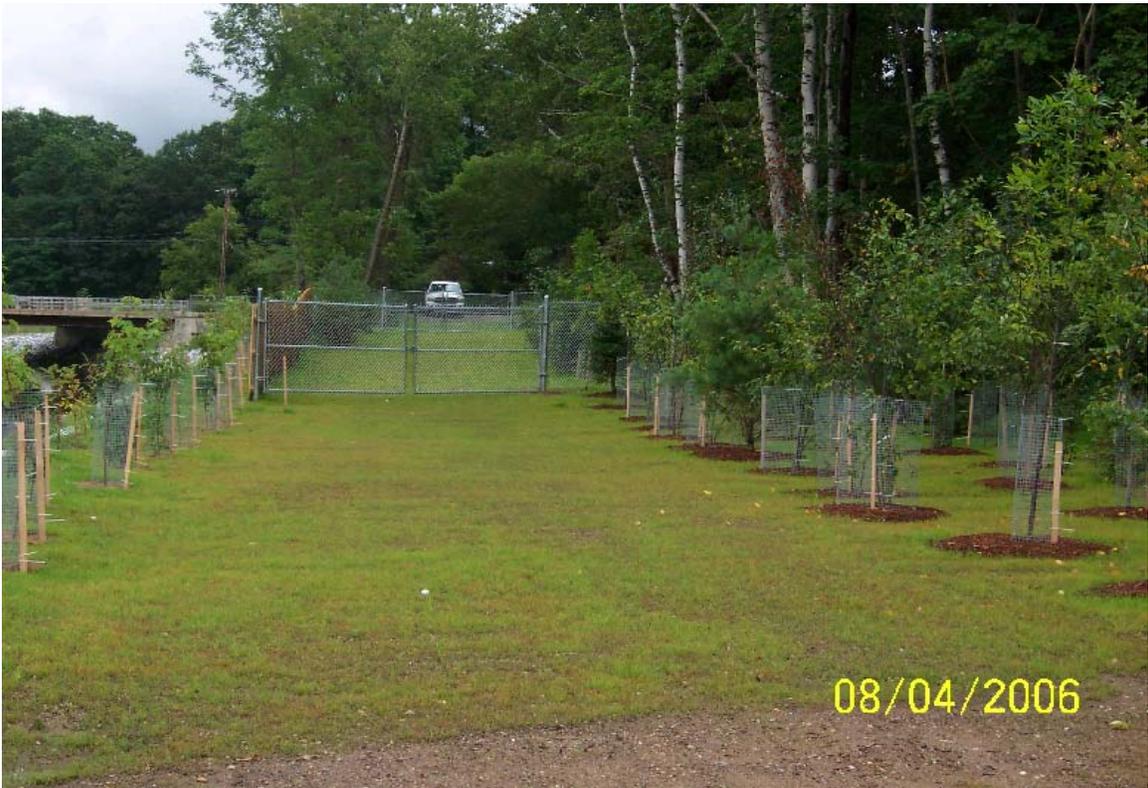
Photograph 1 – Overview of Restored Parcels I6-1-66 and I6-1-67

Application of fertilizers and algacide to the newly hydro-seeded areas on Parcels I6-1-66 and I6-1-67 was performed.

In addition, the site security fencing on Parcel I6-1-67 was removed and minor adjustments to the temporary fence around the Fred Garner Park were completed.

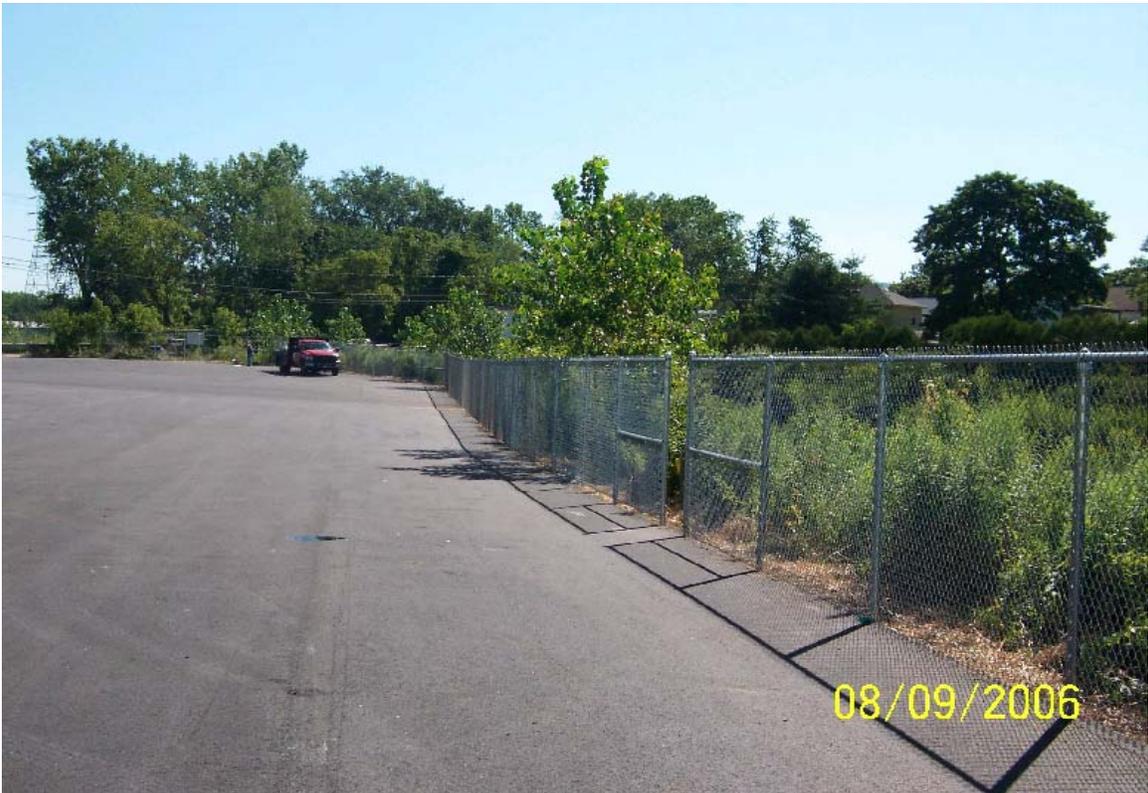
Photograph 2 – Overview of Restored Parcel I9-4-201

Final restoration activities on Parcel I9-4-201 were performed. The installation of the topsoil, seed and mulch around the newly installed pavement and placement of additional 9-inch riprap

on the riverbank swales to raise the elevation of the swales to the new pavement was completed. Also, the installation of permanent chain link fencing was completed.

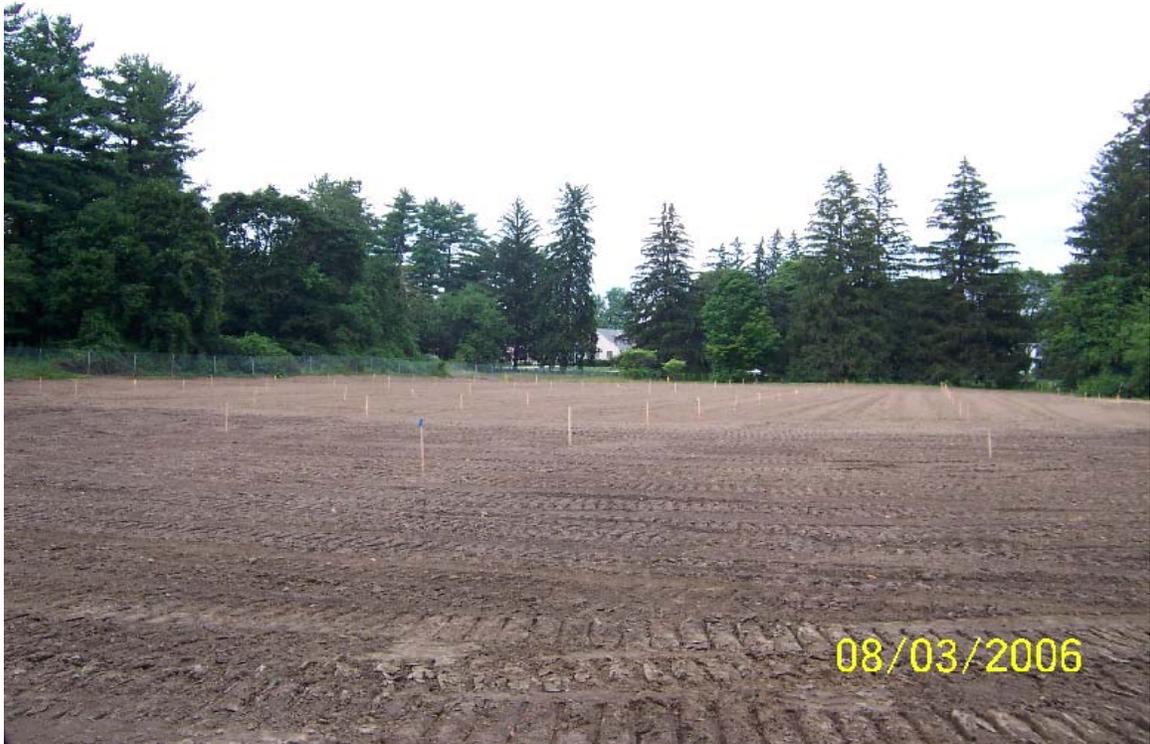
Photograph 3 – Overview of the Rough Graded Topsoil on the Soccer Field in Fred Garner Park

By the end of July, final restoration activities at the Fred Garner Park were initiated, the installation and grading of the sand base over the soccer field was completed and the installation and grading of the 6-inch layer of topsoil over the soccer field was initiated. During the month of August the final restoration activities at the Fred Garner Park continued. First, the installation and rough grading of the topsoil over the soccer field was completed. Next, fine grading using a laser guided fine grader achieving the final grades of ¼-inch from the design elevations was completed. Then, the soccer field was hydro-seeded.

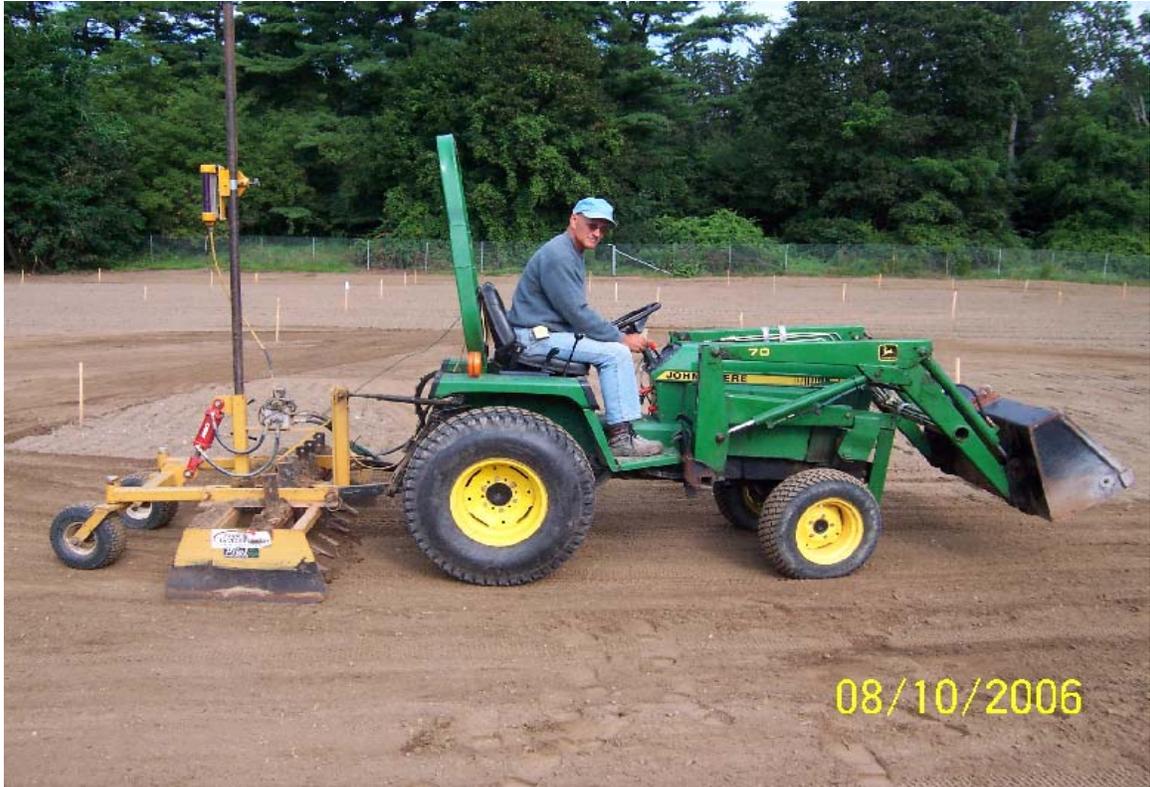
Photograph 4 – Fine Grading of Topsoil on the Soccer Field in Fred Garner Park

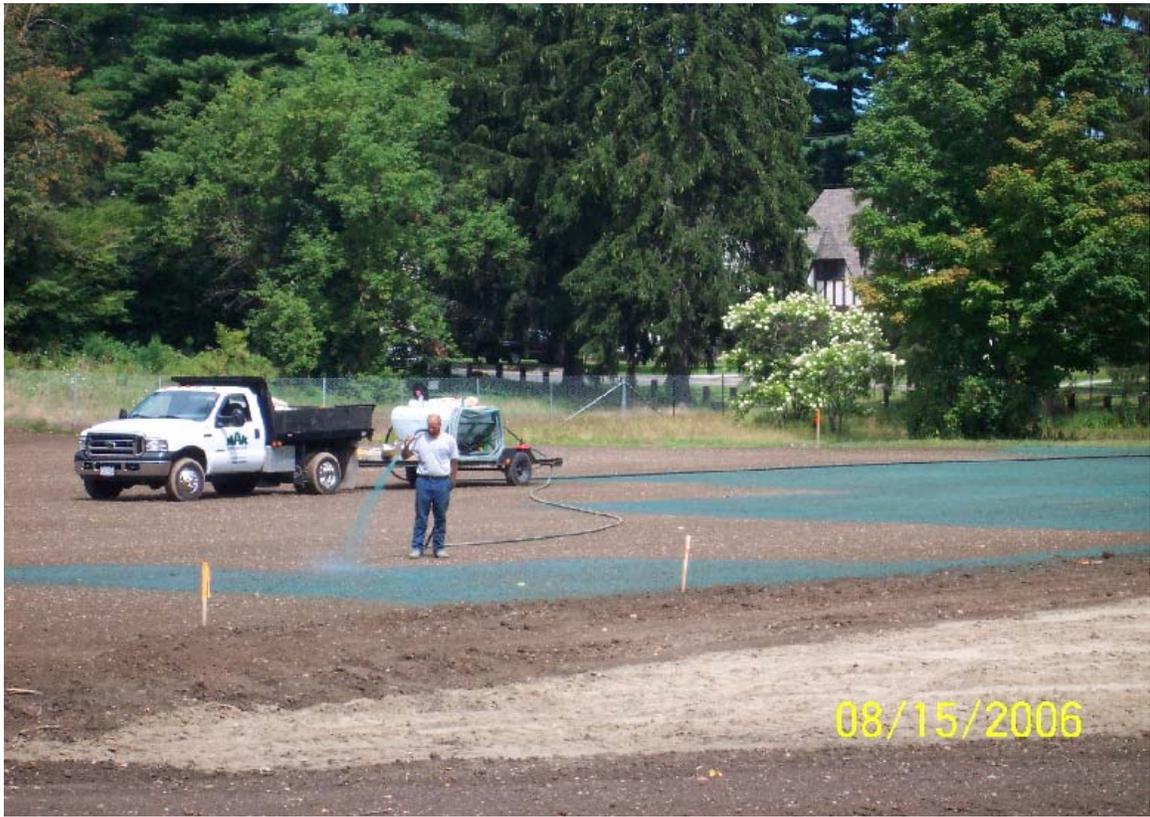
Photograph 5 – Hydro-Seeding Activities on the Soccer Field in Fred Garner Park

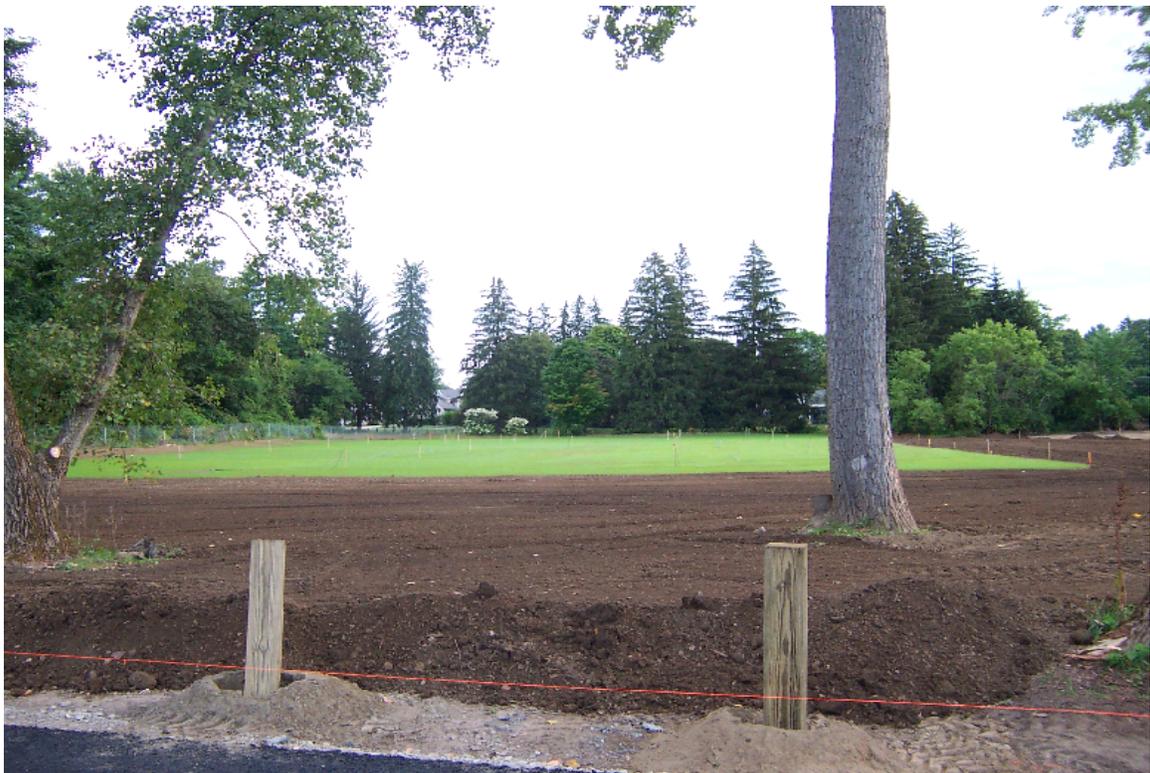
Photograph 6 – Overview of Re-seeded Soccer Field in Fred Garner Park

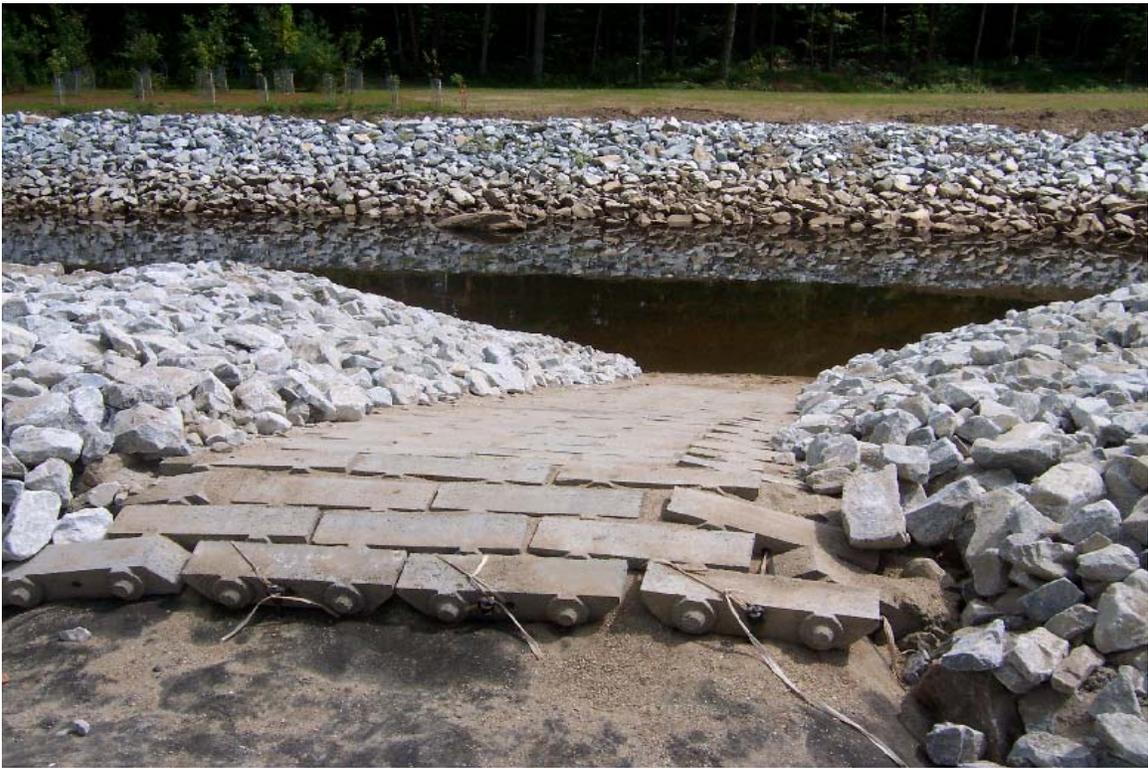
Photograph 7 – Overview of the Completed ACB Canoe Launch at the Fred Garner Park

The installation of the Articulated Concrete Block (ACB) canoe access ramp at Fred Garner Park was completed. First, the riprap was removed from the area of the riverbank where the ramp was to be located. Then to meet the appropriate grades excess riverbank soil material was excavated from the riverbank. The excavated riverbank material was transported to Area 64 stockpile management areas for offsite disposal. Activities associated with installation and compaction of common fill was completed. Geotextile fabric was then placed in the areas of the ramp and the ACB was installed. Sand was placed on top of the ACB to seal in the gaps between the blocks. Concrete grout was installed around the parameter of the canoe launch to seal in the ACB to the riverbed and riverbank riprap as an erosion control measure. Additional 18-inch and 9-inch riprap was placed along the sides of the ramp to create a smooth transition between the canoe launch and the riverbank.

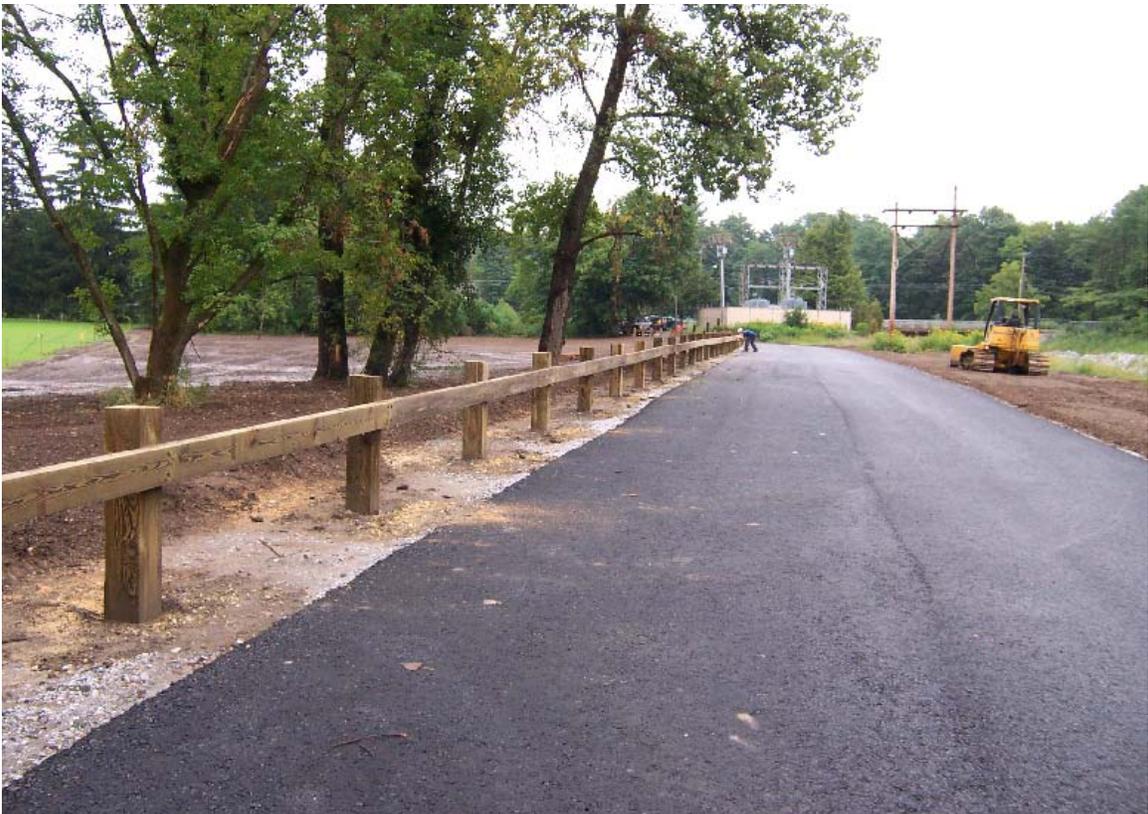
Photograph 8 – Paved Entrance Road and Guardrail at the Fred Garner Park

As part of the Fred Garner Park final restoration activities, the former park entrance road and parking lot will be expanded and paved. Once the dense grade material was removed from the temporary road and staging area/former parking lot, it was observed that the native materials beneath the temporary road/staging area were unsuitable to be used as a sub-base for paving. Therefore, the unsuitable material was removed and transported to Area 64 stockpile management area for offsite disposal. Next, a minimum 4-inch layer of dense grade material was placed and compacted to obtain an appropriate base for paving of the road and the parking lot. Then, the paving of the base course was completed and the installation of the guardrail was initiated. Also, concrete curbs were installed at the entrance to the park. The installation of the paving final surface course, striping of the parking lot and installation of the parking lot bumpers are scheduled to be completed in September 2006.

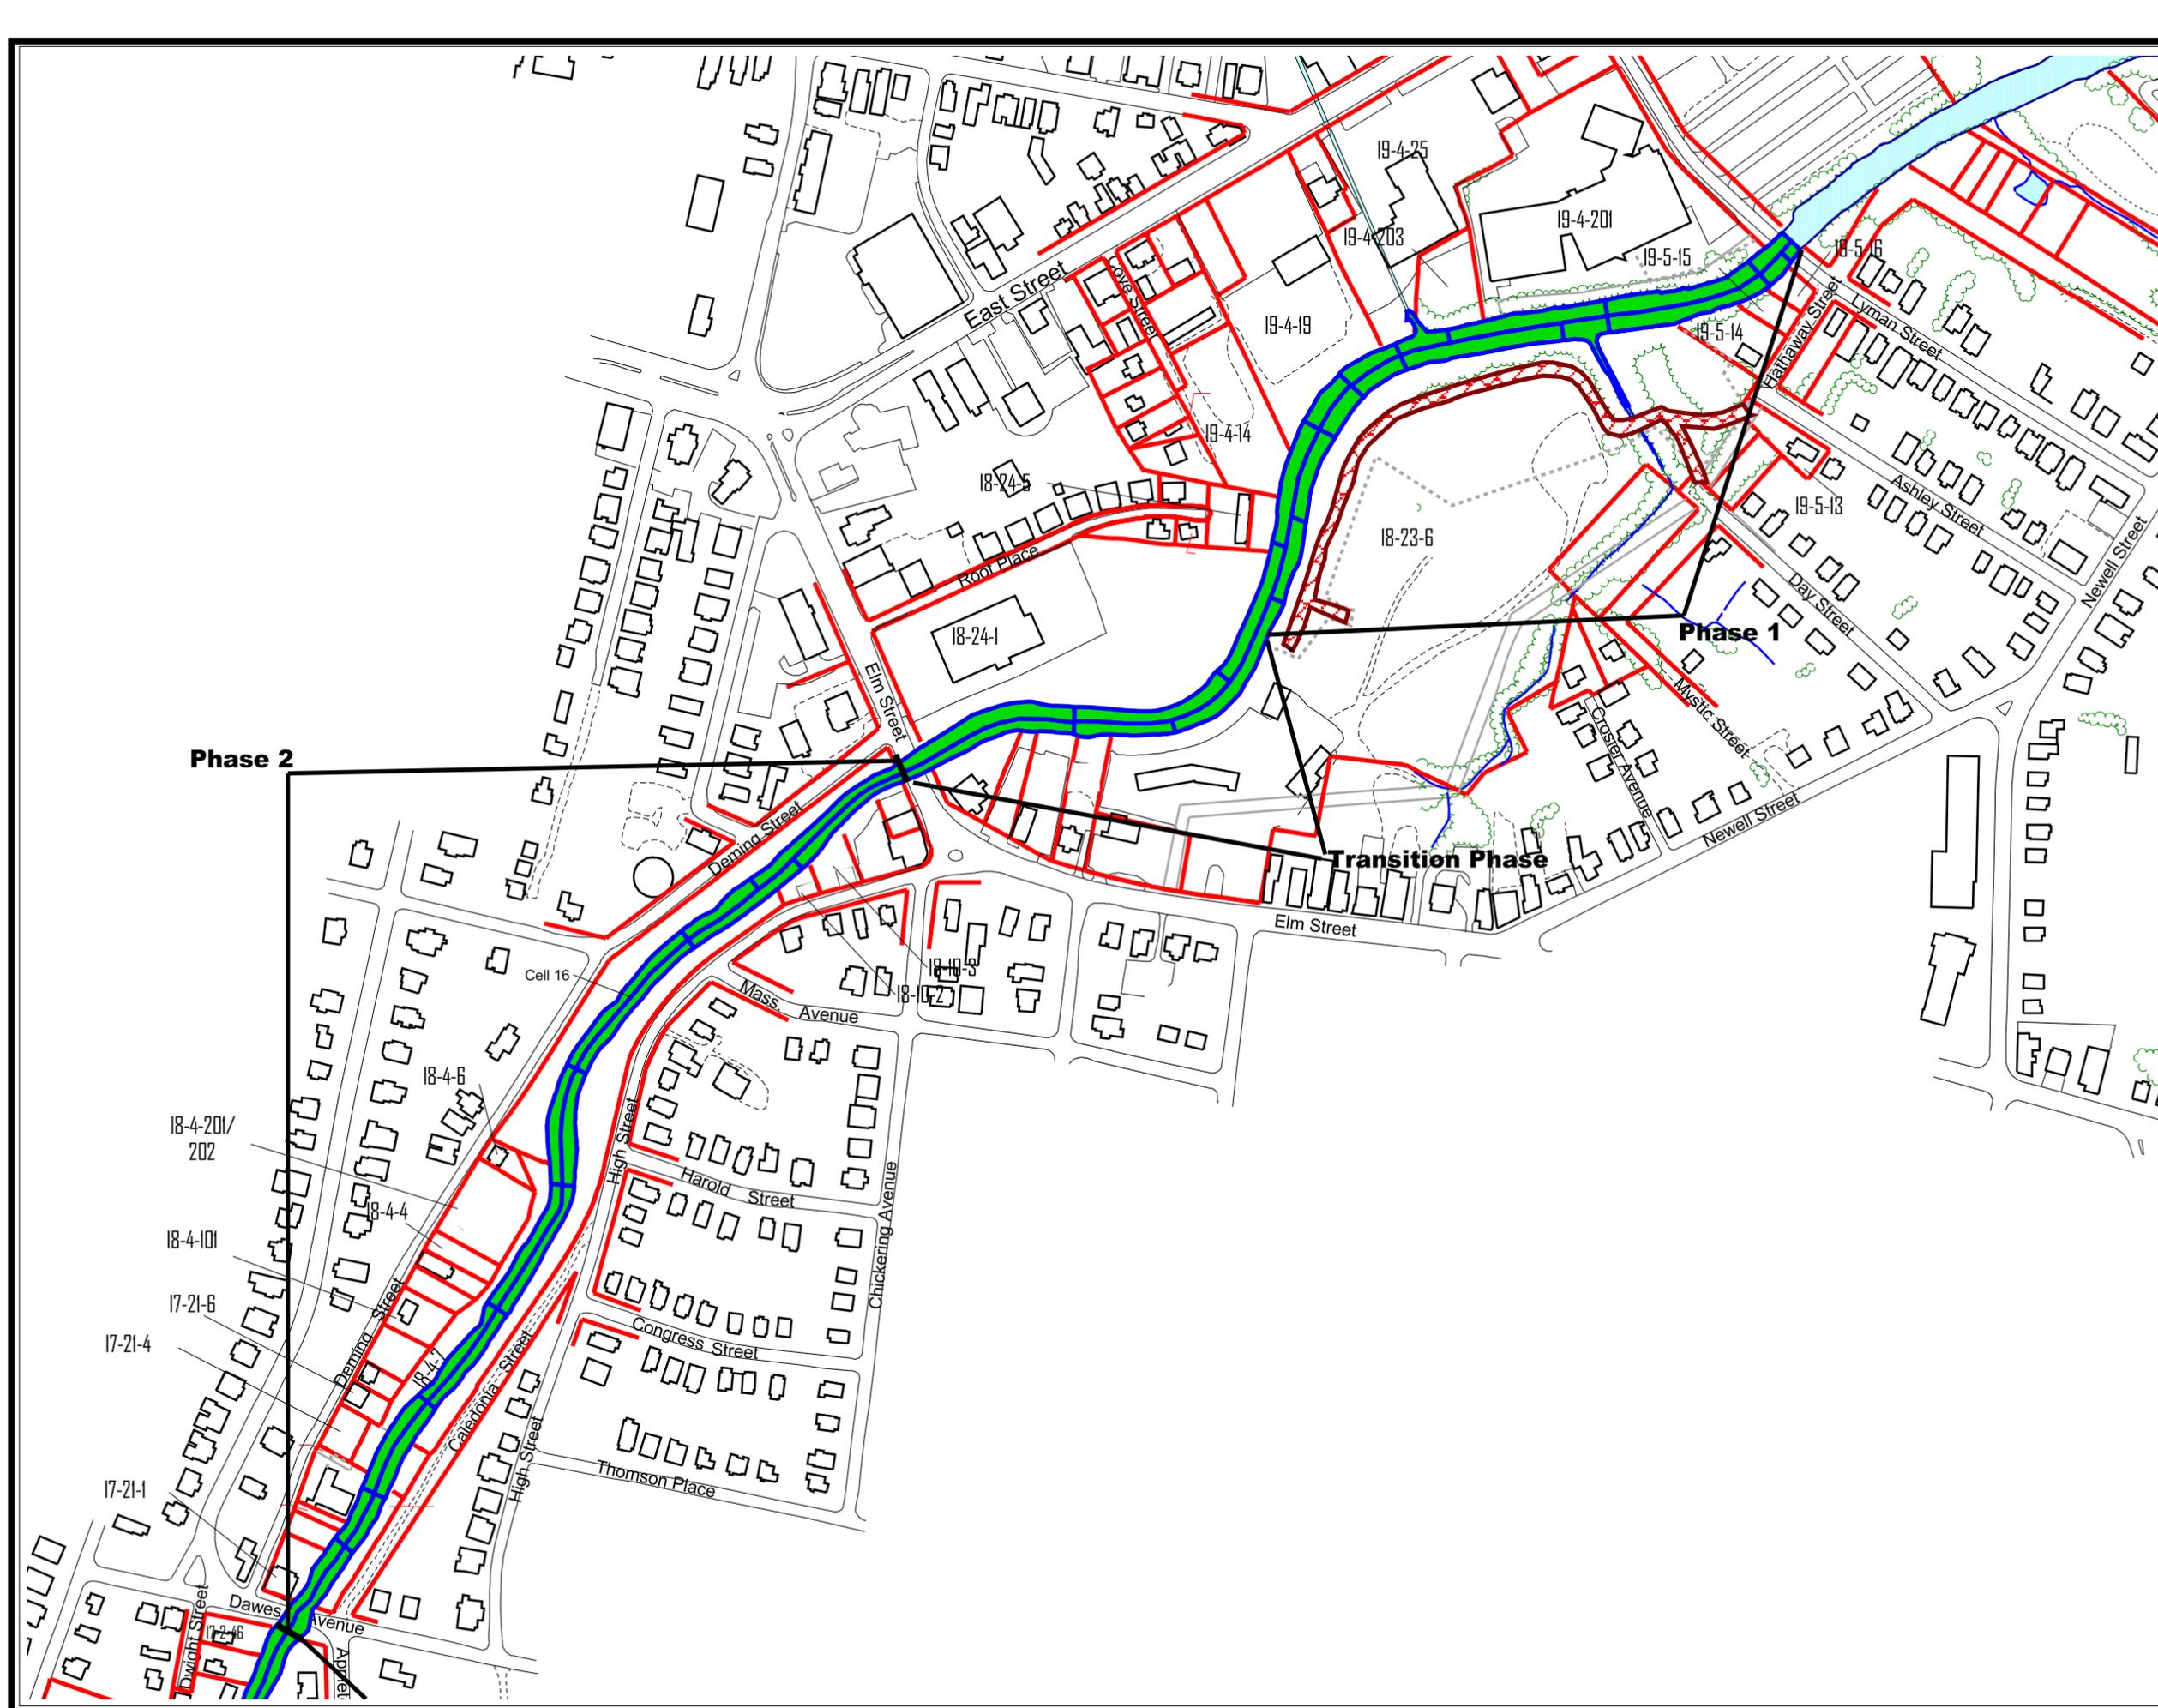
Figure 1 (2 maps) displays the locations of the 1.5 Mile Reach Removal Action Phases including the layout of all excavation cells, access road locations and temporary fence line location.

Refer to Figure 1 (2 maps) for an orientation of the 1.5 Mile Reach Removal Action.
