Figure 5.9.2-3

Kendall Station intake continuous temperatures compared with continuous temperatures measured near the Boston University Bridge. Temperatures taken once a day in the same location by the Massachusetts Water Resources Authority (MWRA) were also included (July - September, 1999).

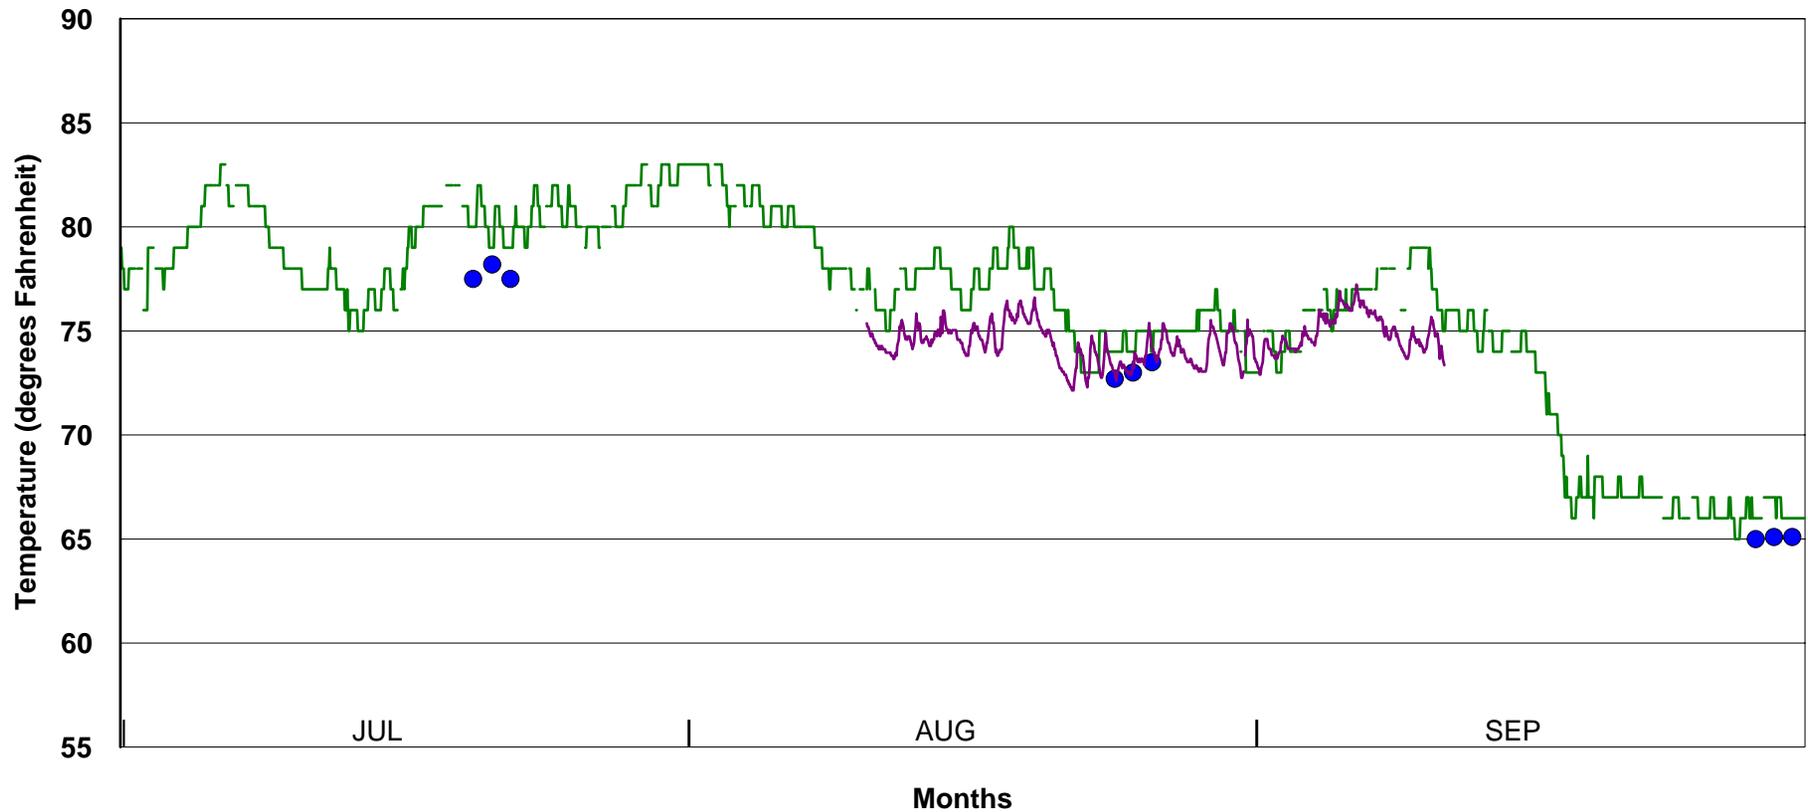
Data Source: Mirant Kendall and MWRA Provisional Data

1999 Intake Temps    MWRA Data    MRI Continuous BU Bridge
