WV CASE STUDY

Trouble at the Truck Stop

K & T Truck Stop Incident

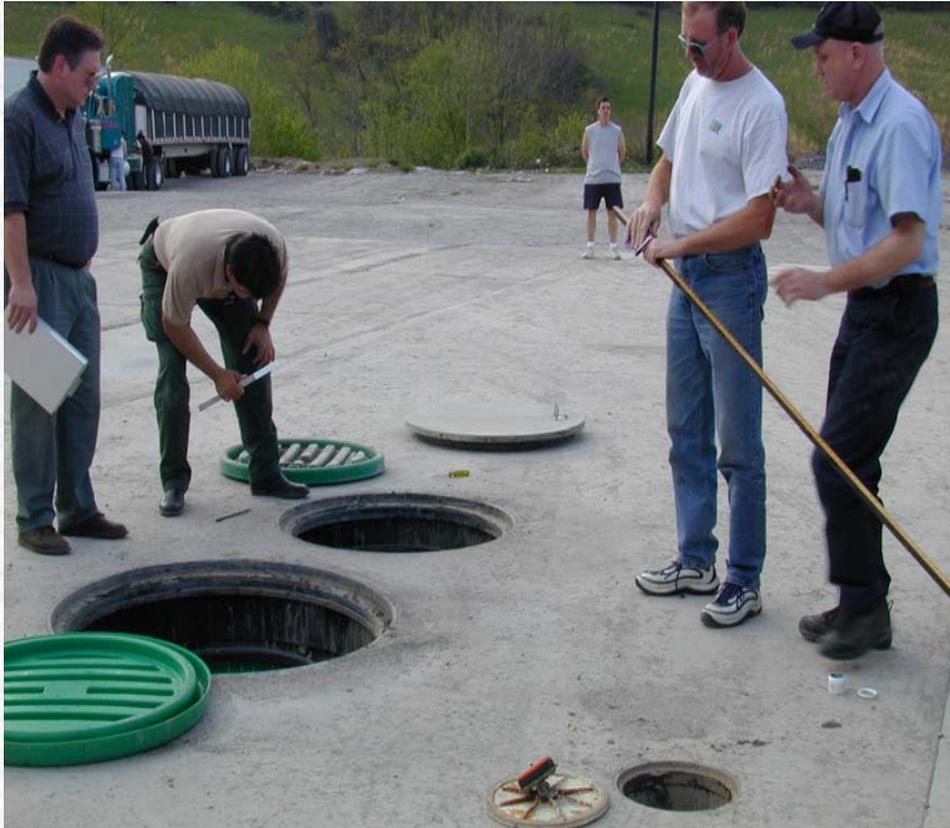
- The UST observation well in the front of the picture had 5" of free product.
- The person at the far end is standing at the UST pit observation well TF-1, where product was off loaded (7500 gallons of Diesel).
- This monitoring well had 21" product.

The UST pit monitoring well near the STP manholes.

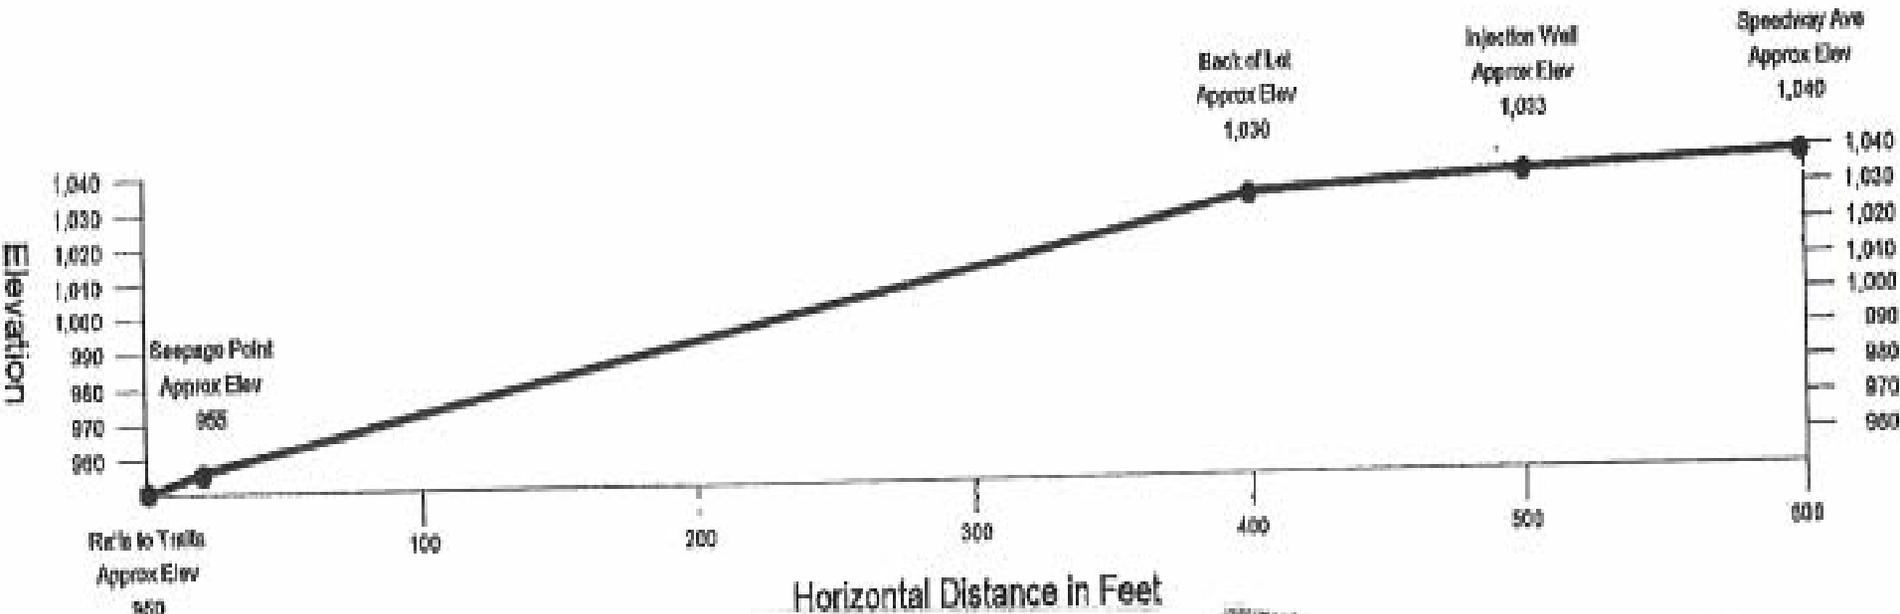
Cross Sectional View of Topography from Marion County Rails to Trails to Speedway Ave.

Attached is the diagram you requested showing vertical elevation and horizontal distances. The data is based off of the Fairmont East topographic map and GPS readings from the Rails to Trails and injection well.

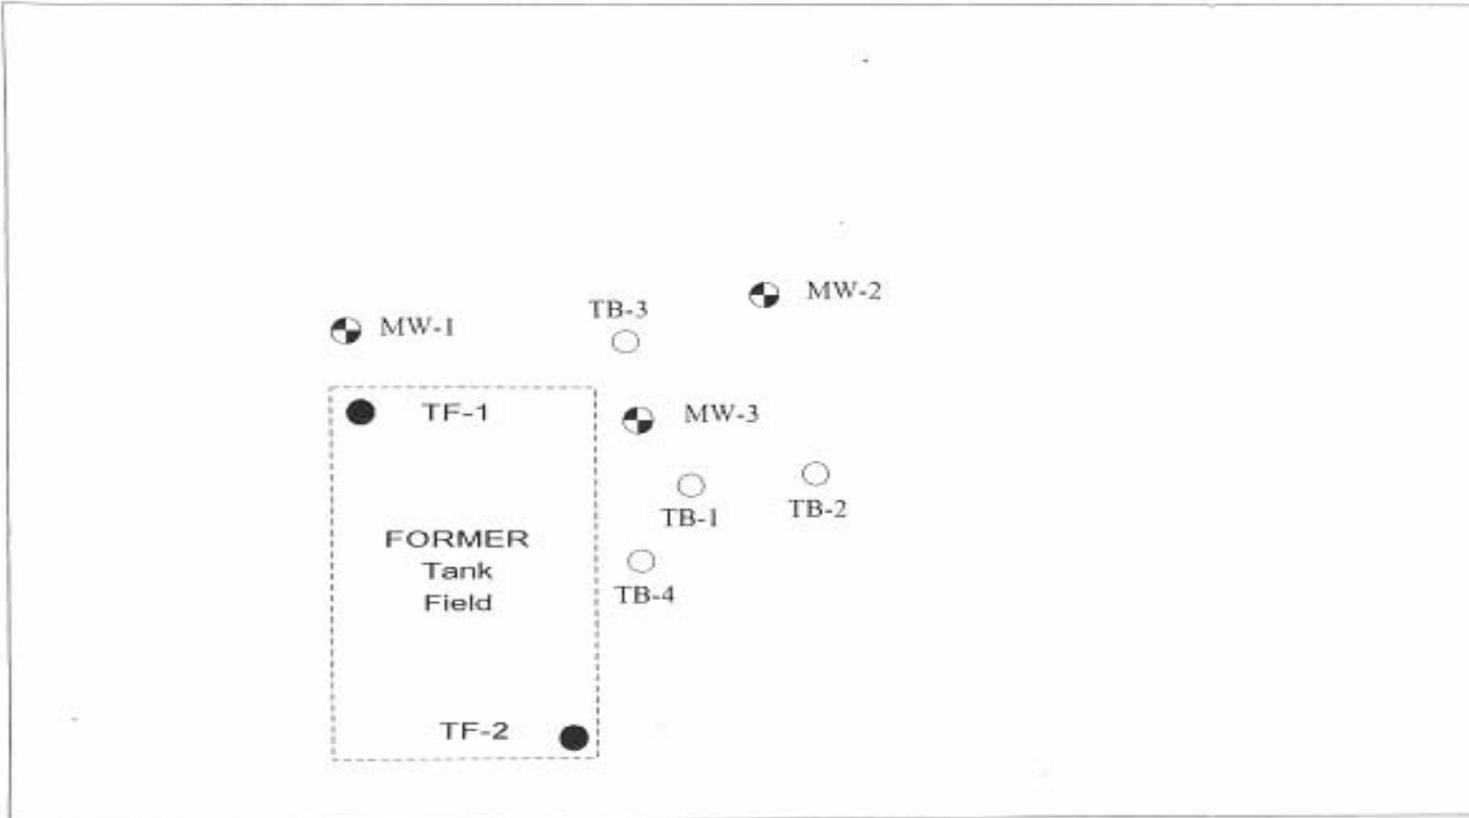
Figure 3
Project No.
02002.001

- ☉ Monitoring Well
- Observation Well
- Soil Boring

Well and Boring Locations
K&T Truck Stop
Speedway Ext., Fairmont, WV

April 19th/20th- 2783 gallons of product was recovered from *TF-1/TF-2*

April 22- 3880 gallons of NAPL product was recovered.

April 24- *TF-1* was over drilled and deepened to enhance product recovery, three monitoring wells were installed and advanced additional 4 soil test borings were performed to delineate NAPL plume. (*MW-1, MW-2, MW-3* and *TB-1, TB-2, TB-3, TB-4* as listed above)

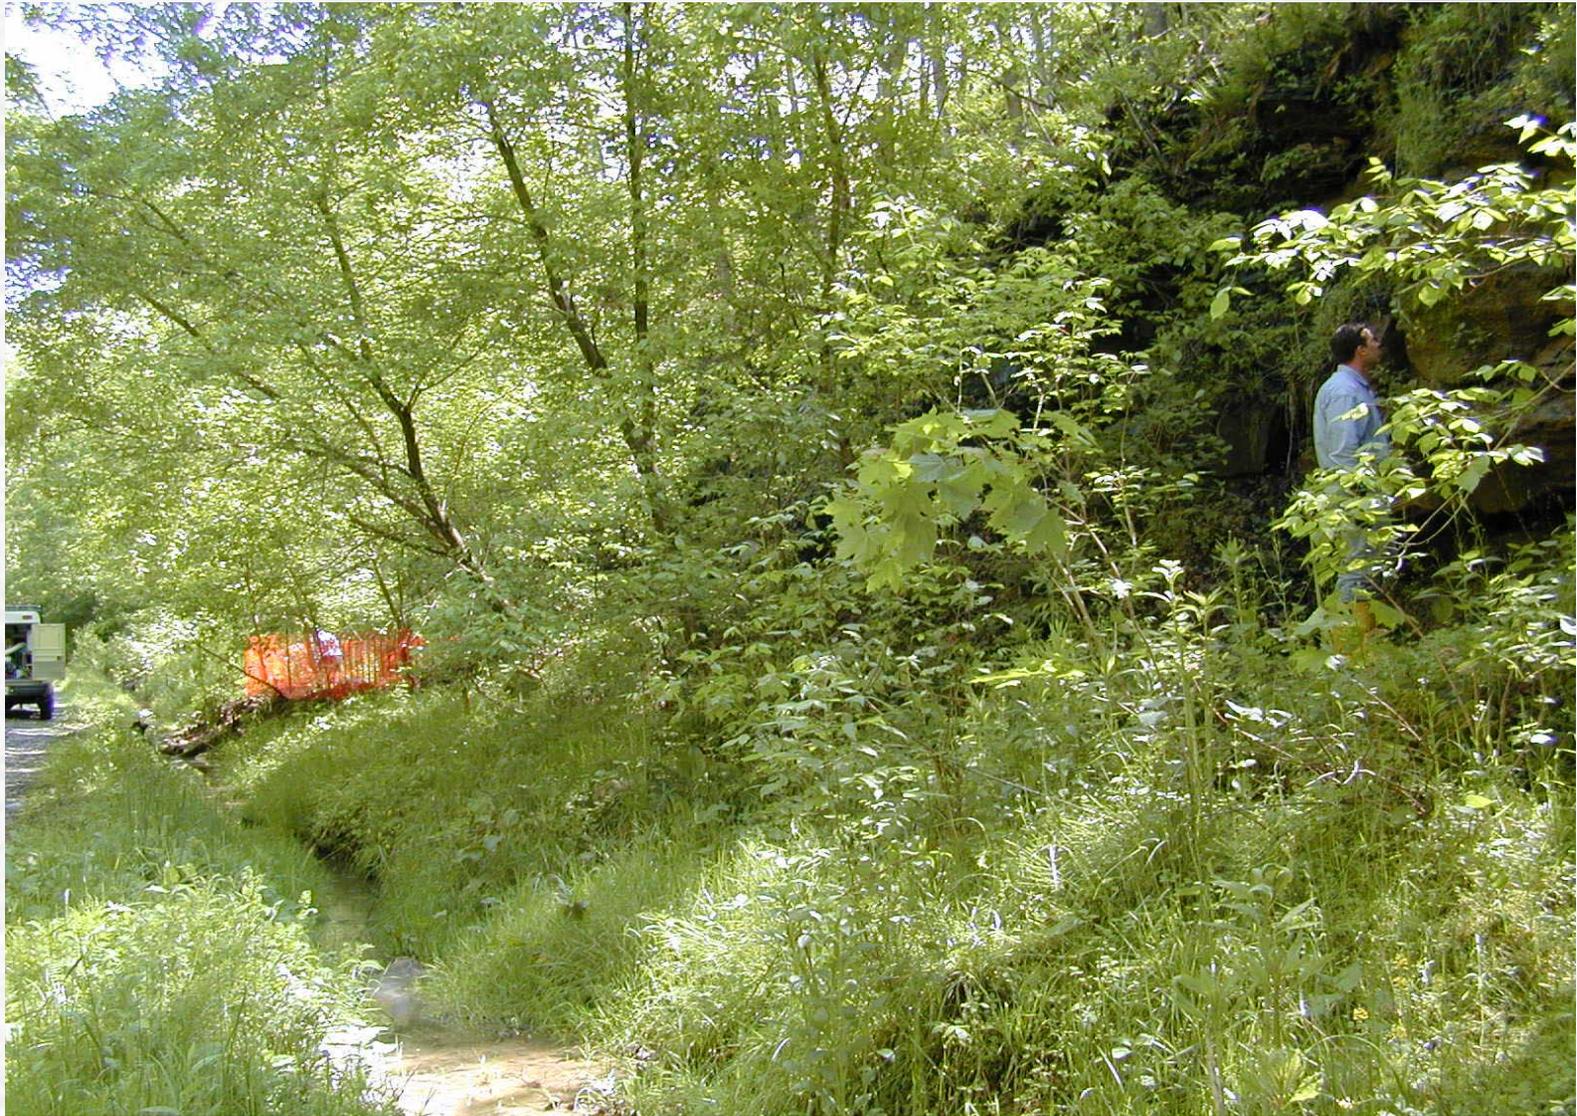
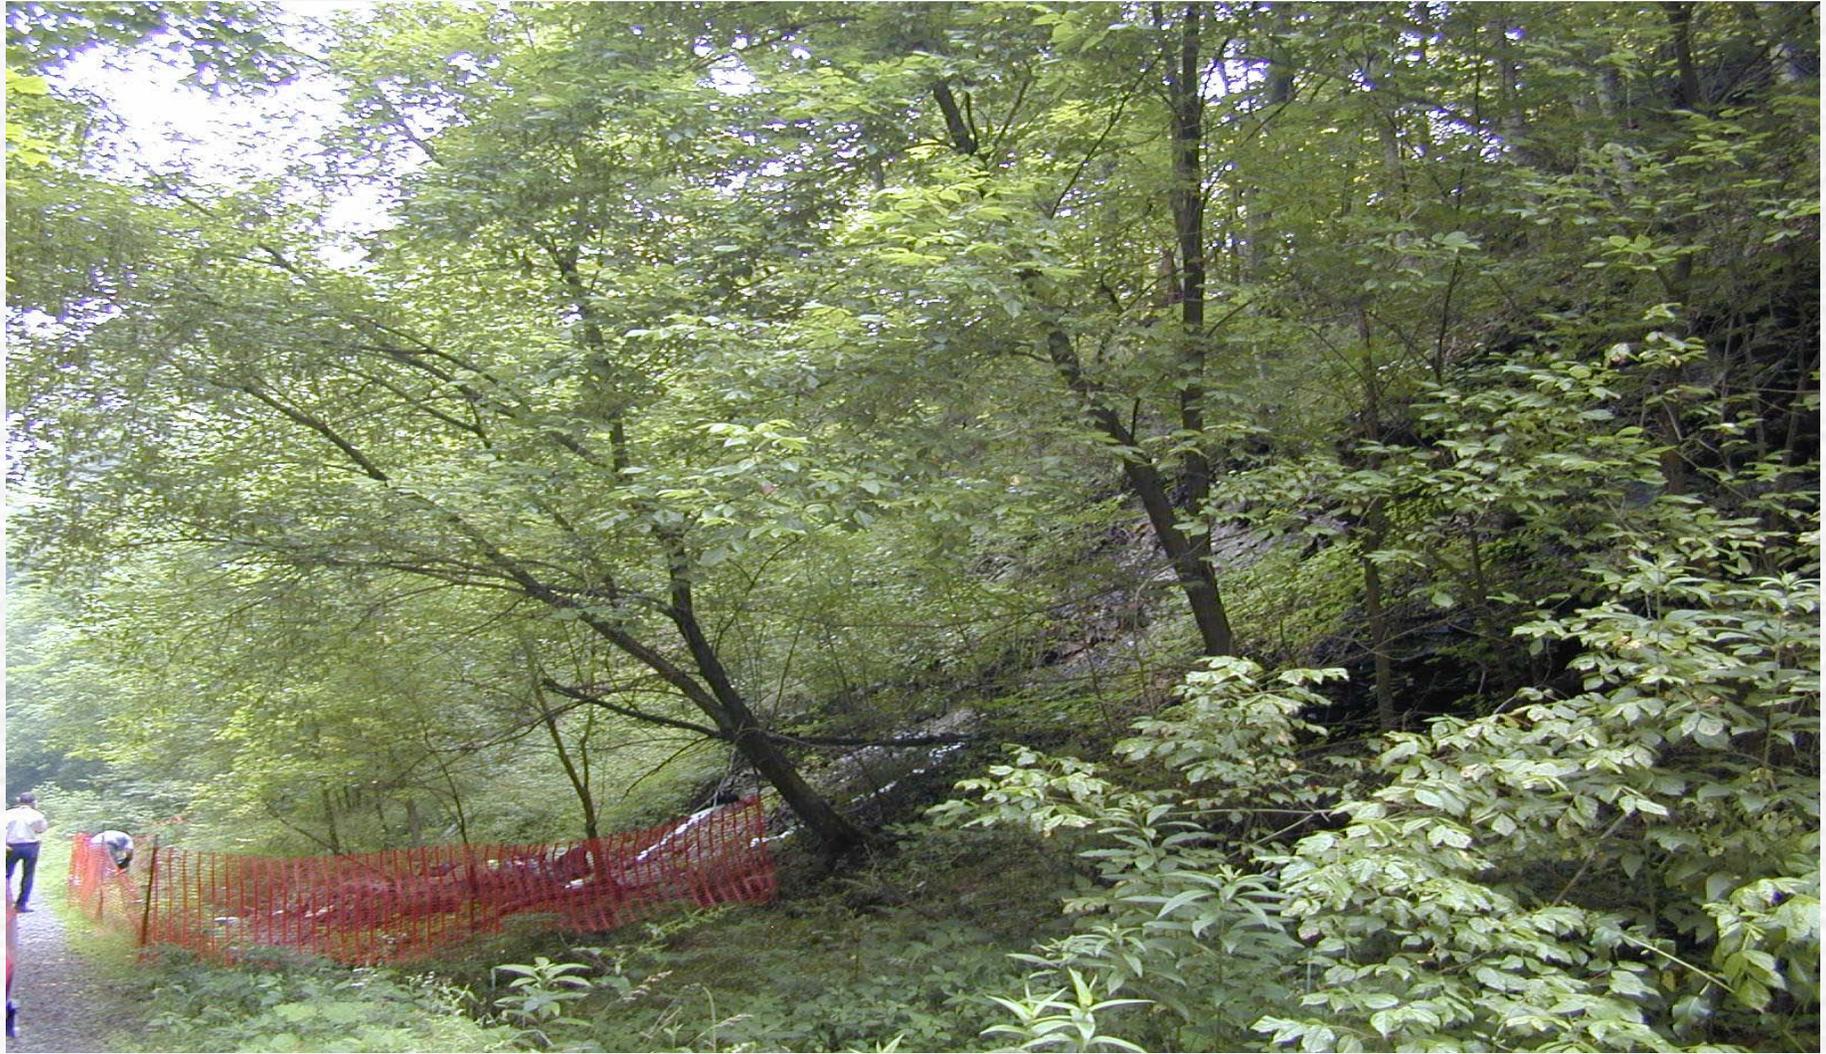
Inspection of Seep at Rails to Trails

On May 13th a sheen of product was discovered in the drainage ditch along the rails to trails pathway below K&T Truck stop, the sheen was traced back upstream and it was determined that the product was coming from joints and bedding planes within the sandstone bedrock on the hillside along the western flank of the subject site

Construction fence was installed to keep the general public out of the area

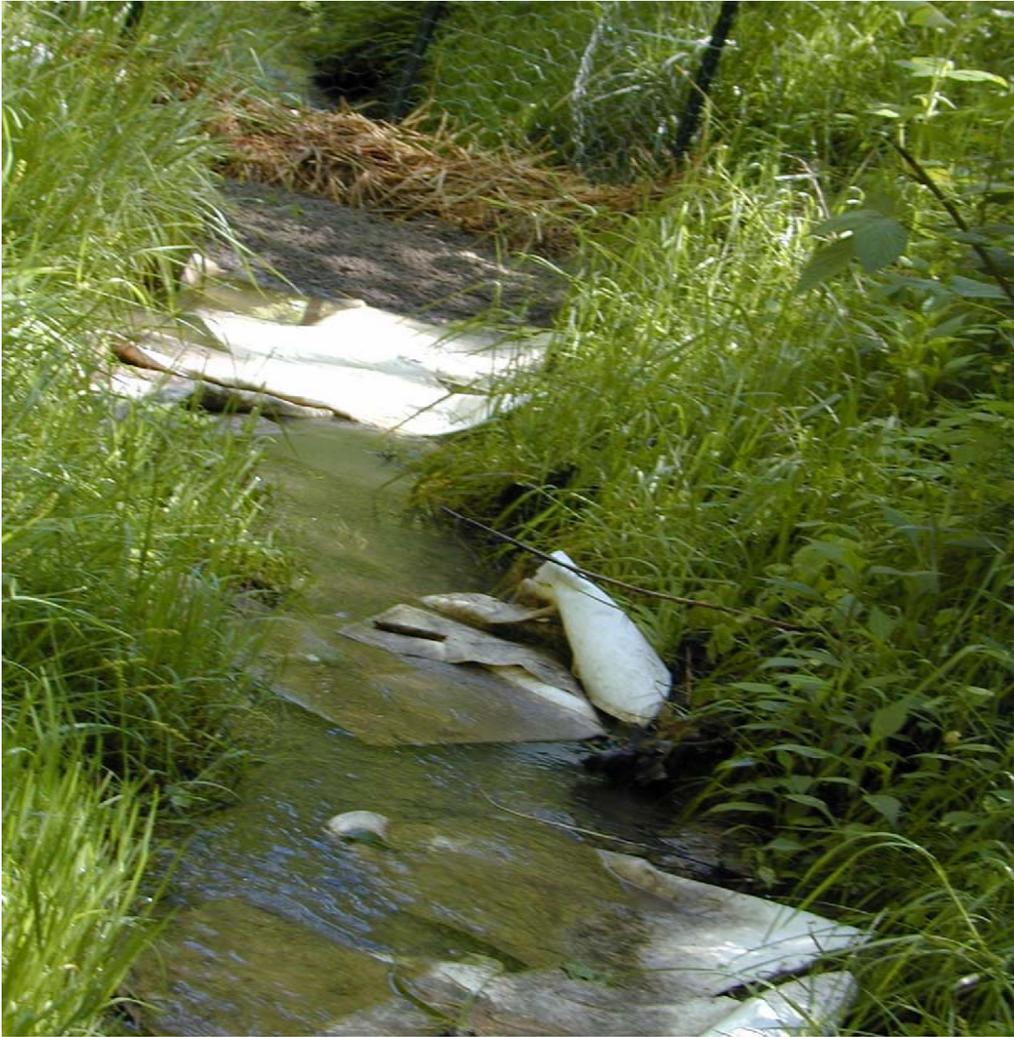
- The site is about 1050 ft. above MSL, and topography is rugged with a relief of approximately 250 ft. within one mile of the site.
- Test borings advanced to 102' and 60' below grade at site, using an air rotary drill rig, indicating no groundwater.

- Booms and Pads were installed at the creek by the Rails to Trails (downhill from site) - where product was visible

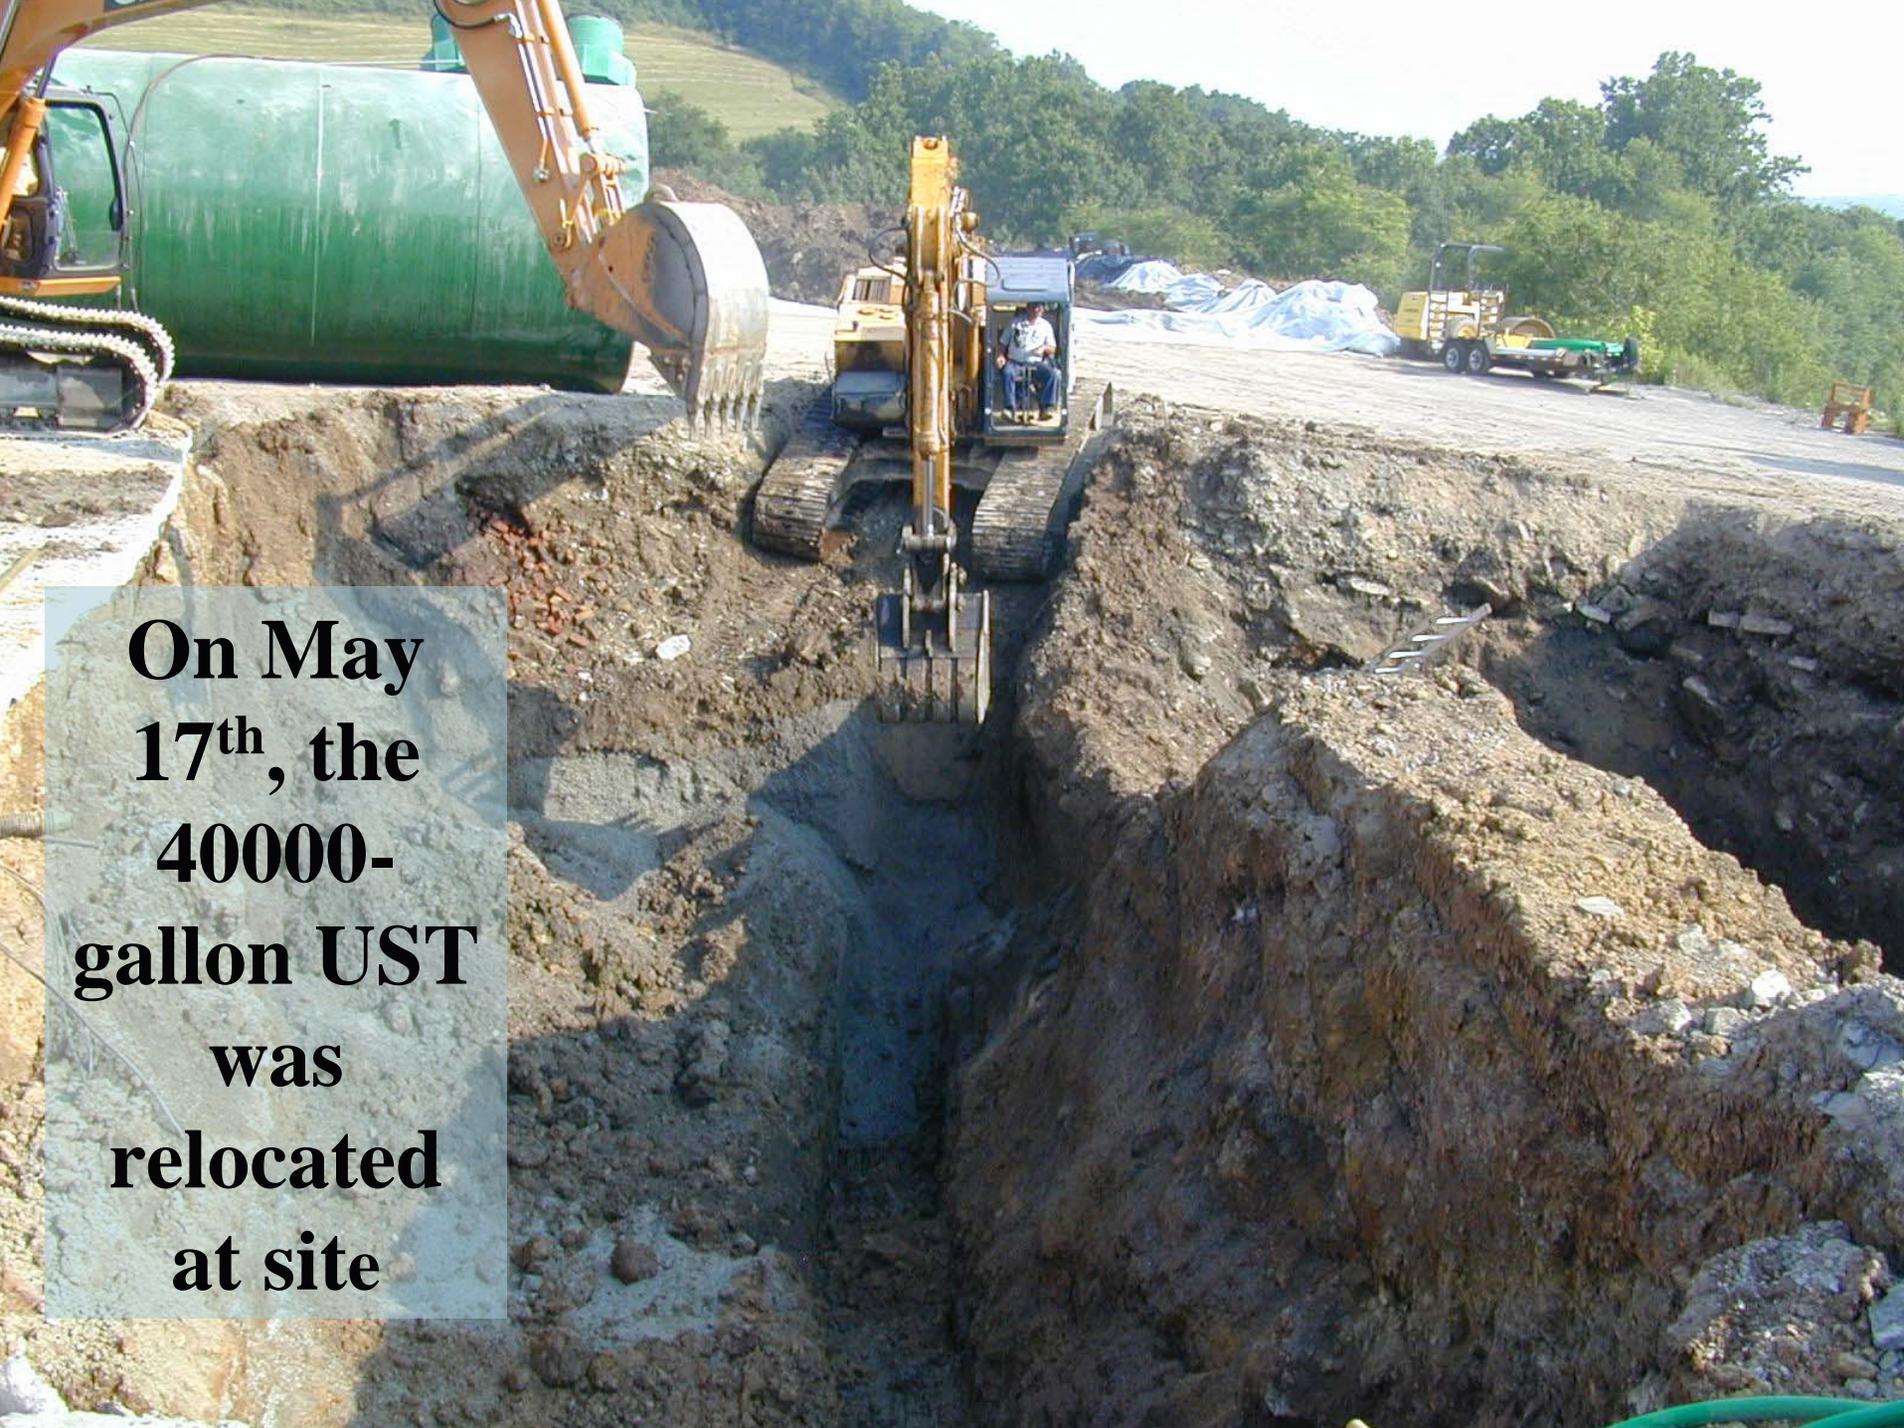
A 10000 gallon above ground tank was installed temporarily to enable business to proceed normally

[with approval from fire marshal]

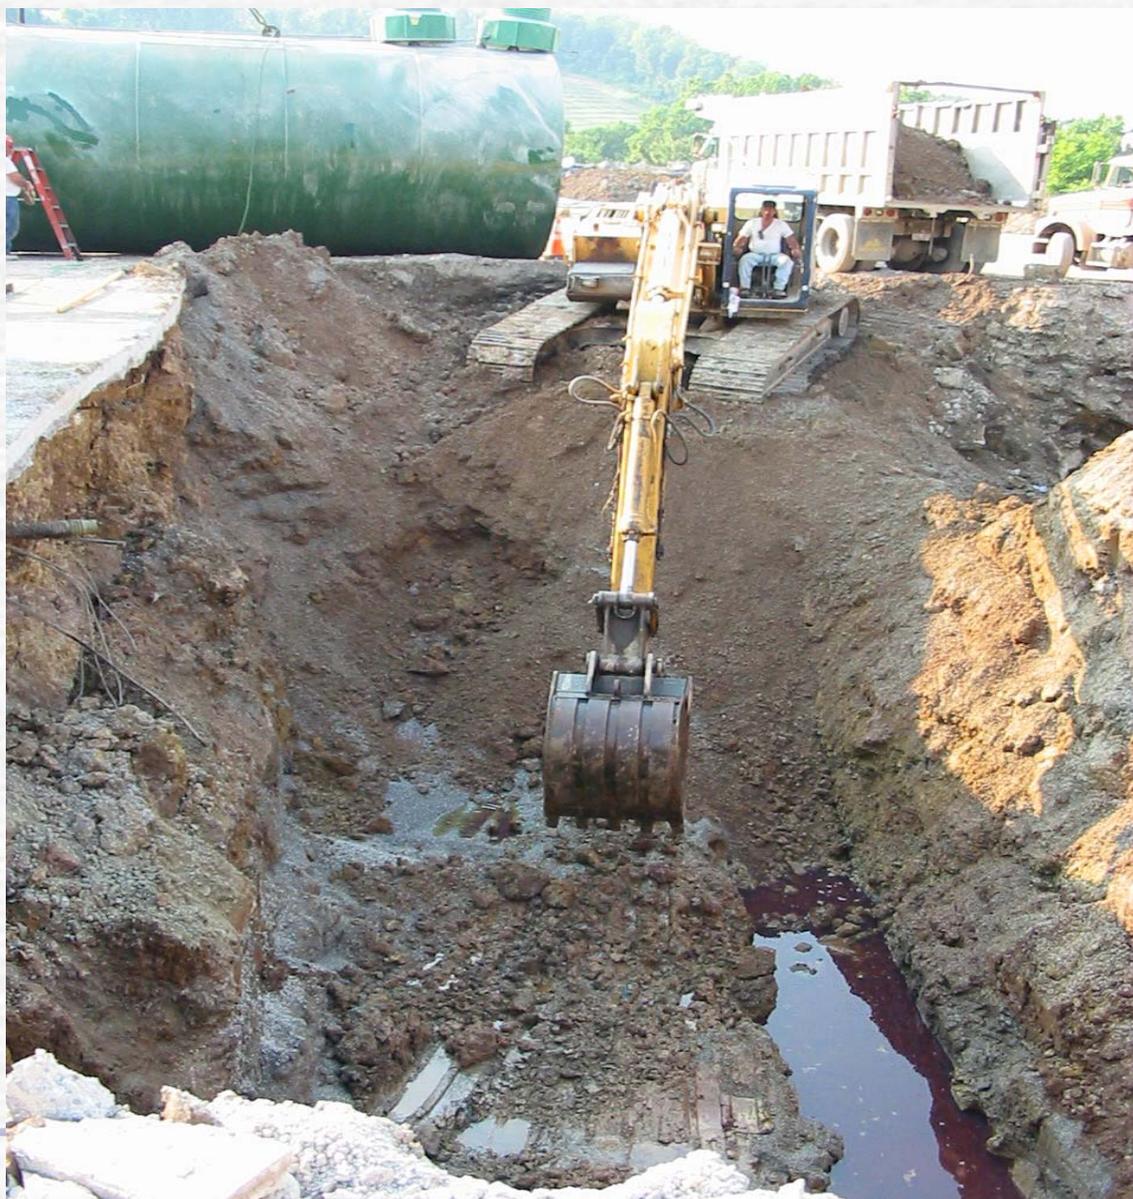
On April 30th – an exploratory pit was excavated around the Northwest portion of the UST. Product saturated soils were observed at 14 ft. to 18 ft. below grade.

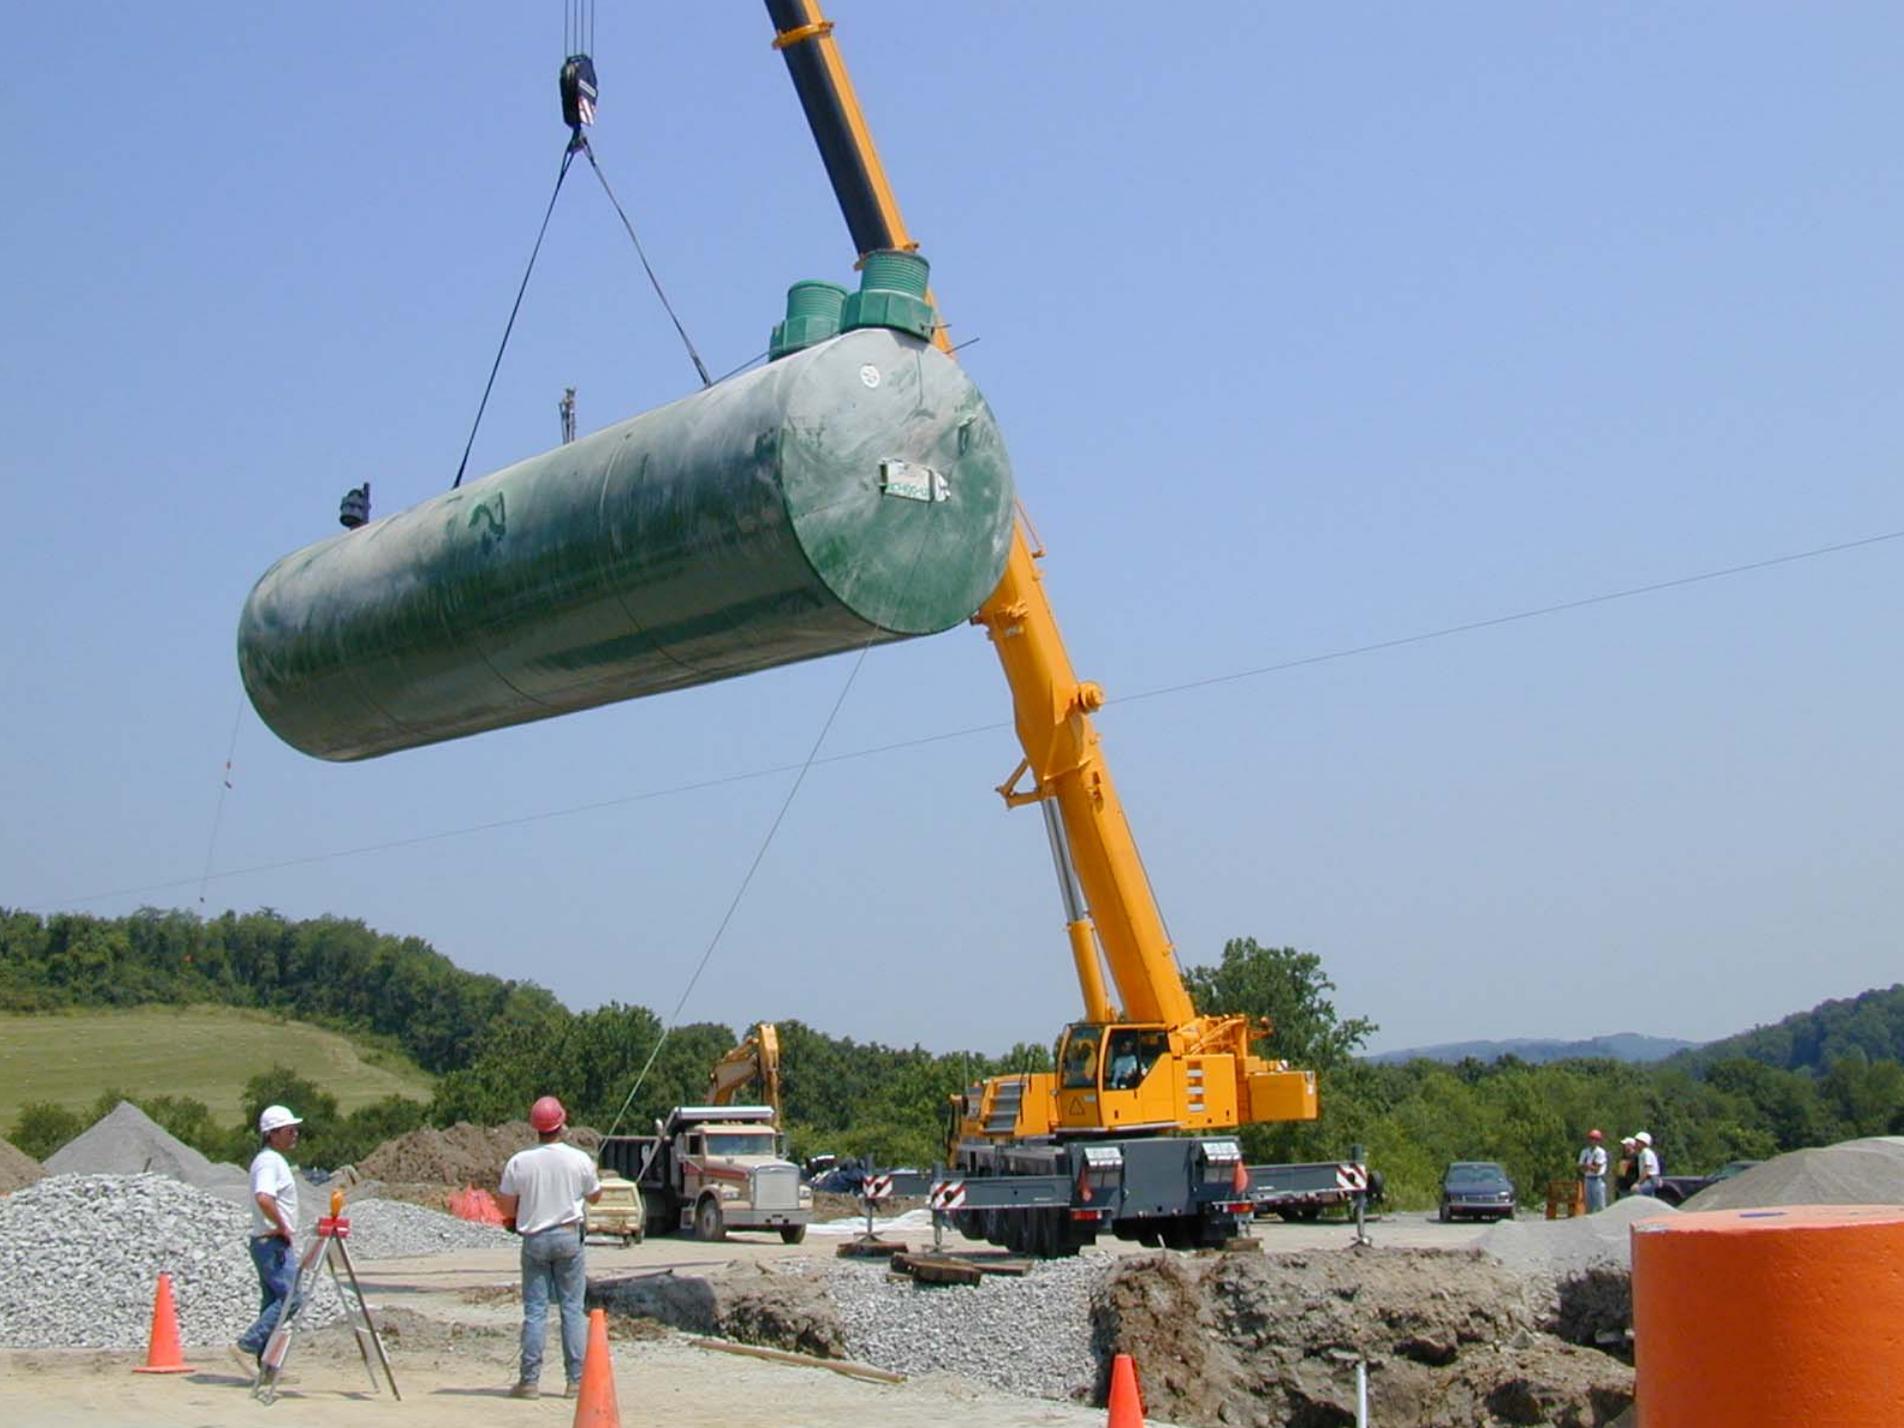
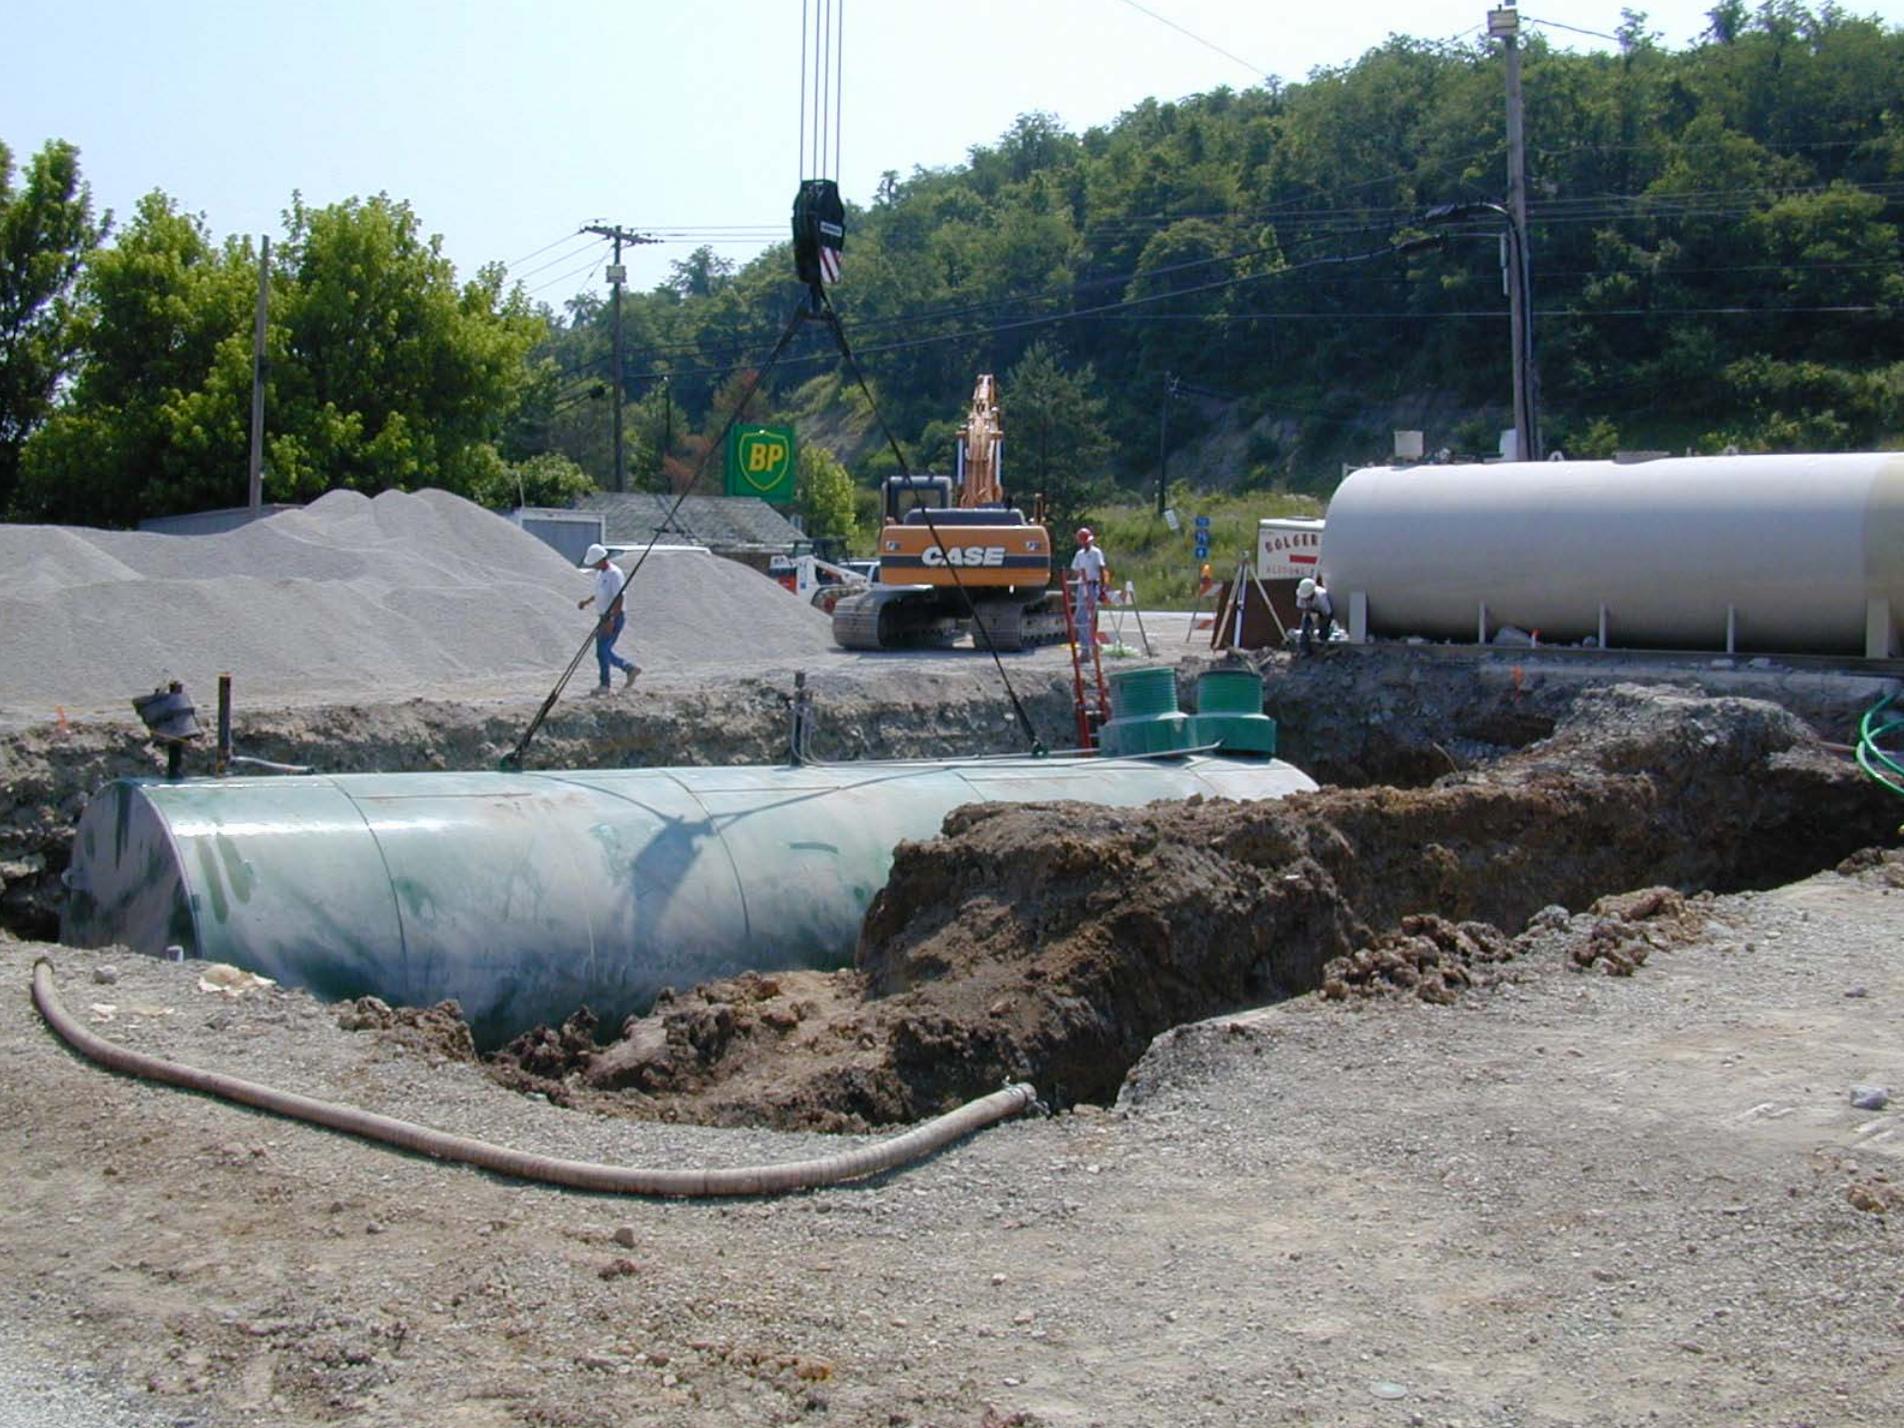
An injection well was installed before backfilling the former tank field

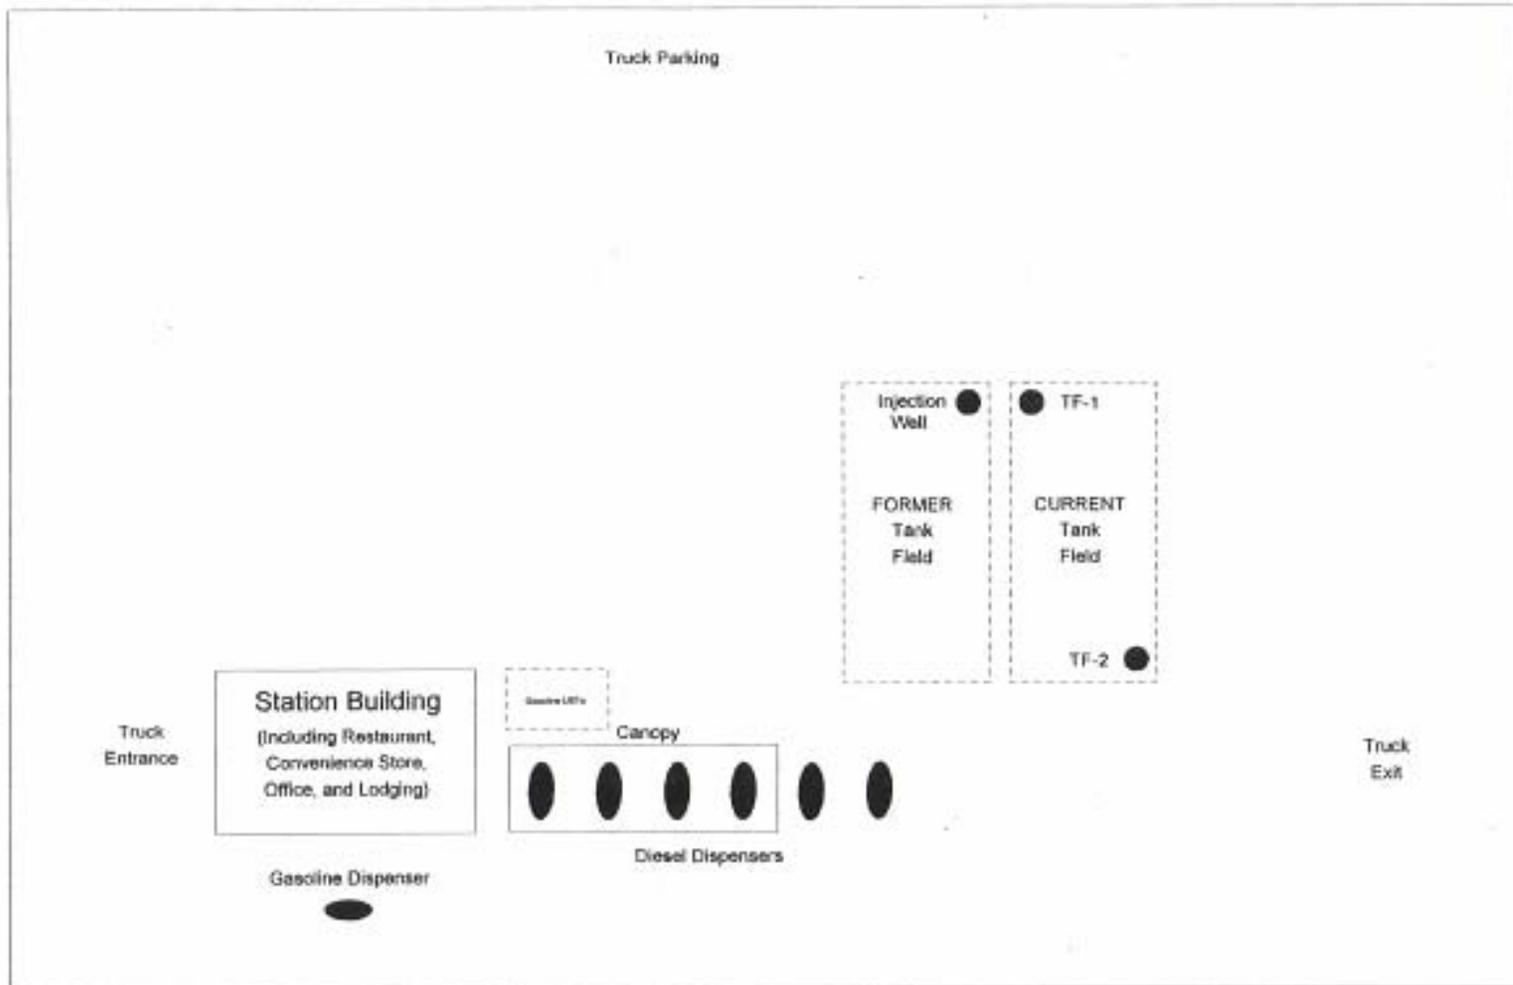
Figure 1
Project No.
02002.001

- Monitoring Well
- Observation Well
- Dispenser Island

Site Plan
K&T Truck Stop
Speedway Ext., Fairmont, WV

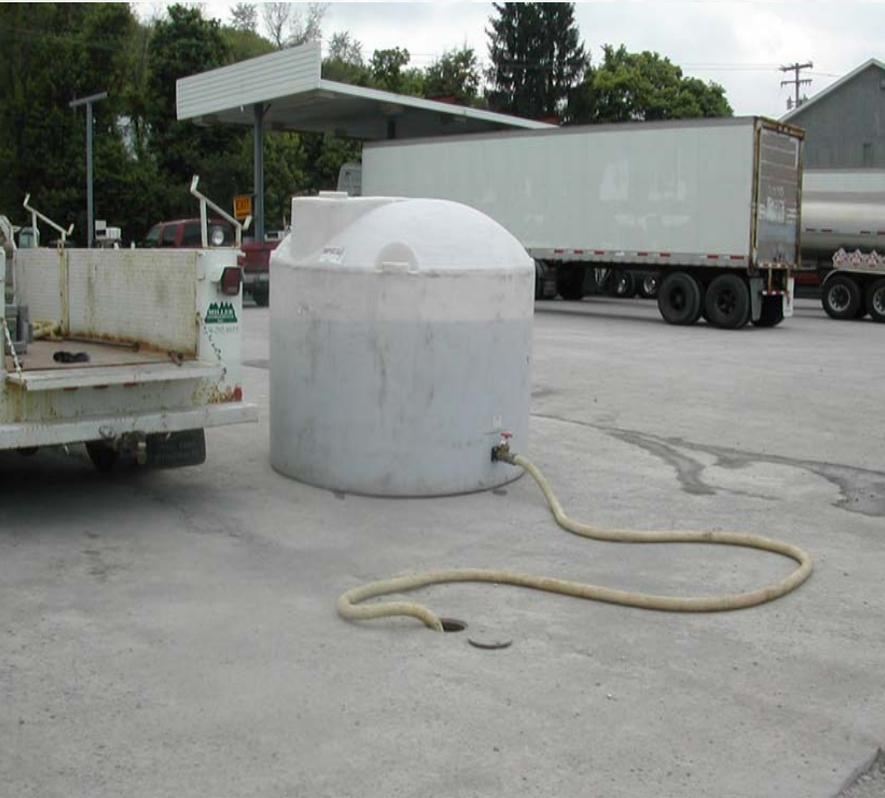
Totally 10,000 gallons of diluted mixture of petroleum degrading bacteria / water / nutrients was injected.

- The injection liquid was a mixture of petroleum degrading bacteria, nutrients.
- Six bio augmentation events occurred during March 2003 to August 2003, and more during May 2004 to November 2004 at the approximate location of the former tank field observation well so the flow path of the released diesel fuel may be duplicated.
