Re: GE/Housatonic River Site  
1.5 Mile Reach Removal Action  
2007 Summer Vegetation Monitoring Report  
DCN: GE-110107-ADRJ

# Memorandum

Re: 2007 Summer Vegetation Monitoring Report

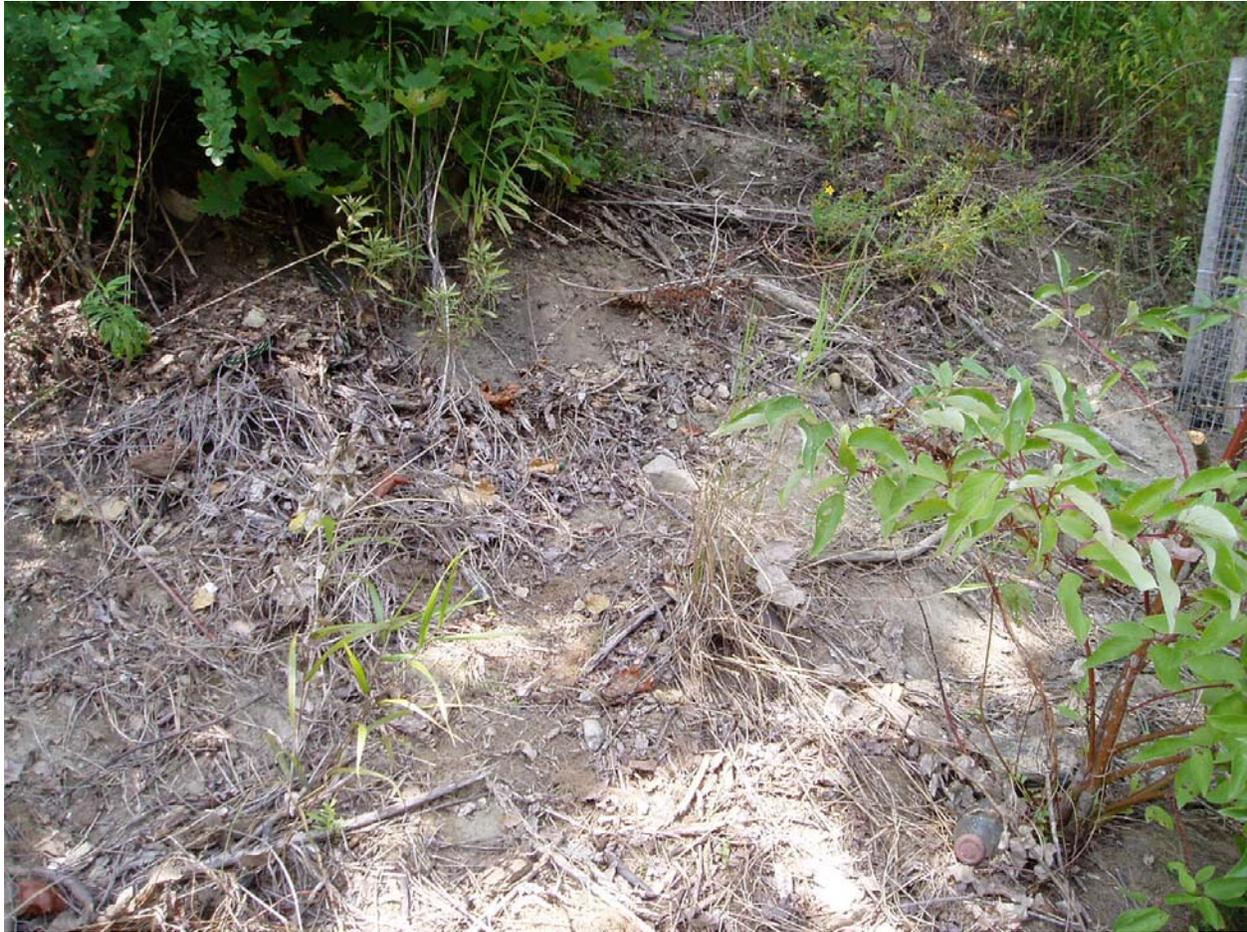
**Photo 1. Bare soil recommended for re-seeding in monitoring plot 2-W-1.**

- Install tree cages on trees exhibiting “pole form” capable of accommodating such protection within Lyman to Elm Street reach.
- Re-seed and mulch plot 2-W-1 and adjacent areas.
- Restrict herbicide use to only Japanese knotweed, common reed, purple loosestrife, Norway maple, black locust, and invasive woody vines and shrubs.
- Restrict herbicide use within 3 feet of planted trees and shrubs.
- Restrict herbicide use under windy conditions.
- Continue hedge bindweed removal.
- Continue tree cage maintenance.
- Install tree protectors on cages on east bank of Pomeroy to Confluence reach.
- Control of purple loosestrife population between plots 2-W-2 and 2-W-3.
- Tree cage maintenance adjacent to plot 2-E-1.
- Replacement of 12 trees at STA 532+50 (east bank). Recommended species for replacement are box elder and eastern cottonwood.

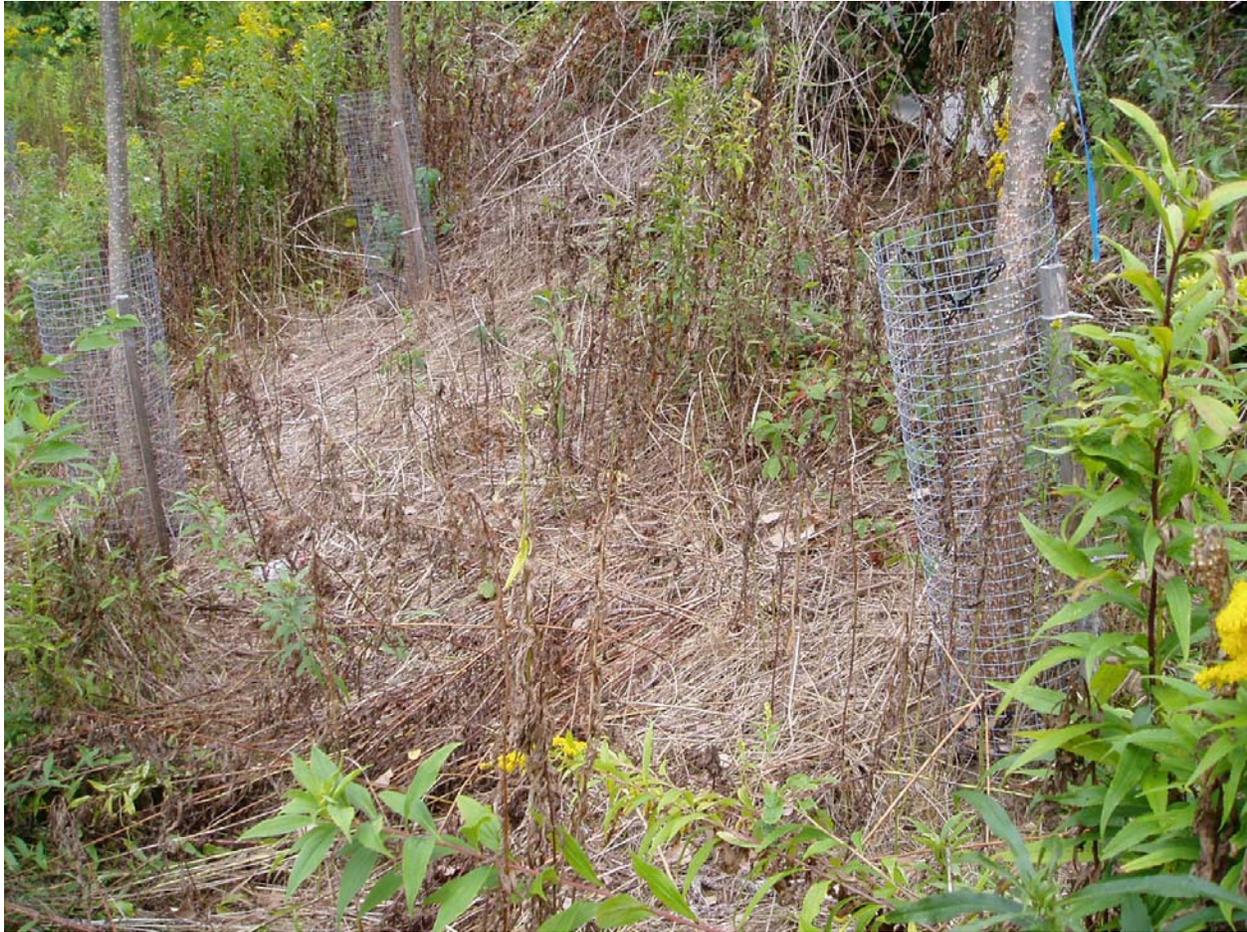
**Photo 3. Loss of herbaceous cover apparently resulting from herbicide treatment.**

All monitoring plots achieved the applicable performance standard of less than 5 percent invasive species cover. As suggested above, a modified herbicide treatment regime is recommended to reduce impacts to desirable native species.

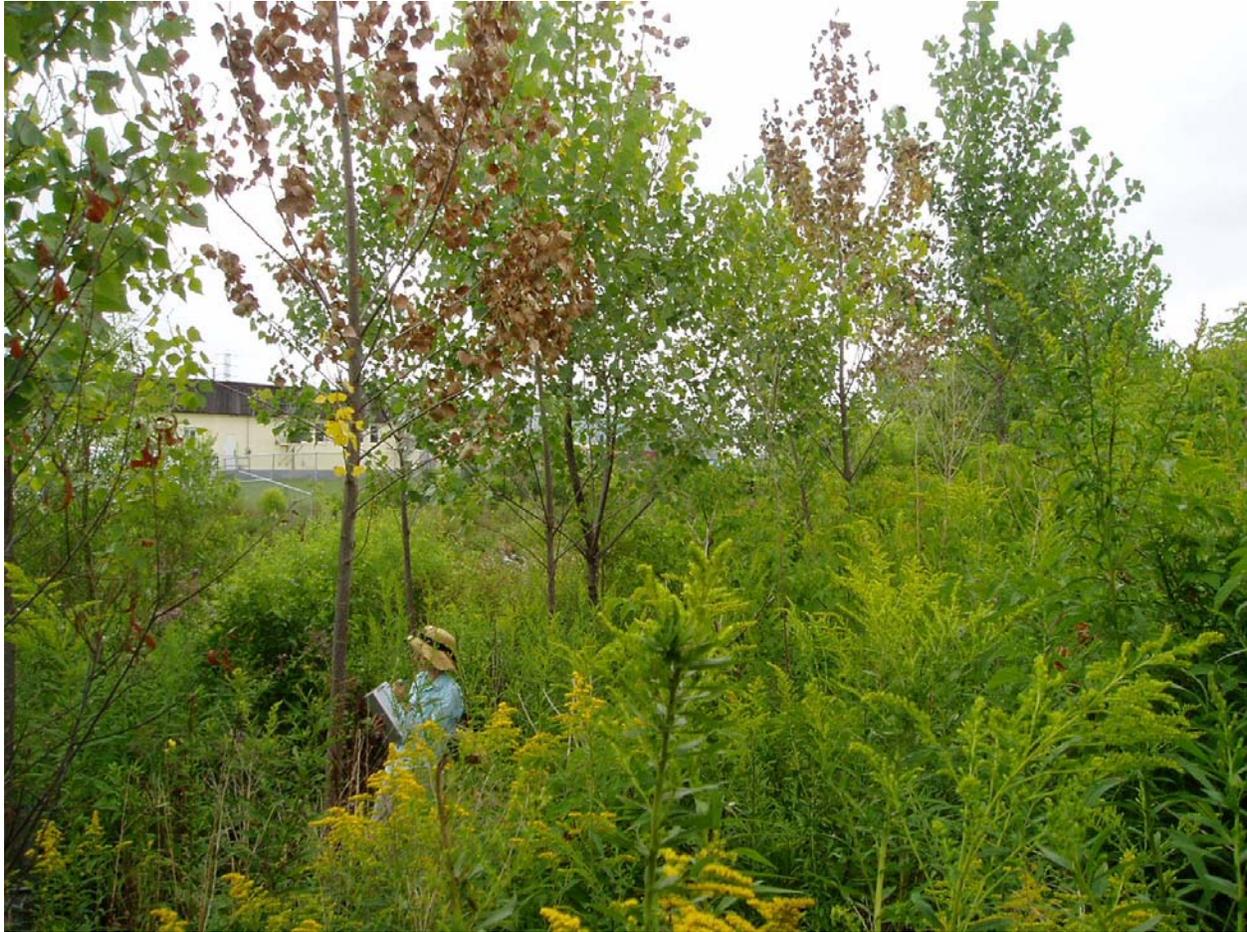
**Photo 4. Eastern cottonwood trees apparently stressed by herbicide exposure.**

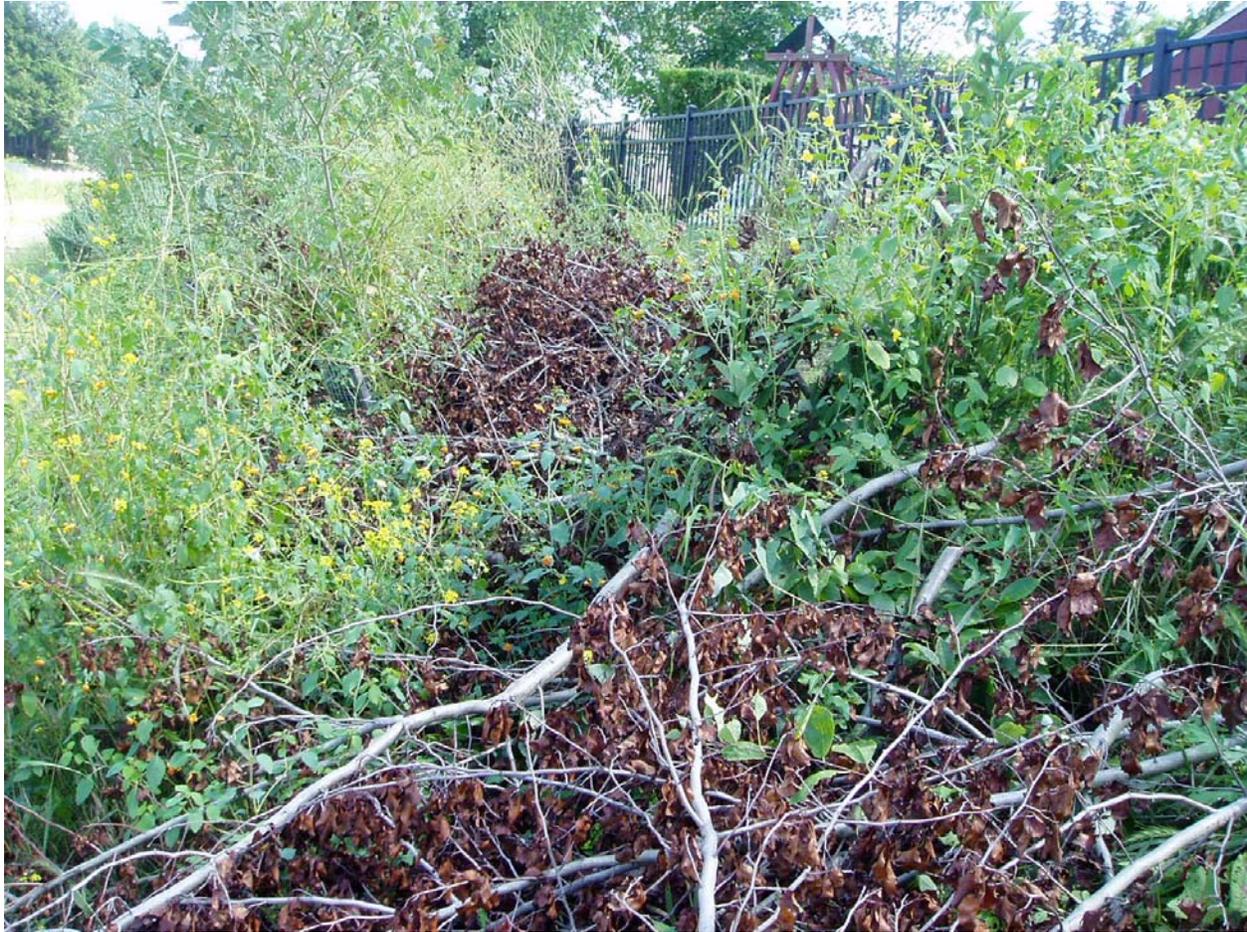
Tree and shrub growth was generally healthy in this reach. Four shrubs within monitoring plot 4-W-3 were apparently mowed by the property owner. Shrub density within this plot still exceeds the performance standard. Lawn debris was observed to have been deposited on tree and shrub plantings behind a private residence between monitoring plots 3-W-2 and 3-W-3 (see photo 5). Minor spray damage to herbaceous cover and trees was observed in this reach.

**Photo 5. Lawn debris placed on planted trees and shrubs behind private residence.**

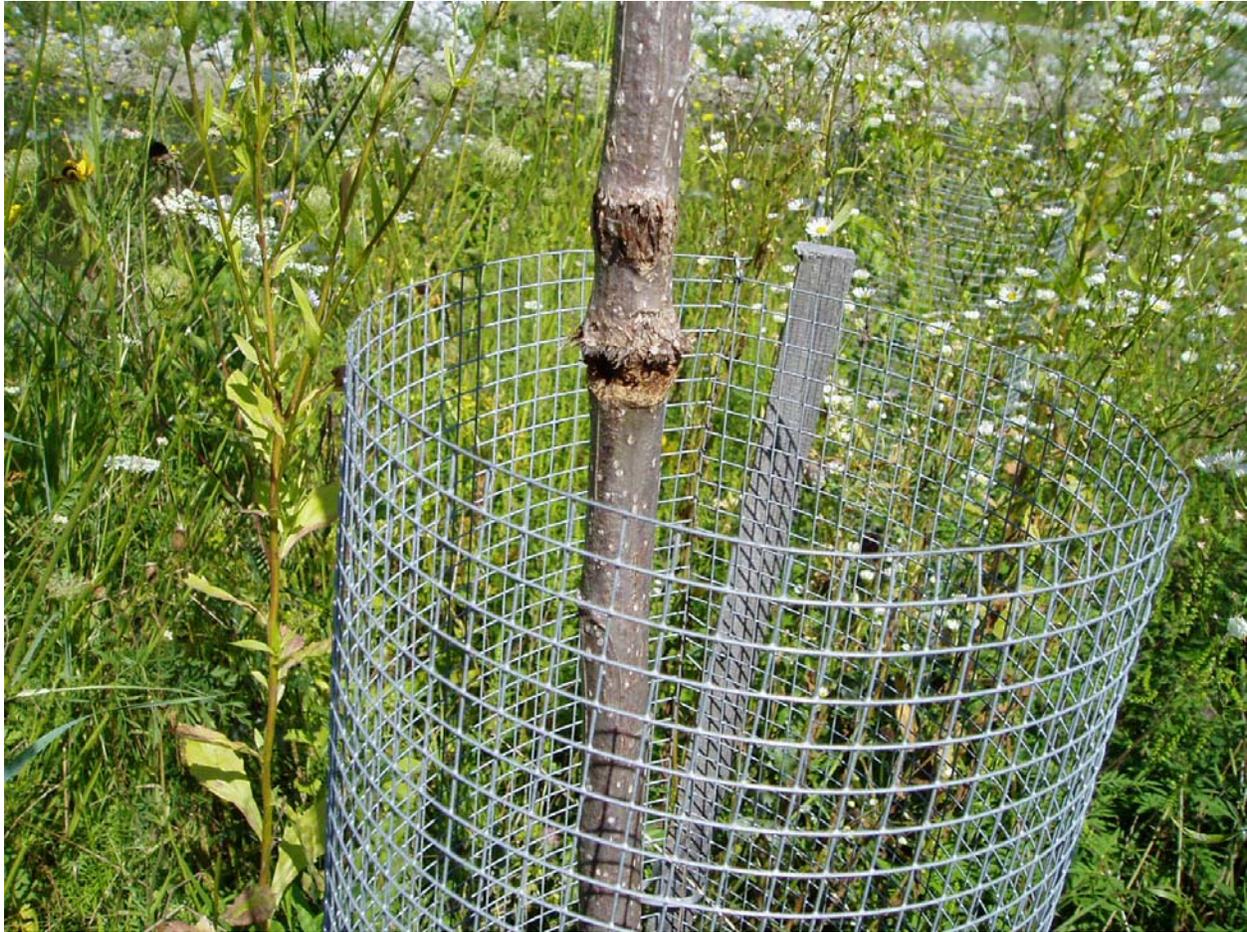
**Photo 6. Damage caused to eastern cottonwood tree resulting from lack of tree protector.**

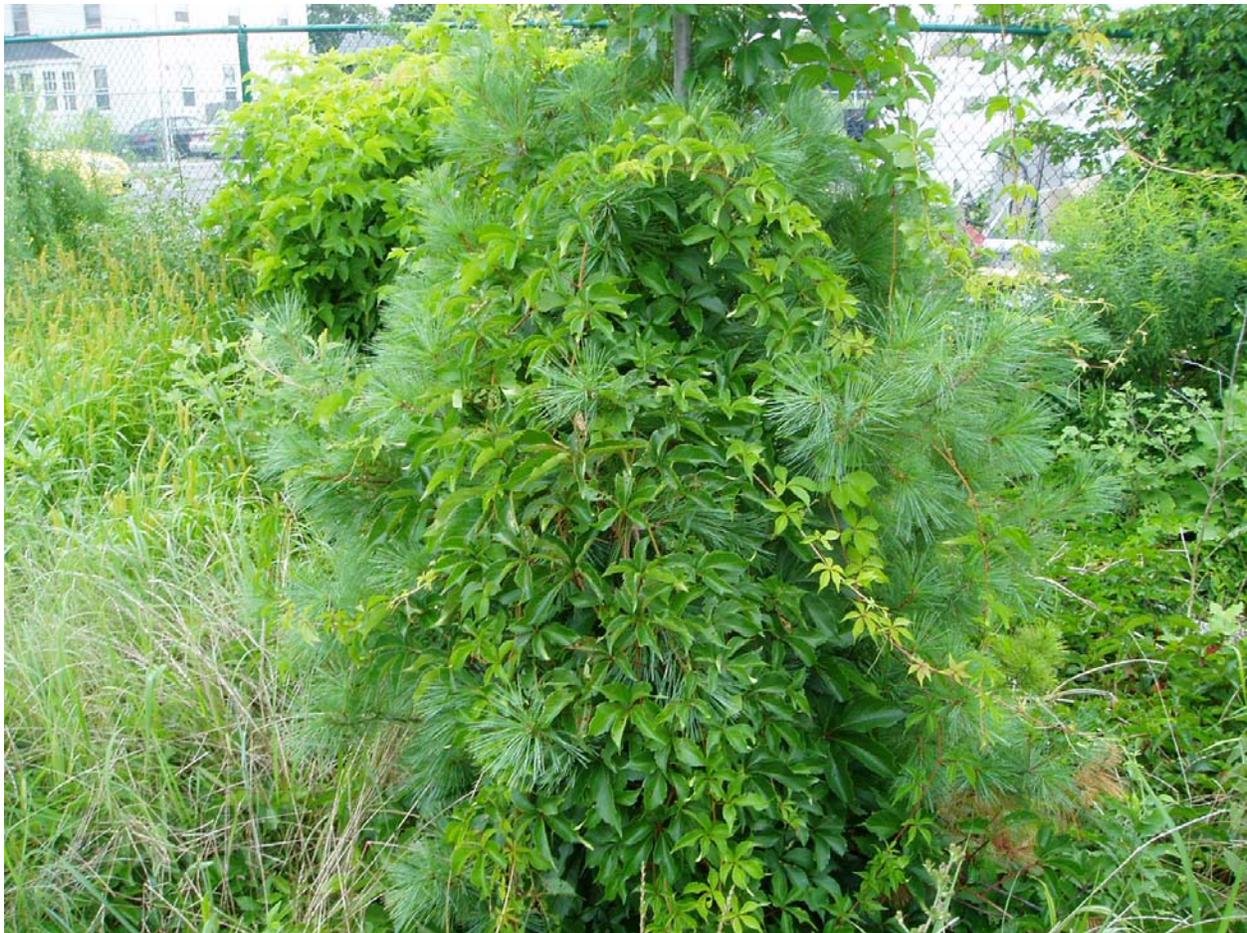
No stressed or dead trees were observed within the upland planting area adjacent to Harry’s Supermarket. Virginia creeper (*Parthenocissus quinquefolia*) was observed to be climbing on one white pine (*Pinus strobus*) and should be removed by hand from this tree (see photo 7). Hedge bind-weed (*Calystegia sepium*) was observed to be growing on one balsam fir (*Abies balsamea*) and should be removed by hand from this tree. Invasive species observed within the planting area include Japanese knotweed, black locust (*Robinia pseudoacacia*), and purple loosestrife. If invasive species are not controlled in this area by herbicide or regular mowing they will likely become prolific within a few years.

**Photo 7. Virginia creeper climbing on white pine in upland planting area adjacent to Harry's Supermarket.**

- Remove by hand Virginia creeper from one white pine and hedge bind-weed from one balsam fir on Parcel I8-24-1 (Harry’s Supermarket)
- Control invasive species (i.e., Japanese knotweed, black locust, and purple loosestrife) observed within Parcel I8-24-1 (Harry’s Supermarket).
- Plant 2 red maple (*Acer rubrum*) on Parcel I6-1-66 to replace the dead white birch

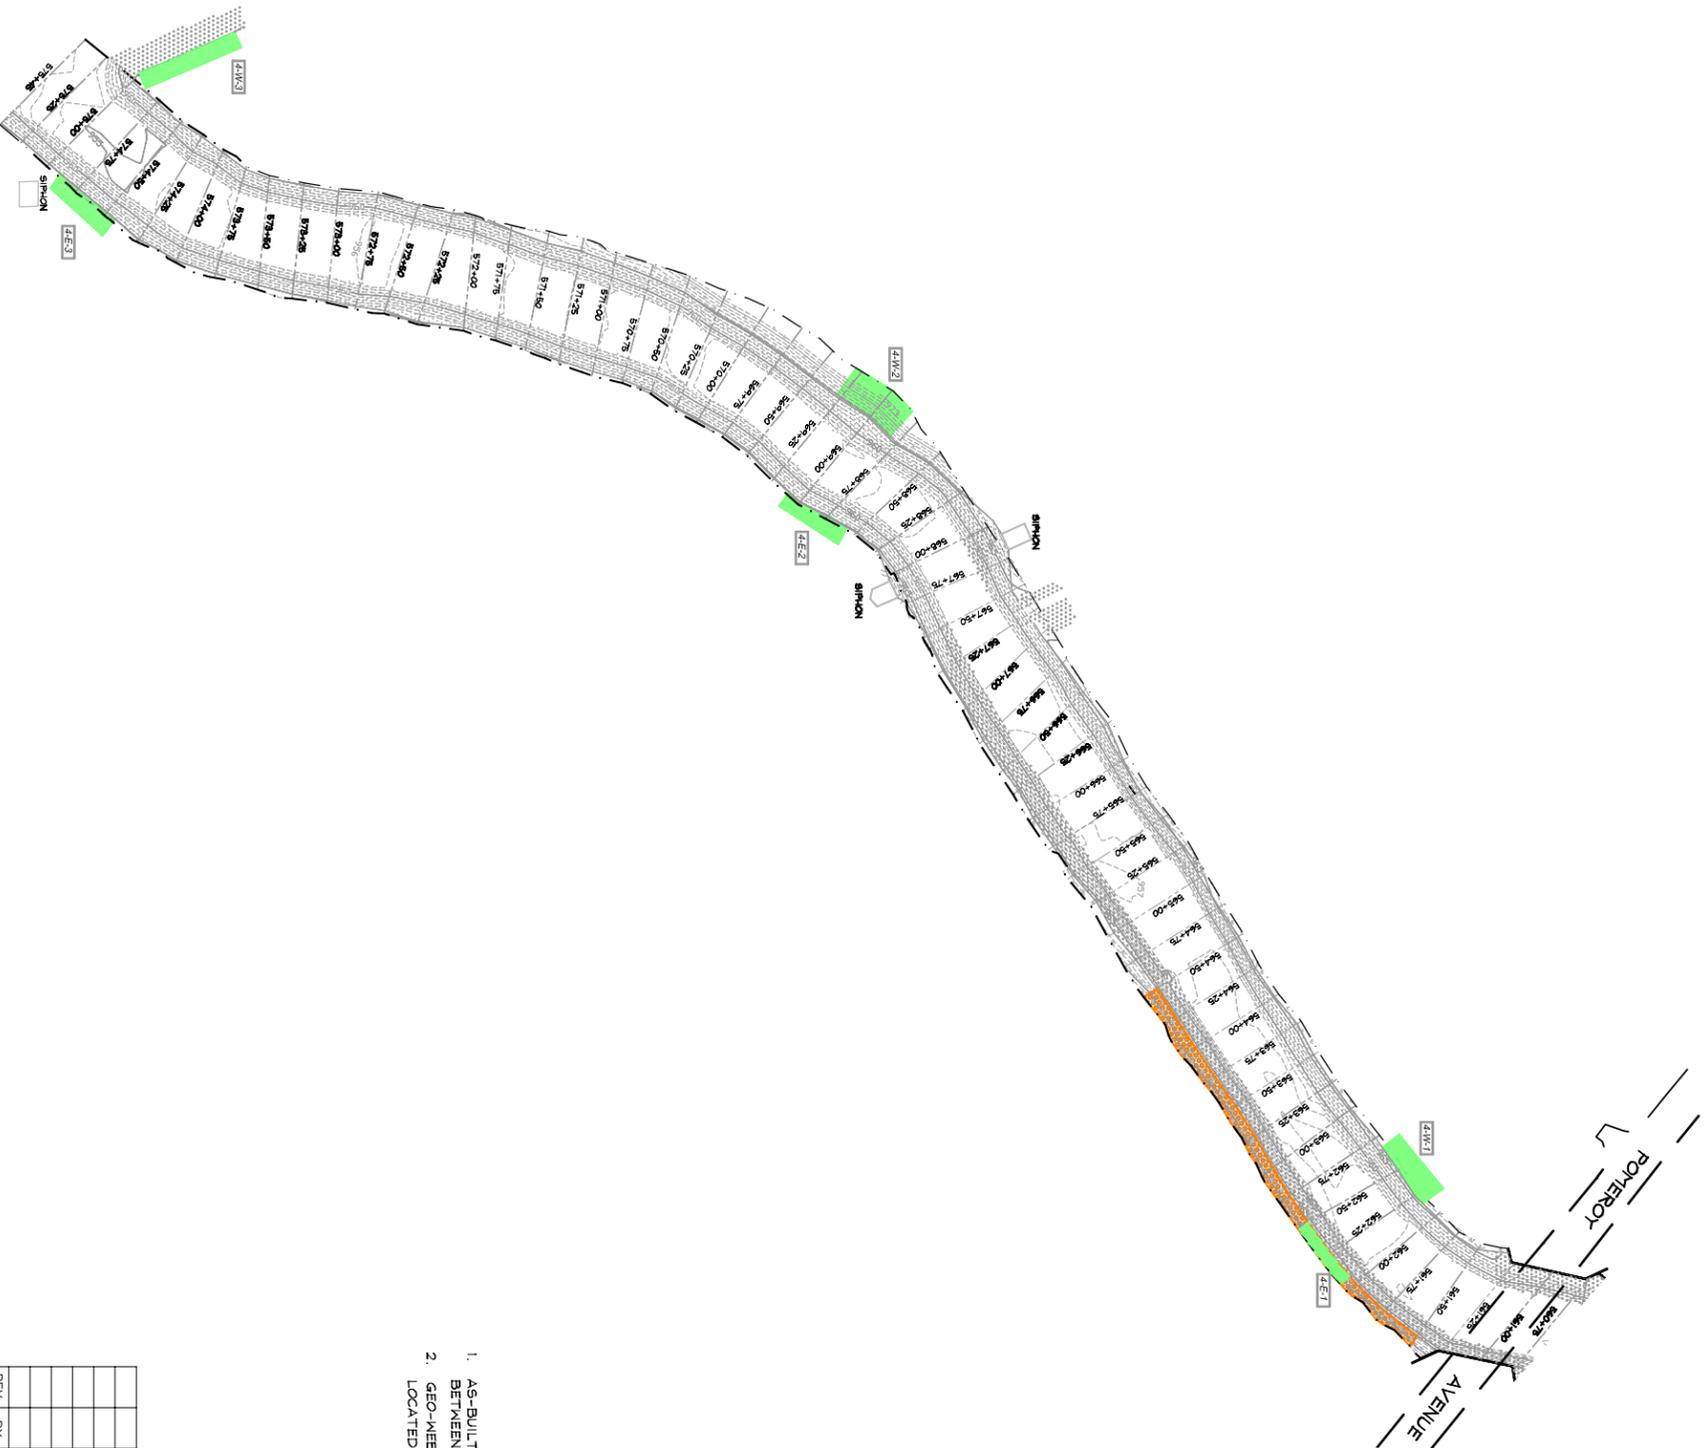
- LEGEND**
- 562+00 RIVER SECTION
  - LIMIT OF WORK
  - TOP OF RIP RAP
  - 96.0 AS-BUILT CONTOUR
  - 95.9
  - GEO-MEB
  - RIPRAP
  - VEGETATIVE MONITORING PLOTS (LOCATED BY WOODLOT ALTERNATIVES)
  - 40x4 PLOT LABEL
