**United States Environmental Protection Agency
EPA New England
One Congress Street, Suite 1100
Boston, MA 02114-2023**

RE: July 2004 Monthly Report
1.5 Mile Reach Removal Action
GE-Pittsfield/Housatonic River Site

Dean Tagliaferro
1.5 Mile Reach Removal Action Project Manager

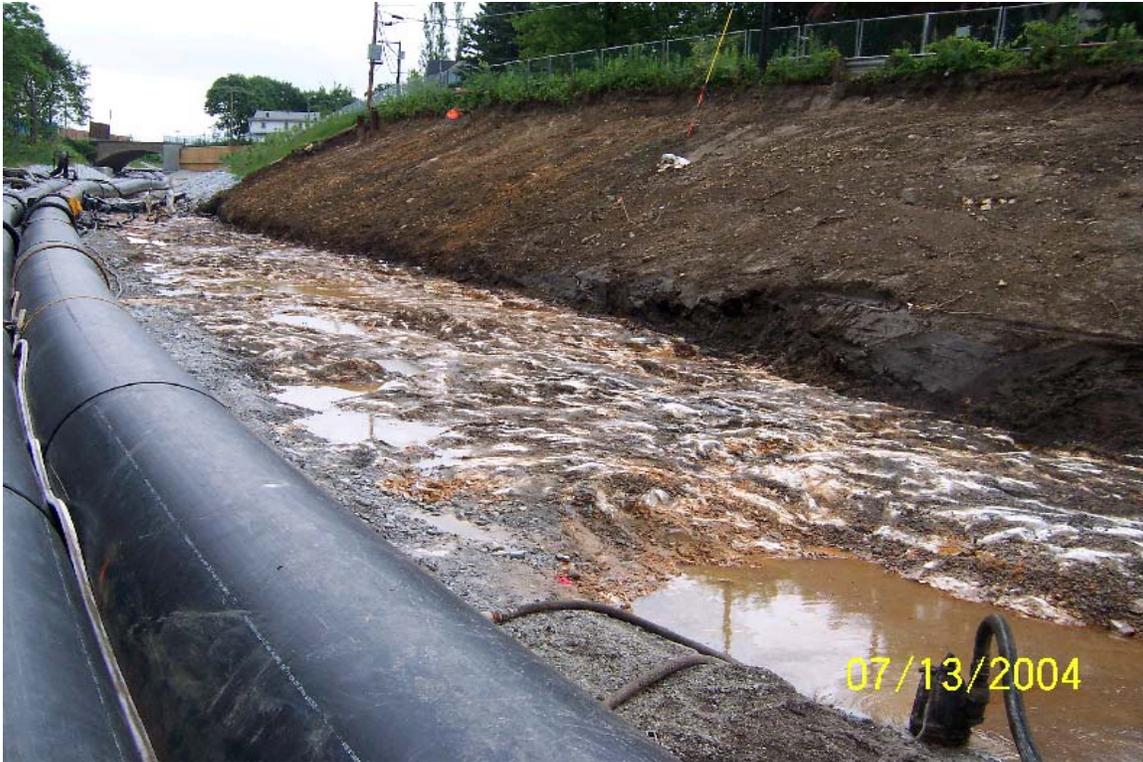
Photograph 1 – Cell 16E, Excavated Riverbed ready for Power Washing

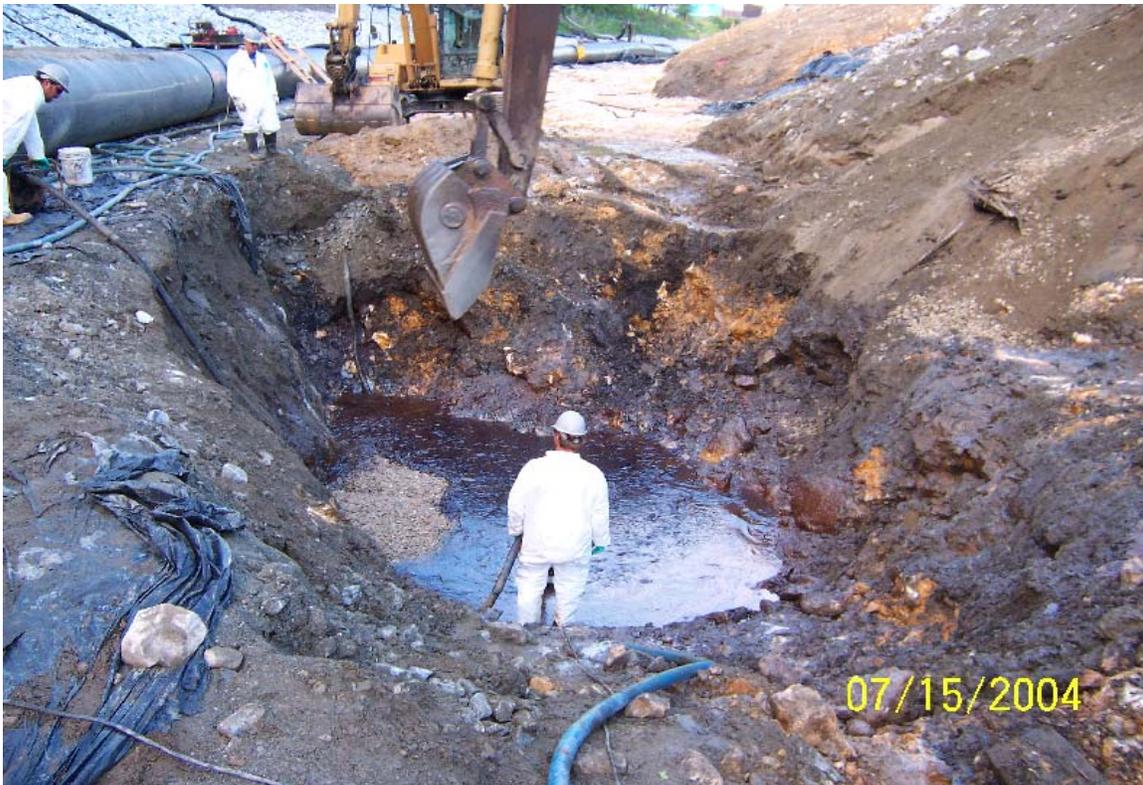
Photograph 2 – NAPL Excavation Activities in Deep Hole, Cell 16E

Most of the depressions in the underlying bedrock in Cells 16E and 17E were two to three feet below the original grade. However, in one twenty-five by fifteen foot area in Cell 16E, bedrock was not encountered within the top three feet of the original grade. Due to the presence of NAPL-impacted material, the excavation depth was extended to eight feet below grade, where bedrock was encountered. All the NAPL impacted material was excavated from this depression and the area was power washed and prepared for the installation of grout and backfill materials. It was observed that the depression had several bedrock fractures, therefore, there was the potential for NAPL to seep out into the restored riverbed in the future. Therefore, a layer of 12-inch riprap was installed on the bottom of the depression followed by a layer of filter stone. Next, a 6-inch PVC pipe was installed into the area for possible recovery of any seeping NAPL in the future. The depression was then encapsulated with a concrete grout mixture. This concluded the excavation activities in Cell 16E.

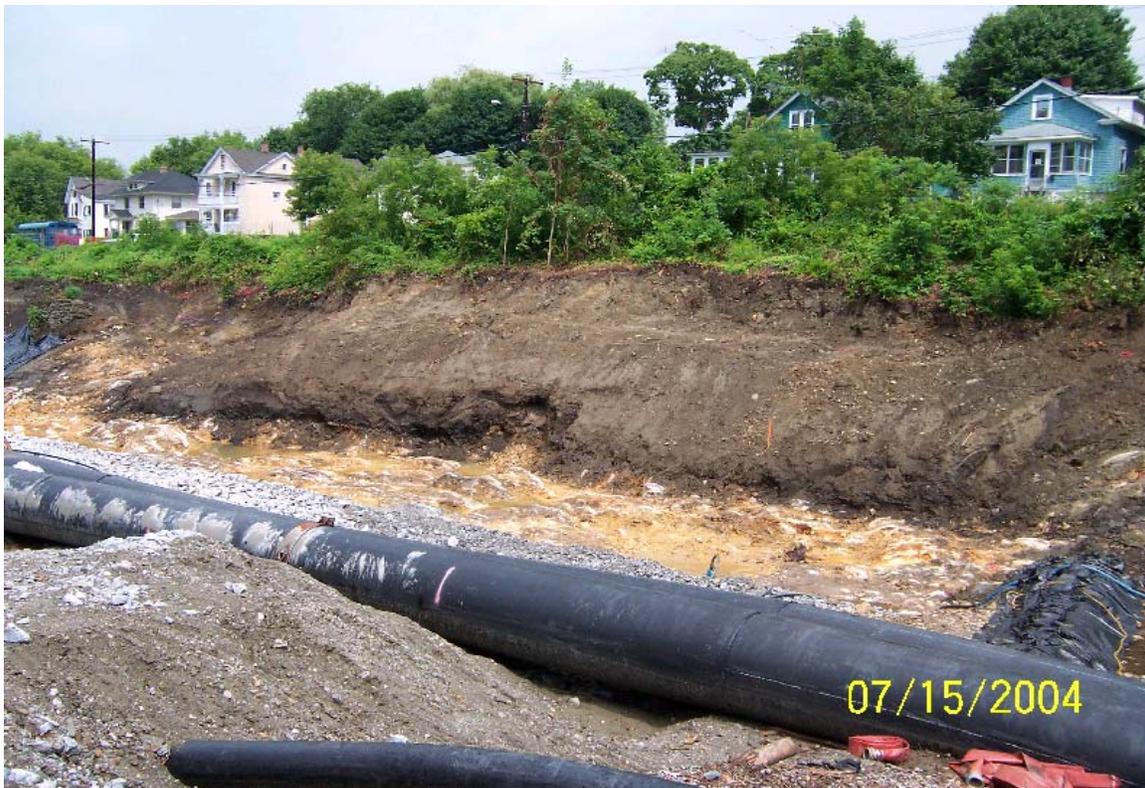
Photograph 3 – Cell 17E Completed Riverbed and Riverbank Excavation

During the fourth week in July, the riverbed and riverbank excavation activities in Cell 17E were completed. The non-TSCA riverbank material pre-characterized for offsite disposal was excavated and transported to Area 64D. Additional NAPL-impacted material was encountered

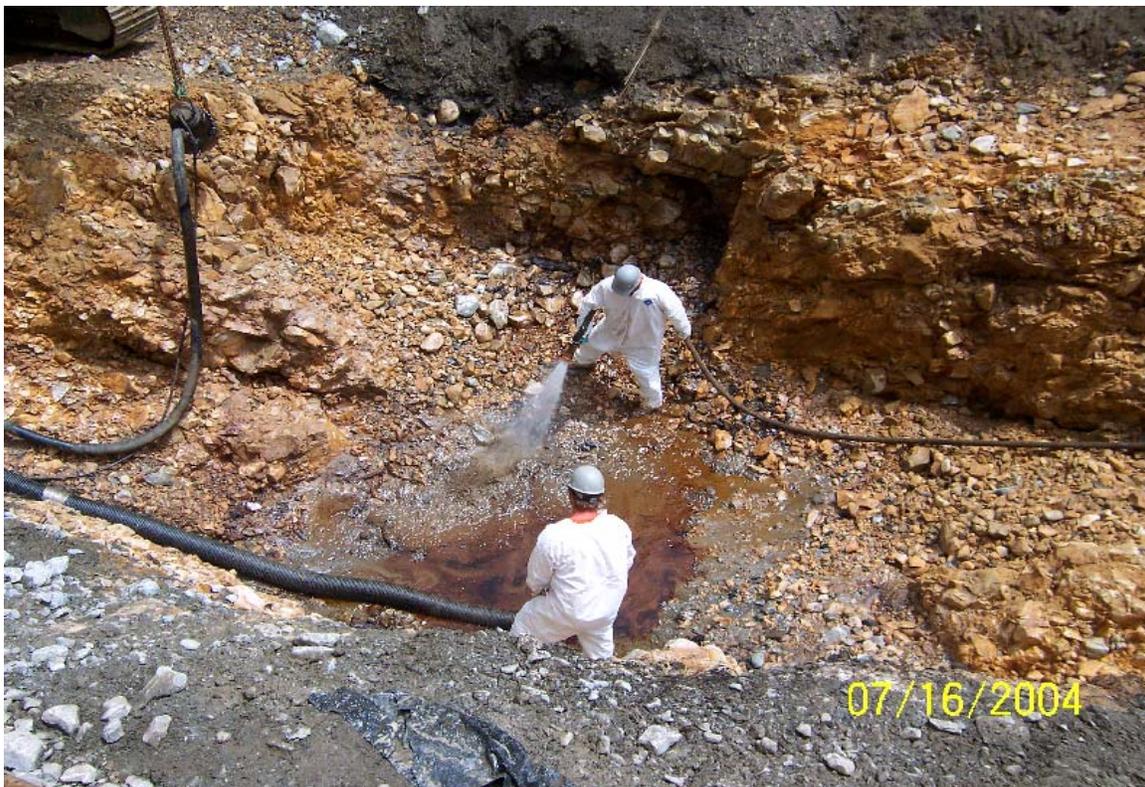
Photograph 4 – High Pressure Washing/Vacuuming of NAPL-Stained Bedrock

Bedrock was encountered in the entire river bottom of Cell 16E and 17E. In addition to the standard excavation equipment, a small track excavator was used to access and remove the NAPL-impacted material from the areas of the river bottom where crevasses and depressions in the weathered bedrock were numerous. In most areas, there was less than 2-feet of sediment above the bedrock. Most of the bedrock within the riverbed was stained with NAPL. The high pressure power washing of bedrock to remove any loose sediment and NAPL staining was initiated. High pressure power washing of bedrock was supplemented with a vacuum truck to remove any residual sediment and NAPL from the bedrock. All water generated during the power washing was diverted to the water treatment system. All the residual sediment material was collected into roll off boxes located in the riverbed and subsequently transferred to the water treatment system modutank. In areas of the riverbed in Cell 16E and 17E where NAPL-impacted material was removed and where fractures in the underlying bedrock were encountered, the bedrock was encapsulated with a concrete mixture.

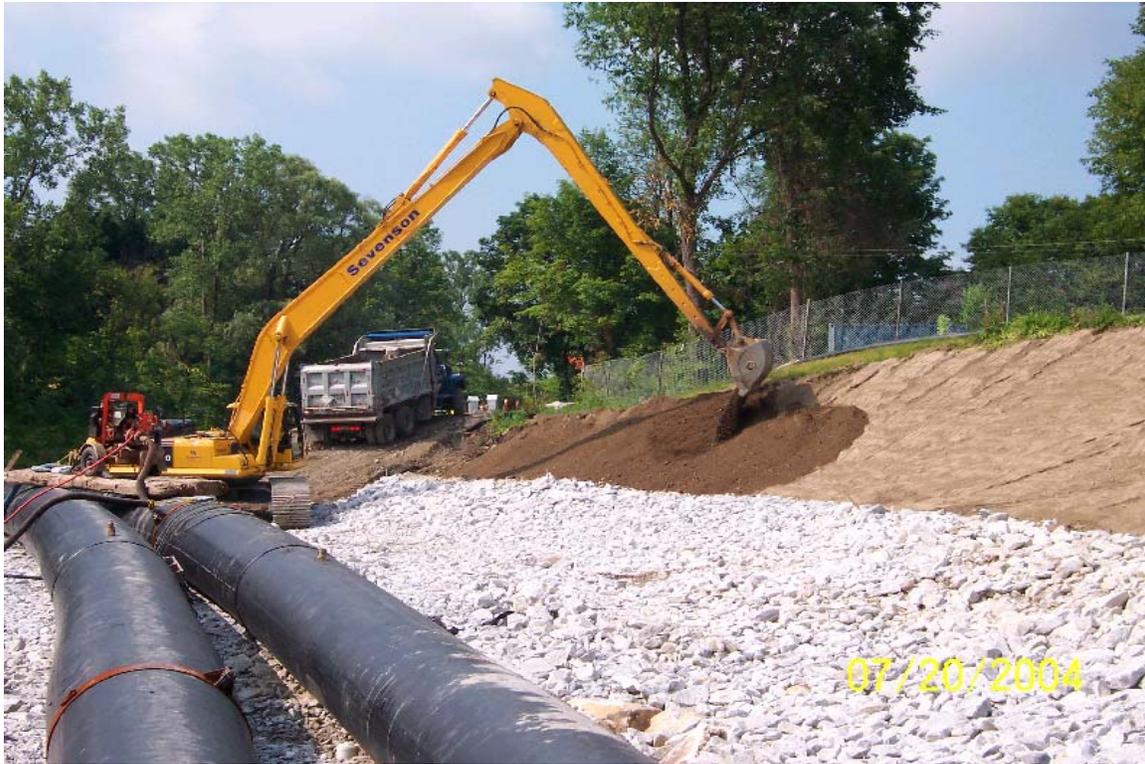
Photograph 5 – Topsoil Placement in Cell 17W

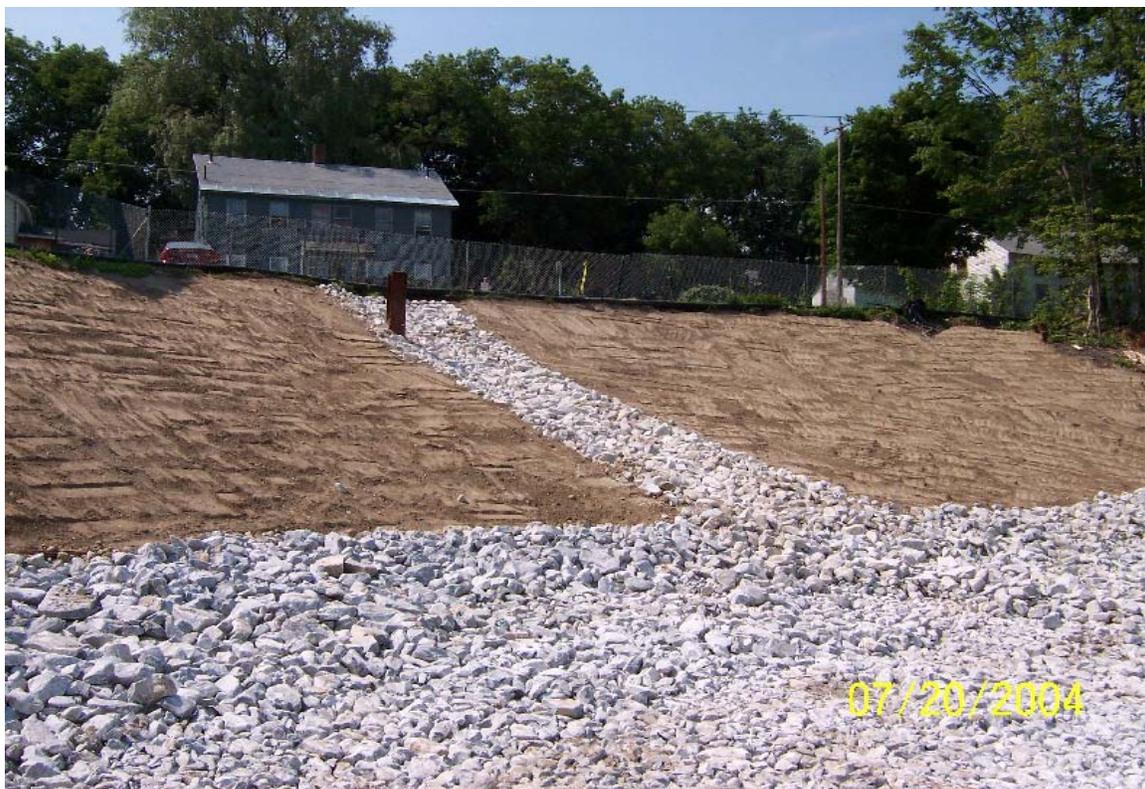
Photograph 6 – Restored Riverbank in Cell 17W

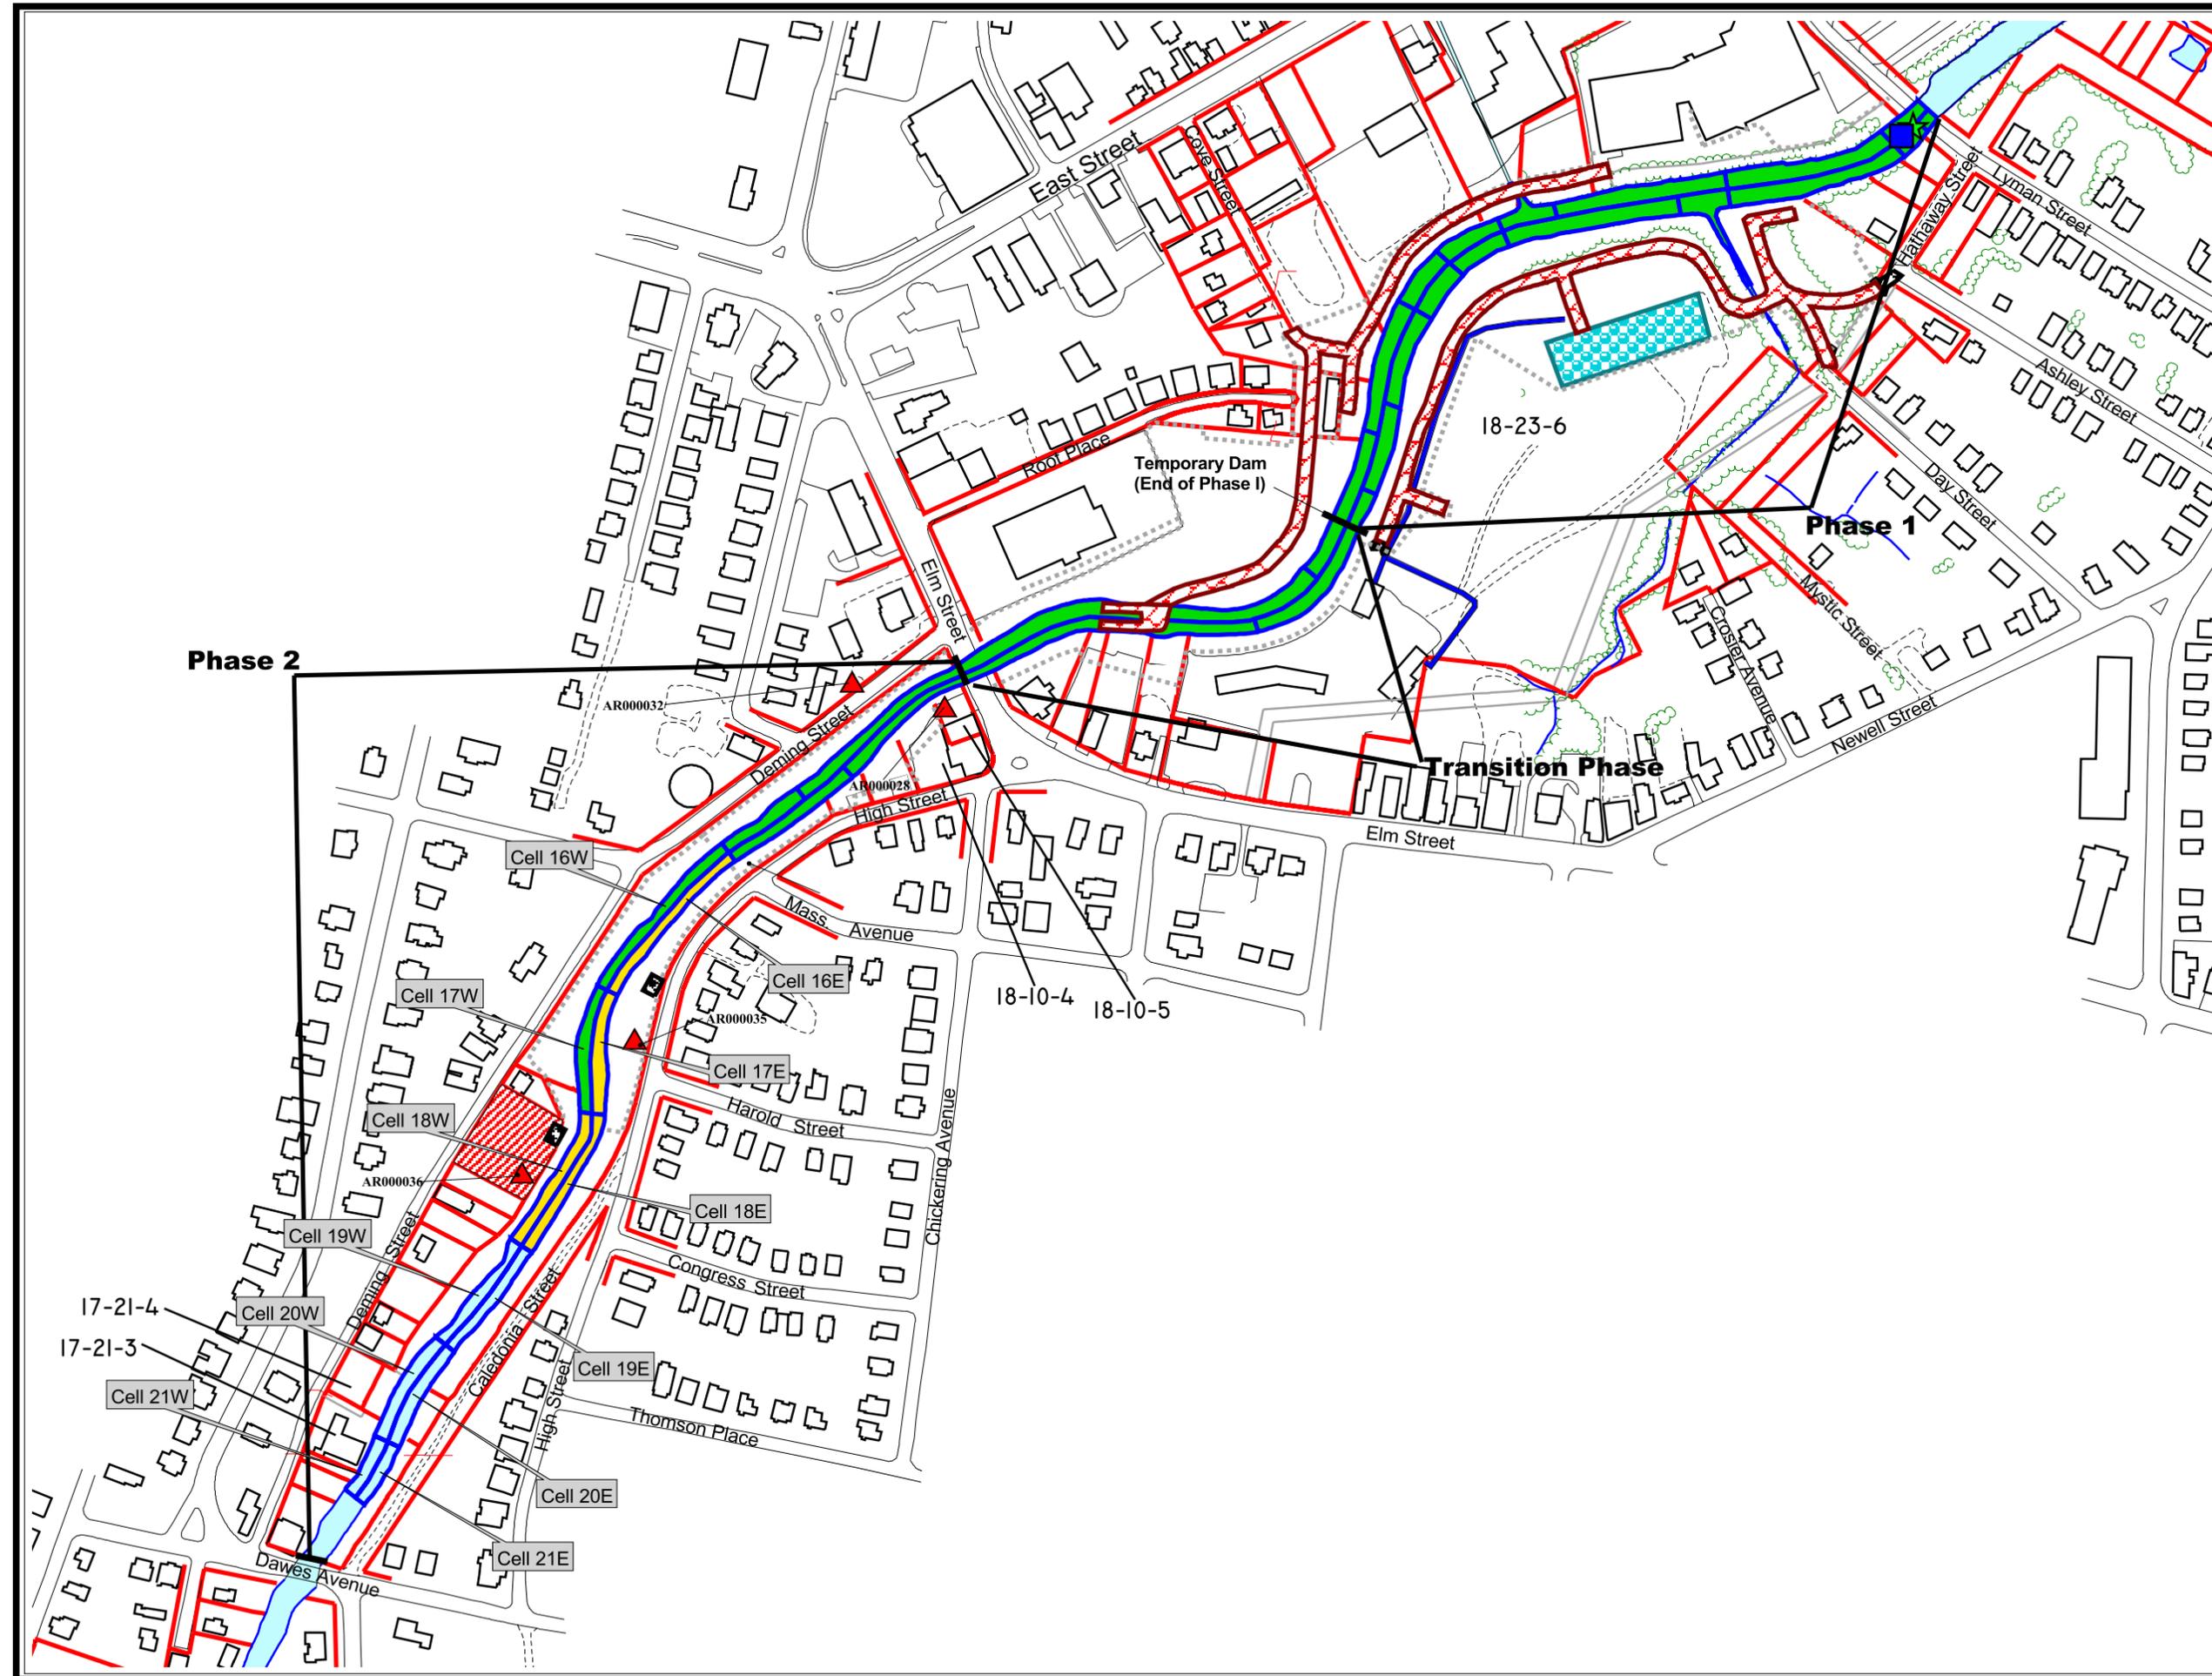
Figure 1
1.5 Mile Removal Action
Site Map
July 2004 Monthly Report

Figure 1 is a map of Phase 1, the Transition Phase and Phase 2 and includes the layout of all excavation cells, temporary dam, water monitoring locations, air sampling locations, access road locations, excavation load out locations, staging area locations, fence line location, the water treatment system pad location, and the utility trench location.

Refer to Figure 1 for an orientation of the excavation cells and their respective locations.
