RE: May 2004 Monthly Report  
1.5 Mile Reach Removal Action  
GE-Pittsfield/Housatonic River Site

**GE-Pittsfield/Housatonic River Project 1.5 Mile Removal Action  
Pittsfield, MA**

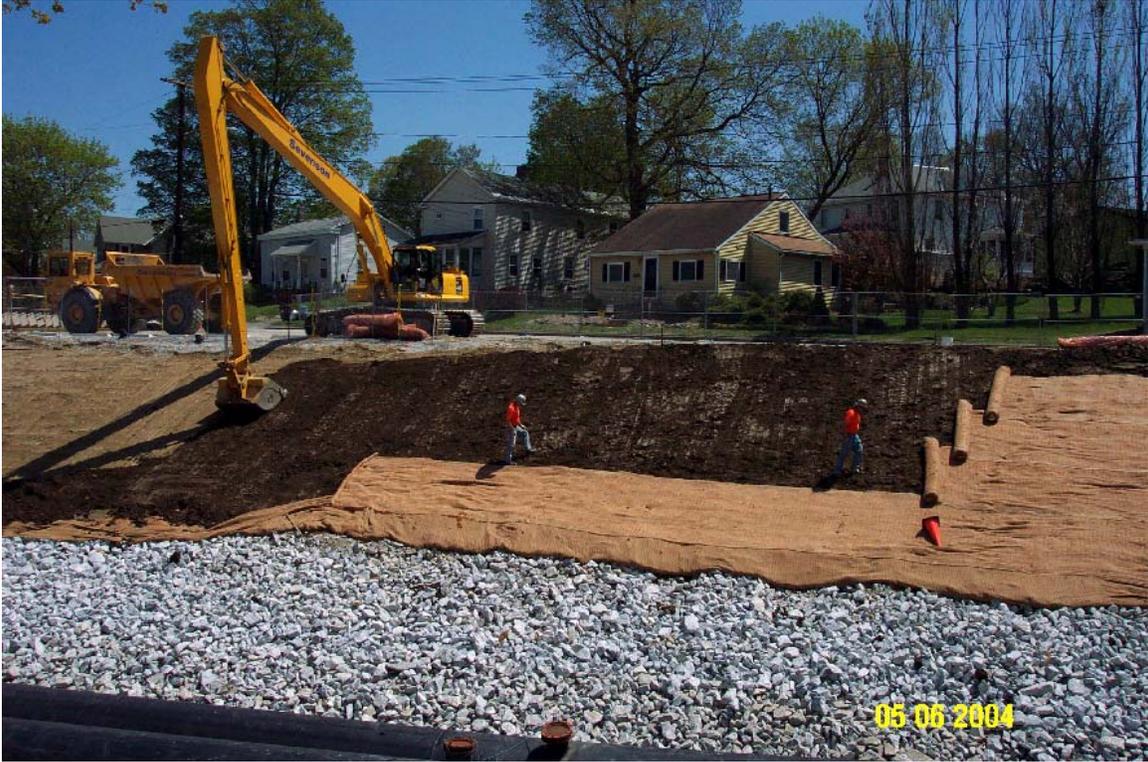
**Photograph 1 – Backfilling Activities in Cell 15E, Placement of Topsoil and the Biodegradable Erosion Control Blankets**

Backfilling on both the east and west riverbanks in Cells 14 and 15 above the ACB and the rip rap was completed. Common fill, topsoil, herbaceous seed and biodegradable erosion control matting were placed on the riverbanks. Once the backfilling activities were completed silt fencing was installed on the riverbanks for erosion control purposes. Also, the survey contractor completed the post restoration verification survey.

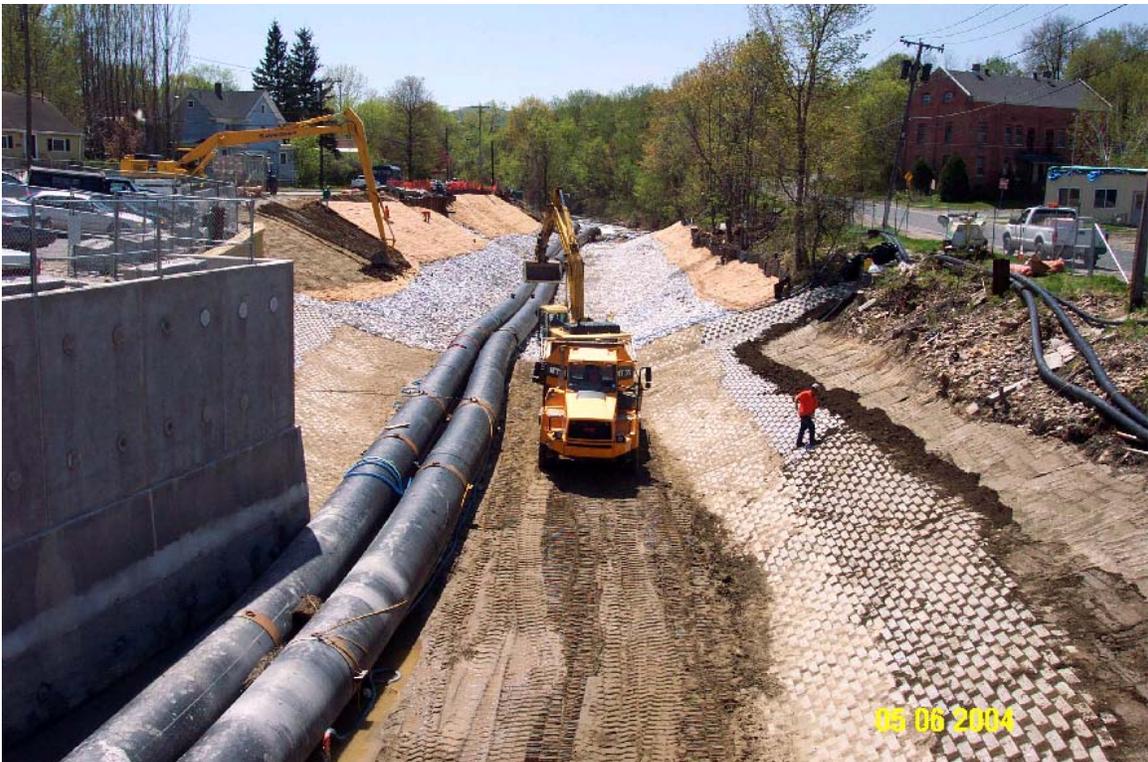
**Photograph 2 – Riverbank Backfill Activities in Cells 14E and 14W, Placement of Topsoil onto the ACB and above the ACB**

The riverbed portion of the ACB was covered with a layer of sand to protect it from heavy equipment traffic. A layer of topsoil was placed on top of the riverbank portion of the ACB. On the east bank of Cell 14, installation of concrete grout was completed to tie in the ACB and the crib wall stabilization structure and the anchored sheetpile wall. On the west bank of Cell 14, installation of concrete grout was completed to tie in the ACB to the two storm water outfall structures. The remaining 345 feet of the riverbed in Cells 14W and 15W were backfilled with a layer of filter material in low lying areas followed by a layer of 12-inch rip rap. Areas of the riverbed where bedrock was encountered at very shallow depths will be left with the bedrock exposed. The remaining 345 feet of the riverbank in Cells 14W and 15W were backfilled with common fill or structural fill, a six inch layer filter material and an 18-inch layer of 12-inch rip rap up to either elevation 973 or 974.2.

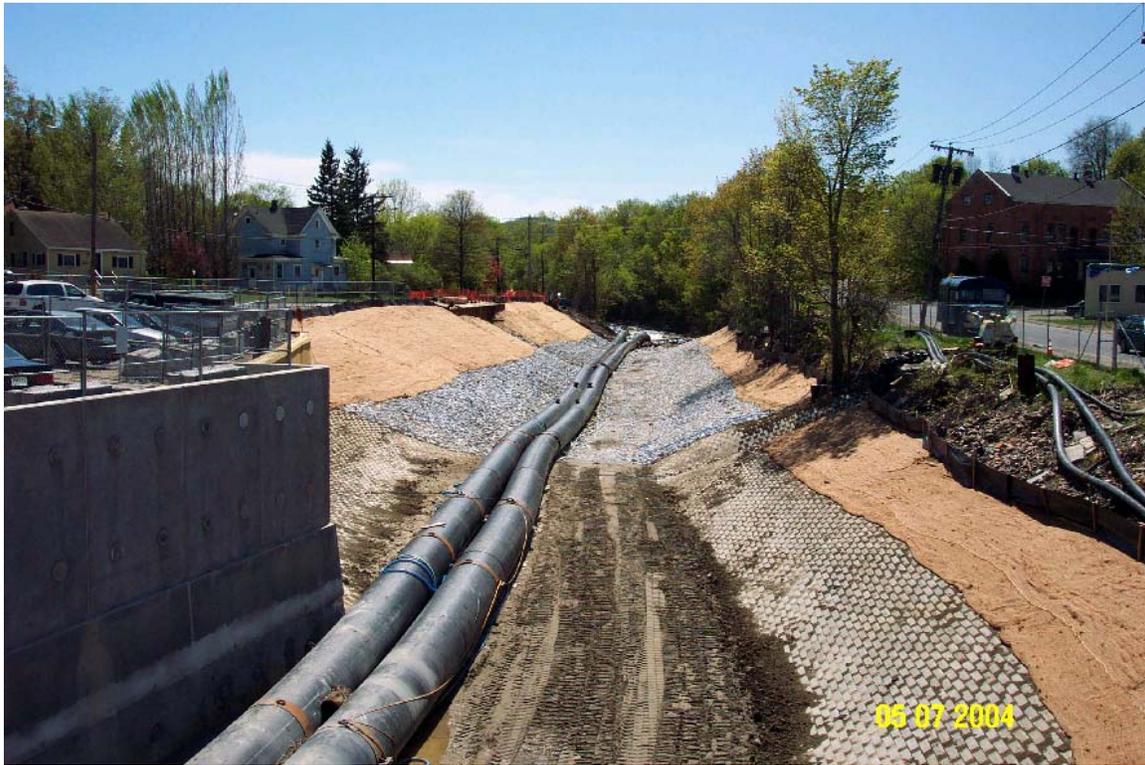
**Photograph 3 – Overview of the Restored Cells 14 and 15**

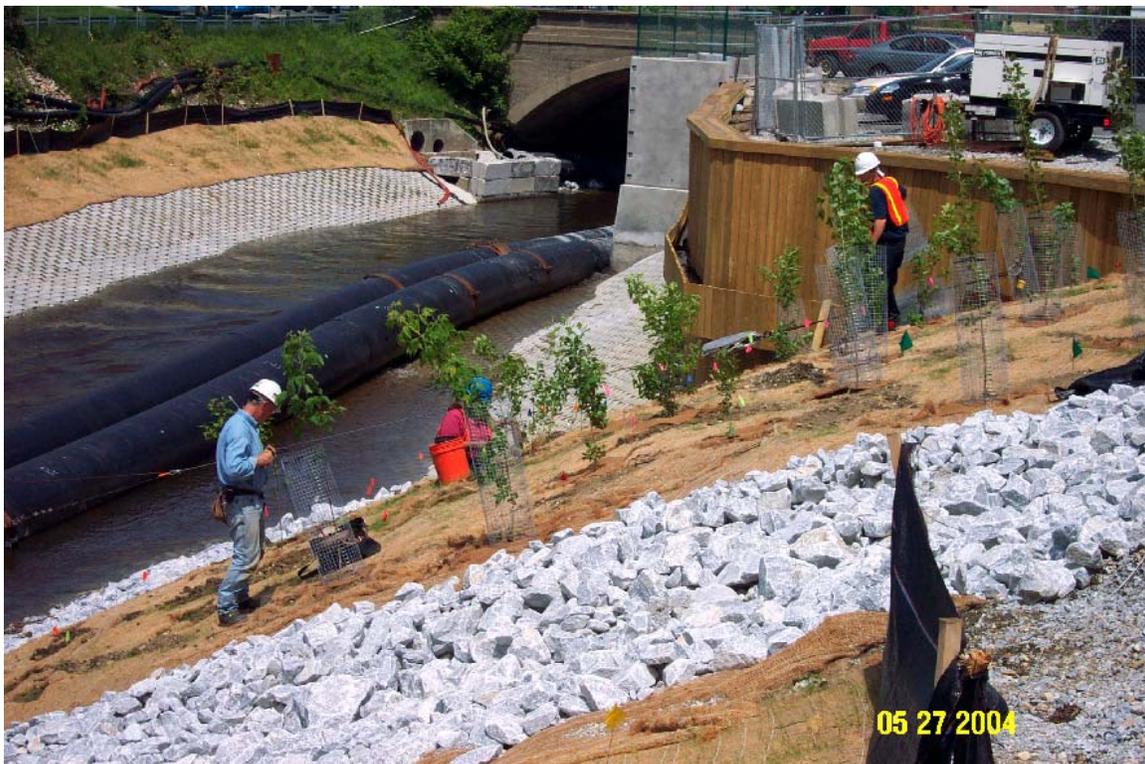
**Photograph 4 – Tree and Shrub Planting Activities in Cell 14E**

Spring 2004 tree and shrub riverbank restoration planting in the Transition Phase and the first 600ft of Phase 2 were initiated. Trees and shrubs were planted on the east and west riverbank of the Transition Phase and the planting in the first 600 feet of Phase 2 was initiated.

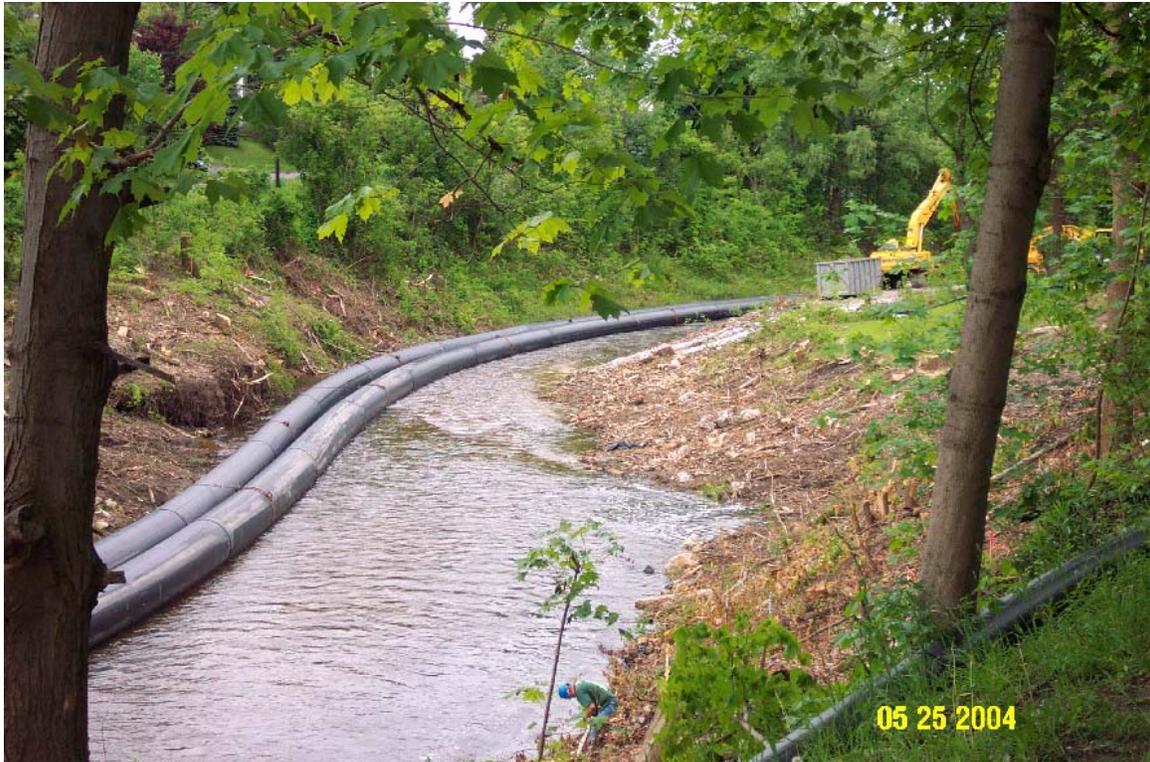
**Photograph 5 – Newly Installed 54-inch HDPE Pipe Gravity System Extension in Phase II**

The assembly and installation of the additional 54-inch gravity bypass pipe was initiated. Two 1,350-foot sections of 54-inch pipe are scheduled to be installed as part of the gravity bypass system extension. The additional pipe will be connected to the existing 54-inch HDPE pipe at approximately 600ft downstream of the Elm Street Bridge. The new pipe additions will extend the gravity bypass system to within 150 feet of the Dawes Avenue Bridge.

The 54-inch pipe segments were connected together by fusion welding. Restraint bands and fittings were installed onto the pipe approximately every 100 feet. As additional pieces were welded together, a bulldozer situated in the riverbed was used to pull the pipe into the river channel. The stop logs were removed from the temporary dam and the river channel was flooded downstream of the dam to assist in the pipe move. A "skid plate" was constructed to enable the pipe to slide into the river as the pipe assembly process proceeded. In addition, temporary H-piles were installed in the staging area on Parcel I8-24-1 to act as a temporary restraint system while the additional pipe was moved into the river channel. As the pipe was moved downstream it was tied off to the H-piles installed along the riverbanks which will be utilized as part of the pipe restraint system.

Activities associated with the assembly and installation of the 54-inch gravity bypass pipe extension continued. The fusion welding of the additional 1,350 feet of the 54-inch pipe was completed. The two 1,350-foot pieces of pipe were connected to the existing two 1,400-foot sections of pipe. The relocation of the 54-inch pipe from the east side of the river channel to the west side was completed. Activities associated with the installation of the anchors for the pipe restraint system were initiated on the east side of the river channel. Six holes were drilled into the bedrock but due to the very brittle condition of the bedrock the bore holes collapsed and the anchors could not be installed. (The condition of the bedrock needed further investigation and an alternative method needs to be proposed for grouted rock anchors).

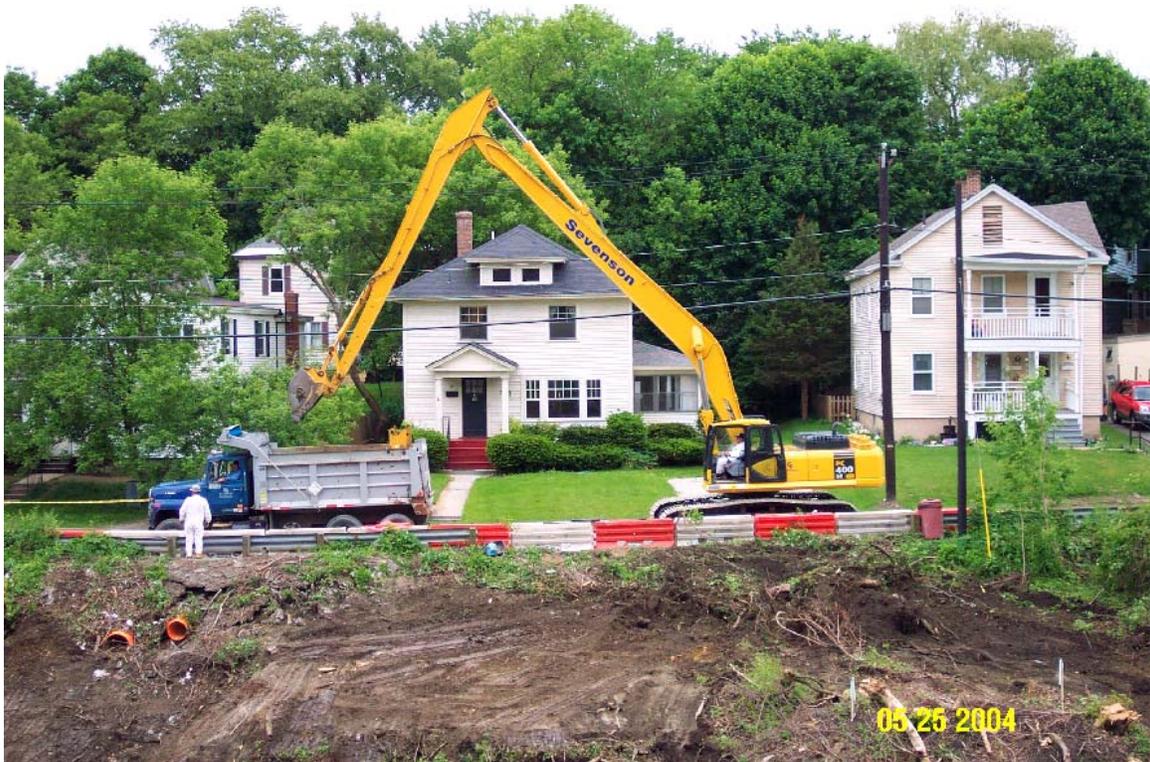
**Photograph 6 – Construction of the Load out Area in Cell 16E, Truck Loading on High Street**
