Addendum to the Preliminary Report for Airborne Data Collected
 In Support of US EPA Region VII
 Barton Solvents
 Valley Center, Kansas

Table 1. Flight Status Sortie II – 17 July 2007

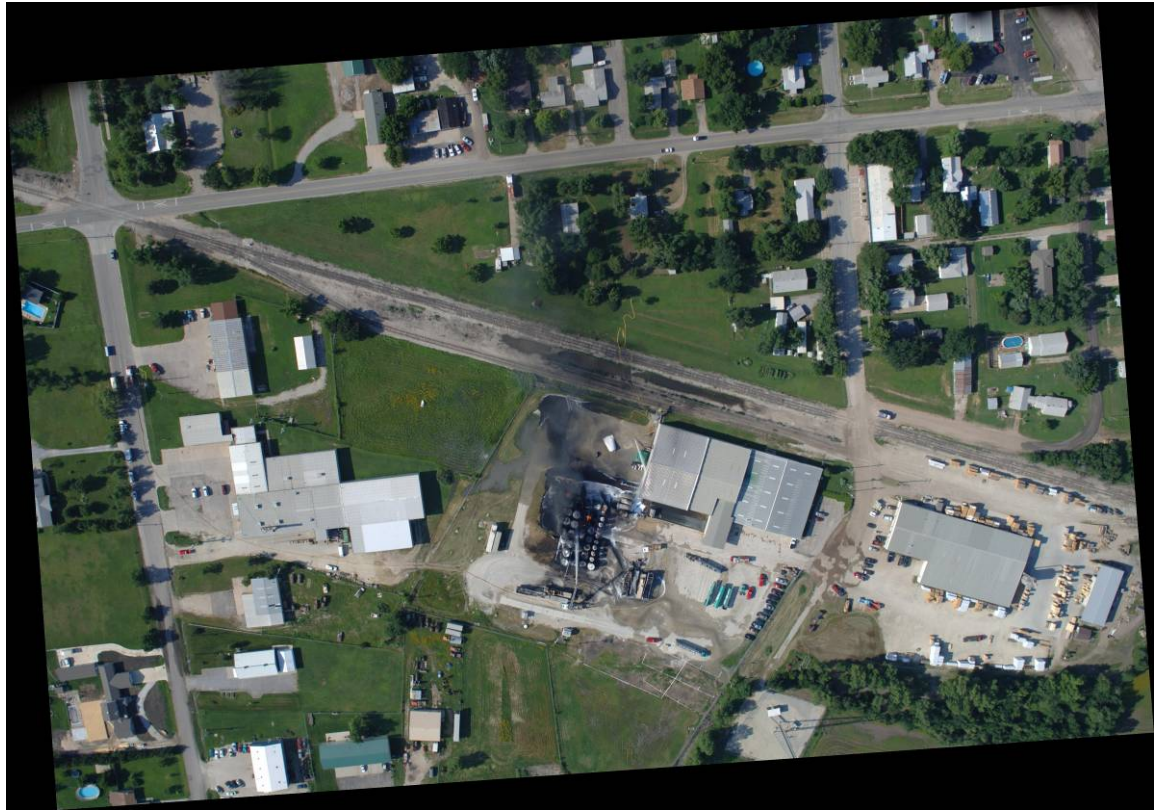
Figure 1. Aerial Image Data Pass 4, Sortie II, Barton Solvents, Valley Center, Kansas

Aerial images collected during the early phases of the sortie II showed a significant reduction in the fire and plume as compared to the earlier data collection. Figure 1 shows a typical image. Following data pass 4 the flight crew noted a large amount of turbulence. The following series of images showed that the fire had significantly accelerated and a plume was fully developed (Figure 2)

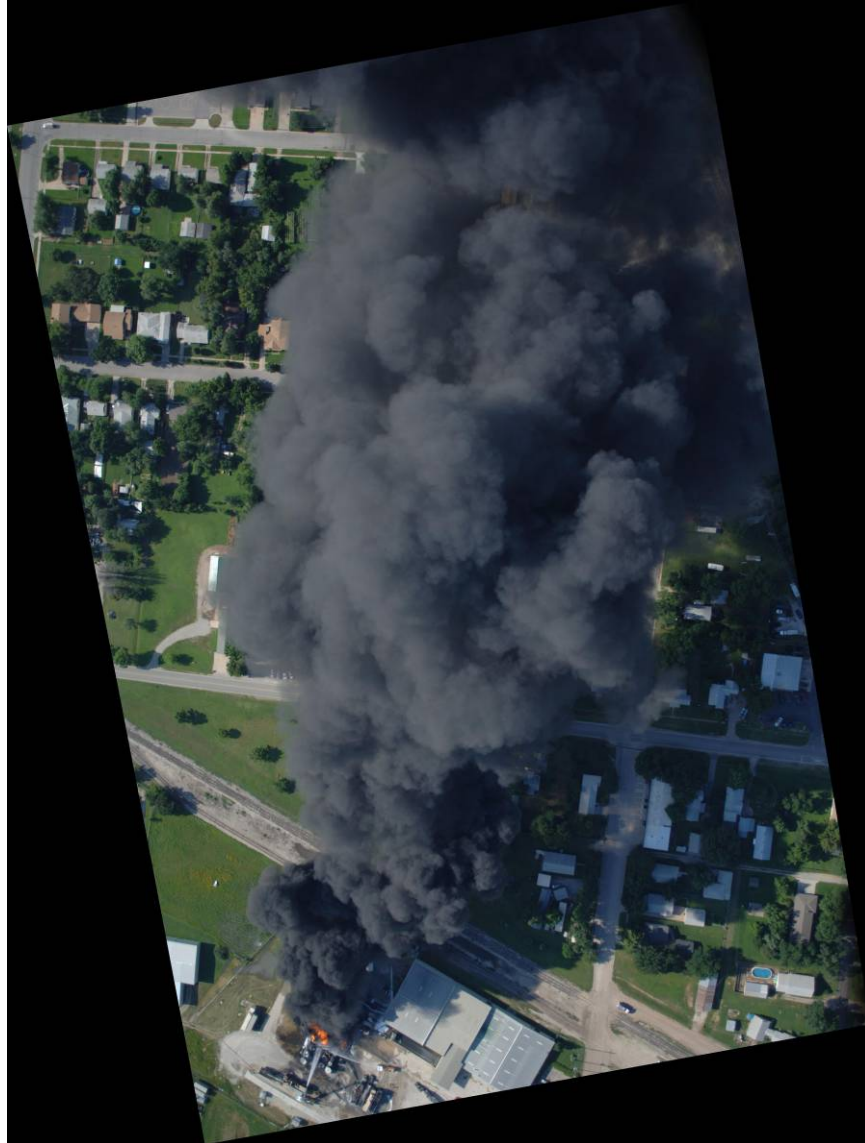
Figure 2. Aerial Image Data Pass 5, Sortie II, Barton Solvents, Valley Center, Kansas

Data collected over the Barton Solvents facility during flight sortie II initially indicated that the fire and resulting plume had greatly decreased from observations made in Sortie I. During data pass 4 the site flared up and the fire and plume redeveloped.

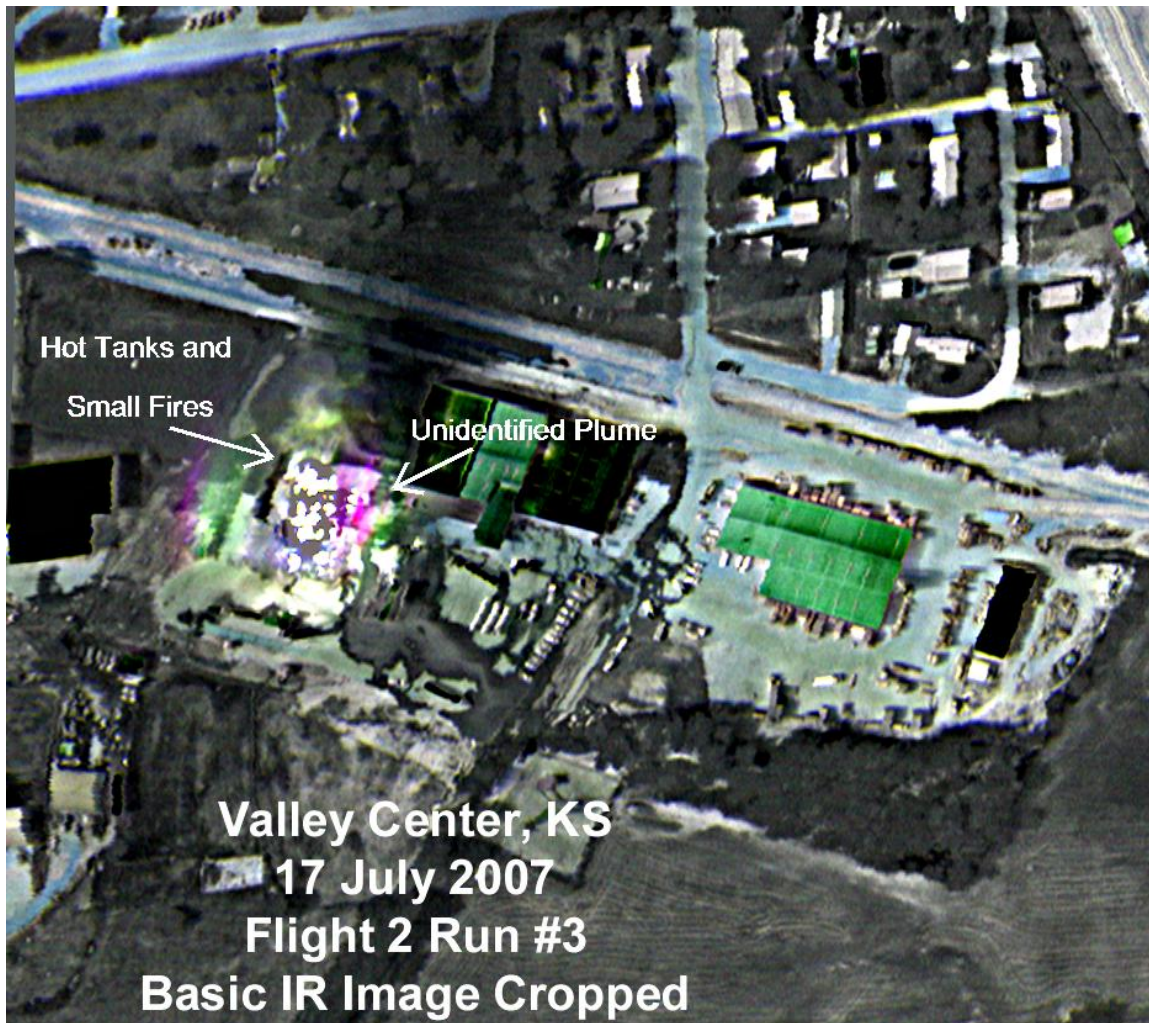
Figure 3. IR image Run 3 – Sortie II, Barton Solvents, Valley Center, Kansas

Results observed in the aerial images were captured in concurrent IR imagery collected. Figures 3, 4, and 5 shows a series of data passes corresponding to data passes 4, 5 and 6. Examination of figure 3 shows a significant reduction in thermal energy at the site as evident by the spotty patches at the site. A small plume can be seen being emitted from a hot tank. The next image (figure 4) looks very similar except for a zone that indicates a large thermal change in the image. This zone appears as an area of distortion in the image but is a result of the rapidly changing thermal environment while the image was being scanned. Figure 5 corresponds to the next data pass. The site is extremely hot due to the accelerating fire.

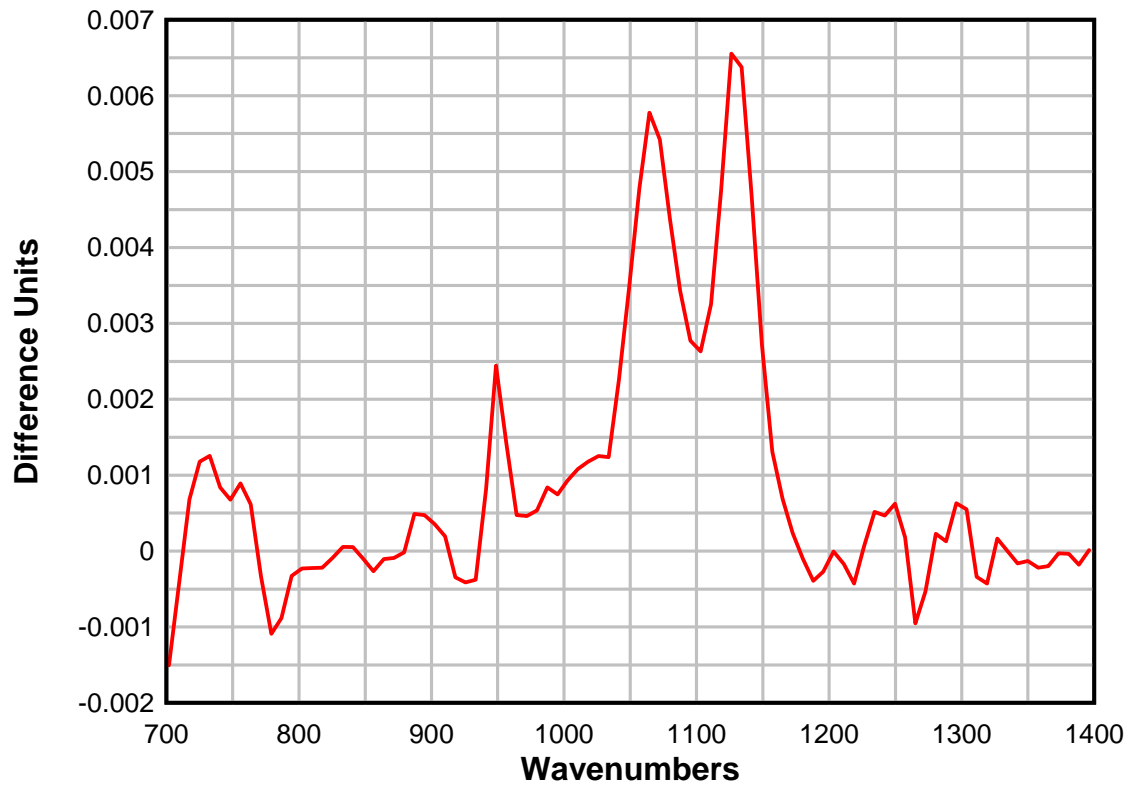
Figure 6. Possible Ketone Detection, Data Pass 7, Barton Solvents, Valley Center, Kansas

Analysis of the FTIR data collected on sortie II tended to show similar detections to those in the sortie I. Glycol, ozone, and benzyl alcohol were detected in most of the runs. Estimated concentrations for the benzyl alcohol appear to be reduced by about 2/3 from those observed in the first sortie. Following the acceleration in the fire, a weak signature of a possible ketone was detected in a few of the spectra for data collection 7. Figure 6 shows a representative spectra of the possible ketone. Spectral features including the peaks observed at 950, 1060, and 1130 wavenumbers suggest that this compound is a ketone. A significant identification was not possible due to the weak nature of the spectrum in addition to possible interference from ozone.

Spectral analysis of the plume generated by the fire showed trace levels of ozone and glycol and approximately 3 ppm of benzyl alcohol. Following the flare-up at the site, a possible signature of a ketone was noted but identification of the exact compound was difficult due to the weak nature of the compound.
