**DOCUMENTATION OF ENVIRONMENTAL INDICATOR DETERMINATION**

**Current Human Exposures Under Control**

**Facility Name:** Honeywell International Inc. Tonawanda - Envirotek  
**Facility Address:** 4000 River Road, Tonawanda, NY 14150  
**Facility EPA ID #:** NYD038641601

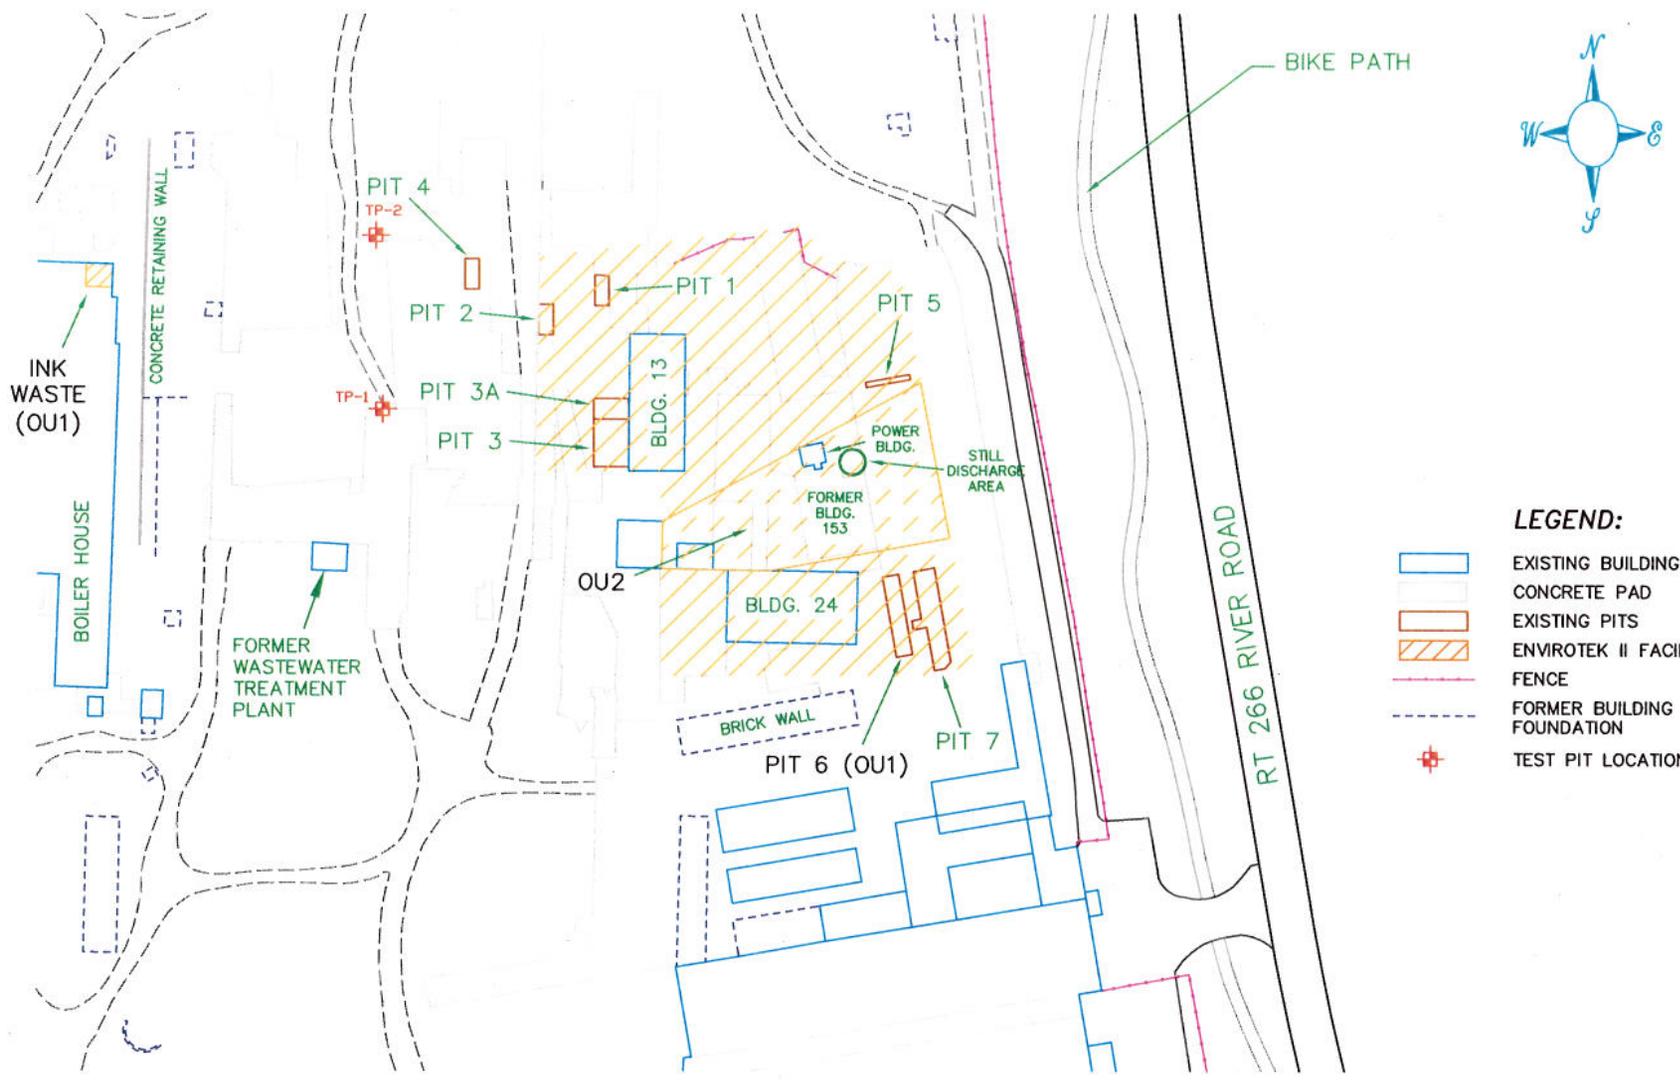
DIVISION OF ENVIRONMENTAL REMEDIATION		
DATE: 12/28/04	DRAWING: Roblin Site Map.dwg	
SITE NAME: Envirotek II Portion/Roblin Steel Site		Figure 3

This operable unit consisted of waste present in the Boiler House and Waste Pit No. 6 (Figure 3). While operating, Envirotek disposed of hazardous substances and wastes in various pits and buildings throughout the Roblin Steel property. Lead contaminated ink waste was disposed of in the Boiler House, while liquid wastes were dumped into Waste Pit No. 6 (Figure 3).

This operable unit consisted of volatile organic compounds (VOC) contaminated soil in the area of the former Envirotek facility (Figure 3). Numerous leaks and spills associated with the handling and storage of hazardous substances and wastes occurred at the facility when it was operating. These releases resulted in the contamination of fill and soil near and under the former Envirotek II facility (Figure 3).

Following Envirotek's abandonment of their facility in 1989, the United States Environmental Protection Agency (USEPA) conducted a preliminary investigation of the entire Roblin Steel Property. At the Envirotek II Site, unsecured drums and other containers, along with contaminated process vessels and tanks, were observed. Adjacent to one of the former waste chemical processing buildings, soil contaminated by liquid discharge from a processing still was encountered. This area was designated the Still Discharge Area (SDA; Figure 3).

The preliminary USEPA investigation also included smoke testing of the Roblin Plant sewer system associated with the Envirotek facility and sampling of sewer sediments. The investigation also encountered hazardous substances in concrete pits of the former plant rod mill building. These pits were designated 1 through 3, 3A, 4 and 5 (Figure 3).

Subsurface soil and fill samples were also collected from two test pits (Figure 3) completed along a former sewer line to determine if the sewer was a route of contaminant migration. The analytical results from these samples are also summarized in Table 1. Four VOCs were detected in these samples (1,2-dichloroethene, methylene chloride, tetrachloroethene, and trichloroethene), with the concentrations of each contaminant well below its respective TAGM 4046 soil cleanup objective (Table 1).

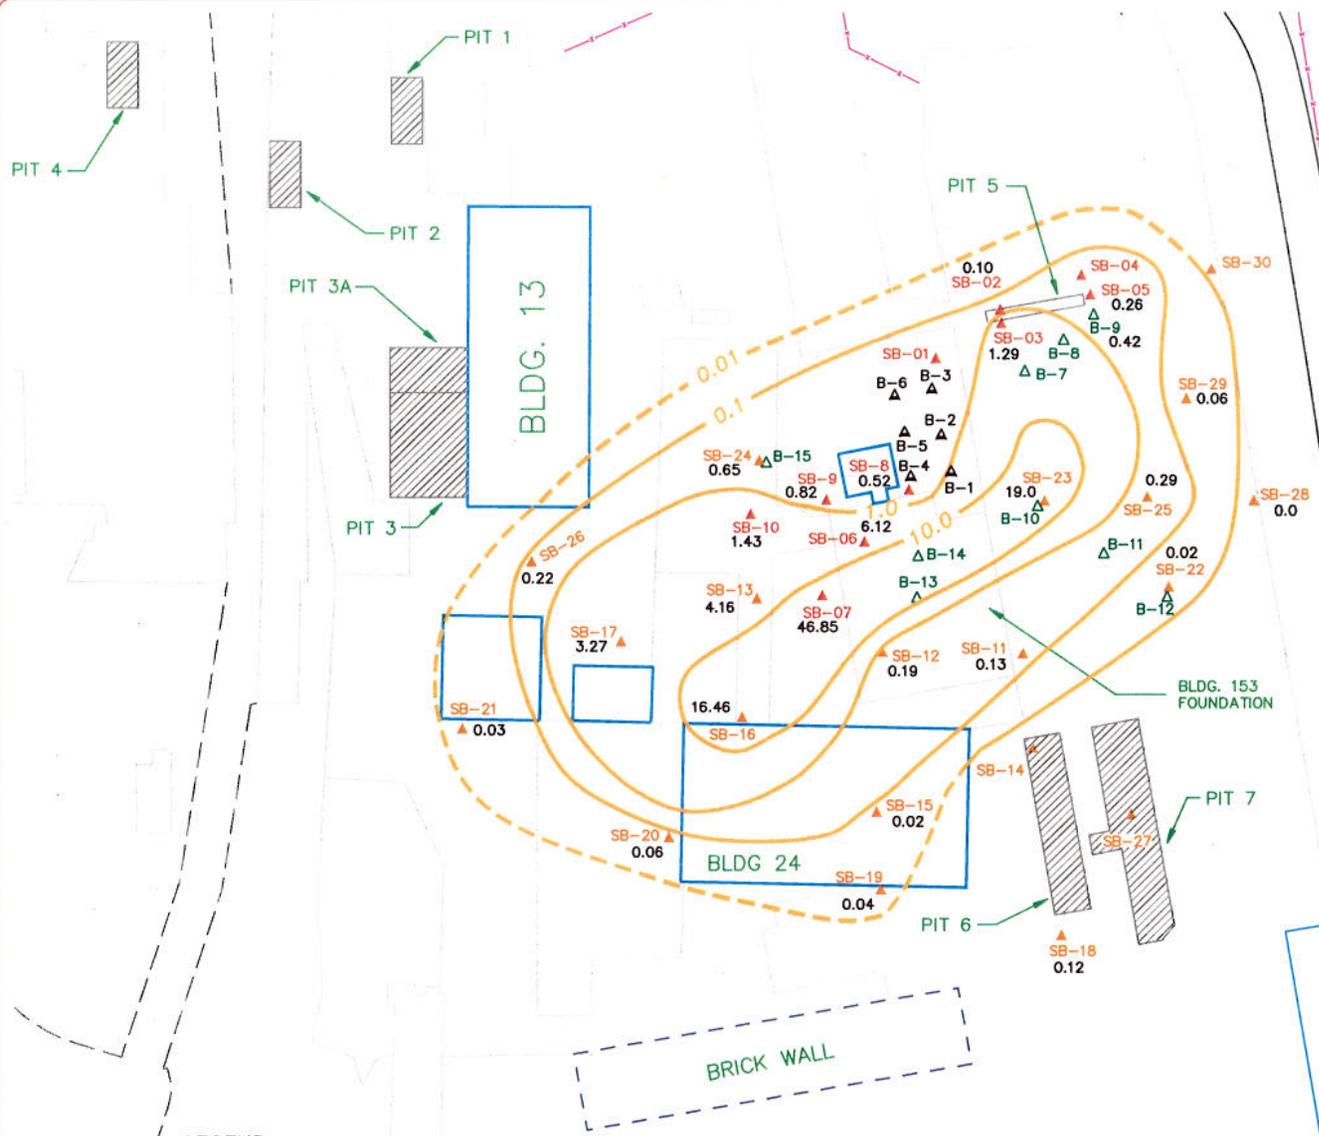
The analytical data for subsurface soil and fill (Table 1) indicated that the Still Discharge Area was extensively contaminated with VOCs. Within this area the most frequently detected VOCs above the TAGM 4046 soil cleanup objectives were 1,1-dichloroethane, 1,2-dichloroethene, tetrachloroethene, 1,1,1-trichloroethane, trichloroethene and xylenes. Of these contaminants, tetrachloroethene and trichloroethene exhibited more exceedances of their respective TAGM 4046 soil cleanup objectives than the other VOCs. The lateral extent of this VOC contamination is shown on Figure 5.

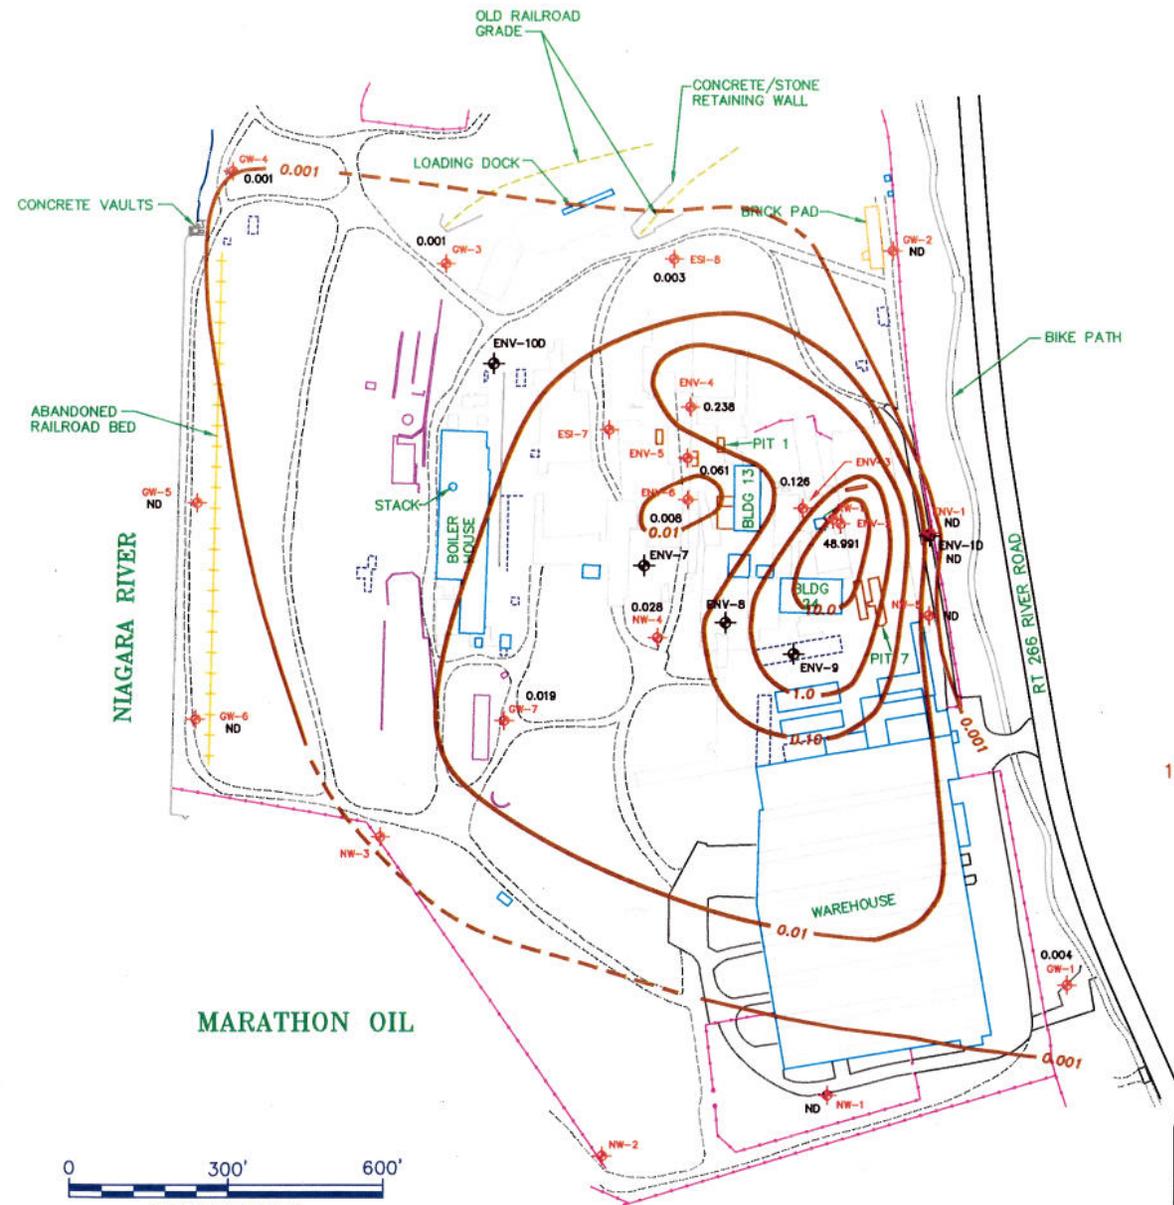
The lateral extent of total VOC contamination in shallow groundwater in 1999 is shown on Figure 6. This figure indicates that total VOC contamination is greatest at the former Envirotek facility and decreases significantly downgradient of the site. Figure 6 also indicates that total VOC concentrations in wells near the Niagara River are below the ambient groundwater quality standards. These data indicate that contaminants from the Envirotek II site are not adversely impacting the Niagara River.

Groundwater data also show that total VOC concentrations have decreased significantly over time in individual wells. For example, in wells ENV-4 (northwest of Pit 1 on Figure 6) and GW-7 (south of the Boiler House on Figure 6) the concentrations have decreased over 99% (Figure 9). Other wells also exhibit decreases in total VOC concentrations but not as remarkable as ENV-4 and GW-7.

<u>Yes</u>	<u>No</u>	<u>?</u>	<u>Rationale / Key Contaminants</u>
Groundwater	<u>X</u>	—	—	<u>See Figure 6</u>
Air (indoors) <sup>2</sup>	—	<u>X</u>	—	<u>No structures are over the groundwater plume</u>
Surface Soil (e.g., <2 ft)	—	<u>X</u>	—	<u>Removed during IRMs</u>
Surface Water	—	<u>X</u>	—	<u>See Figure 6</u>
Sediment	—	<u>X</u>	—	<u>Site has not impacted the Niagara River</u>
Subsurf. Soil (e.g., >2 ft)	—	<u>X</u>	—	<u>Removed during IRMs</u>
Air (outdoors)	—	<u>X</u>	—	<u>No breathing zone organic vapors</u>

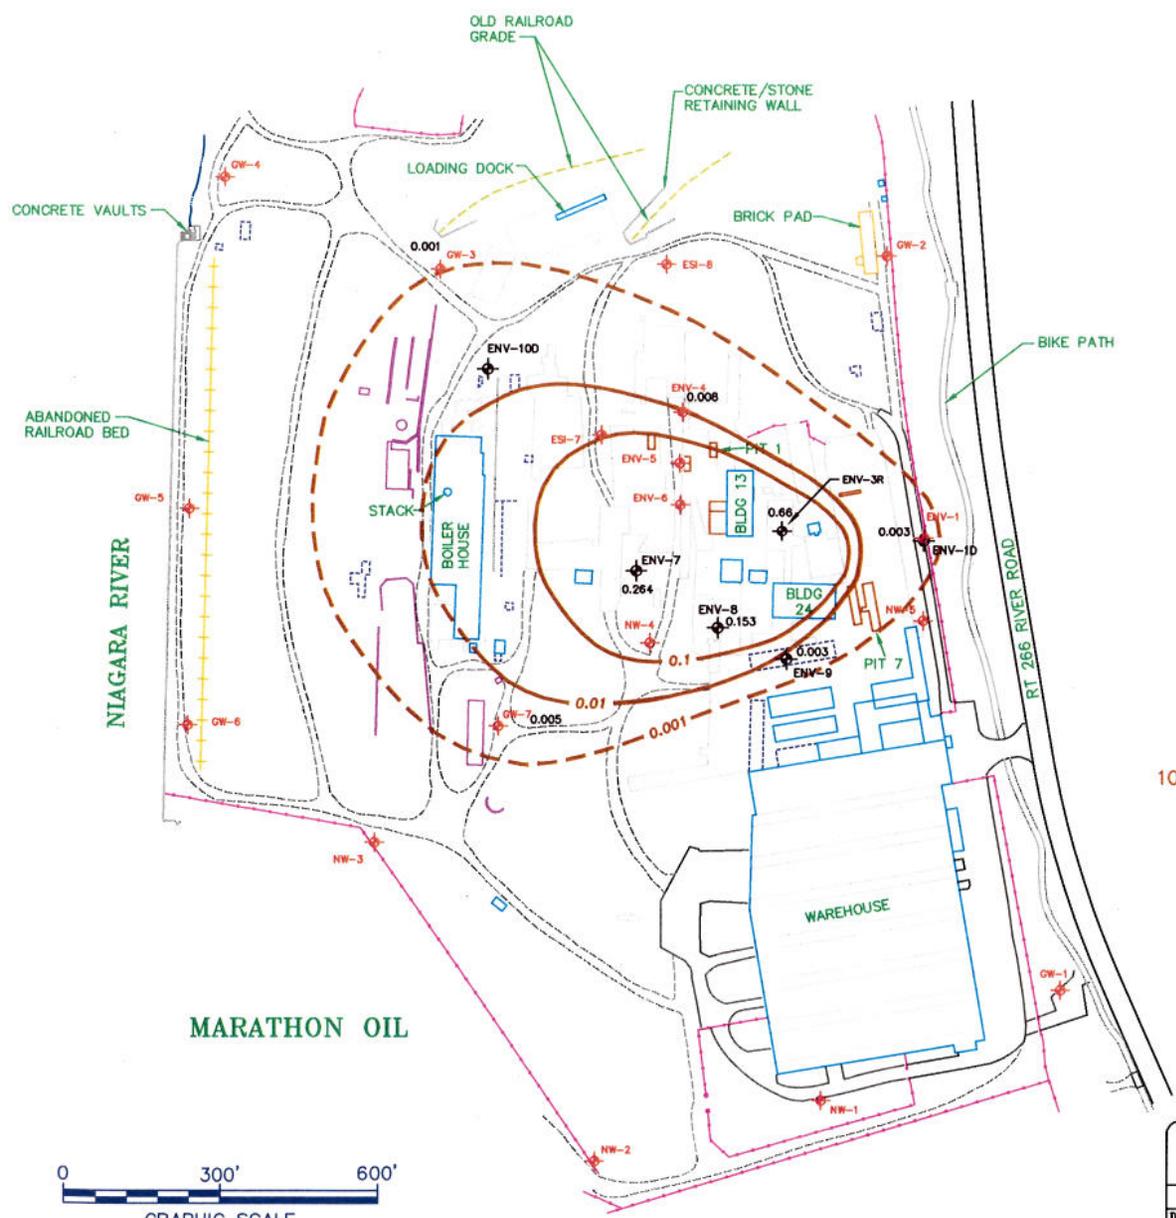
Following the completion of the IRM at Operable Unit 2, selected monitoring wells were sampled to assess the affect of the IRM on groundwater contamination. The results from these samples are shown on Figure 8, and reveal that groundwater contamination has been reduced significantly since the completion of the IRM (compare Figure 6 with Figure 8). In addition, monitored natural attenuation parameters (e.g., dissolved oxygen, oxidation-reduction potential, chloride, methane) provide evidence that biochemical degradation is the mechanism responsible for the natural attenuation of the groundwater plume.

The groundwater analytical results obtained between 1988 and 2004 indicate that natural attenuation of VOCs is occurring at the site. Figure 8 illustrates that the total VOC concentration at the site decreases significantly downgradient of the former Envirotek facility, and also shows that total VOC concentrations have decreased significantly since the completion of the IRM at Operable Unit 2 (compare with Figure 6). In addition, monitored natural attenuation parameters (e.g., dissolved oxygen, oxidation-reduction potential, chloride, methane) provide evidence that biochemical degradation is the mechanism responsible for the natural attenuation of the groundwater plume.
