2013 HAWAII OCEAN DISPOSAL SITE MONITORING SYNTHESIS REPORT

Prepared by:
Dredging and Sediment Management Team
USEPA Region 9
San Francisco, CA

April 27, 2015

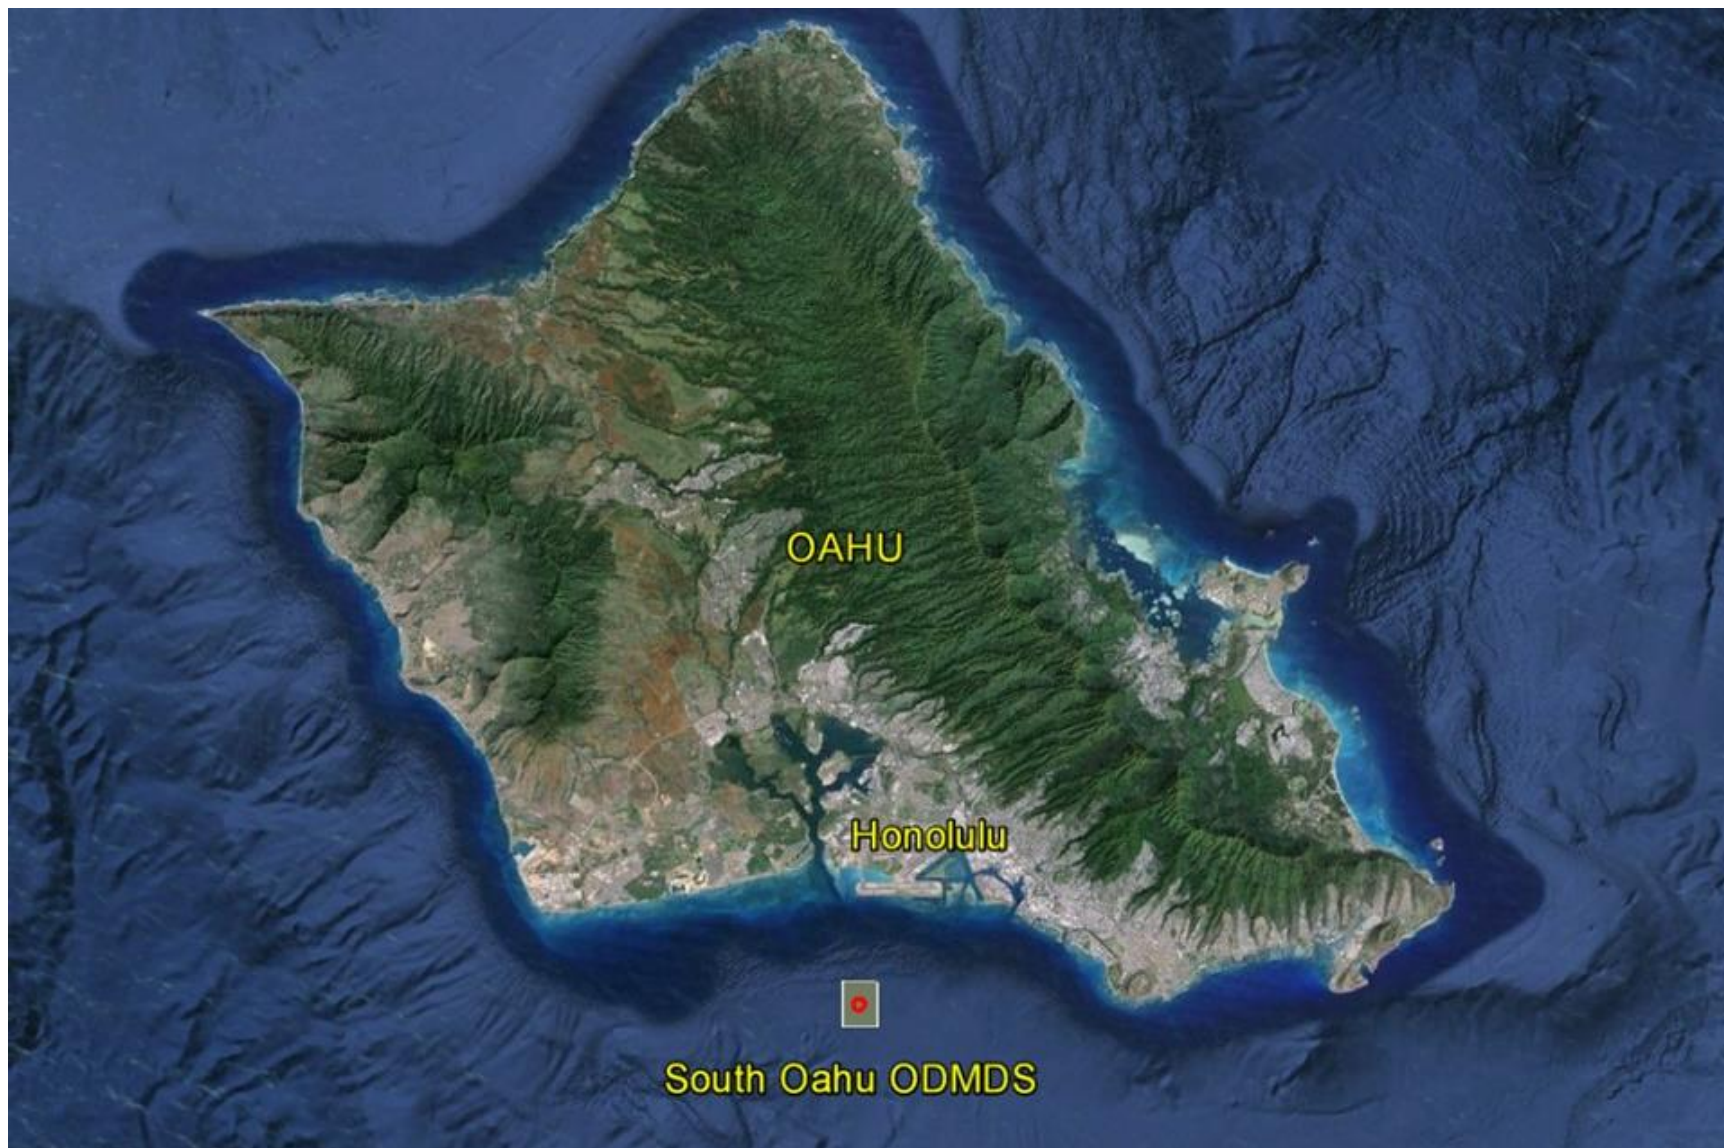
Figure 2. General location of the South Oahu Ocean Dredged Material Disposal Site, showing overall site (yellow box) and Surface Disposal Zone (red circle).

The South Oahu site (Figure 2) is located approximately 3 nautical miles offshore of Pearl Harbor in water depths ranging from about 1,300 to 1,650 feet (400 to 500 meters). It is a rectangular ocean disposal site 2 kilometers wide (west-east) and 2.6 kilometers long (north-south), and occupies an area of about 5.2 square kilometers on the sea floor. Although the overall site is rectangular, all disposal actions must take place within a 1,000 foot (305 meter) radius Surface Disposal Zone at the center of the site. Its center coordinates are 21 degrees 15.167 minutes North Latitude, 157 degrees 56.833 minutes West Longitude (NAD 83).

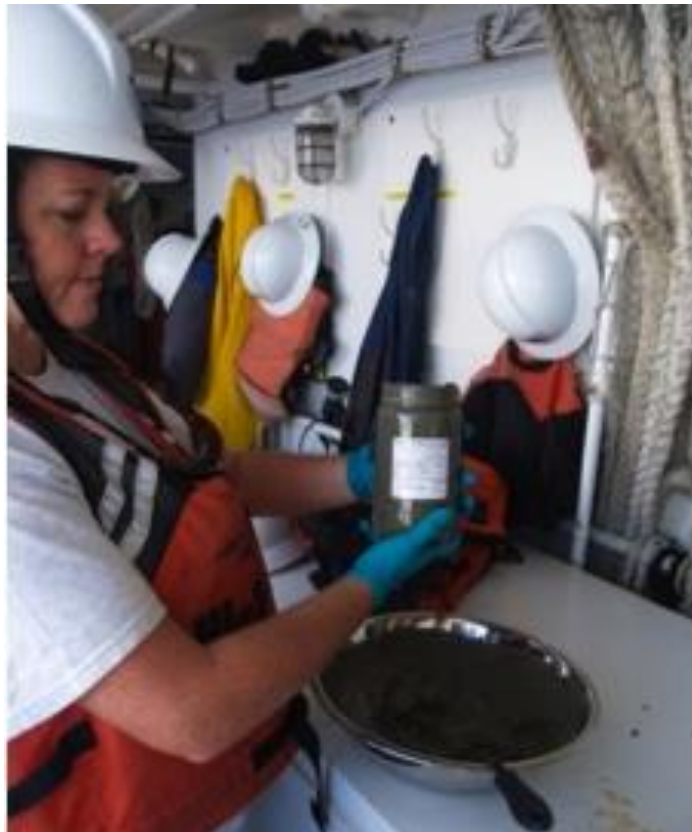
Figure 11. Processing a sediment sub-sample for chemical analysis.

After each acceptable grab sample was measured for depth of penetration and photographed, a subsample for chemistry was extracted from one side of the grab sampler with a stainless steel spoon (Figure 10). This subsample was homogenized and divided into separate jars (Figure 11) for chemistry analyses (grain size, metals and organics). After the chemistry subsample was extracted, the entire volume of the other side of the grab was processed to create a benthic community sample for that station (Figure 12). A 500 micron sieve was used to separate organisms from the sediment, and the separated organisms were placed into bottles where they were initially preserved with formalin. A total of 18 sediment grab sample stations were sampled in the two survey areas combined: 10 at South Oahu, and 8 at Hilo (see Figures 7 and 8, respectively). Chemistry subsamples were collected from all 18 stations and benthic community samples were collected at 14 of the 18 stations (the lower number of benthic community samples was due to some grabs being used for field and laboratory chemistry duplicates, and one station where QAPP metrics were not met for an acceptable benthic sample).

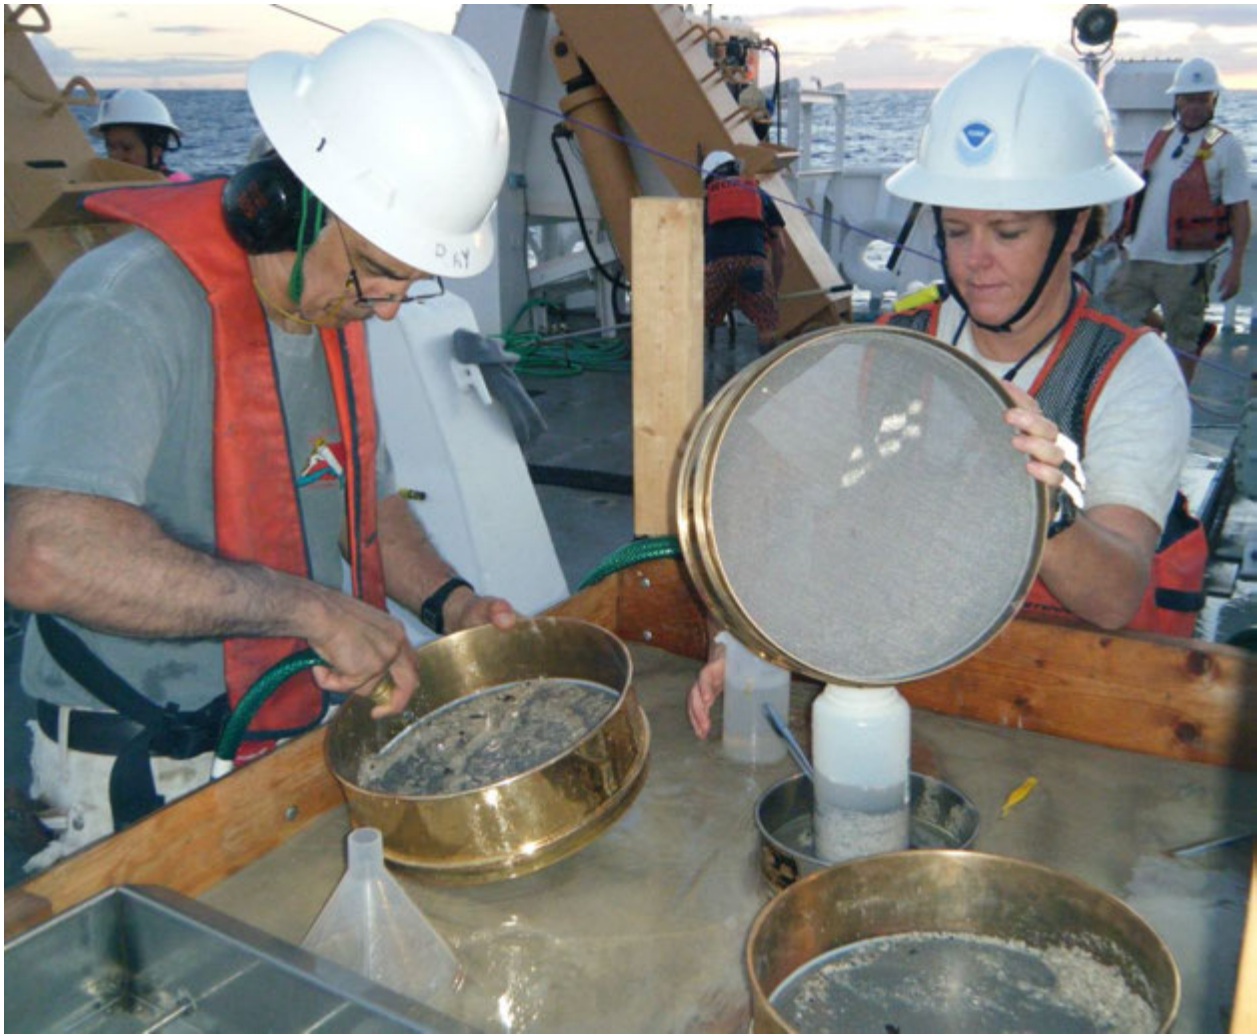
Figure 12. Processing a sediment sample for benthic community analysis.

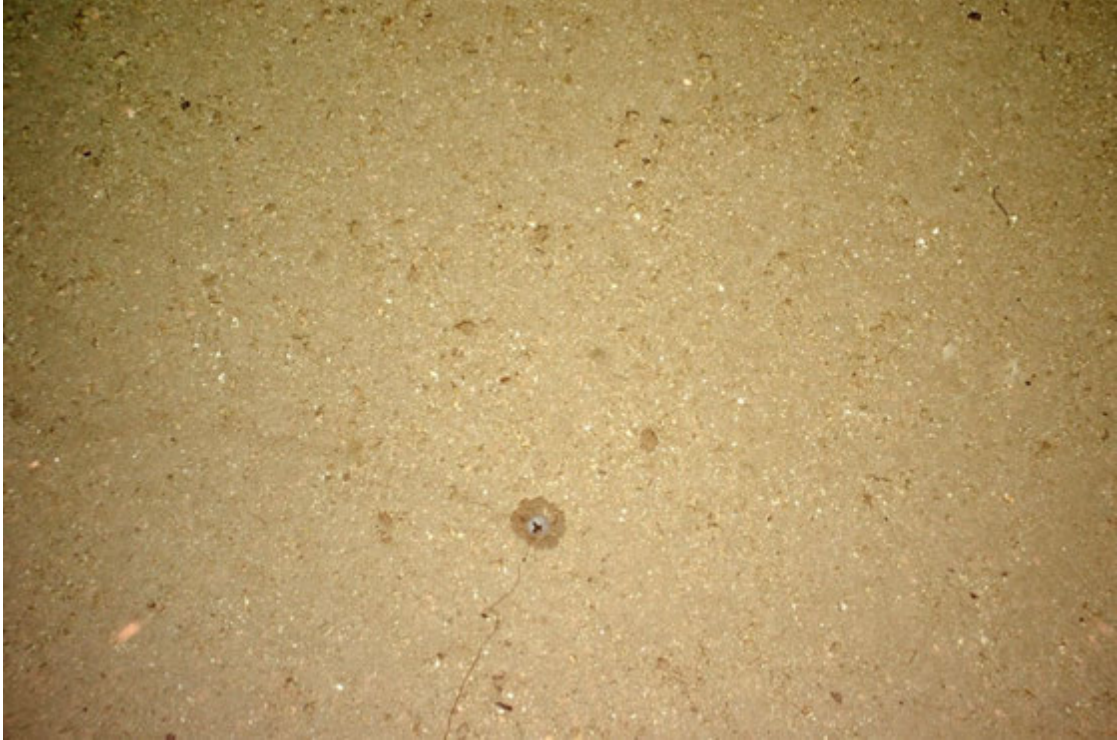
Figure 16. Plan view images of the dredged material deposit compared to the native seafloor at South Oahu. Station C1 on dredged material (top) shows the visual difference in both sediment color and surface texture/features of dredged material compared to the ambient bottom at Station NW6 (bottom). Scale: width of each PV image is approximately 4 m. (Germano & Assoc., 2013)
