ACTION MEMORANDUM

SUBJECT: Approval and Funding for a Removal Action at the Red and Bonita Mine Site in San Juan County, Approximately Seven Miles North of Silverton, Colorado.

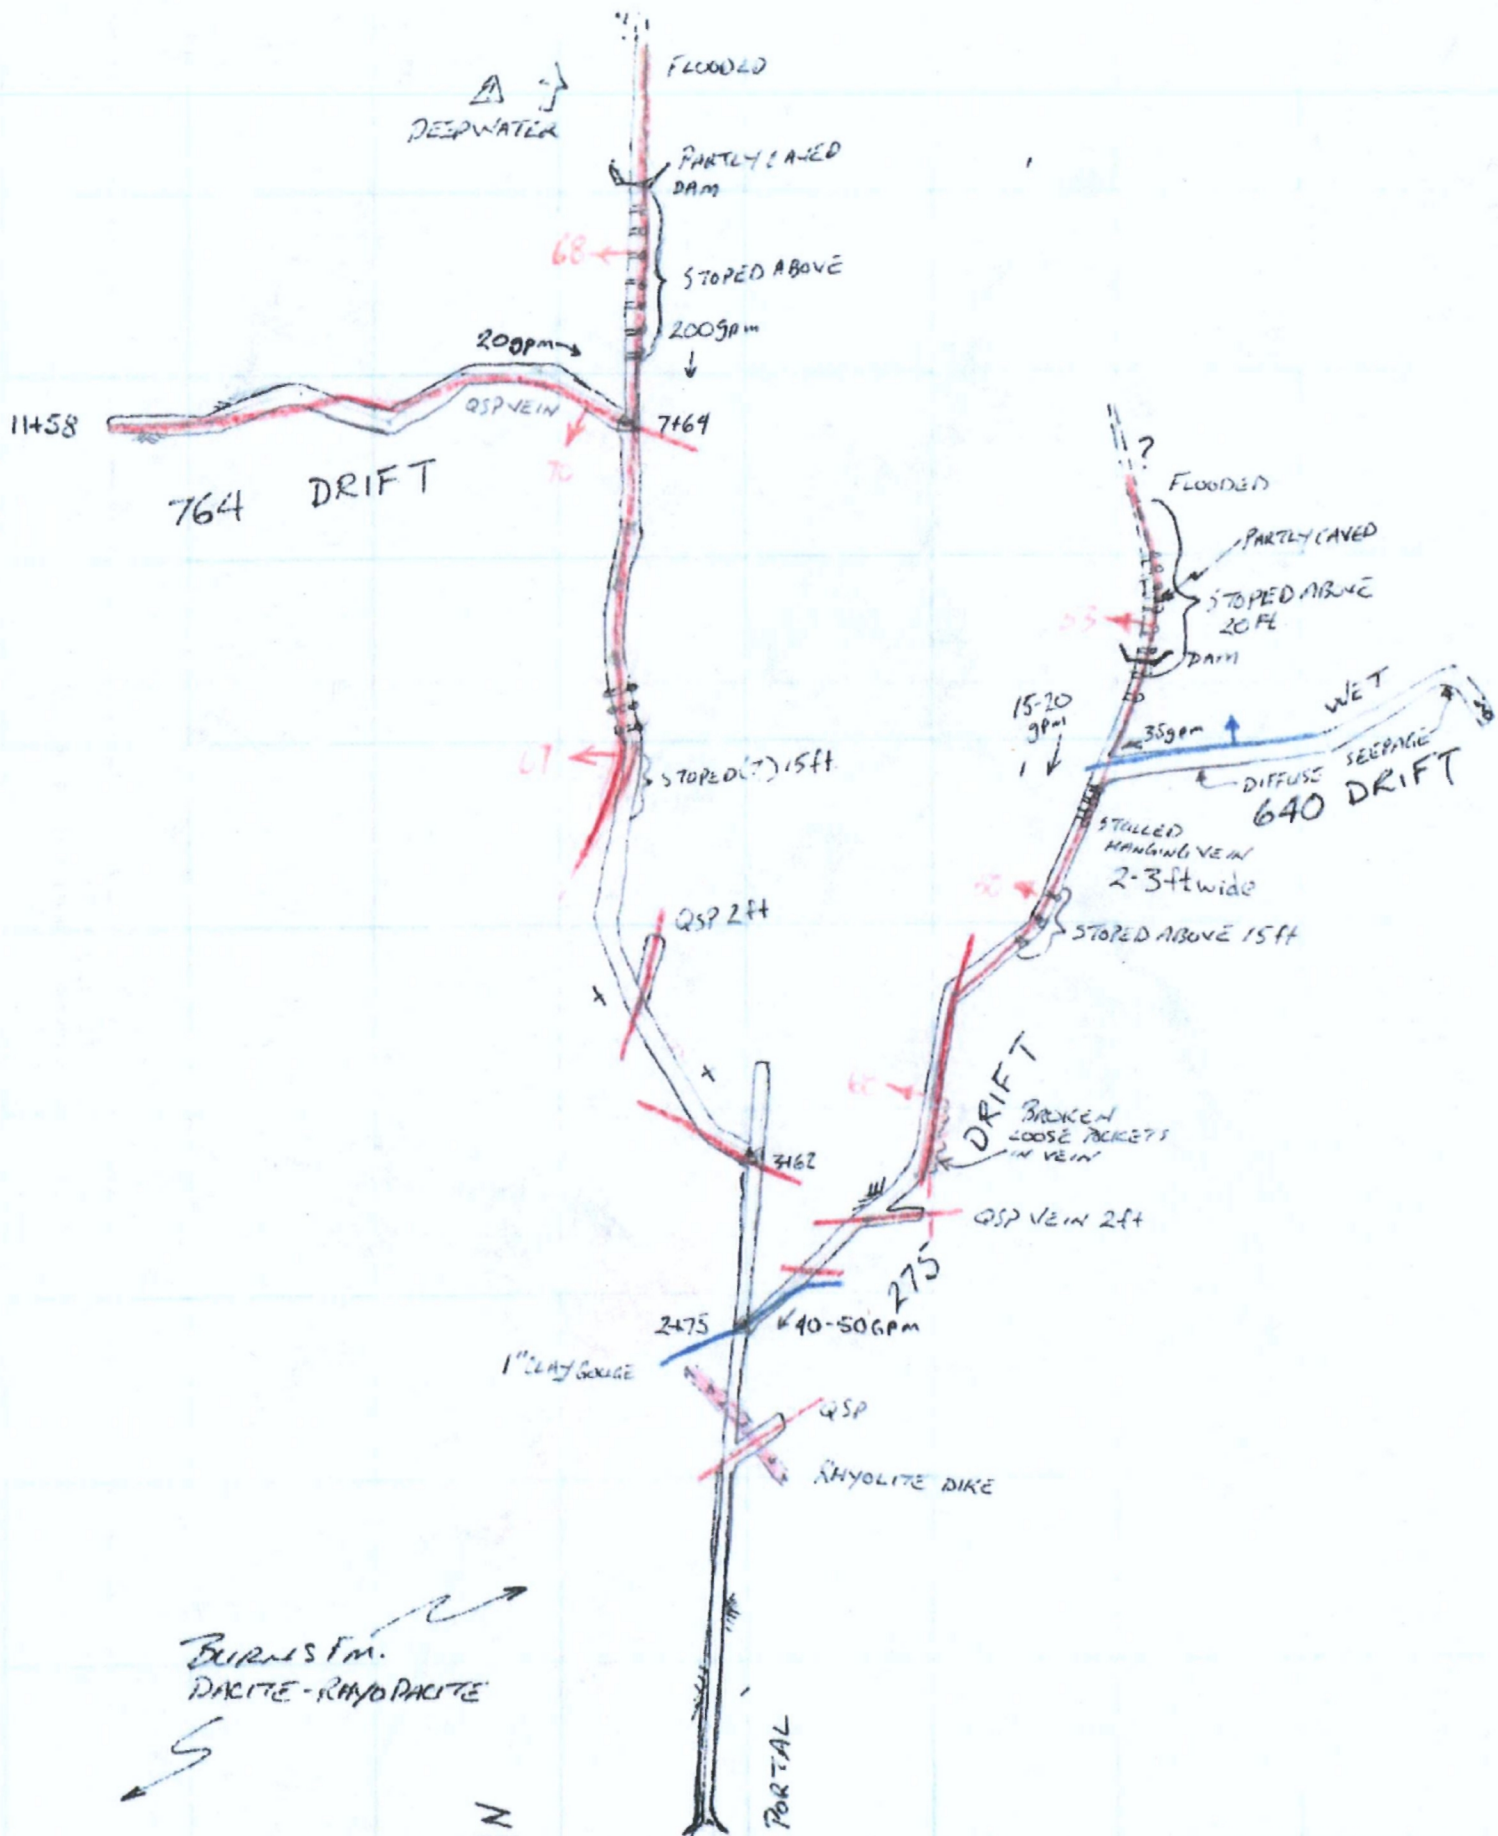
MINE GEOLOGY BY RED & BONITA BKS

LEVEL MILL LVL SCALE 1"=100ft

In September/October 2011, the EPA removed blockage in the Red and Bonita Mine opening and constructed a temporary portal for accessing the mine. The mine adit is approximately five feet wide by seven feet high and extends underground for several hundred feet in multiple directions (Attachment 1-Figure 2). Investigations of the mine allowed access to approximately 2,000 feet of workings. Collapsed ground within the tunnels prevented further investigation. However, based on historic

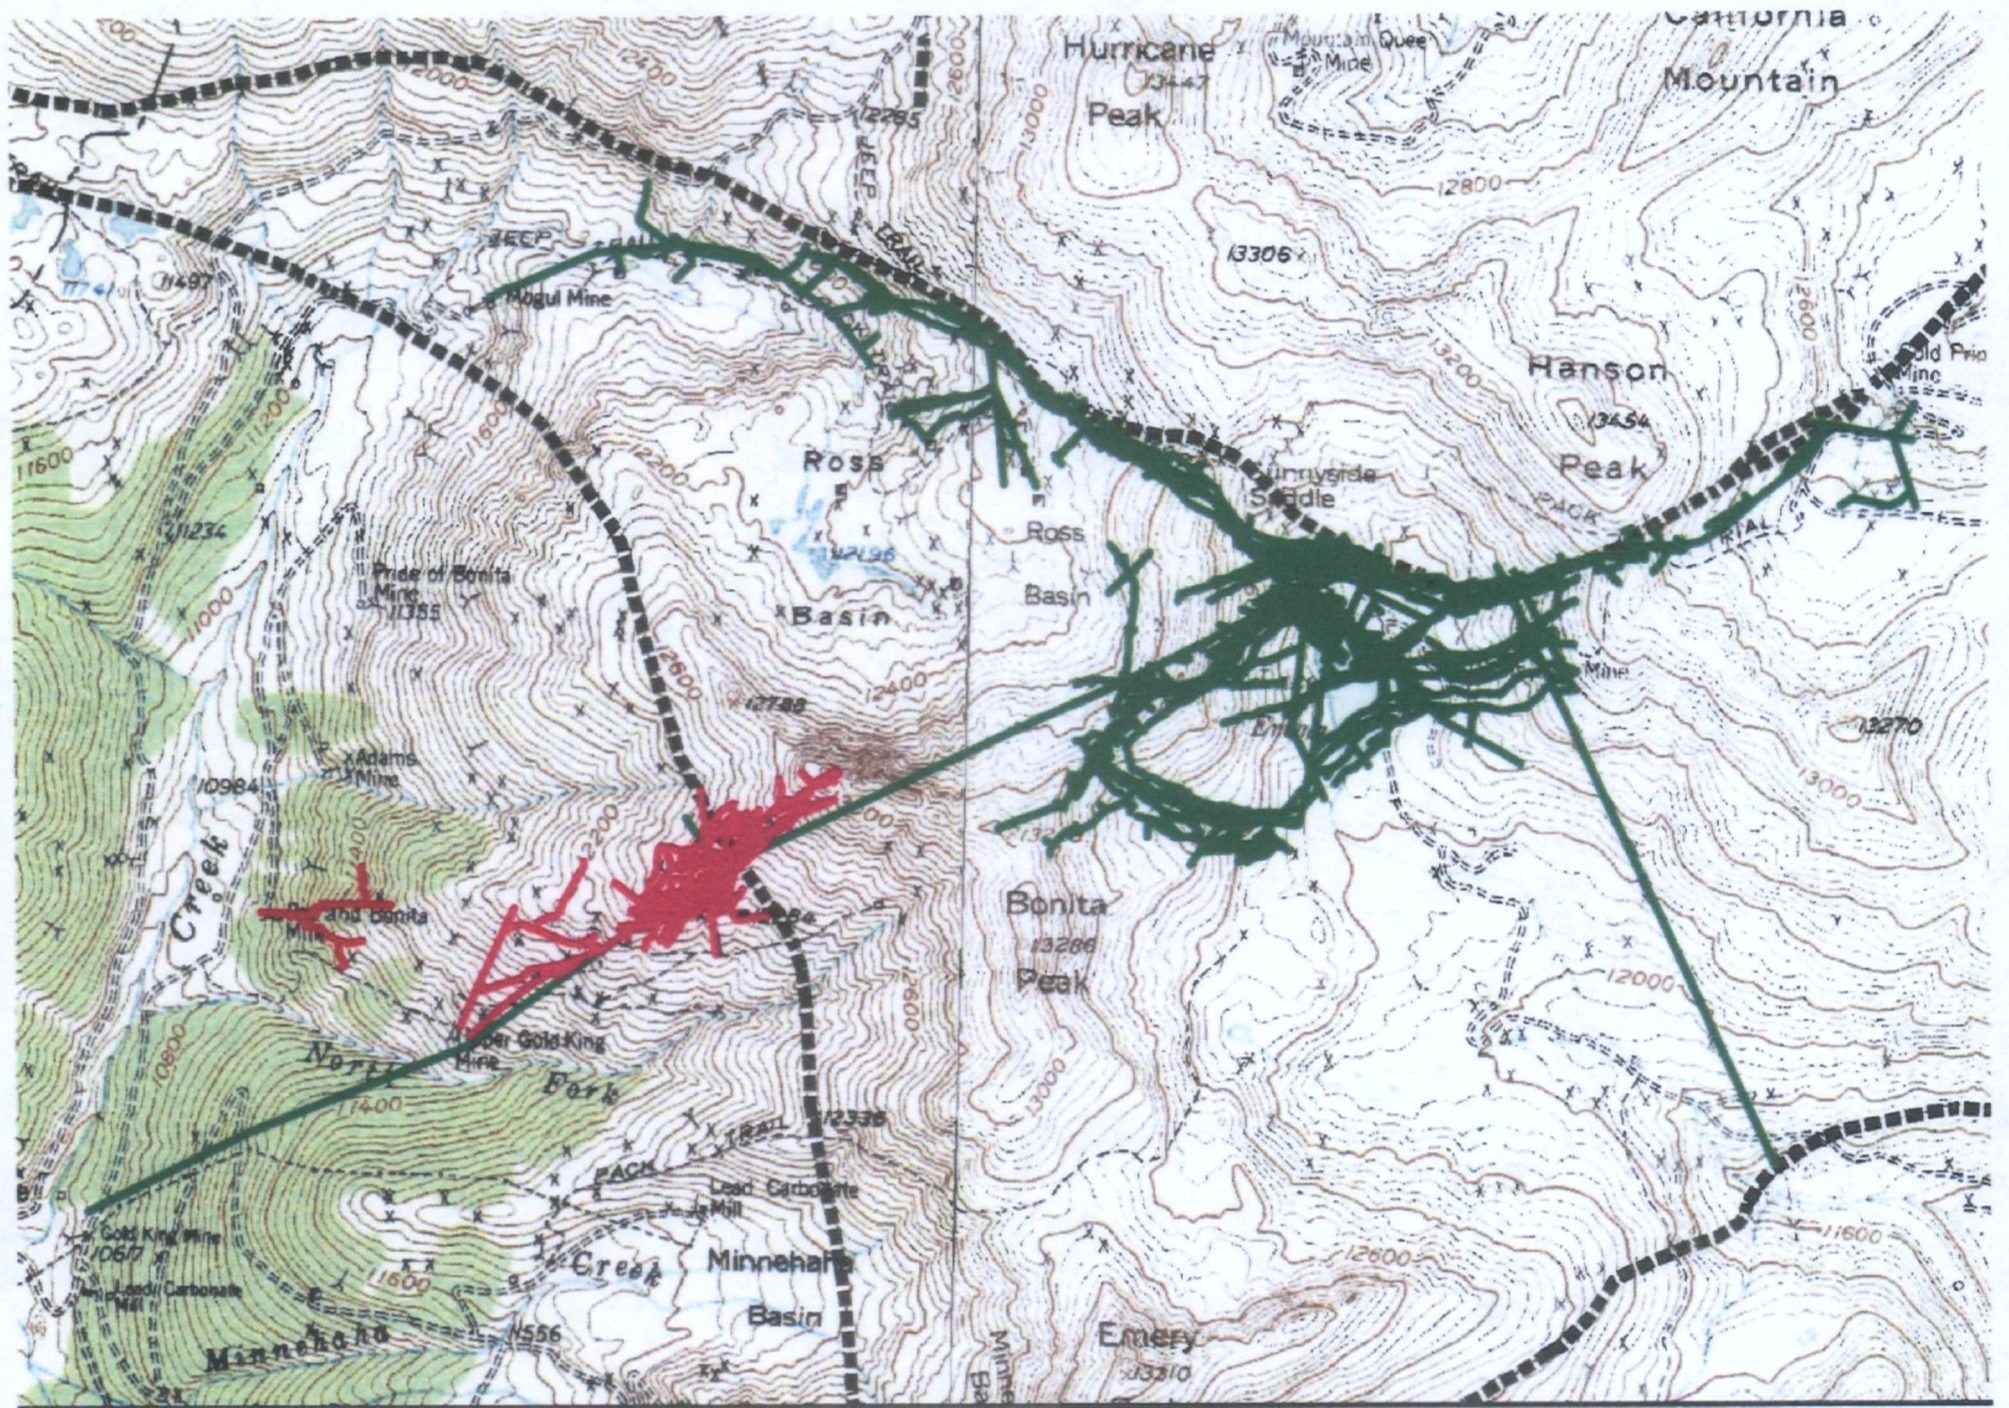
RED AND BONITA MAP
 Mine Workings past cave-ins are only projected to line of sight
SUNNYSIDE WORKINGS
 Most Recent workings, needs more work
GOLD KING WORKINGS

information and the estimated waste dump volumes, it is estimated that there are only approximately 3,500 feet of underground workings and that the adit does not connect to other mines (Figure 3). In addition, there is no mapped surface opening to the mine and none were found during Site investigations in September 2014 or previously.

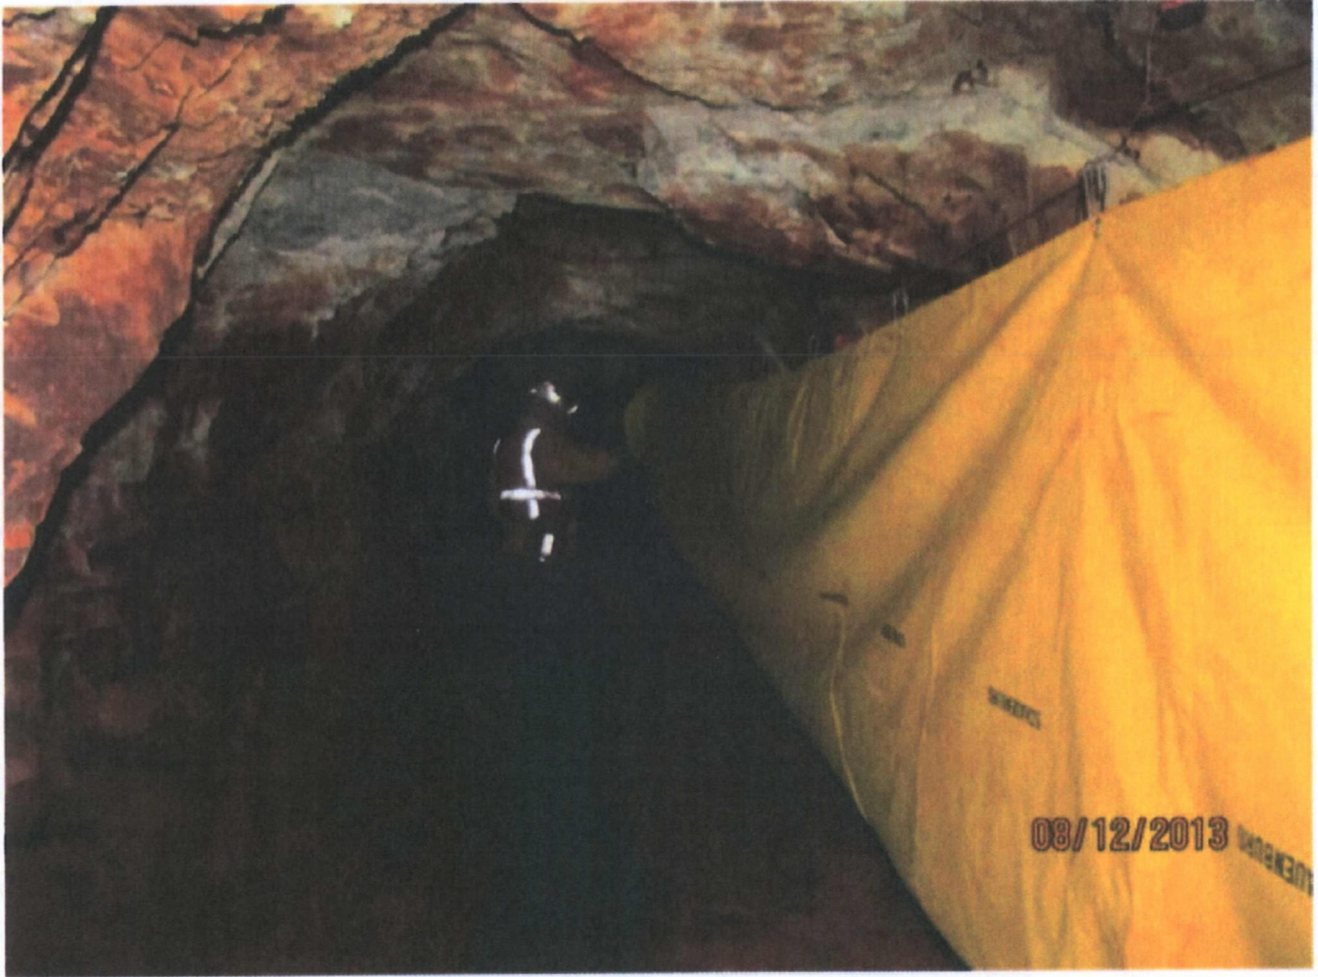
Red and Bonita Mine adit

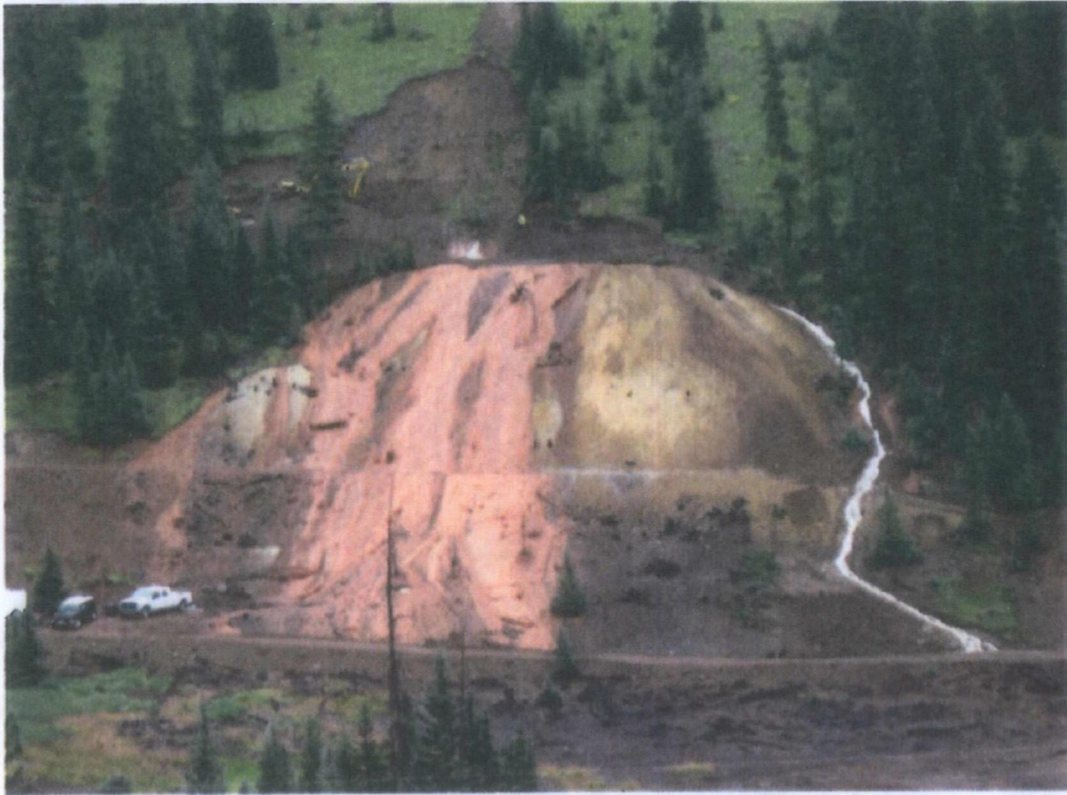
Red and Bonita Mine tailings dump view

The Red and Bonita Mine Site consists of approximately 1.25 acres of waste rock and suspected tailings material and includes an estimated 3,500 feet of underground workings (Stover 2007). The adit, which drains approximately 300 gpm throughout the year with some fluctuations seasonally, discharges to Cement Creek after crossing through a wetland. Prior to the removal assessment work, the mine water discharged through rock debris, as a result of a tunnel collapse that occurred decades ago..

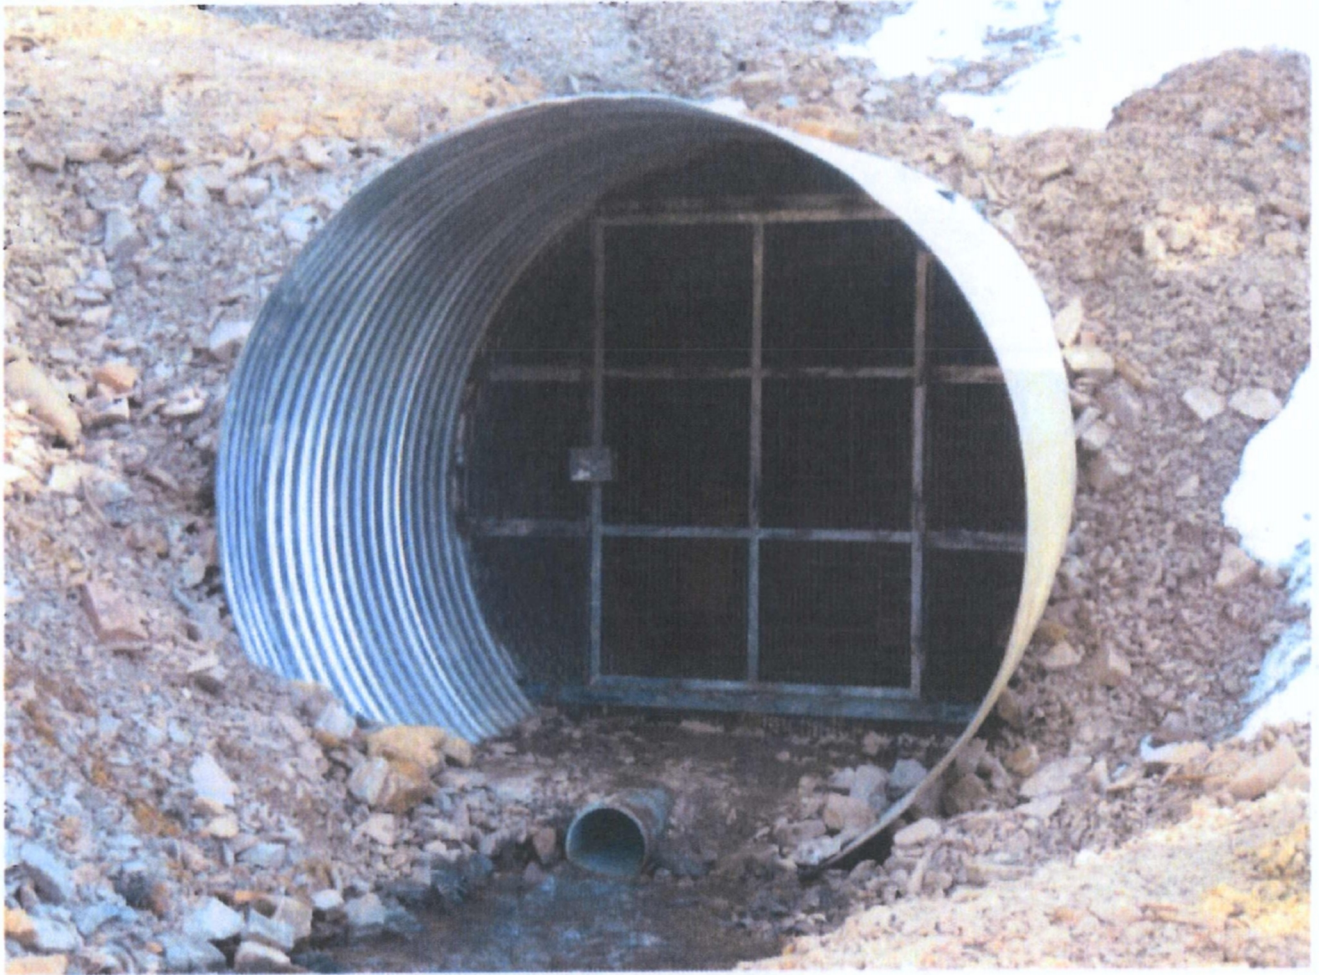
Red and Bonita Mine portal

EPA installed a new portal structure in October 2011 after removing 30 feet of blockage at the adit entrance. Adit discharge flows overland across, and approximately 200 feet down, a mine dump face before being channelized at the toe of the dump. The channel directs flow into an iron bog en route to Cement Creek approximately 500 feet down gradient of the toe of the dump.
