**SUBJECT: START 3, EPA Region 8, Contract No. EP-W-05-050, TDD No. 1008-13  
Trip Report-Revision 1-for August 2011 Sampling and Field Activities,  
Upper Animas Mining District, Silverton, San Juan County, Colorado**

**TRIP REPORT**  
**Upper Animas Mining District**  
**Silverton, San Juan County, Colorado**

**Photo Log  
Cement Creek  
San Juan County, Colorado  
August 2011**

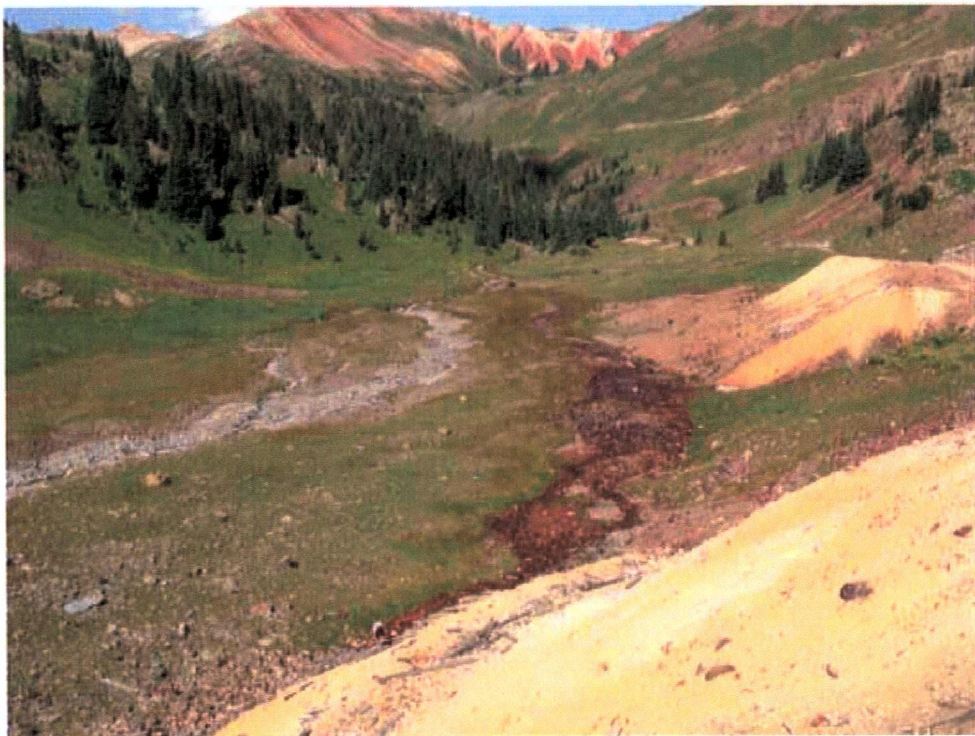
**PHOTO 1**

View to the west of surface water flowing from the toe of the Grand Mogul Mine waste rock dumps toward Cement Creek. Note iron staining of flow path.

- **Grand Mogul Mine:** The overland flow pathway for the Grand Mogul Mine begins at the western toe of the main mine waste pile and continues westward for approximately 300 feet until it enters Cement Creek (Appendix A, Photos 1 & 2). The actual point of exit from the ground is buried by the mine waste. The overland flow path as shown in Photo 1 is heavily stained with iron oxides (that begin to precipitate out of solution when the pH rises above 3.5) as compared to the stream course of Cement Creek on the left center of the photograph.

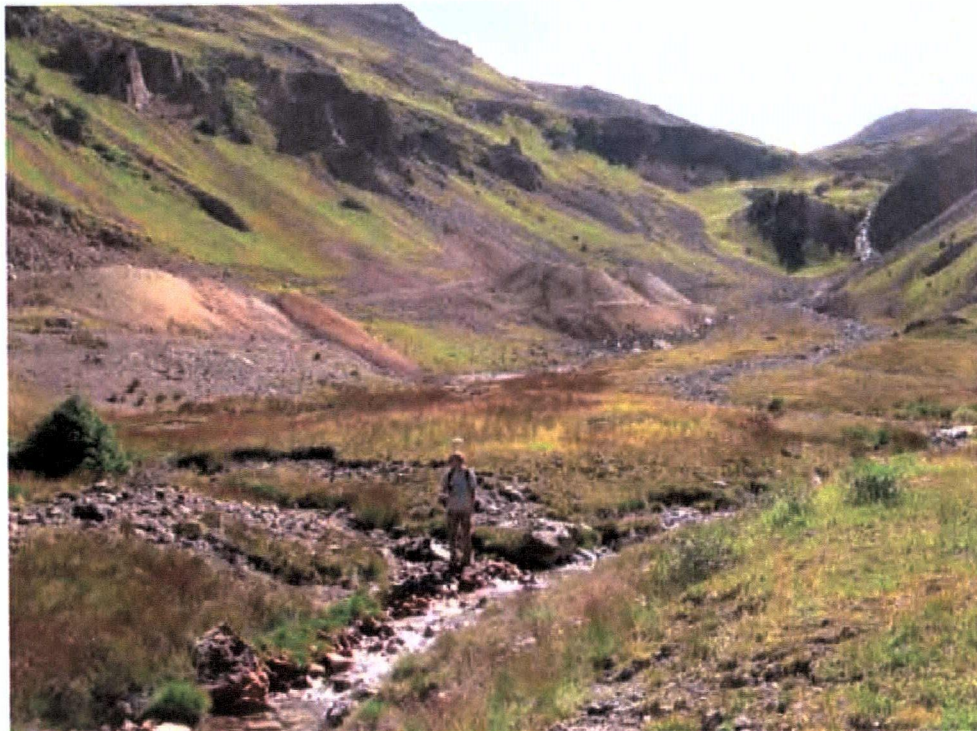
**PHOTO 2**

View to the east of the PPE from the Grand Mogul Mine into Cement Creek. Note iron staining of rocks in Cement Creek downstream of flow from Grand Mogul Mine. J. Miller of START at PPE collecting GPS location data.

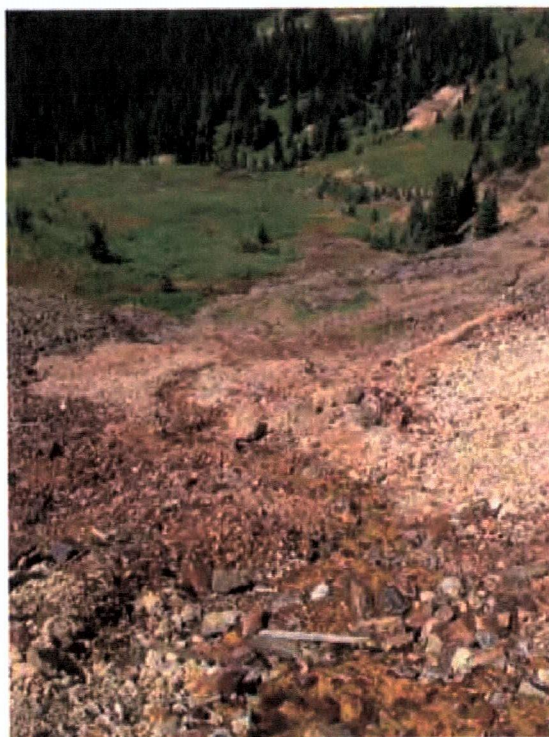
**PHOTO 3**

View to the southwest showing adit discharge water from the Mogul Mine flowing over mine waste rock into wetlands immediately downstream of Mogul Mine waste rock. Note the mix of scrap lumber and waste rock. Note staining of flow path into wetlands. Cement Creek is at the shallow part of the valley in the background.

- **Mogul Mine:** The discharge from the Mogul exits through an adit on the northeast side of the mine waste pile and flows across the top of the mine waste pile in a tarp lined ditch to the access road. Once the adit discharge crosses the road, it flows over a mixture of mine waste and mine trash into a series of wetlands below the mine (Appendix A, Photo 3). The overland flow pathway from the Mogul Mine covers approximately 1,200 feet before the PPE into Cement Creek. It can be observed that iron oxides are precipitating on the side of Cement Creek where discharge water from the Mogul Mine is entering Cement Creek (Appendix A, Photo 4).

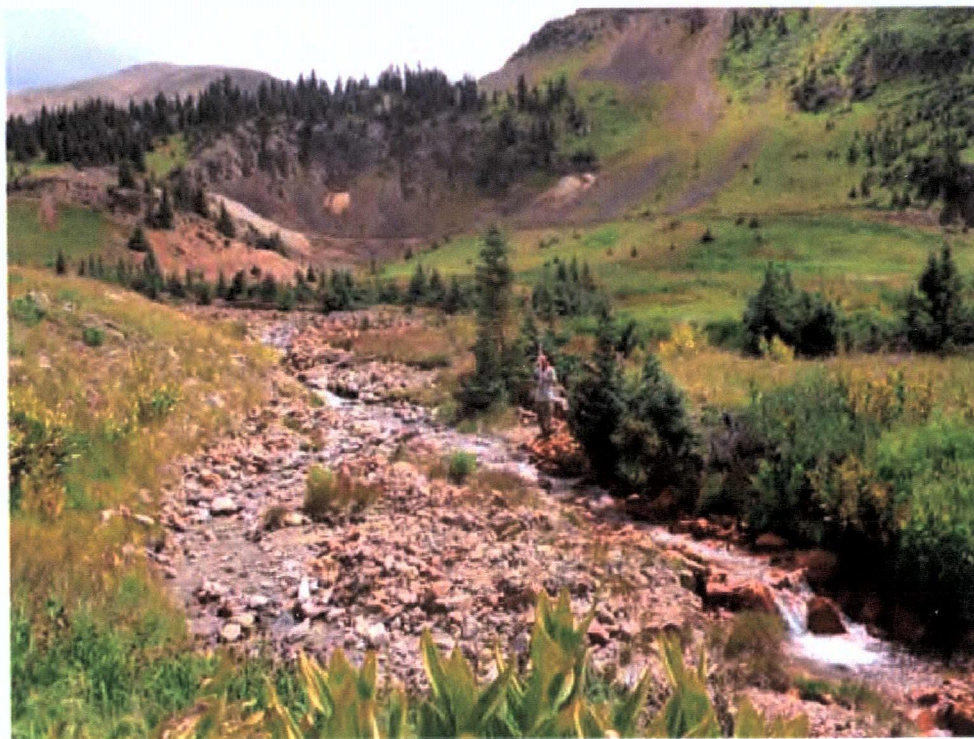
**PHOTO 4**

View to the east of the PPE of the discharge from the Mogul Mine into Cement Creek. The surface water pathway from the adit flows down to the road on the other side of the white patch of waste rock and through the wetlands. Note iron staining of Cement Creek on the inflow side of the creek from the PPE where J. Miller of START at PPE collecting GPS location data.

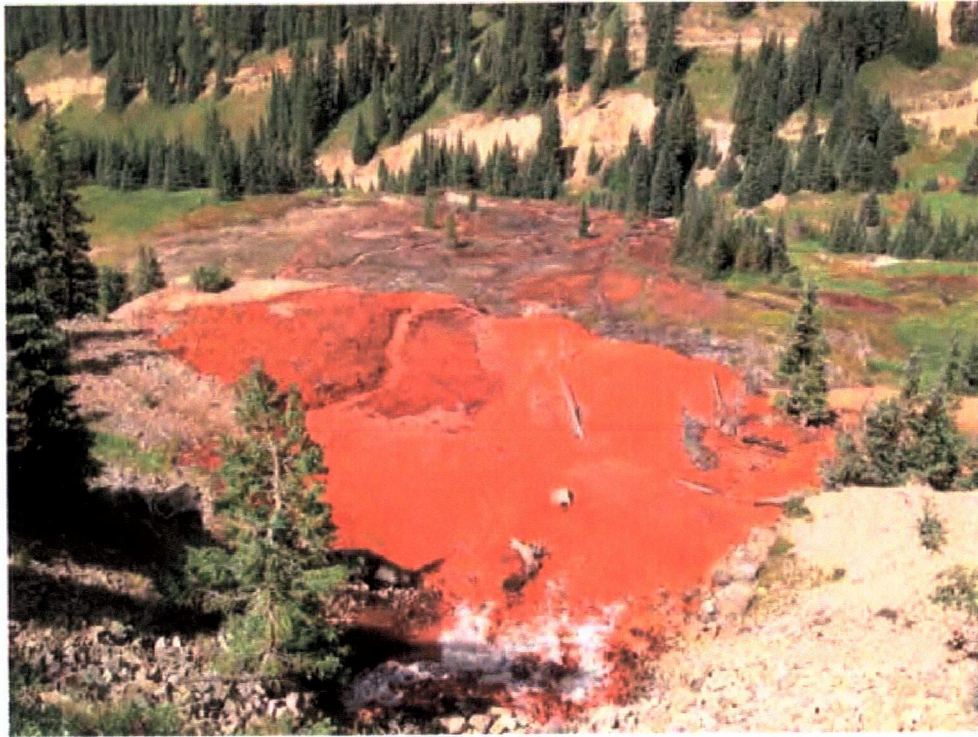
**PHOTO 5**

View to the west of the adit discharge from the Red and Bonita Mine. Note the strong color of iron oxide precipitation and the staining to Cement Creek along valley floor.

where it flows southward, then into a culvert directed westward under the road, and then directly westward across a barren iron oxide stained landscape to Cement Creek (Appendix A, Photo 5). The overland flow path after flowing under the road splits into two streams in the barren area before entering Cement Creek. The more upstream flow path was visually estimated to carry approximately 75 percent of the flow, and the smaller stream enters Cement Creek approximately 50 feet downstream of the larger stream. Photo 6 shows the upper dominant discharge point. Note the iron oxide staining in the Cement Creek streambed on the side of the PPE from the Red and Bonita Mine (Appendix A, Photo 6).

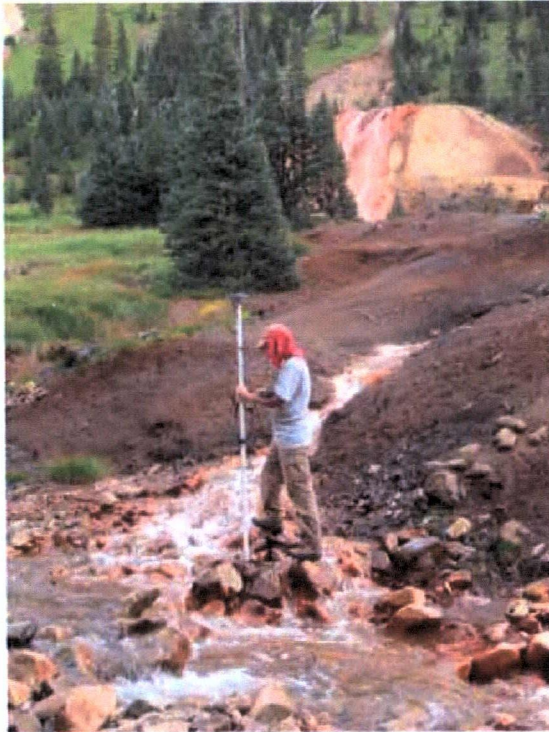
**PHOTO 6**

PPE from the adit discharge at the Red and Bonita Mine to Cement Creek. Note iron oxide staining on the same side of the Cement Creek as the PPE discharge point. J. Miller of START at PPE collecting GPS location data.

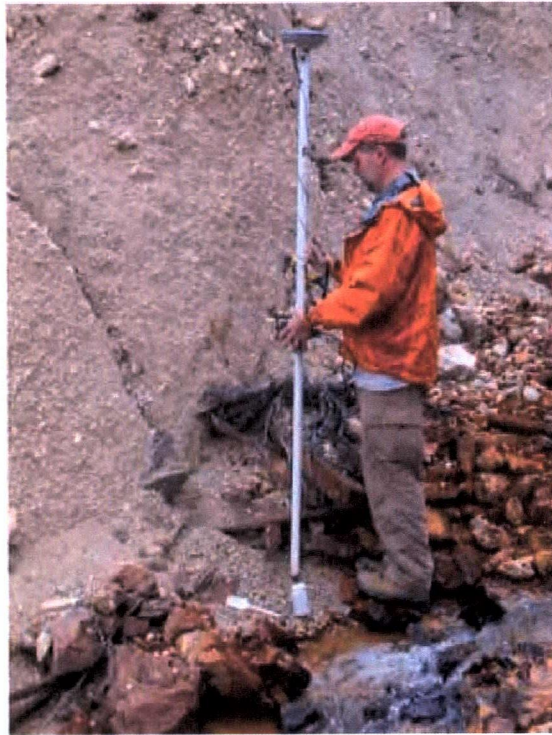
**PHOTO 7**

Gold King 7 Level Mine waste rock pile being eroded by the North Fork of Cement Creek. Note the erosion rills on the waste rock pile and undercutting by stream. J. Miller of START collects source sample UASO015 GPS coordinates.

Four samples of the mine waste pile at the Gold King 7 Level Mine were collected in accordance with the approved FSP. Sample UASO015 was collected from an area that was being actively eroded by the North Fork of Cement Creek, from material that appeared to be similar to the fine-grained limonite colored material (Appendix A, Photo 7). START personnel also collected source samples from each of the three types of mine waste material identified with the field XRF. One Matrix Spike/Matrix Spike Duplicate (MS/MSD) sample was collected with the sample from location UASO018.

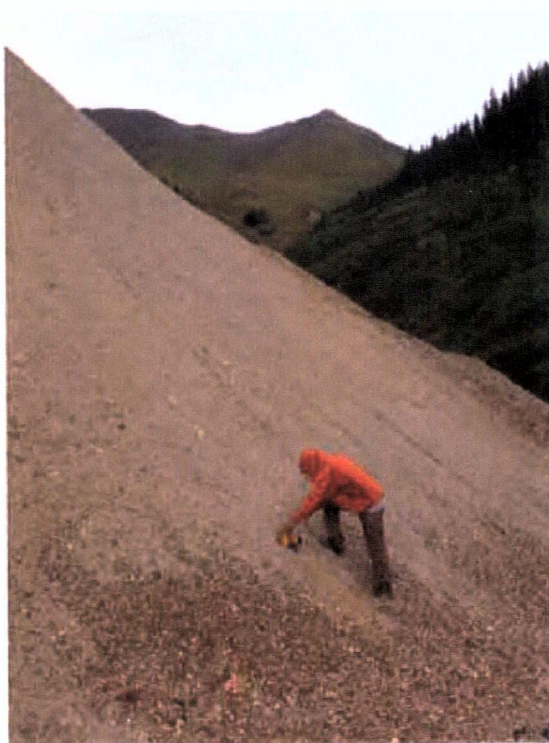
**PHOTO 8**

Gold King 7 Level Mine waste rock pile. J. Miller of START collecting field XRF data from sample location UASO019.

The Gold King 7 Level Mine mine waste pile was first screened using a Innov-X Systems Model OSD-4000 portable X-ray fluorescence (XRF) instrument (Appendix A, Photo 8). Twelve field readings identified three different types of mine waste:

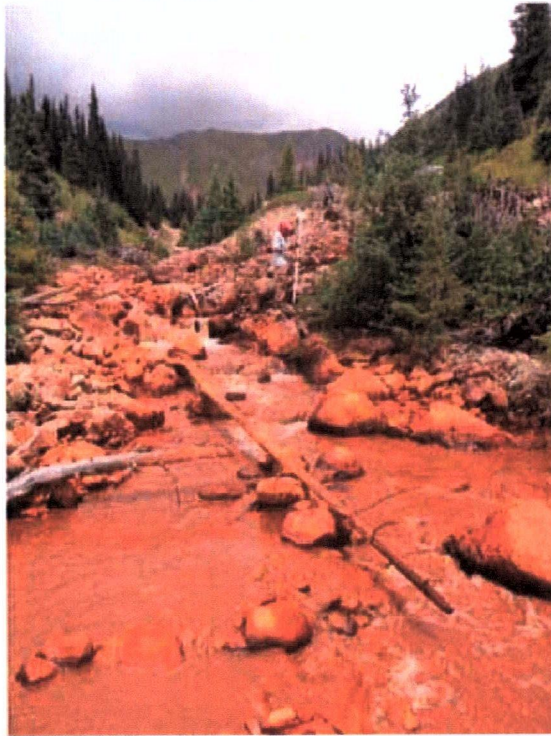
**PHOTO 9**

Cement Creek immediately downstream of confluence with N. Fork of Cement Creek draining from Gold King 7 Level Mine. J. Miller of START at PPE collecting GPS coordinates.

- **Gold King 7 Level Mine:** There are two adit discharges at the top of the Gold King 7 Level Mine mine waste pile. The main discharge on the east side of the pile is channelized into a segmented plastic channel to flow down to the North Fork of Cement Creek just beyond the east side of the mine waste pile. The smaller western discharge is not provided with any engineering controls and flows westward eventually percolating through the mine waste pile into the North Fork of Cement Creek. The North Fork of Cement Creek is actively eroding the mine waste pile, and evidence of sloughing and erosional rills were observed in the mine waste pile (Appendix A, Photo 7). The North Fork of Cement Creek flows approximately 1,500 feet westward from the toe of the Gold King 7 Level Mine mine waste pile to the PPE with Cement Creek. Iron oxide precipitation in the Cement Creek streambed below the confluence of Cement Creek and the North Fork of Cement Creek is pronounced (Appendix A, Photo 9).

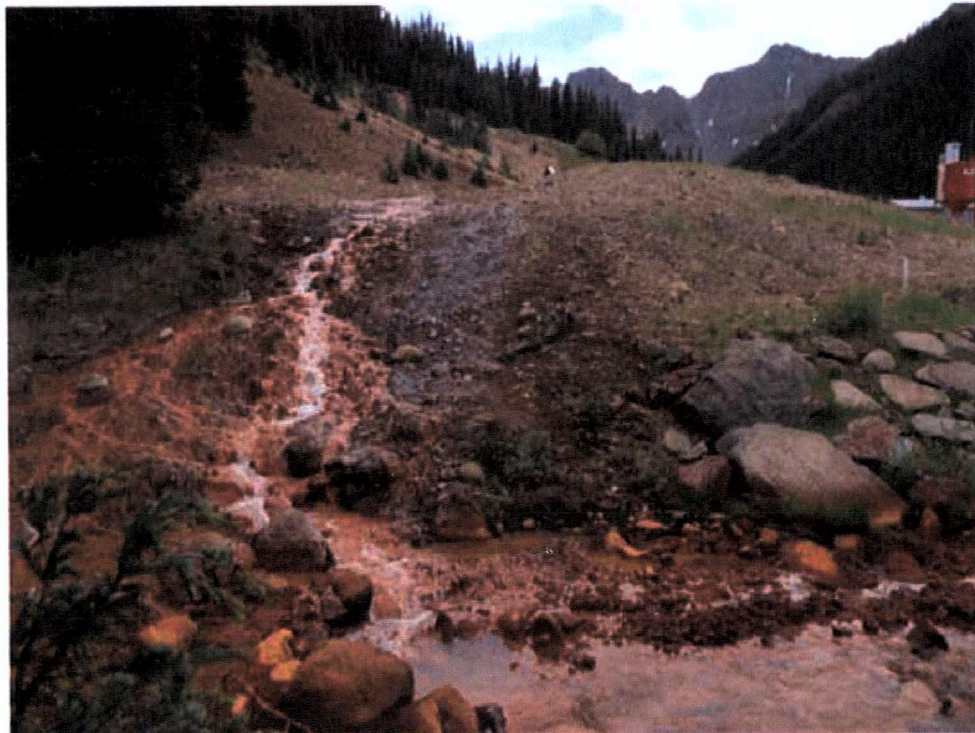
**PHOTO 10**

PPE from the American Tunnel outlet entering into Cement Creek. Note strong iron oxide staining downstream of PPE.

- **American Tunnel:** The discharge point for the American Tunnel is found just upstream of Gladstone where the discharge emerges from the diversion structure and flows approximately 200 feet westward to its PPE with Cement Creek. Strong iron oxide precipitate staining of the discharge and Cement Creek below the PPE was observed in August 2011 (Appendix A, Photo 10).

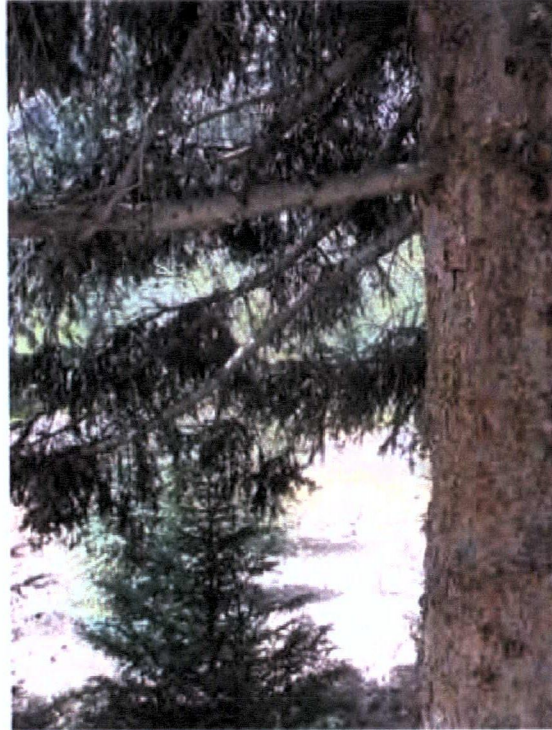
**PHOTO 12**

A fishing lure found imbedded on a tree limb along the banks of the Animas River in Elk Park. Lure is bright green on larger limb near the trunk.
