# SUMMARY REPORT

## EPA Internal Review of the August 5, 2015 Gold King Mine Blowout 8/24/2015

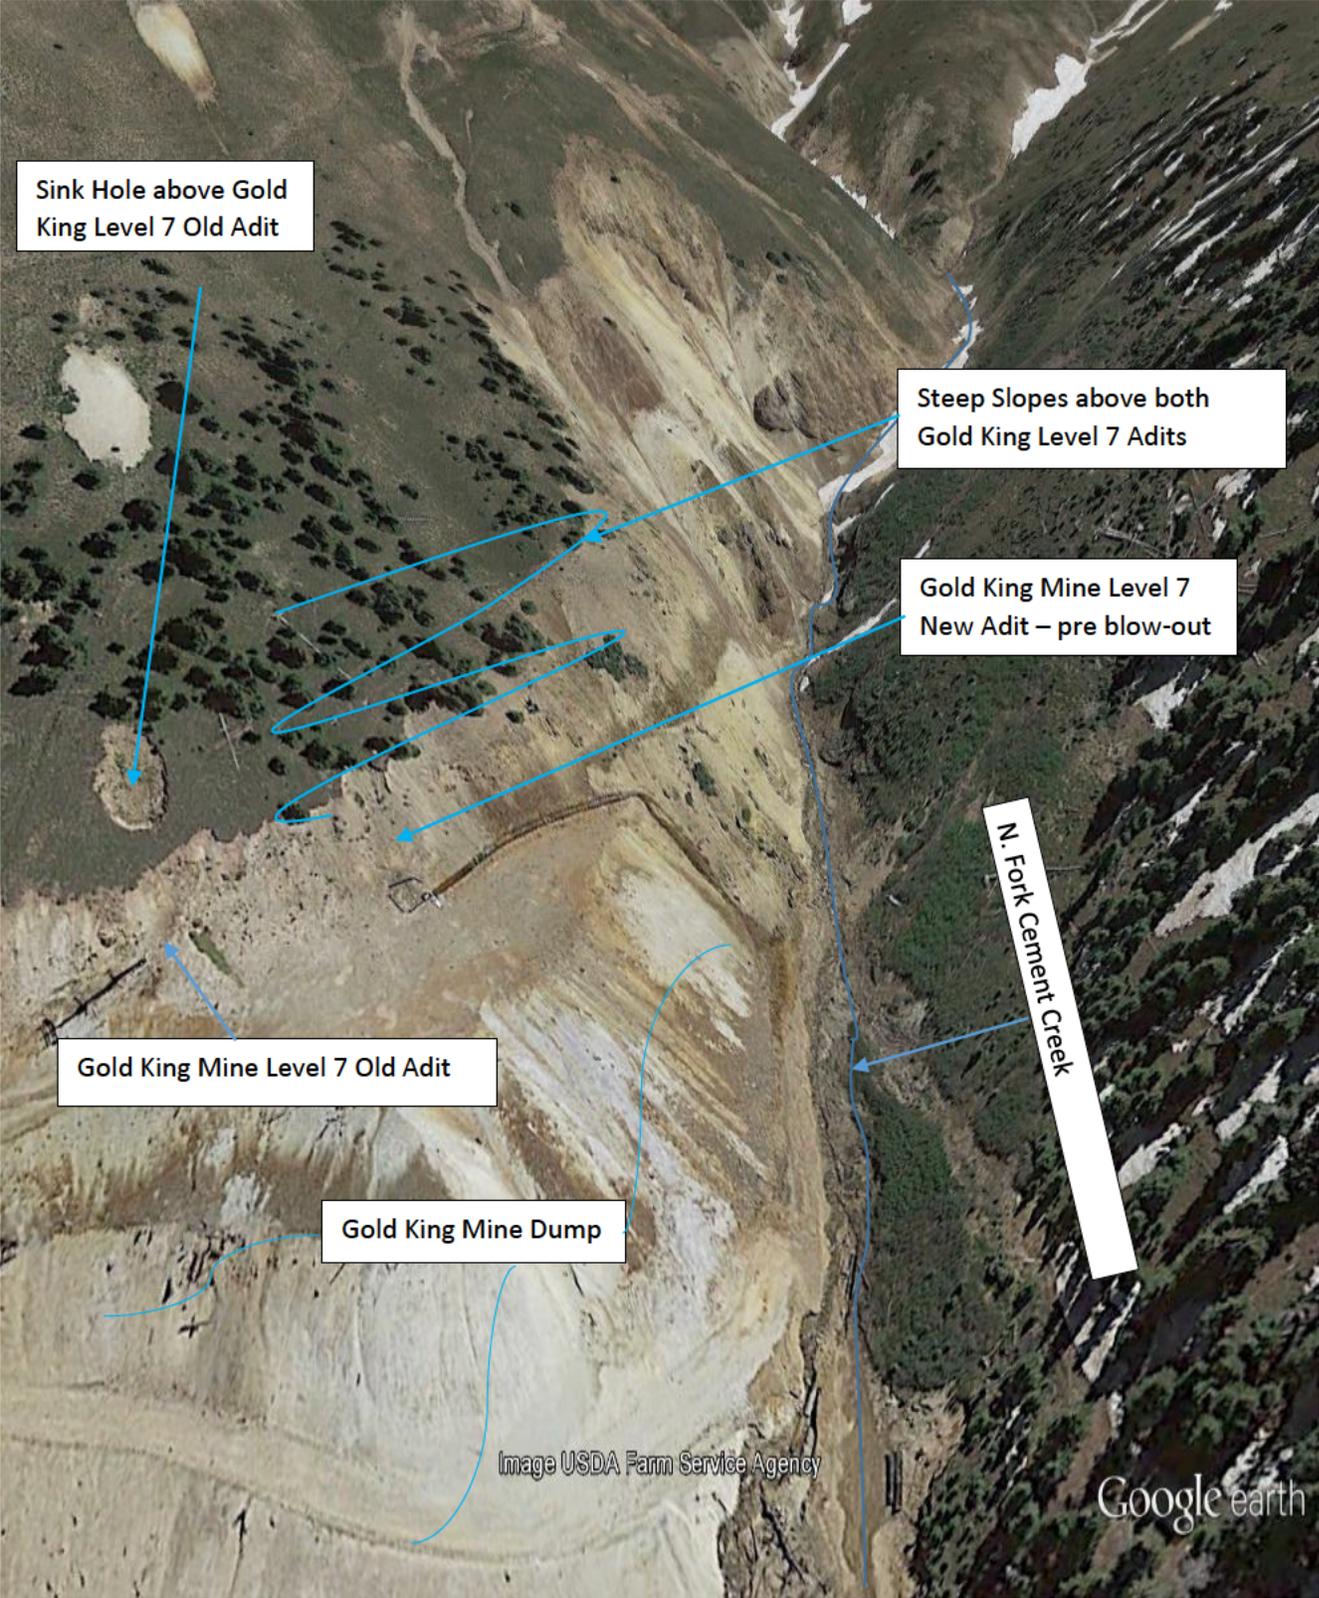
**Photo 1 Google Earth June 2015 Image - Gold King Level 7 Adits and Mine Dump**

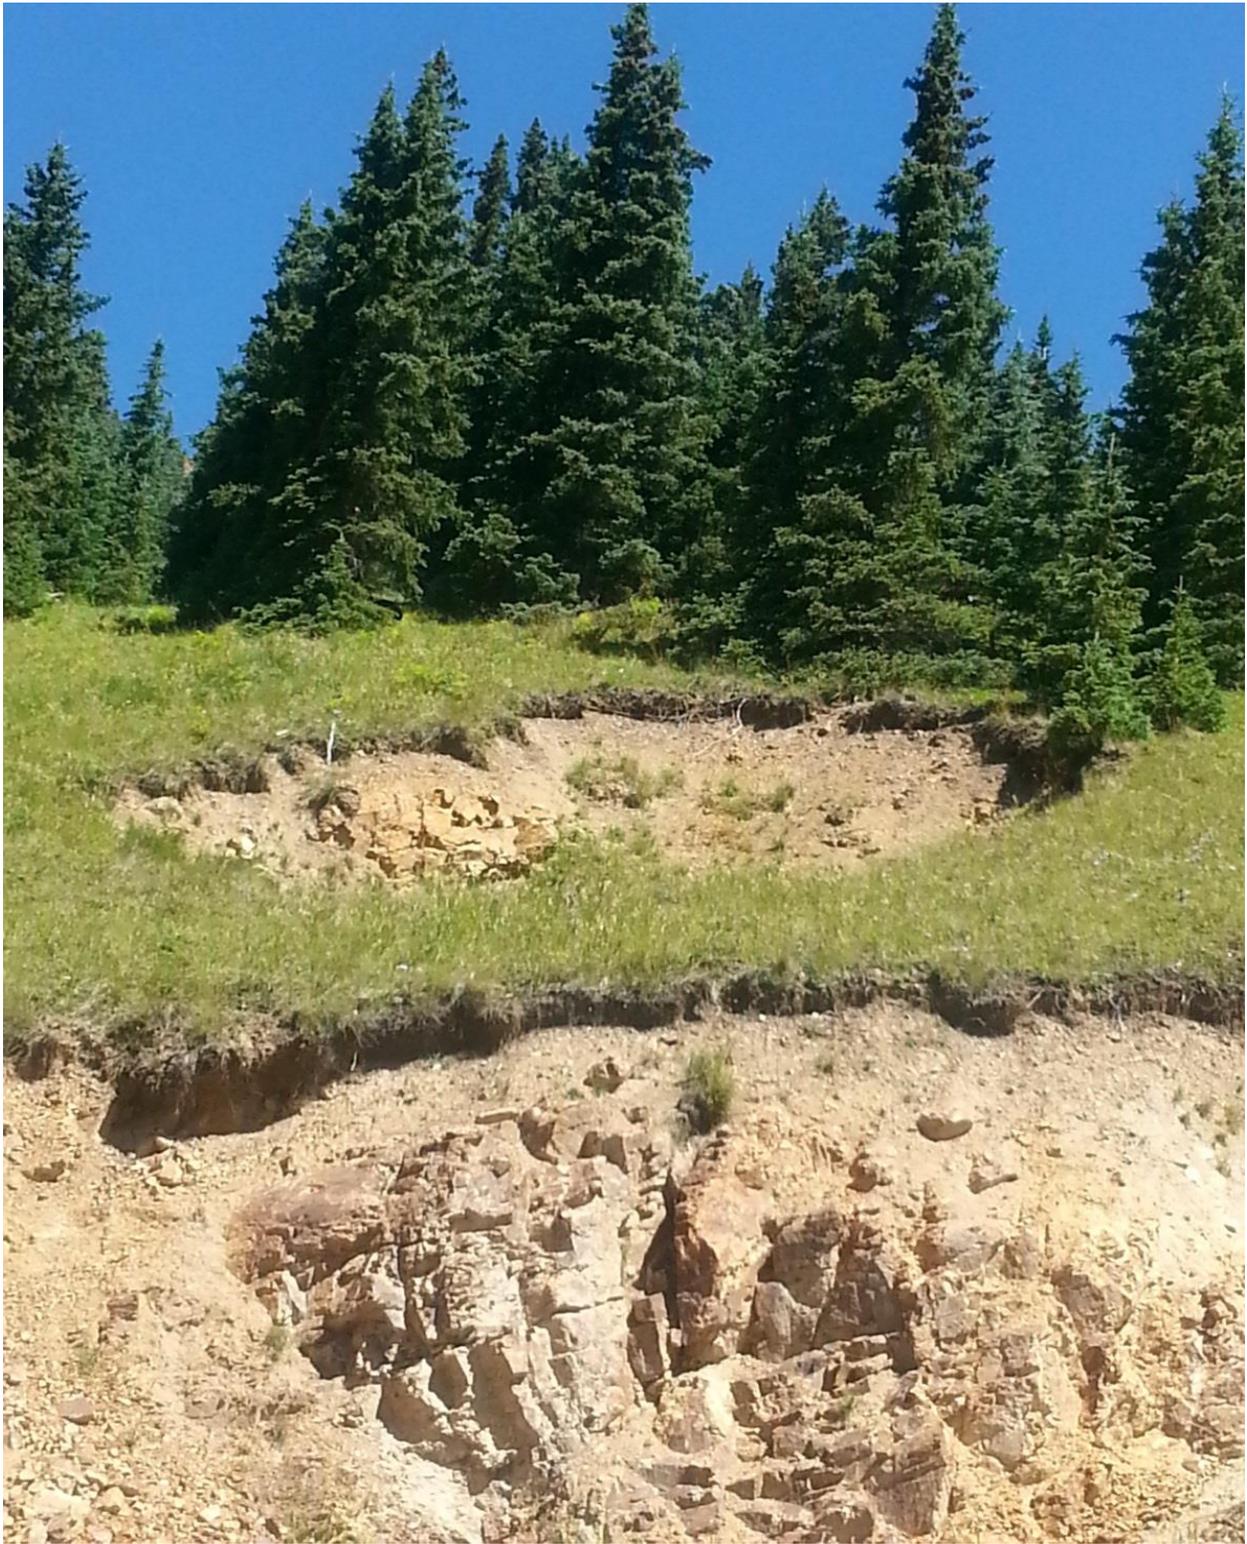
**Photo 3 August 18, 2015 – Sink Hole and Slope above Gold King Mine Old Adit**

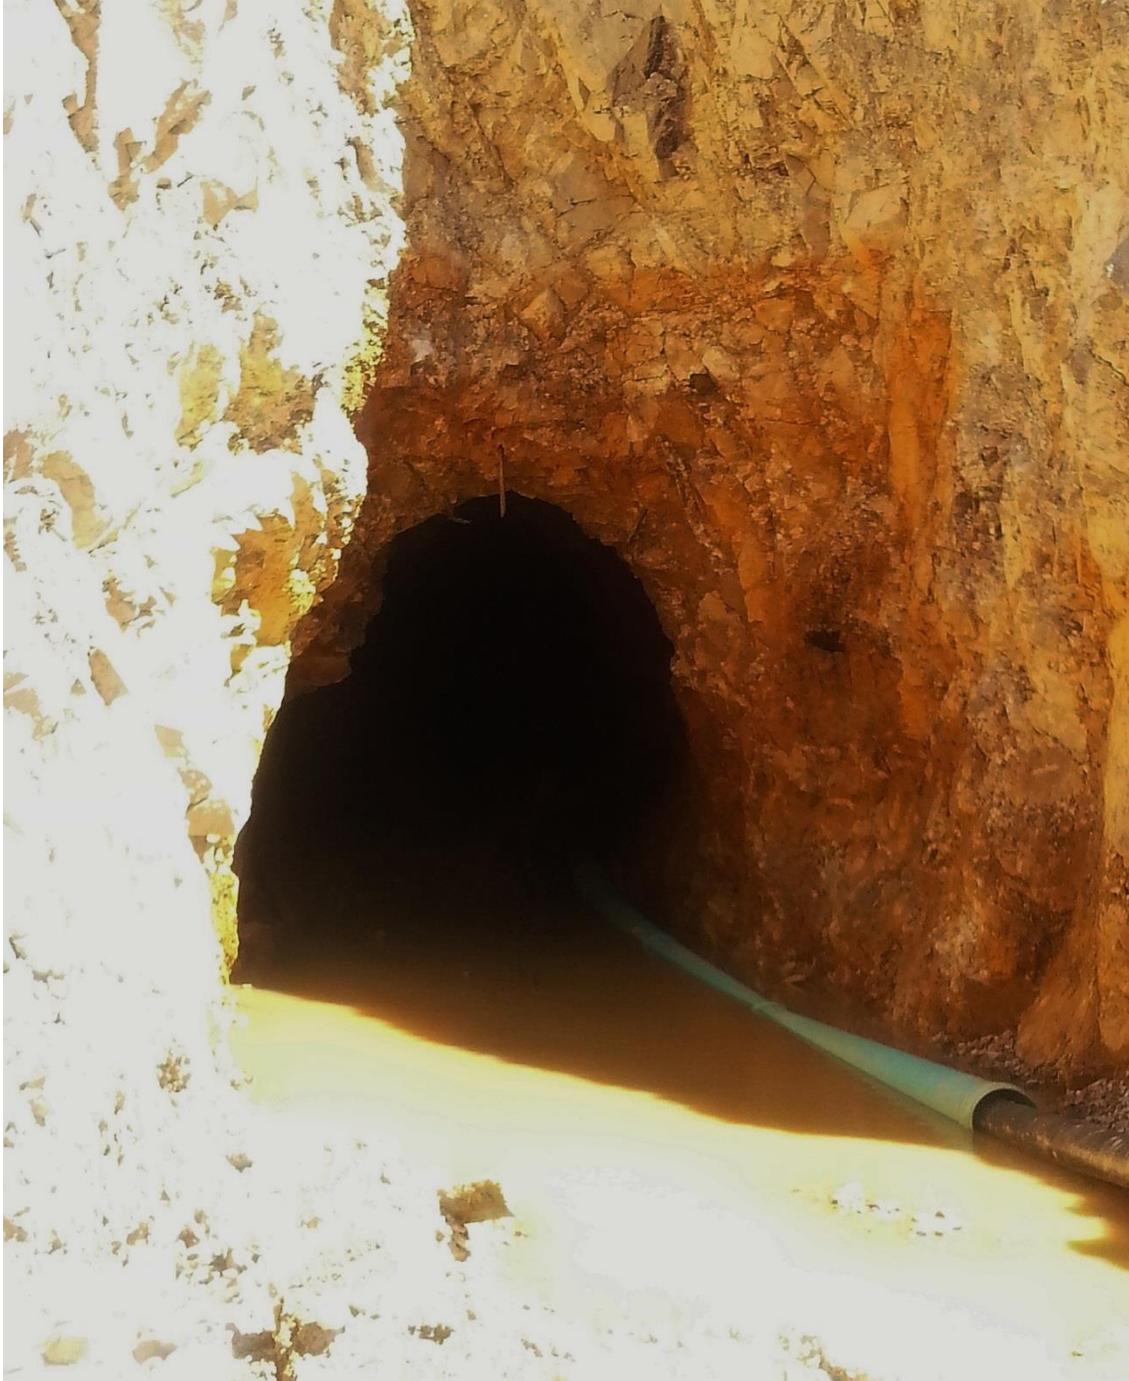
**Photo 4 August 18, 2015 – Gold King Mine Level 7 Adit post-blowout**

On August 5, excavation resumed. The OSC observed a solid rock surface and constructed a ramp above the external Adit blockage to remove soil from the bedrock surface. During the excavation, the lower portion of the bedrock face crumbled away and there was a spurt of water from the area in the lower part of the excavation area. Shortly after the water spurting, more water started coming from the localized area of the spurt. The color of the water was initially clear but then changed to red/orange. The OSC speculated that the excavation might have knocked something loose when removing the soils from the rock face.
