Summary of EPA Surface Water Sampling of Select Metals Results to Date

Gold King Mine Blowout

August 7, 2015

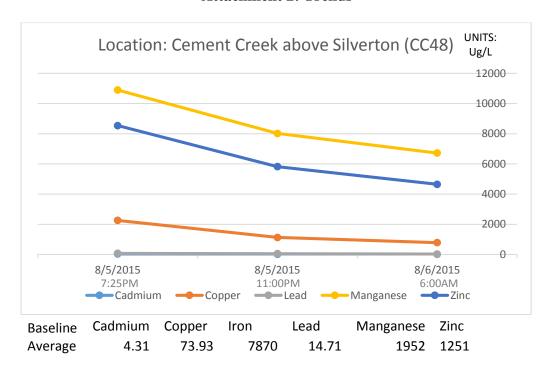
The first graph provides data on Cement Creek, the downstream from the blowout (CC48). Concentrations throughout the first day following the blowout are above historical averages for the copper, lead and manganese. However, the graphs demonstrate a decrease in those concentrations over the 24 hour period.

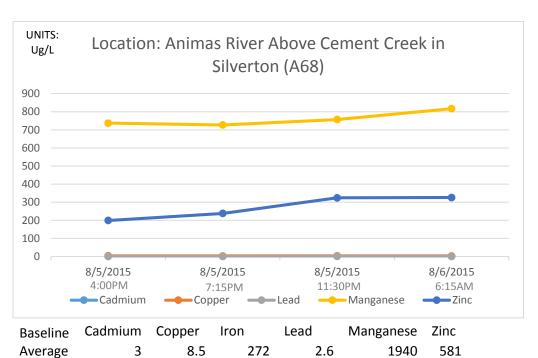
The second graph provides data on the Animas River above the town of Silverton (A68) and above Cement Creek. This graph demonstrates relatively unchanging metals concentrations that are at or below historical averages.

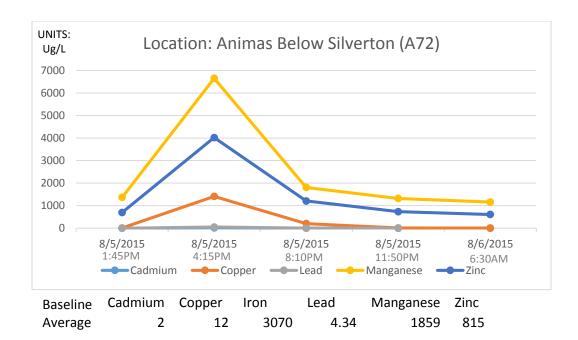
The third graph demonstrates the data from the Animas River just below the town of Silverton (A72). The graph shows an initial spike in metals concentrations with levels returning to historical averages by the morning of August 6, 2015.

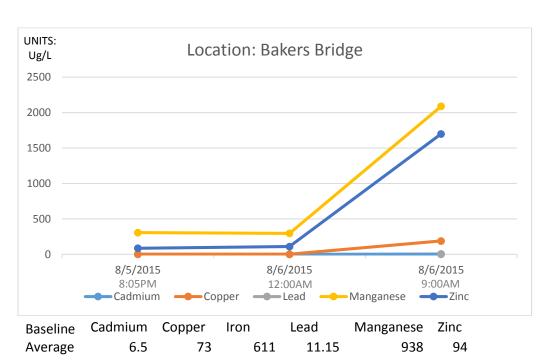
The fourth graph demonstrates the data from Bakers Bridge on the Animas River just above Durango, CO. Since this location is about 20 miles from Silverton, the metals concentrations are

increasing above historical averages. But, it is believed that subsequent data collection activities will demonstrate a decrease in concentrations similar to those seen at upstream locations.

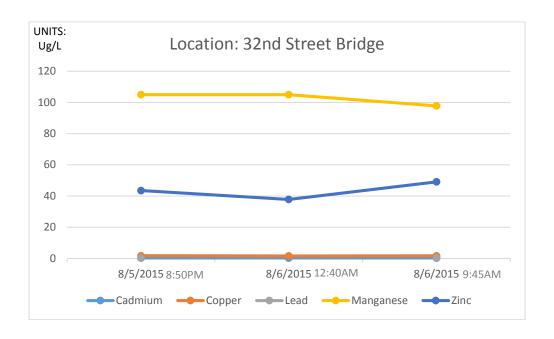
The fifth graph is of the 32nd Street Bridge sampling location. At the time the samples were collected, it does not appear that the contamination had yet reached this sampling location.
