NONPOINT SOURCE PROGRAM SUCCESS STORY

Pennsylvania

Addressing Abandoned Mine Discharges Allows Stream to Recover

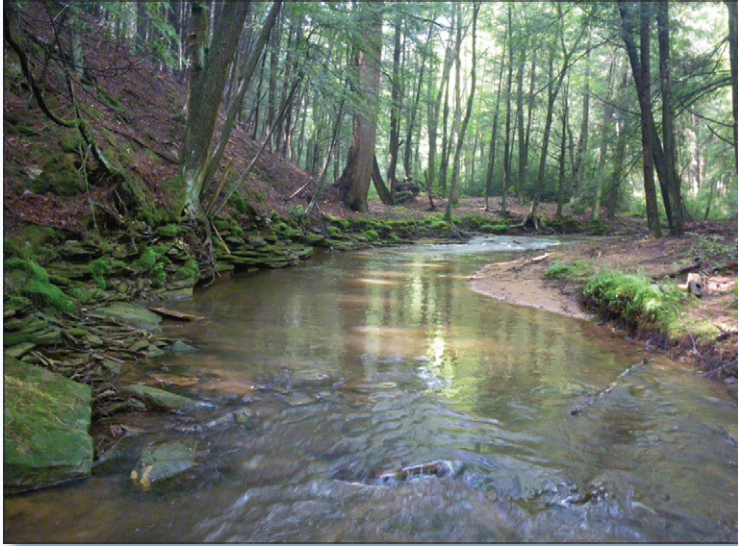
Figure 2. Remediation projects to address AMD have significantly improved the water quality in Little Coon Run.

According to the restoration project's final report, sample results from the mouth of Little Coon Run demonstrate significantly improved water quality (Figure 2). In 2001, before the restoration projects were completed, the average pH was 4.5 standard units. The average pH at the same location in 2008 was 6.2, and the final reading in September of that year was 7.0 standard units, which meets state water quality standards for attaining the designated use of aquatic life.

Metal concentrations have also shown significant improvement. The largest decrease was in manganese, which dropped 70 percent between 2001 and 2008; aluminum declined 26 percent. Iron and aluminum concentrations had begun

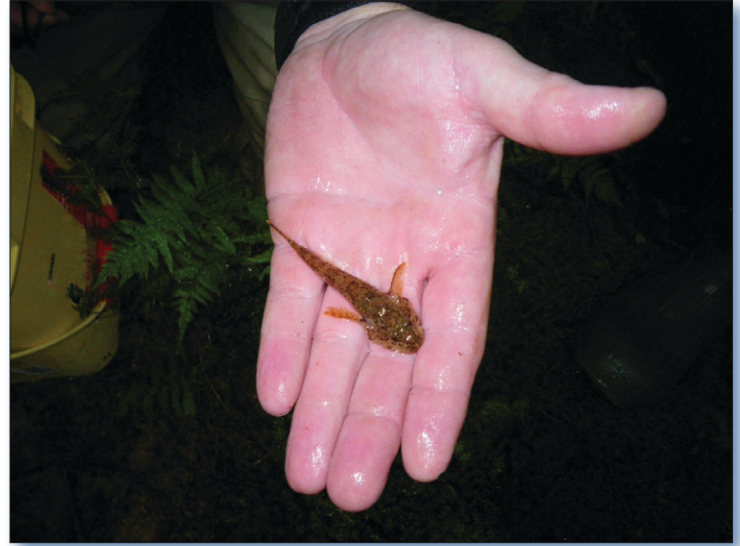
Figure 3. Biologists found this mottled sculpin, a pollutant-intolerant fish species, near the mouth of Little Coon Run.

In addition, fish collected in a recent (2010) survey indicate water quality has improved as a result of remediation efforts. For example, the 2010 survey found a mottled sculpin (Figure 3), a pollution-intolerant species that is not frequently found in streams with elevated levels of pollutants.
