Rapid Seafloor Reconnaissance and Assessment of Southeast Florida Ocean Dredged Material Disposal Sites Utilizing Sediment Profile Imaging

May 2006 Post-Disposal SPI Mapping at the Port Everglades Harbor ODMDS

Germano & Associates, Inc.

**MAY 2006 POST-DISPOSAL SPI MAPPING AT THE PORT
EVERGLADES HARBOR ODMDS**

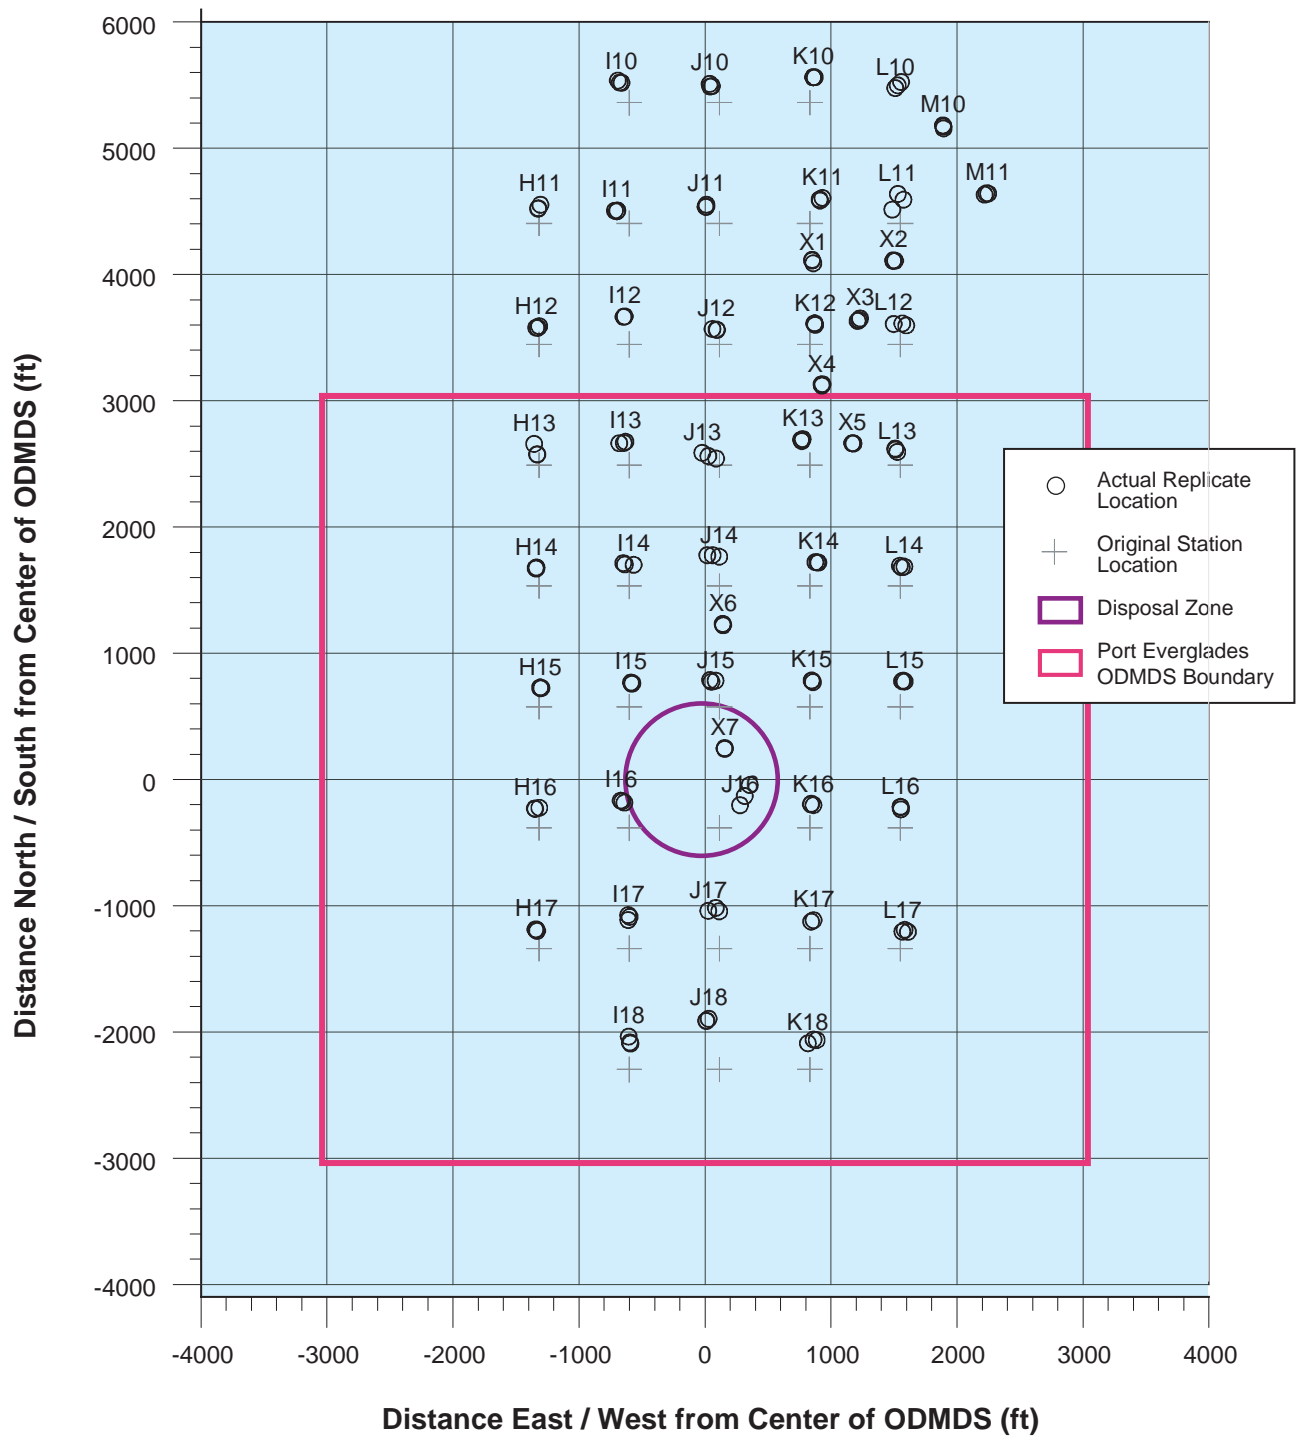
Figure 2-2: Map showing the target sampling location versus the actual location of each replicate camera drop for the May 2006 SPI survey at the Port Everglades Harbor ODMDS.

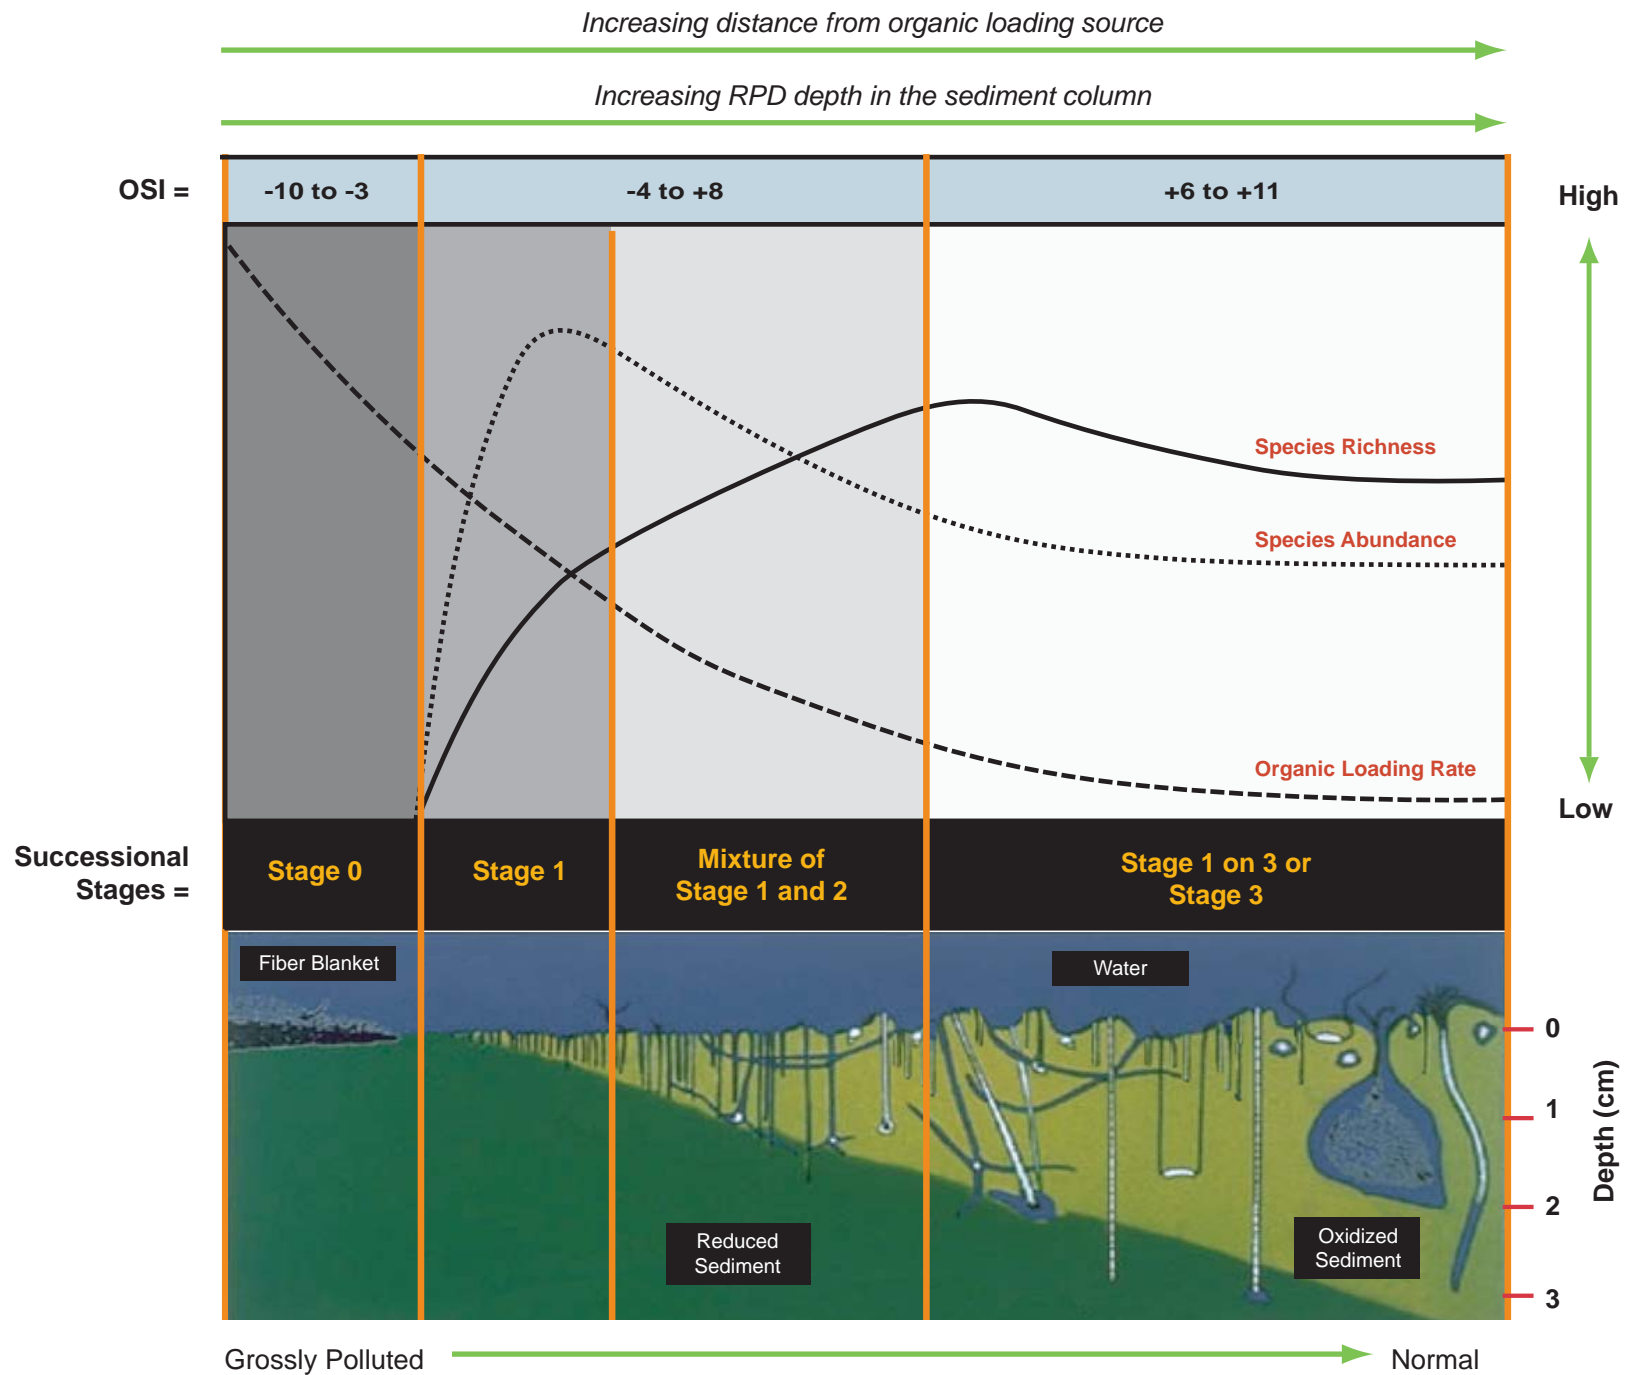
Figure 2-5: Model illustrating the relationships among key SPI parameters and traditional measures of species richness and abundance along an organic enrichment gradient.

Physical measurements made with the SPI system from profile images provide background information about gradients in physical disturbance (caused by dredging, disposal, oil platform cuttings/drilling muds discharge, trawling, or storm resuspension and transport) in the form of maps of sediment grain size, boundary roughness, sediment textural fabrics, and structures. The concentration of organic matter and the SOD can be inferred from the optical reflectance of the sediment column and the apparent RPD depth. Organic matter is an important indicator of the relative value of the sediment as a carbon source for both bacteria and infaunal deposit feeders. SOD is an important measure of ecological health; oxygen can be depleted quickly in sediment by the accumulation of organic matter and by bacterial respiration, both of which place an oxygen demand on the porewater and compete with animals for a potentially limited oxygen resource (Figure 2-5; see also Kennish 1986).

The distribution of successional stages in the context of the mapped disturbance gradients is one of the most sensitive indicators of the ecological condition of the seafloor (Rhoads and Germano 1986; Figure 2-5). The presence of Stage 3 equilibrium taxa (mapped from subsurface feeding voids as observed in profile images) can be a good indication of high benthic habitat stability and relative lack of disturbance from natural or anthropogenic factors. A Stage 3 assemblage indicates that the sediment surrounding these organisms has not been disturbed severely in the recent past and that the inventory of bioavailable contaminants is relatively small. These inferences are based on past work, primarily in temperate latitudes, showing that Stage 3 species are relatively intolerant to sediment disturbance, organic enrichment, and sediment contamination. Stage 3 species expend metabolic energy on sediment bioturbation (both particle advection and porewater irrigation) to control sediment properties, including porewater profiles of sulfate, nitrate, and RPD depth in the sedimentary matrix near their burrows or tubes (Aller and Stupakoff 1996; Rice and Rhoads 1989). Bioturbation results in an enhanced rate of decomposition of polymerized organic matter by stimulating microbial decomposition (“microbial gardening”). Stage 3 benthic assemblages are very stable and are also called climax or equilibrium seres.

As described in Section 2.3.9 and illustrated in Figure 2-5, the OSI is a summary metric that provides a way to order, or rank, the stations in terms of the relative degree of benthic habitat disturbance or degradation. For the May 2006 SPI survey at the Port Everglades Harbor ODMDS, the median OSI values at almost all of the disposal site stations, as well as at all three of the reference stations, were in the range of +7 to +11 (Figures 3-21 and 3-22). Values in this range are considered indicative of little or no appreciable benthic habitat disturbance.

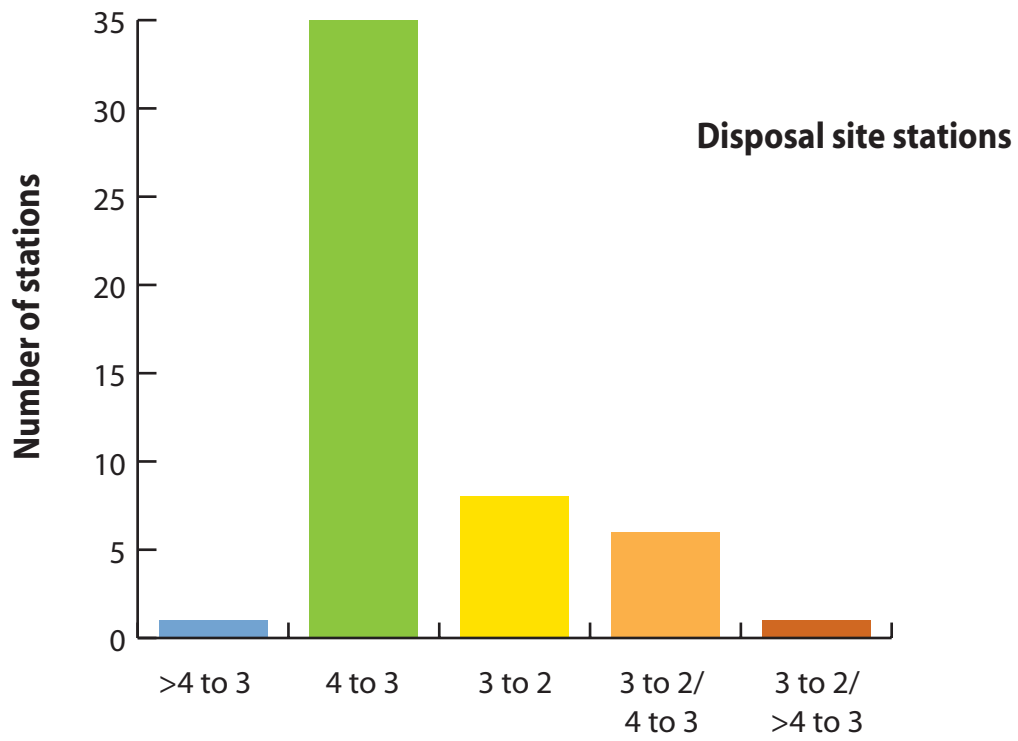
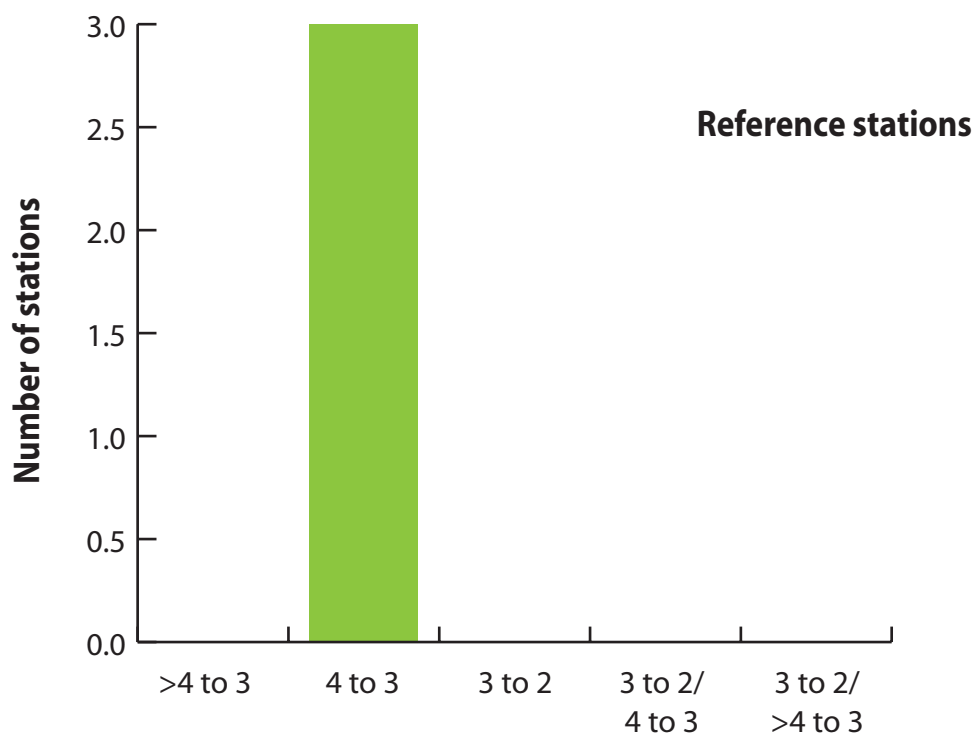
Figure 3-5: Frequency distributions of grain size major mode (in phi units) at the disposal site stations (top) and reference stations (bottom).

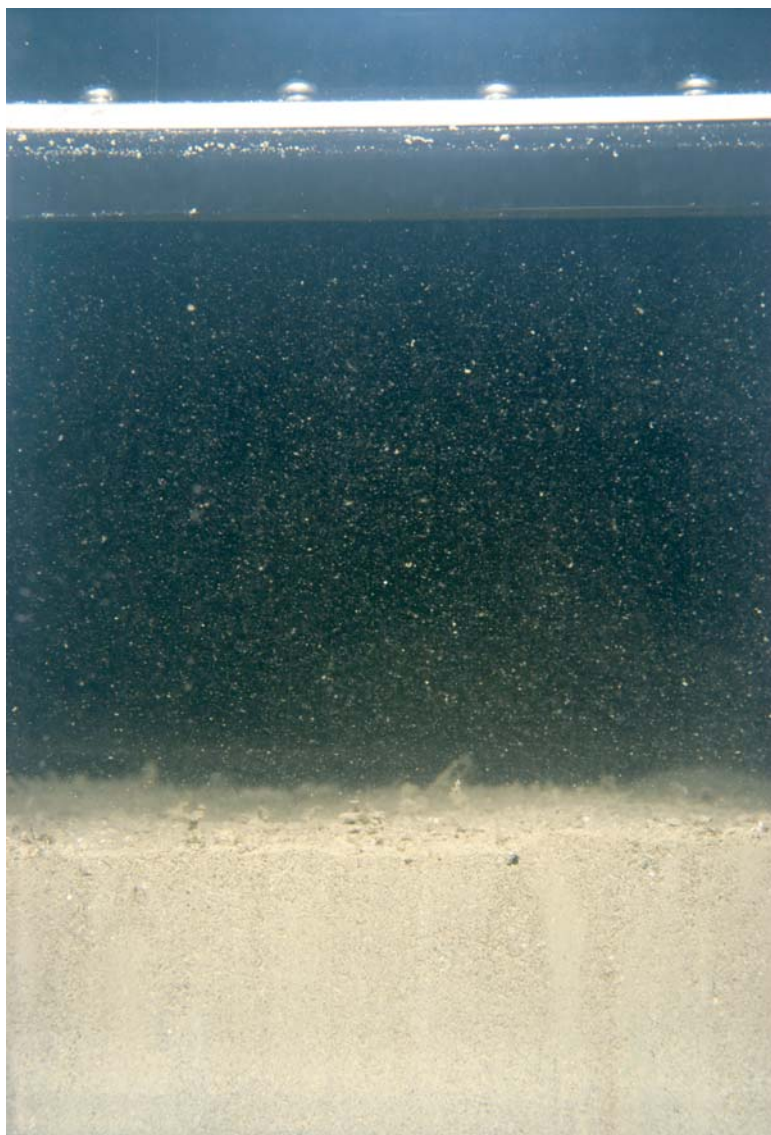
Figure 3-6: SPI images from disposal site station H12 (left) and reference station R2 (right) showing typical ambient sediment consisting of very homogenous, silty, very fine sand (grain size major mode of 4 to 3 phi). Numerous tubes of different types and sizes occur at the sediment surface in both images (Stage 2), and the right image also shows a few small subsurface worms and burrows (Stage 2 going to 3). The sediment in both images is uniformly light-colored, without any strong vertical color contrasts that typically denote the aRPD. Scale = actual image width is 14.4 cm.

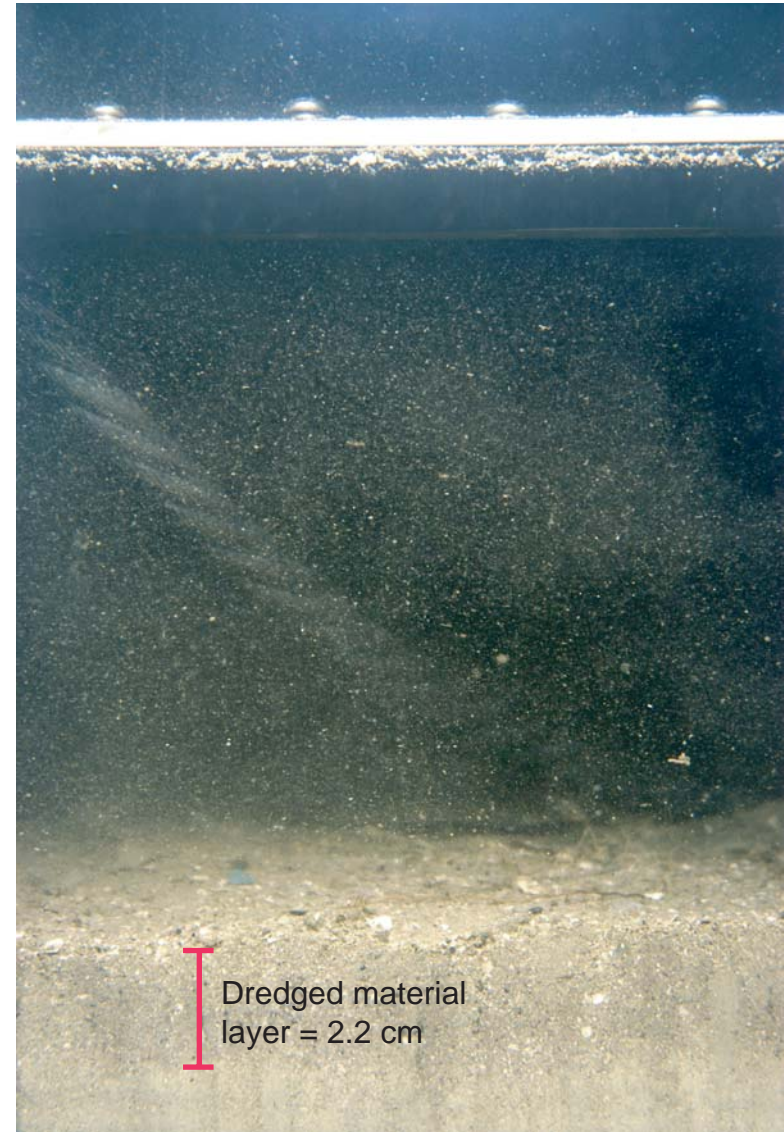
Figure 3-8: SPI images from stations J15 (left) and K13 (right) showing discrete surface layers of recent dredged material consisting of dark, silty fine sand (3 to 2 phi) with shell fragments overlying ambient very fine sand (4 to 3 phi) at depth. Scale = actual image width is 14.4 cm.

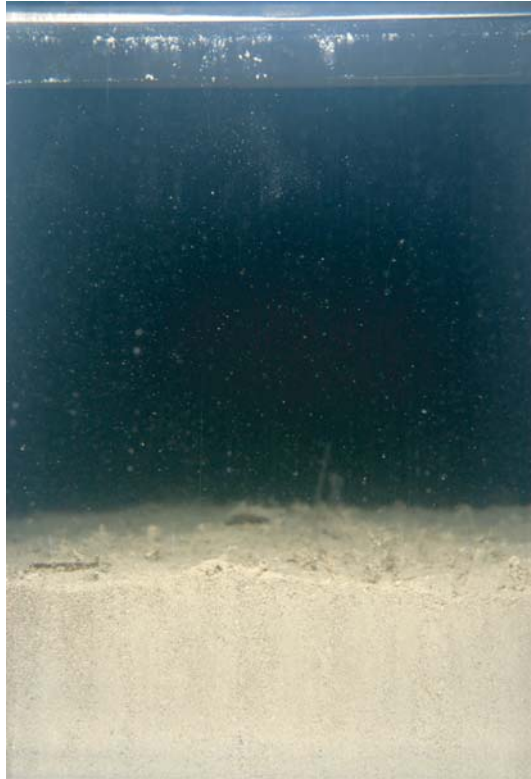
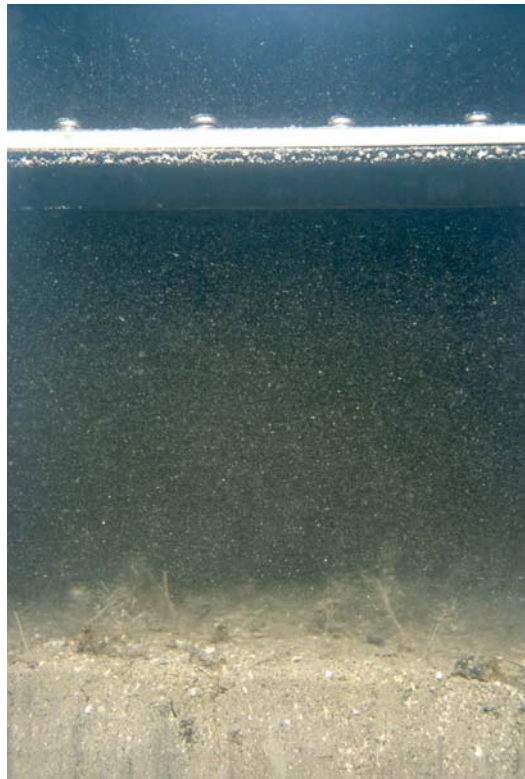
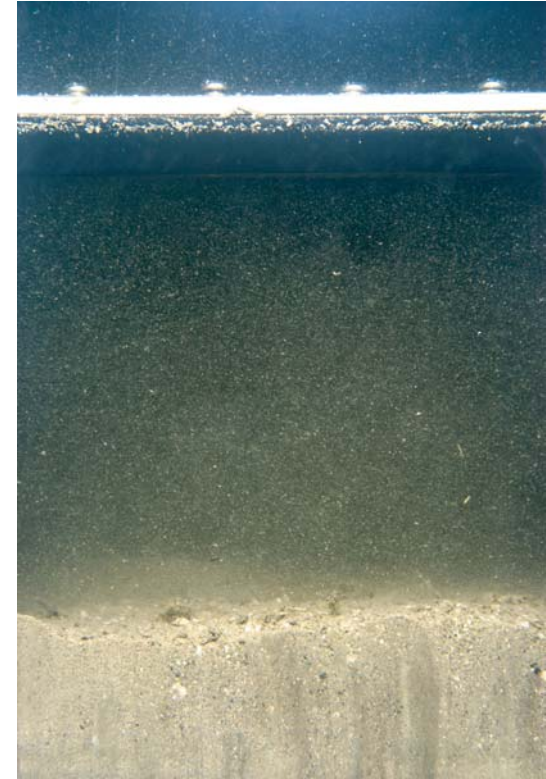
Figure 3-9: Three replicate SPI images illustrating how the appearance of the dredged material contrasted with the ambient sediment. Image A (left) shows ambient sediment at Station K18, consisting of silty, light-colored, very fine sand with an homogenous texture. Image B (center) from Station X5 and Image C (right) from Station J14 both show dredged material that is characterized by overall darker color, patches of dark silt, and a coarser/more homogenous texture due to the presence of numerous small white shell fragments. In both of these images, the dredged material extends from the sediment surface to below the camera's imaging depth. Scale = actual image width is 14.4 cm.

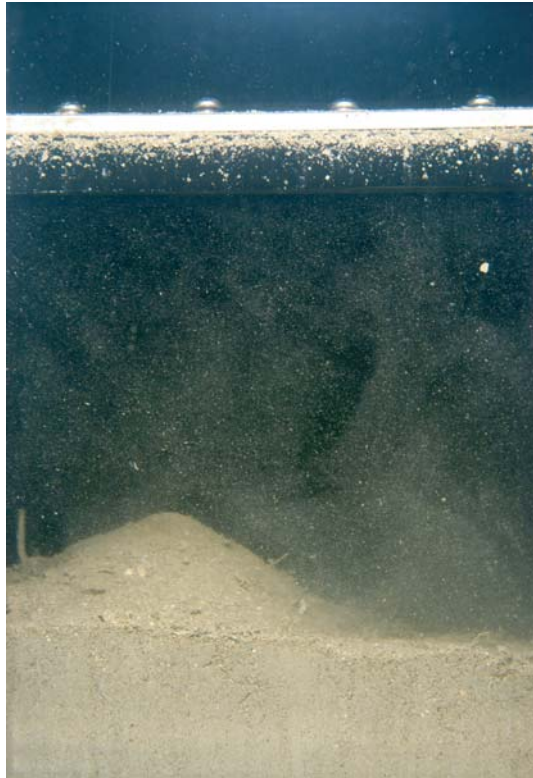
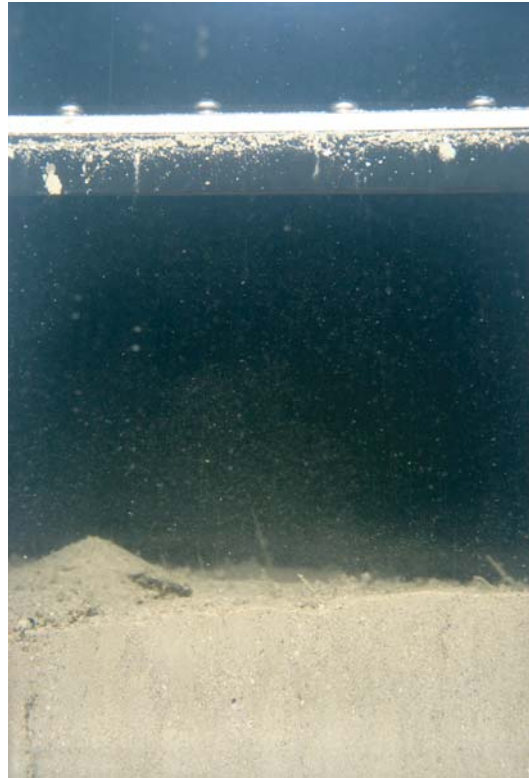
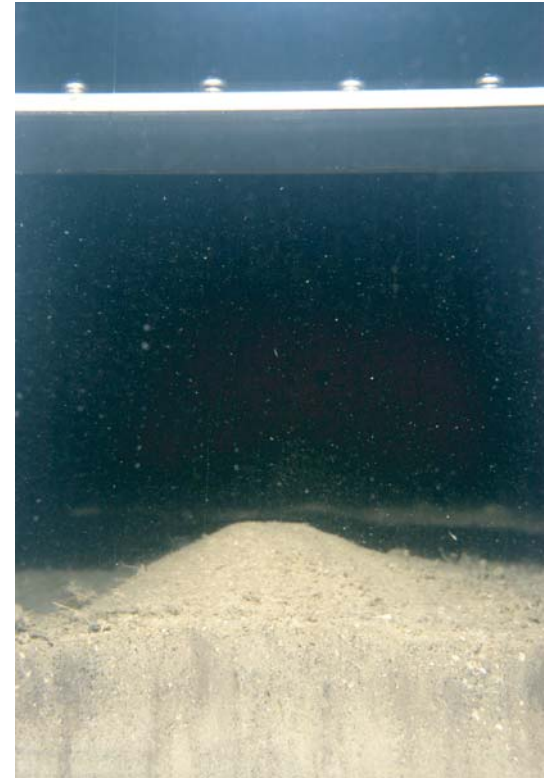
Figure 3-10: In these SPI images from Stations H13 (left), I12 (center) and K14 (right), the small-scale vertical relief across the field-of-view (i.e., "boundary roughness") is due primarily to the presence of small circular mounds of sediment excavated by organisms. This is an example of biogenic boundary roughness. Scale = actual image width is 14.4 cm.

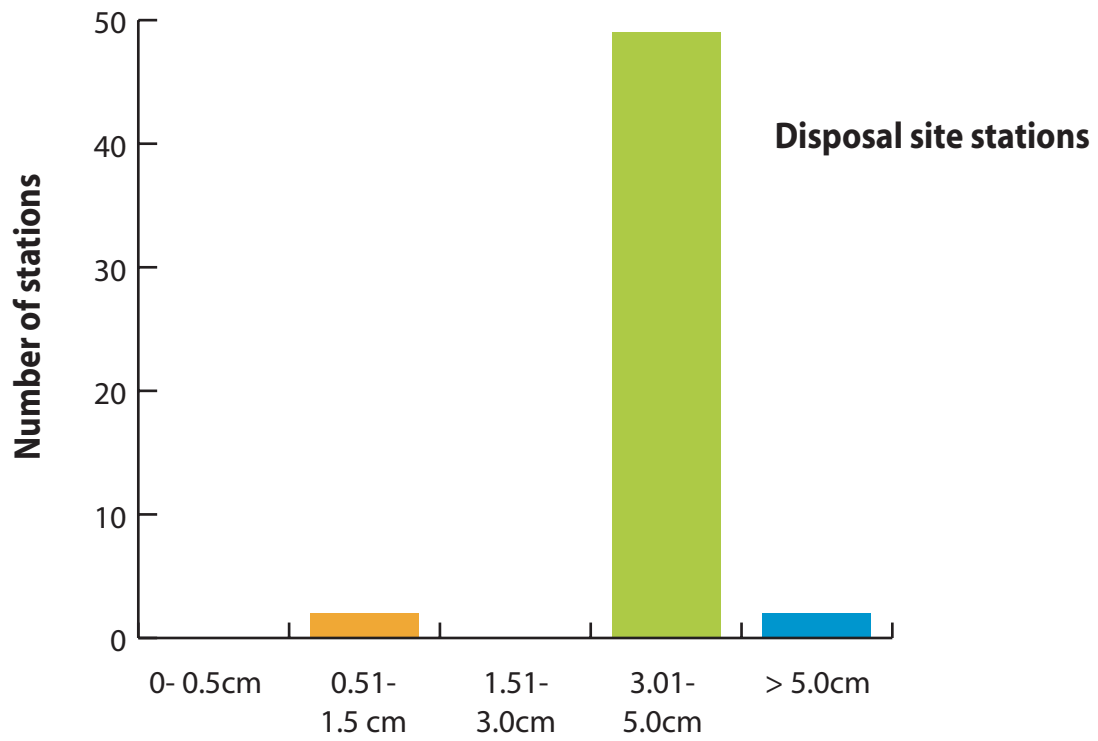
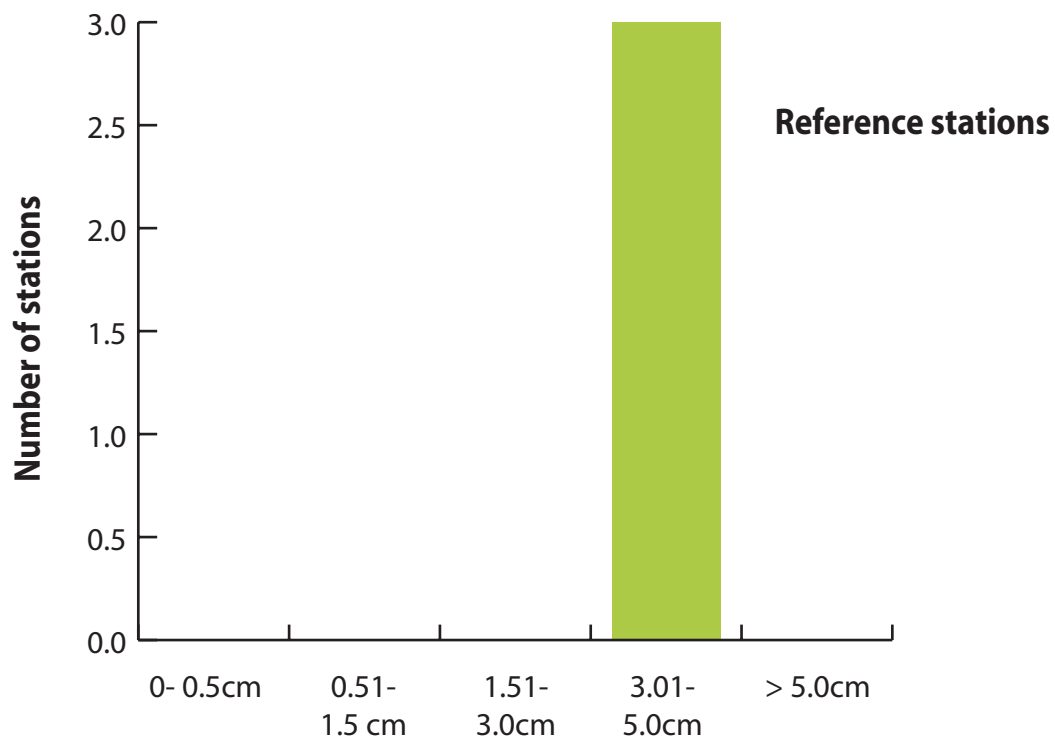
Figure 3-13: Frequency distribution of average RPD depths at the disposal site stations (top) and reference stations (bottom).

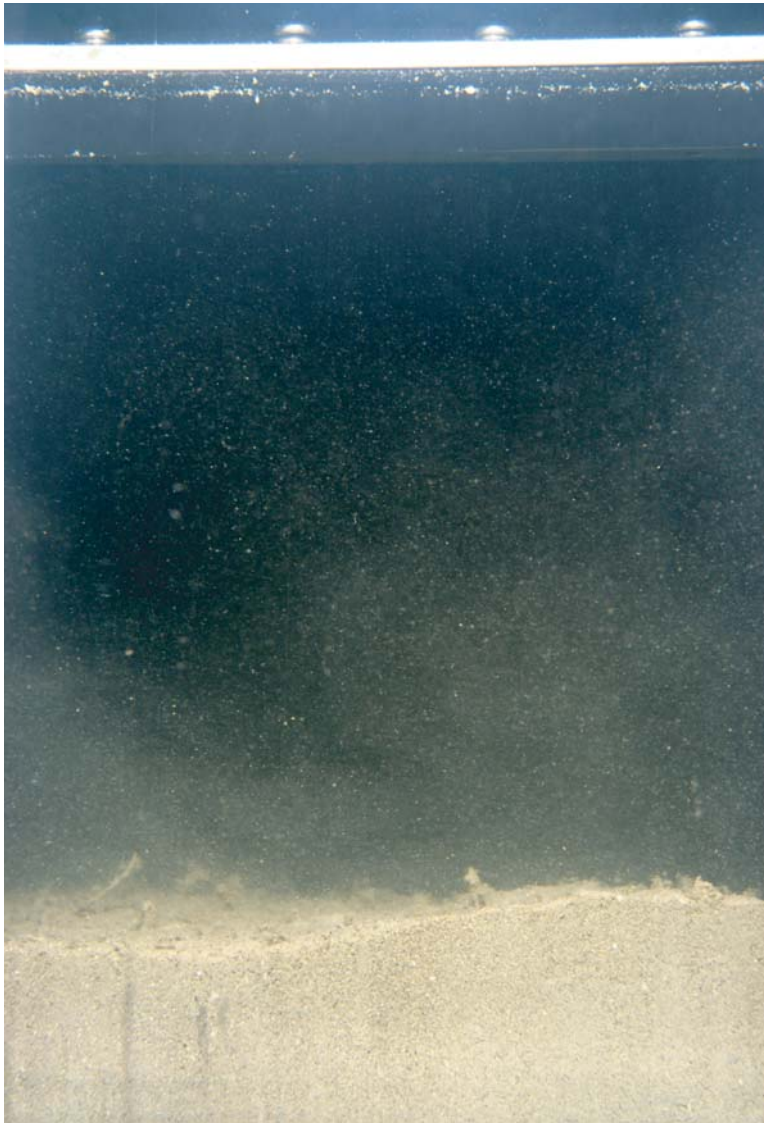
Figure 3-16: SPI images from Stations I13 (left) and L12 (right) illustrating Stage 2, where the visible evidence of biological activity consisted of several different types/sizes of tubes occurring at the sediment surface. Scale = actual image width is 14.4 cm.

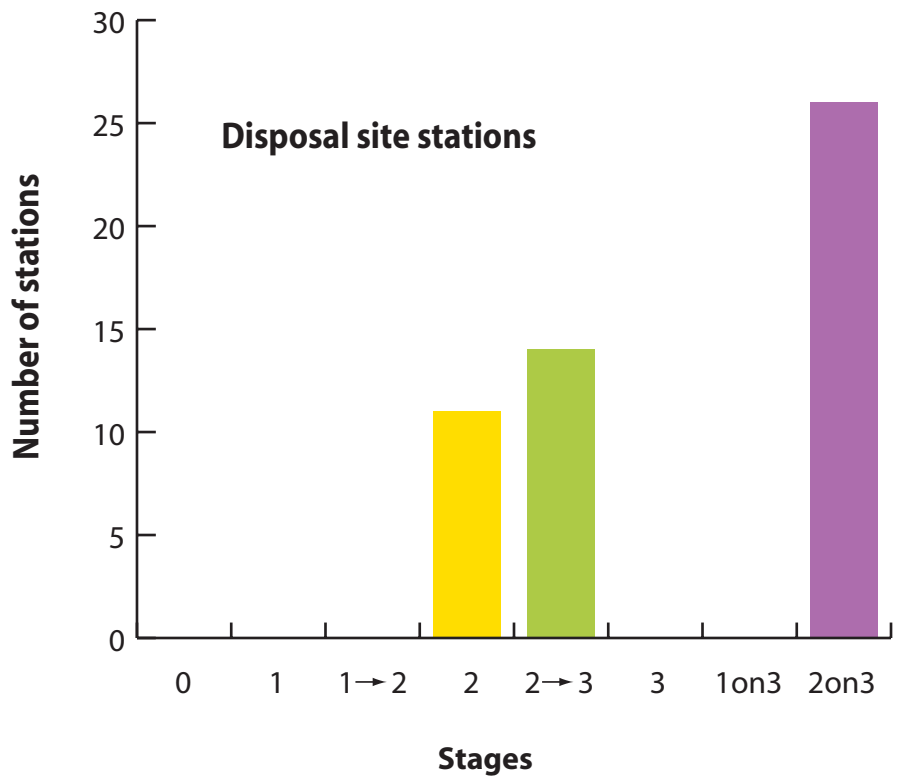
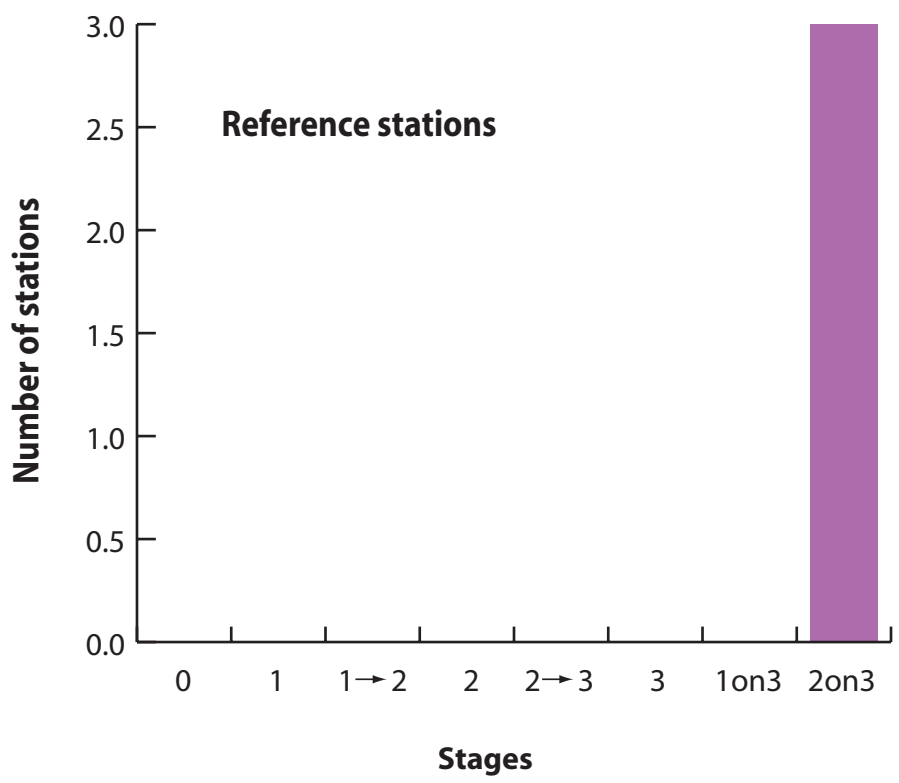
Figure 3-17: Frequency distribution of the highest infaunal successional stage observed at each of the disposal site stations (top) and reference stations (bottom).

Just over half of the disposal site stations (26 of 51, or 51%) had an advanced successional status consisting of Stage 2 on 3 (Table 3-2; Figures 3-15 and 3-17). At some stations, the Stage 3 designation was assigned because biogenic mounds, indicative of subsurface activity by larger-bodied infauna, were observed at the sediment surface along with the Stage 2 tubes (e.g., Figures 3-1 and 3-10). At other stations, the presence of Stage 3 was based on the presence of larger-bodied polychaetes at depth within the sediment (Figure 3-20).

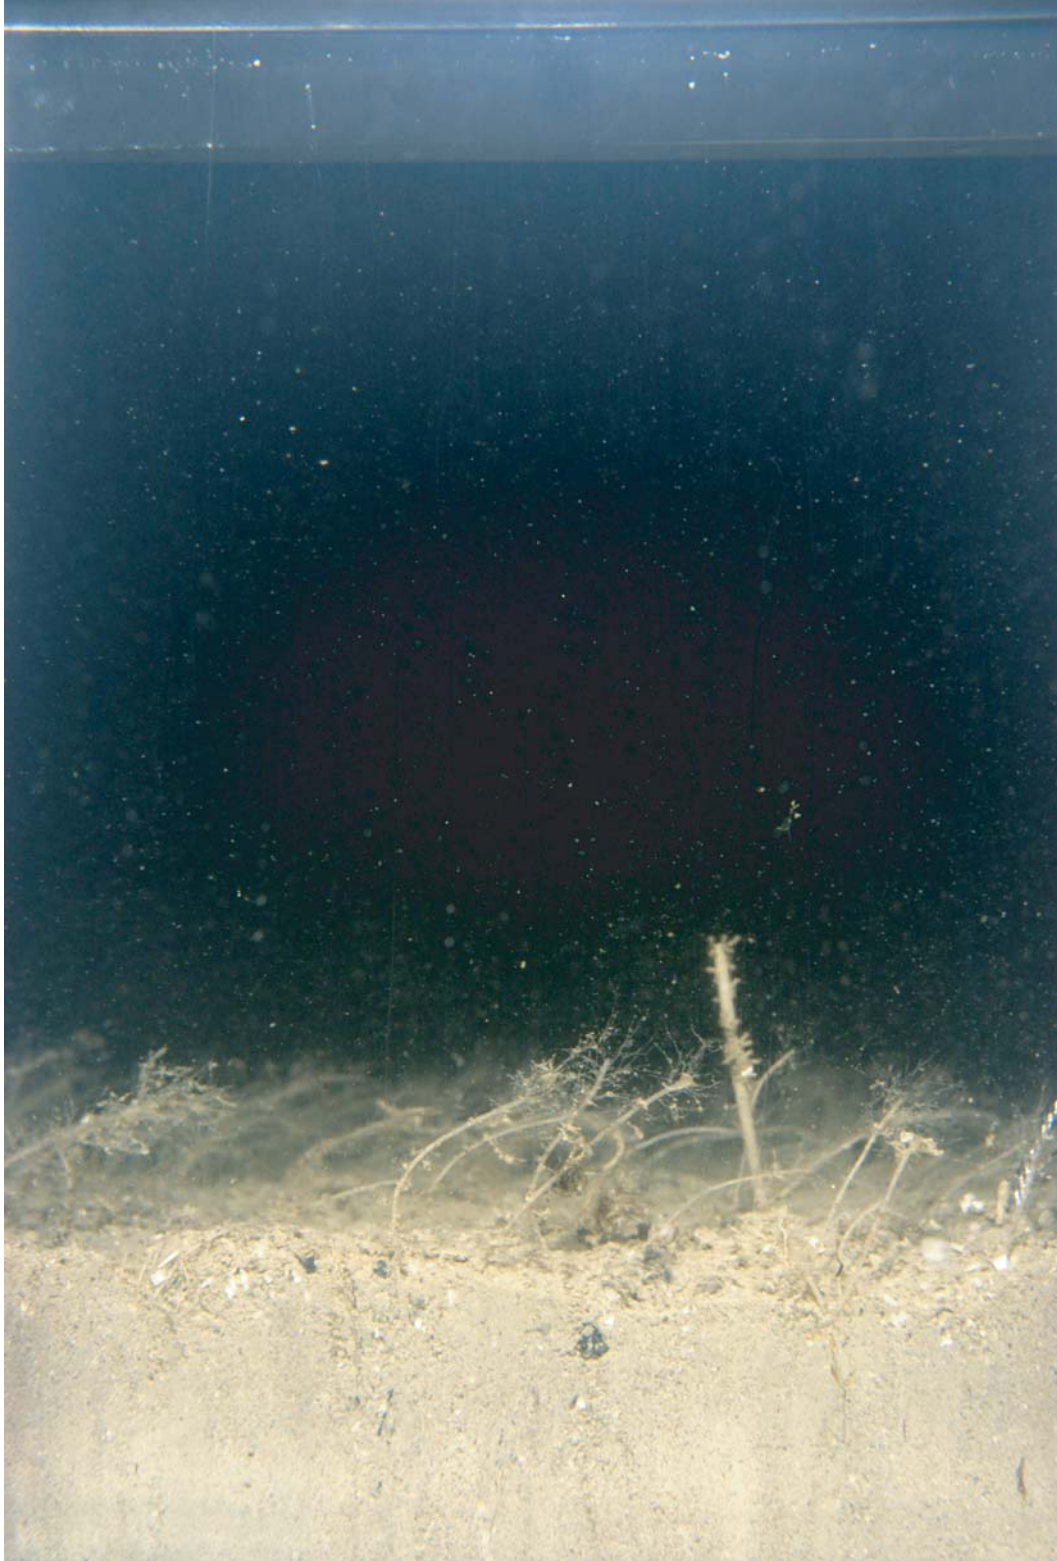
Figure 3-19: SPI image from Station L13 showing relatively long, tube-like stalks with frilly ends (hydroids?) that were common at the sediment surface at many of the surveyed stations. Scale = actual image width is 14.4 cm.

Among the different types of Stage 2 surface tubes observed in the images, distinct, thin, tube-like stalks with frills near the top were observed at many stations (Figure 3-19). These are tentatively identified as a type of hydrozoan.

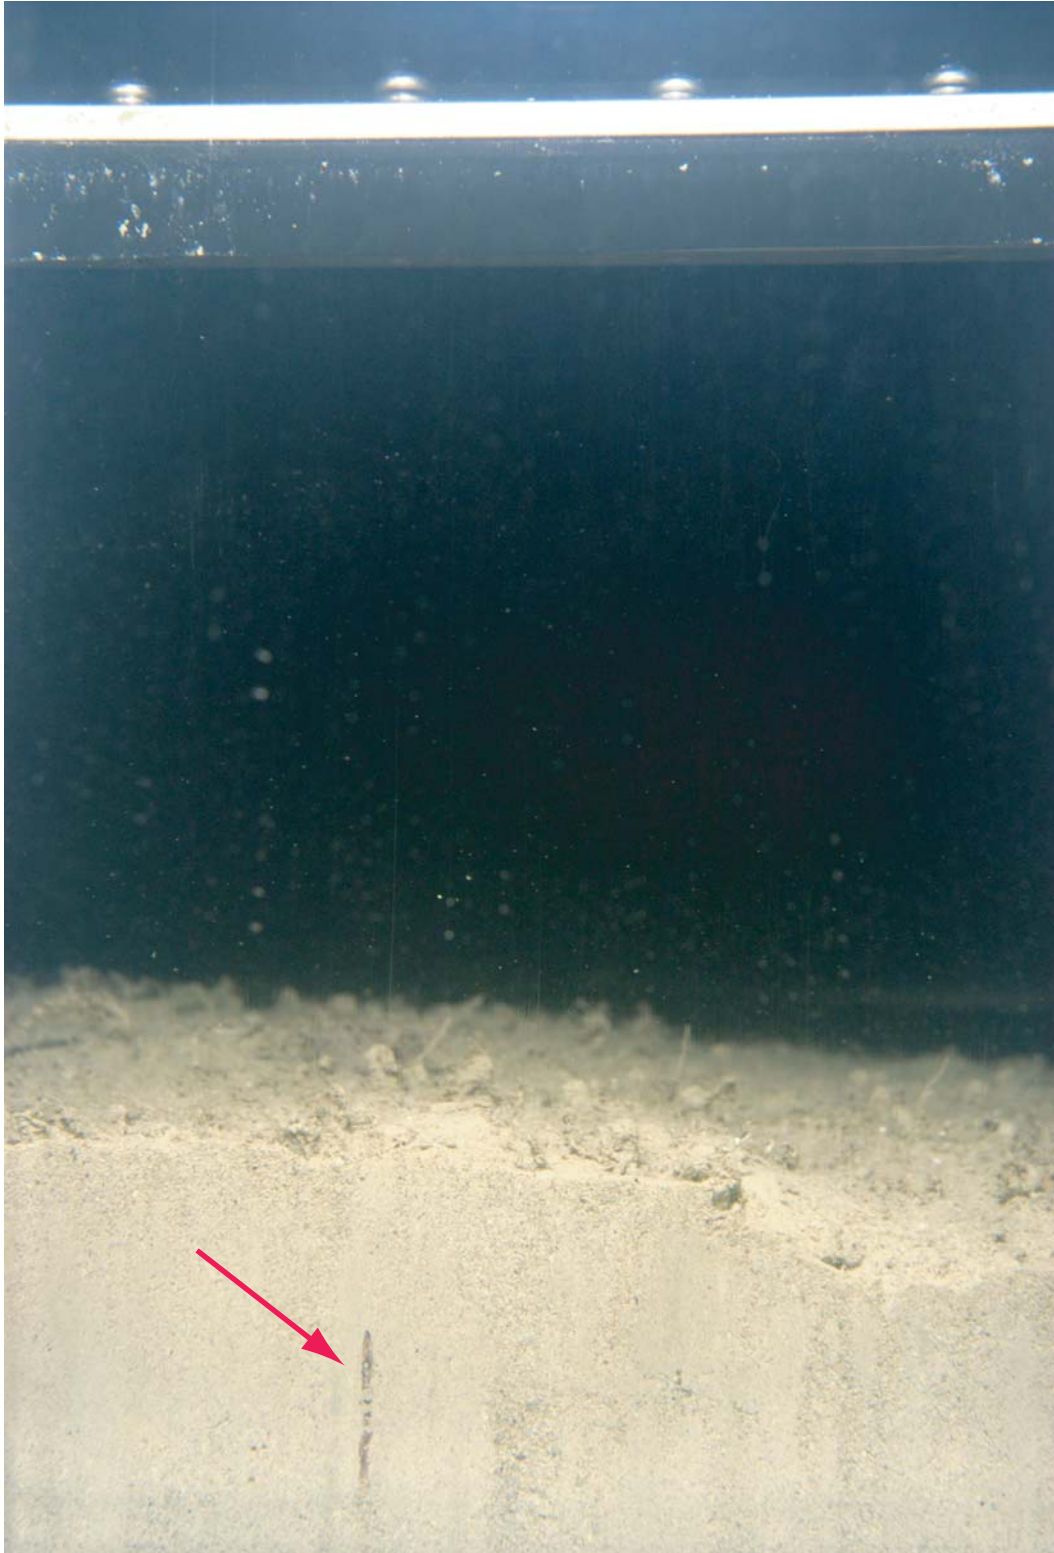
Figure 3-20: SPI image from station H15 illustrating Stage 2 on 3, based on the presence of high numbers of different types of surface tubes and a larger-bodied polychaete visible at depth within the sediment (arrow). Scale = actual image width is 14.4 cm.

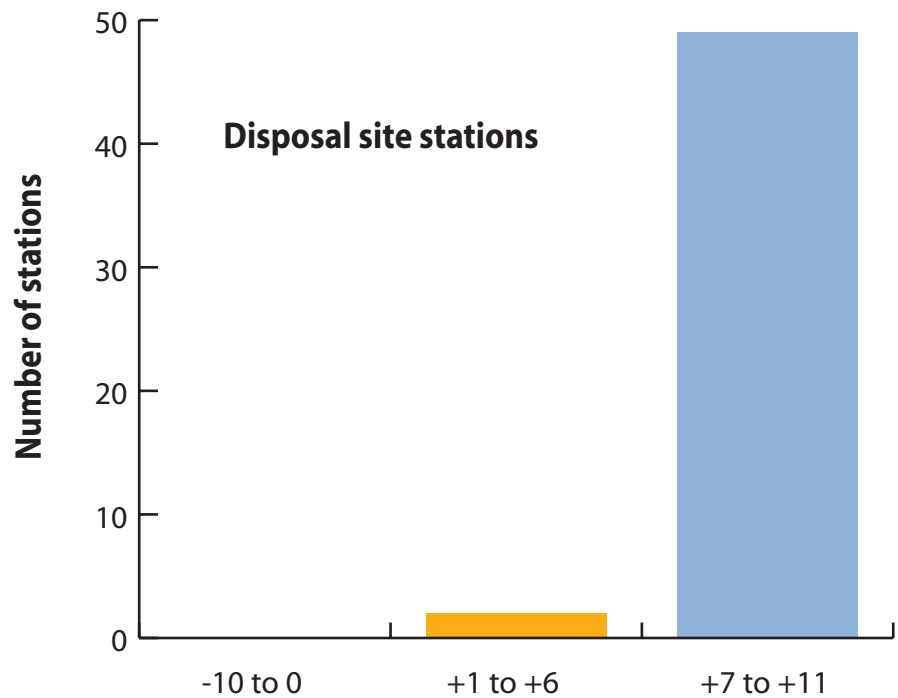
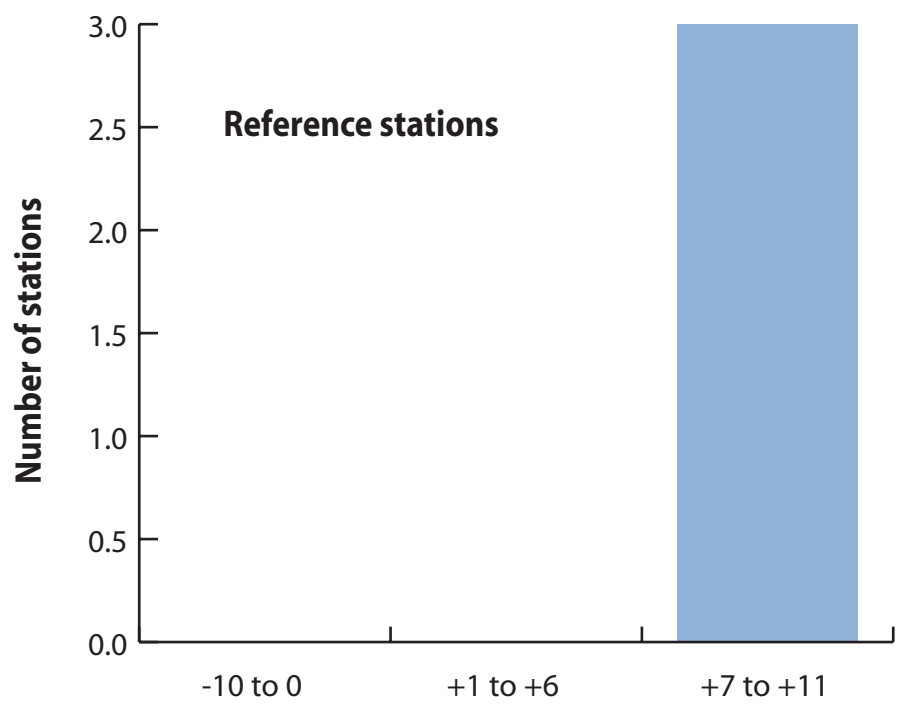
Figure 3-22: Frequency distribution of median OSI values at the disposal site stations (top) and reference stations (bottom).

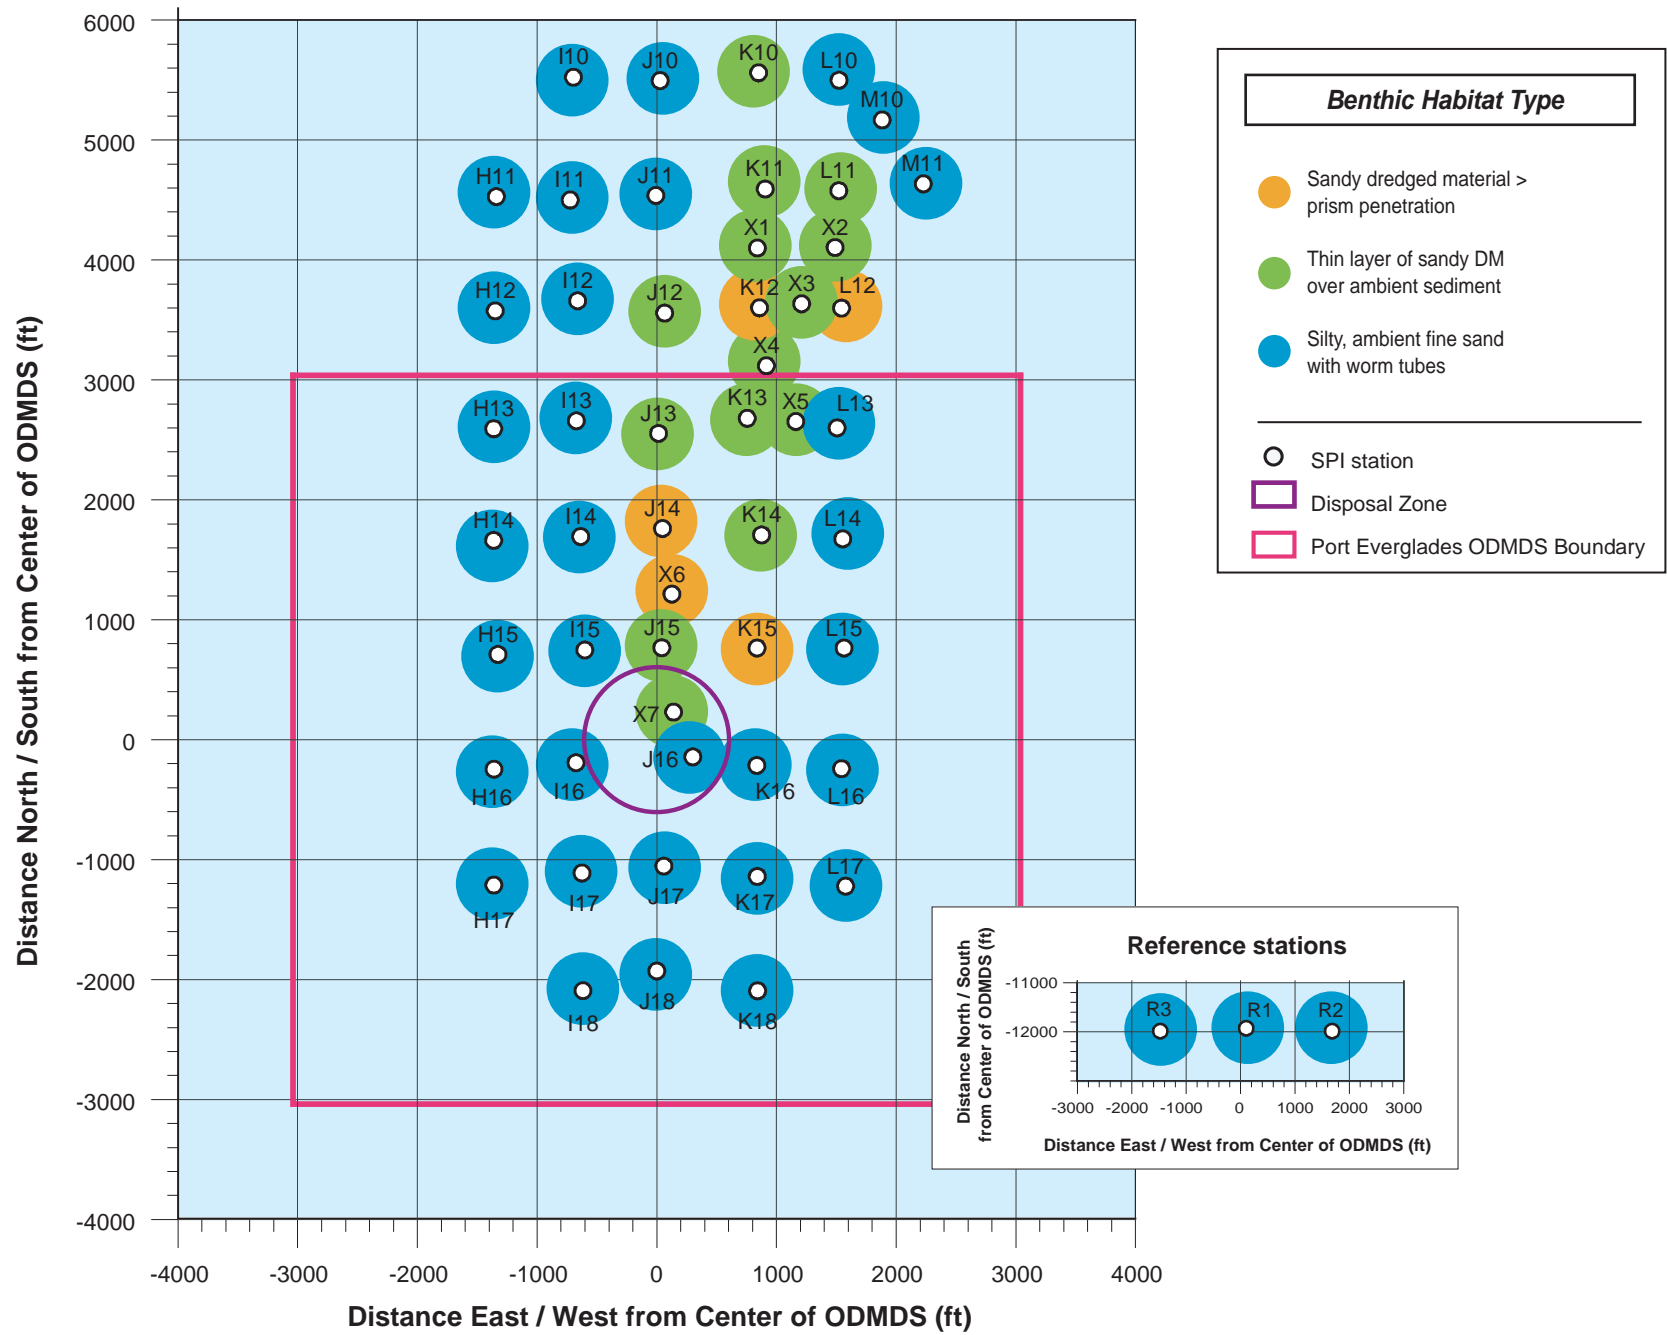
Figure 3-23: Map of benthic habitat types at the Port Everglades Harbor ODMDS SPI stations.

The benthic habitat classification scheme developed for the Port Everglades Harbor ODMDS largely reflects the information on sediment grain size, presence/absence of dredged material layers, and biological features discussed above. There was little variation in benthic habitat conditions across the surveyed area. The most common habitat type consisted of silty, native (i.e., ambient) fine sand, with tubes present at the surface (Figure 3-23). Within the dredged material footprint, there was typically a very slight and subtle coarsening of the sediment texture, due to higher apparent amounts of fine sand and small shell fragments. Stations within the dredged material footprint therefore had a benthic habitat type consisting of either sandy dredged material exceeding the prism penetration depth, or a thin surface layer of sandy dredged material overlying ambient very fine sand at depth (Figure 3-23).
