NEW MEXICO
ENVIRONMENT DEPARTMENT

DOE Oversight Bureau

Subject: Storm Flow Monitoring along the Rio Grande and Chama River New Mexico Conducted by NMED/DOE Oversight Bureau for FFY 2009 Q-4 April 19, 2010

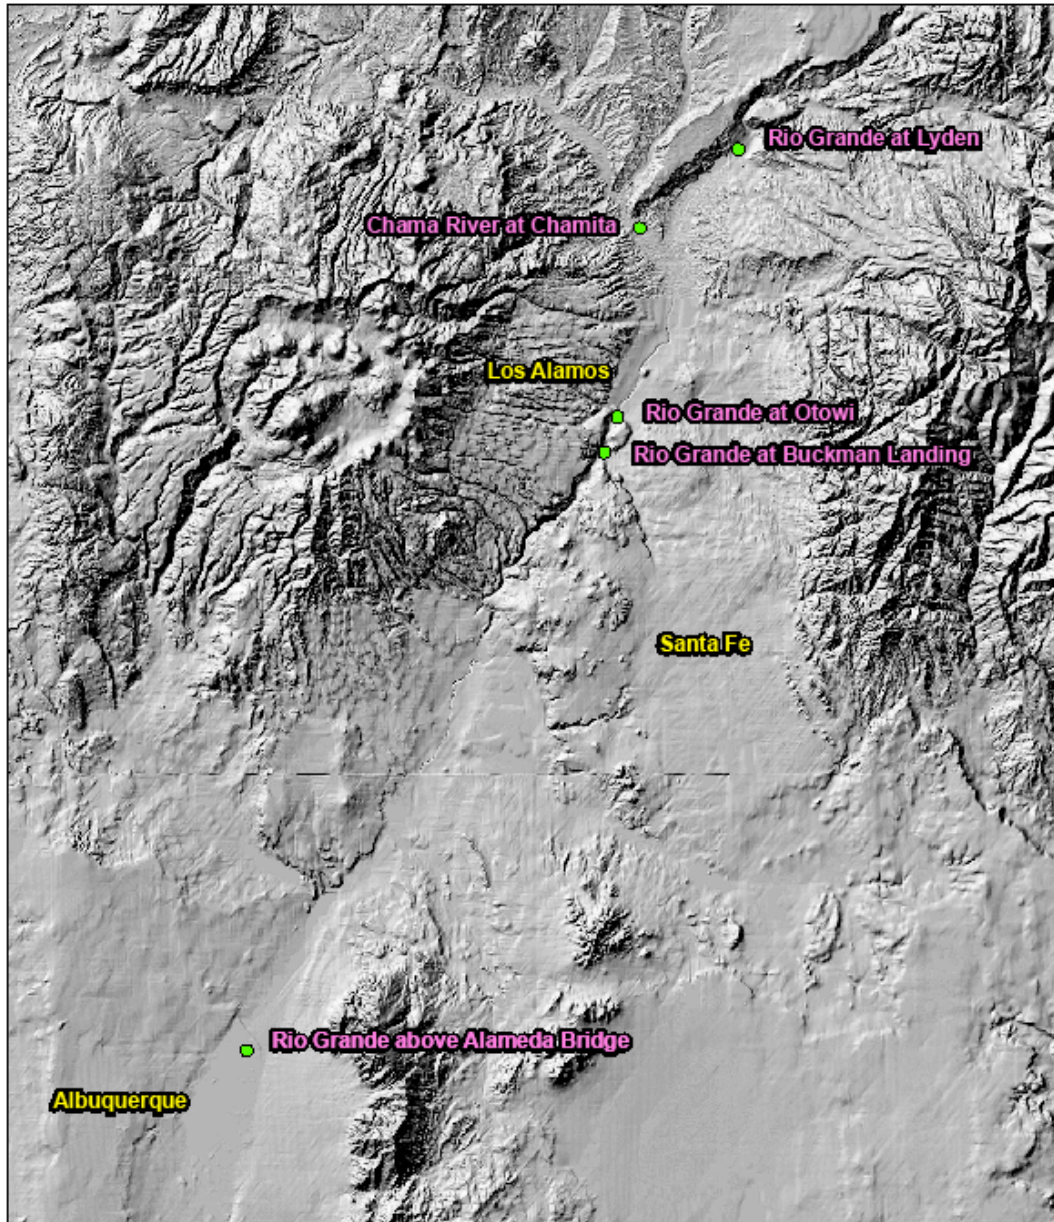
Figure 1. Rio Grande and Chama River Water Quality Monitoring Locations

NMED Rio Grande water quality monitoring locations, Q4 FY2009

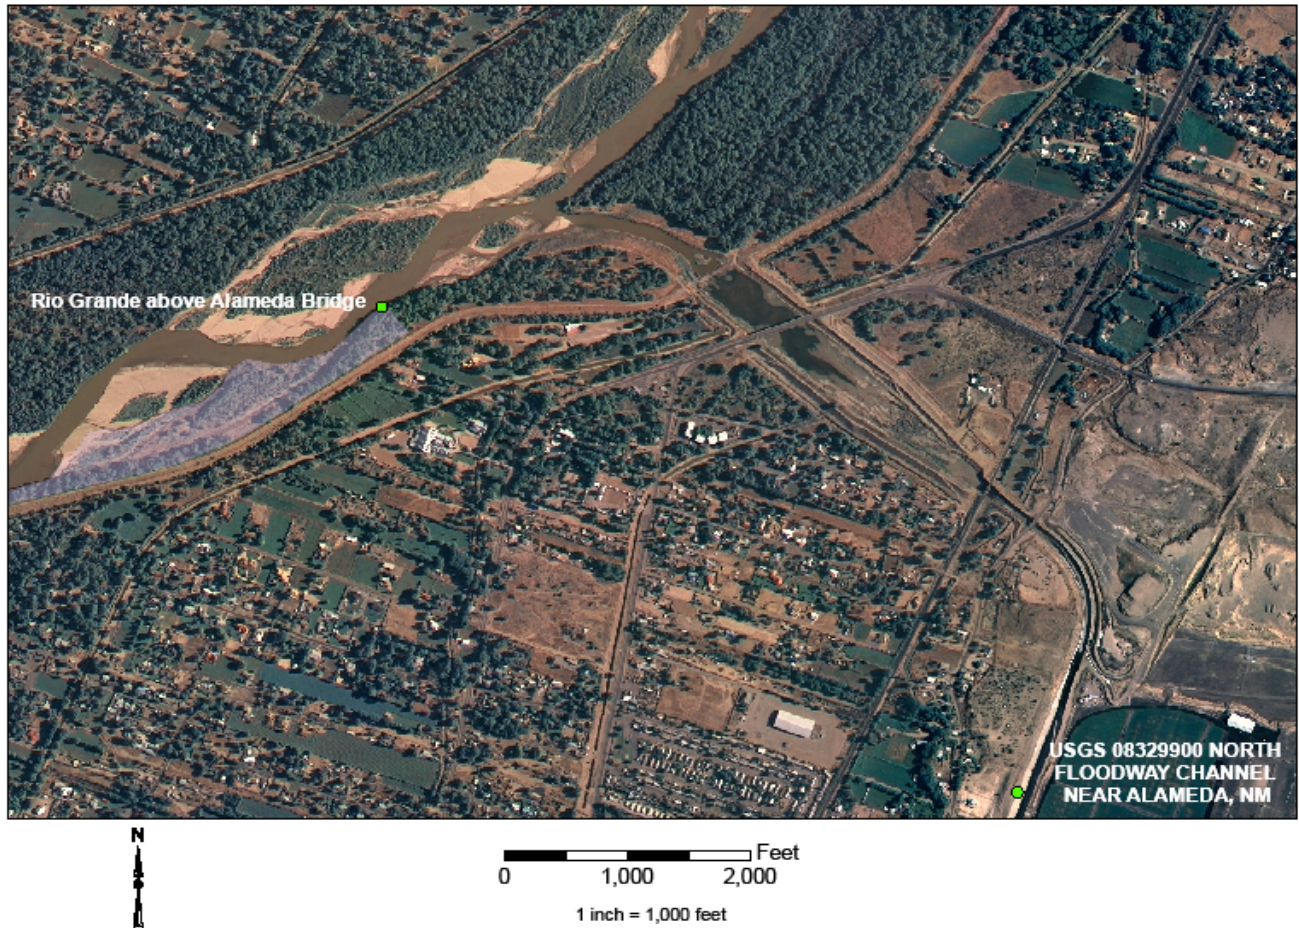
Figure 1B Sample Location for Rio Grande above Alameda

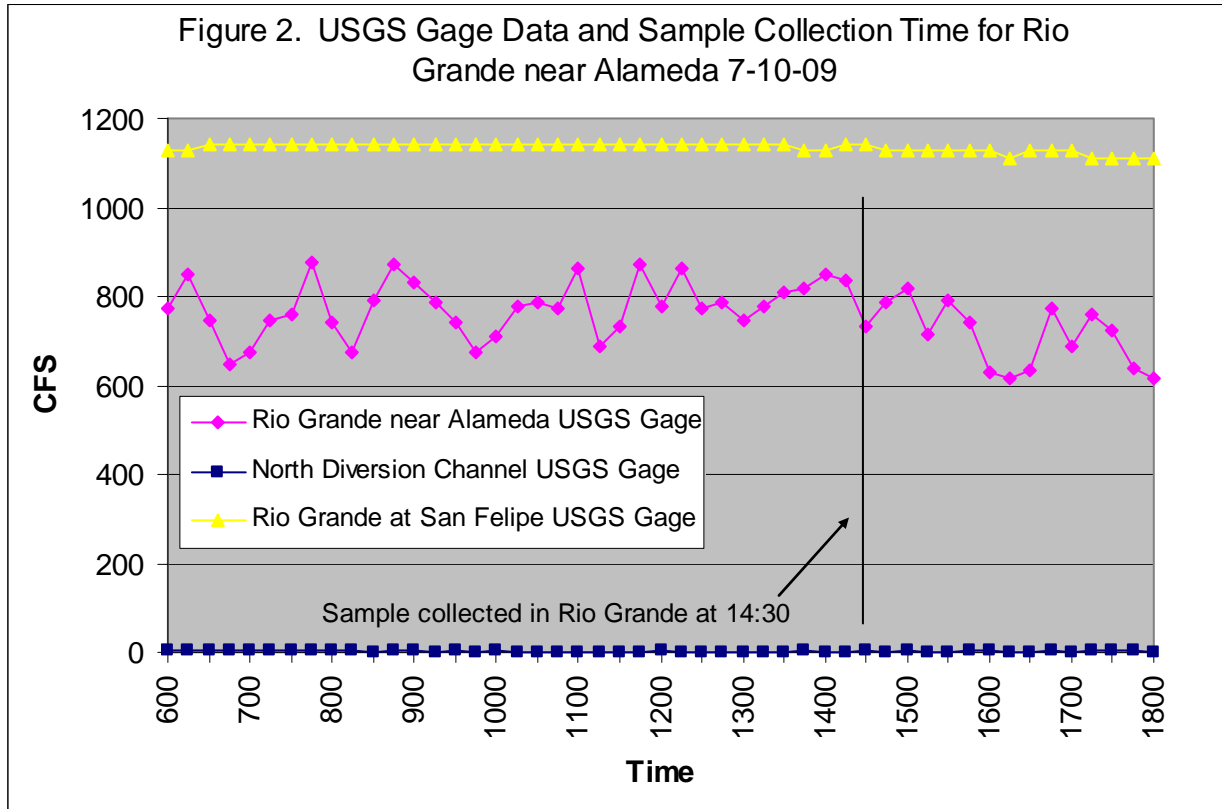
Figure 2 demonstrates flows in the Rio Grande at San Felipe and near Alameda USGS gages along with the NDC during the 7-10-09 baseflow sample collected at the Rio Grande above Alameda location. Flows were steady at the Rio Grande at San Felipe and Rio Grande near Alameda gages and there was no discharge from the NDC at the time of sample.

The distance between USGS gages along the Rio Grande and in the NDC largely govern the relative time delays in response to precipitation caused runoff events. Flow registered at the San Felipe gage at the Rio Grande (22.4 miles upstream) takes approximately 8 hours to manifest at the Rio Grande above Alameda gage. It takes approximately 40 minutes for flows registered at the NDC gage to manifest at the Rio Grande above Alameda sampling station and approximately one hour and 30 minutes for flows from the NDC gage to manifest at the Rio Grande above Alameda gage. These travel times may vary considerably depending on the volume of water discharged from the NDC, changing flows from upstream (Cochiti Reservoir releases or other tributary influences), and the actual flow in the Rio Grande.

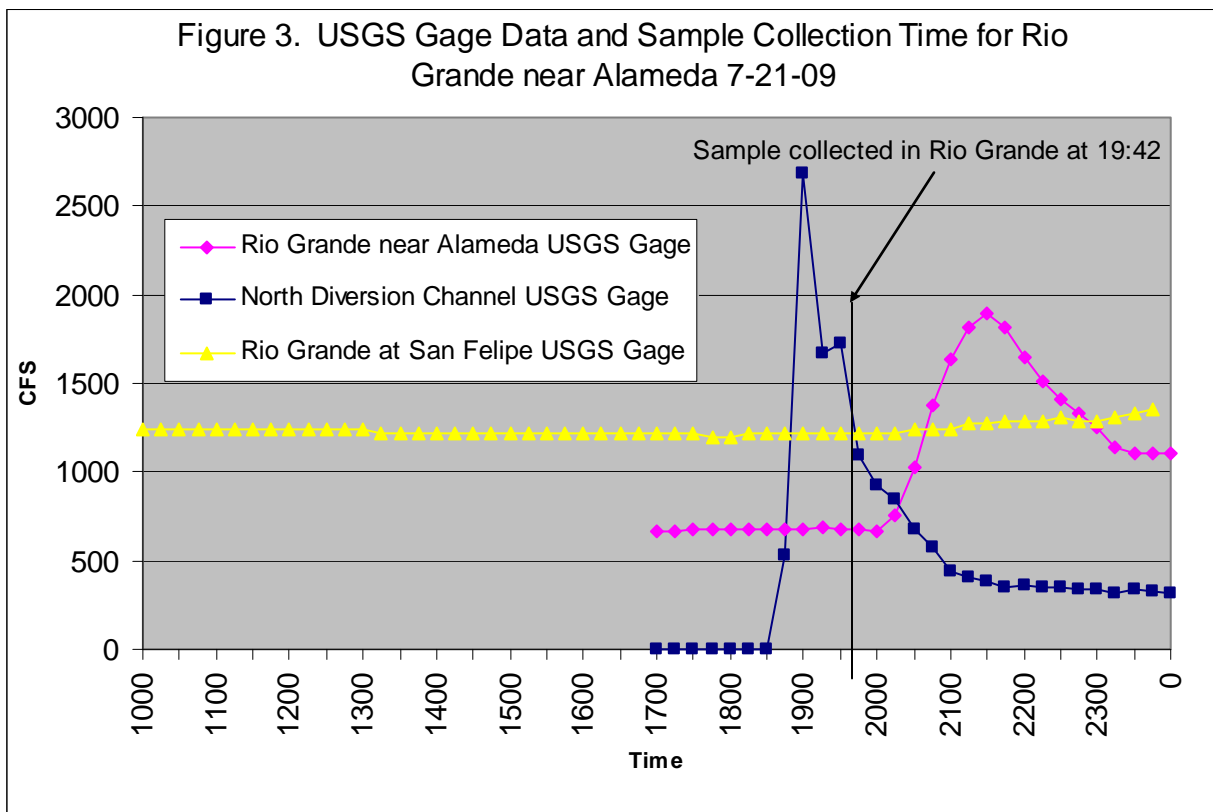
Figure 3 demonstrates flows in the Rio Grande at San Felipe and near Alameda USGS gages along with the NDC during the time of the 7-21-09 storm flow sample collection. Flows were steady in the Rio Grande at San Felipe for over 8 hours prior to sample collection. Discharge from the NDC peaked at 19:00, the sampler was enabled at 19:21, and the sample was collected in the Rio Grande at 19:42.

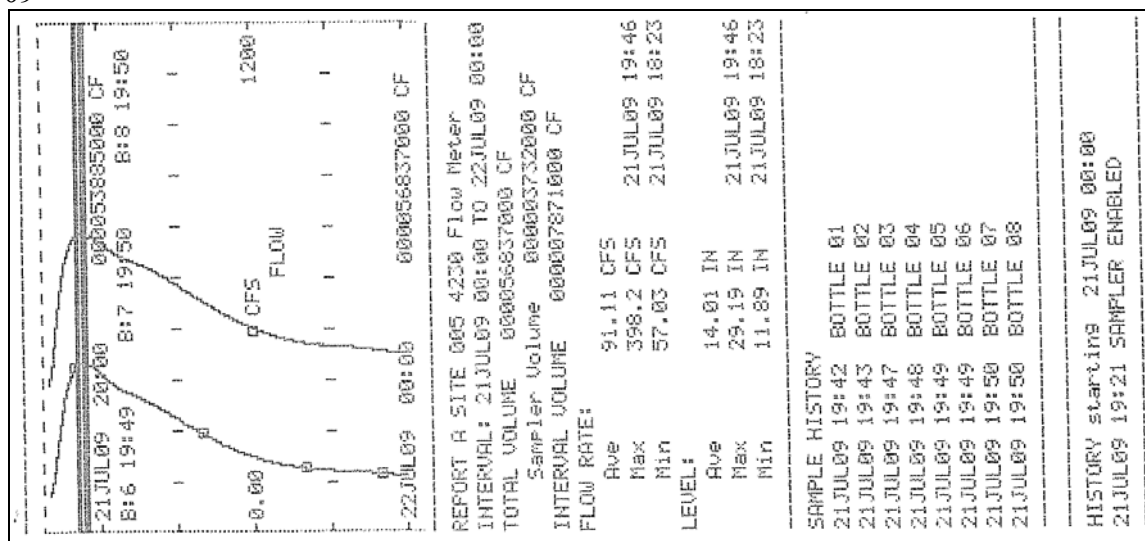
Figure 4 is a copy of the strip chart from the ISCO sampler and shows that the sample was collected near the peak of the hydrograph as the storm surge passed the sampler location.

Figure 4. ISCO Sampler Hydrograph and Sample Collection times for Rio Grande above Alameda 7-21-09

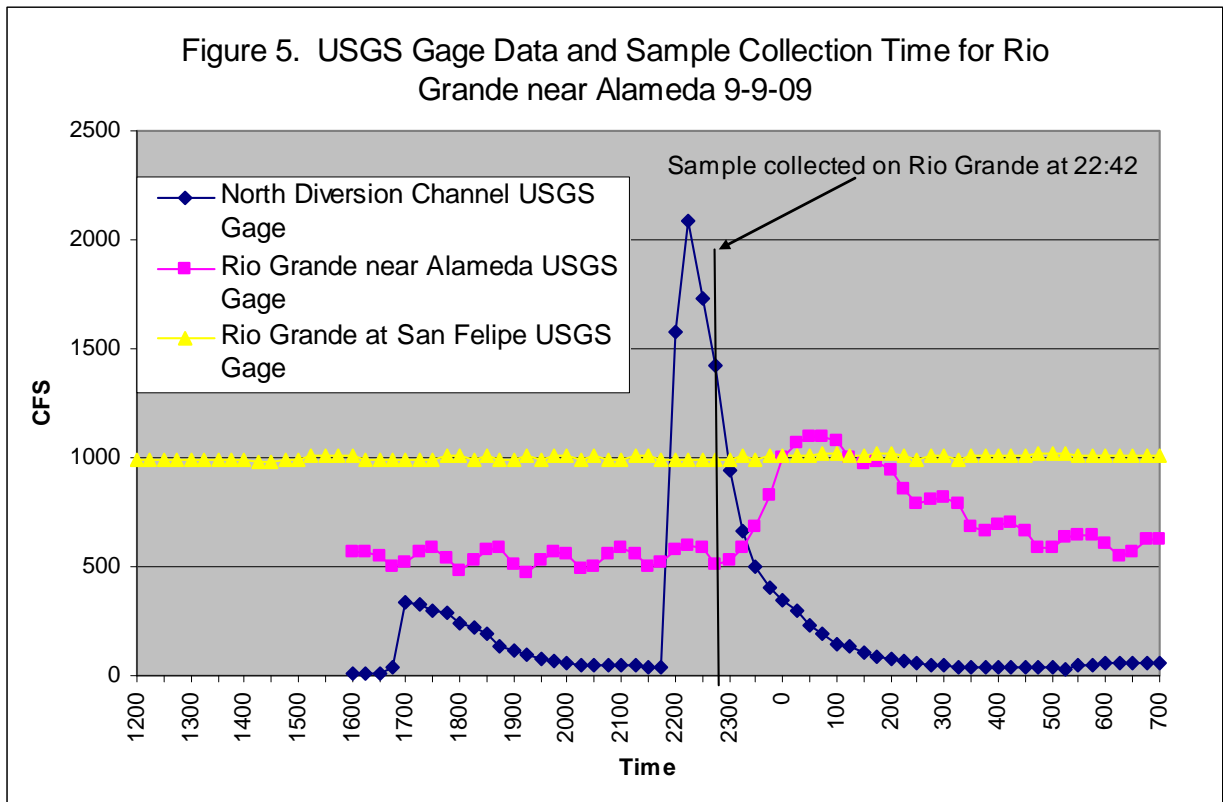
Figure 5 demonstrates flows in the Rio Grande at San Felipe and near Alameda USGS gages along with the NDC during the time of the 9-9-09 storm flow sample collection. Flows were steady in the Rio Grande at San Felipe for over 8 hours prior to sample collection. Discharge from the NDC peaked at 22:15, sampler was enabled at 22:21, and the sample was collected in the Rio Grande at 22:42.

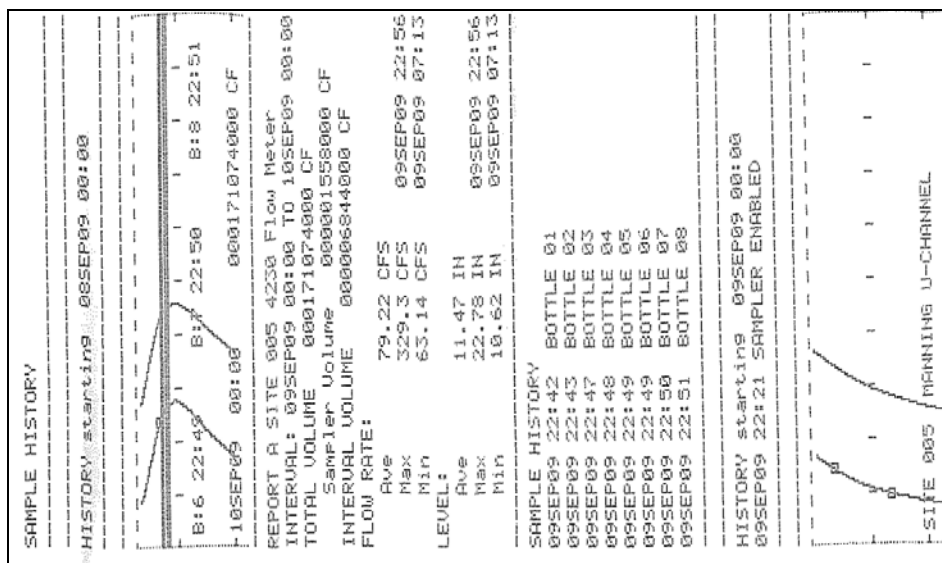
Figure 6 is a copy of the strip chart from the ISCO sampler and shows that the sample was collected near the peak of the hydrograph as the storm surge passed the sampler location.

Figure 6. ISCO Sampler Hydrograph and Sample Collection times for Rio Grande above Alameda 9-9-09

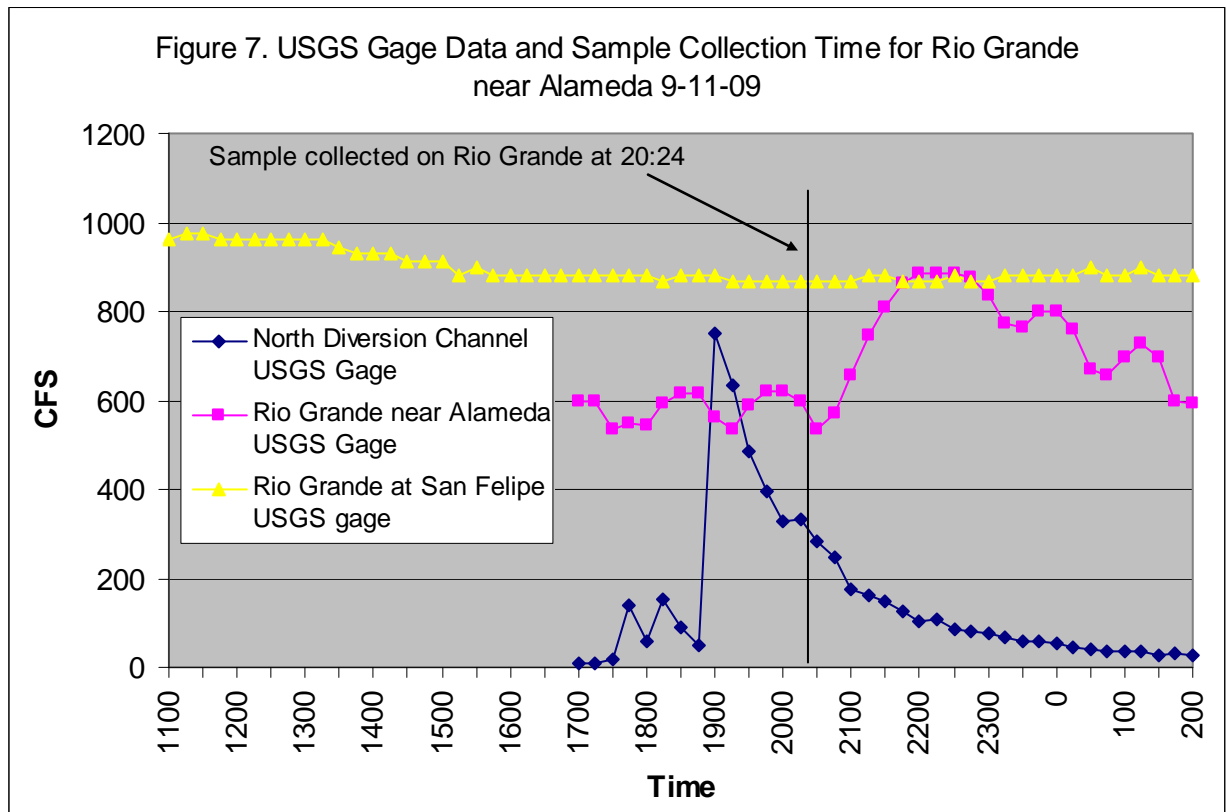
Figure 7 demonstrates flows in the Rio Grande at San Felipe and near Alameda USGS gages along with the NDC during the time of the 9-11-09 storm flow sample collection. Flows were steady (or slightly decreasing) in the Rio Grande at San Felipe for over 8 hours prior to sample collection. Discharge from the NDC peaked at 19:00, sampler was enabled at 19:47, and the sample was collected in the Rio Grande at 20:24.

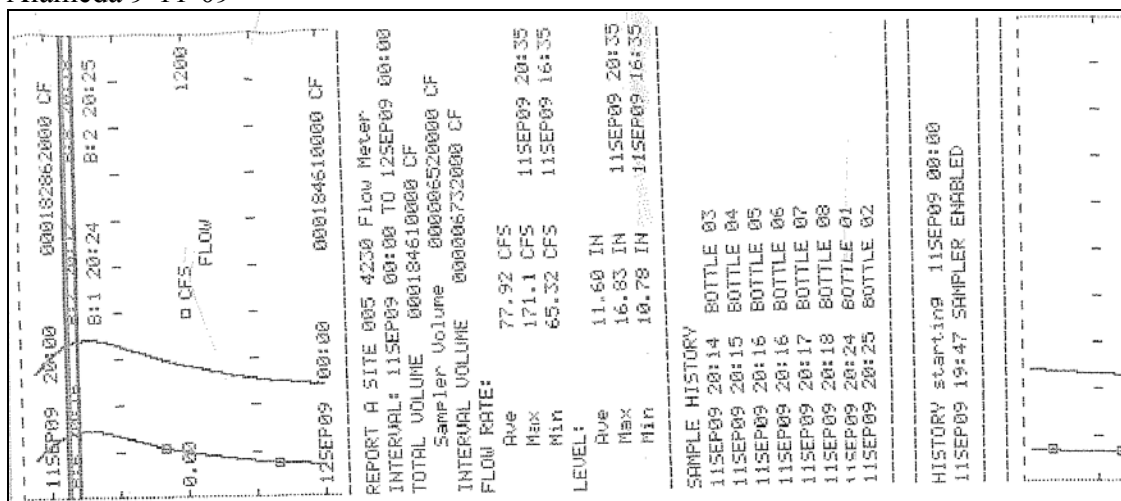
Figure 8 is a copy of the strip chart from the ISCO sampler and shows that the sample was collected on the rising leg near the peak of the hydrograph as the storm surge passed the sampler location.

Figure 8. ISCO Sampler Hydrograph and Sample Collection times for Rio Grande above Alameda 9-11-09

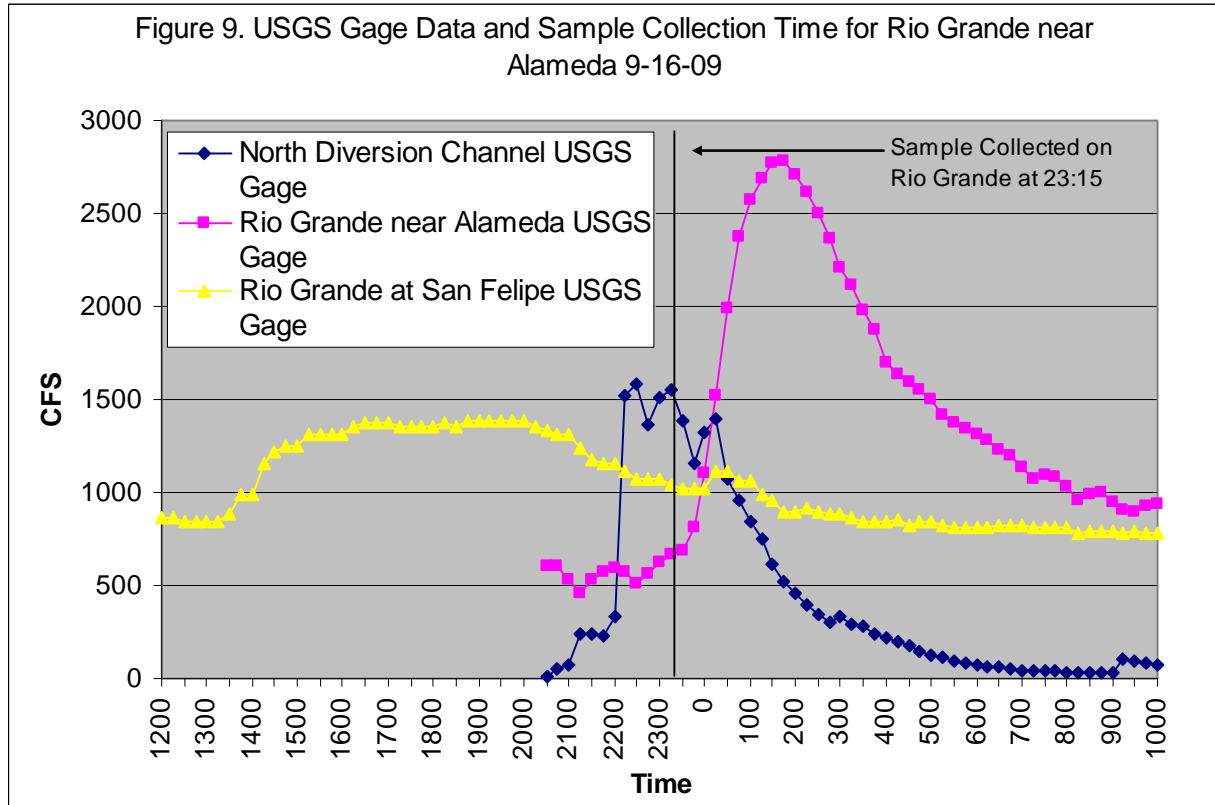
Figure 9 demonstrates flows in the Rio Grande at San Felipe and near Alameda USGS gages along with the NDC during the time of the 9-16-09 storm flow sample collection. Flows had increased nearly 500 CFS in the Rio Grande at San Felipe about 8 hours prior to sample collection. Discharge from the NDC peaked at three intervals between 22:30 and 00:15, sampler was enabled at 22:38, and the sample was collected in the Rio Grande at 23:15.

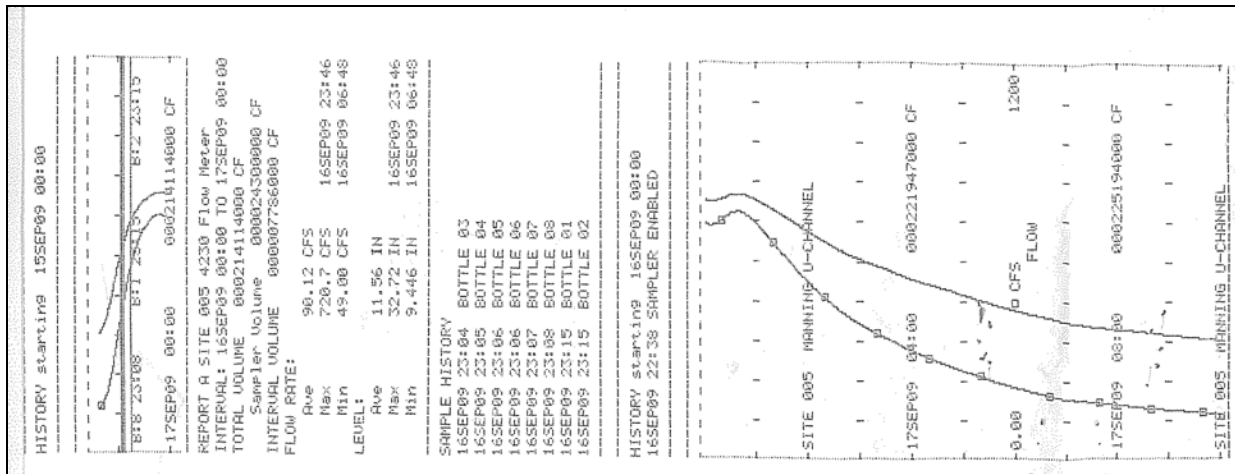
Figure 10 is a copy of the strip chart from the ISCO sampler and shows that the sample was collected on the rising leg of the hydrograph as the storm surge passed the sampler location.

Figure 10. ISCO Sampler Hydrograph and Sample Collection times for Rio Grande above Alameda 9-16-09

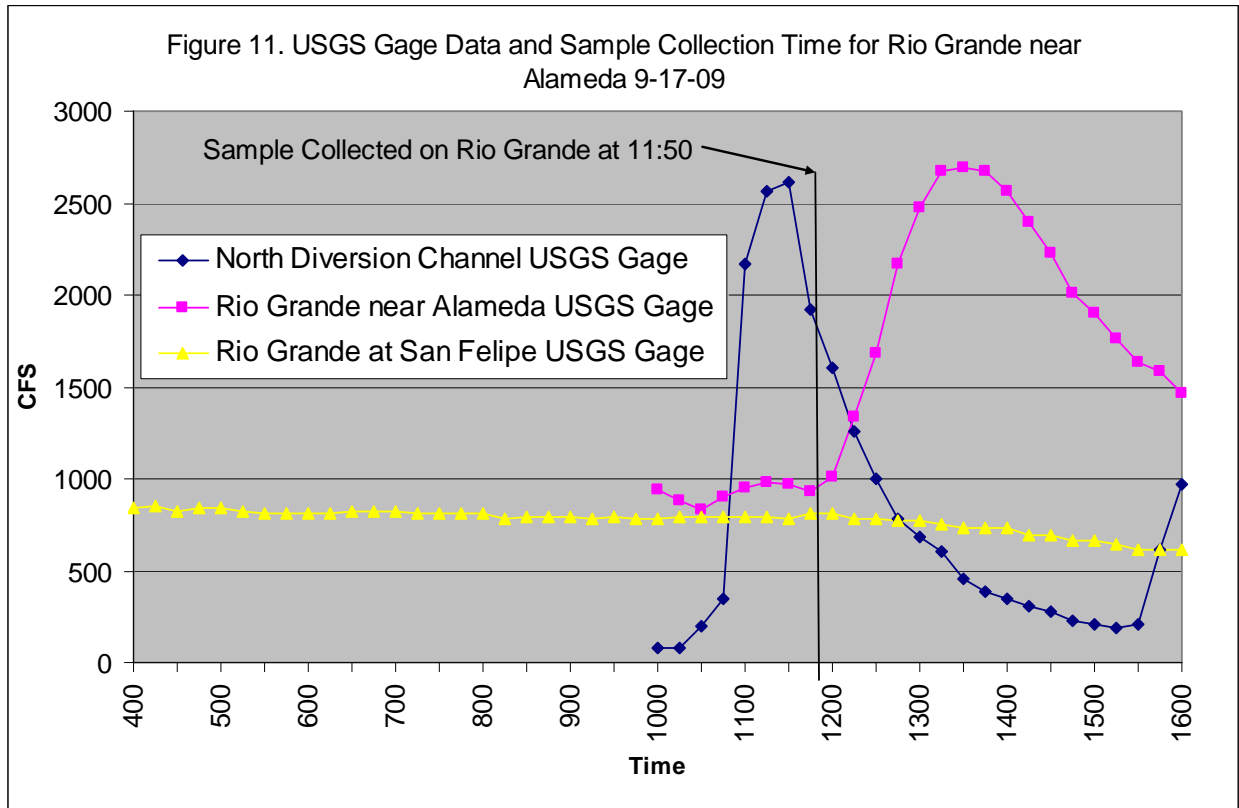
Figure 11 demonstrates flows in the Rio Grande at San Felipe and near Alameda USGS gages along with the NDC during the time of the 9-17-09 storm flow sample collection. Flows were steady in the Rio Grande at San Felipe for over 8 hours prior to sample collection. Discharge from the NDC peaked at 11:30, sampler was enabled at 11:13, and the sample was collected in the Rio Grande at 11:50.

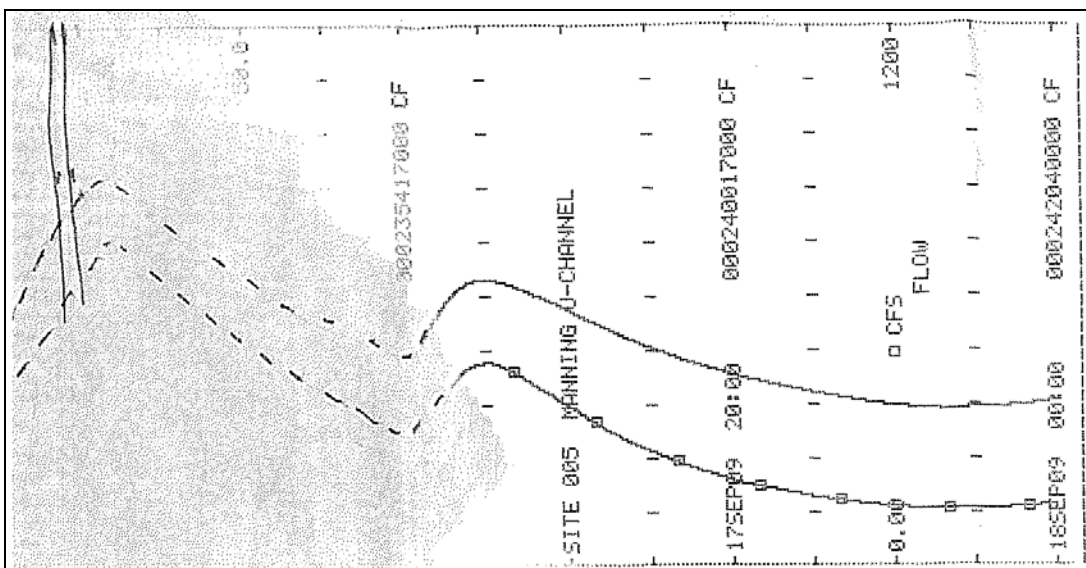
Figure 11 is a copy of the strip chart from the ISCO sampler and shows that the sample was collected on the rising leg of the hydrograph as the storm surge passed the sampler location.

Figure 12. ISCO Sampler Hydrograph and Sample Collection times for Rio Grande above Alameda 9-17-09. Dashed line indicates estimated hydrograph (rain during sample collection smeared graph)

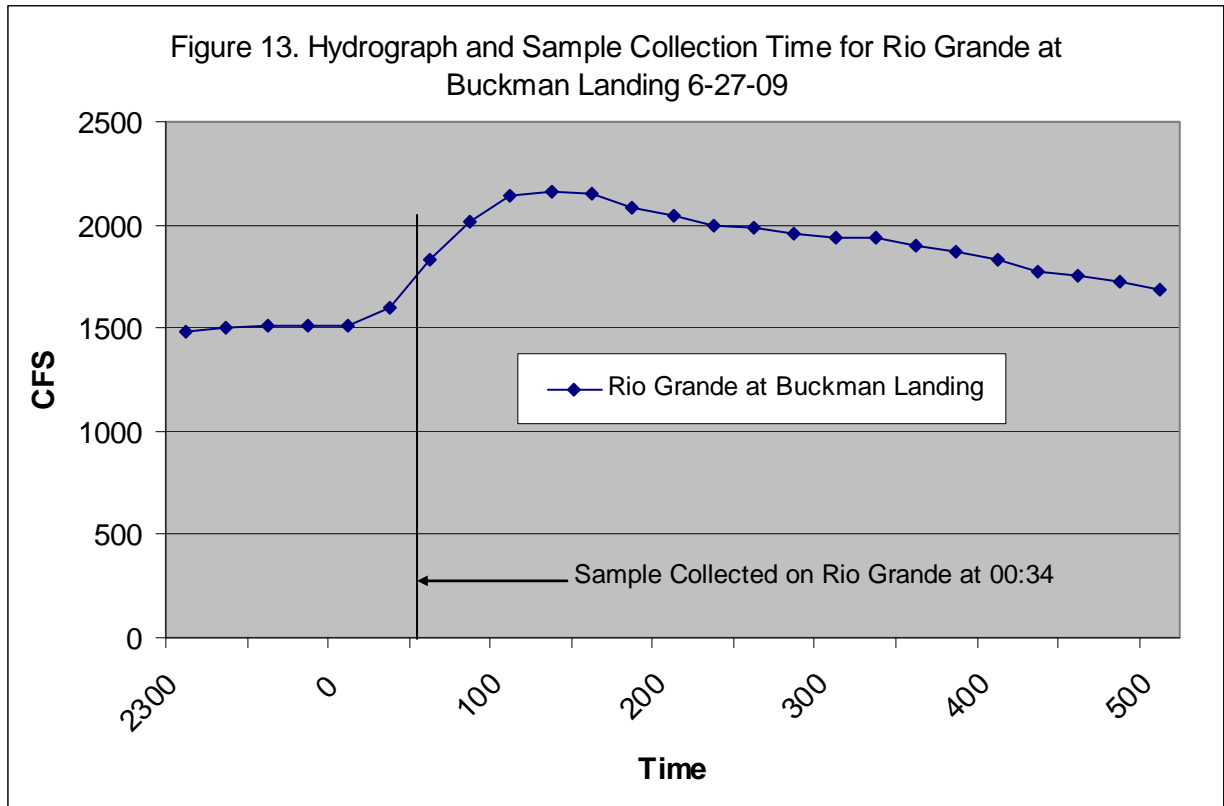
Figure 13 demonstrates flows in the Rio Grande at Buckman Landing on 6-27-09. Flow at the Buckman landing peaked at 01:15 and the sample was collected 41 minutes earlier on the rising leg of the hydrograph. It is approximately 3.3 miles from Otowi Bridge to the Buckman Landing.

Otowi gage data is used as a surrogate for Buckman Landing flows. Peak flow occurred at Buckman Landing 49 minutes after the peak at Otowi and times have been adjusted on graph to compensate. No adjustment of sample time was needed.

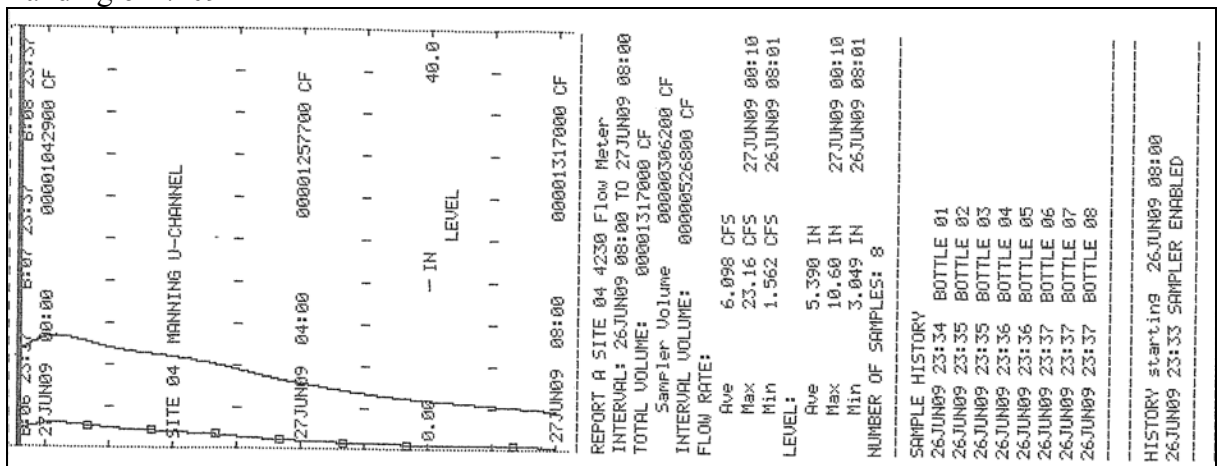
Figure 14. ISCO Sampler Hydrograph and Sample Collection times for Rio Grande at Buckman Landing 6-27-09

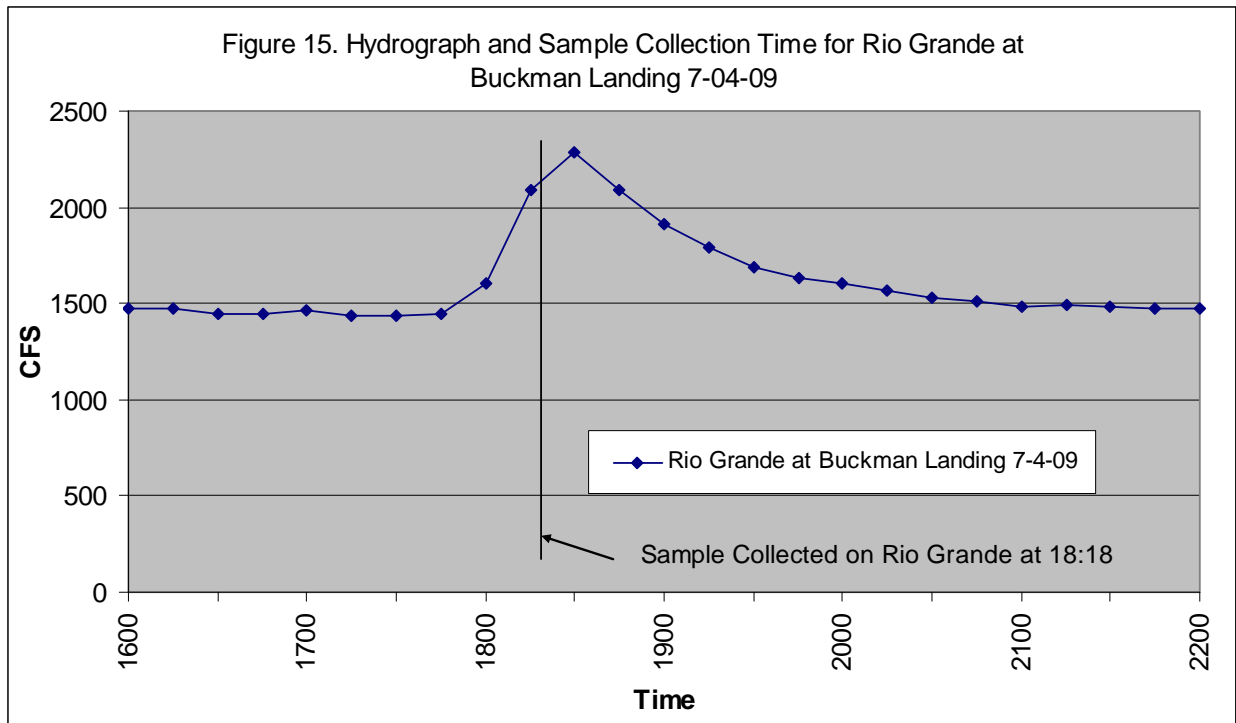
Figure 15 demonstrates flows in the Rio Grande at Buckman Landing on 7-4-09. Flow at the Buckman landing peaked at 18:30 and the sample was collected 12 minutes earlier on the rising leg of the hydrograph.

Otowi gage data is used as a surrogate for Buckman Landing flows. Peak flow occurred at Buckman Landing 35 minutes after the peak at Otowi and times have been adjusted on graph to compensate. No adjustment of sample time was needed.

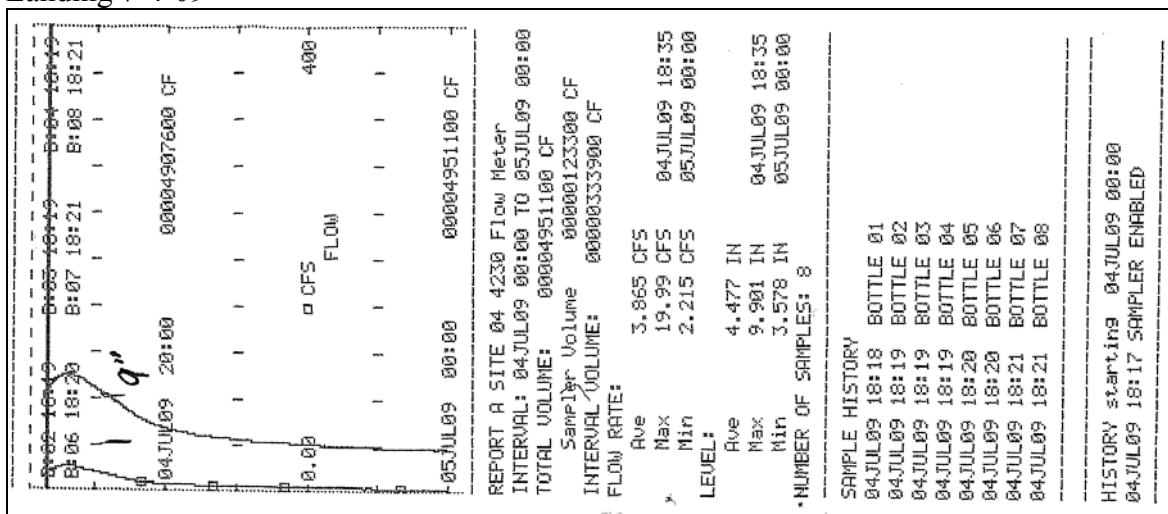
Figure 16. ISCO Sampler Hydrograph and Sample Collection times for Rio Grande at Buckman Landing 7-4-09

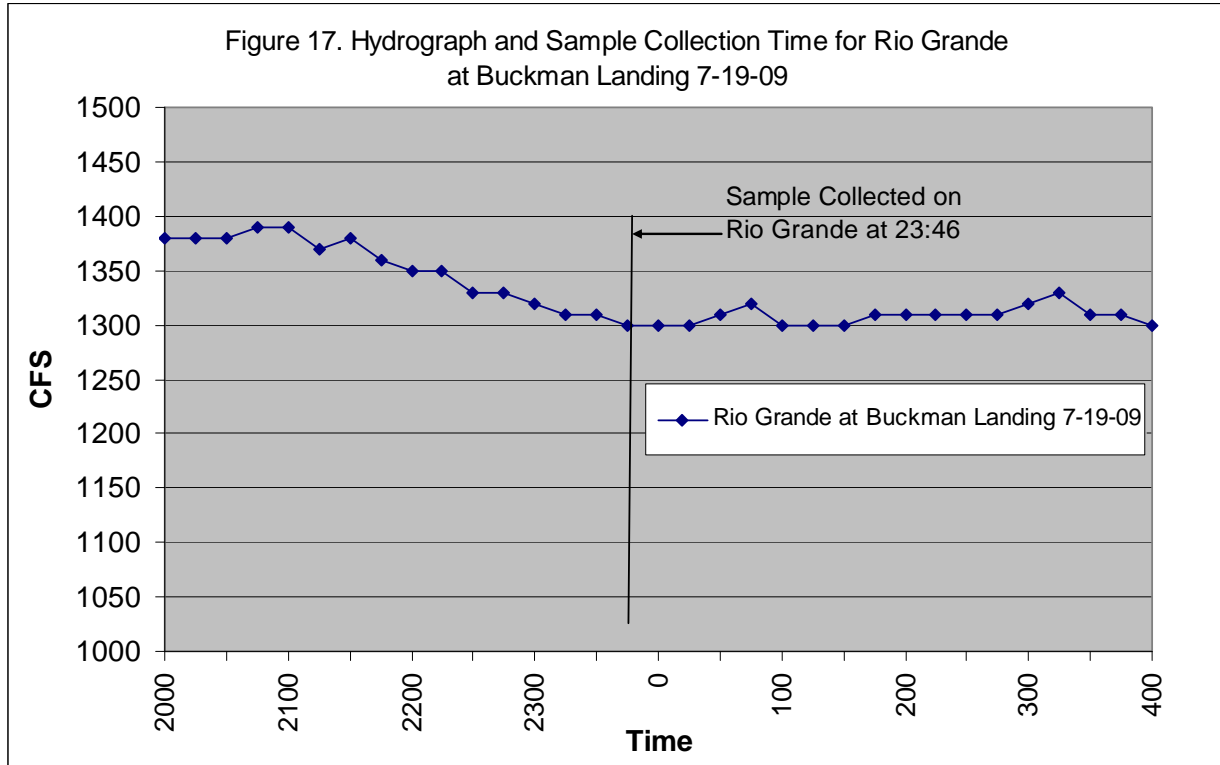
Figure 17 demonstrates flows in the Rio Grande at Buckman Landing on 7-19-09. Flow at the Buckman landing remained constant or declined slightly on this day. The sampler tripped on a spurious signal (most likely a plugged stage sensor line) and a non-storm influenced flow. Particle size and SSC data indicate this sample is not representative of baseflow conditions due to probable covering of sample port with sand deposits.

Otowi gage data is used as a surrogate for Buckman Landing flows. Peak flow occurred at Buckman Landing 45 minutes after the peak at Otowi and times have been adjusted on graph to compensate. No adjustment of sample time was needed.

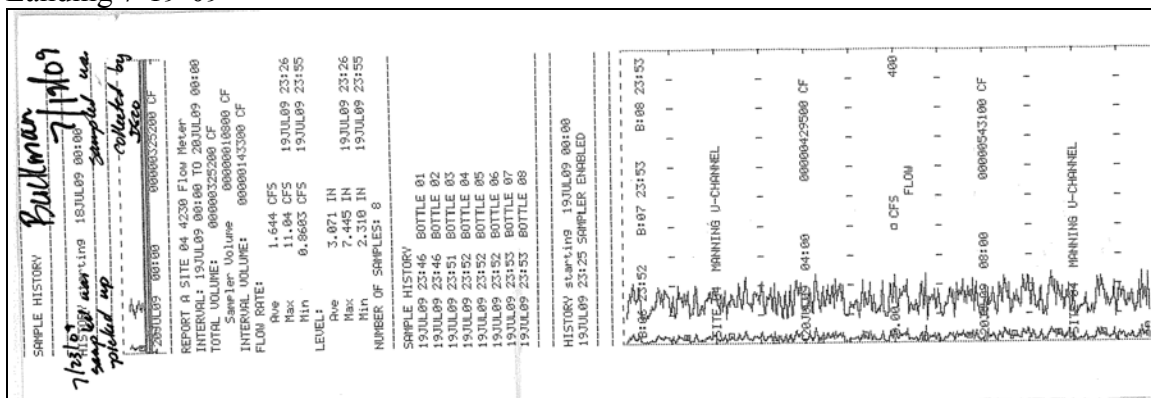
Figure 18. ISCO Sampler Hydrograph and Sample Collection times for Rio Grande at Buckman Landing 7-19-09

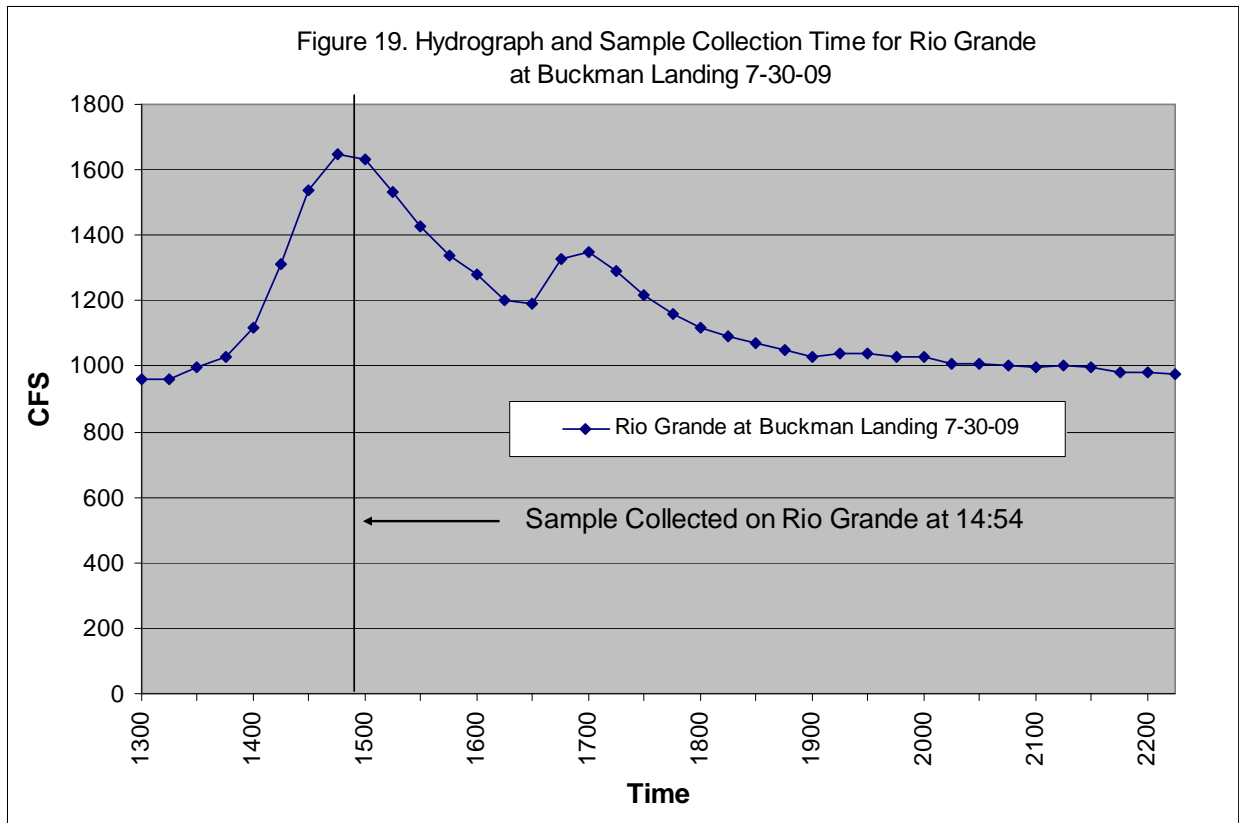
Figure 19 demonstrates flows in the Rio Grande at Buckman Landing on 7-30-09. Flow at the Buckman landing peaked at 14:45 and the sample was collected 9 minutes later very near the peak of the hydrograph.

Otowi gage data is used as a surrogate for Buckman Landing flows. Peak flow occurred at Buckman Landing 48 minutes after the peak at Otowi and times have been adjusted on graph to compensate. No adjustment of sample time was needed.

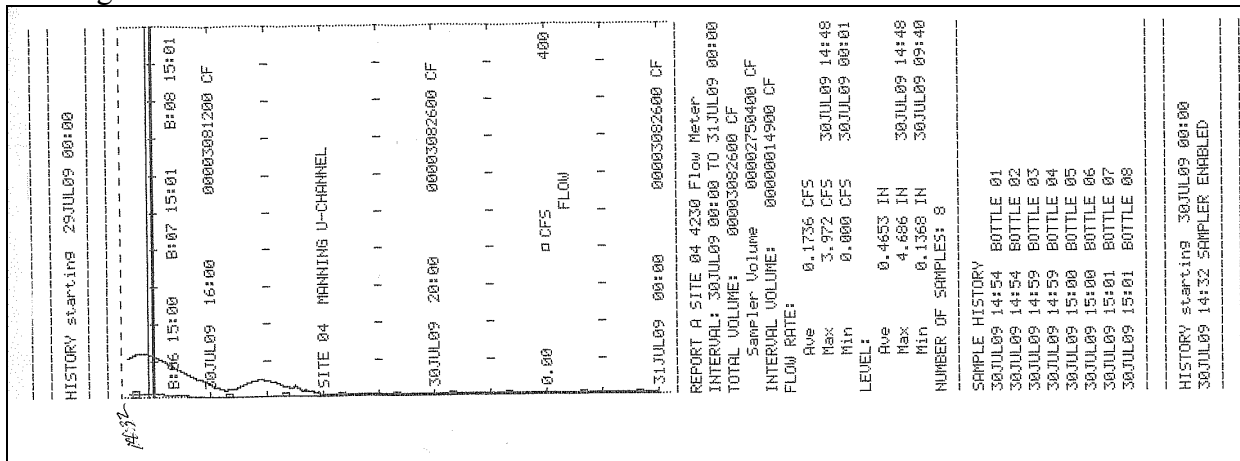
Figure 20 is a copy of the strip chart from the ISCO sampler at Buckman Landing on 7-19-09.

Figure 20. ISCO Sampler Hydrograph and Sample Collection times for Rio Grande at Buckman Landing 7-30-09

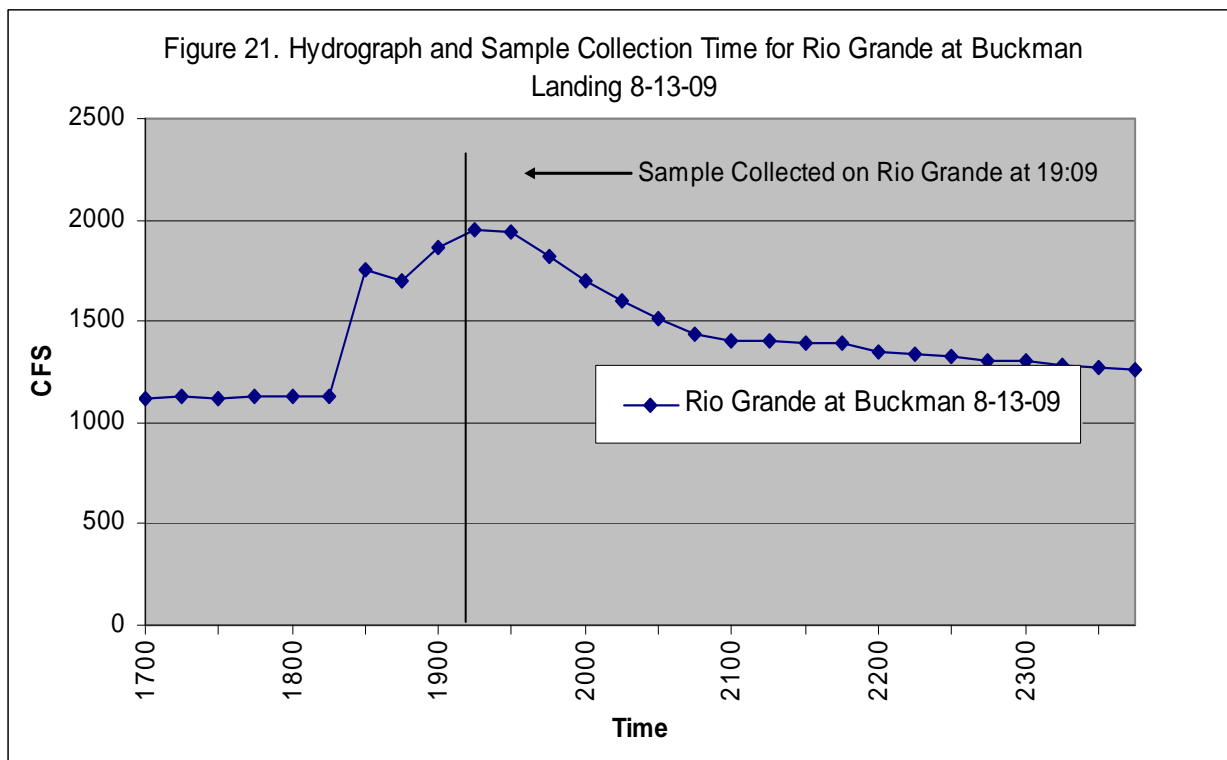
Figure 21 demonstrates flows in the Rio Grande at Buckman Landing on 8-13-09. Flow at the Buckman landing peaked at 19:15 and the sample was collected 6 minutes earlier very near the peak of the hydrograph.

Otowi gage data is used as a surrogate for Buckman Landing flows. Peak flow occurred at Buckman Landing 46 minutes after the peak at Otowi and times have been adjusted on graph to compensate. No adjustment of sample time was needed.

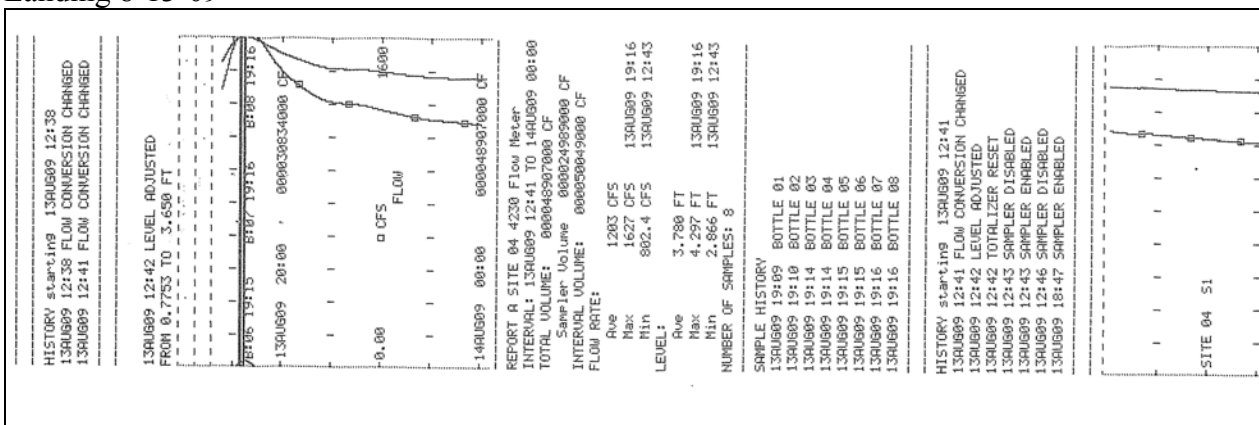
Figure 22 ISCO Sampler Hydrograph and Sample Collection times for Rio Grande at Buckman Landing 8-13-09

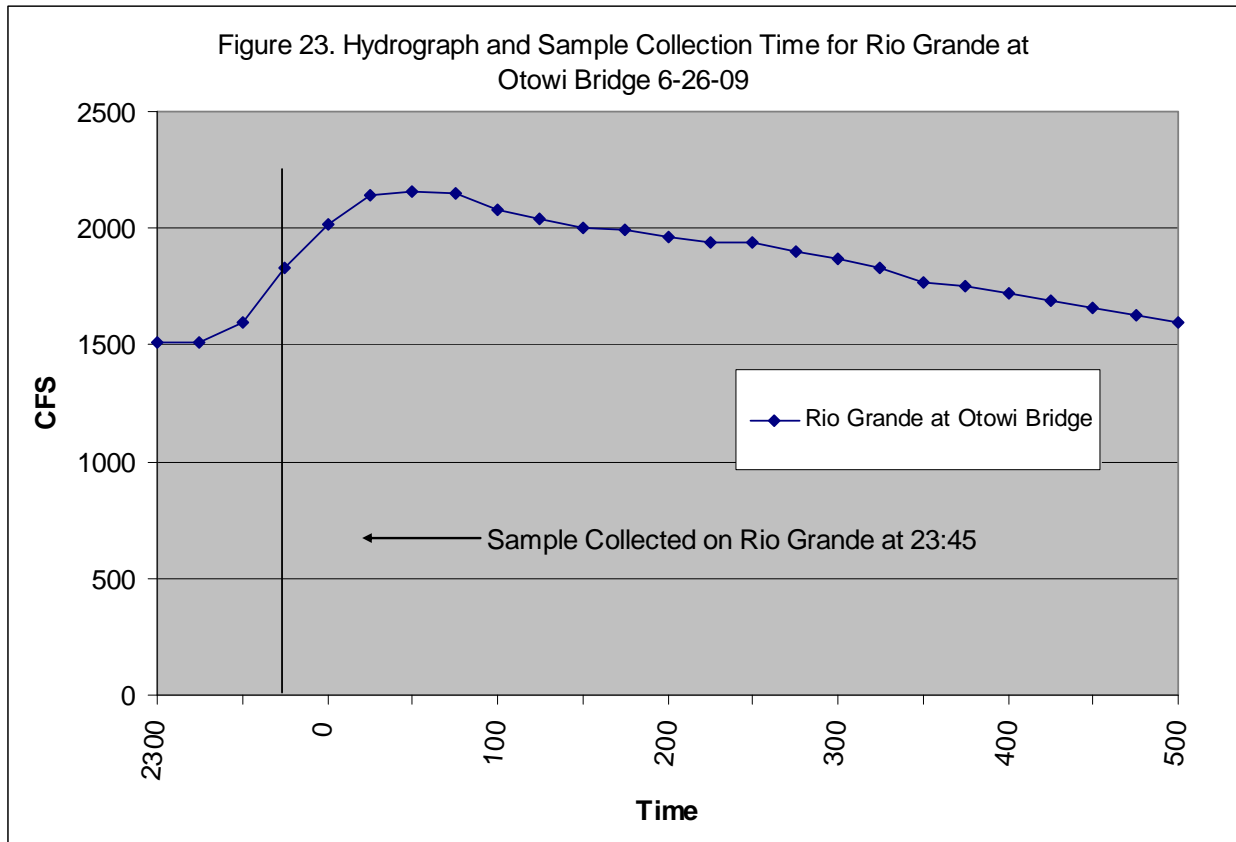
Figure 23 demonstrates flows in the Rio Grande at Otowi Bridge on 6-26-09. Flow at Otowi Bridge peaked at 00:30 and the sample was collected 45 minutes earlier on the rising leg of the hydrograph.

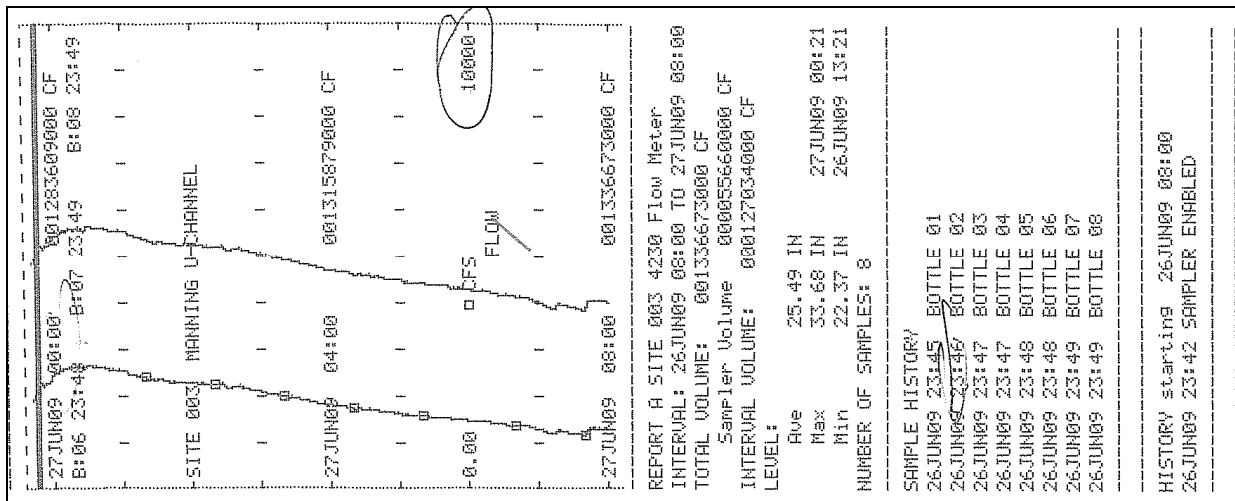
Figure 24 is a copy of the strip chart from the ISCO sampler at Otowi Bridge on 6-26-09.

Figure 24 ISCO Sampler Hydrograph and Sample Collection times for Rio Grande at Otowi Bridge on 6-26-09.
