NEW MEXICO
ENVIRONMENT DEPARTMENT

DOE Oversight Bureau

Subject: Storm Flow Monitoring along the Rio Grande and Chama River New Mexico Conducted by NMED/DOE Oversight Bureau for FFY 2009 Q-4 April 19, 2010

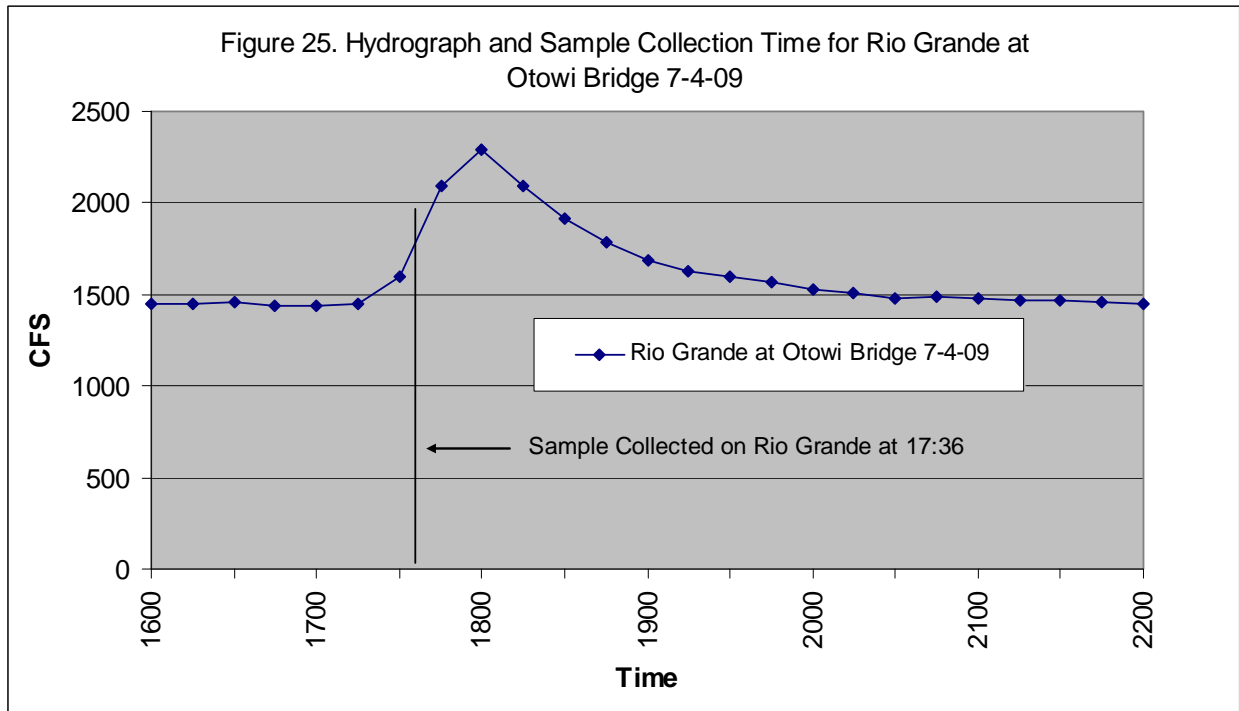
Figure 25 demonstrates flows in the Rio Grande at Otowi Bridge on 7-4-09. Flow at Otowi Bridge peaked at 18:00 and the sample was collected 24 minutes earlier on the rising leg of the hydrograph..

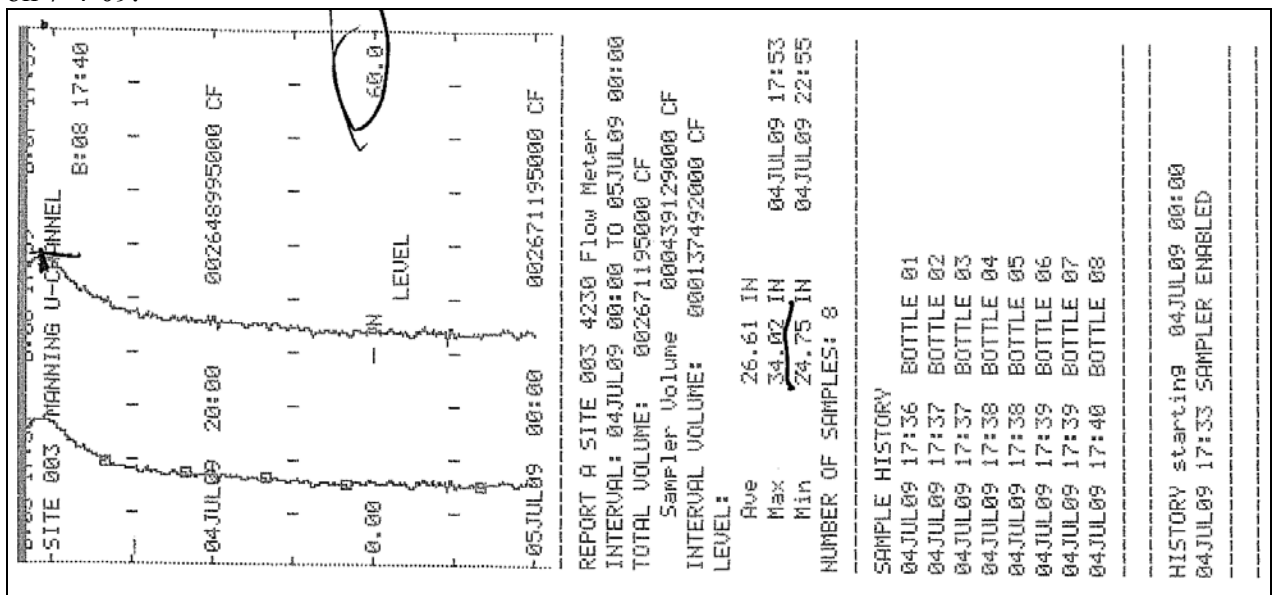
Figure 26 is a copy of the strip chart from the ISCO sampler at Otowi Bridge on 7-4-09.

Figure 26. ISCO Sampler Hydrograph and Sample Collection times for Rio Grande at Otowi Bridge on 7-4-09.

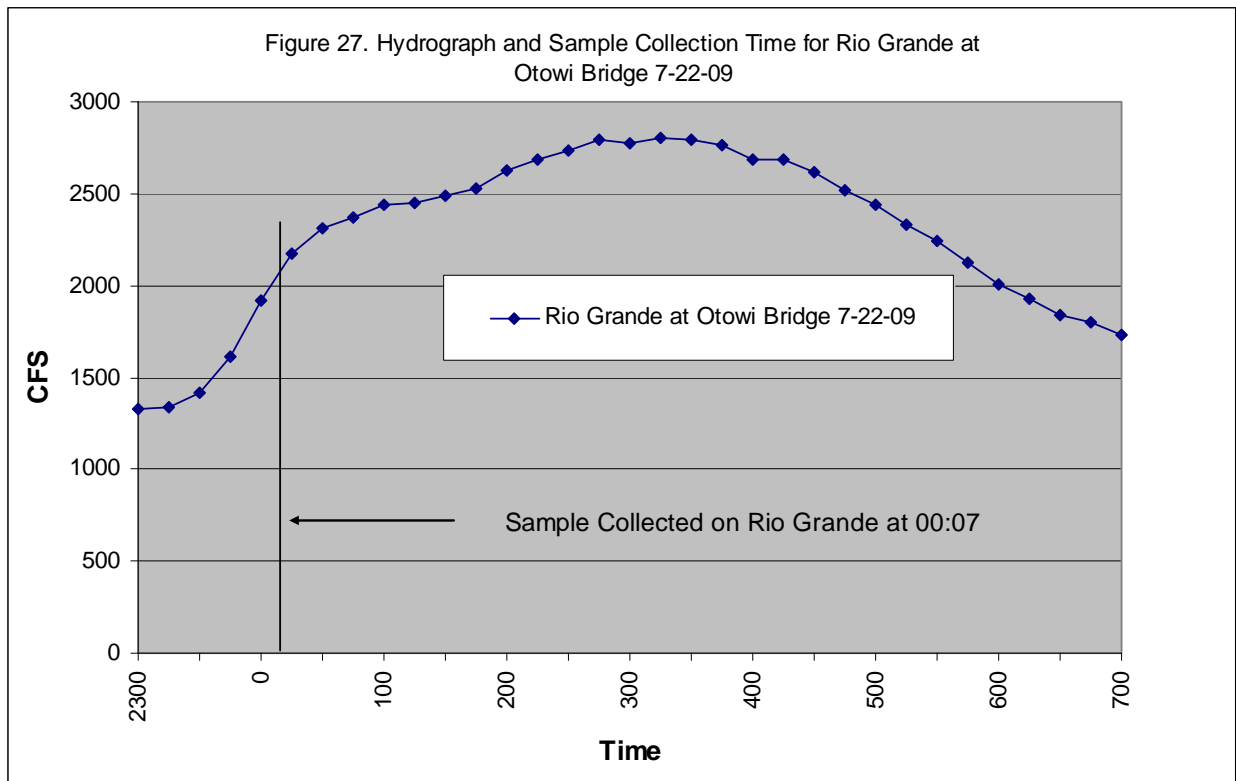
Figure 27 demonstrates flows in the Rio Grande at Otowi Bridge on 7-22-09. Flow at Otowi Bridge peaked at 03:15 and the sample was collected 3 hours and 8 minutes earlier on the rising leg of the hydrograph. This was a slowly rising hydrograph that took over 4 hours to reach the peak of the hydrograph.

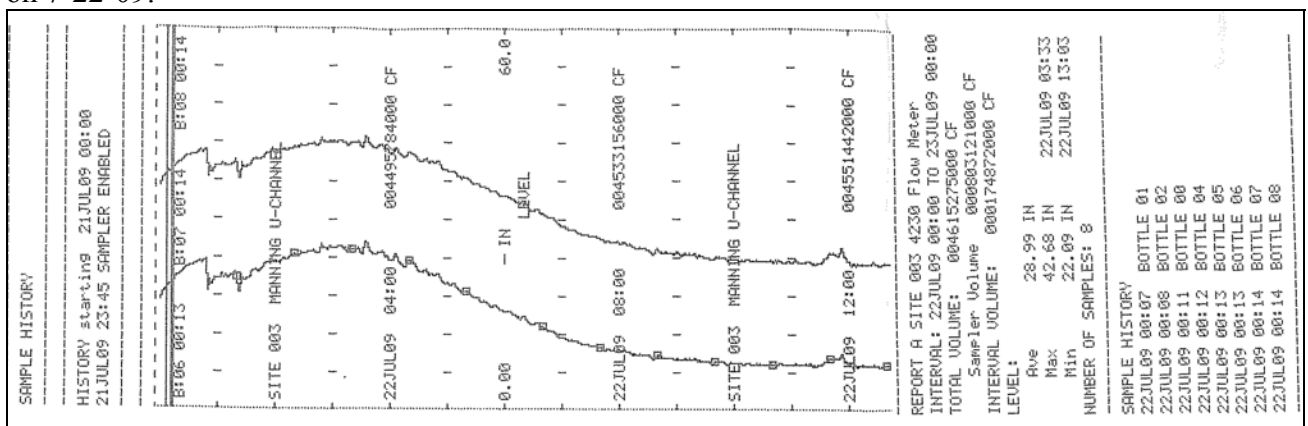
Figure 28 is a copy of the strip chart from the ISCO sampler at Otowi Bridge on 7-22-09.

Figure 28. ISCO Sampler Hydrograph and Sample Collection times for Rio Grande at Otowi Bridge on 7-22-09.

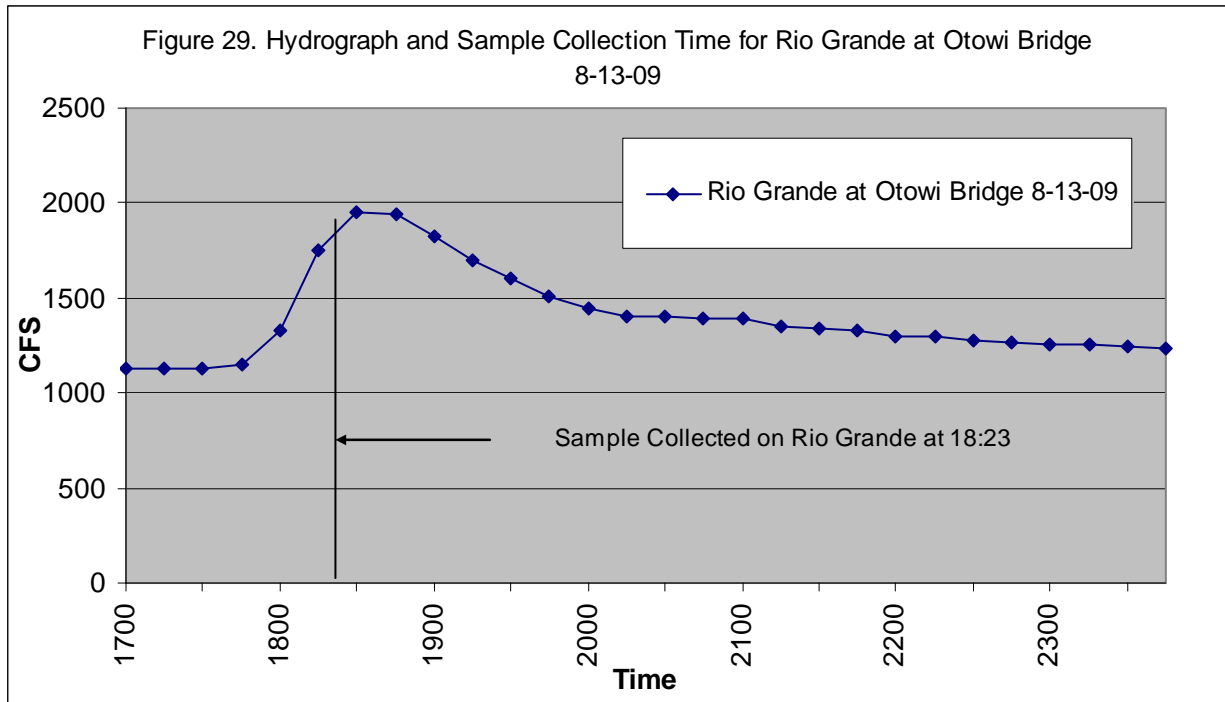
Figure 29 demonstrates flows in the Rio Grande at Otowi Bridge on 8-13-09. Flow at Otowi Bridge peaked at 18:30 and the sample was collected 7 minutes earlier on the rising leg and very near the peak of the hydrograph.

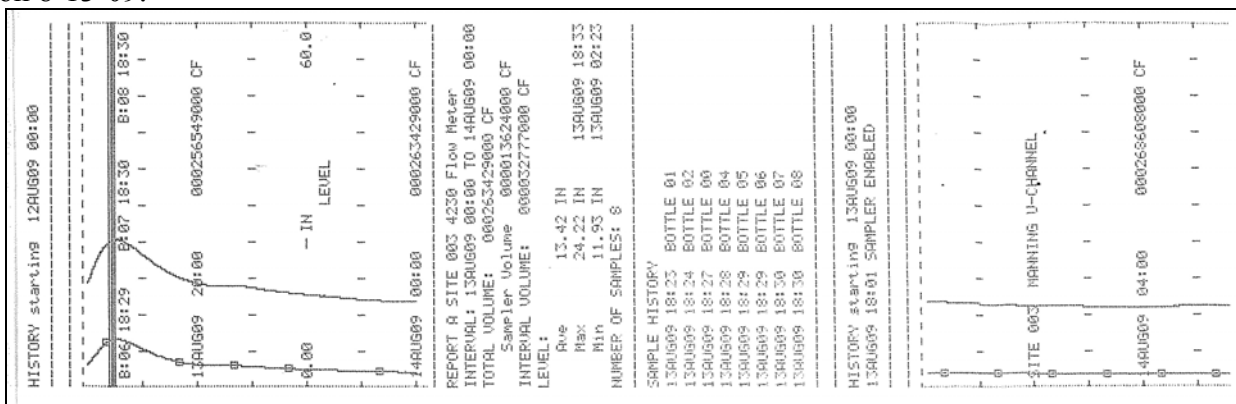
Figure 30 is a copy of the strip chart from the ISCO sampler at Otowi Bridge on 8-13-09.

Figure 30. ISCO Sampler Hydrograph and Sample Collection times for Rio Grande at Otowi Bridge on 8-13-09.

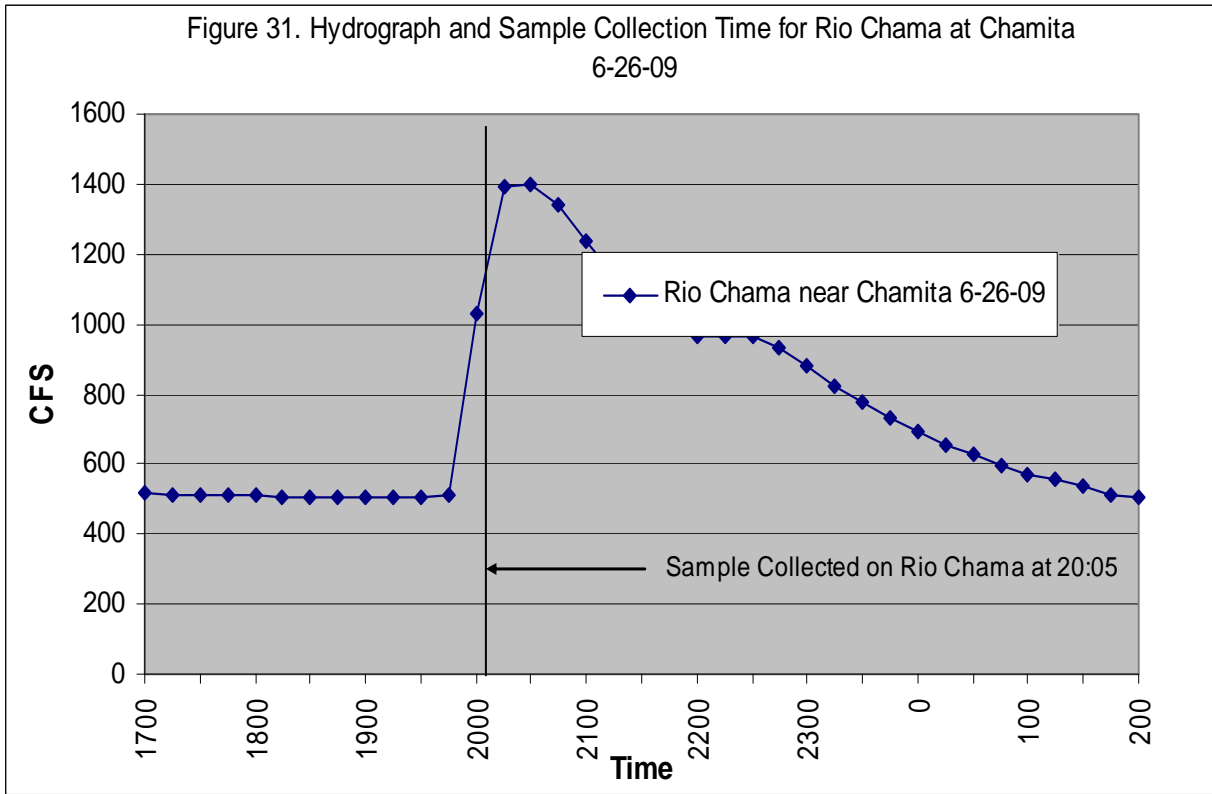
Figure 31 demonstrates flows in the Rio Chama at Chamita on 6-26-09. Flow at Chamita peaked at 20:30 and the sample was collected 25 minutes earlier on the rising leg and near the peak of the hydrograph.

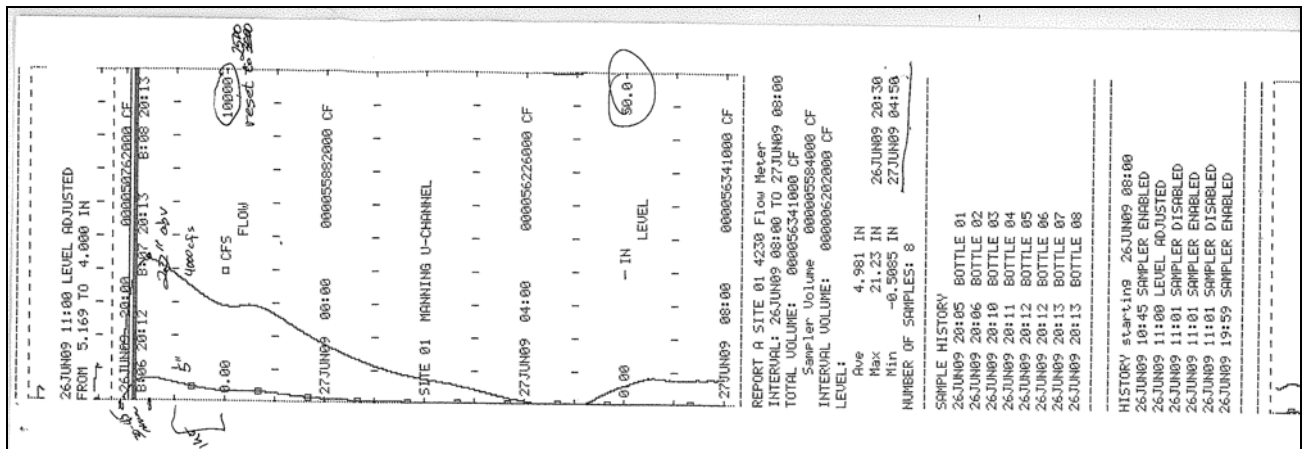
Figure 32 is a copy of the strip chart from the ISCO sampler at Rio Chama at Chamita on 6-26-09.

Figure 32. ISCO Sampler Hydrograph and Sample Collection times for Rio Chama at Chamita on 6-26-09.

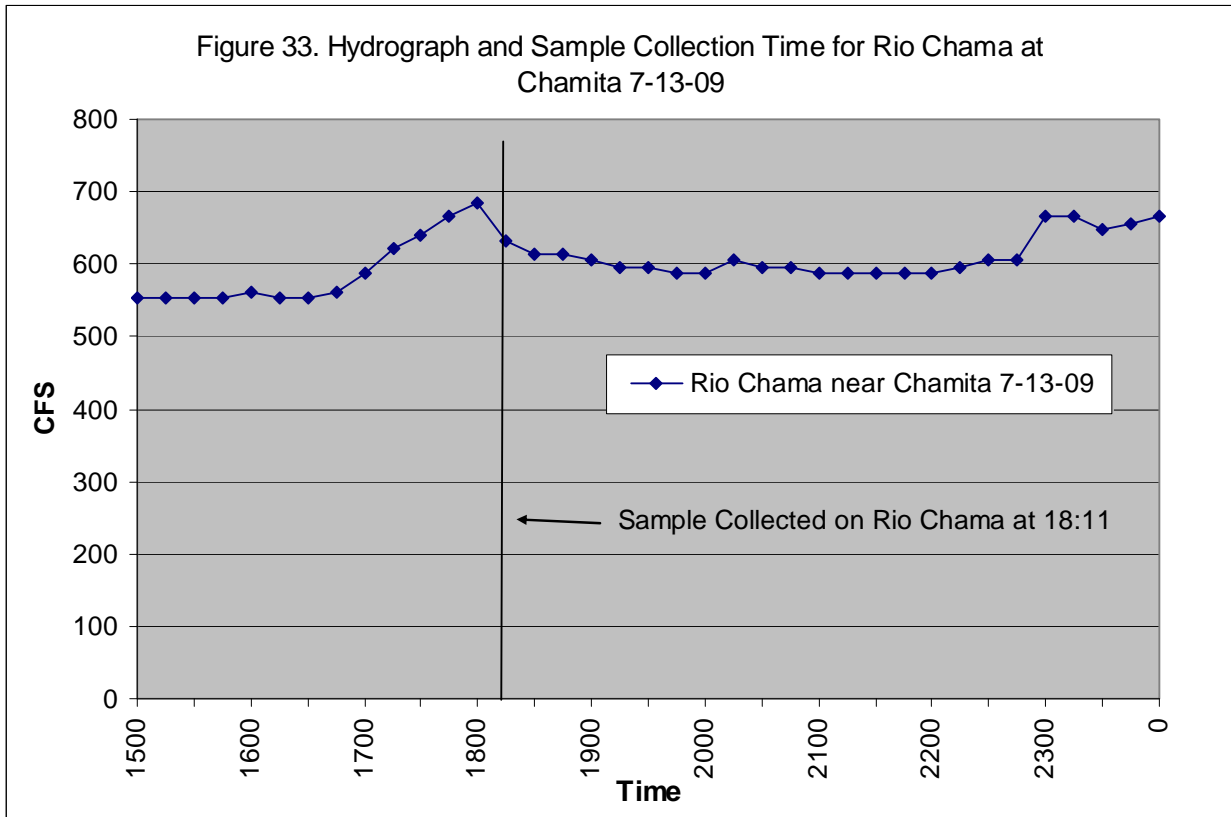
Figure 33 demonstrates flows in the Rio Chama at Chamita on 7-13-09. Flow at Chamita peaked at 18:00 and the sample was collected 11 minutes later on the falling leg of the hydrograph. This was a small flow event and the flows stopped increasing after an approximate 150 CFS increase.

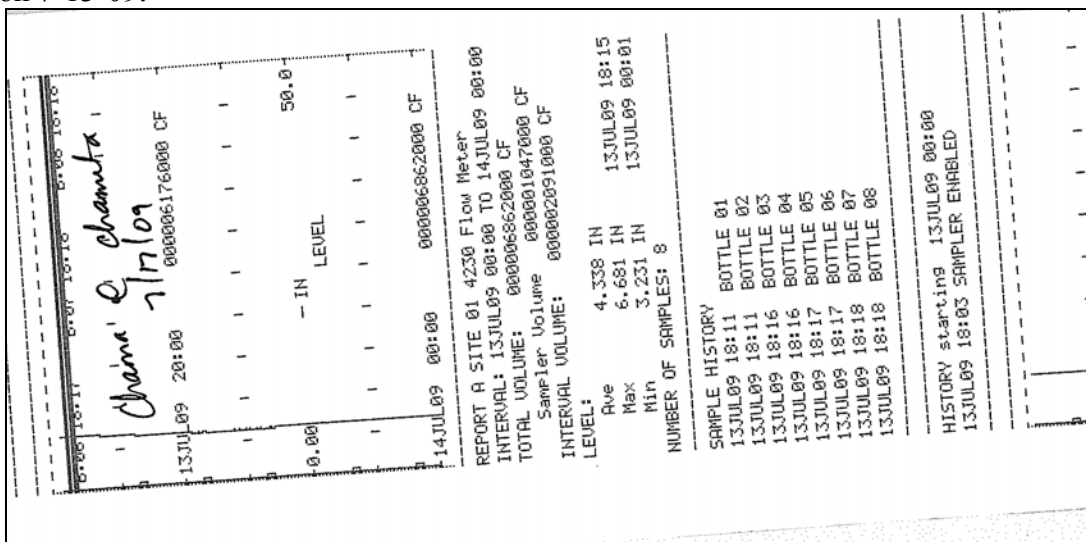
Figure 34 is a copy of the strip chart from the ISCO sampler at Rio Chama at Chamita on 7-13-09.

Figure 32. ISCO Sampler Hydrograph and Sample Collection times for Rio Chama at Chamita on 7-13-09.

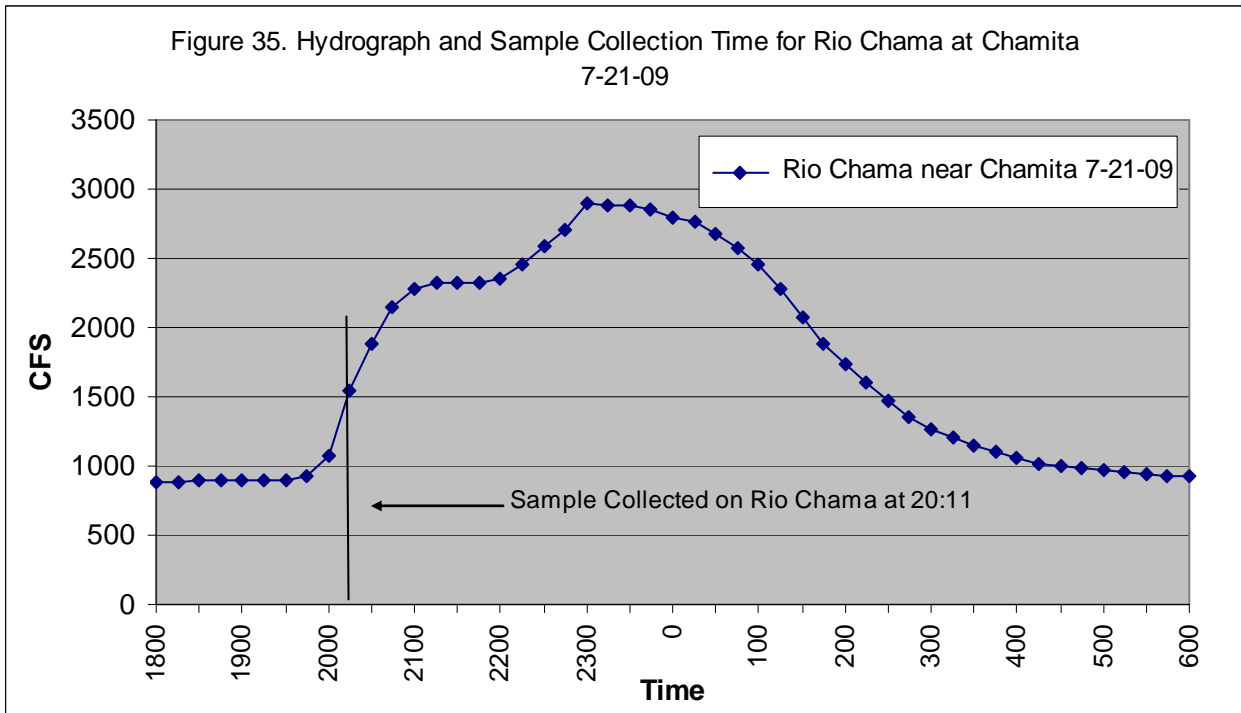
Figure 35 demonstrates flows in the Rio Chama at Chamita on 7-21-09. Flow at Chamita peaked at 23:00 and the sample was collected 2 hours and 49 minutes earlier at the beginning of the rising leg of the hydrograph.

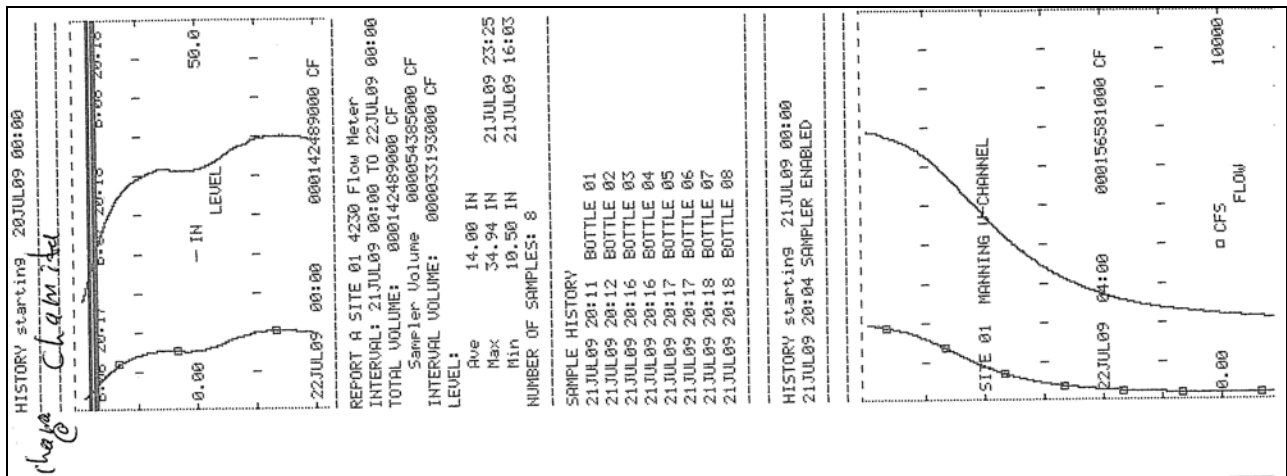
Figure 36 is a copy of the strip chart from the ISCO sampler at Rio Chama at Chamita on 7-21-09.

Figure 36. ISCO Sampler Hydrograph and Sample Collection times for Rio Chama at Chamita on 7-21-09.

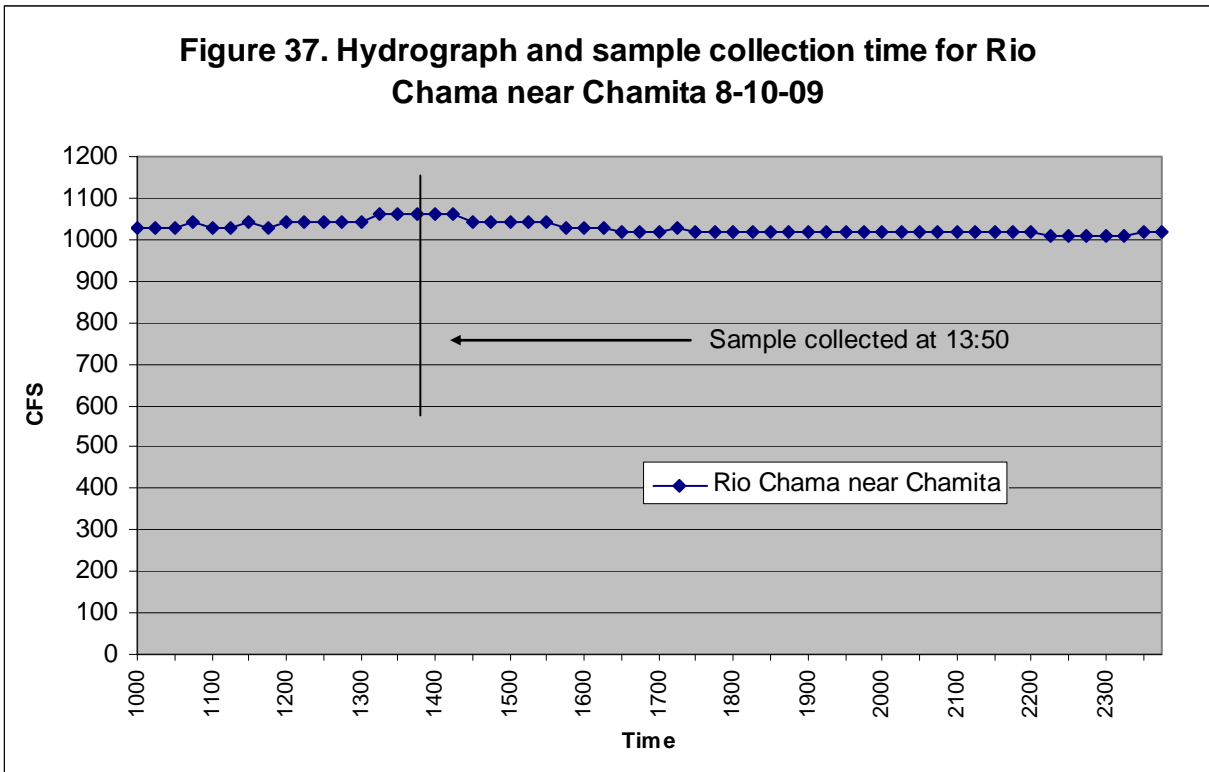
Figure 37 demonstrates flows in the Rio Chama at Chamita on 8-10-09. The sampler malfunctioned and initiated a sample with no apparent rise in discharge. Flow remained constant at Chamita on 8-10-09. No strip chart from the ISCO sampler at Rio Chama at Chamita on 8-10-09 is available.

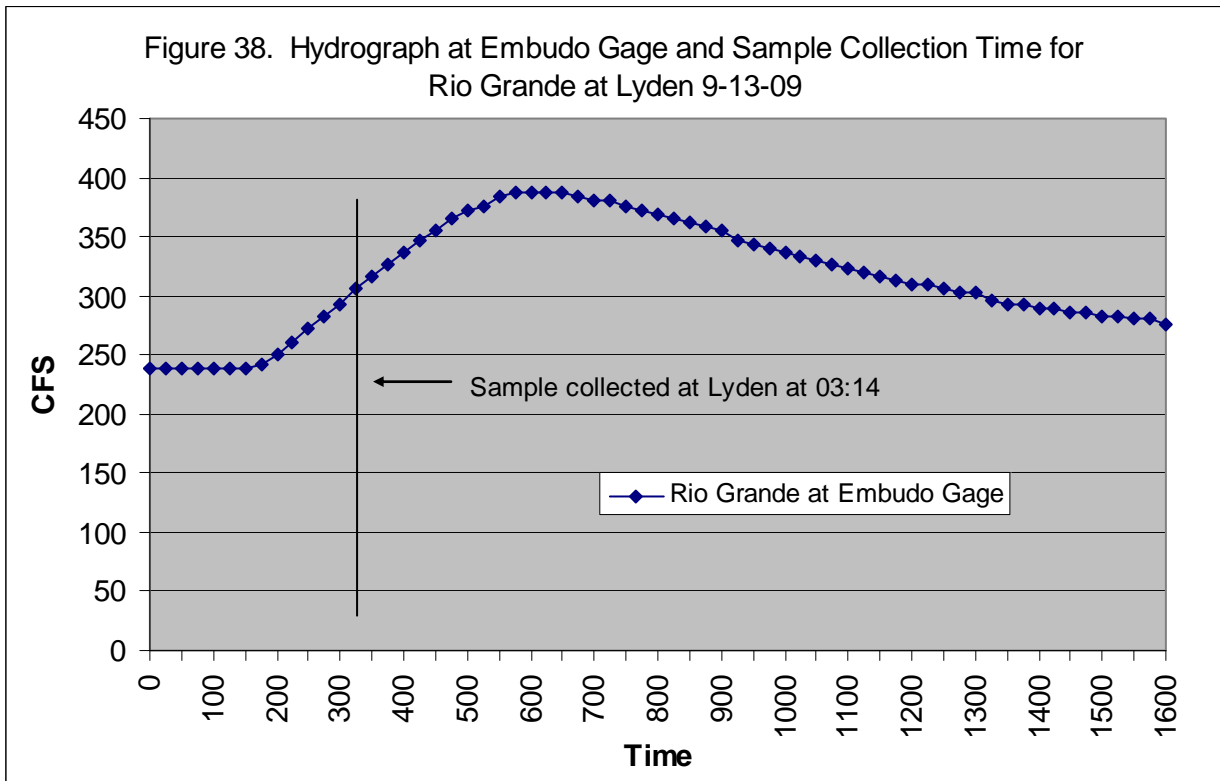
Figure 38 demonstrates flows in the Rio Grande at the Embudo gage on 9-13-09. Flow at the Embudo gage peaked at 05:45 and the sample was collected at Lyden 2 hour and 30 minutes earlier. The gage data shows a gradual 4 hour rise to peak of the hydrograph. There is approximately a 2 hour travel time between the gage at Embudo and the sampler at Lyden.

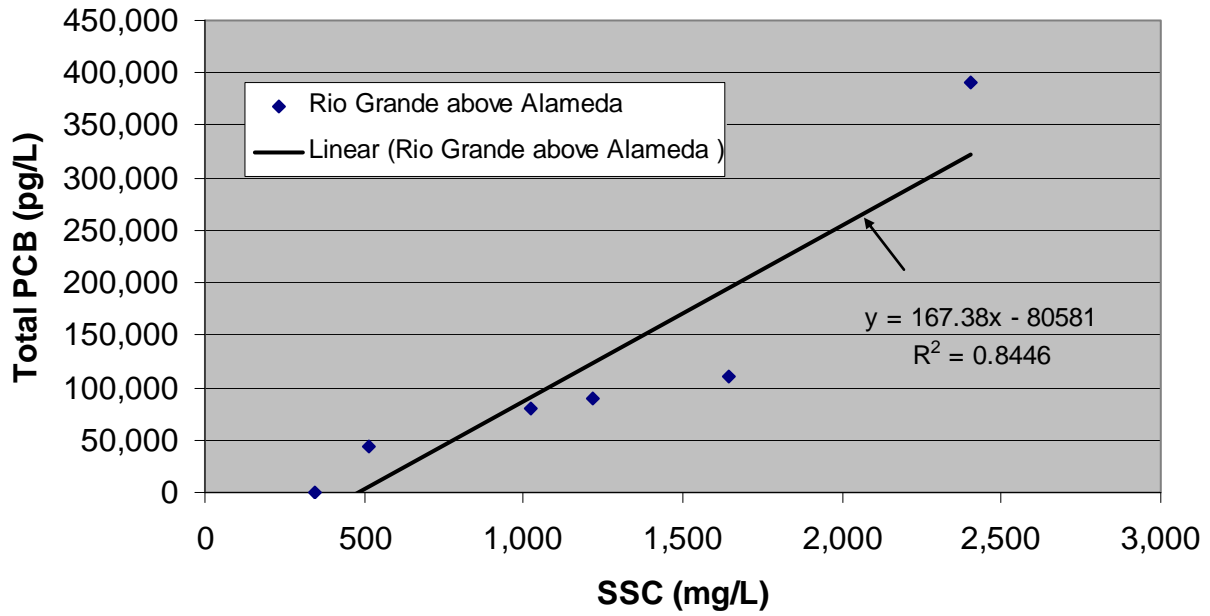
Figure 39. Pearson R² correlation between suspended sediment concentration and total PCB at Rio Grande above Alameda

In the case of Figure 39, the x and y are the concentrations of suspended sediments and total PCBs measured in six samples from the Rio Grande at Alameda. An R^2 value of 0.8442 or linear correlation coefficient r value of 0.919 was derived. The r value is greater than the critical value 0.917 for a significance level 0.01 for $n = 6$ (found in Table A-6. Critical Values of the Pearson Correlation Coefficient r , page 724 in Triola 1999) indicating a significant correlation at a 99% confidence level. A strong correlation exists suggesting that the equation (Total PCBs = $167.38 * (\text{SSC}) - 80581$) could be used to predict the concentration of one parameter if the other is known, i.e. total PCB concentration of a sample from similar circumstance could be predicted if the SSC is known.

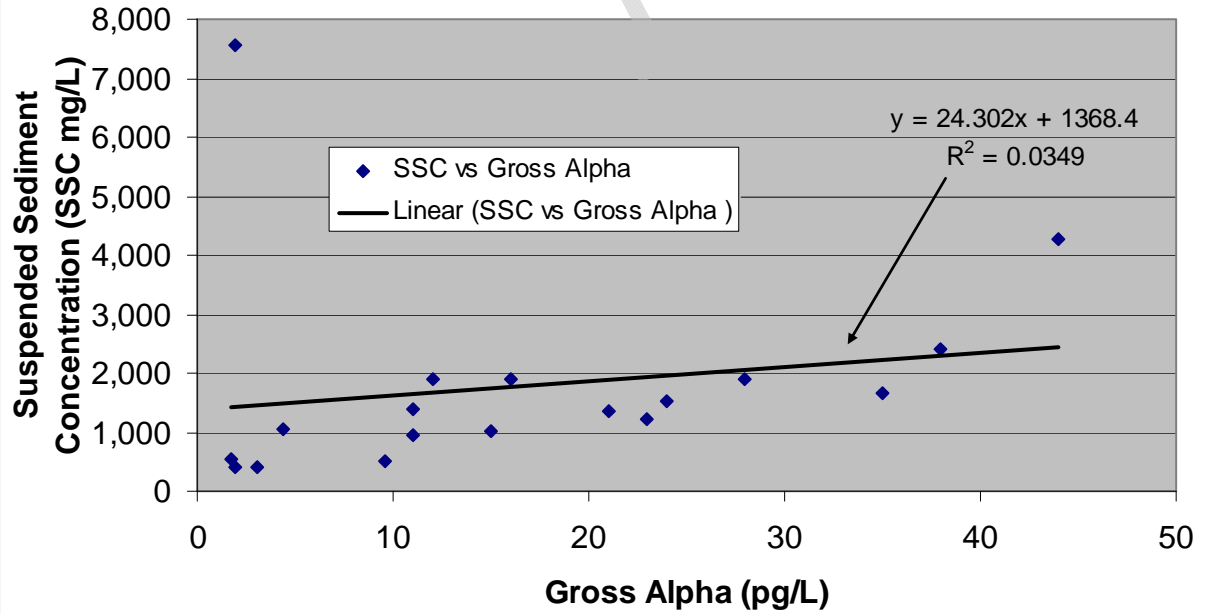
Figure 40. The Pearson R² correlation between suspended sediment concentration and gross alpha for all samples (including outlier with high sand content)

In the case described by Figure 40, it appears that a correlation may exist except for one pair of SSC and gross alpha measurements. Upon further examination of the particle size determinations, we found this sample contained a much larger content of sand than all the others.

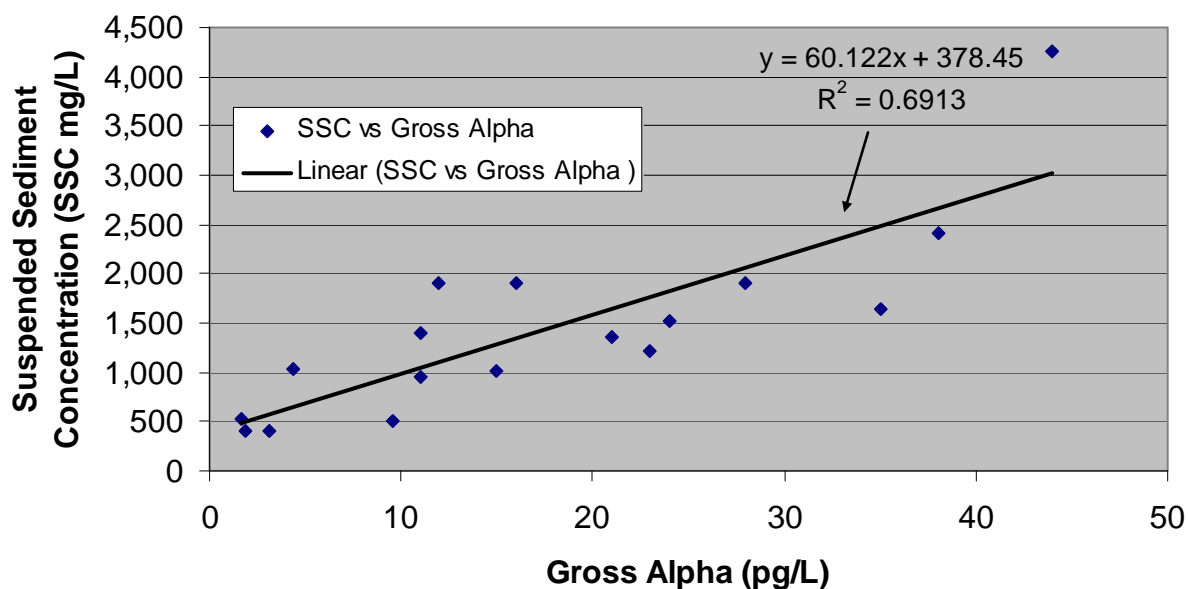
Figure 41. The Pearson R² correlation between suspended sediment concentration and gross alpha for all samples (excluding outlier with high sand content)

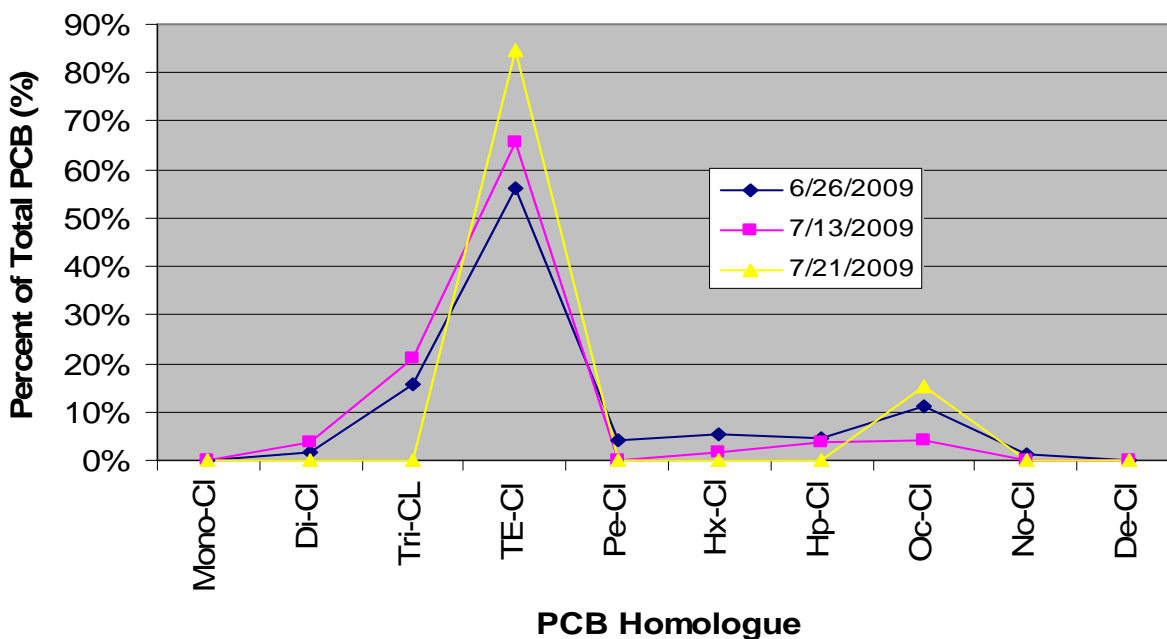
Figure 42. PCB Homologue Data from Storm Flow Samples Collected from the Rio Chama at Chamita Location

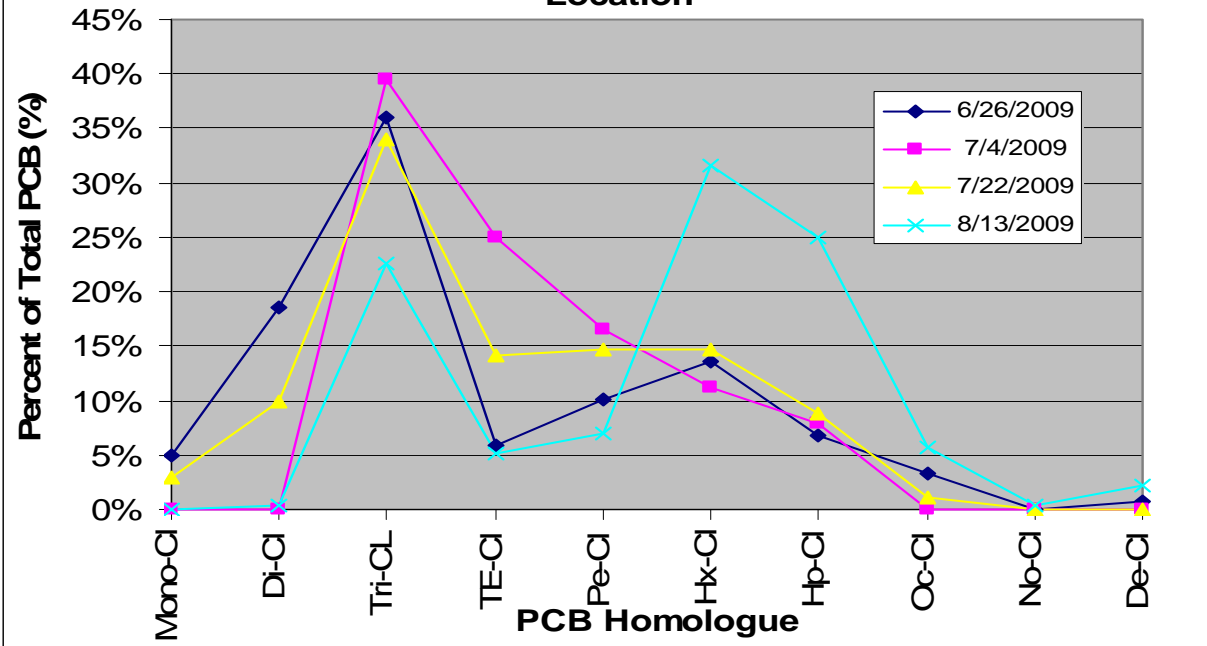
Figure 43. PCB Homologue Data from Storm Flow Samples Collected from the Rio Grande at Otowi Bridge Location

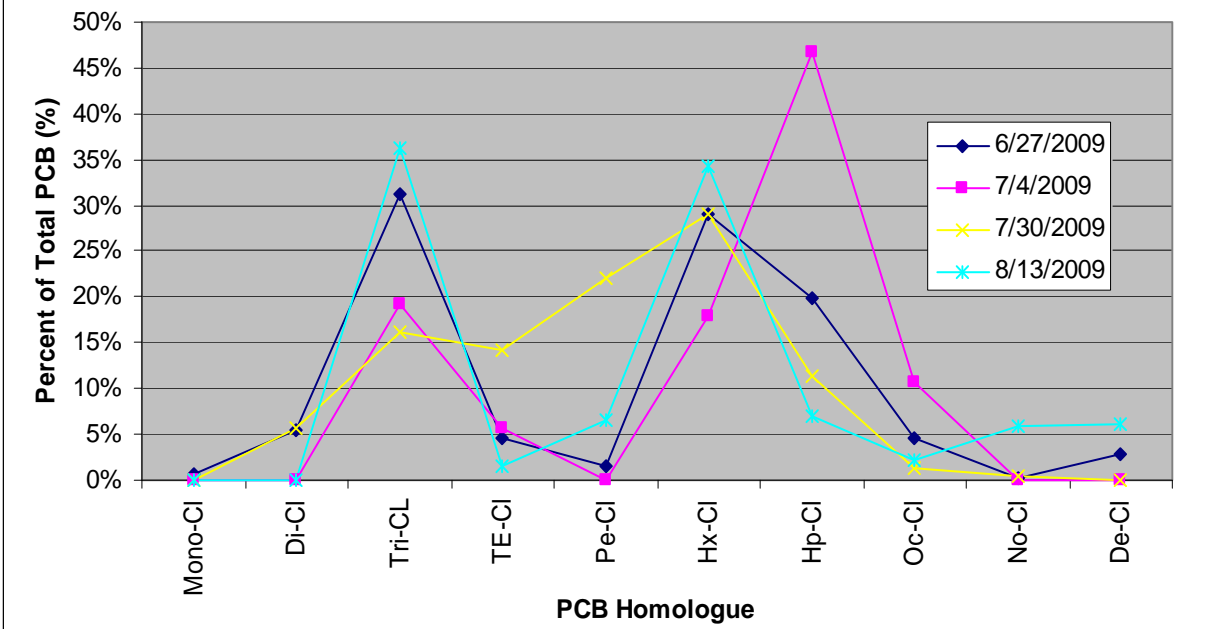
Figure 44. PCB Homologue Data from Baseline and Storm Flow Samples Collected from the Rio Grande at Buckman Landing Location

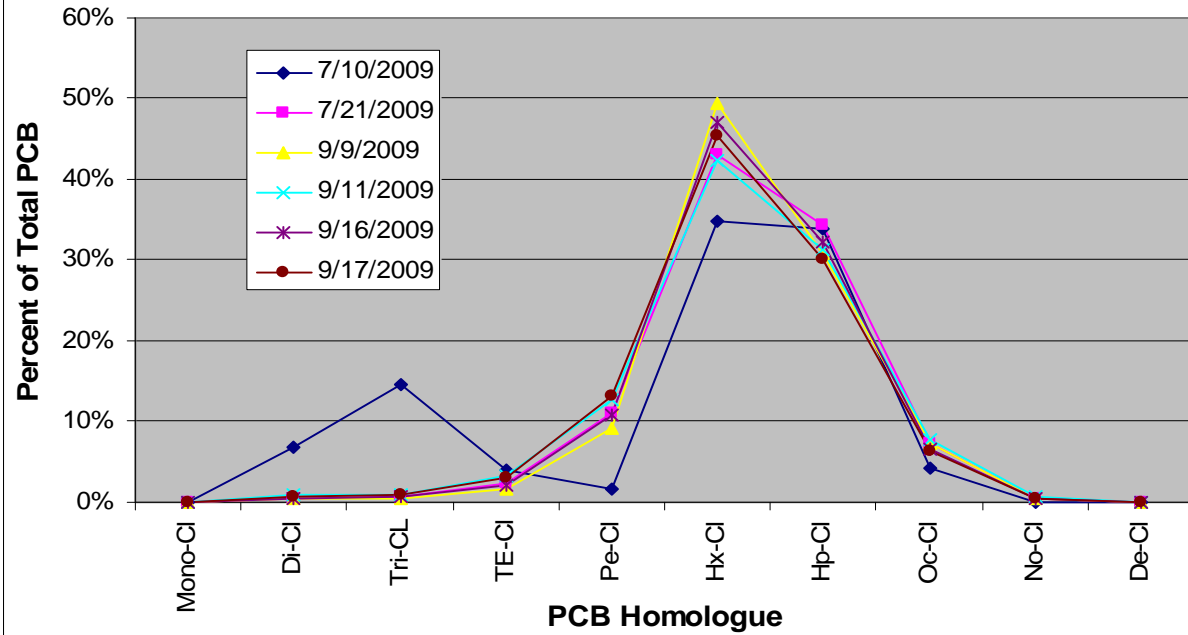
Figure 45. PCB Homologue Data from Baseline and Storm Flow Samples Collected from the Rio Grande above Alameda Location

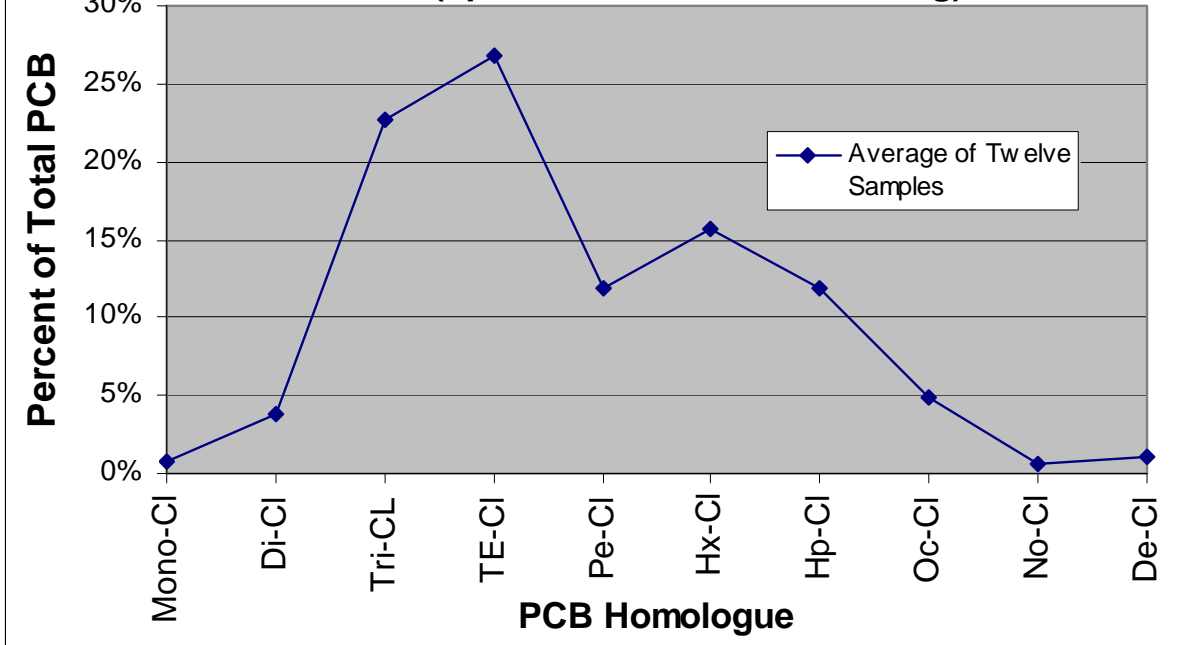
Figure 46. PCB Homologue Data from Storm Flow Samples Collected from the Rio Grande and Chama River Locations (upstream of Buckman Landing)

4. The PCB homologue patterns found at Rio Grande above Alameda suggest that the PCBs found there are from a different source than those found upstream of Buckman Landing

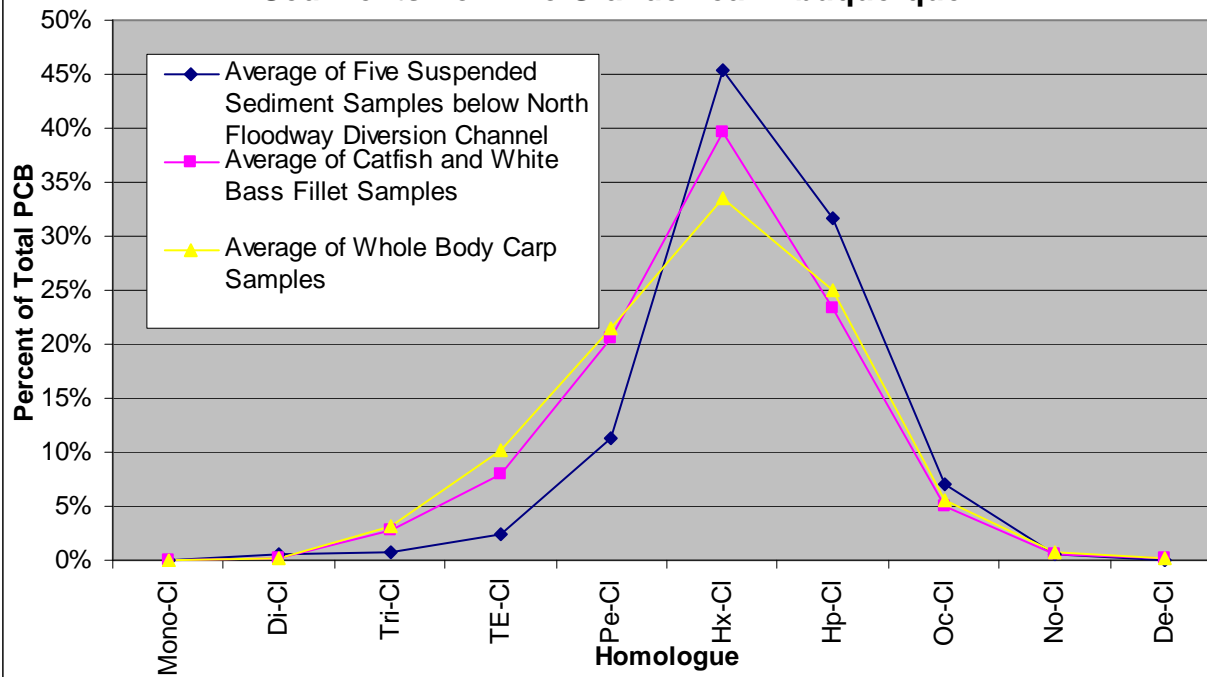
Figure 48. PCB Distribution in Fish Tissue and Suspended Sediments from Rio Grande near Albuquerque

We also compared the PCB homologue patterns in suspended sediment from storm flow samples collected from the Rio Grande above Alameda to PCB homologue patterns found in fish tissue samples collected by SWQB in 2007 and 2008 (unpublished data). Figure 48 shows a similar homologue pattern in fish tissue and the suspended sediments found in storm flow.

6. The PCB homologue patterns found at Rio Grande above Alameda are similar to those found in fish tissue samples collected from the Rio Grande near Albuquerque.

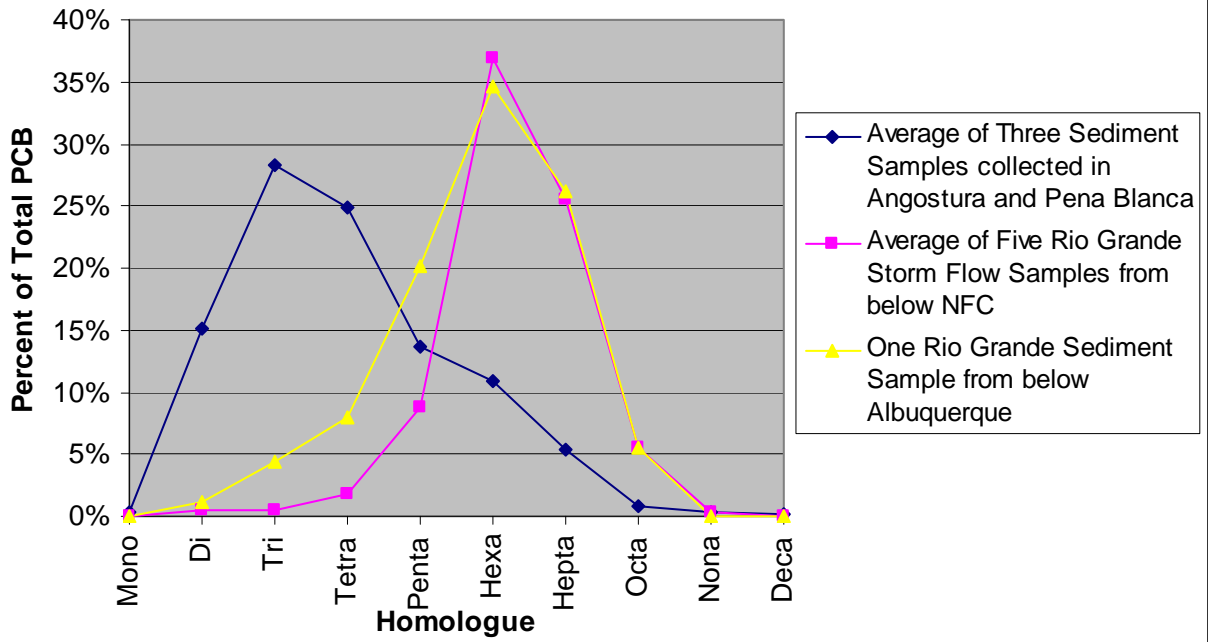
Figure 49. PCB Distribution in Rio Grande Sediments and Storm Flow Samples from Rio Grande above Alameda

We also compared the suspended sediment PCB values in Rio Grande above Alameda storm flow samples to the values found in sediment deposits from the Rio Grande collected during a 2002 – 2003 LANL and NMED Cooperative PCB study (unpublished data). In that study, sediment samples were collected from six locations along the Rio Grande from Embudo south to Albuquerque. Locations included Rio Grande at Embudo, Otowi Bridge, near White Rock (below Ancho Canyon), Peña Blanca, Angostura Diversion, and below Albuquerque (upstream of I-25). These sediment samples were collected with bias towards the finest grained sediments available at each location. One additional sample of sediments from the Rio Grande at Angostura Diversion was collected by the Surface Water Quality Bureau (SWQB) in 2005 (unpublished data) and is included in the assessment illustrated in Figure 49. Using only data from upstream of the Rio Grande above Alameda location, we generated a reference value of 1,035 pg/g total PCB based on the mean plus 2 standard deviations of the data set for the upstream sediments in the Rio Grande. This reference value represents the largest probable value, at a 95% confidence level, for PCB in sediments for the data set from the upstream locations in the Rio Grande. The mean concentration of total PCB in suspended sediment (calculated) of the five storm flow samples from the Rio Grande above Alameda from this study is 93,184 pg/g which is 90 times the generated reference value. This also suggests that the PCB levels in suspended sediment from storm flow samples collected from the Rio Grande above Alameda are not representative of Rio Grande sediments previously collected.

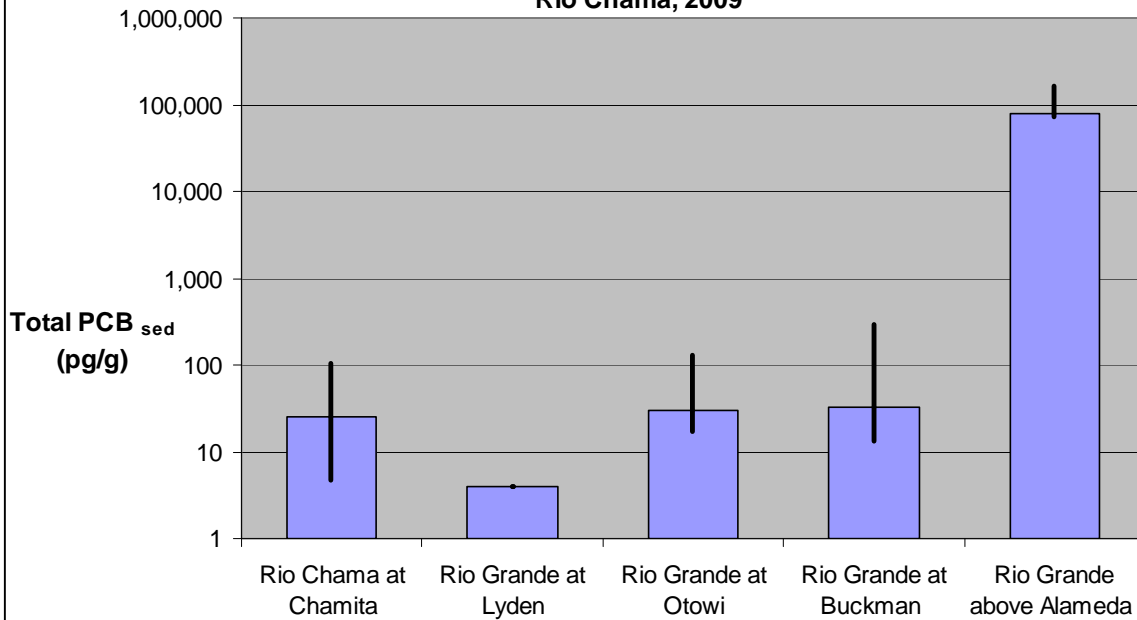
Figure 50. PCB Concentration in Suspended Sediments of the Rio Grande and Rio Chama, 2009

Column height indicates the median
Error bars indicate the range
