**WASTE MANAGEMENT DIVISION  
RCRA ENFORCEMENT OFFICE  
RCRA COMPLIANCE EVALUATION INSPECTION REPORT**

**Purpose:** RCRA Compliance Evaluation Inspection (CEI)

**Facility Location:** Siemens Industries, Inc.  
2523 Mutahar Street  
Parker, AZ 85344

**Date of Investigation:** March 7, 2012

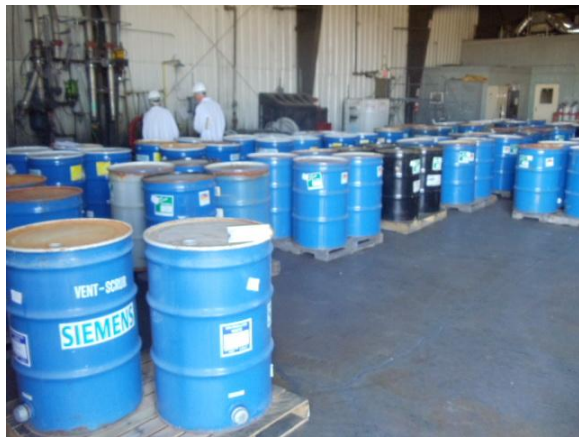
Photo #3: Numerous 55-gallon containers of spent carbon (26 hazardous waste storage containers; rest are nonhazardous) in the IS container storage area.

The inspector noted that all 55-gallon hazardous waste spent carbon containers (see Photos #3 through 7) were structurally sound, closed, labeled with the words “hazardous waste,” and marked with accumulation start dates. The earliest accumulation start date noted was approximately six weeks before the date of the CEI.

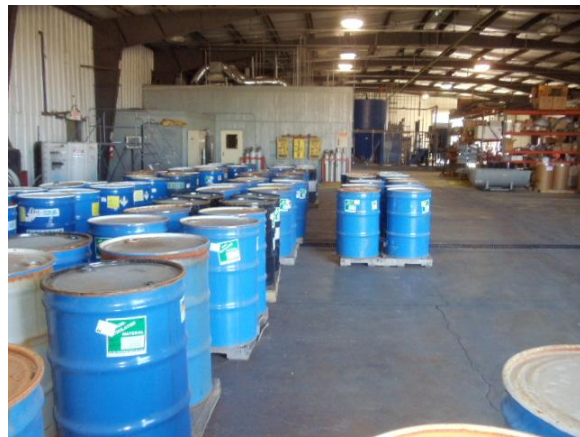
Photo #4: Another view of the 55-gallon spent carbon storage containers in the IS container storage area.

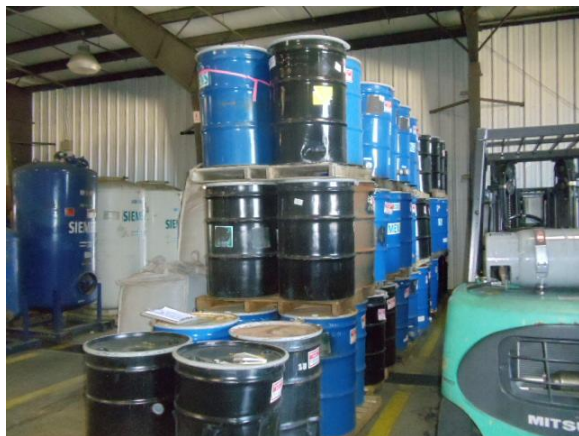
Photo #11: 76, 55-gallon hazardous waste storage containers holding filter press cake in IS container storage area.

The inspector noted that all 76, 55-gallon hazardous waste filter press cake storage containers (see Photos #11 through 14) were closed, labeled with the words “hazardous waste,” and marked with accumulation start dates. The earliest accumulation start date noted was approximately four weeks before the date of the CEI. One of these containers (see Photos #13 & 14) was significantly dented. No leaks or spills were observed from this container, but the inspector determined that this container was not in good condition. All other containers appeared to be in good condition.

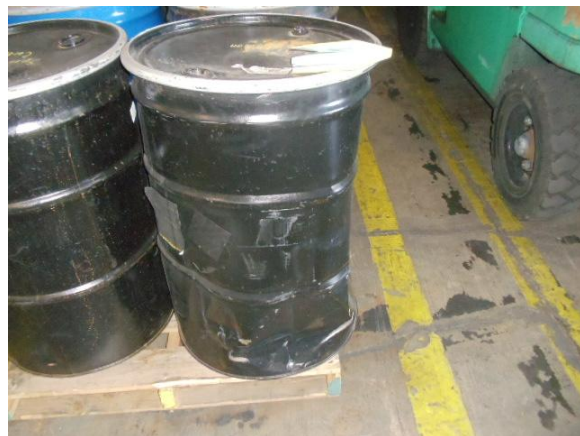
Photo #13: View of hazardous waste storage container on bottom right in Photo #11. The container is not in good condition (dented).

**Findings:** One hazardous waste storage container holding hazardous filter cake was observed to be in poor condition (dented container).

Note: Facility personnel emptied the filter press cake from the dented container shown in Photos #13 & 14 into an undamaged hazardous waste storage container during the CEI. The dented container was triple-rinsed and placed in the empty container storage area for disposal (see Photos #15 & 16 below).

**Note:** Facility representatives transferred the hazardous waste out of the dented storage container during the CEI. See walkthrough section of this report for further information on the facility response.

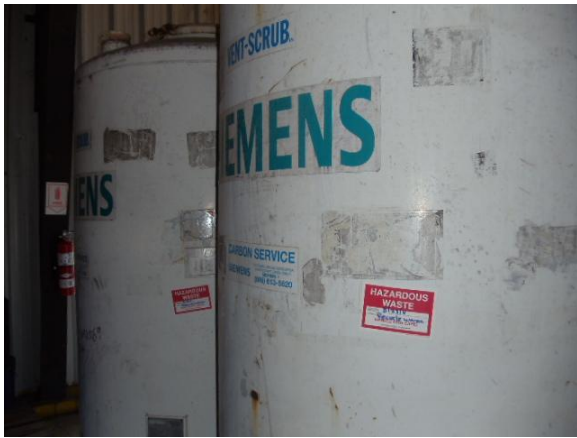
Photo #21: Portable tanks holding hazardous excess recycle water in the IS container storage area.

The two portable tanks holding hazardous recycle water (see Photos #21 & 22) were structurally sound, labeled with the words “hazardous waste,” and marked with accumulation start dates of August 23, 2011. The two portable tanks holding hazardous waste spent carbon and clusters (see Photos #23 through 25) were structurally sound, labeled with the words “hazardous waste,” and marked with accumulation start dates of August 29, 2011 and January 13, 2012.

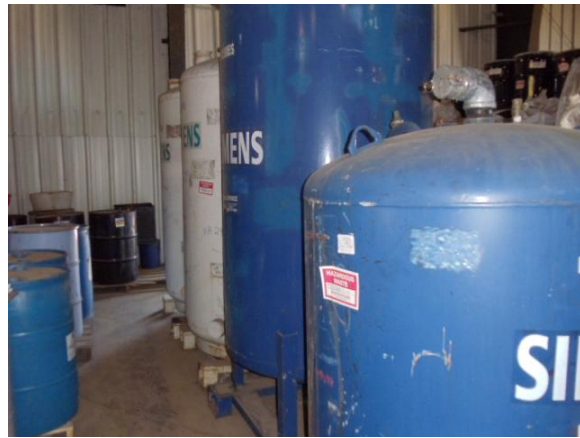
Photo #23: Portable tanks holding hazardous waste spent carbon and clusters in the IS container storage area.

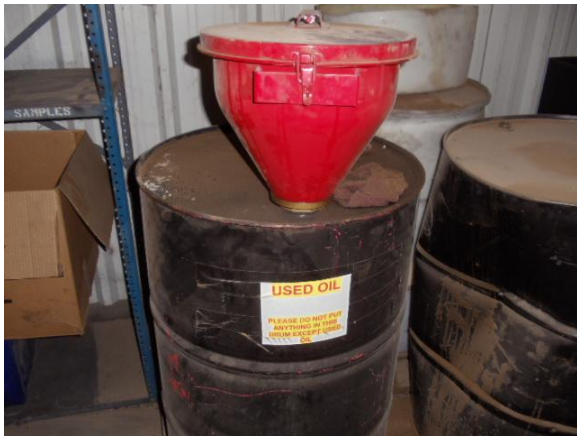
Photo #26: Used oil storage container in the IS container storage area.

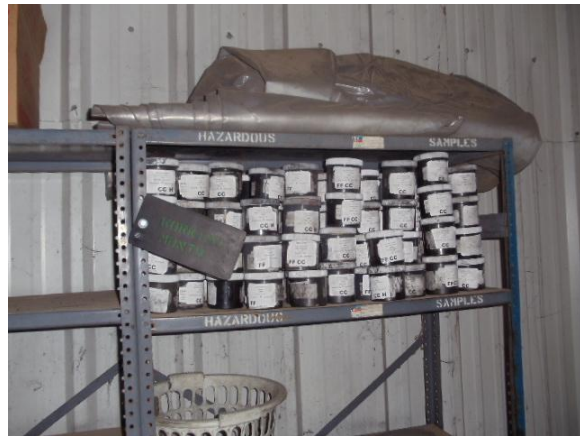
Photo #27: Hazardous spent carbon retain samples in the IS container storage area.

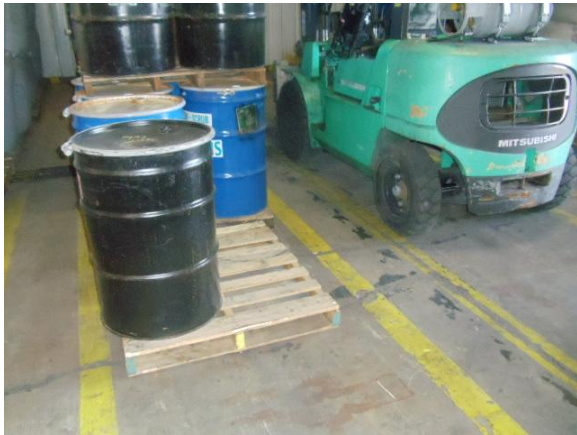
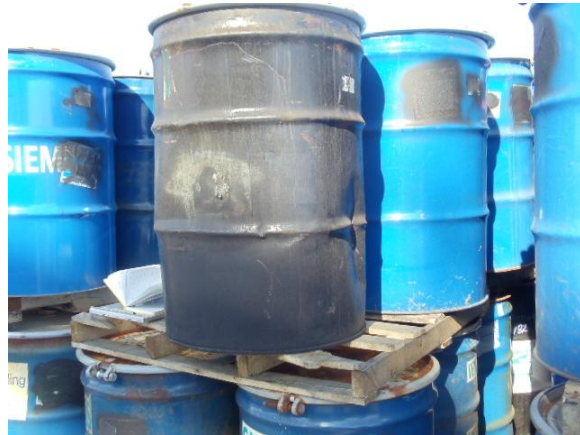
Photo #15: Dented container shown in Photo #13 after facility personnel emptied sludge, rinsed the container, and placed the container in the empty container storage area.

Photo #16: Facility personnel emptied sludge from the dented container shown in Photo #13, triple rinsed the container, and placed it in the empty container storage area.

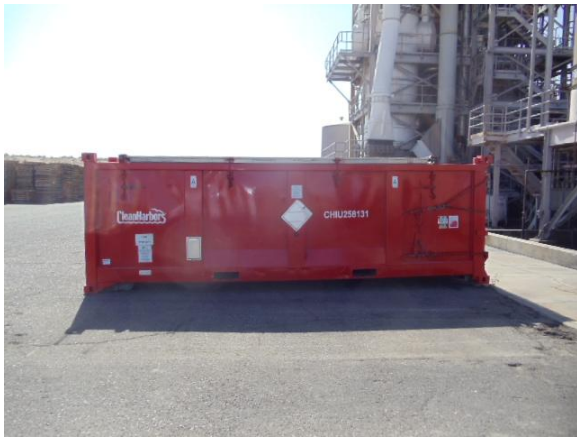
Photo #40: 90-day hazardous waste storage container of debris near Hopper H-1.

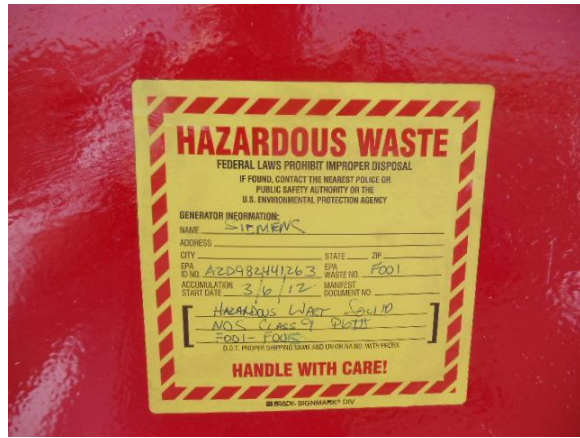
Photo #42: View of the label on the hazardous waste storage container shown in Photo #40.

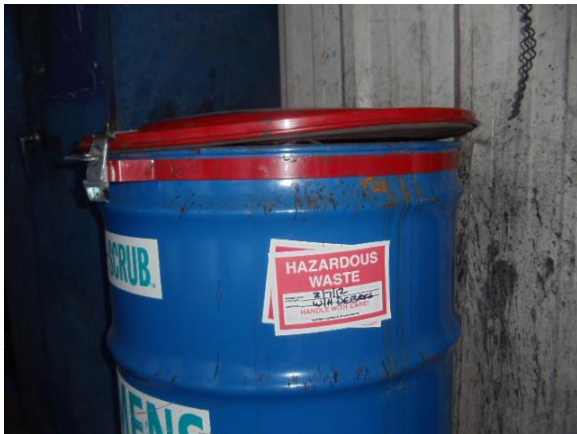
Photo #48: Warehouse Loading Area satellite accumulation container; lid is damaged and will not close.

**Findings:** *One (1) of five (5) satellite accumulation containers (Warehouse Loading area) was not closed.*

Note: Facility representatives replaced the damaged satellite accumulation container lid during the CEI with a lid that closed the container (see Photo #50).

**Note:** *Facility representatives closed the satellite accumulation container during the CEI. See walkthrough section of this report for further information on the facility response.*

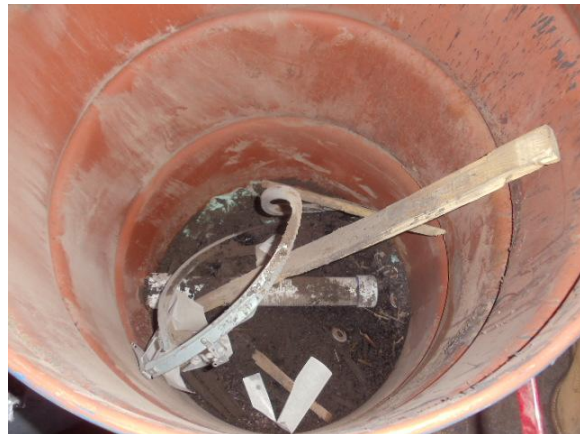
Photo #49: View inside of the satellite accumulation container shown in Photo #48.

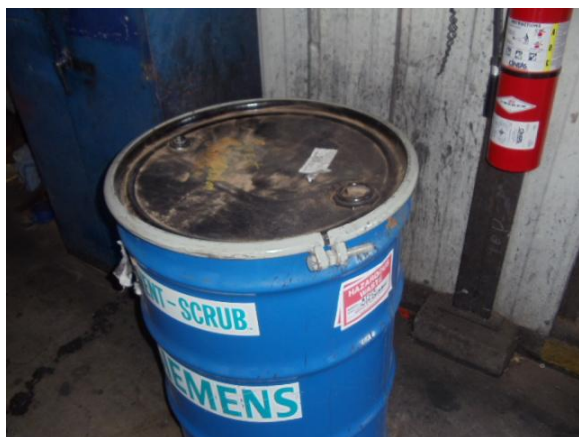
Photo #50: Satellite accumulation container shown in Photo #48 after facility representatives replaced the lid.

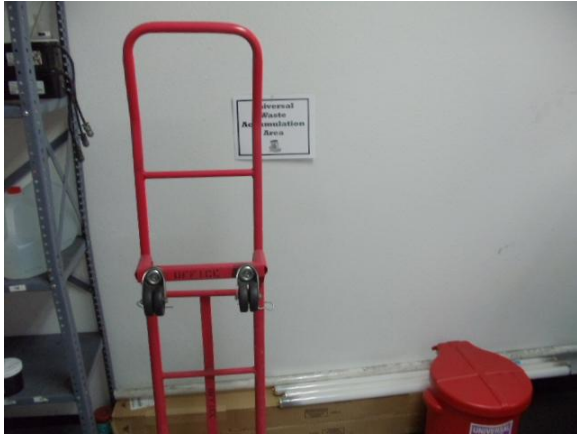
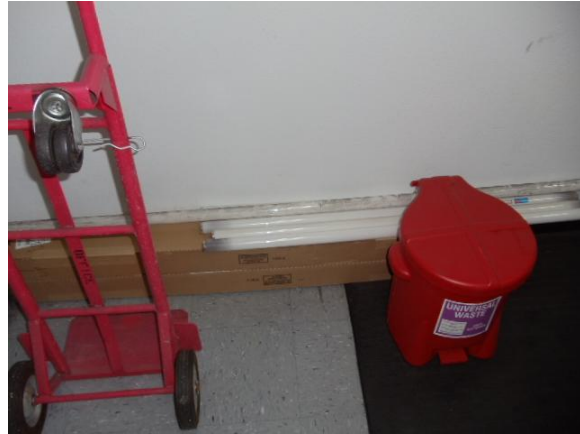
Photos #54 & 56: View of universal waste batteries storage container (red container), two unlabeled and undated/tracked universal waste lamps storage containers, and five uncontainerized universal waste lamps in the Testing Lab.

**Findings:** *Five universal waste lamps in the Testing Lab were not stored in containers.*

**Findings:** Two (2) of two (2) universal waste lamps storage containers in the Testing Lab were not labeled with the specific wording “universal waste – lamp(s)” or “waste lamp(s)” or “used lamp(s).”

***Findings:*** *None of the universal waste lamps accumulating in the Testing Lab were dated or otherwise tracked to demonstrate length of time of accumulation.*

Note: Facility representatives placed the “loose” universal waste lamps in a storage container, and labeled all three universal waste lamps storage containers with the words “universal waste used lamps” and an accumulation start date of June 30, 2011 during the CEI (see Photos 57 through 60).

**Note:** *Facility representatives containerized the five universal waste lamps during the CEI. See walkthrough section of this report for further information on the facility response.*

**Note:** Facility representatives labeled the two universal waste lamps storage containers during the CEI. See walkthrough section of this report for further information on the facility response.

***Note:*** *Facility representatives marked an accumulation start date on the universal waste lamps storage containers during the CEI. See walkthrough section of this report for further information on the facility response.*

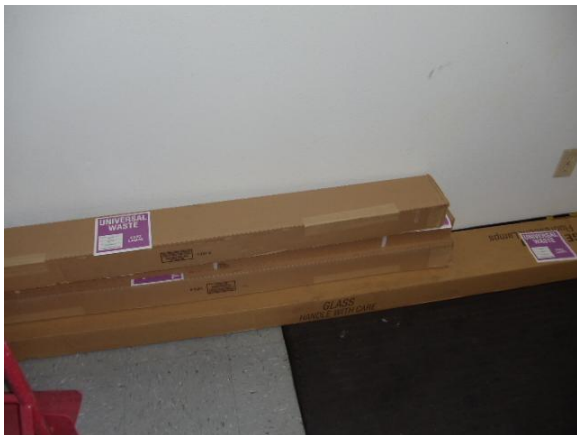
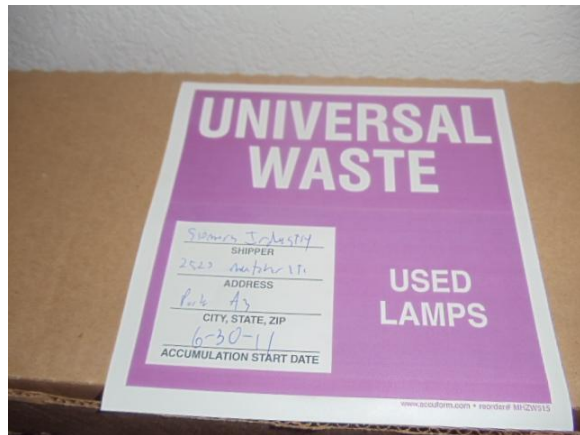
Photos #57 & 60: View of the universal waste lamps storage containers and a close-up of the labeling after facility representatives containerized, labeled, and dated the universal waste lamps during the CEI.
