Practical Considerations for Citizen Science Studies In the Field

Lessons Learned in implementing the 2015 Ironbound citizen science study

Ironbound Citizen Science Air Monitoring Project

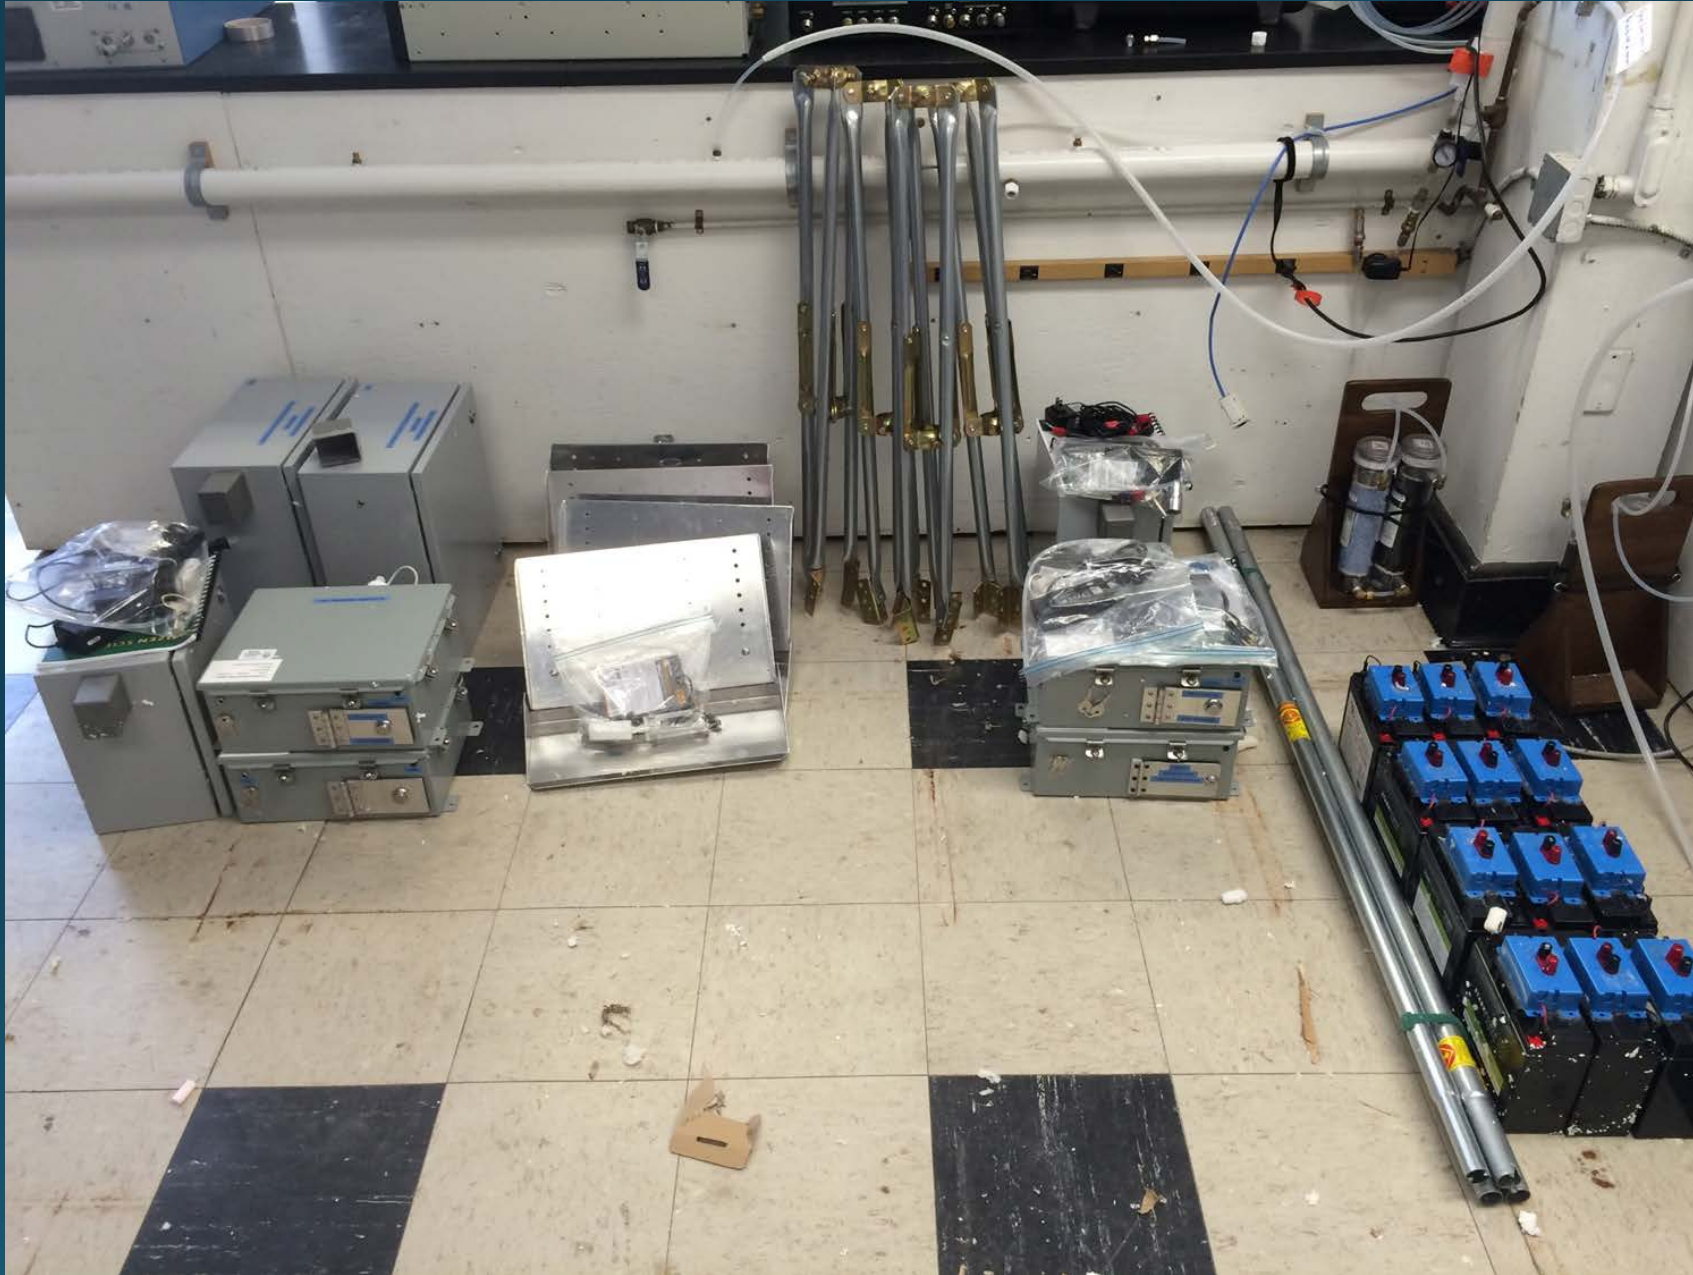
Boxes unpacked.

4 complete CSAM units.

Note lack of boxes/containers to transfer samplers to contractors (ICC) or to ship samplers from site to site

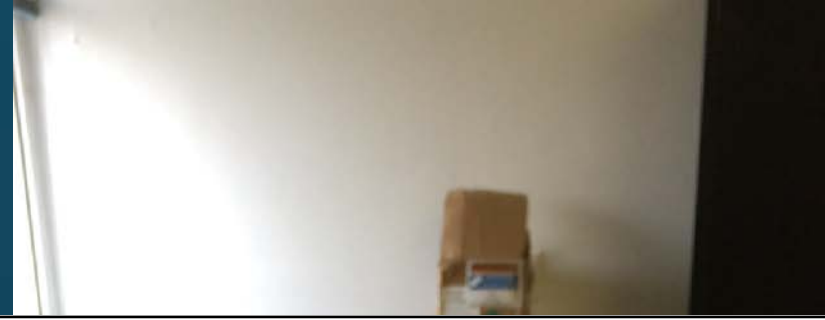
Video of Lack of Tripod
Stability. Mouse Over
the Picture and Press
Play

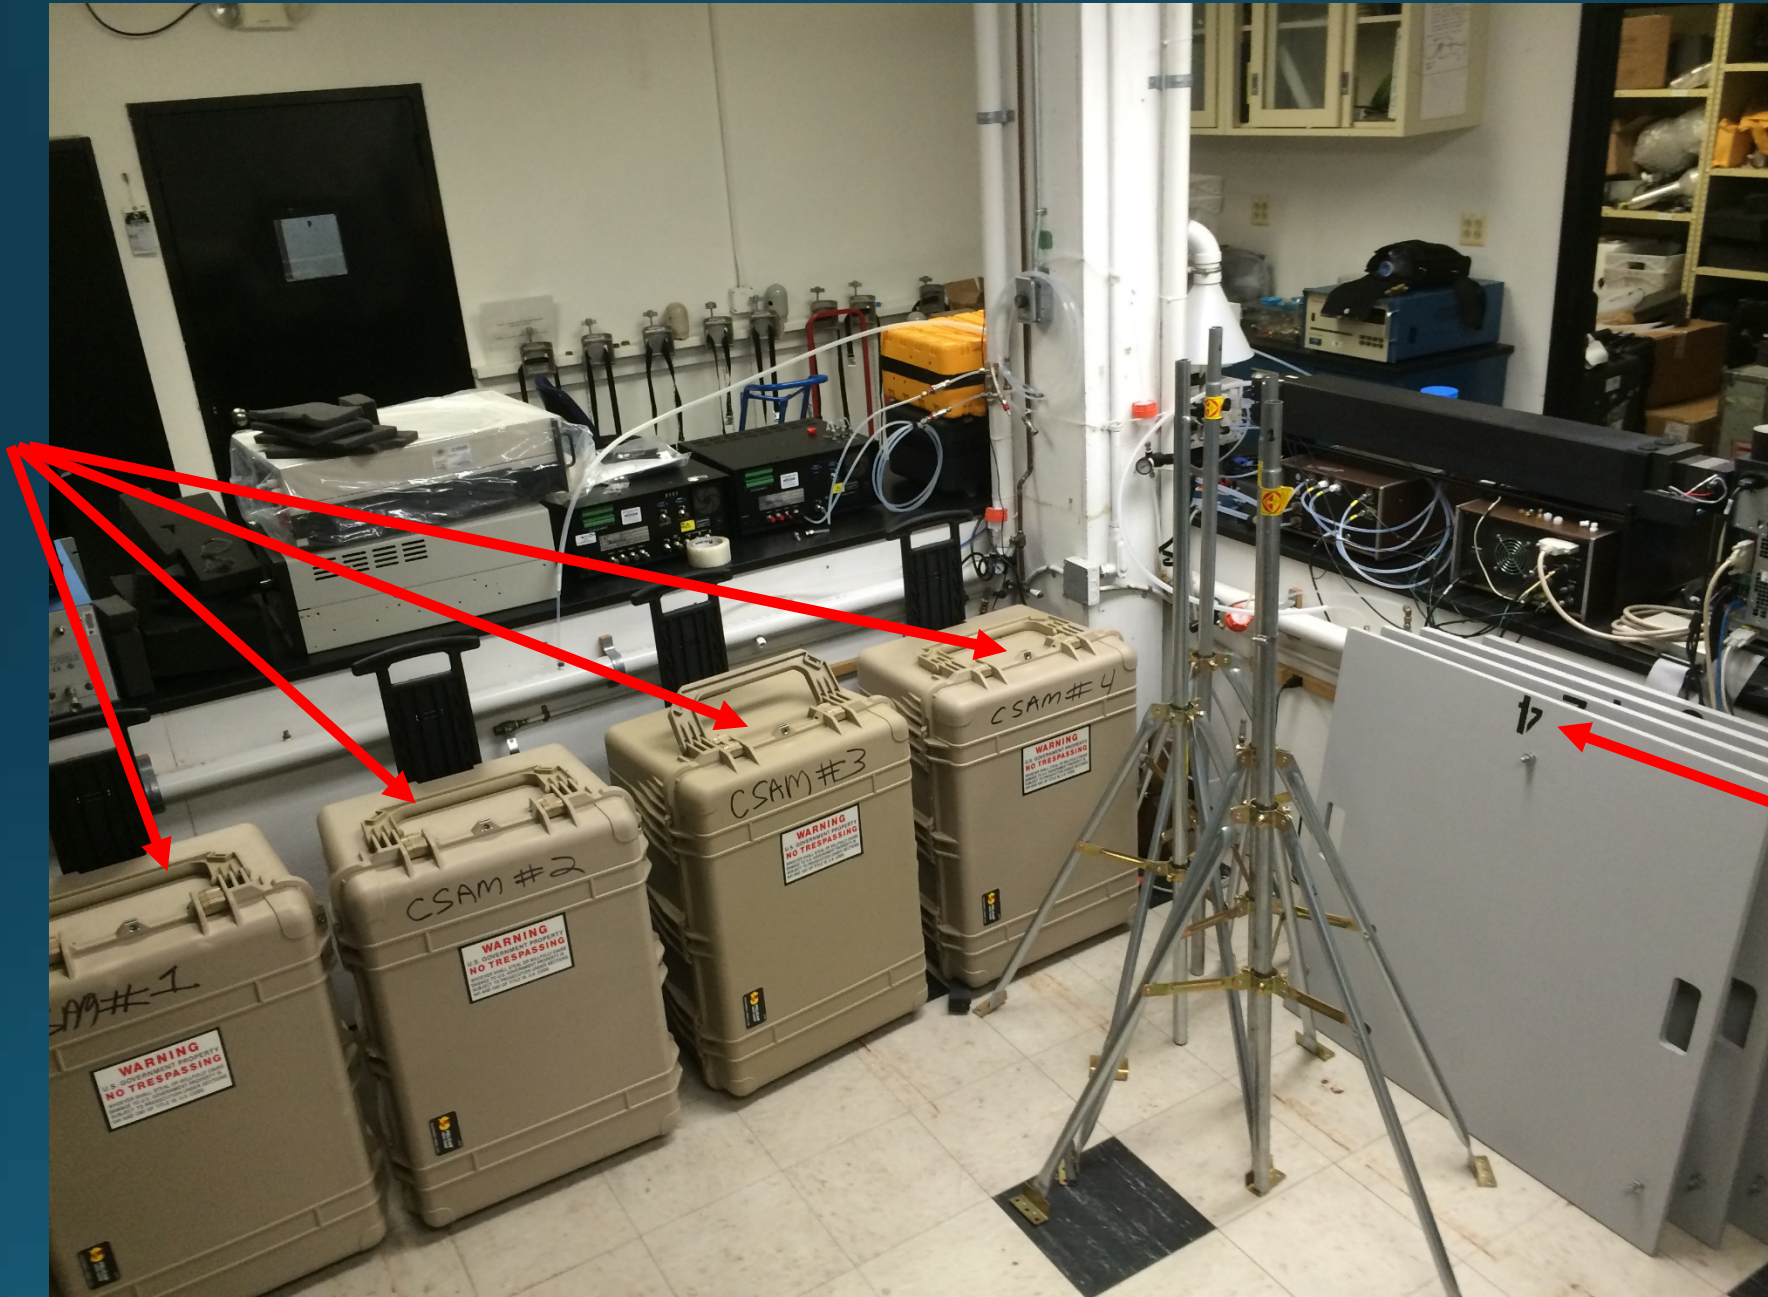
Pelican 1660 cases

5/8" marine plywood, sanded, painted, with added mounting hardware and handhold cutouts (4 units)

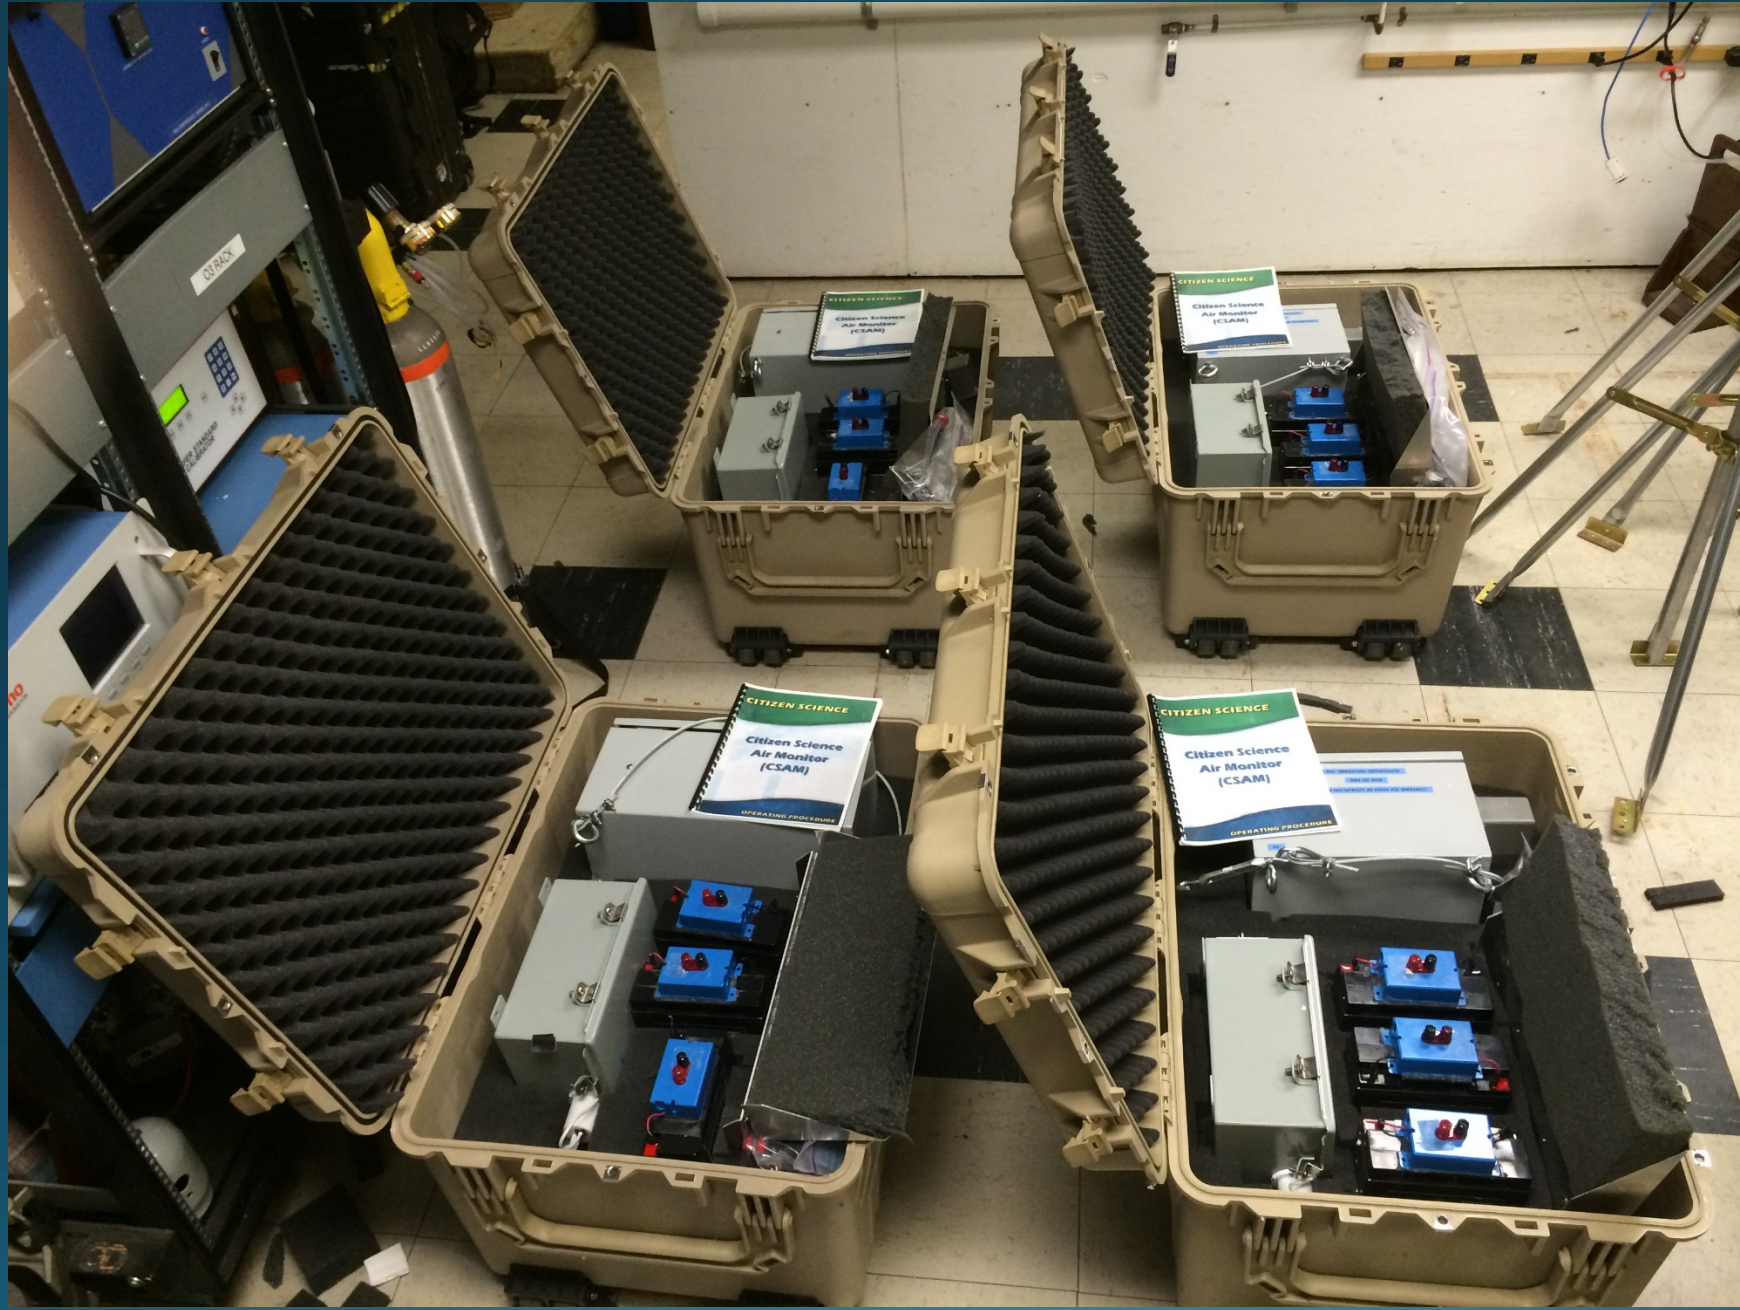
Inside view of
Pelican 1660
cases

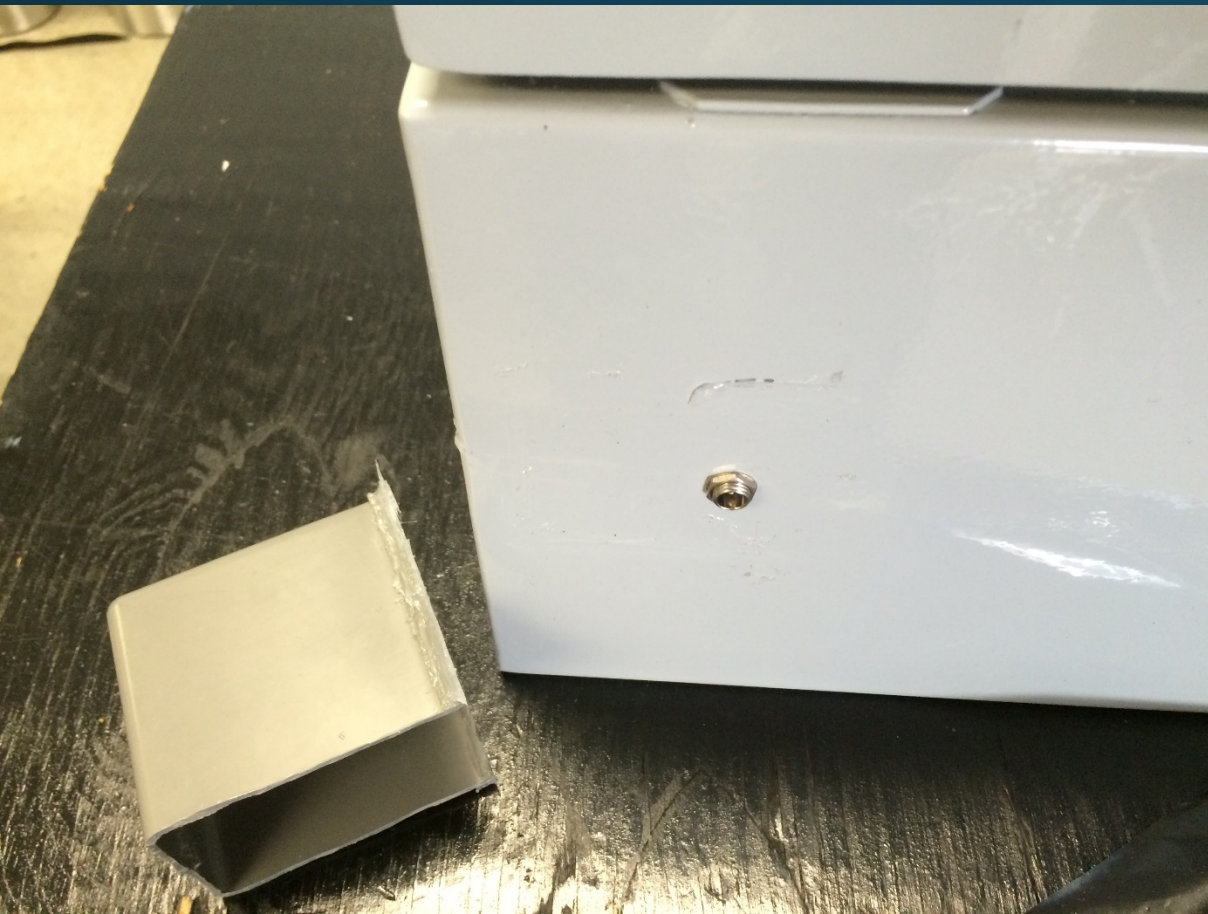
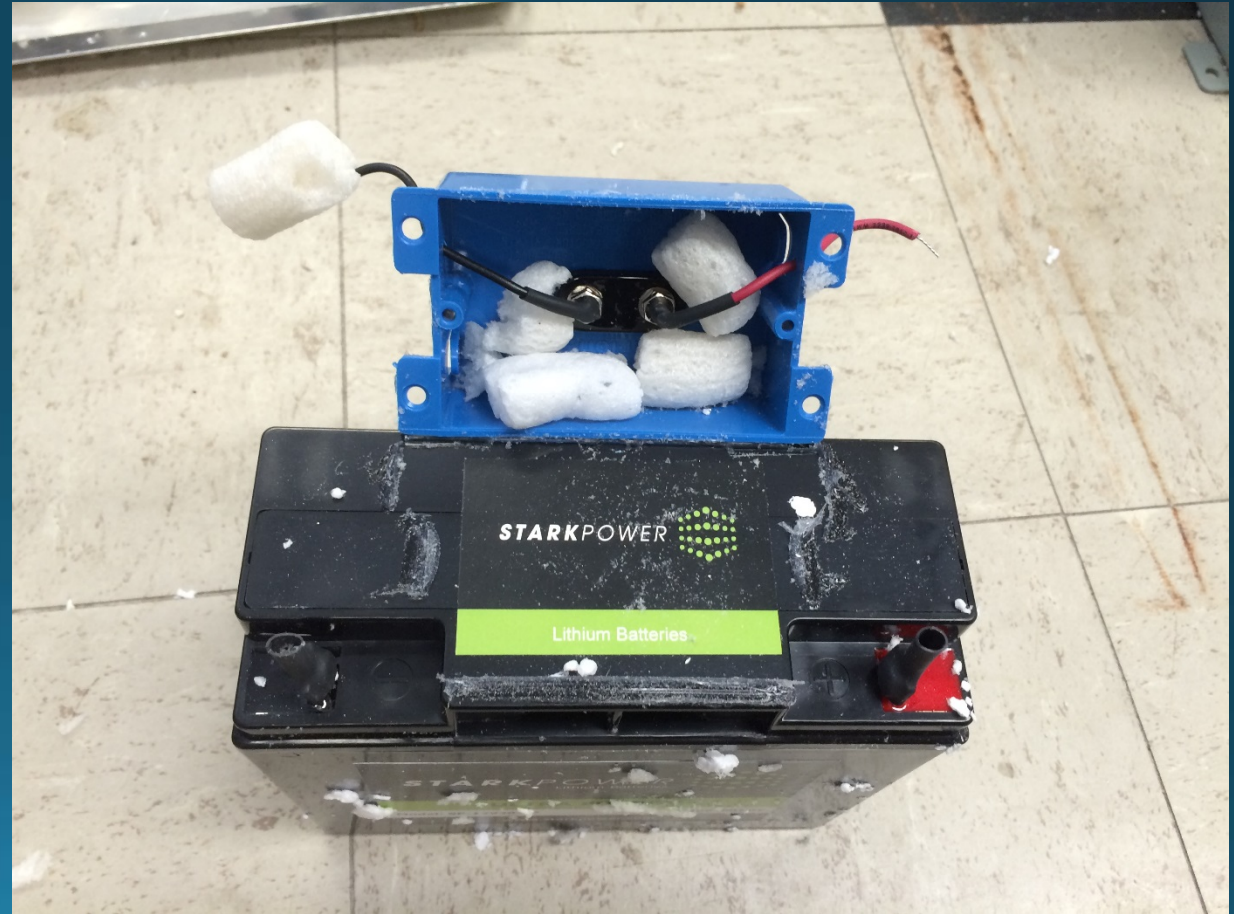
Broken Parts

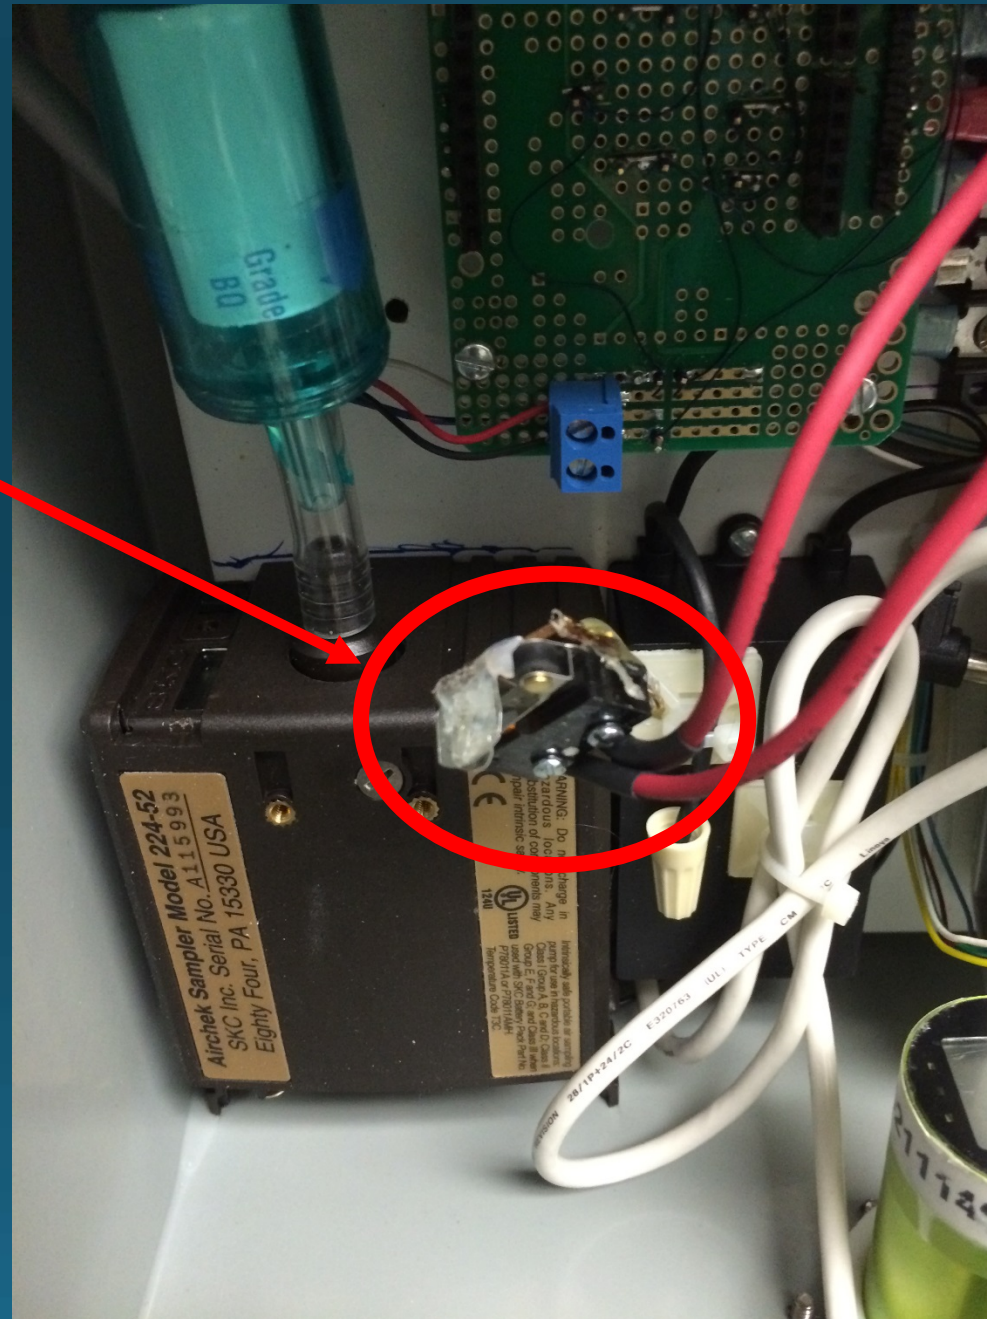
Loose pump
cutoff switch

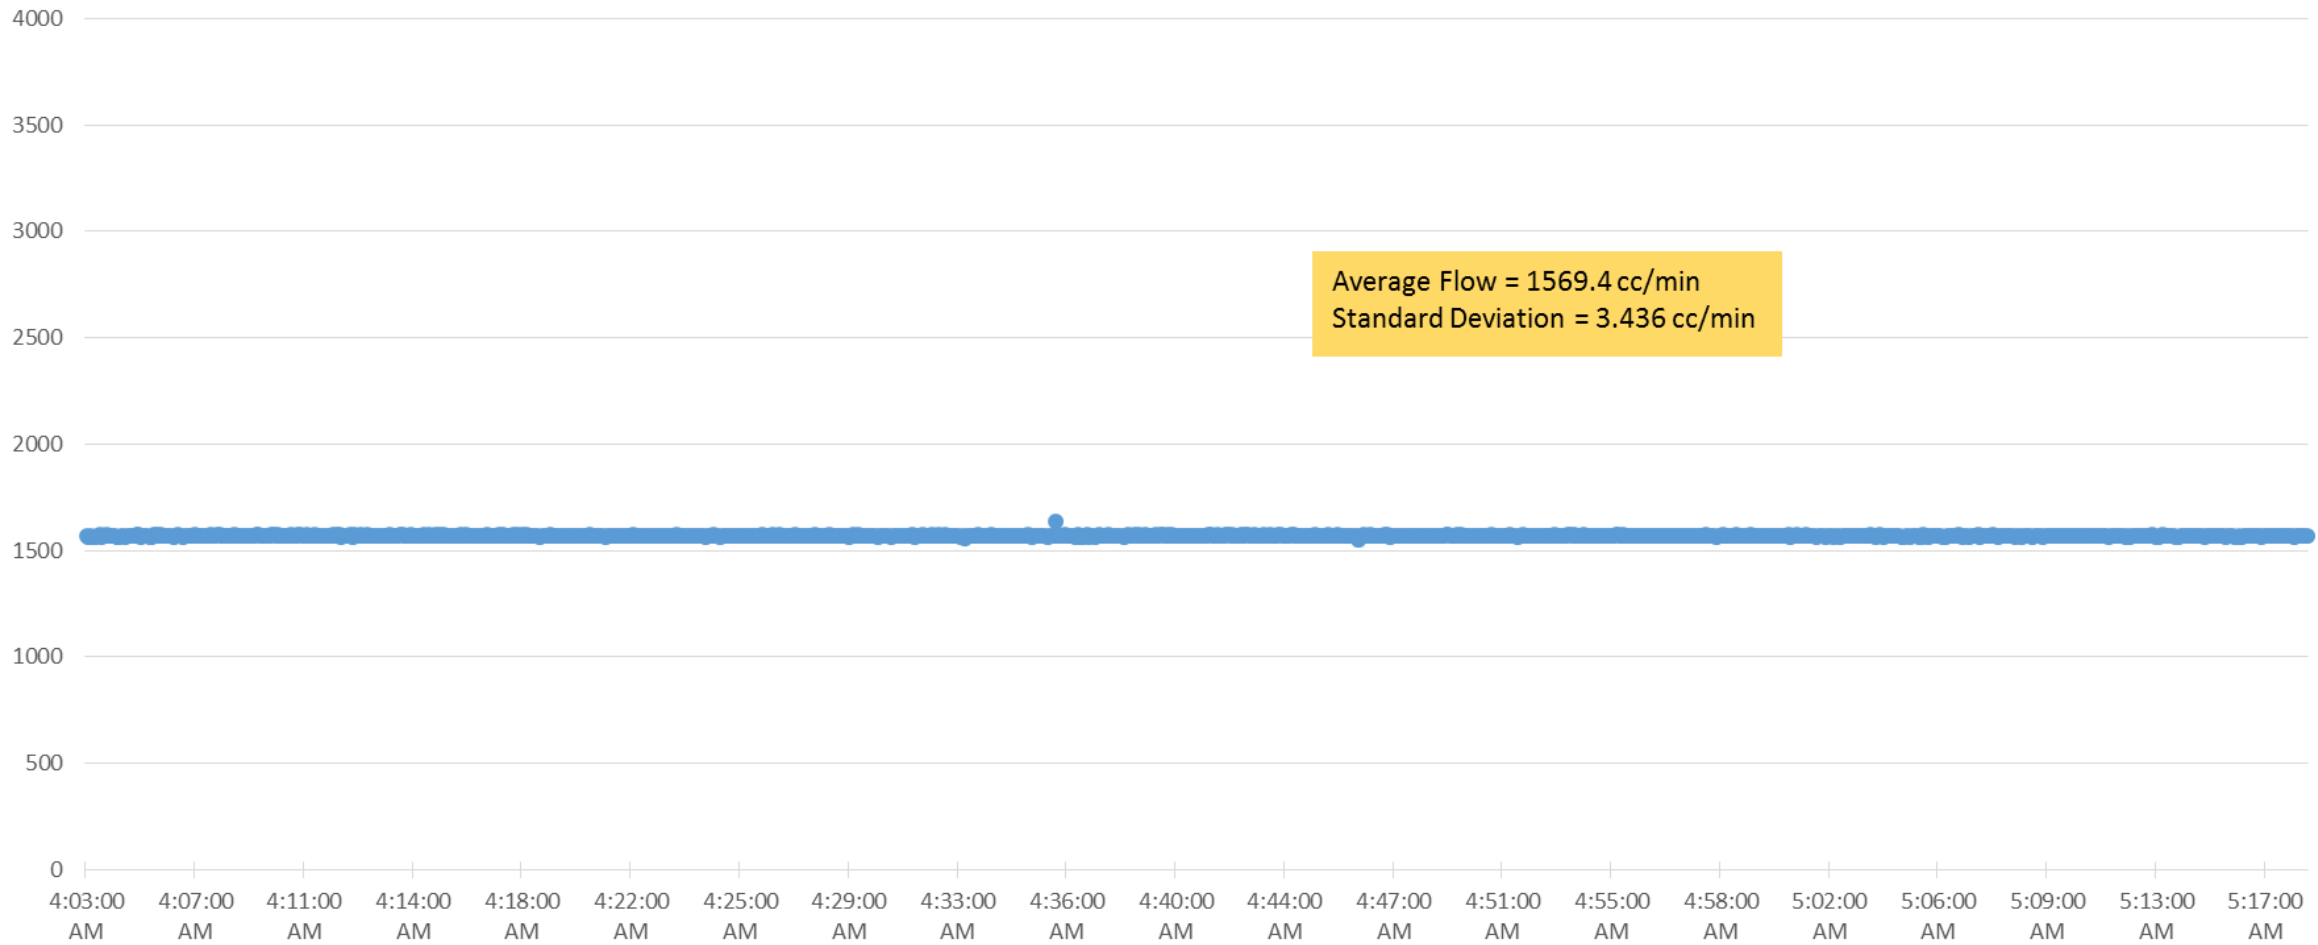
CSAM #4 Particulate Matter Flow @ Jan 29, 2015
Immediately Prior to Initial Deployment

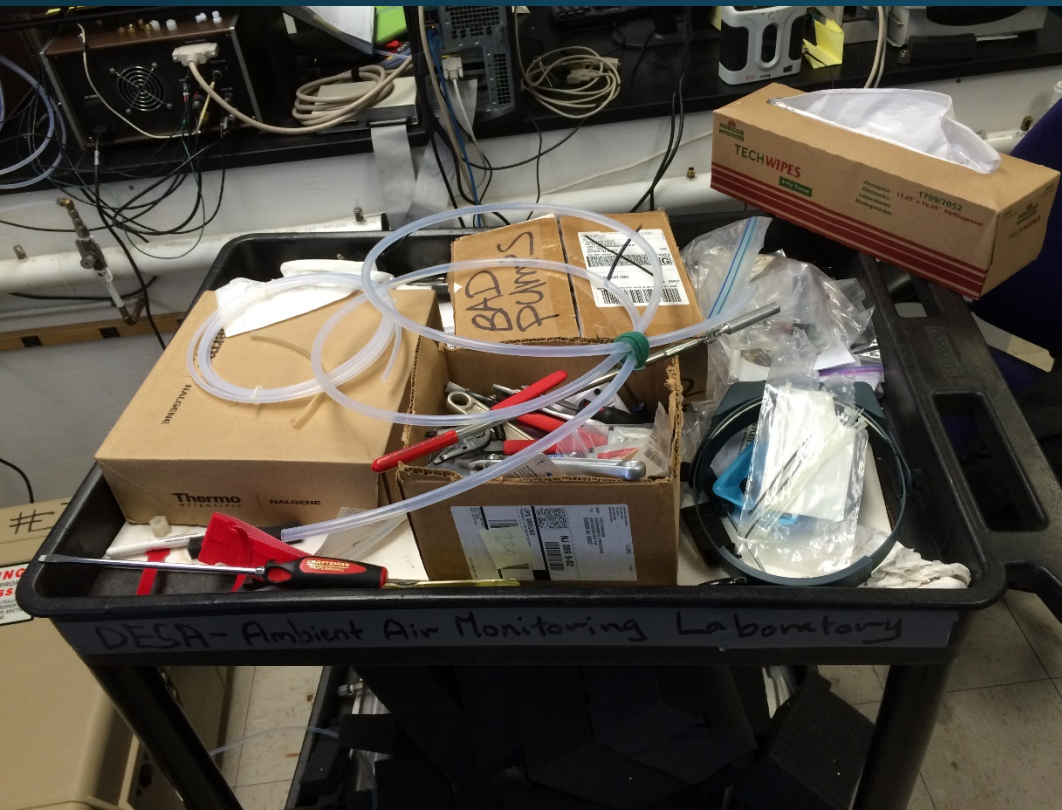
During the course of the study, pumps were replaced 7 times.

Pumps either had unreliable flow, intermittent flow, or stopped altogether.

DNU =
Do Not Use

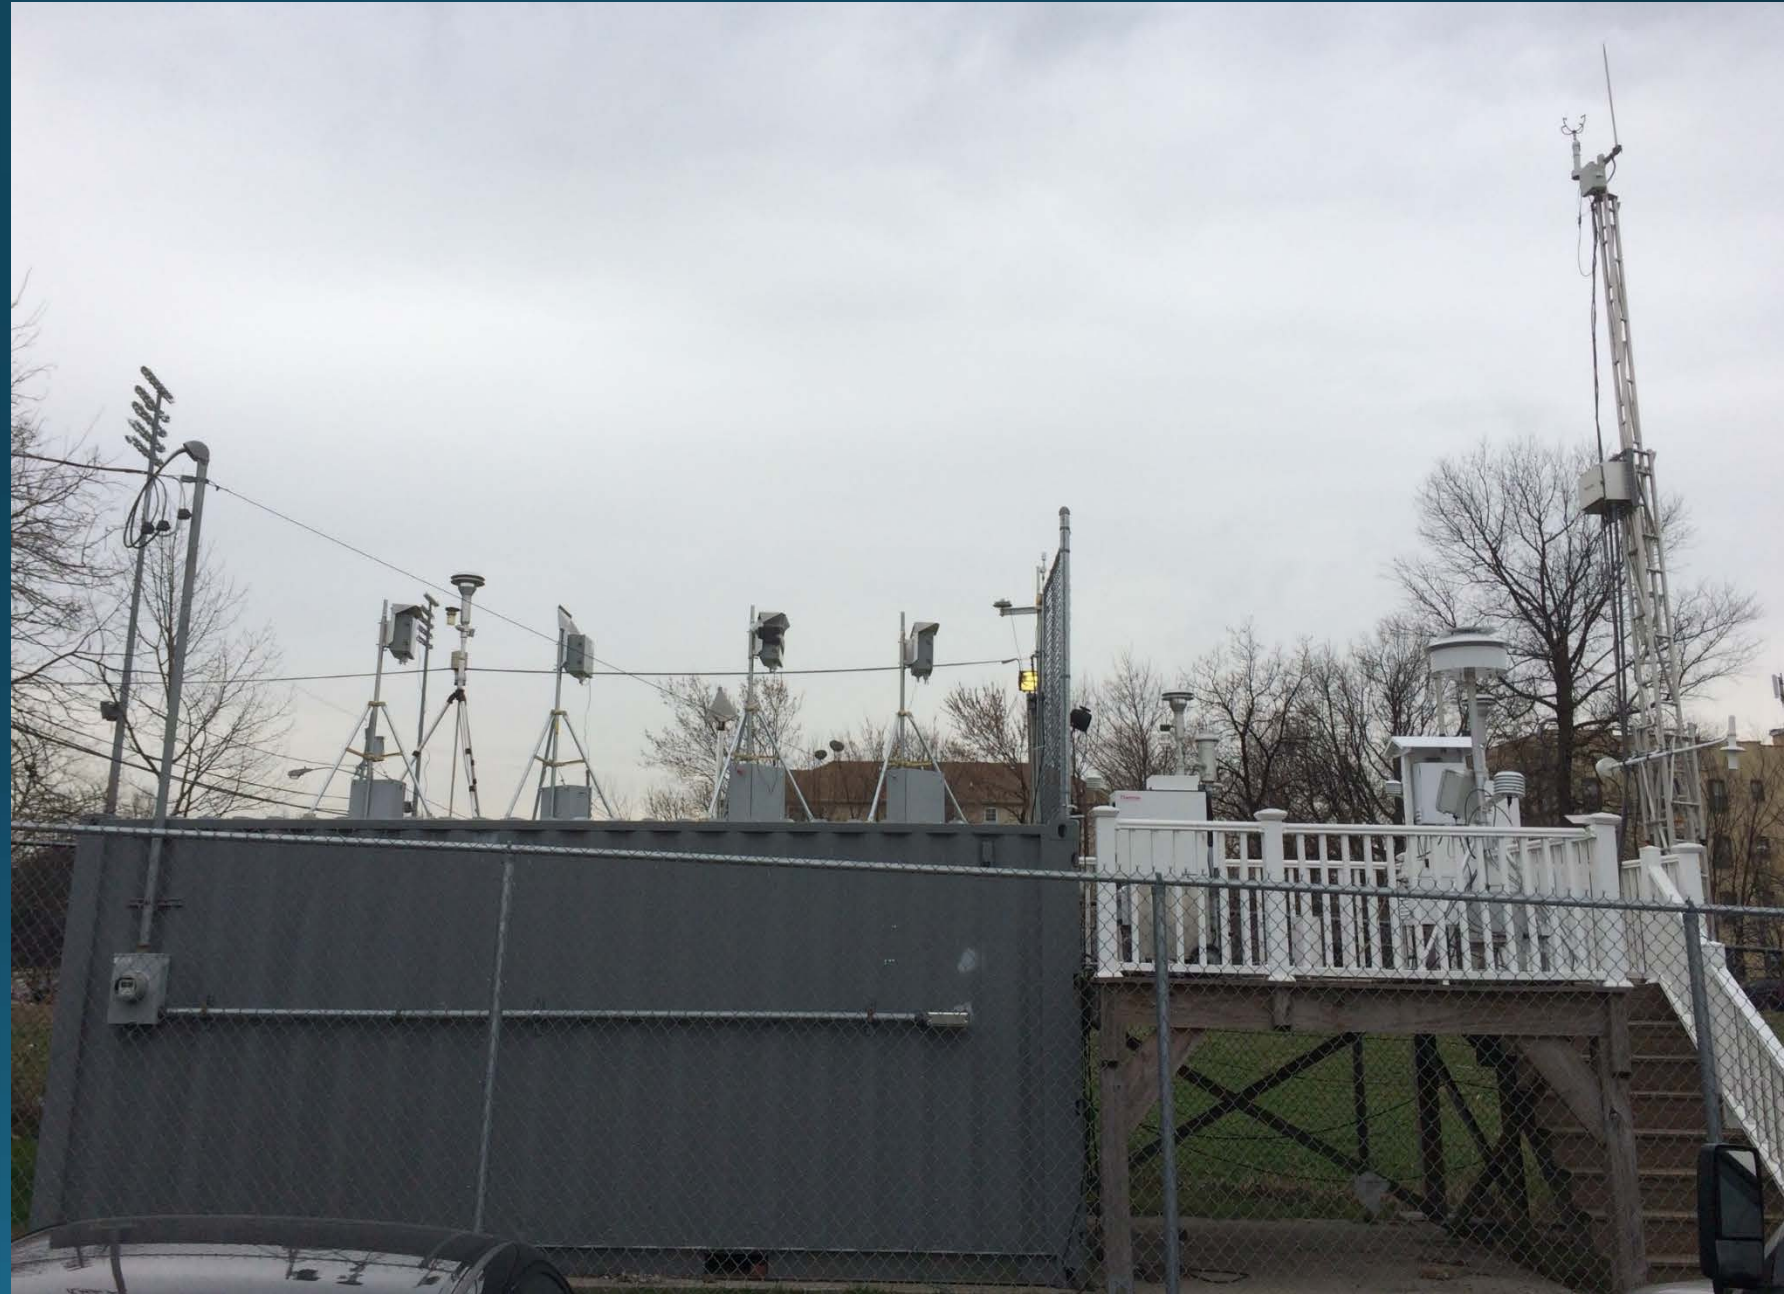
4 CSAM samplers were deployed on the roof of NJDEP's Ncore station at the Clinton Avenue Firehouse in Newark, NJ.
