SECTION 2.2: TANK INSPECTION, REPAIR, AND MAINTENANCE REPORT, dated 11 October 2016

**SITE SPECIFIC REPORT  
SSR-NAVFAC EXWC-CI-1655  
11 OCTOBER 2016**

**RED HILL FACILITY  
TANK INSPECTION, REPAIR, AND MAINTENANCE  
REPORT  
ADMINISTRATIVE ORDER ON CONSENT (AOC)  
STATEMENT OF WORK (SOW), SECTION 2.2**

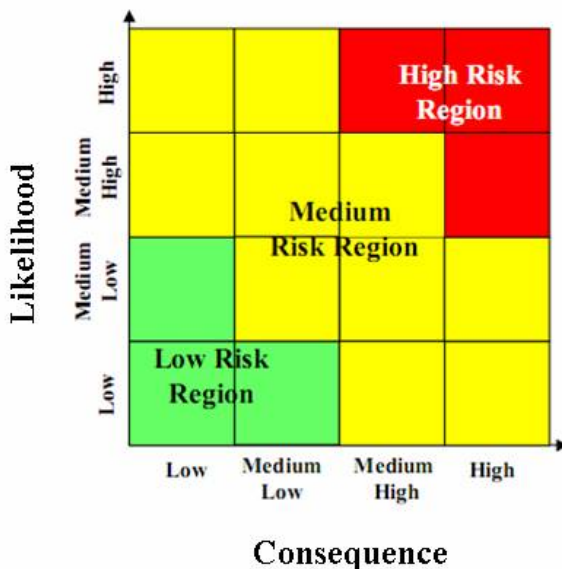
19-3.1 API RP 580 was first published in 2002 and provides a method to determine the frequency of inspection based on the probability of failure verses consequence of failure.

API RP 580 was developed to provide specific guidelines to use in performing a risk-based analysis for tanks, pressure vessels, piping, etc. The document first describes risk assessments. The risks are first identified, and then a determination is made on how to reduce or manage the risk. The document further states that there can never be zero risk based on inspection alone, since there are residual risks due to outside influences such as human error, natural disasters, external events, etc.

API RP 580 discusses how to “determine what incident could occur (consequence)” and “how likely (probability) is that the incident could happen.” This exercise is performed and documented for a variety of events. The document describes the qualitative, quantitative, and semi-quantitative approaches, and then provides the process in combining the approaches for defining probability and consequences.
